# Unmanned Aerial Vehicle Augmented Bridge Inspection Feasibility Study

FINAL REPORT

August 2017

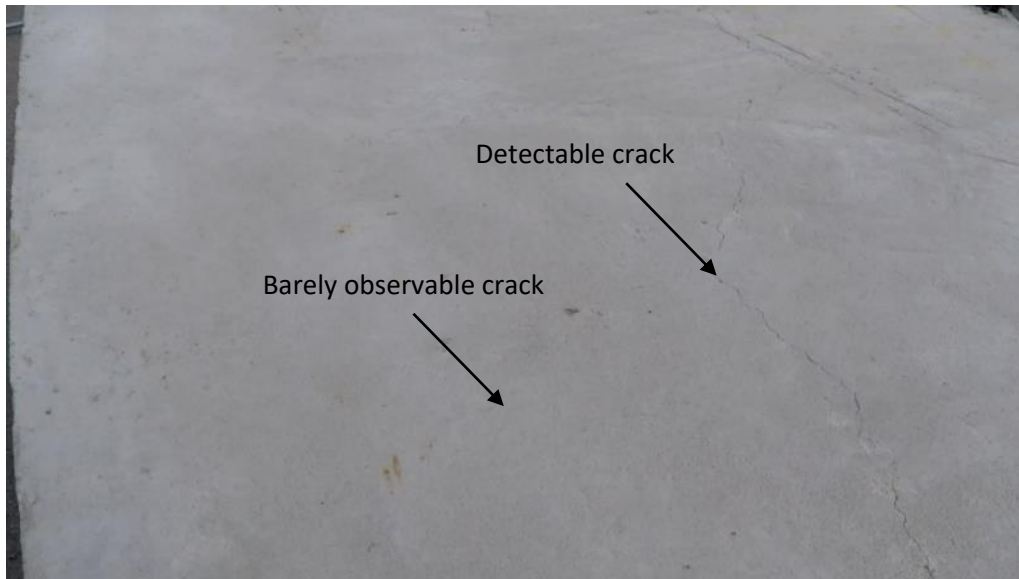
*Figure 3.3 Variety of cracks' Dimensions on the Bridge Deck, E001*

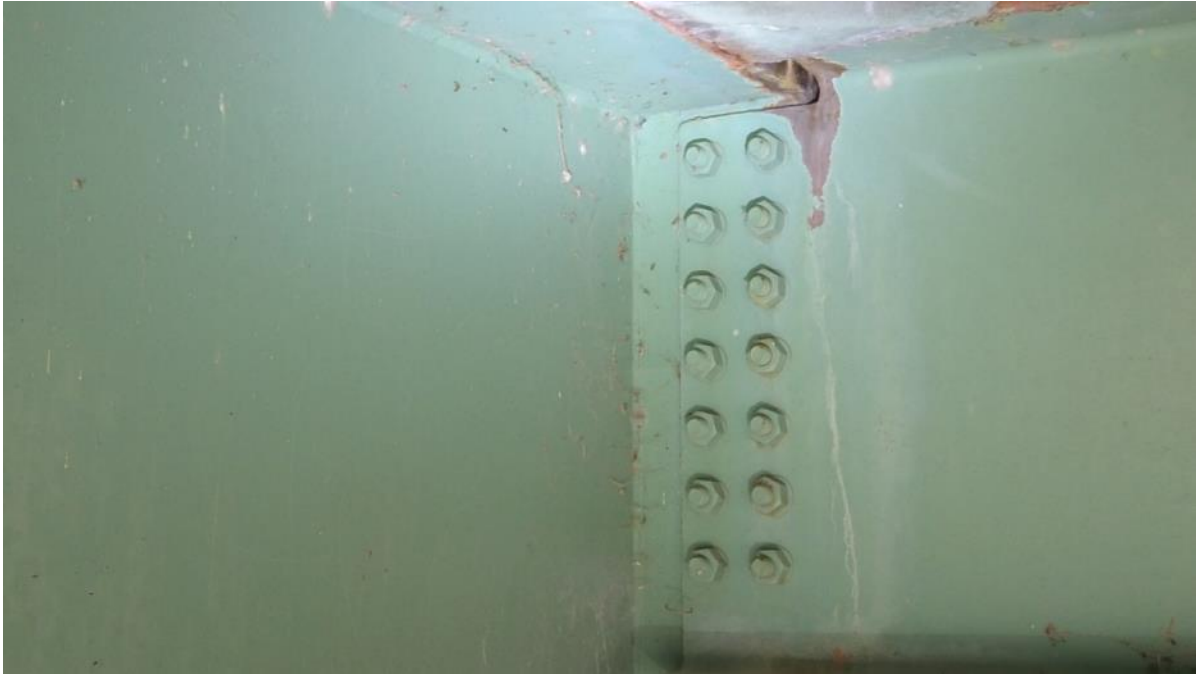
*Figure 5.9 First Floor Beam on East, Northern Corner, No Noticeable Crack, E021*

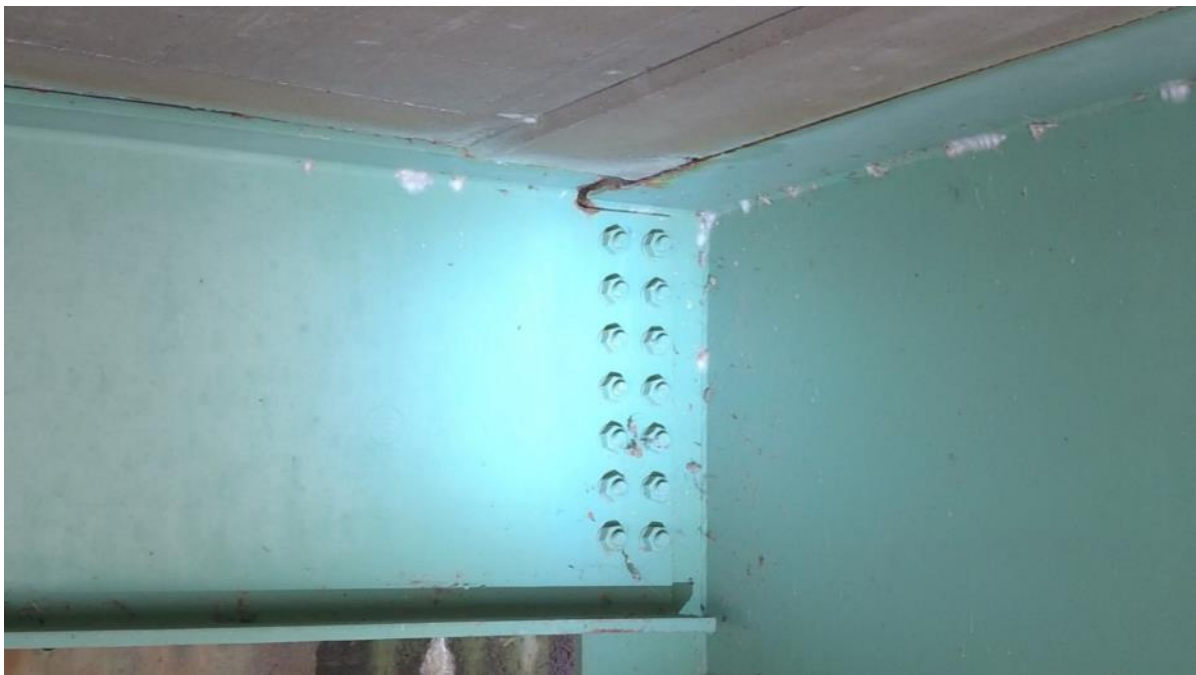
*Figure 5.10 First Floor Beam on East, Southern Corner, Debris on the Weld, E022*

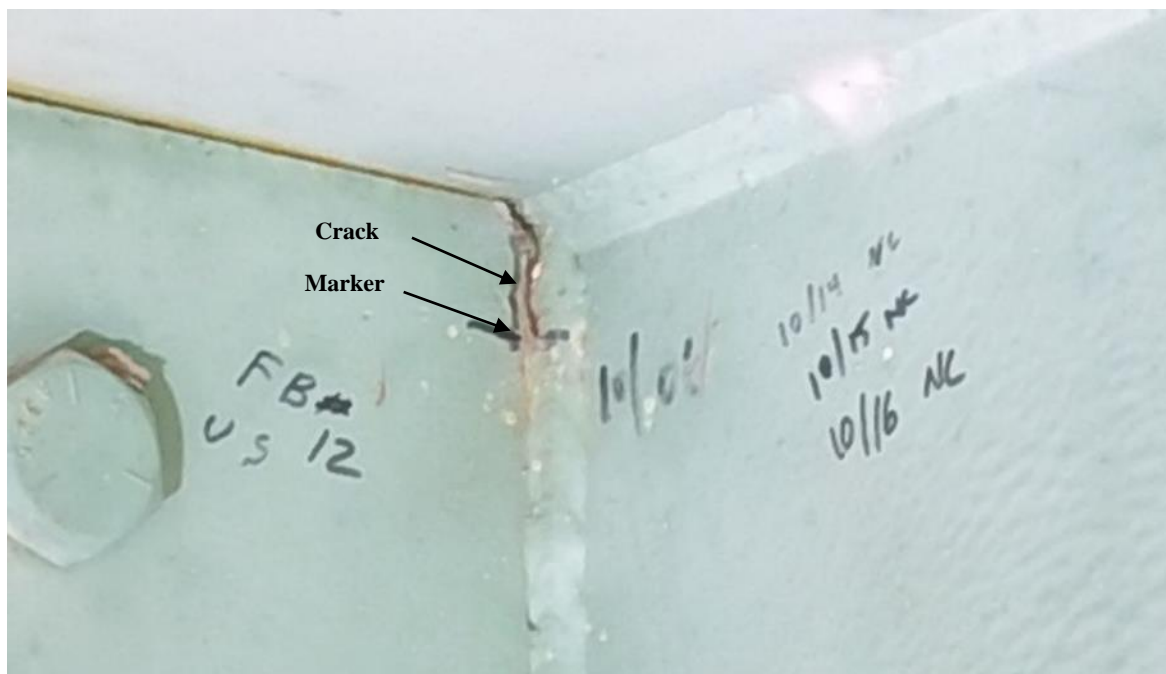
*Figure 5.15 Zoomed Image from the Fatigue Crack, E031*

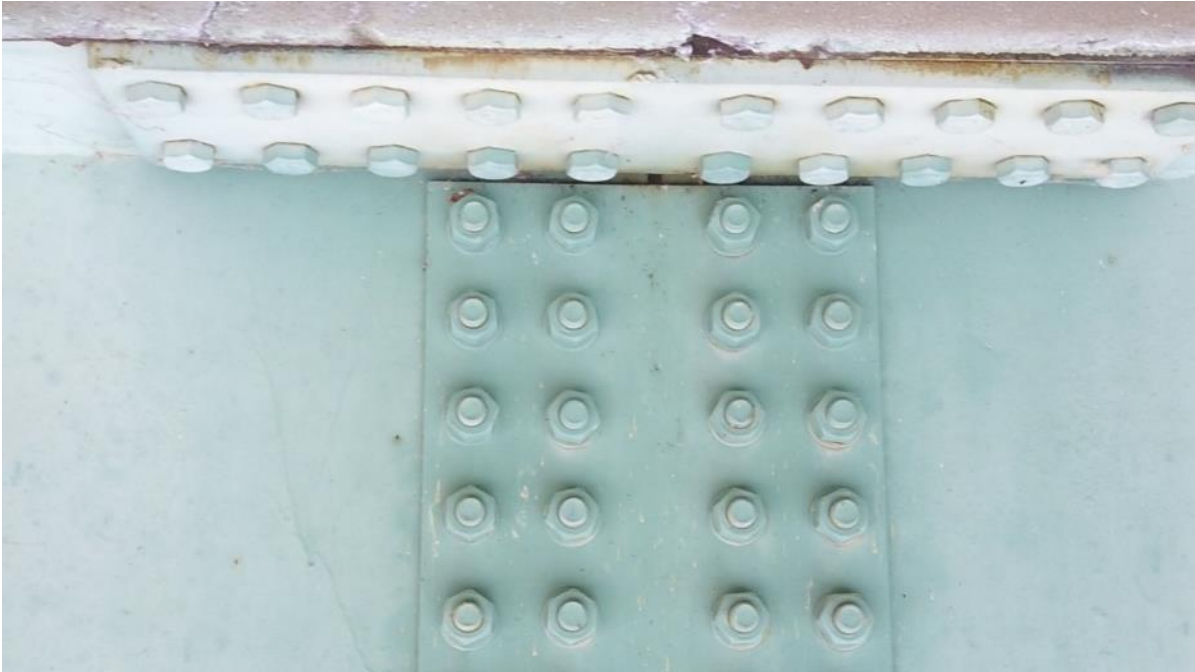
*Figure 5.19 Minor Corrosion on Top of the Northern Girder Splice (First Splice from East), E033*

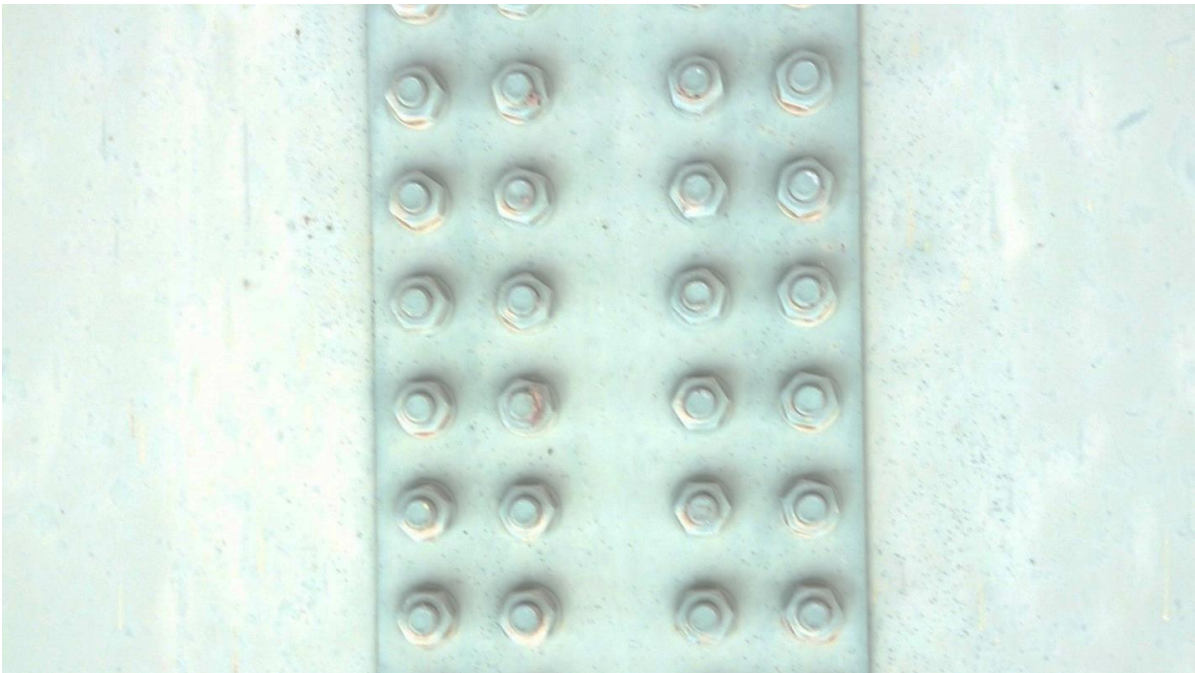
*Figure 5.20 Minor Corrosion on the Plate and Nuts, Southern Girder Splice (First Splice from East), E034*

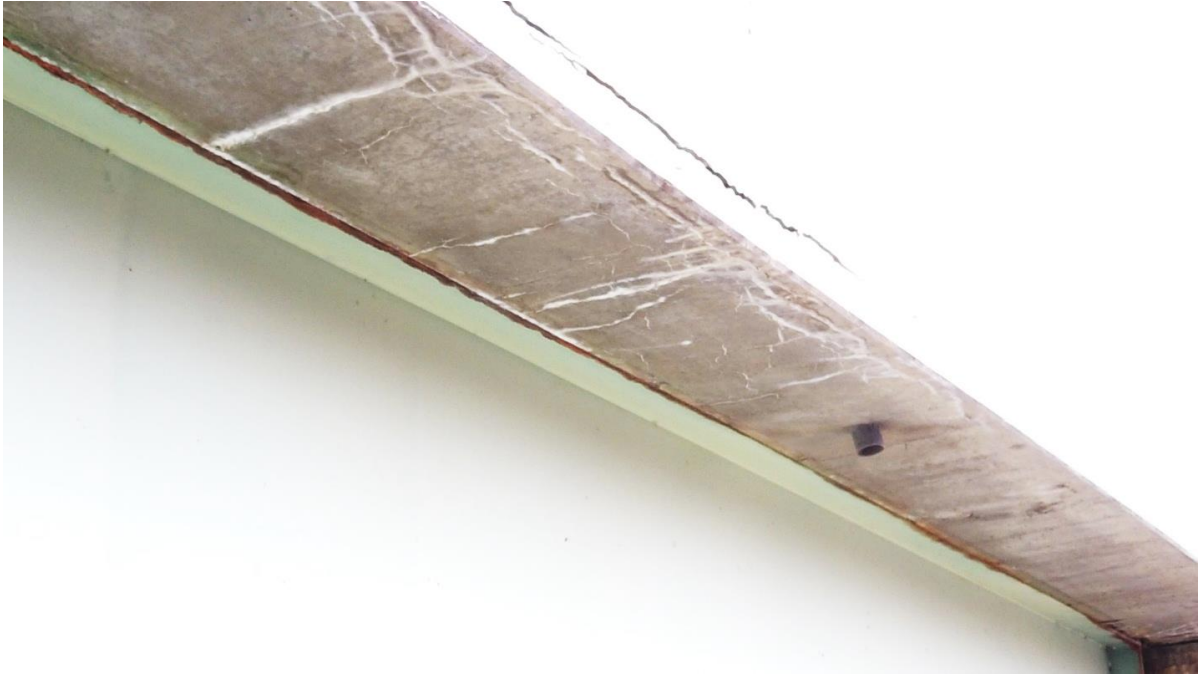
*Figure 5.21 Cracks, Possible Delamination, and Efflorescence on the Southern Bearing, E035*

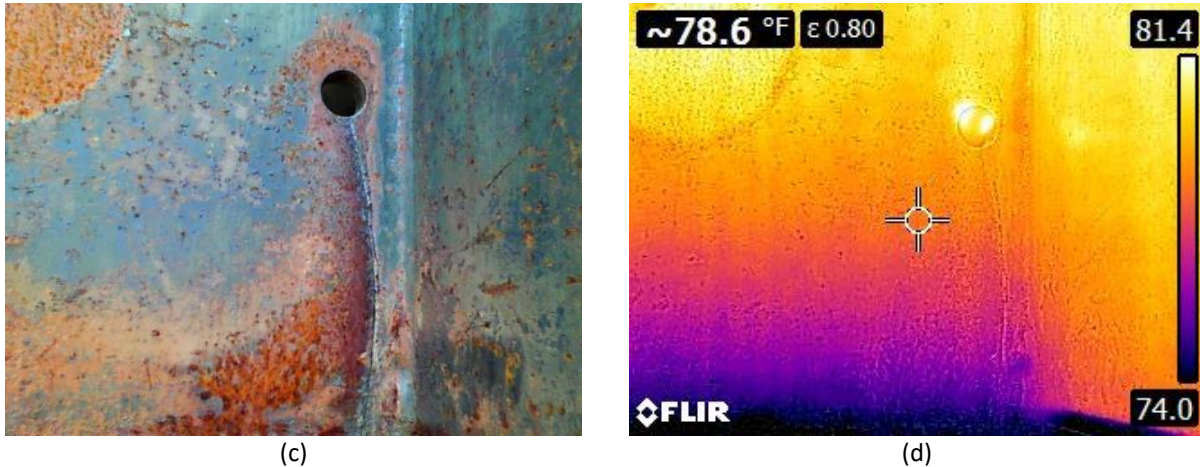
Figure 6.10 Fatigue crack in the railroad bridge: (a) DJI Mavic image, (b) Samsung Tablet image, (c) Visual image from the thermal camera, and (d) thermal image from the thermal camera using passive thermography
