Improving Transportation Infrastructure Resilience against Hurricanes, other Natural Disasters, and Weathering: Part I - Analysis of failure of transportation signs due to Hurricane Maria

Volume 1

FINAL REPORT
June 2022

Transportation Infrastructure Research Center – TIRC
Polytechnic University of Puerto Rico
377 Ponce de Leon Ave, San Juan, PR 00918

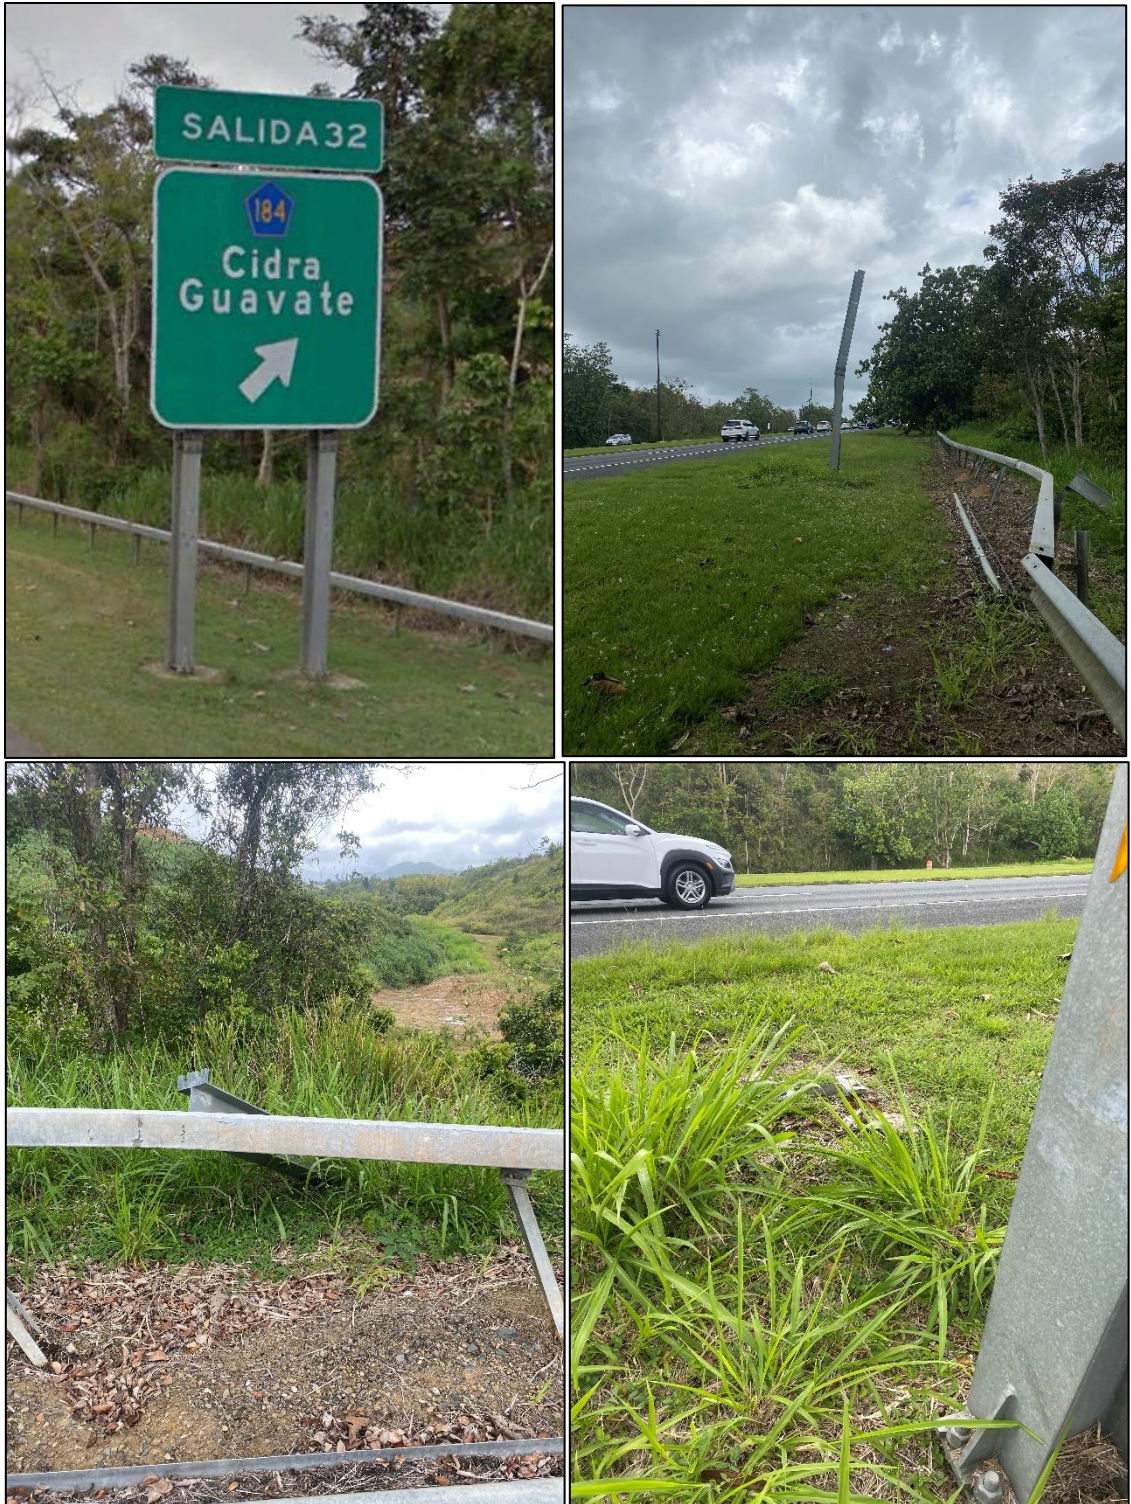
Figure 4.6: Sign 12 before (top left; Source: Google Earth Pro) and after failure

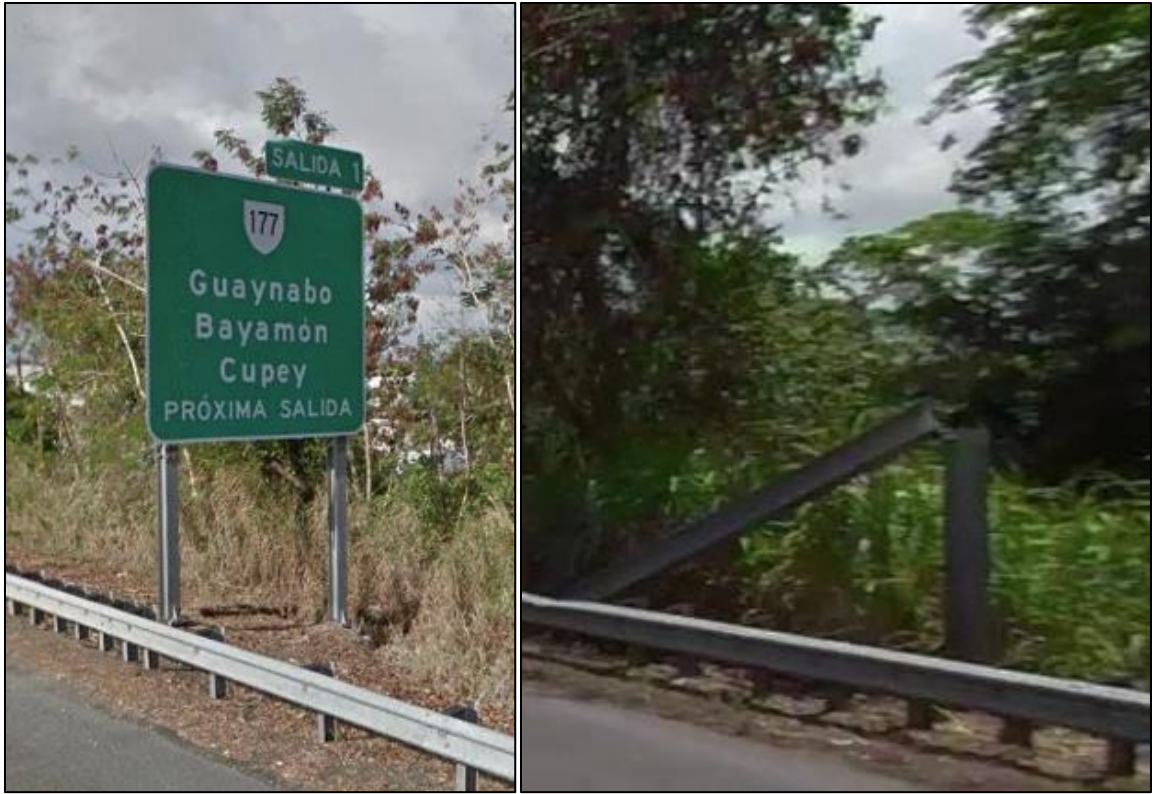
Figure 4.11: Sign 11 before and after failure (Source: Google Maps)

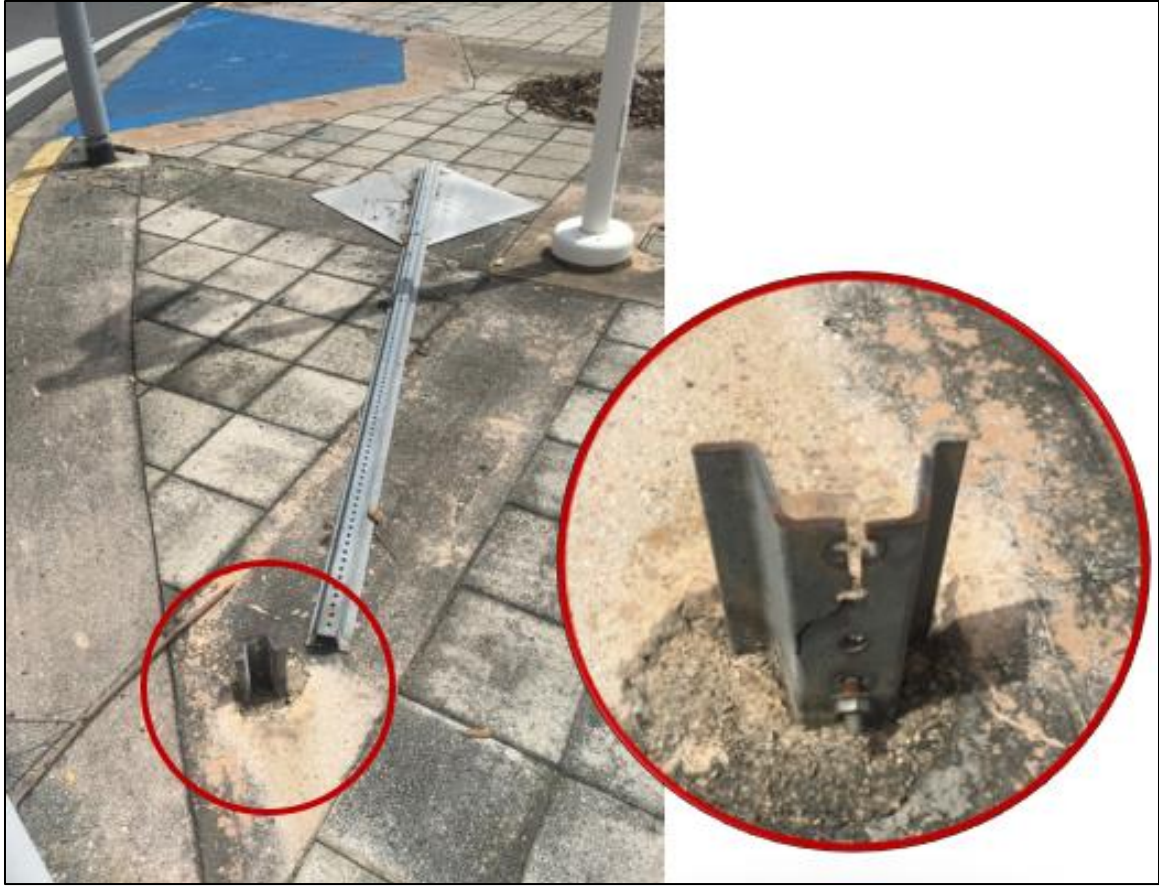
Figure 4.6: Example of tear-out failure

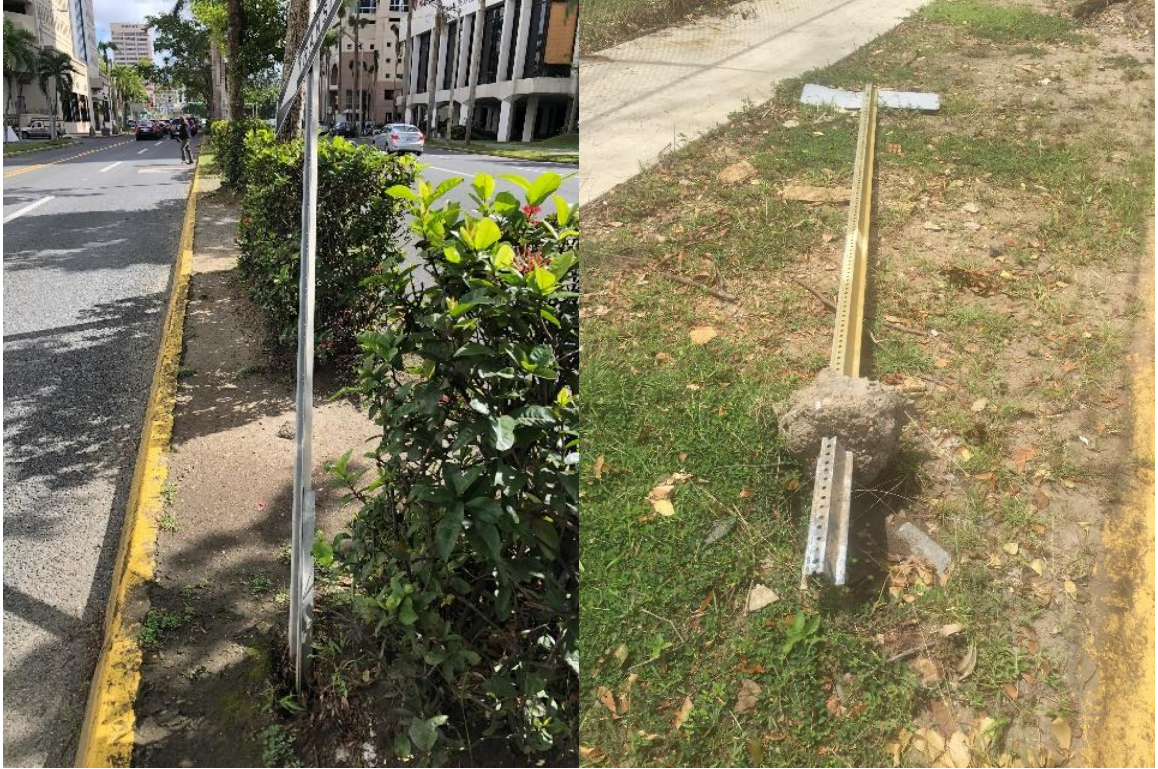
Figure 4.7: Examples of foundation on soil failure

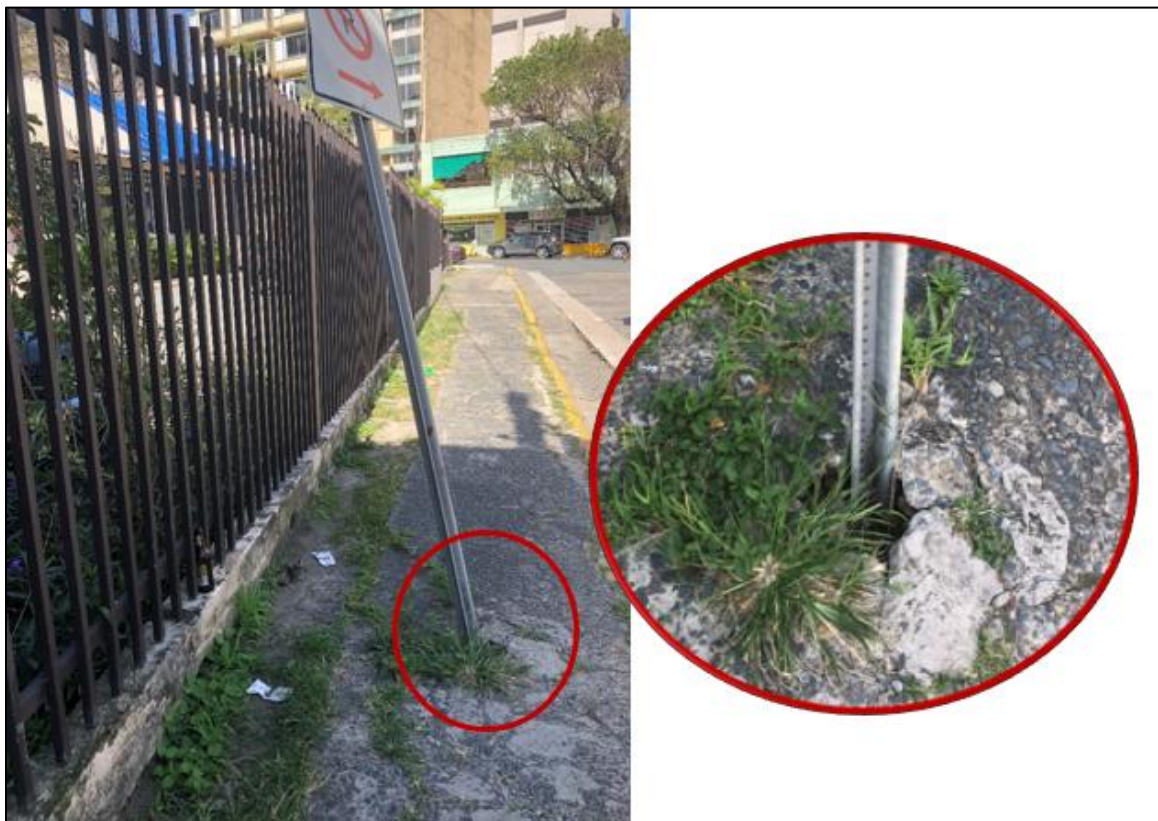
Figure 4.8: Example of Backfill concrete failure

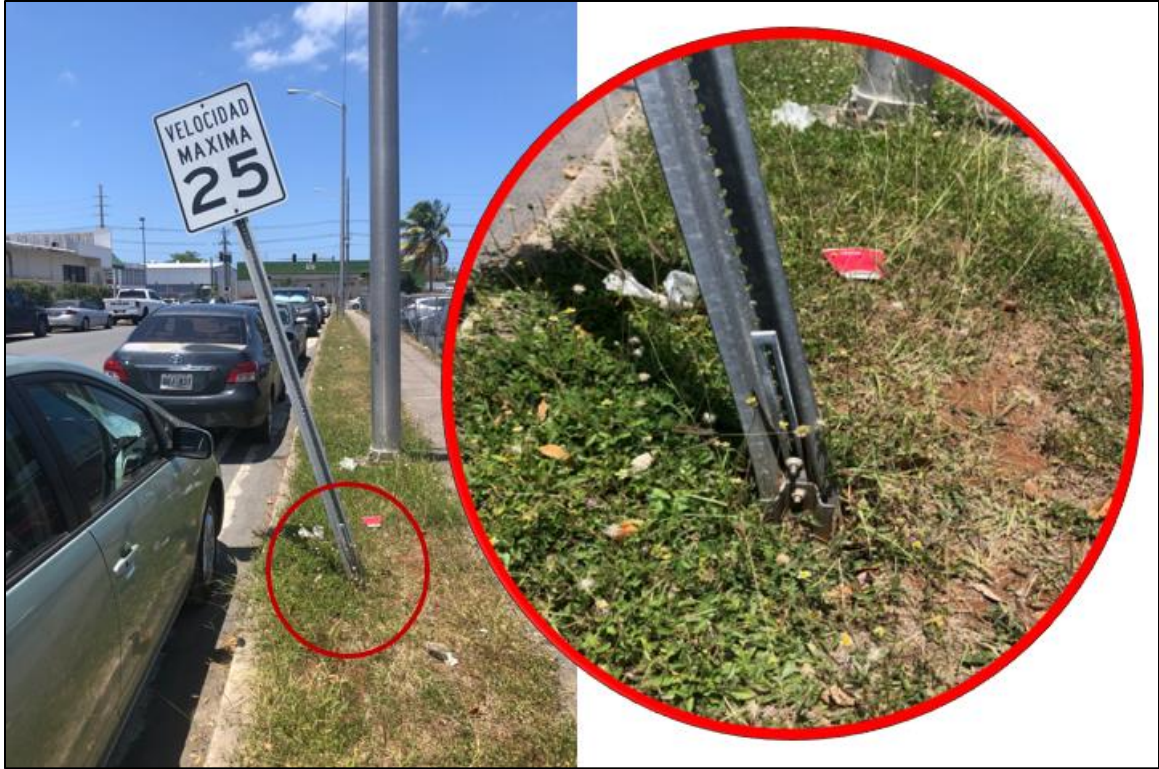
Figure 4.9: Example of retainer strap deformation

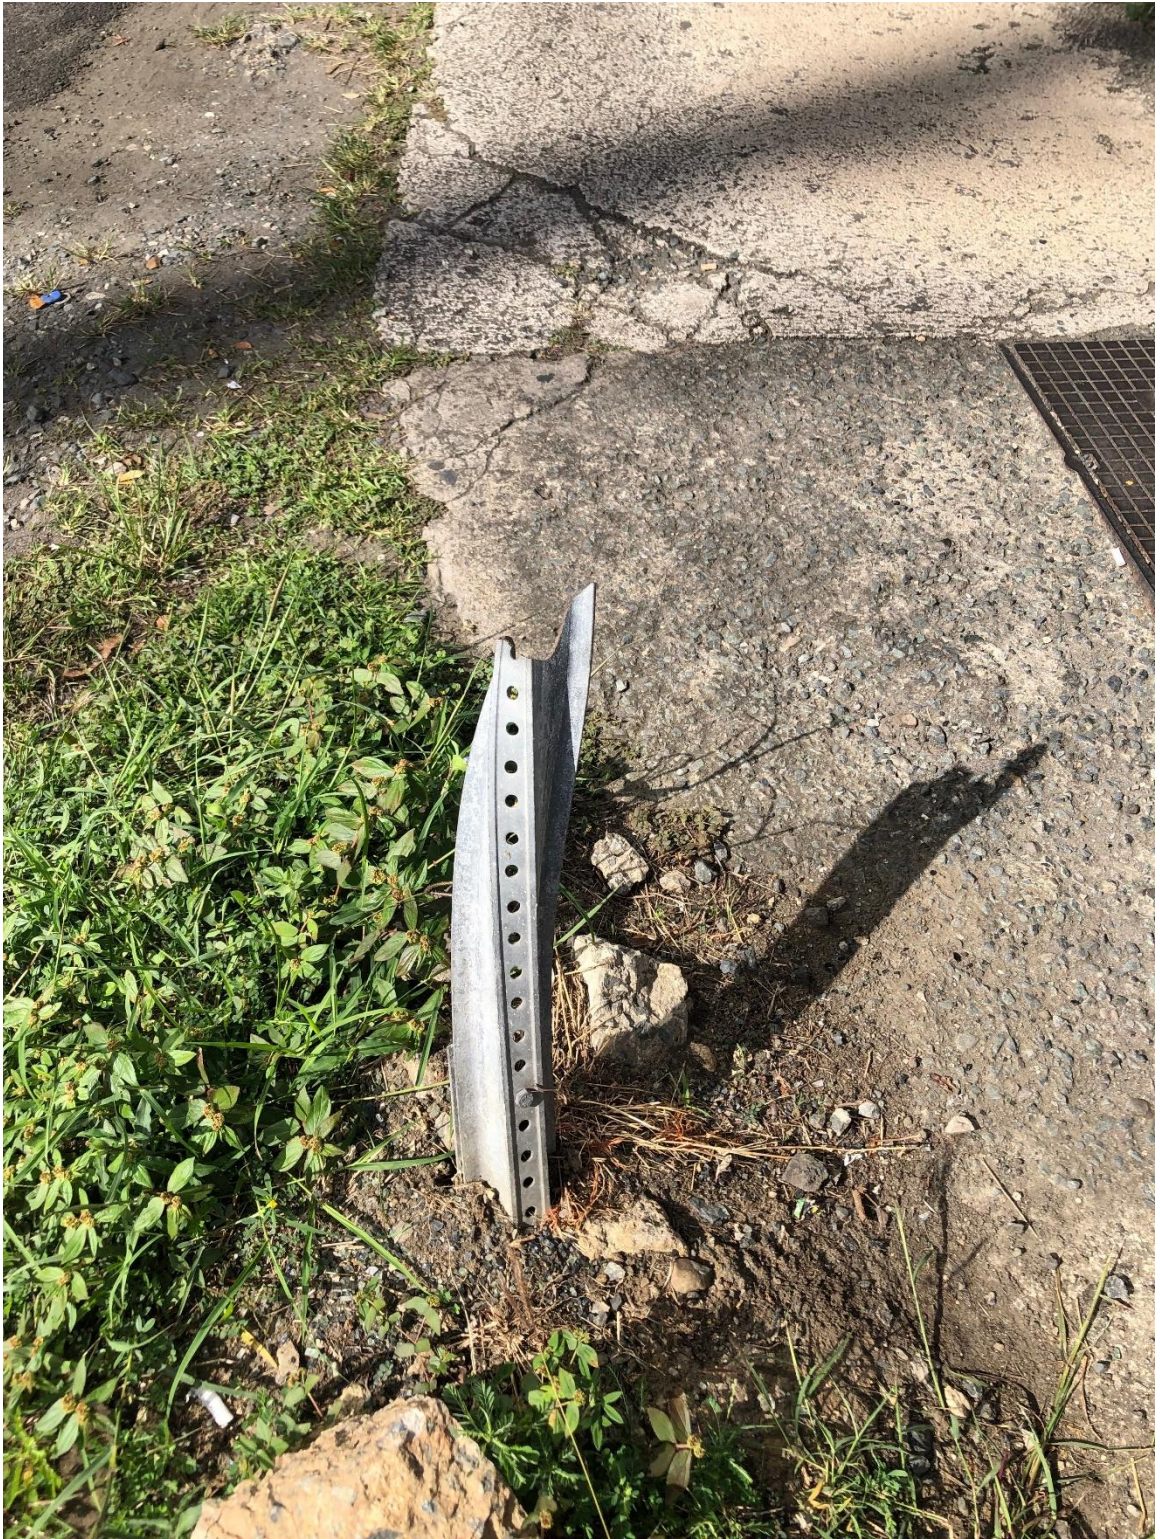
Figure 4.13: Permanent twisting deformation that led to collapse by post fracture

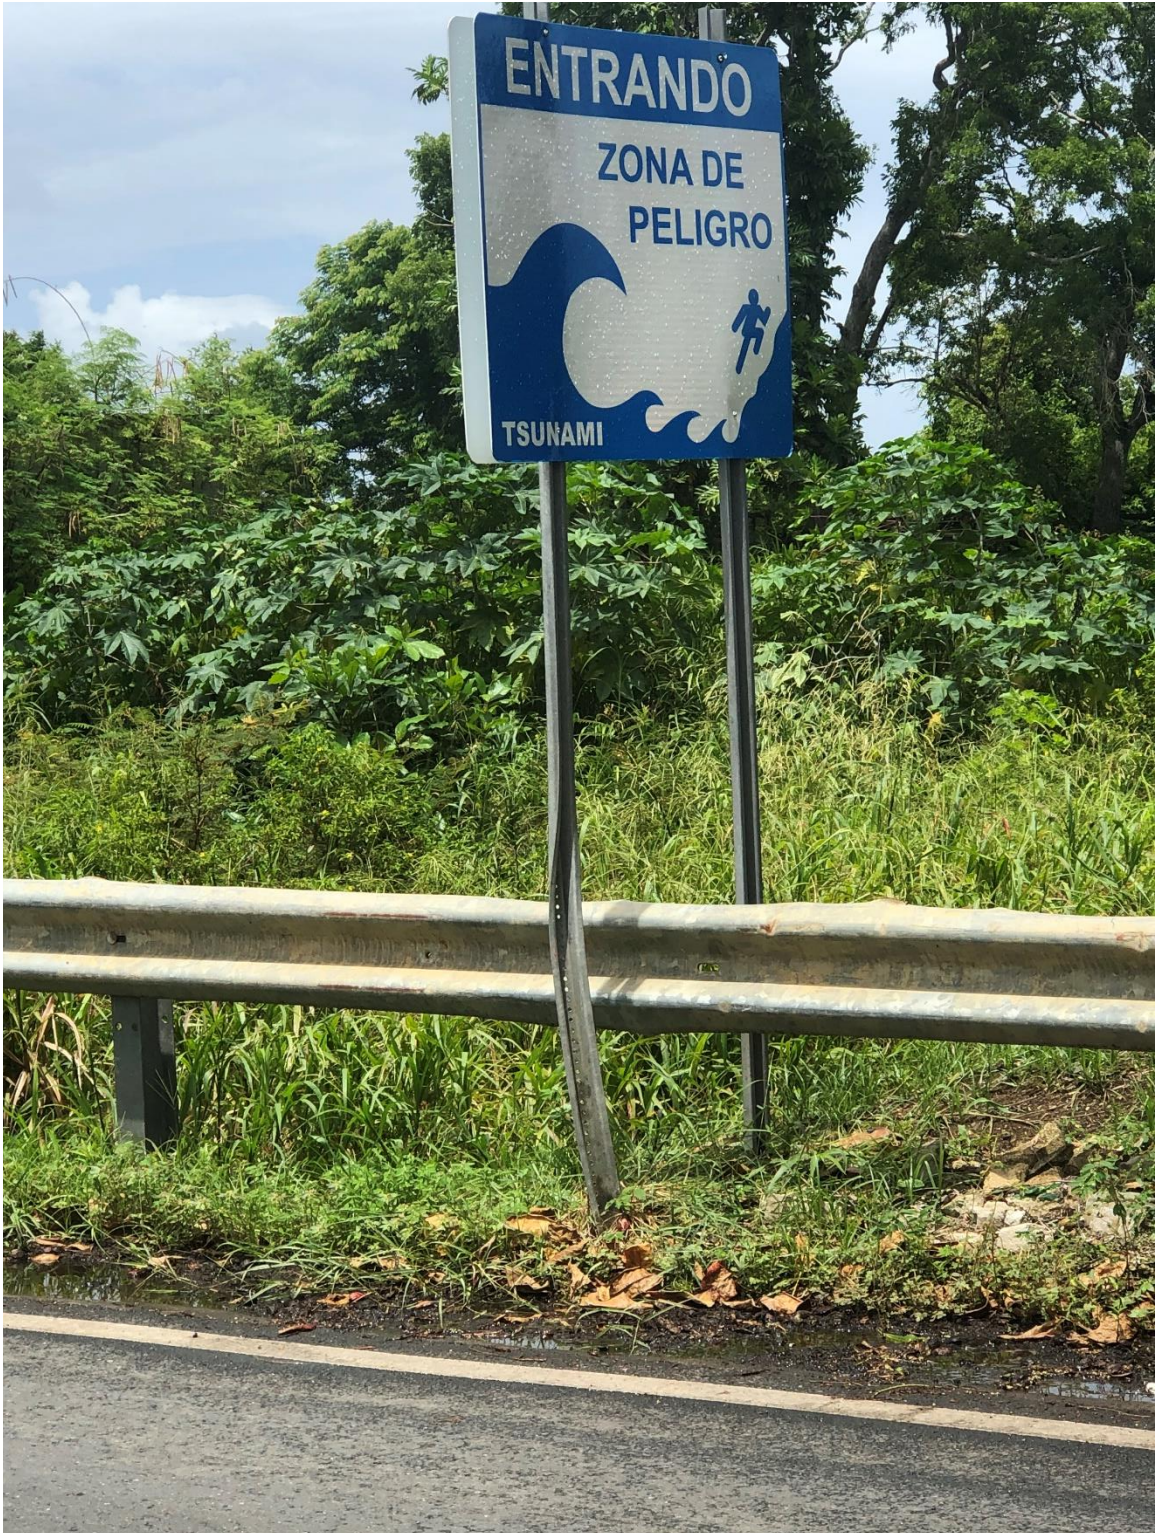
In addition to the 60 documented cases, five other sign structures that failed during Hurricane Maria were also found. These were not included because they consisted in multiple U-channel posts supporting one sign, or multiple U-channel posts interconnected and supporting several small signs. Out of the five, four experienced permanent twisting deformation in one or more of the supporting U-channels (see example in Figure 4.15) and one was tilted due to foundation on soil failure.

Figure 4.15: Sign with multiple U-channel posts where one post experienced permanent twisting deformation

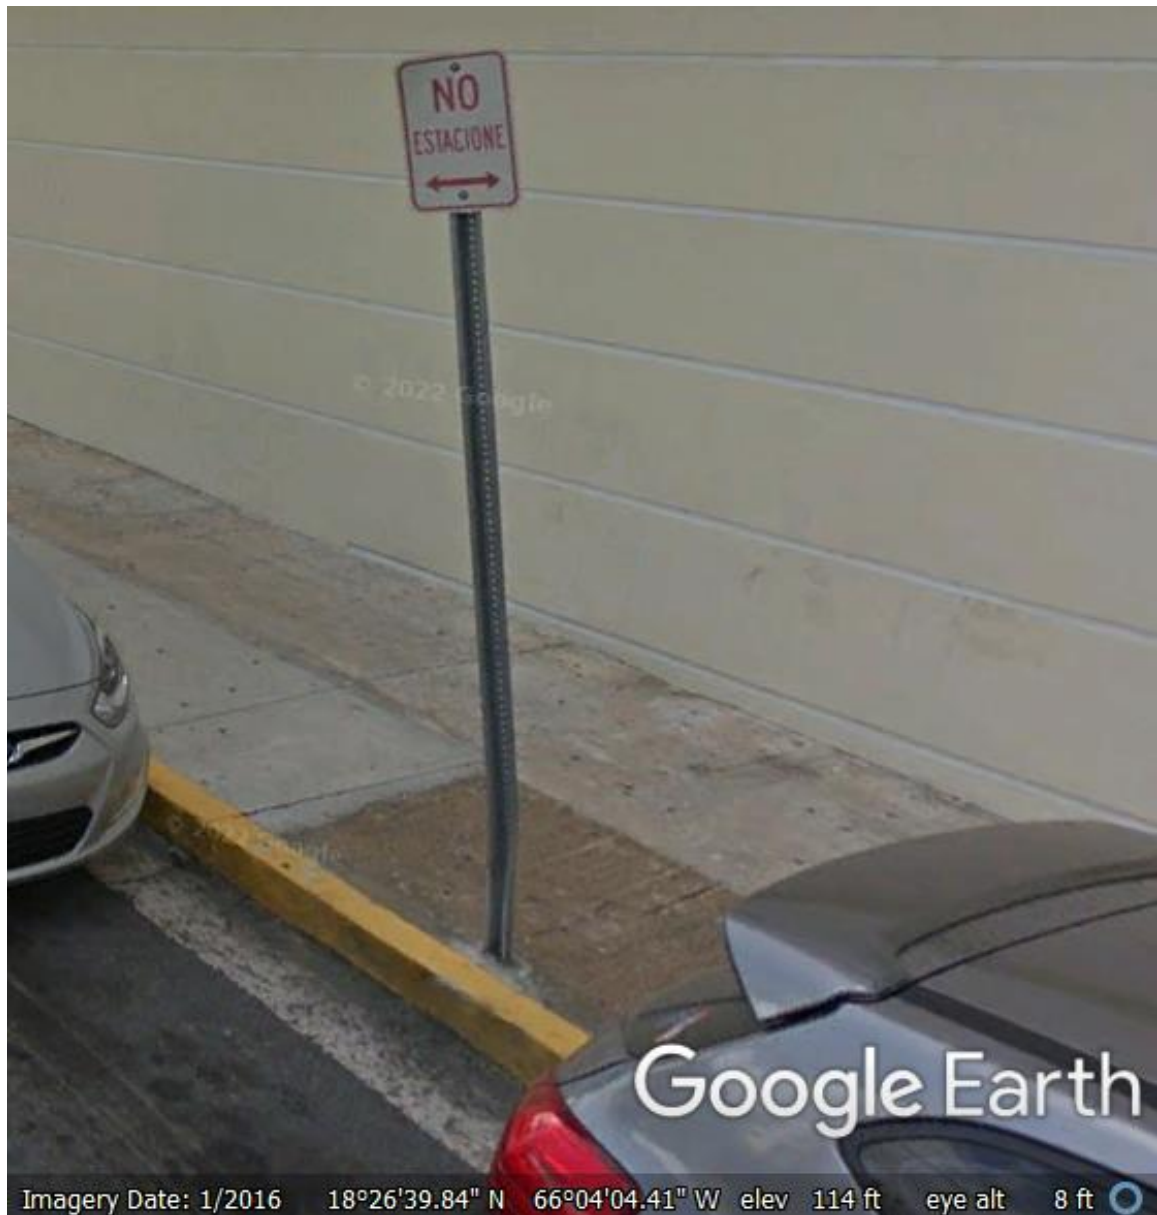
posts already presented this damage in 2016, prior to Maria's arrival. An example of one of these cases is shown in Figure 4.16. These signs were then eliminated from the study; therefore, they are not included in the 60 documented cases.

Figure 4.16: Example of sign with permanent twisting deformation before Hurricane Maria

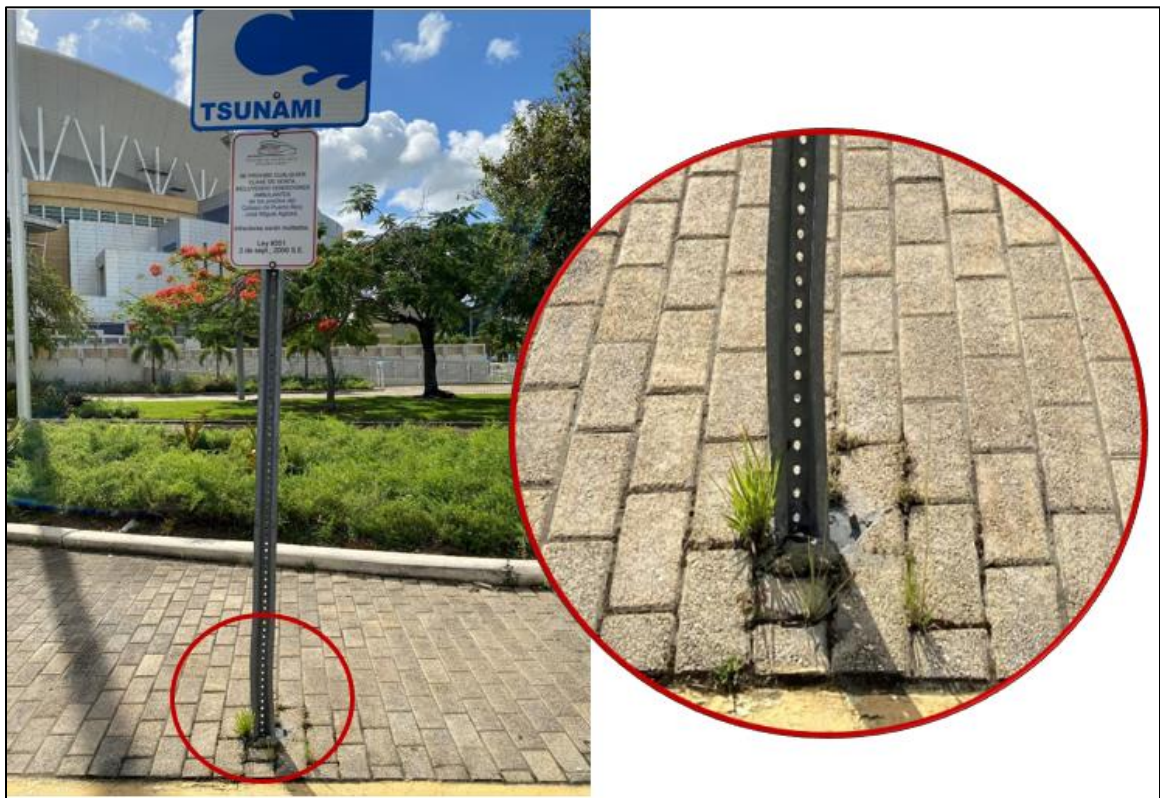
- Some cases did not appear to have the top post to base post connection as required by the PRHTA, (refer to Figure 2.20 and Figure 2.21). An example of this is shown in Figure 4.17.
- Figure 4.18 shows a U-channel post with a reflective plastic cover. This post behaved is located in a street segment of about 500 ft where five other signs failed. The reflective plastic cover may have contributed to avoid permanent twisting deformation.

Figure 4.17: U-channel top post without a visible base post

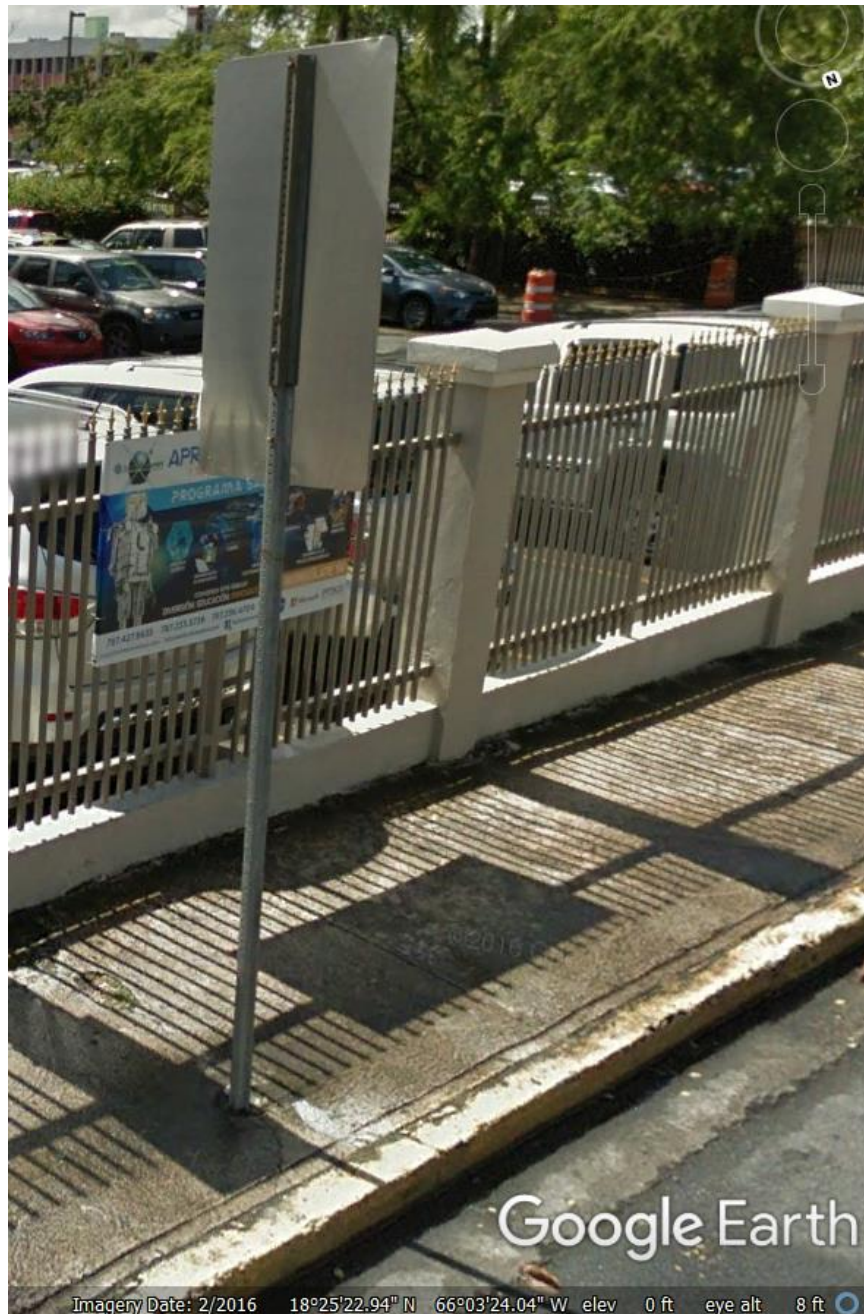
Figure 6.3 shows a back view of the sign structure before the passing of Hurricane Maria. The change in color of the post is due to two U-channels being connected together. The darker U-channel at the top should have been the base post, while the lighter channel should have been the top post. In other words, the post assembly was incorrectly installed upside down.

Figure 6.3: Back view of Case Study 2 before Hurricane Maria

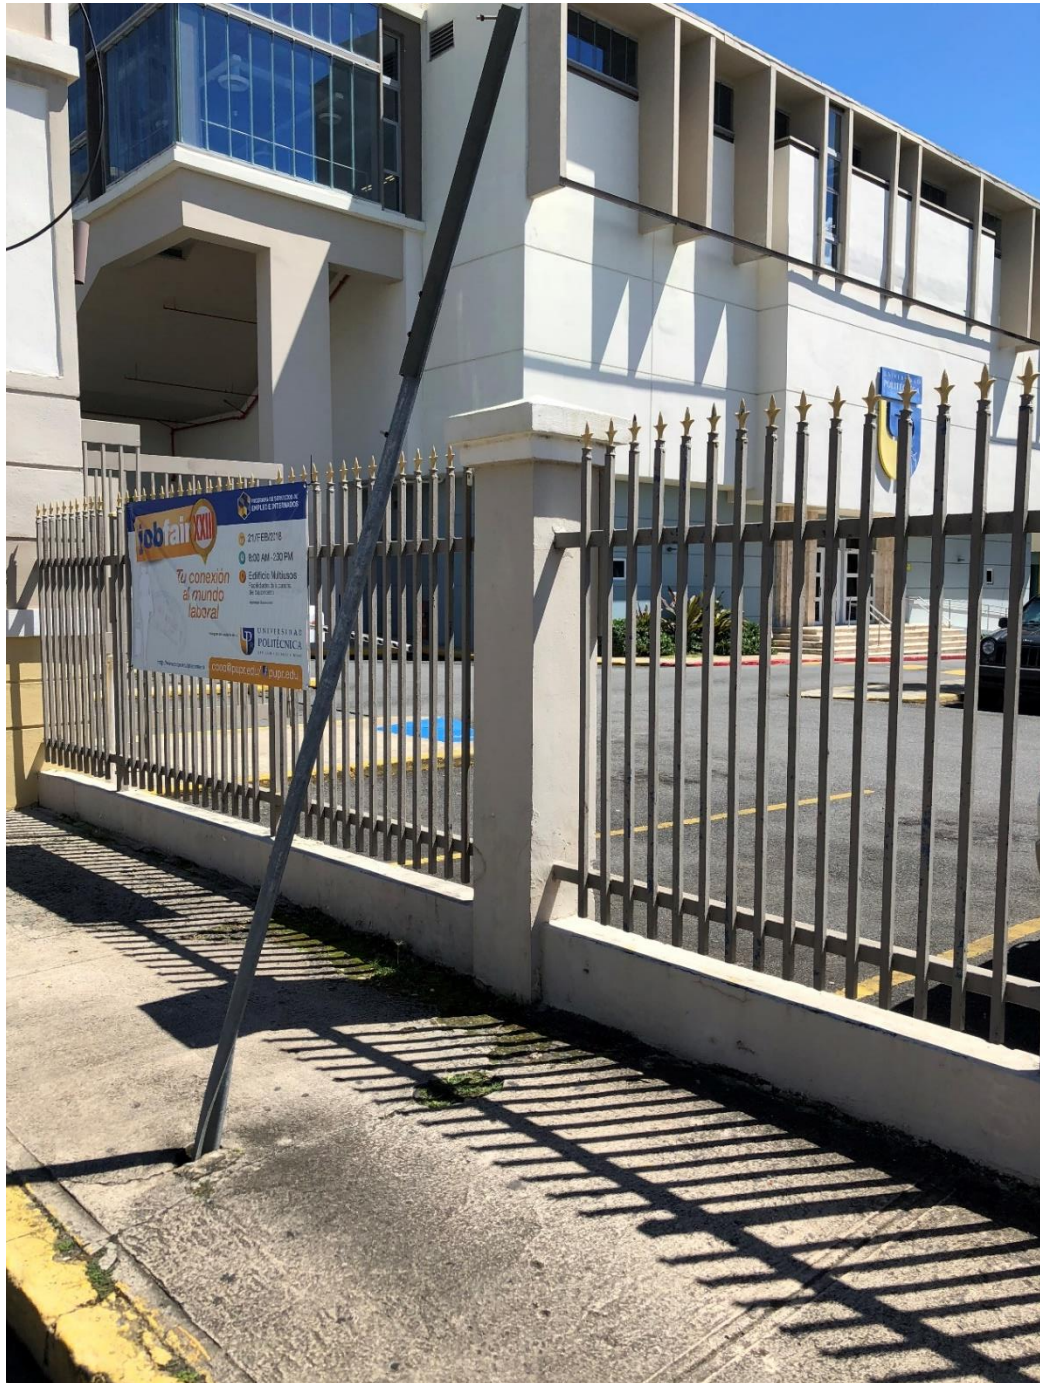
After hurricane Maria, the post was found without the transit sign, as shown in Figure 6.4. Therefore, it was concluded that the sign panel was blown away during the hurricane. It can be noticed in the figure that the post exhibits permanent twisting deformation near its base.

Figure 6.4: Case Study 2 after Hurricane Maria

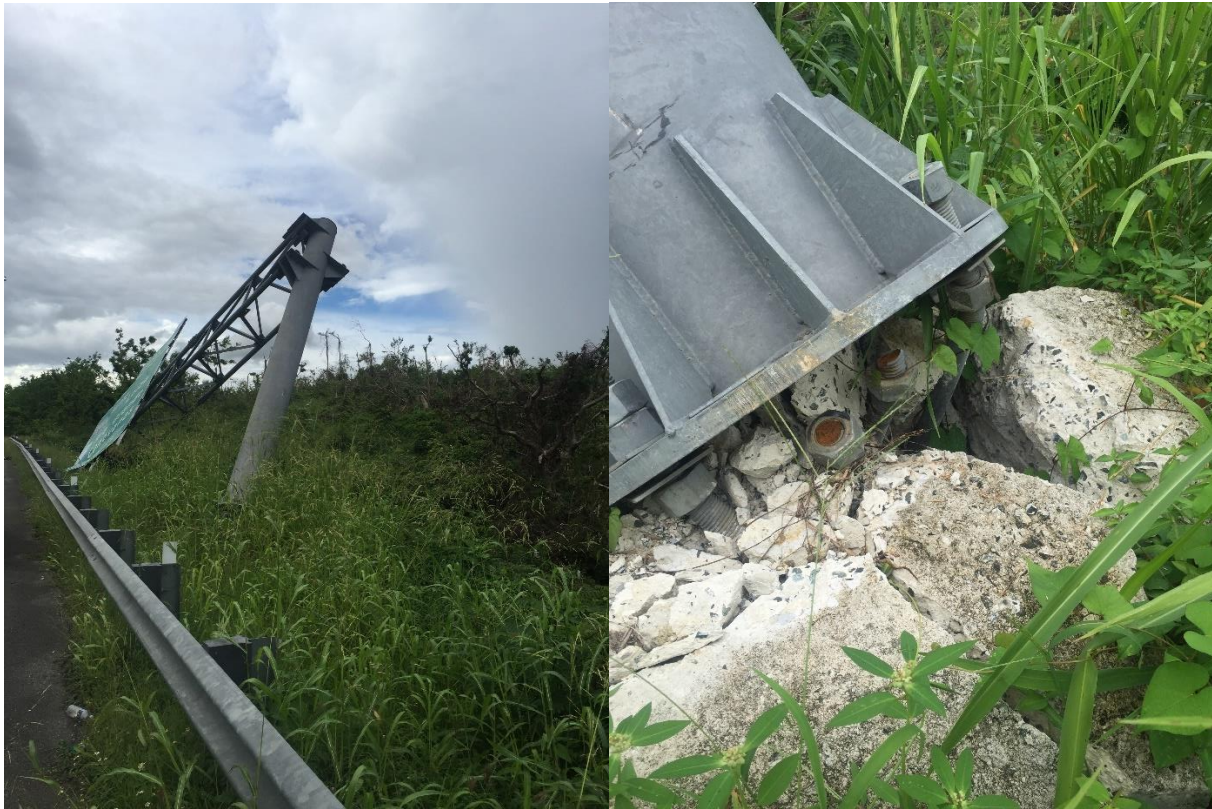
In Figure 4-3, the total collapse of a cantilever traffic sign located on PR-66 Highway, near Loíza, can be appreciated. The mode of failure suggested that not only rotation about a vertical axis but also about a horizontal axis was present, producing not only large deflections and shear failure on the anchor bolts, but also tension on the anchor bolts, and compression and crushing on the concrete. The necessity of documenting the pedestal condition was reinforced.

Figure 4-3: Total Collapse of a Cantilever Sign Located in PR-66 Highway

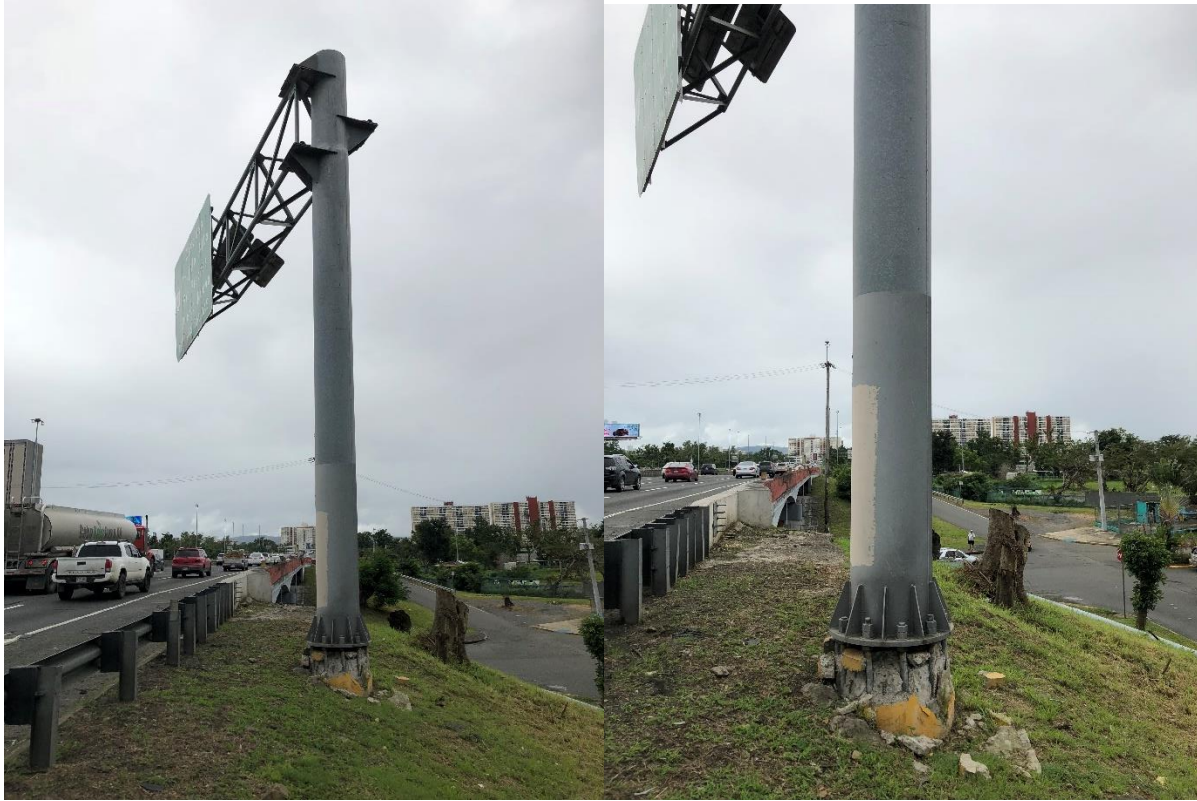
Figure 4-4 presents the condition found on a cantilever traffic sign located on PR-18 Highway, in the San Juan Area, near the Luis Muñoz Marín Park. The post was in the vertical position, but the sign experienced a rotation of more than 45 degrees. The concrete pedestal experienced damages, with concrete cracks. But the anchors bolts did not experience large lateral deflections, indicating that the hole foundation was subjected to large rotations about the vertical axis, due to lack of enough shear resistance between soil and foundation. These findings reinforced the necessity of documenting the pedestal and foundation condition.

Figure 4-4: Partial Collapse and Damages on a Cantilever Traffic Sign Located on PR-18 Highway

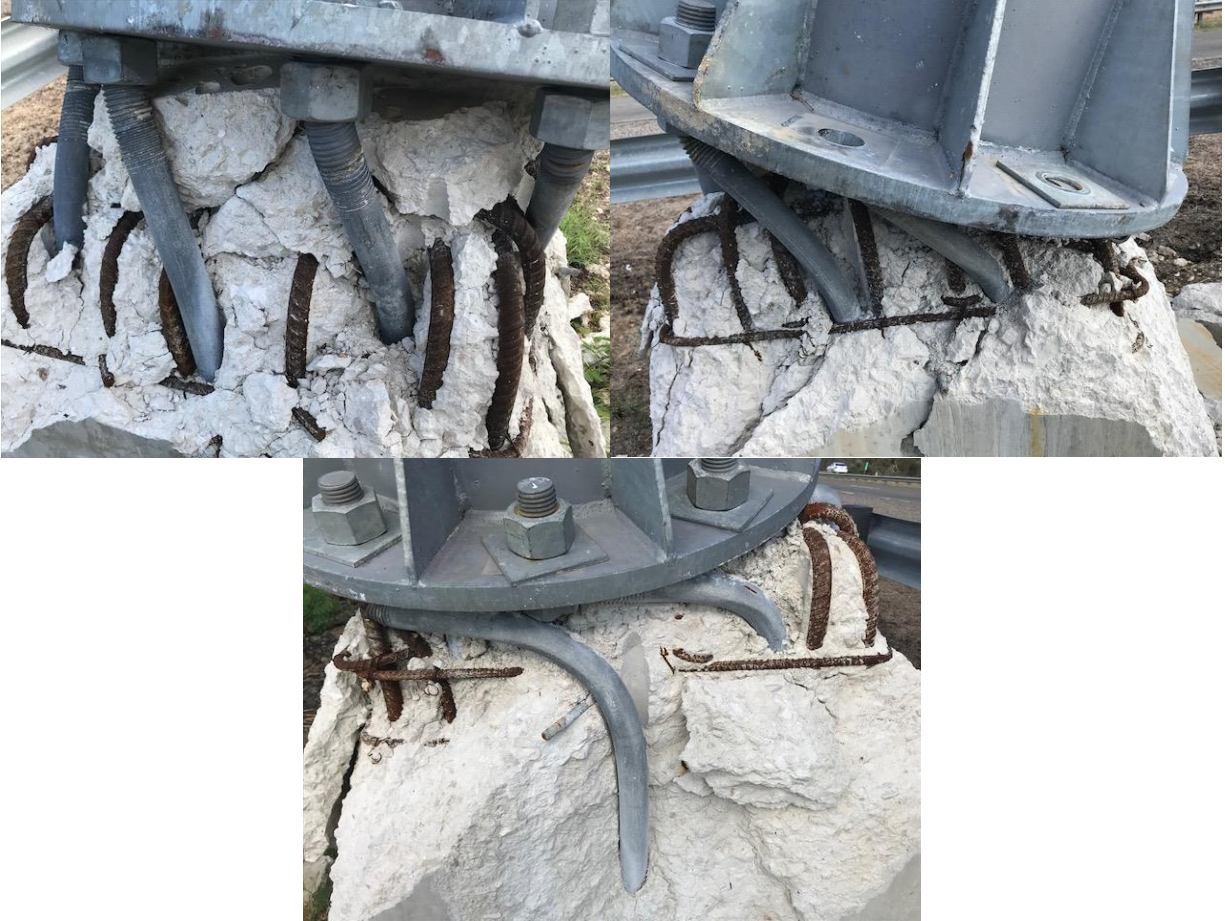
Figure 5-38: Photos of Cantilever Traffic Sign Foundation Structural Failure to the Pedestal at P-46; with Large Deflections and Bending on the Plastic Range and Shear Fracture of the Anchor Elements, and Fractures, Detachments and Crushing of the Concrete

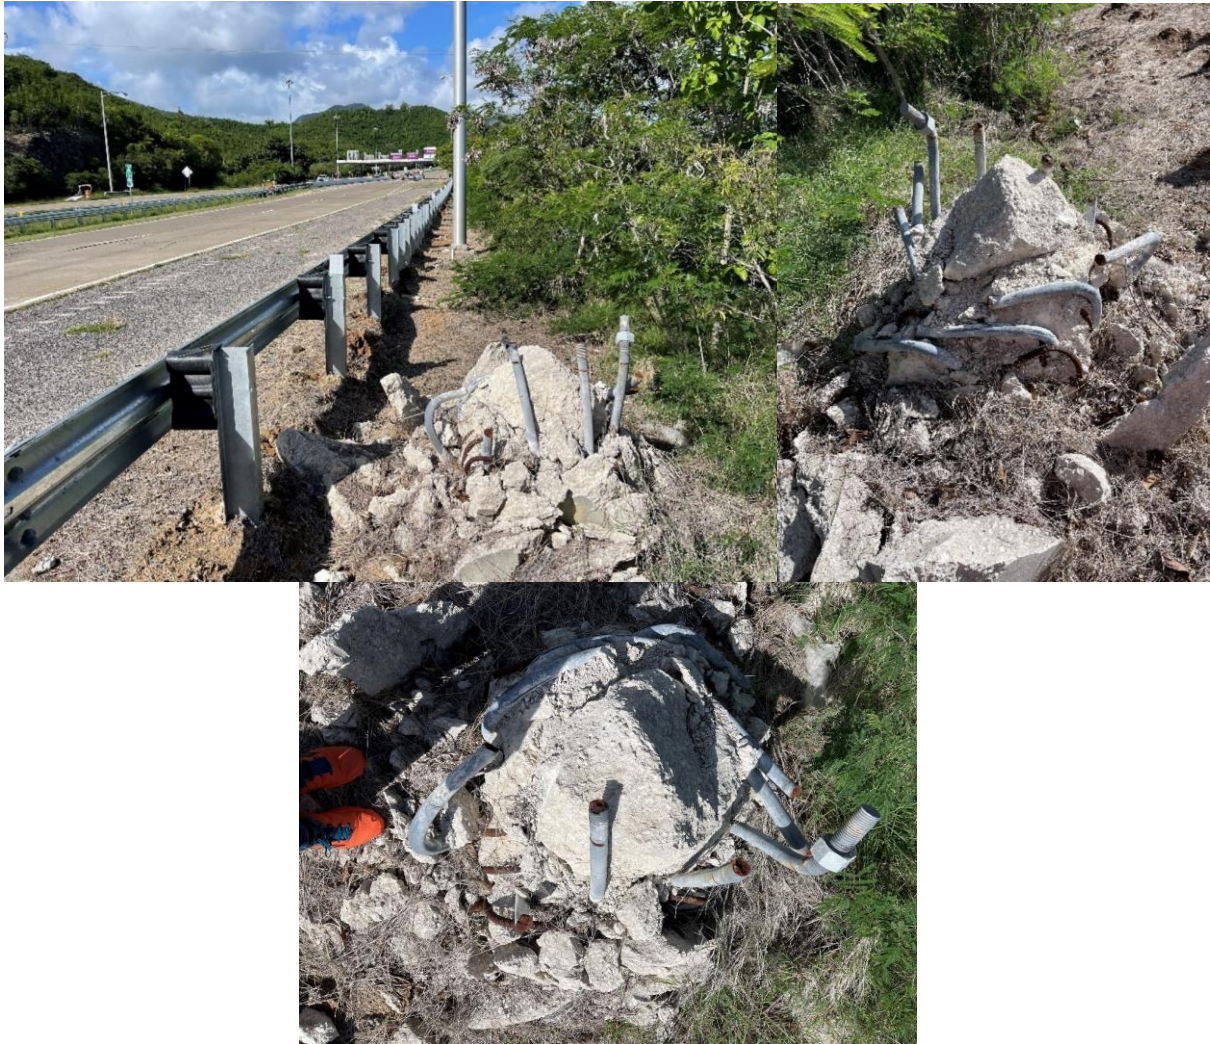
Figure 5-40: Photos of Cantilever Traffic Sign Foundation Structural Failure to the Pedestal at P-47; with Large Deflections and Bending on the Plastic Range and Shear Fracture of the Anchor Elements, and Fractures, Detachments and Crushing of the Concrete. Bolts outside the confinement of Stirrups

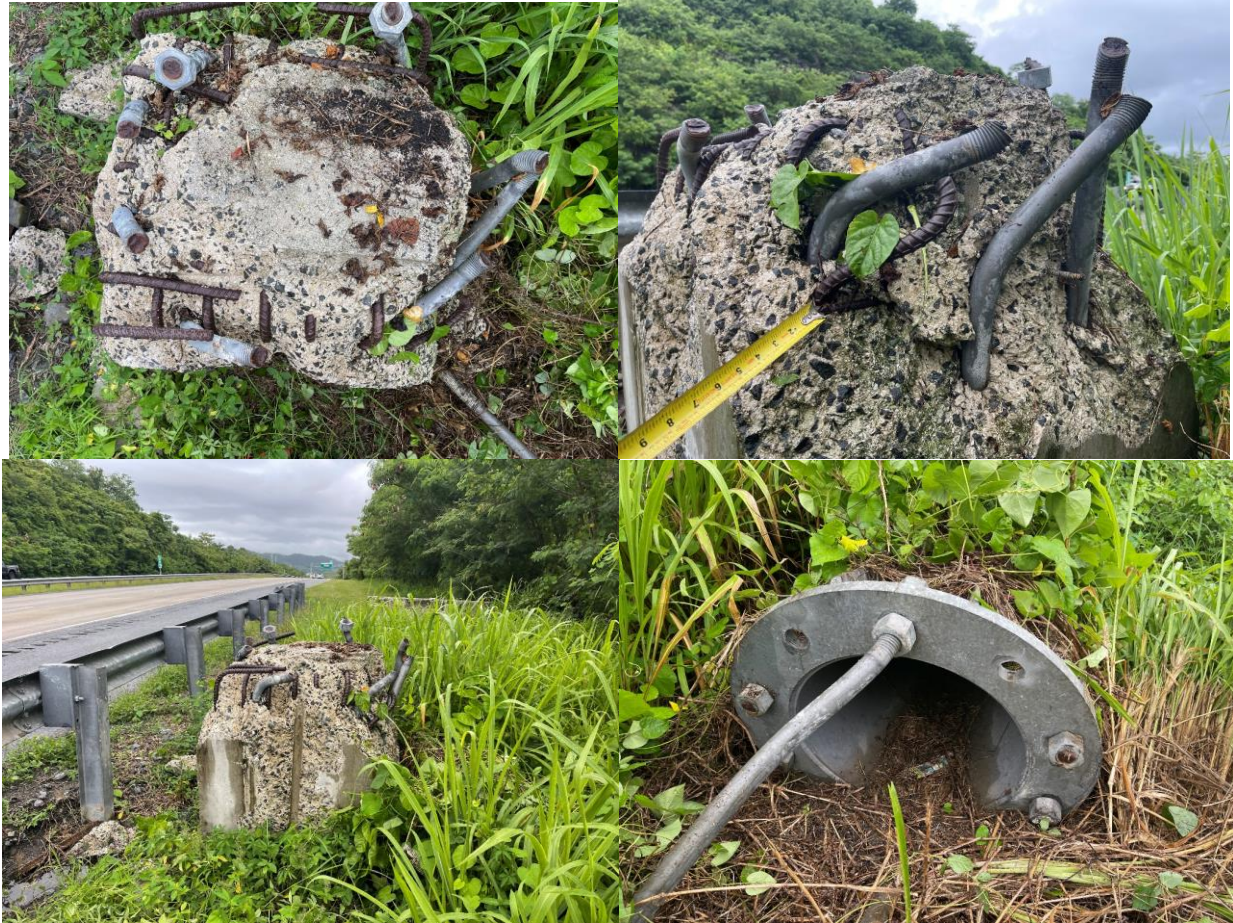
Figure 5-43: Photos of Cantilever Traffic Sign Foundation Structural Failure to the Pedestal at P-46; with Large Deflections and Bending on the Plastic Range and Shear Fracture of the Anchor Elements, and Fractures and Detachments of the Concrete

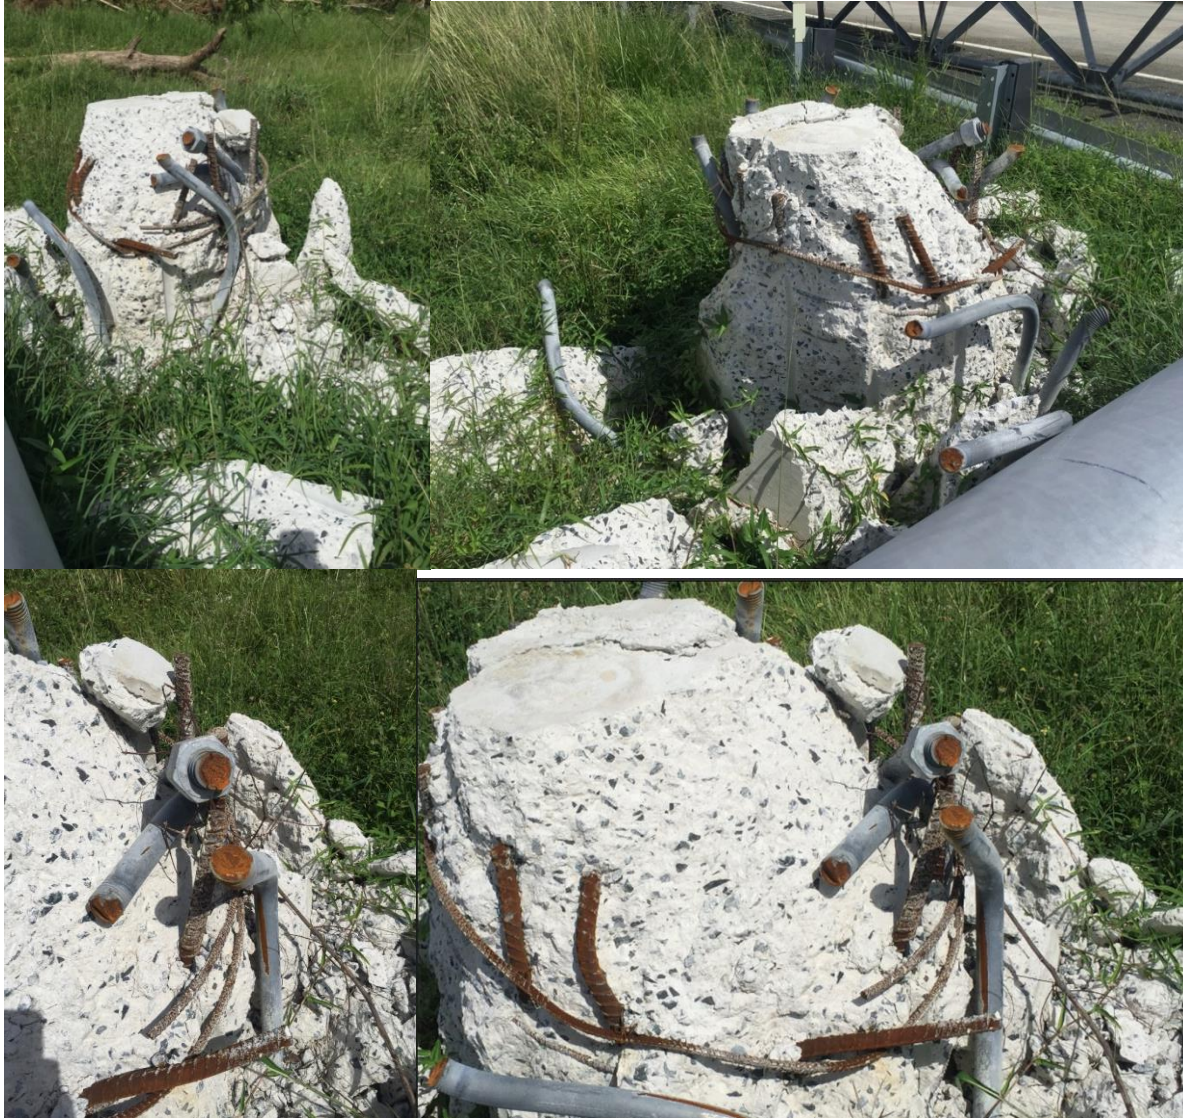
Figure 5-45: Photo of Cantilever Sign Foundation Structural Failure at P-100; with Large Deflections and Bending on the Plastic Range and Shear Fracture of the Anchor Elements, and Fractures, Detachments and Crushing of the Concrete. Anchor elements outside the confinement provided by Stirrups
