Improving Transportation Infrastructure Resilience against Hurricanes, other Natural Disasters, and Weathering: Part I - Analysis of failure of transportation signs due to Hurricane Maria

Volume 1

FINAL REPORT
June 2022

Transportation Infrastructure Research Center – TIRC
Polytechnic University of Puerto Rico
377 Ponce de Leon Ave, San Juan, PR 00918

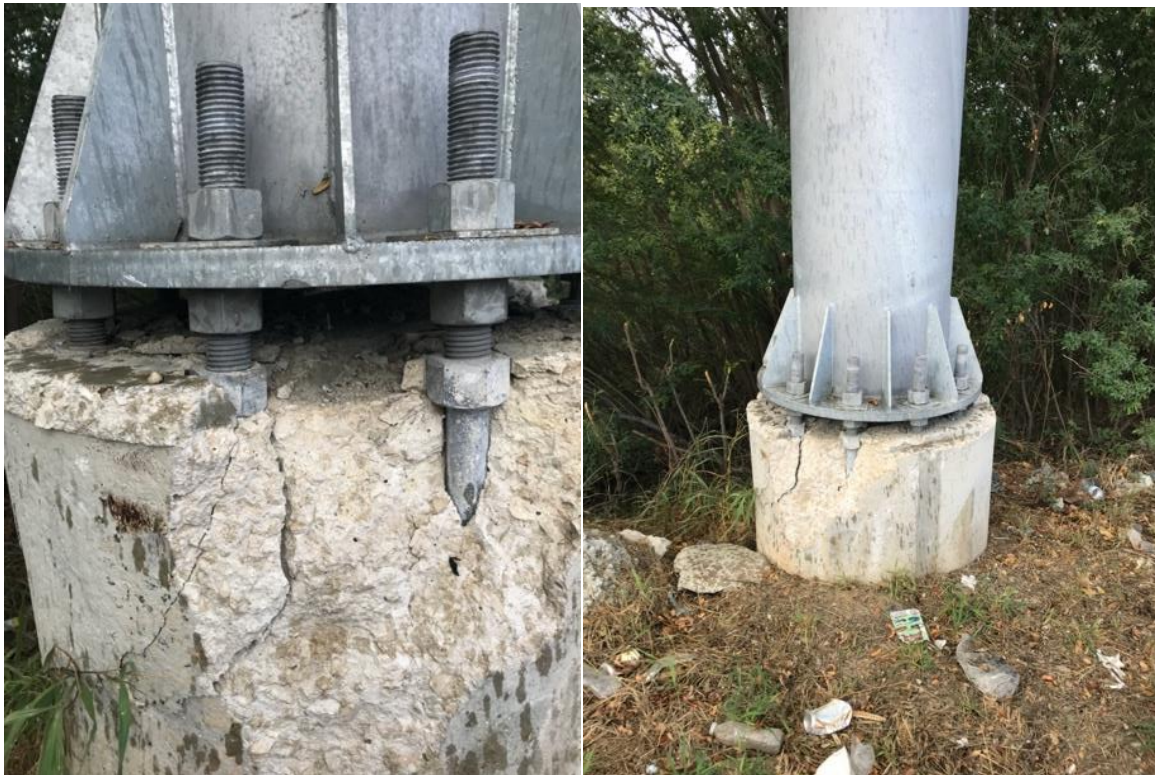
Figure 5-57: Photo of Cantilever Sign P-1. Damages, Fractures on Concrete Pedestal. Location: 17°59'25.25"N; 66°37'16.63"W

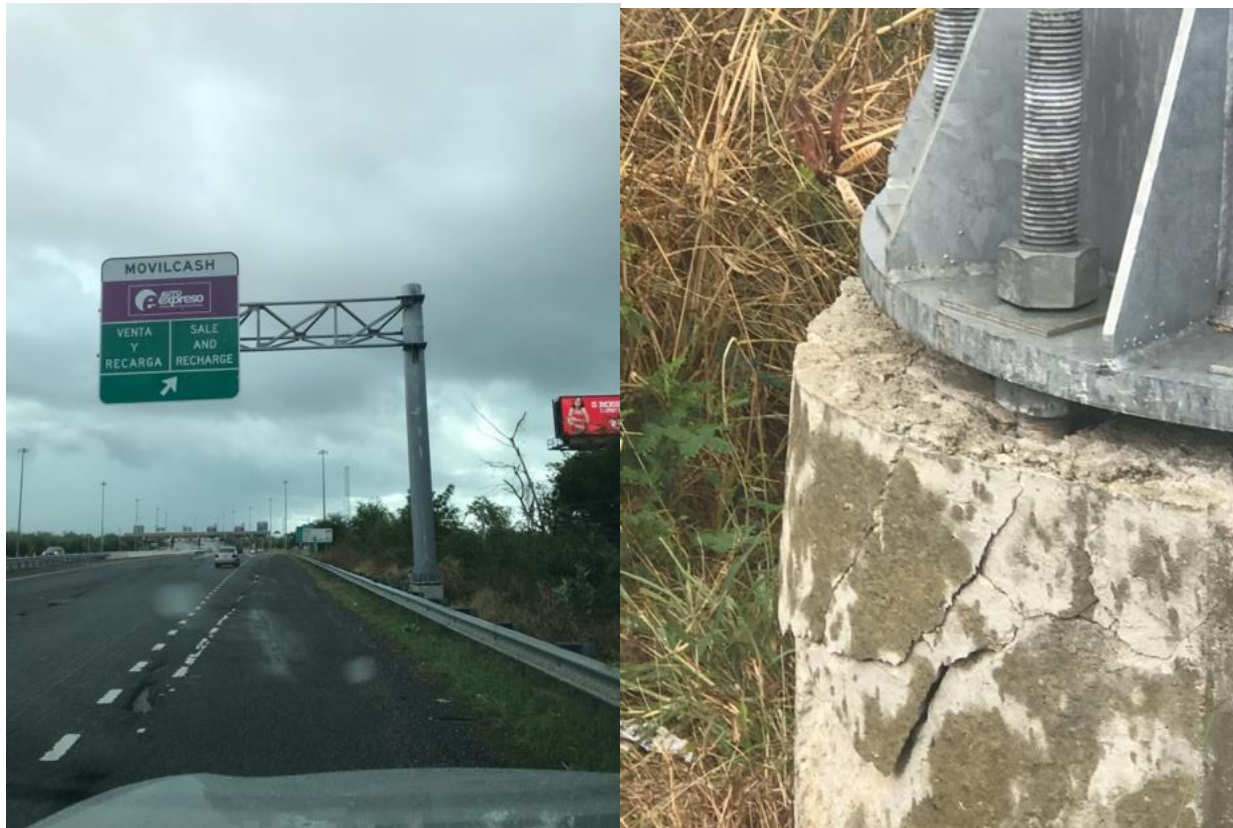
Figure 5-58: Photo of Cantilever Sign Foundation Structural Damages on the Pedestal at P-3, Damages (Fractures on the Concrete Base) Location: 17°59'19.75"N; 66°37'0.41"W

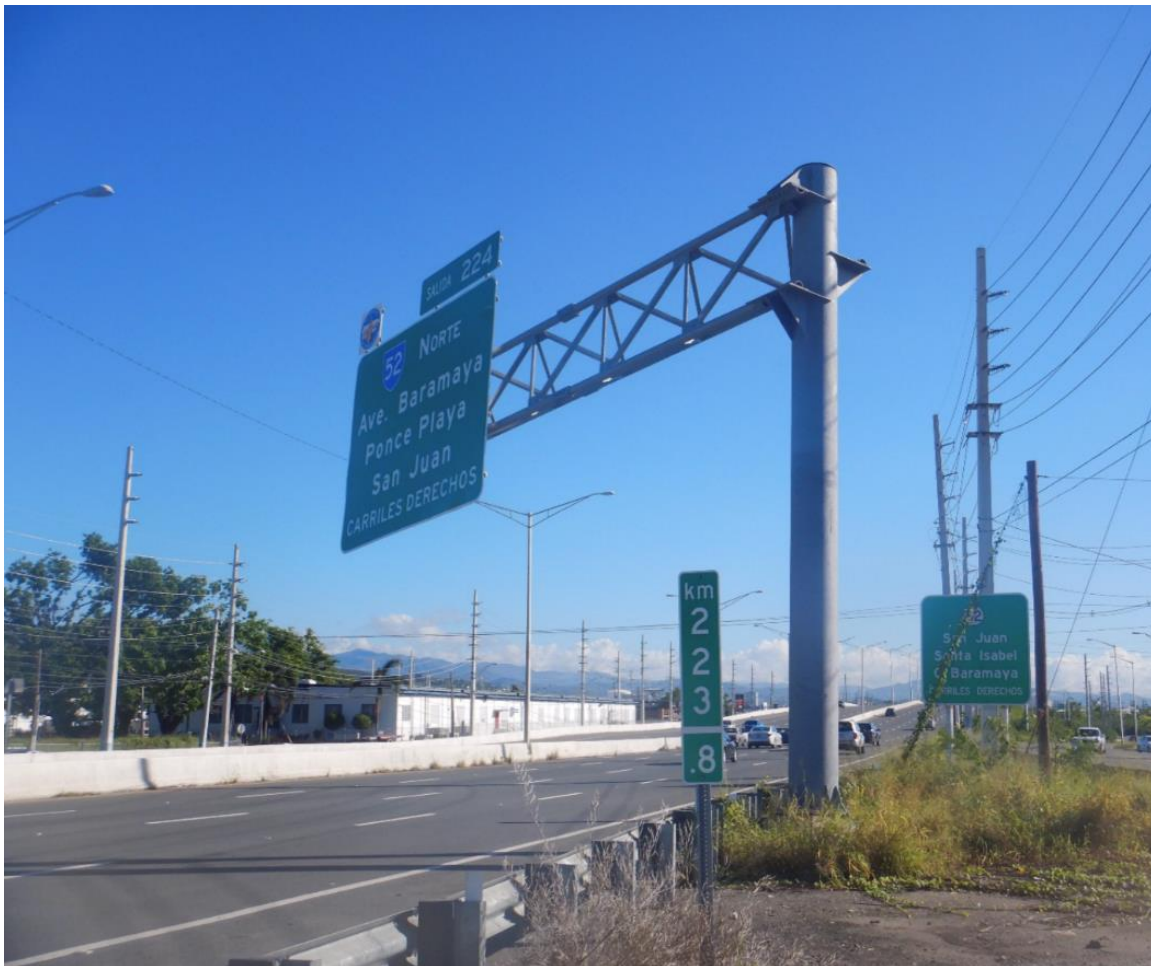
Figure 5-61: Photo of Cantilever Traffic Sign Foundation Failure at P-94 Location: 17°59'16.80"N; 66°38'55.39"W

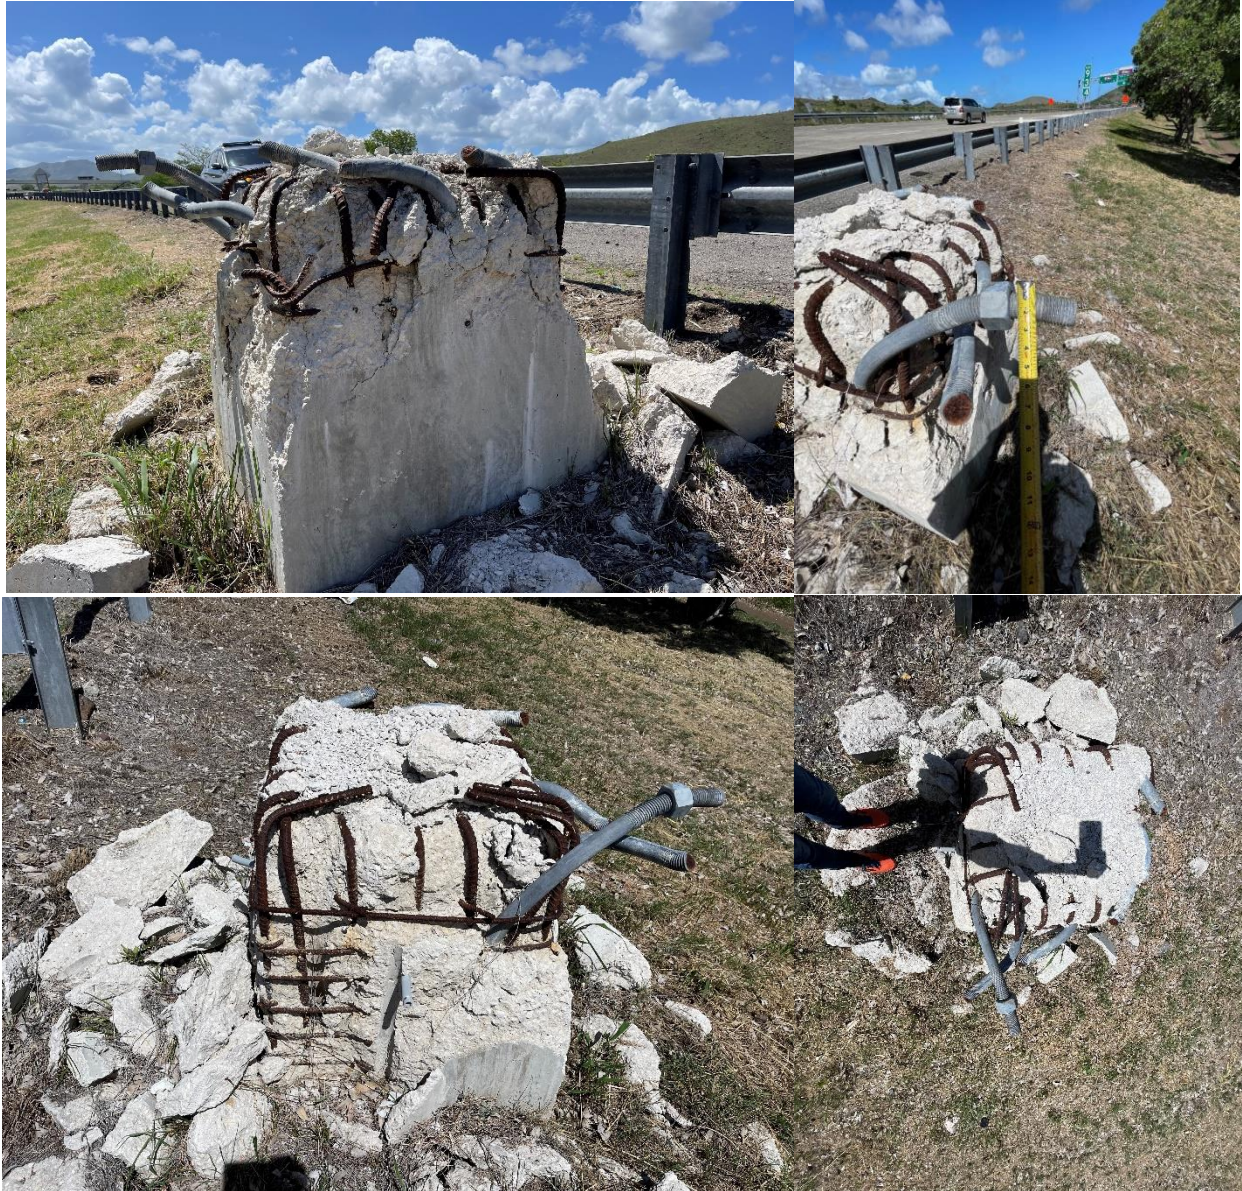
Figure 5-65: Photo of Cantilever Sign Structural Foundation Failure at P-12; Collapsed Post Presented Torsional Pattern and Large Deflections of the Anchoring Elements, which also Exhibit Shear Fracture

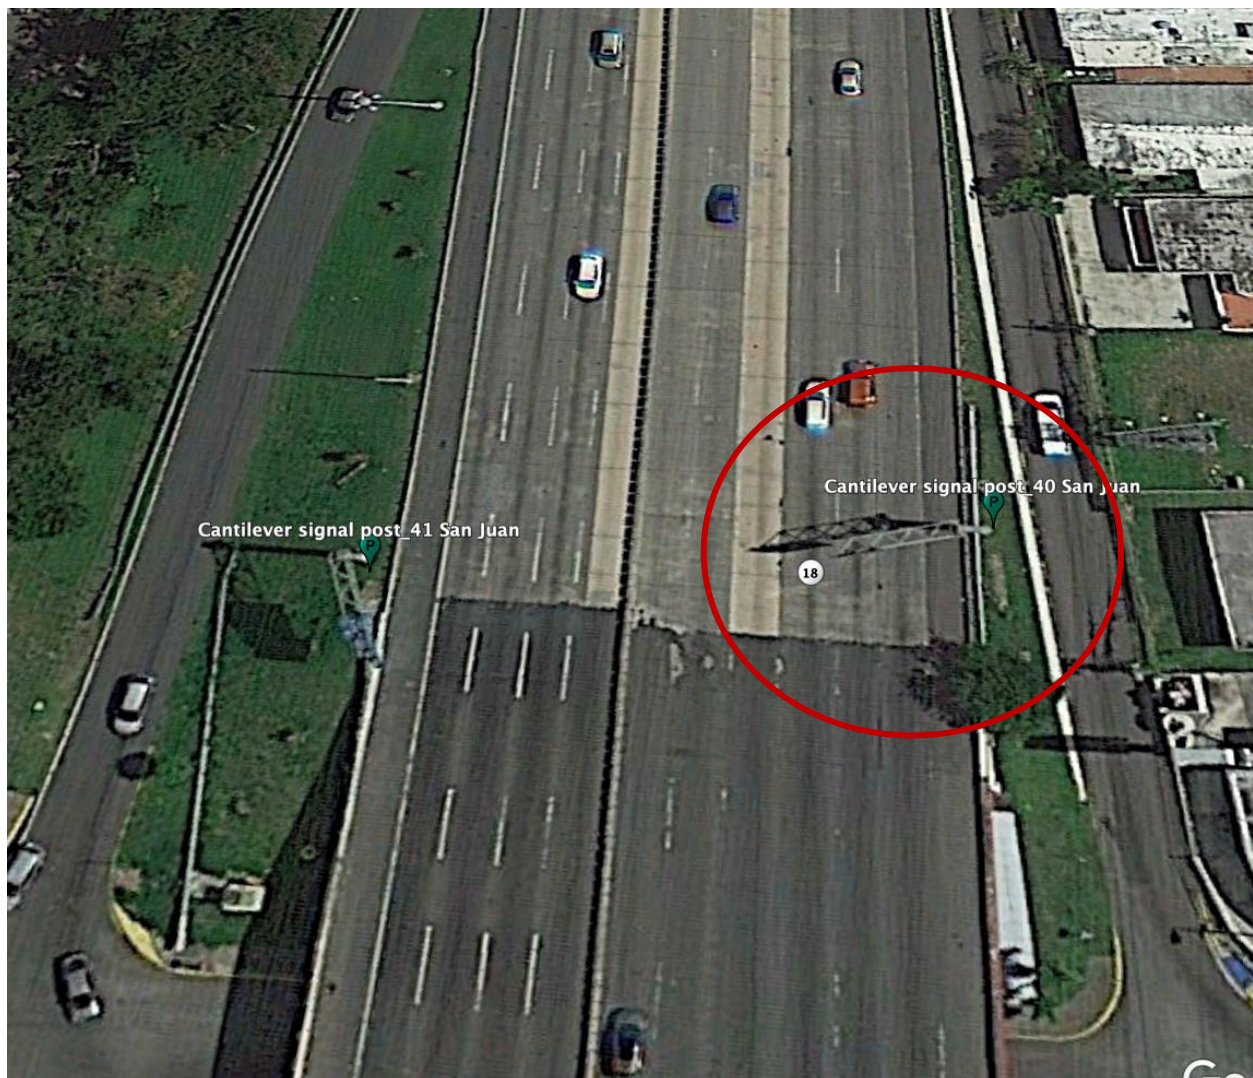
Figure 5-71: Satellite Image of Cantilever Sign Soil Foundation Failure (Torsional Rotation) at P- 40 Photo Location: 18.413125°N; 66.06986944°W

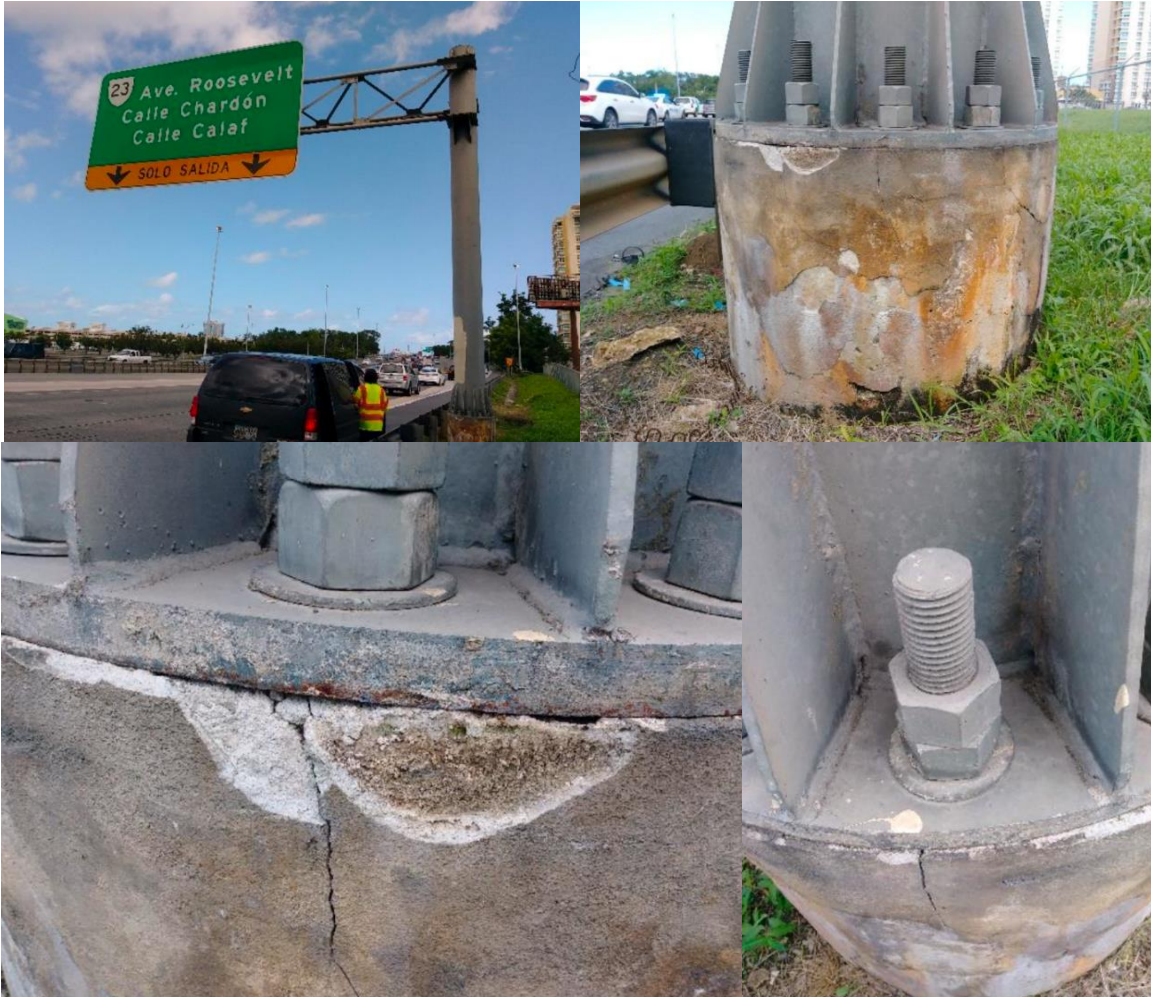
Figure 5-76: Photo of Cantilever Sign Foundation Failure (Torsional Rotation), Damages to the Concrete Pedestal, and Small Gap Between Soil and Shaft at P- 43 Photo Location: 18.41561389°N; 66.06995°W

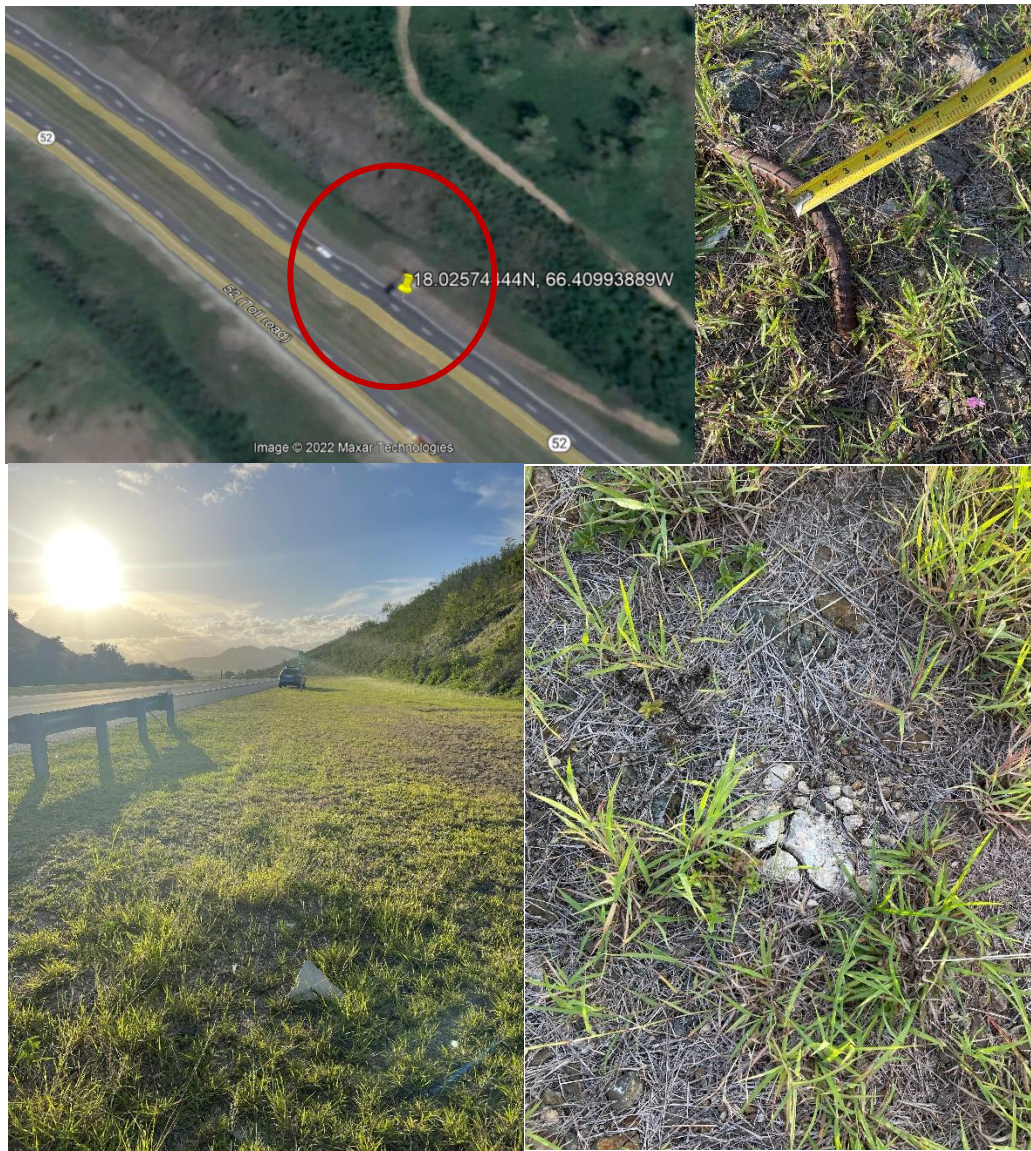
Figure 5-80: Photo of Cantilever Sign Location and Possible Collapse at P-7 Photo Location: 18.02574444°N; 66.40993889°W

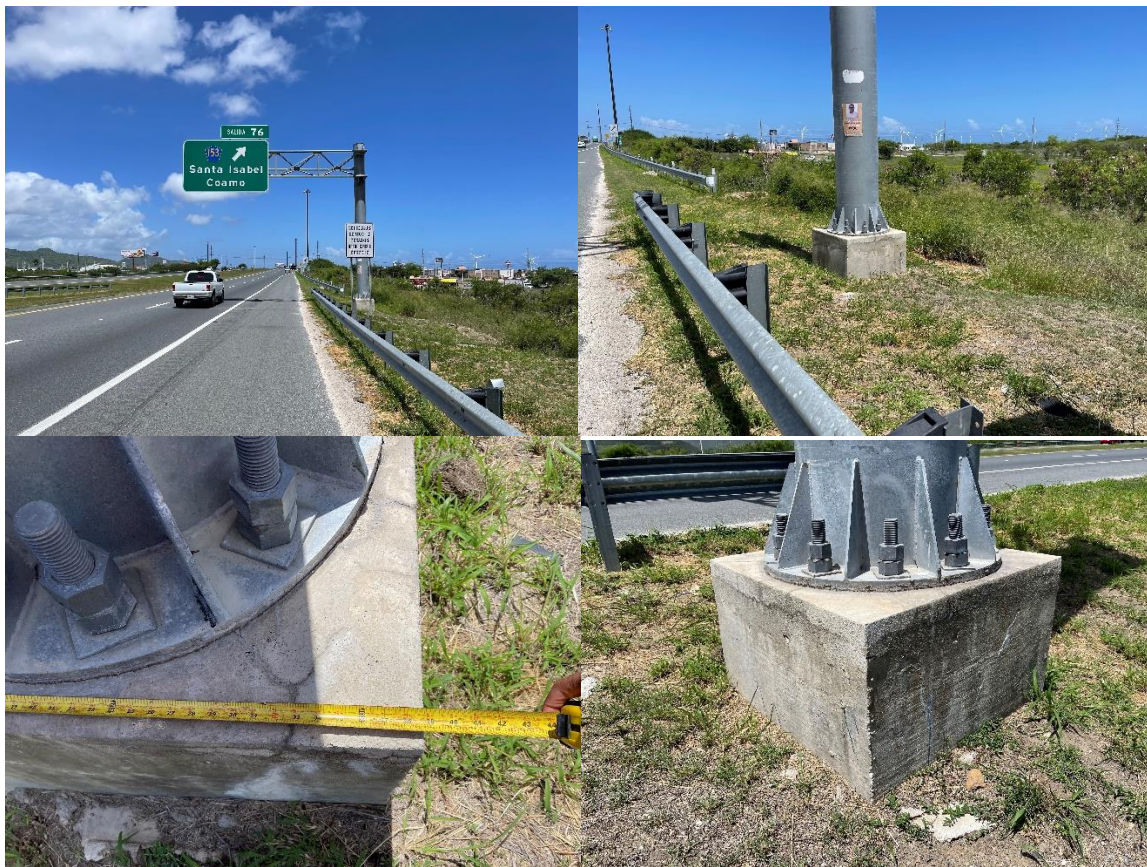
Figure 5-81: Photo of Cantilever Sign Location and Pedestal Cracks at P-8 Photo Location: 18.01293333°N; 66.389025°W

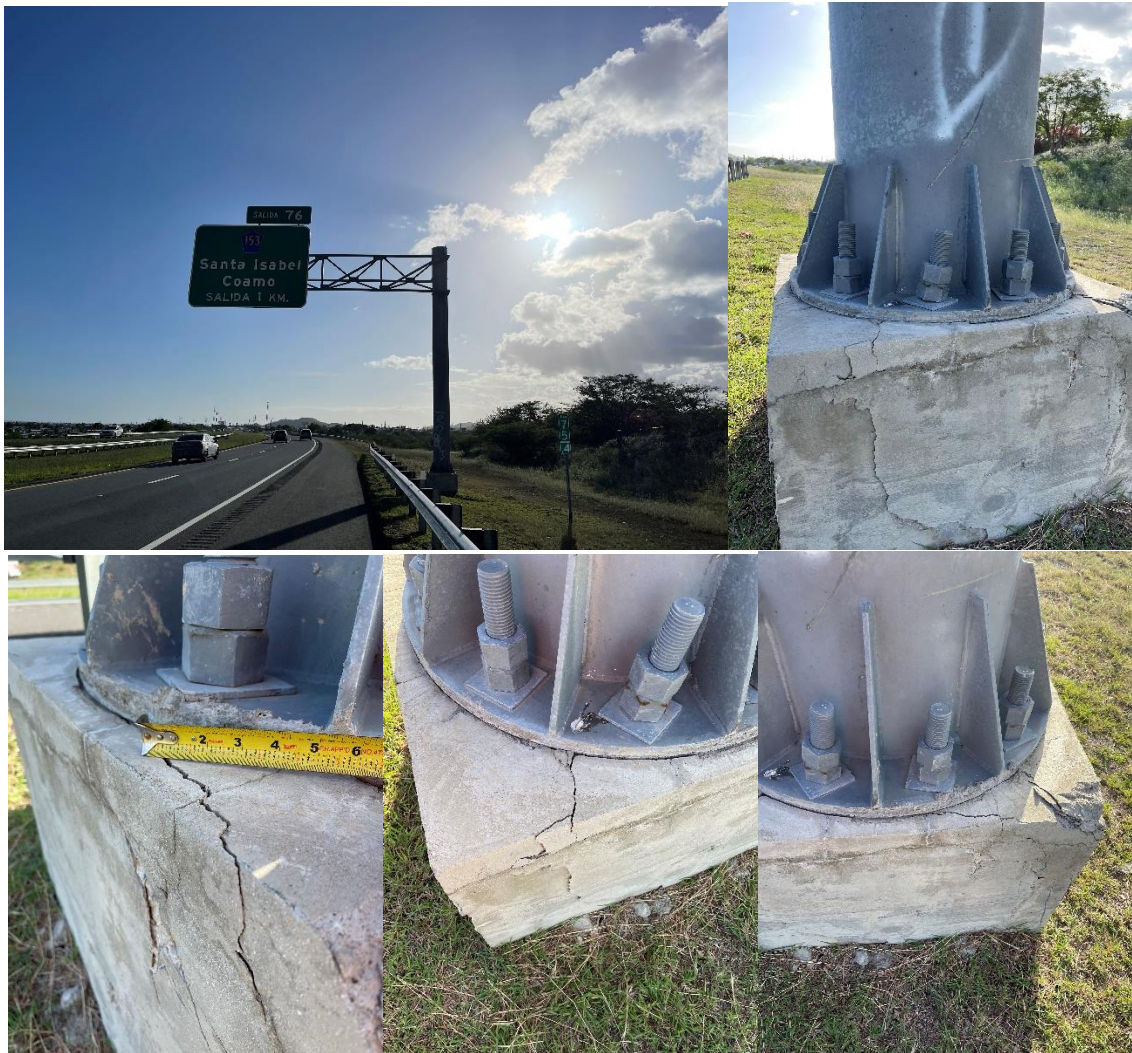
Figure 5-82: Photo of Cantilever Sign Location and Pedestal Cracks at P-10 Photo Location: 18.01423056°N; 66.36989167°W

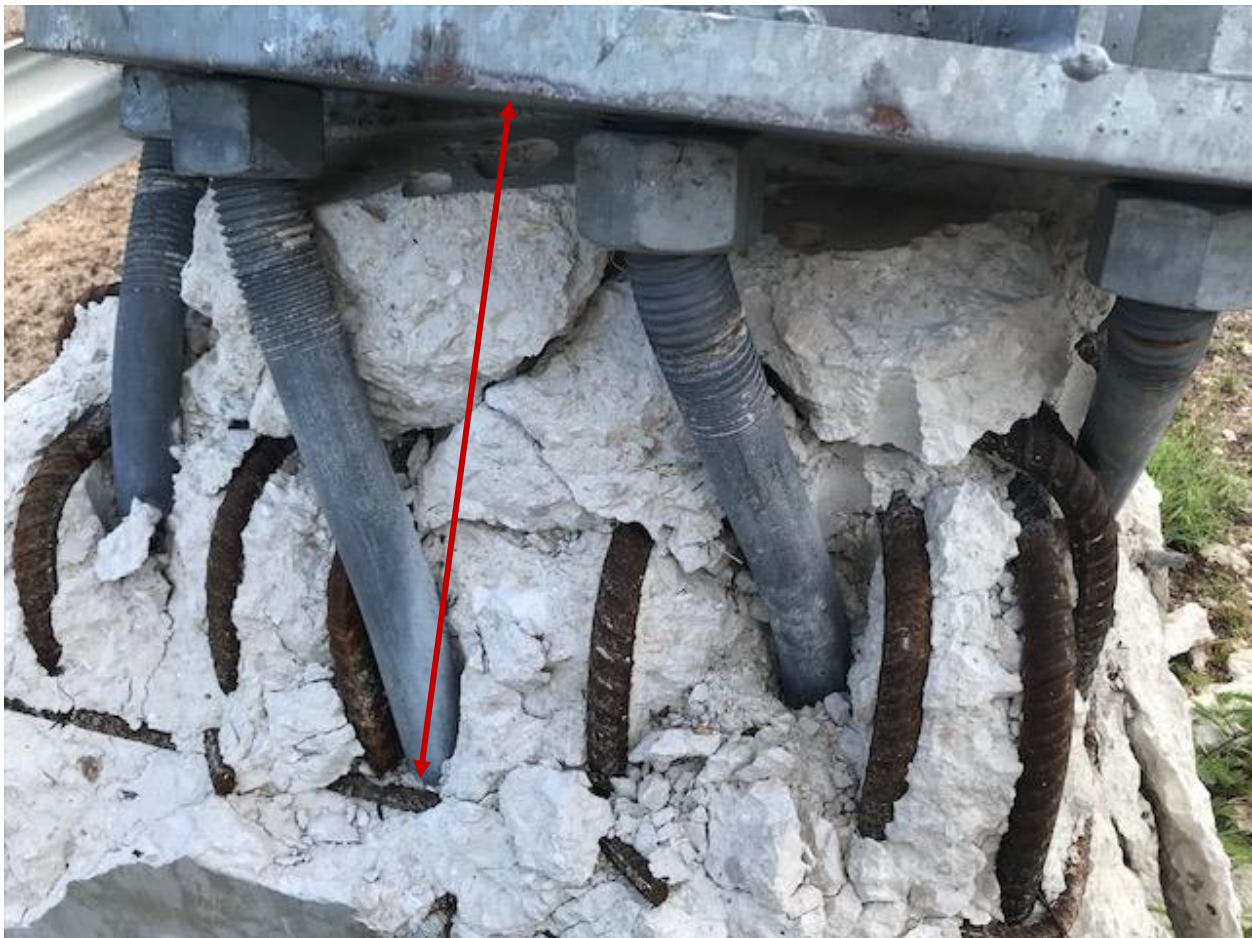
Figure 6-7: Large Deflections of Anchor Bolts due to Lack of Lateral Confinement (Sign P-46)

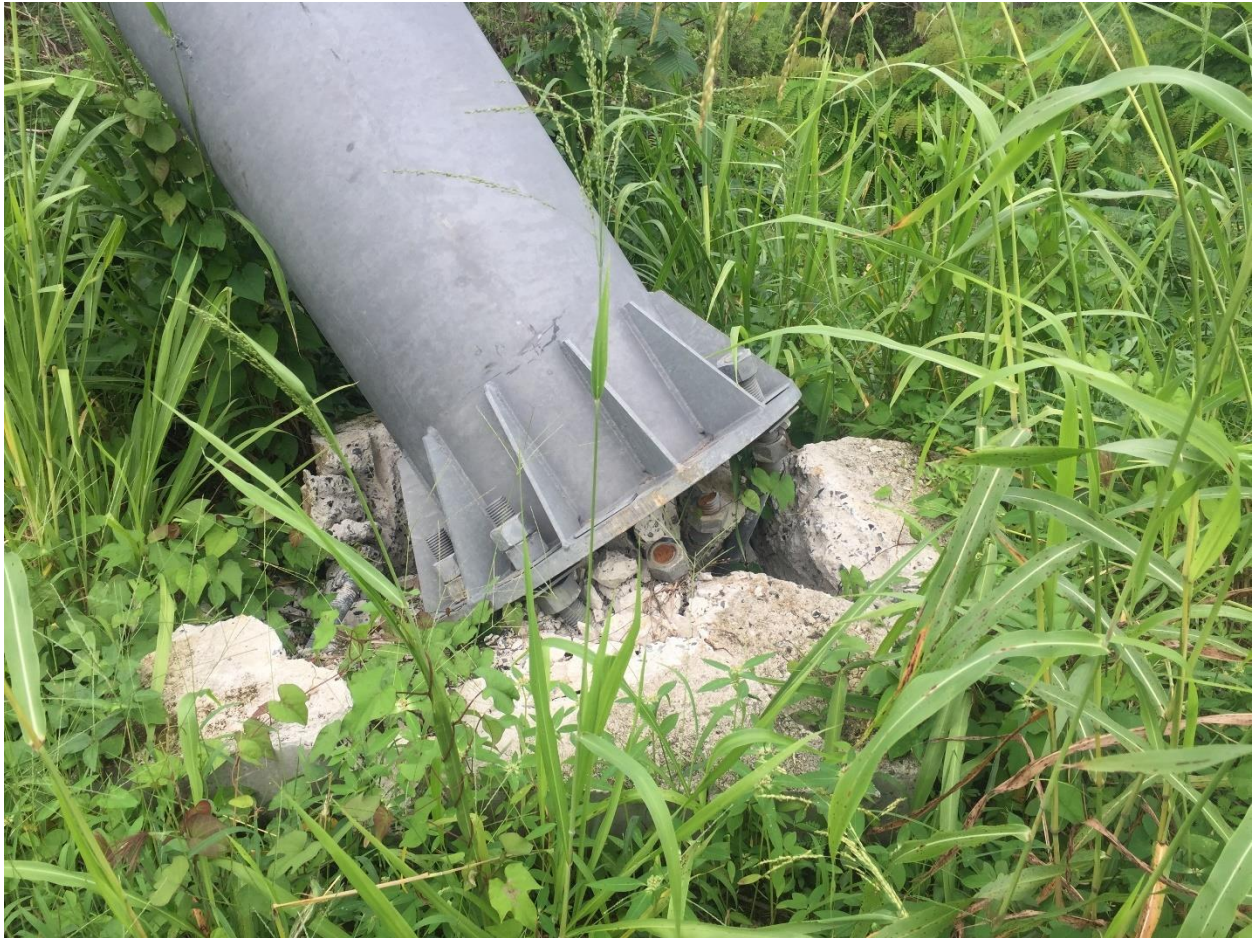
Figure 6-11: Large Deflections of Anchor Bolts due to Lack of Lateral Confinement (Sign P-106)

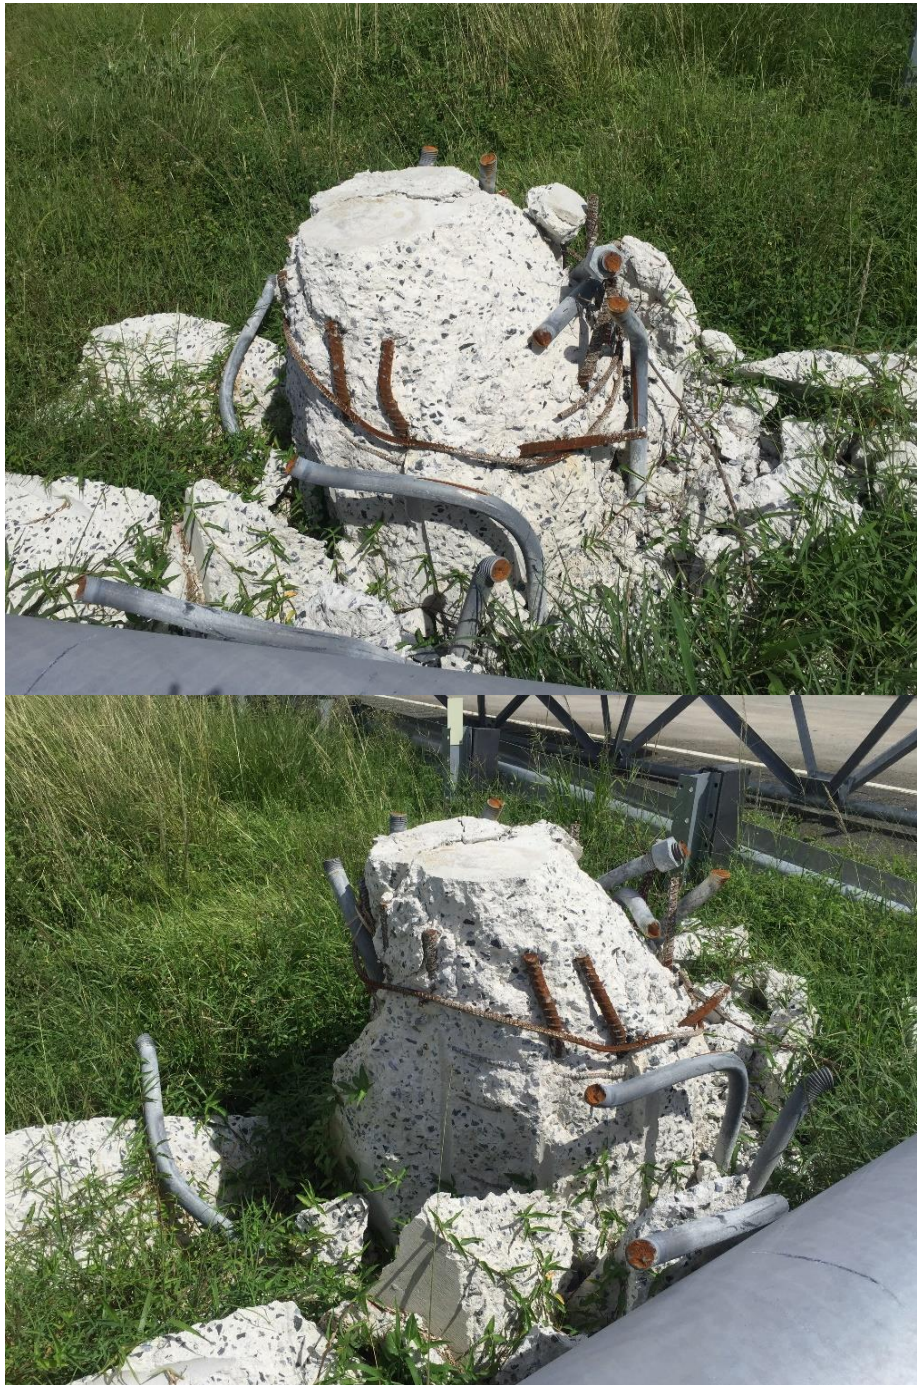
Figure 6-12: Several Anchor Bolts Outside the Transverse Confinement Steel / Concrete Core (Sign P-100)

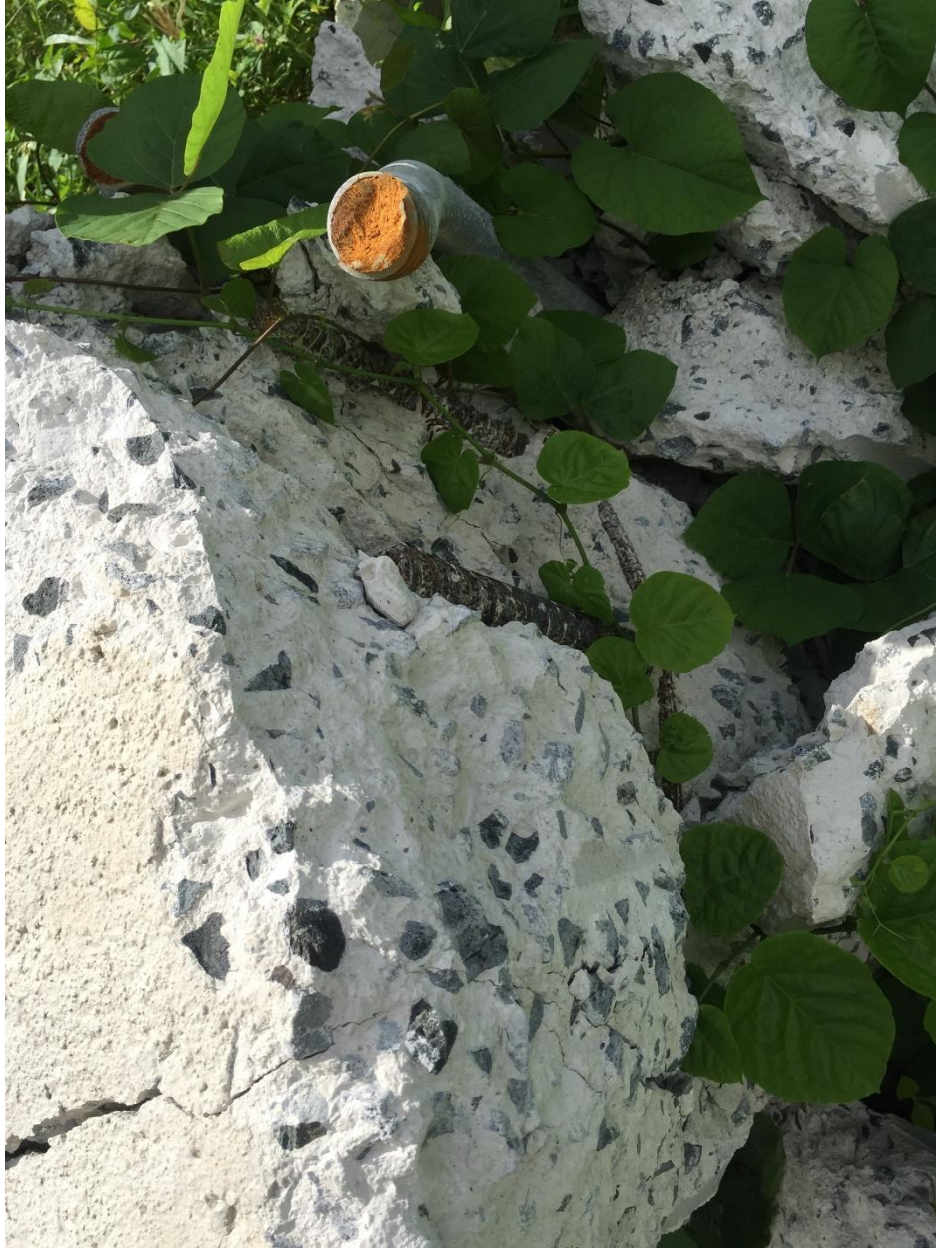
Figure 6-14: Several of the Anchor Bolts Outside the Transverse Confinement Steel / Concrete Core (Sign P-105)

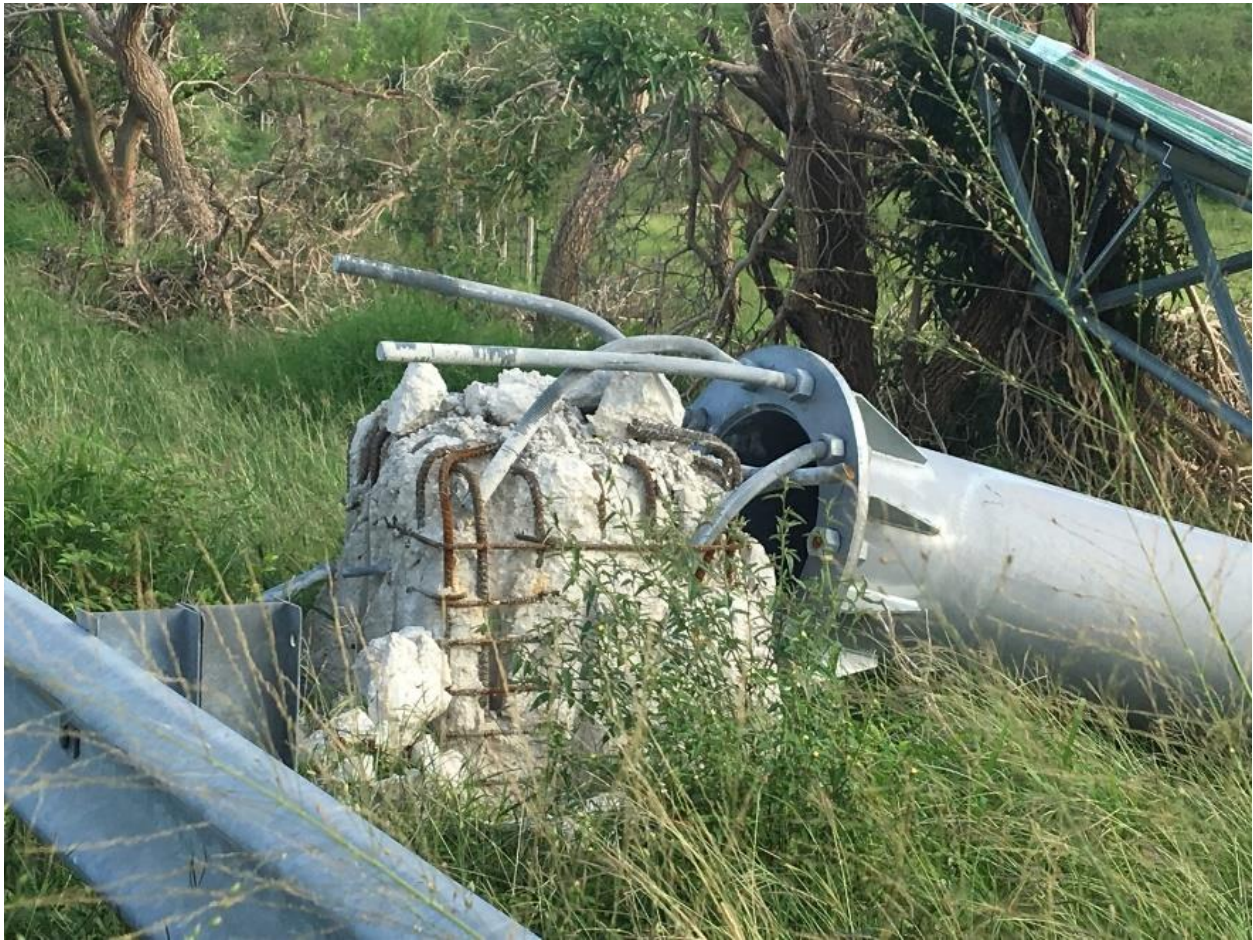
Figure 6-15: Anchor Bolts Pullout

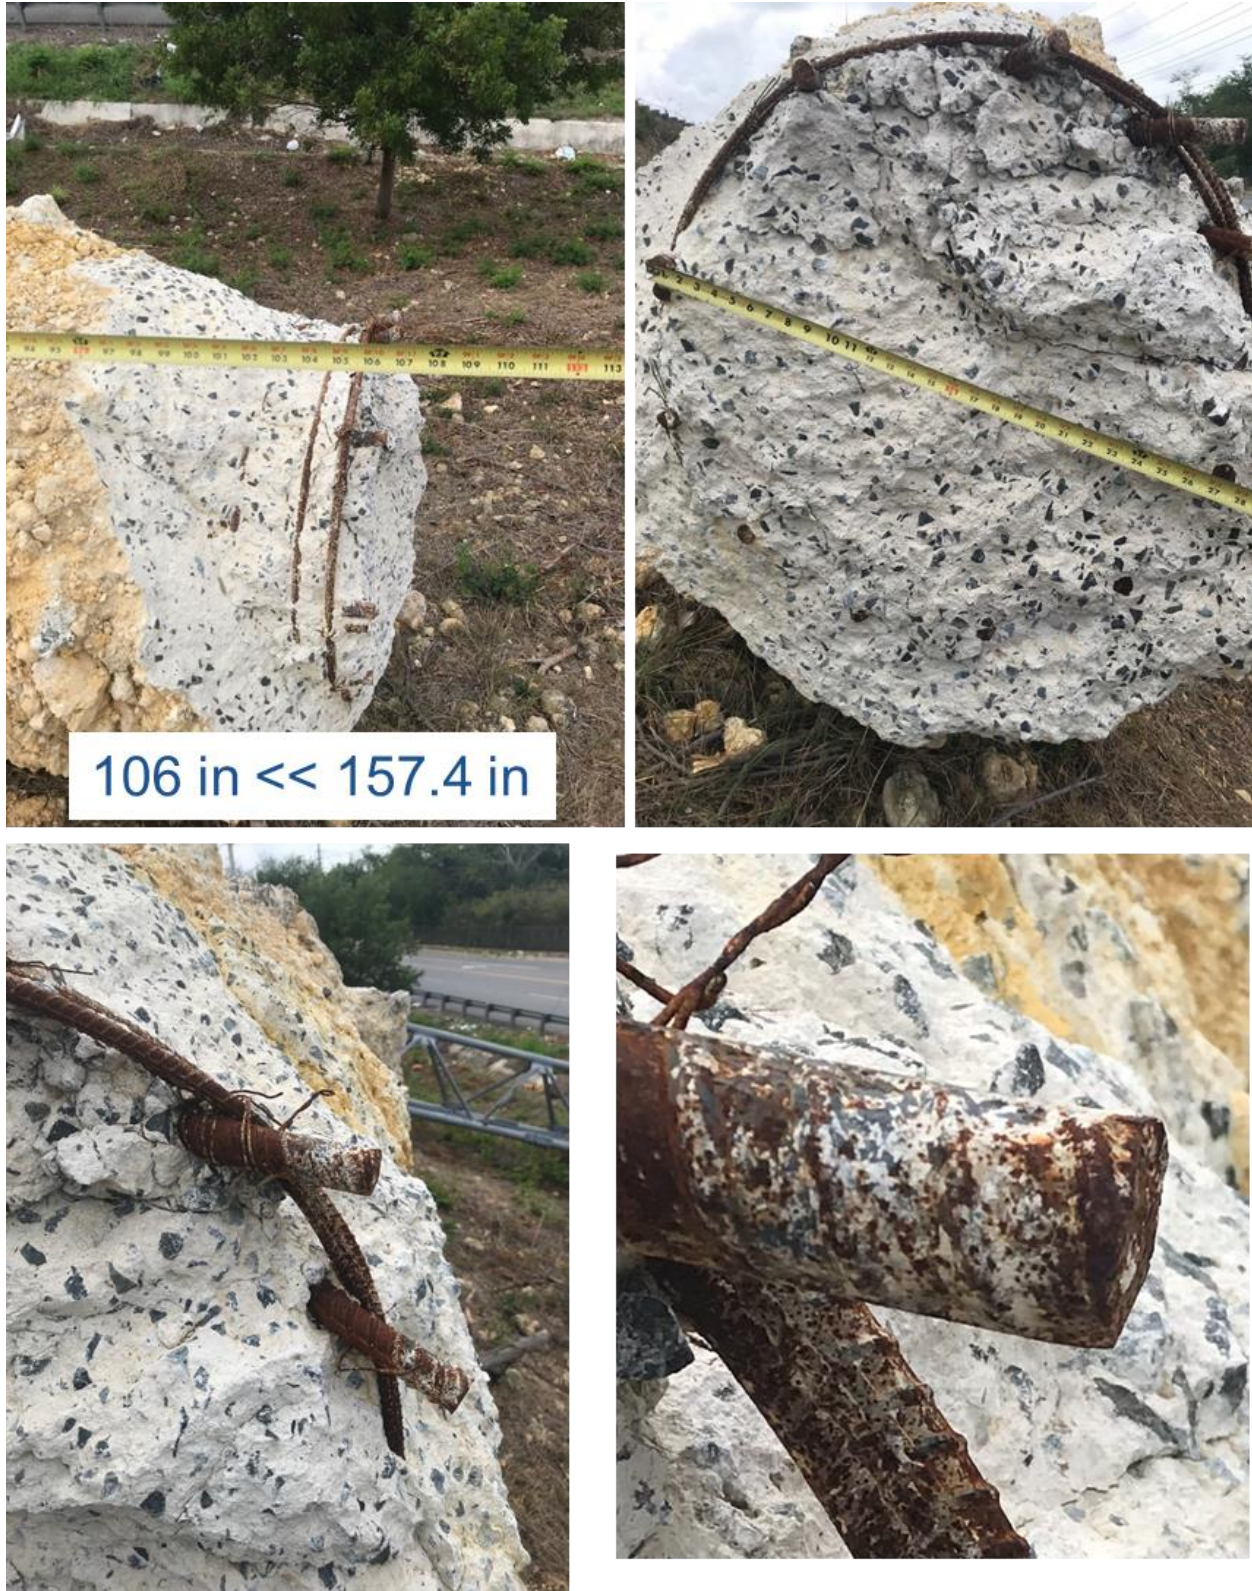
Figure 6-19: Interrupted Steel and Shear Fracture of the Concrete of the Drilled Shaft

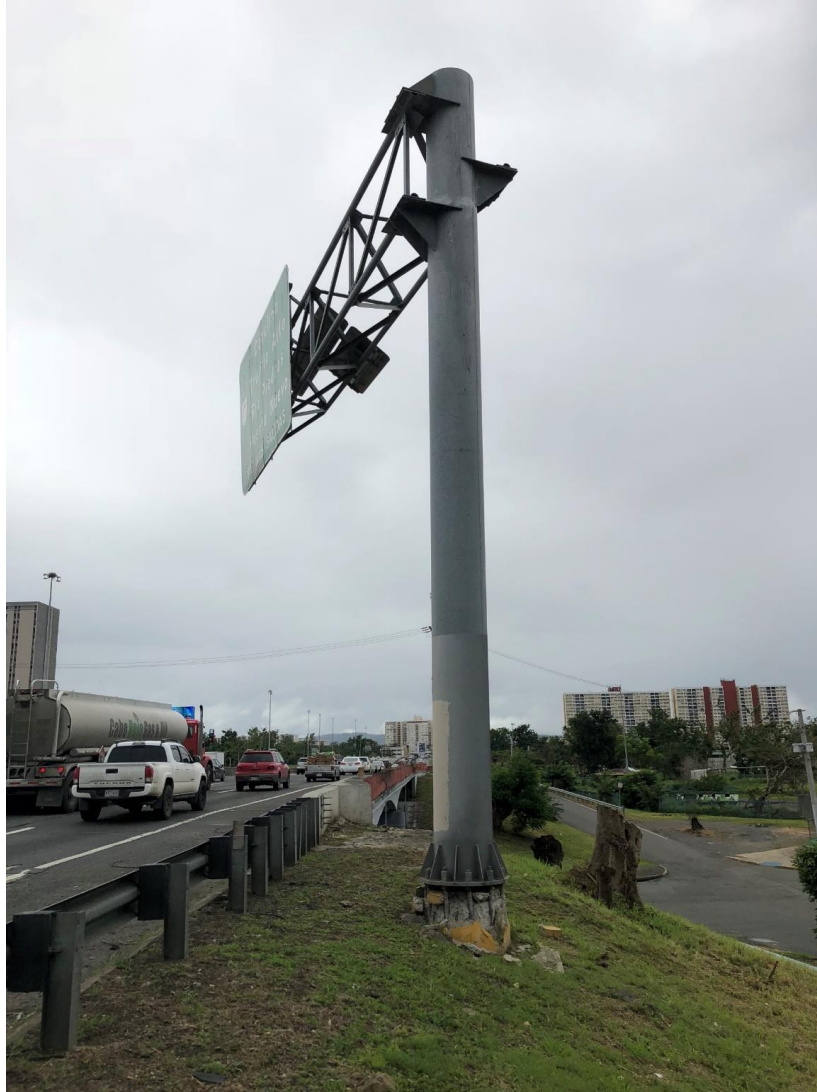
Figure 6-21: Cylindrical Precast Concrete Base that Experienced Torsional Rotation. PR 18 in San Juan
