Improving Transportation Infrastructure Resilience Against Hurricanes, Other Natural Disasters, and Weathering: Part II - Analysis of Pedestrian Bridges Failures Due to Hurricane Maria

FINAL REPORT
August 2021

Transportation Infrastructure Research Center – TIRC
Polytechnic University of Puerto Rico
377 Ponce de Leon Ave, San Juan, PR 00918

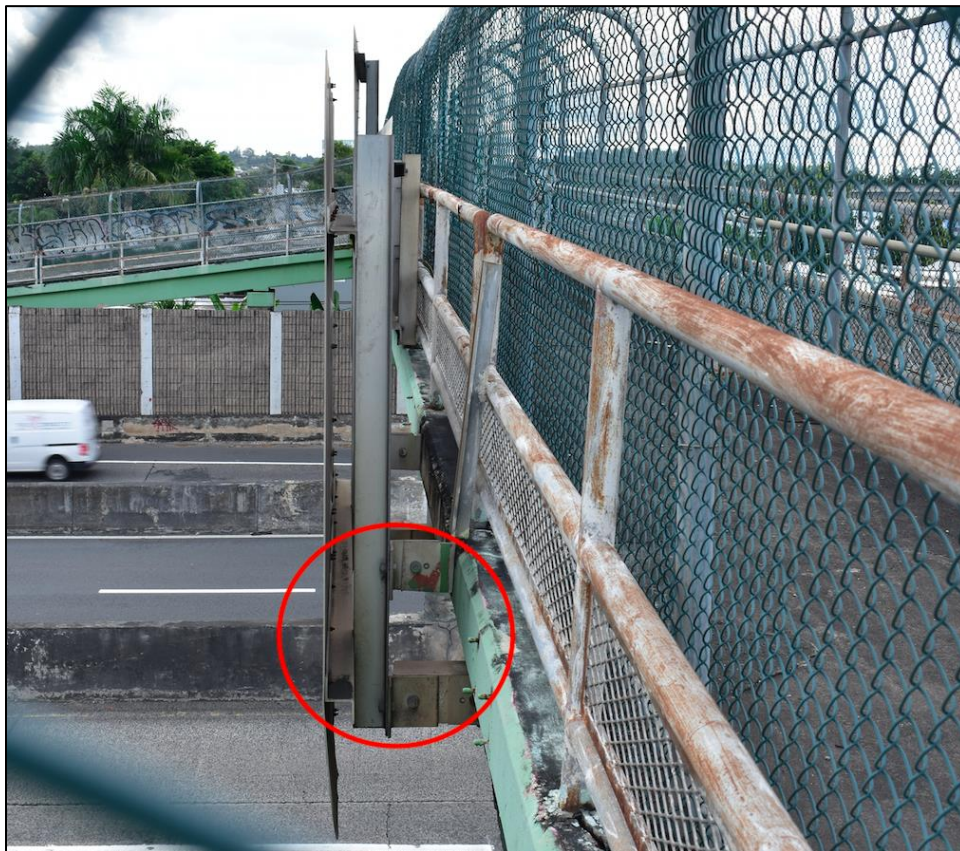
At the time of the inspection, the bridge had attached five signs of different sizes, as it can be appreciated in Figure 5.1 and Figure 5.2. In terms of possible damages caused by Hurricane Maria, it was observed that one of the traffic signs mounted on the bridge was detached at the bottom end from the mounting assembly, as indicated in Figure 5.16. It is theorized that the detachment was due to wind induced vibrations that occurred during the hurricane.

Figure 5.16: Traffic Signs partially detached from support

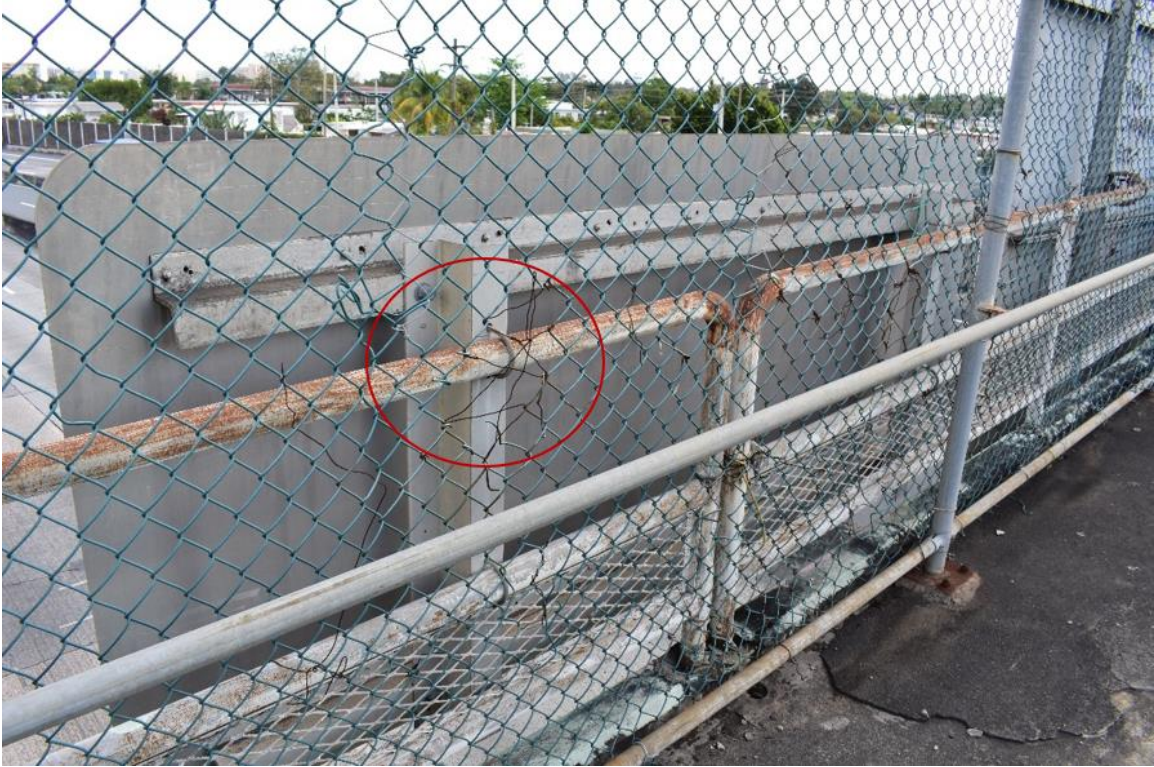
It was observed that all the traffic signs mounted on the bridge were attached to the handrails, as shown in Figure 5.17. It was noticed that there were cracks at the base of handrails posts (see Figure 5.18), and one section was detached (see Figure 5.19) and bent, affecting the sign (see Figure 5.20). Wind vibrations may have induced the cracks and triggered the bent.

Figure 5.17: Sign mount attached to handrail

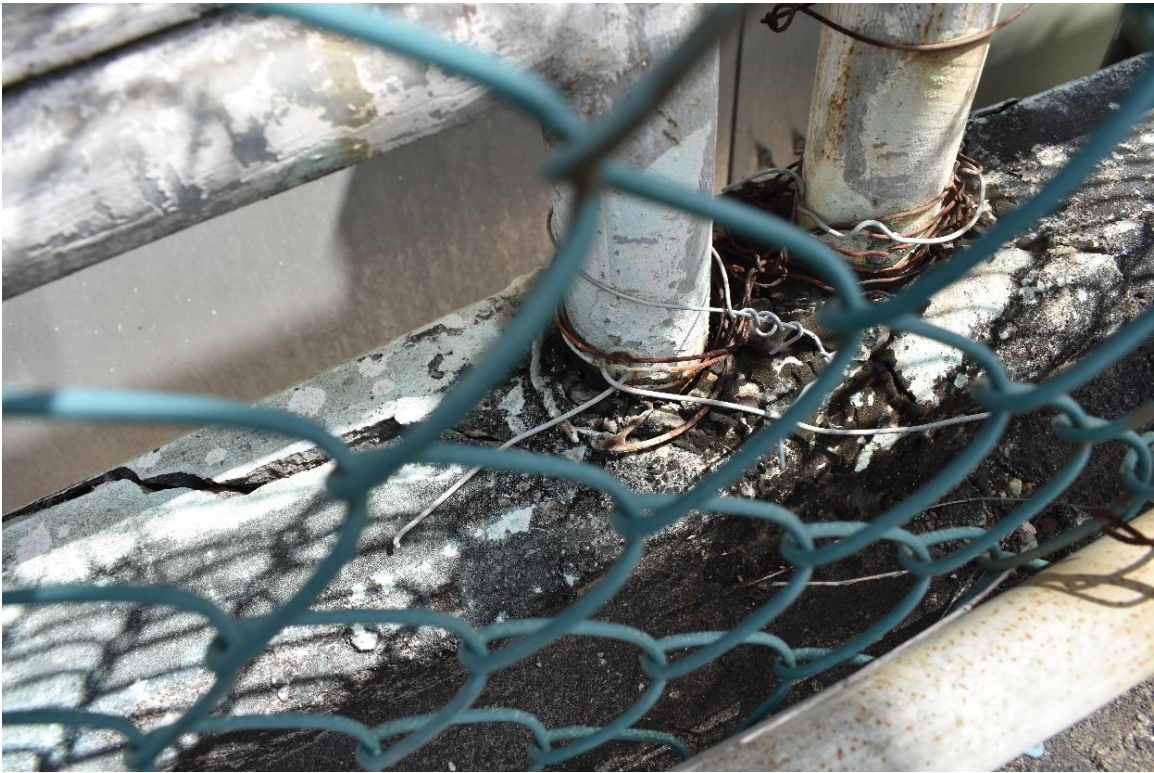
Figure 5.18: Cracks at the base of the handrail posts

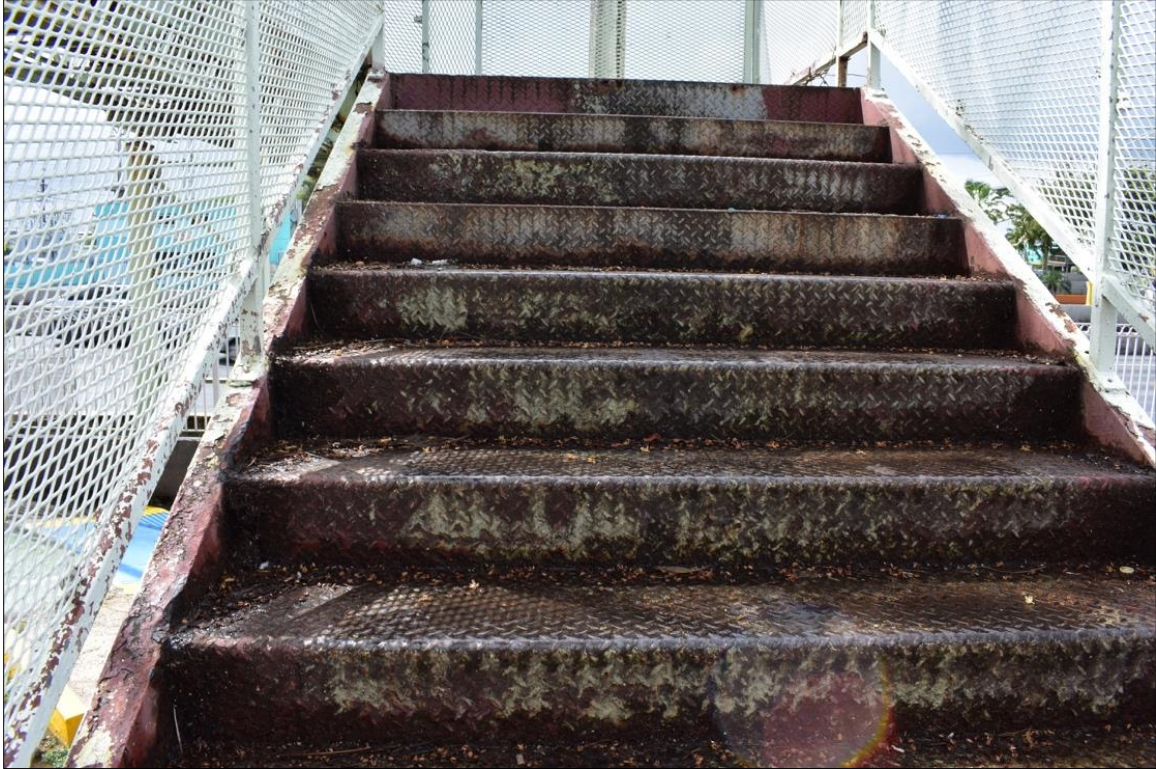
During the inspection, the stairs and deck exhibited corrosion, as shown in Figure 5.61 and Figure 5.62, respectively. It can also be observed in Figure 5.62 that sections of the security meshing attached to the guardrail had fallen off. Gaps and holes in the deck were observed as shown in Figure 5.63 and Figure 5.64.

Figure 5.61: Corrosion on stairway

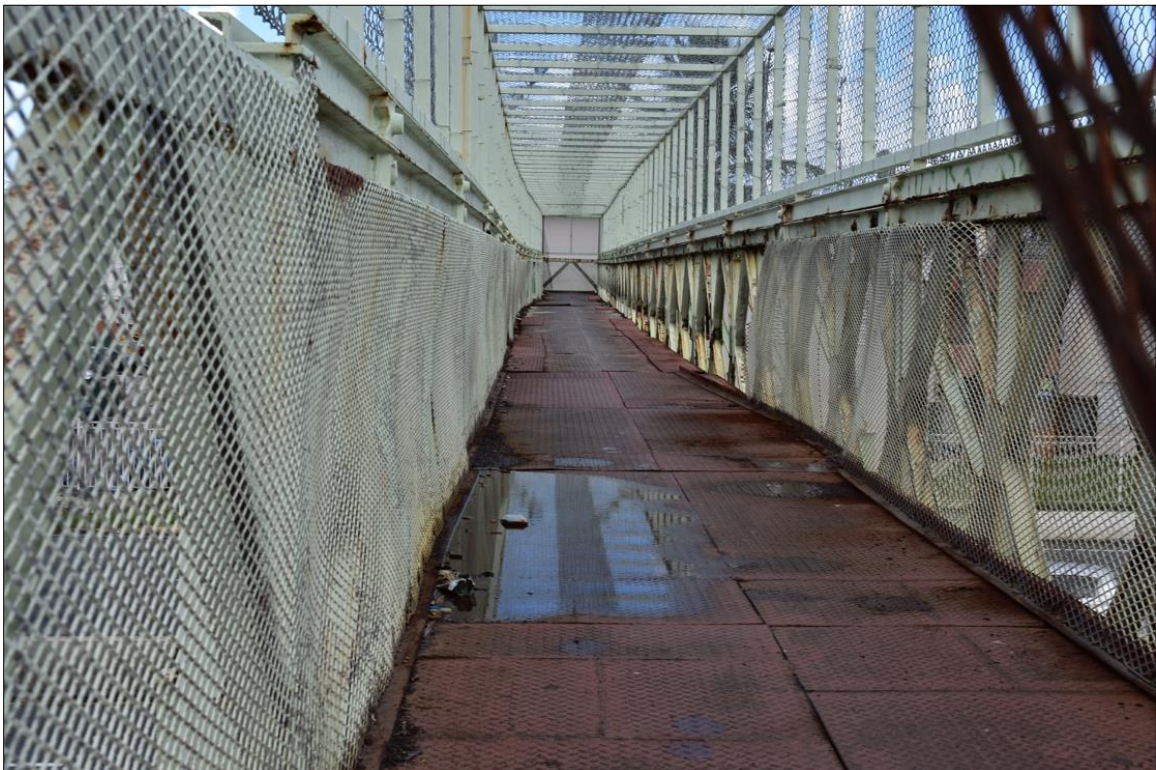
Figure 5.62: Corrosion on deck and section of guardrail without security meshing

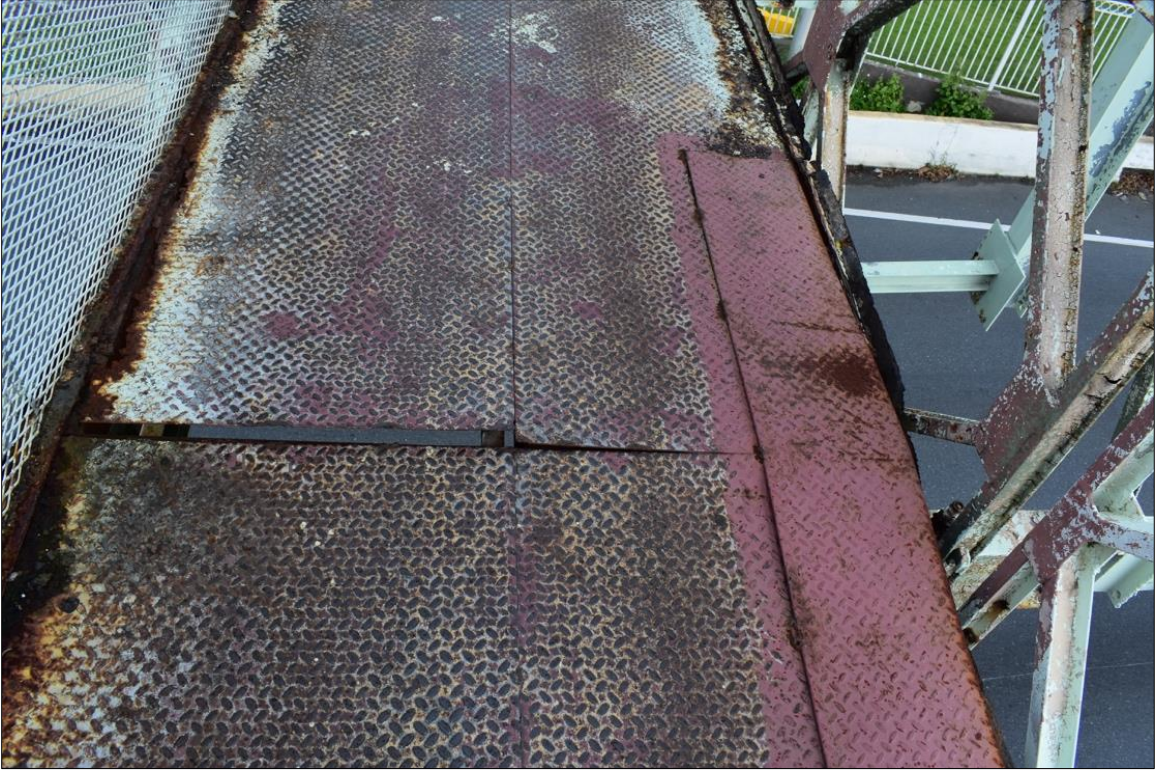
Figure 5.63: Detached plates

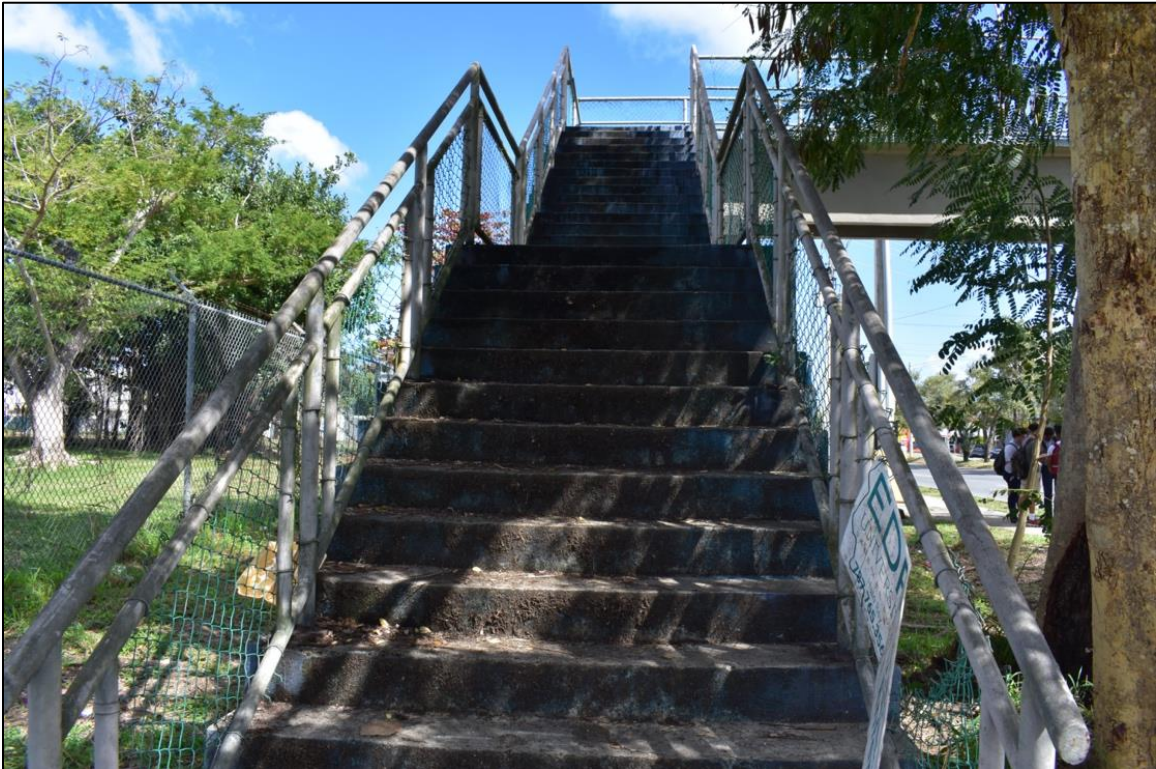
Figure 6.12: Mold on stairways of PB 1418

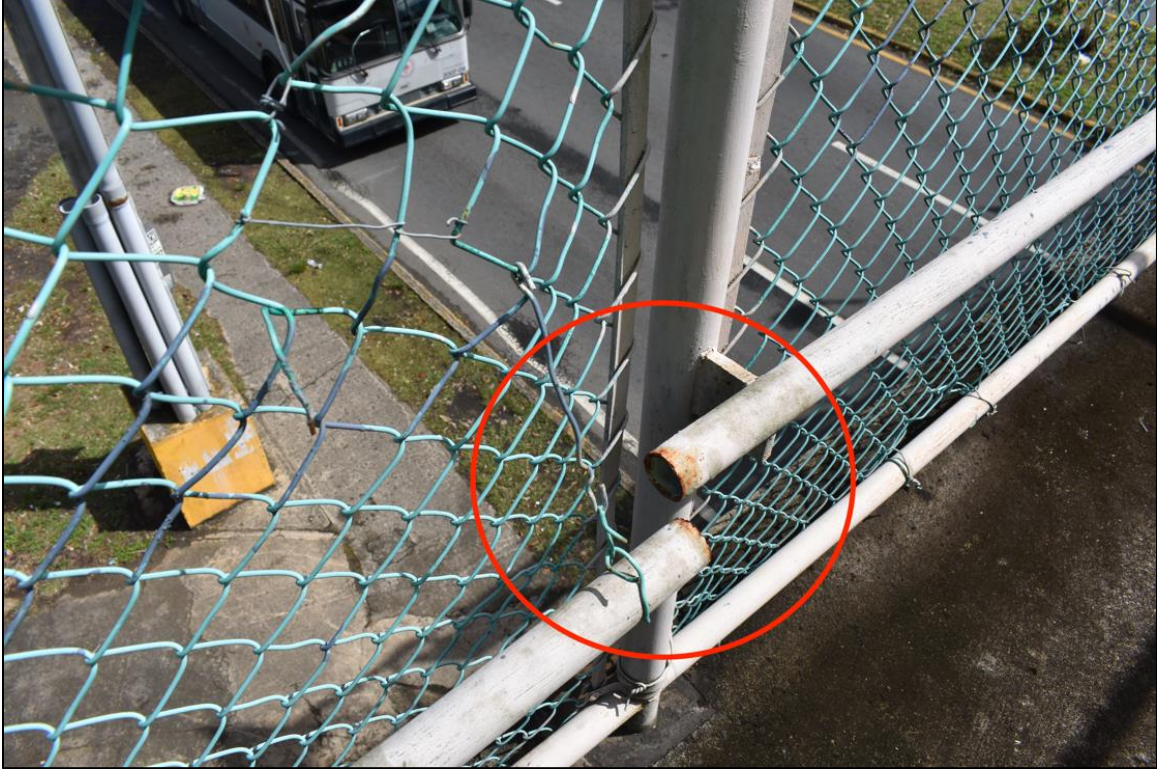
Figure 6.15: Broken railings on PB 1418

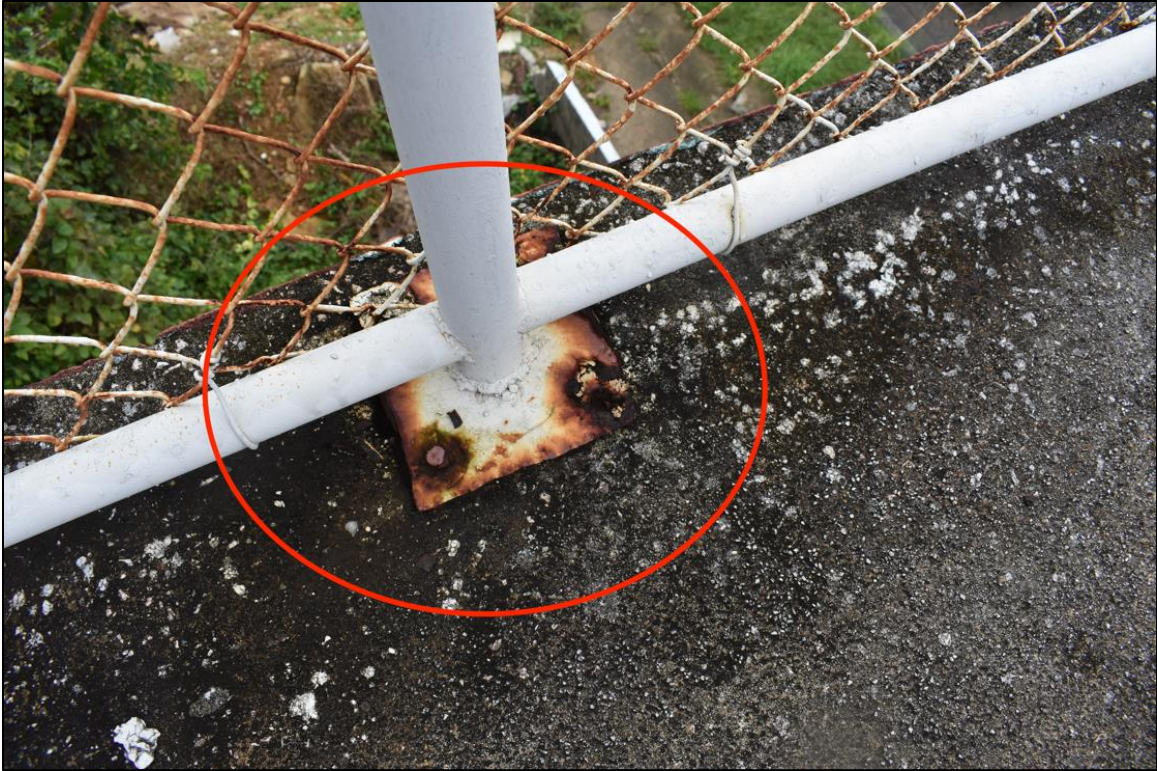
Figure 6.23: Corrosion of security fencing on PB 1736

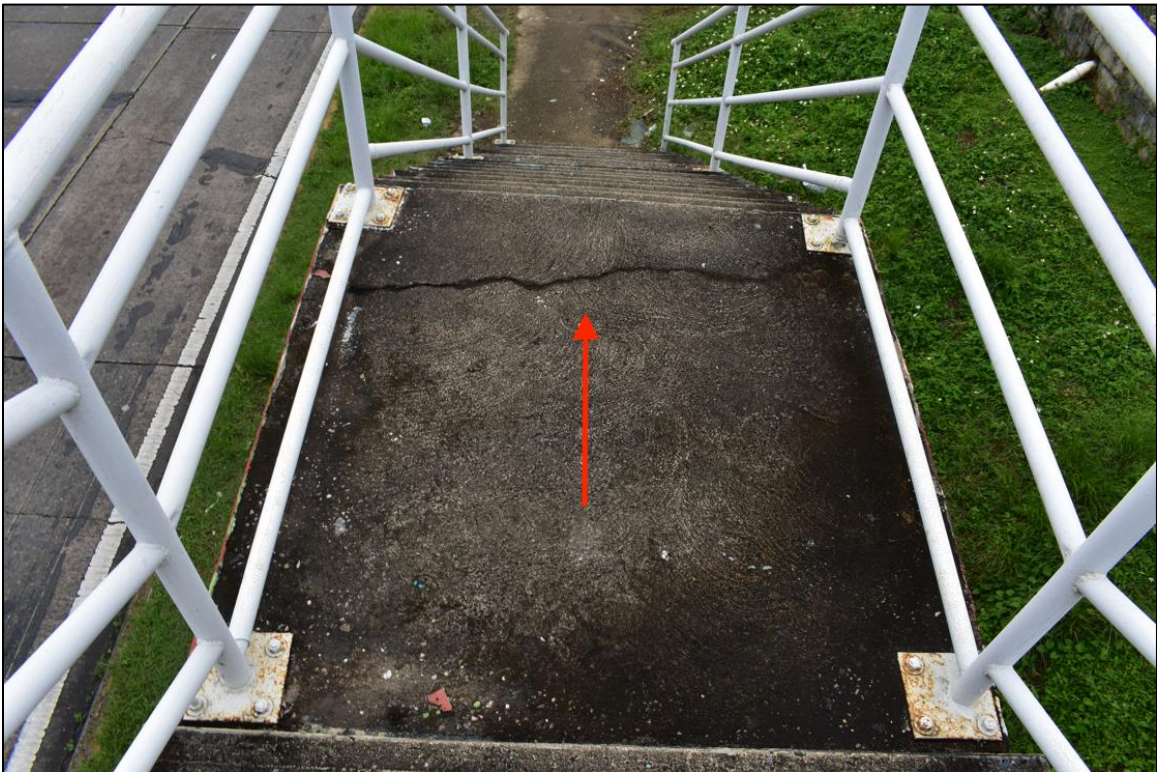
Figure 6.24: Crack on stairway of PB 1736

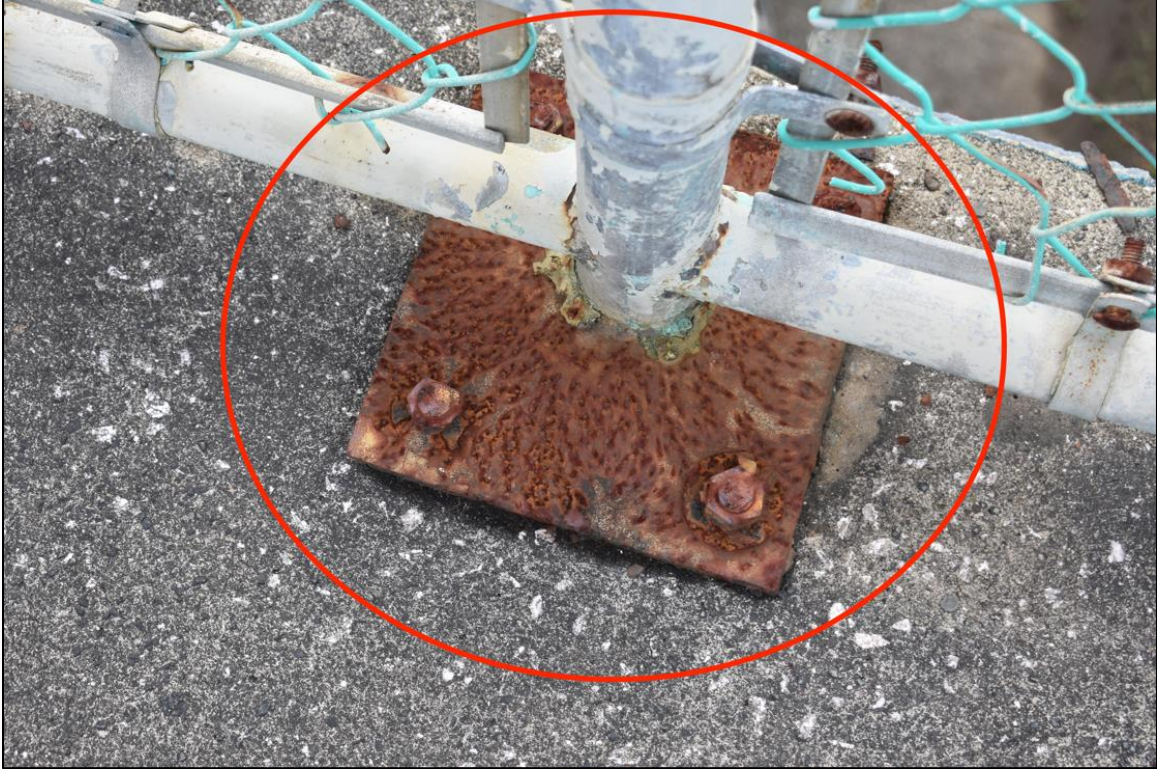
Figure 6.26: Corrosion of security fencing of PB 1743

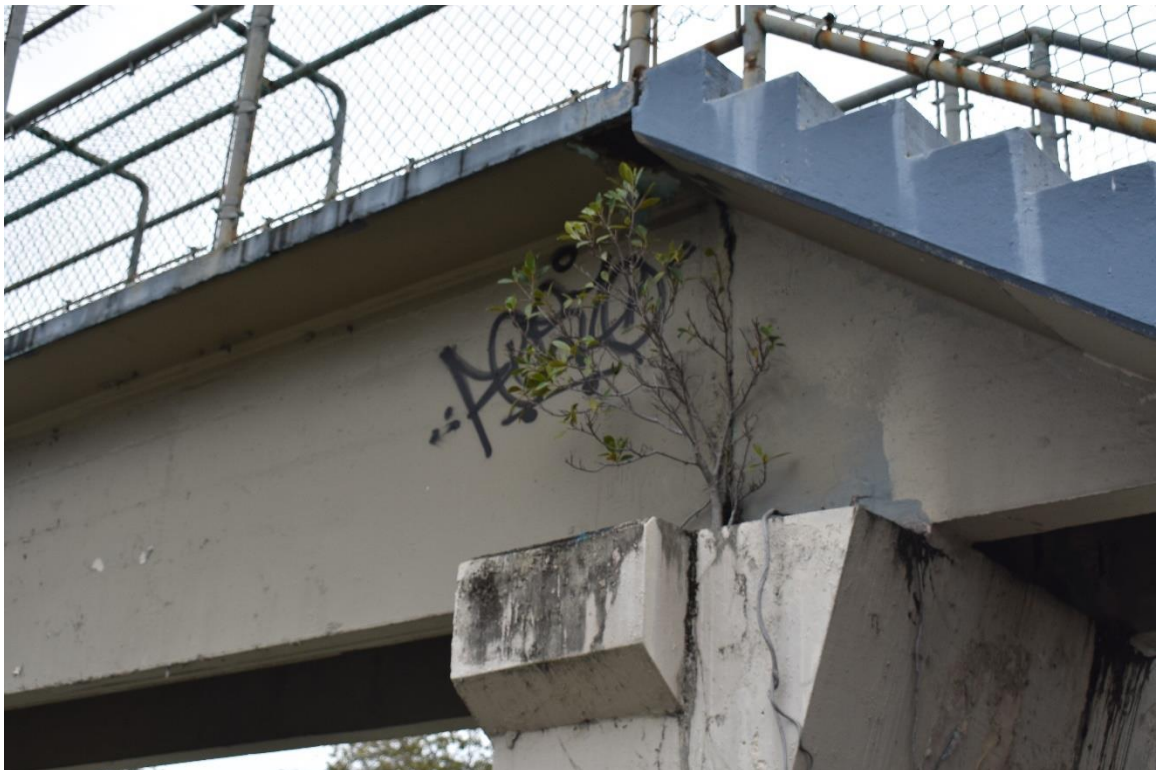
Figure 6.27: Vegetation on pier of PB 1743

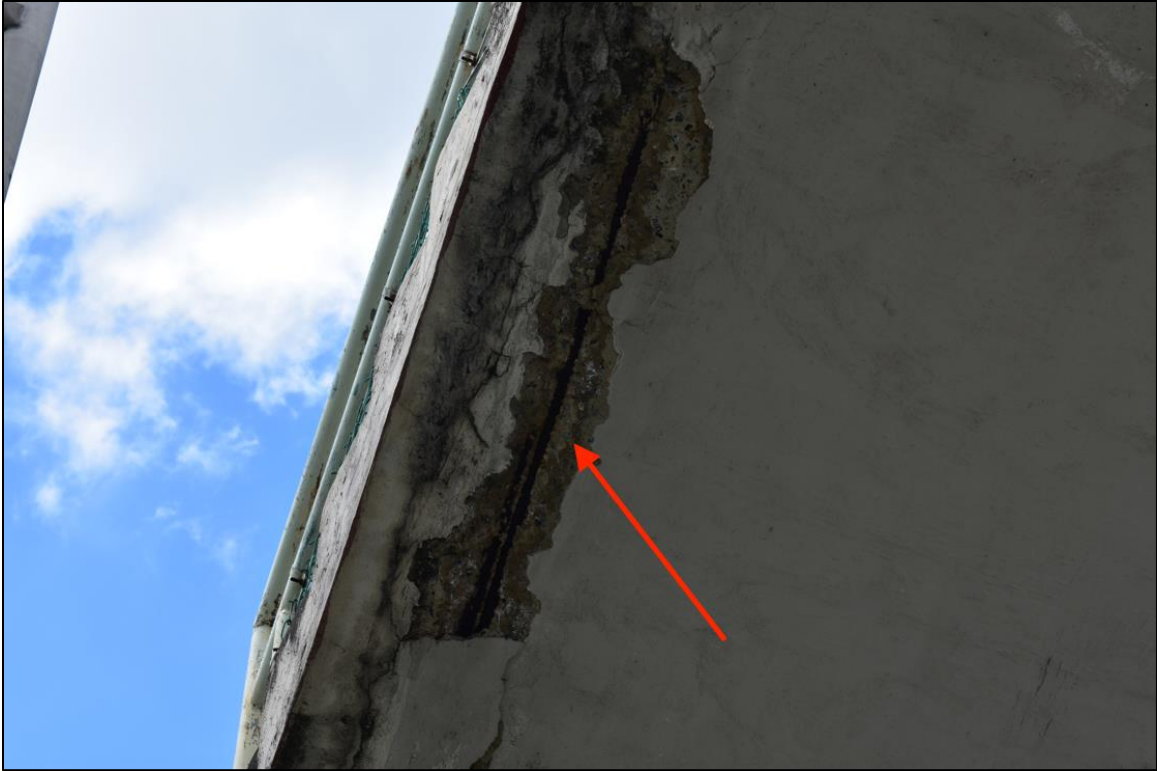
Figure 6.30: Exposed rebar on PB 2087

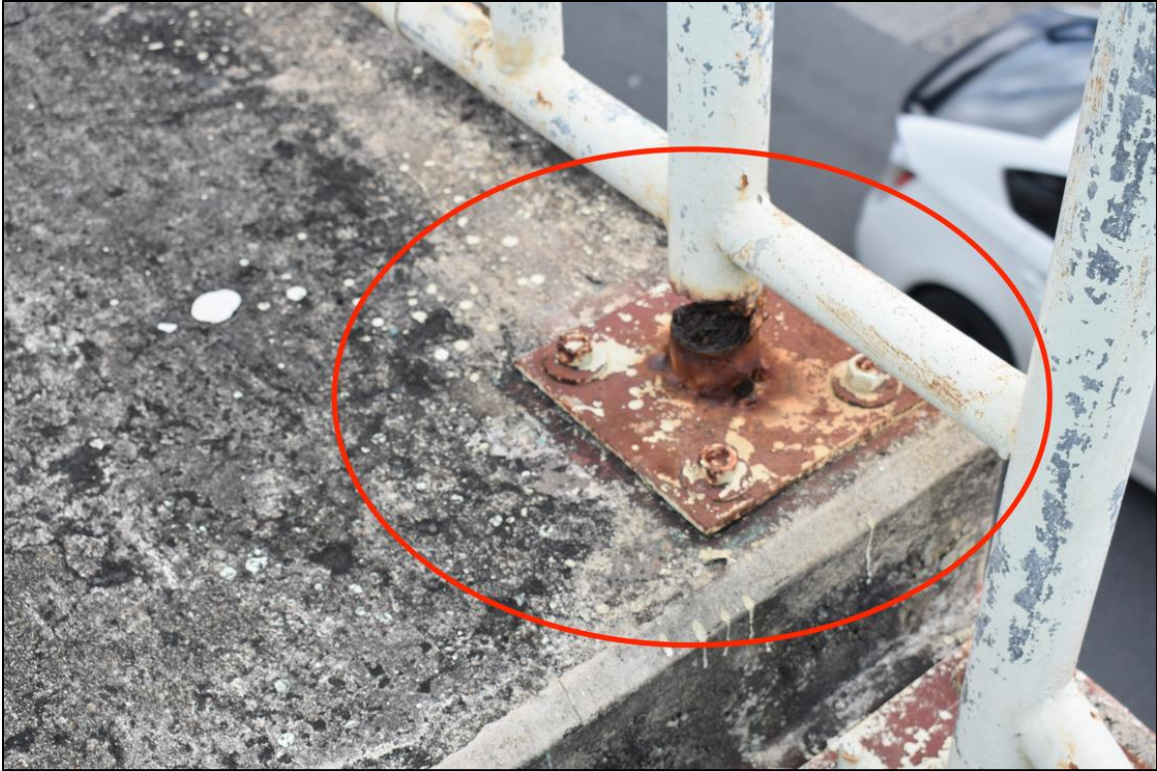
Figure 6.32: Corrosion of guardrail on PB 2087

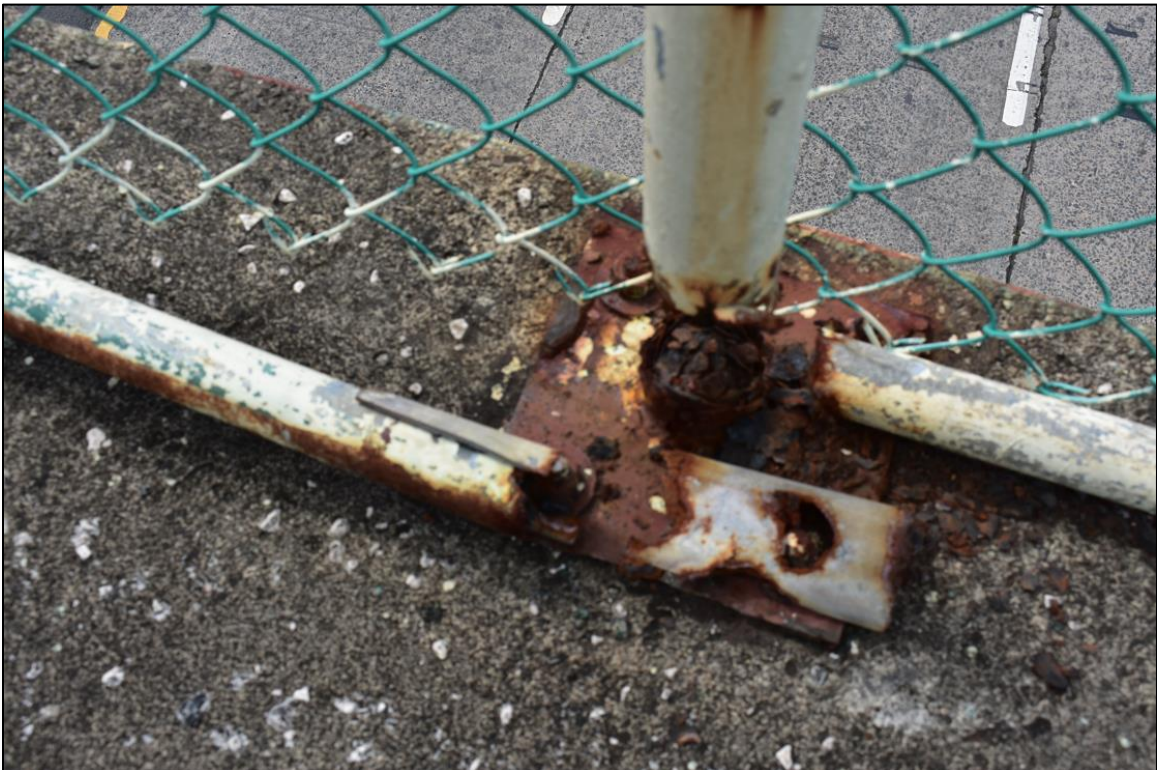
Figure 6.33: Corrosion of security fencing on PB 2087

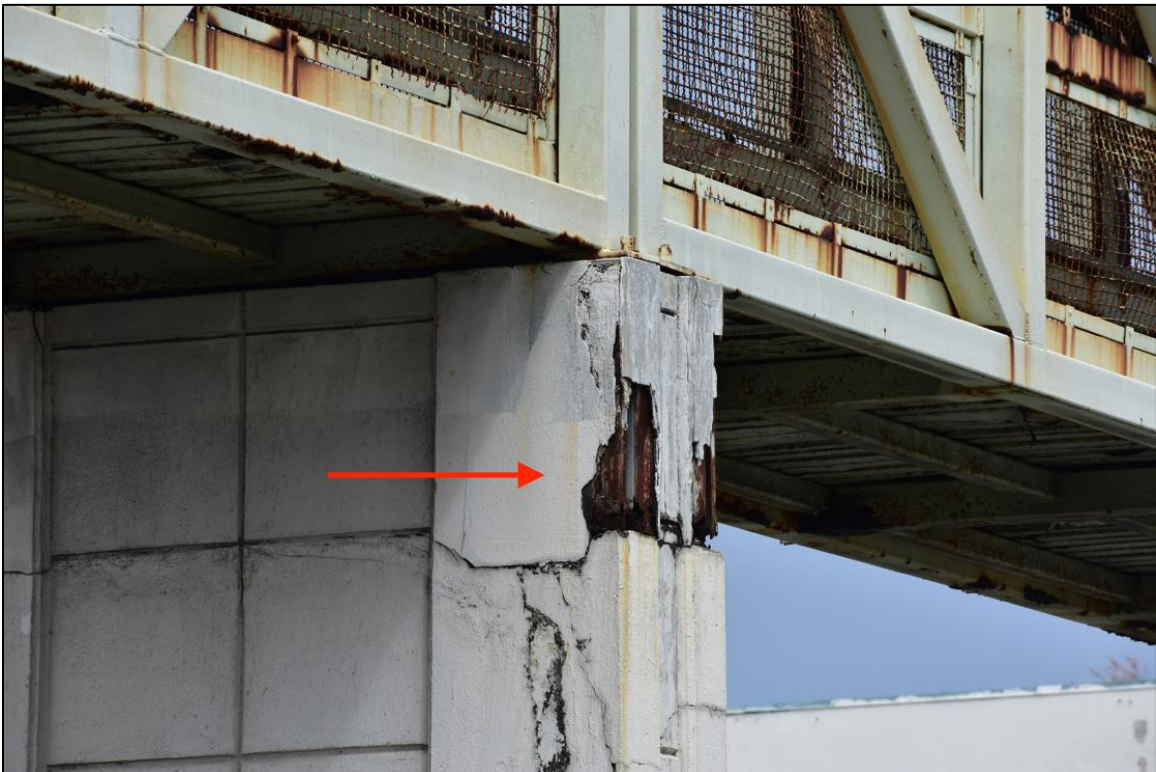
Figure 6.37: Damage to the façade and signs of corrosion on the center pier of PB 2682

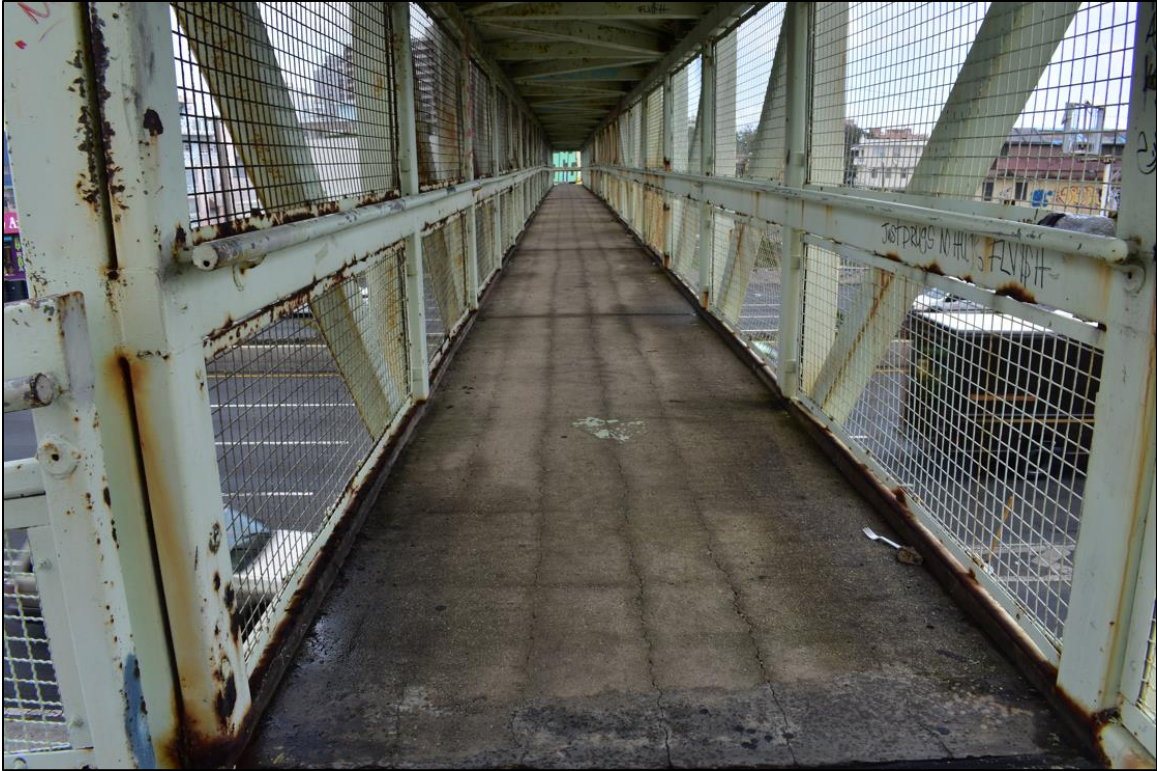
Figure 6.38: Corrosion on the superstructure of PB 2682

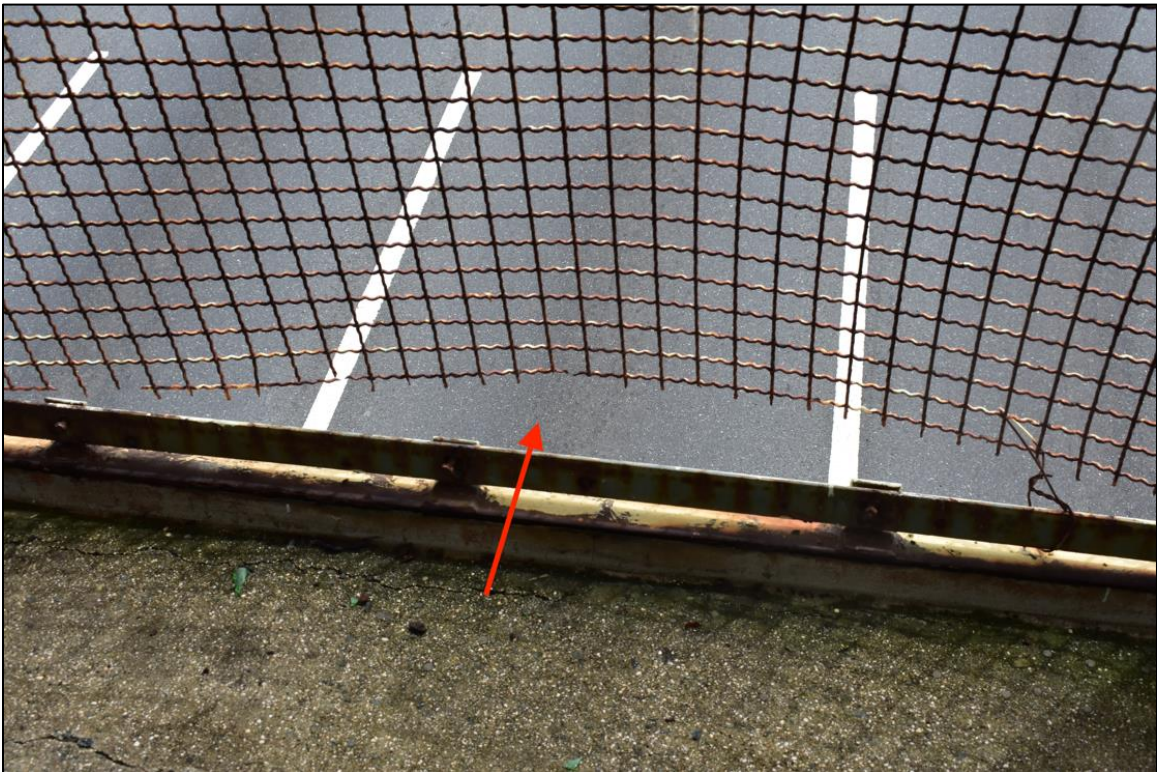
Figure 6.39: Detachment of security mesh on PB 2682

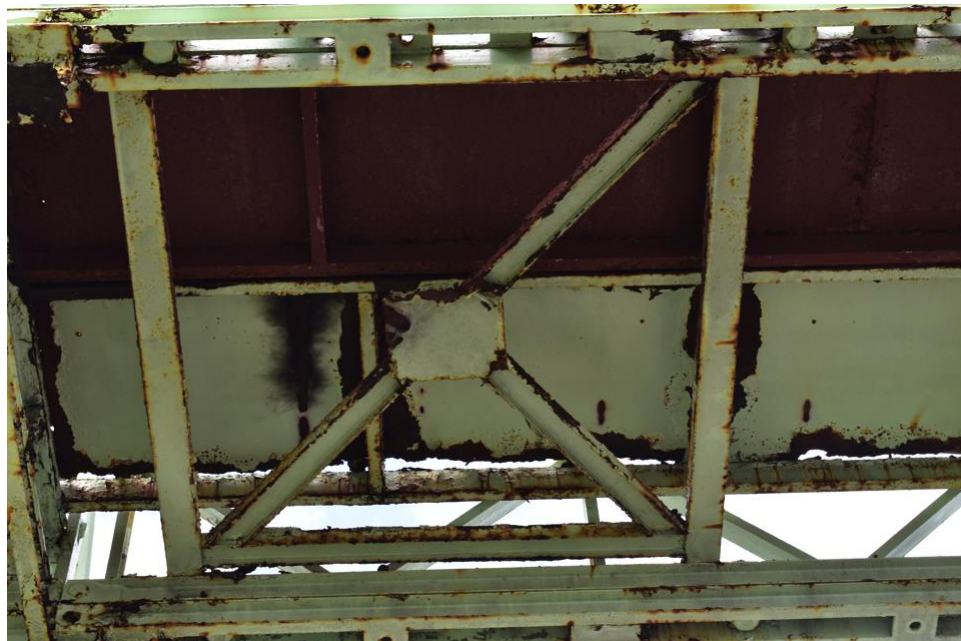
- Deck - Condition State 4 - It was evaluated in this condition due to the corrosion along the complete deck, causing some holes. Also due to corrosion, some bracing elements had fallen off. Falling elements are a major threat to safety since the bridge is located above a principal roadway of Puerto Rico. Figure 5.8 shows that corrosion had already eaten up part of the steel deck surface (as appreciated by the sunlight passing through the deck) and that diagonal bracings have fallen off. The type of diagonal bracing that is missing in Figure 5.8, can be somewhat appreciated in Figure 5.9, which itself shows an incomplete set of diagonals.

Figure 5.9: Missing Bracing Elements

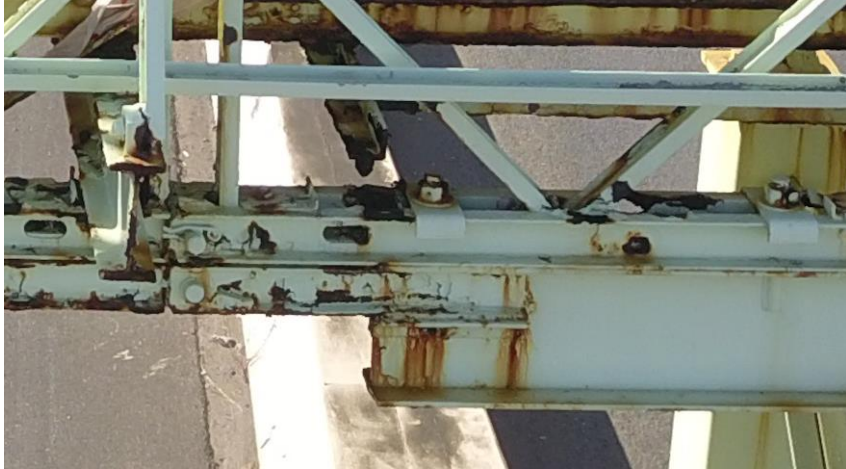
Figure 5.11: Corrosion in Truss Element (Example 2)

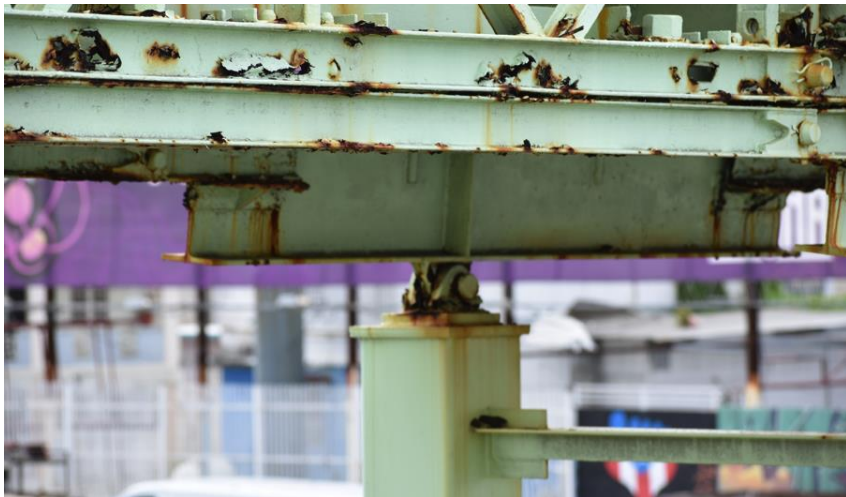
Figure 5.12: Corrosion in Truss Element (Example 3)

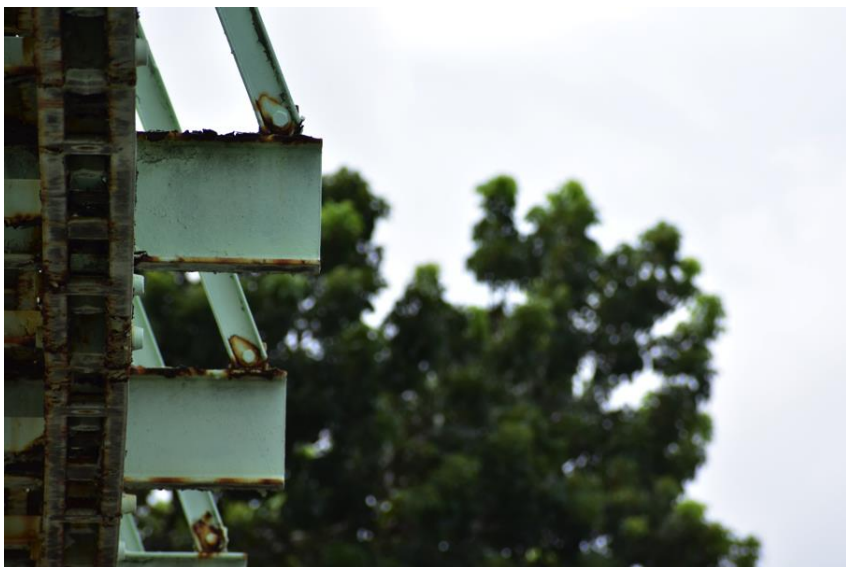
Figure 5.13: Corrosion in Floor Beams (Example 1)

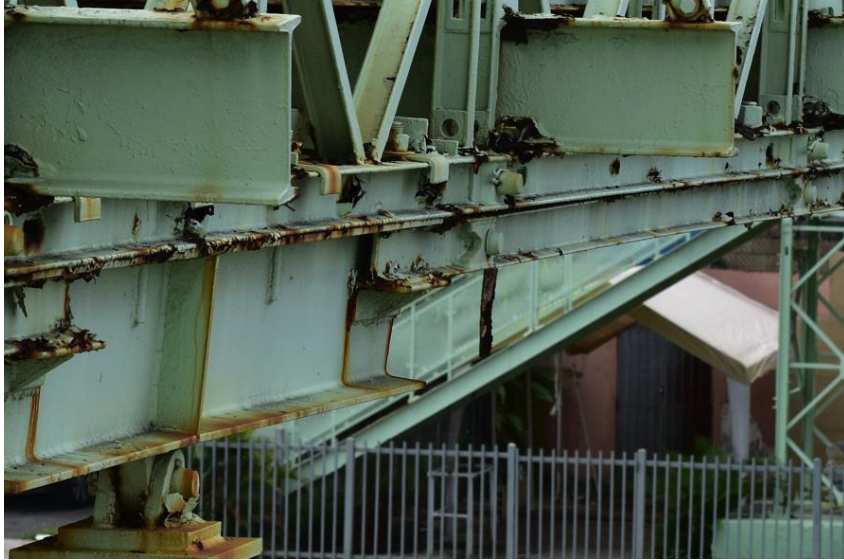
Figure 5.14: Corrosion in Floor Beams (Example 2)

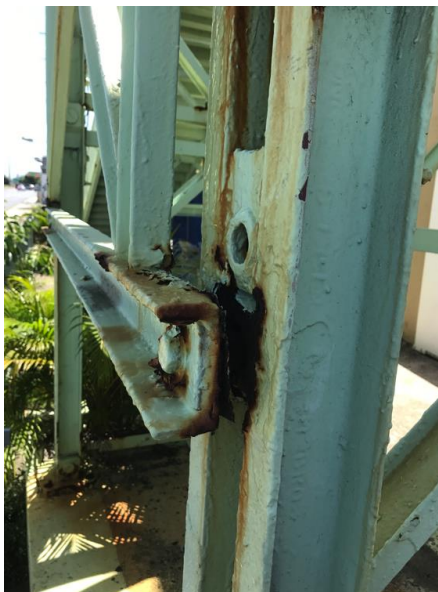
- Substructure - Condition State 4 - The substructure consists of the columns and the column tower. Even though the columns were found in good condition, the column towers were missing connections. Due to the missing connections the overall condition given to the substructure was 4, as in the case of the superstructure. In Figure 5.15 and Figure 5.16 a loose connection and a section loss due to corrosion are presented, respectively.

Figure 5.15: Loose Connection at Column Tower

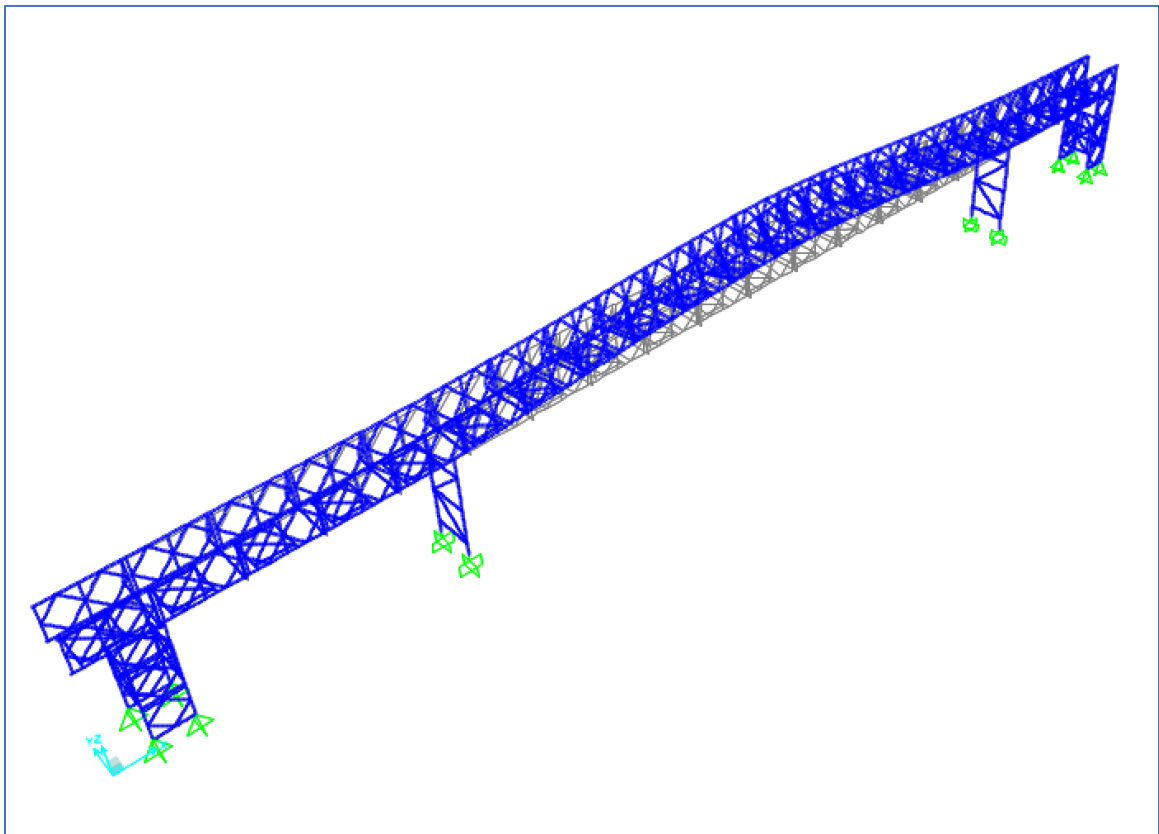
Figure 8.12 presents an image of the resulting lateral deflections due to wind action. It can be appreciated that the general behavior observed on the bridge, with the plastic deformation, is captured.

Figure 8.12: Lateral Deflections due to Wind - With Signs Included
