Improving Transportation Infrastructure Resilience against Hurricanes, other Natural Disasters, and Weathering: Part III - Analysis of motor vehicle bridges failures due to Hurricane Maria

FINAL REPORT
August 2022

Transportation Infrastructure Research Center – TIRC
Polytechnic University of Puerto Rico
377 Ponce de Leon Ave, San Juan, PR 00918

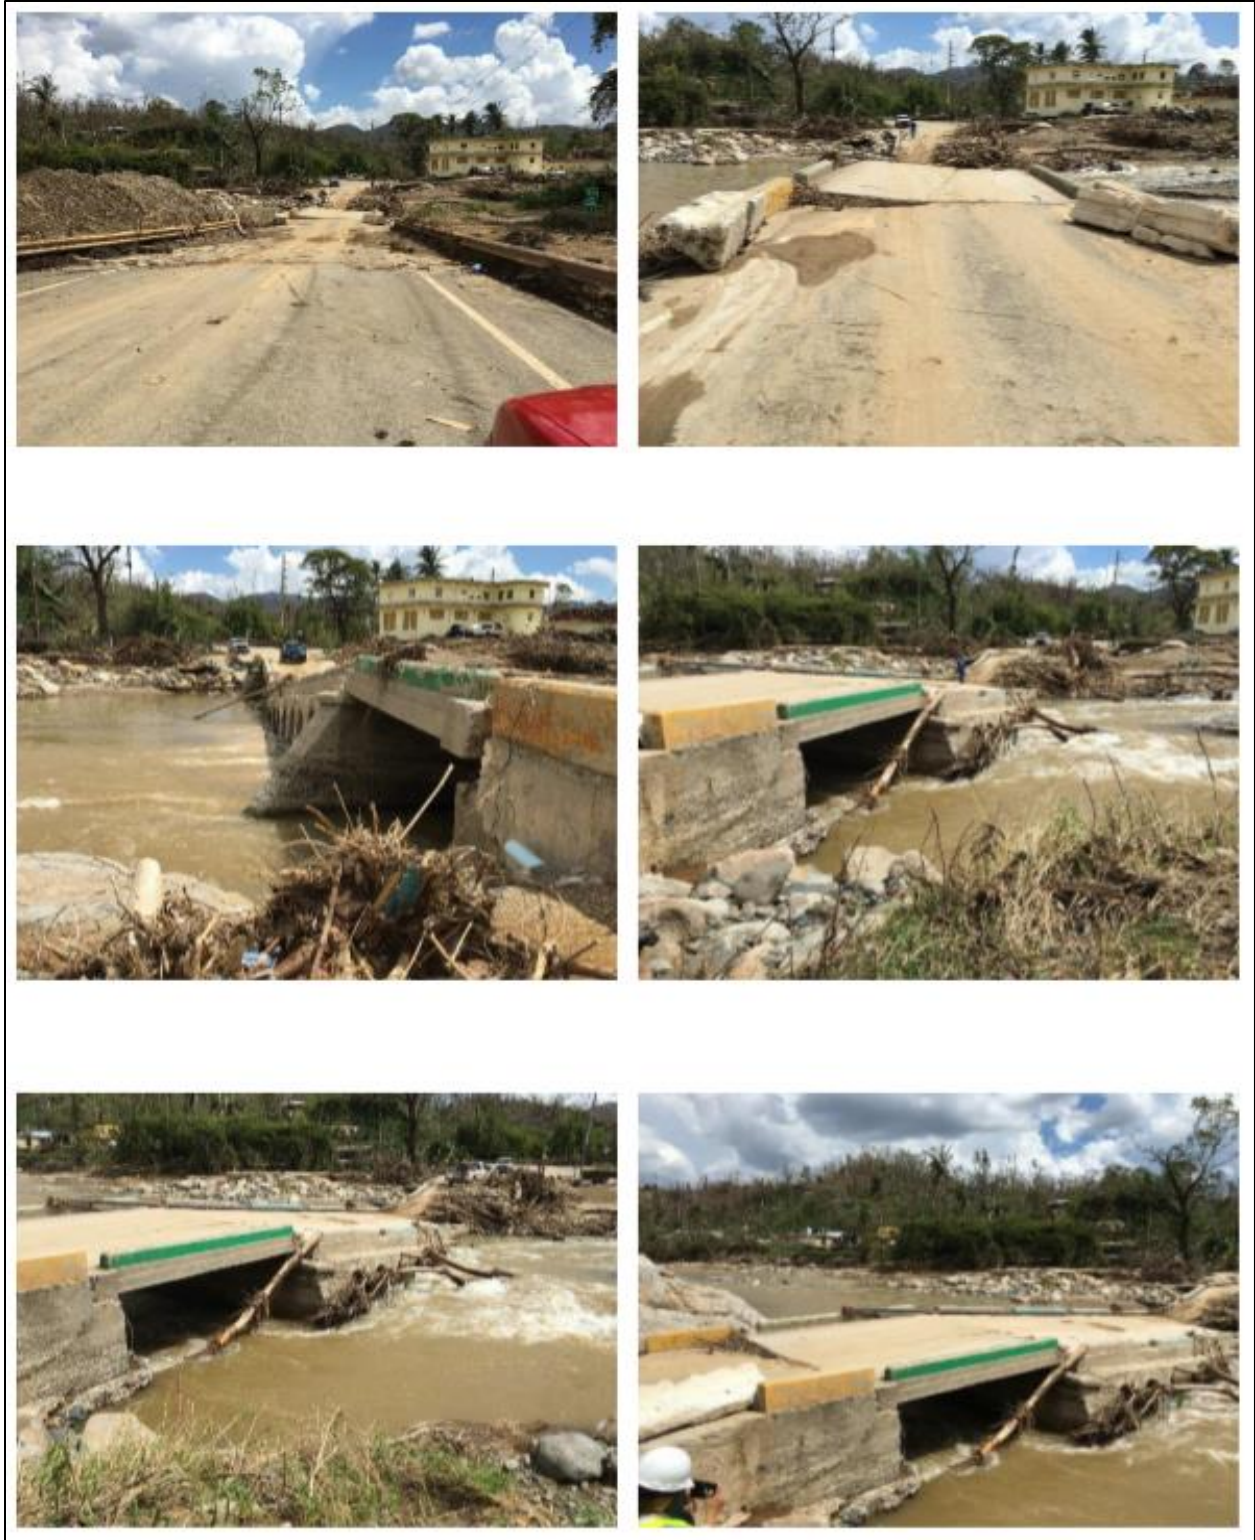
Figure 2-14: Bridge 505 photos from October 12, 2017 inspection (source: PRHTA)

INCLUDE PHOTOS IN A SEPARATE SHEET

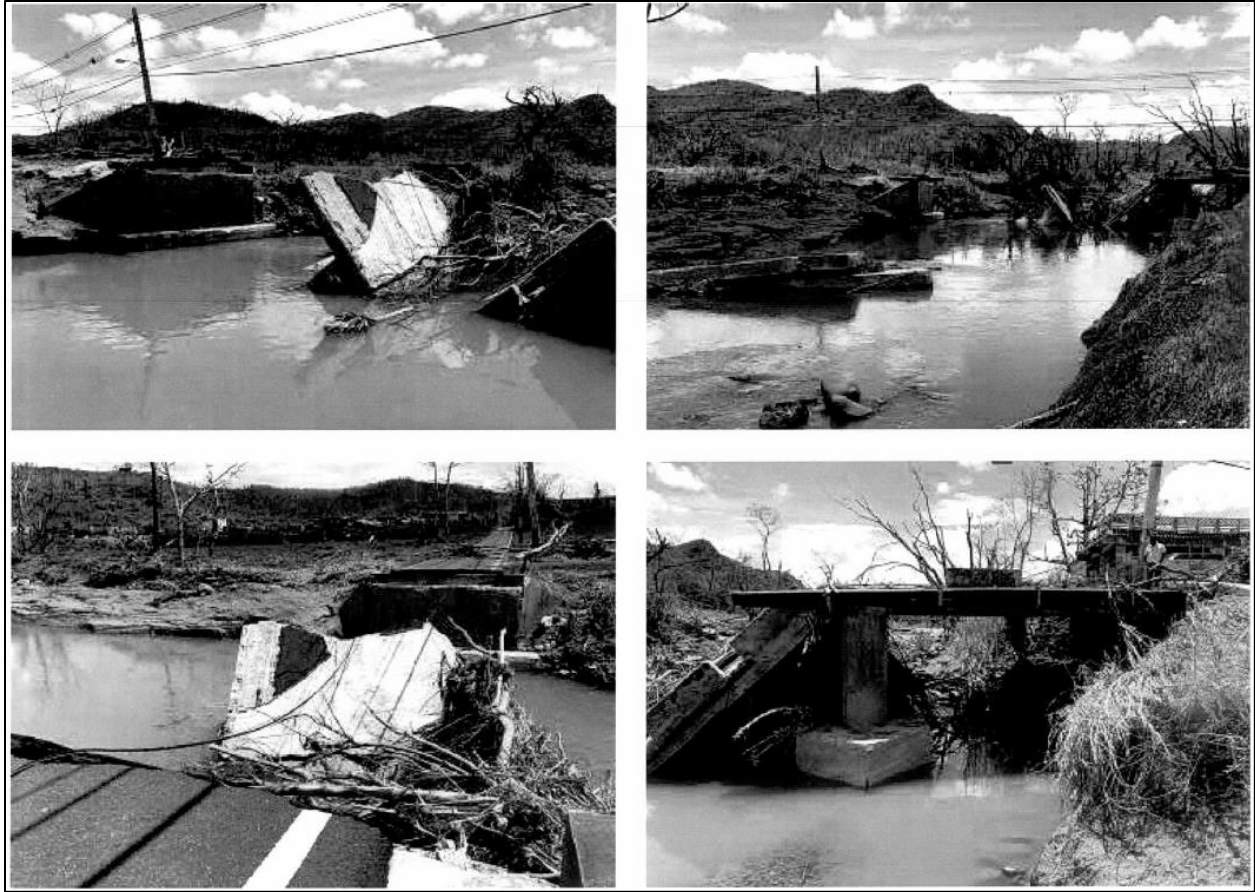
Figure 2-34: Bridge 653 photos from September 25, 2017 inspection (source: PRHTA)

COMMENTS: <u>Bridge already collapsed and reported to CoE</u> <u>for traffic/roadway closure and/or repair.</u>		
INCLUDE PHOTOS IN A SEPARATE SHEET

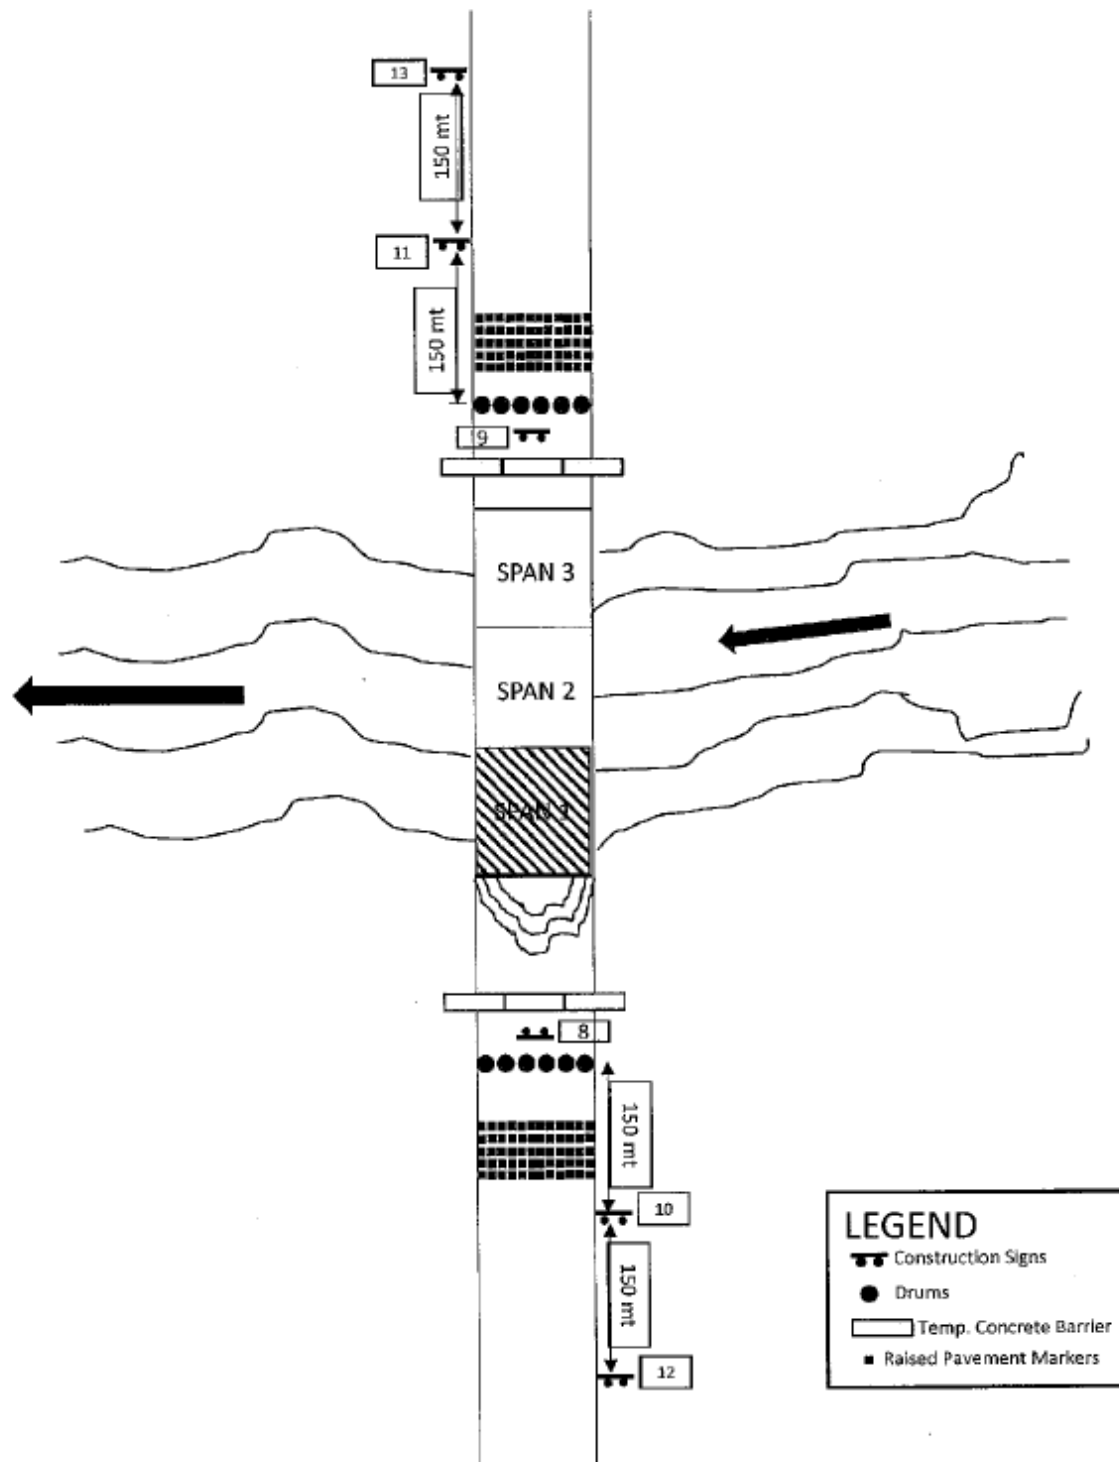
Figure 2-74: Diagram from October 9, 2017 report indicating collapsed span of Bridge 769 (source: FHWA)

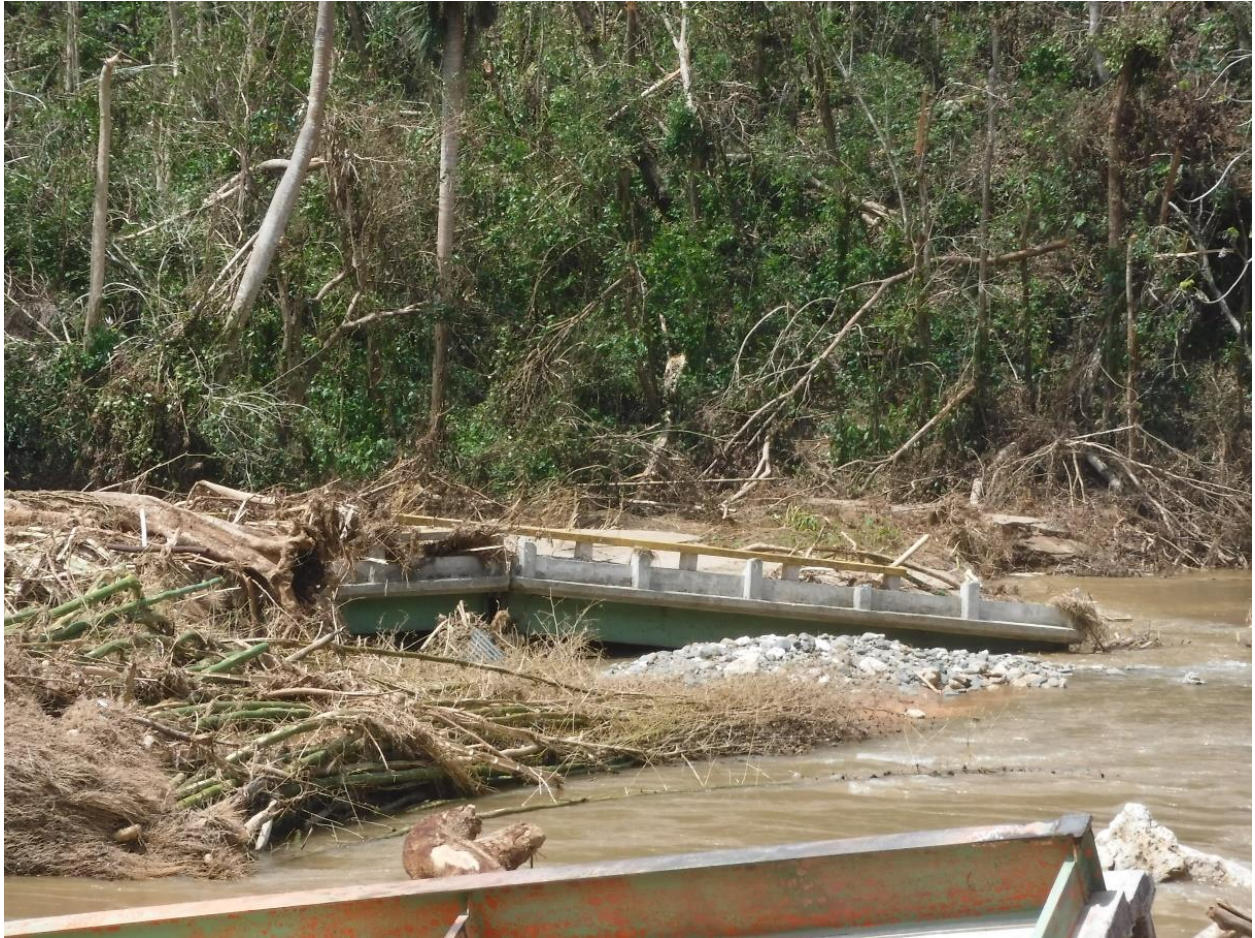
Figure 2-142: Image of deck of Bridge 505 washed down the river (source: PRHTA)

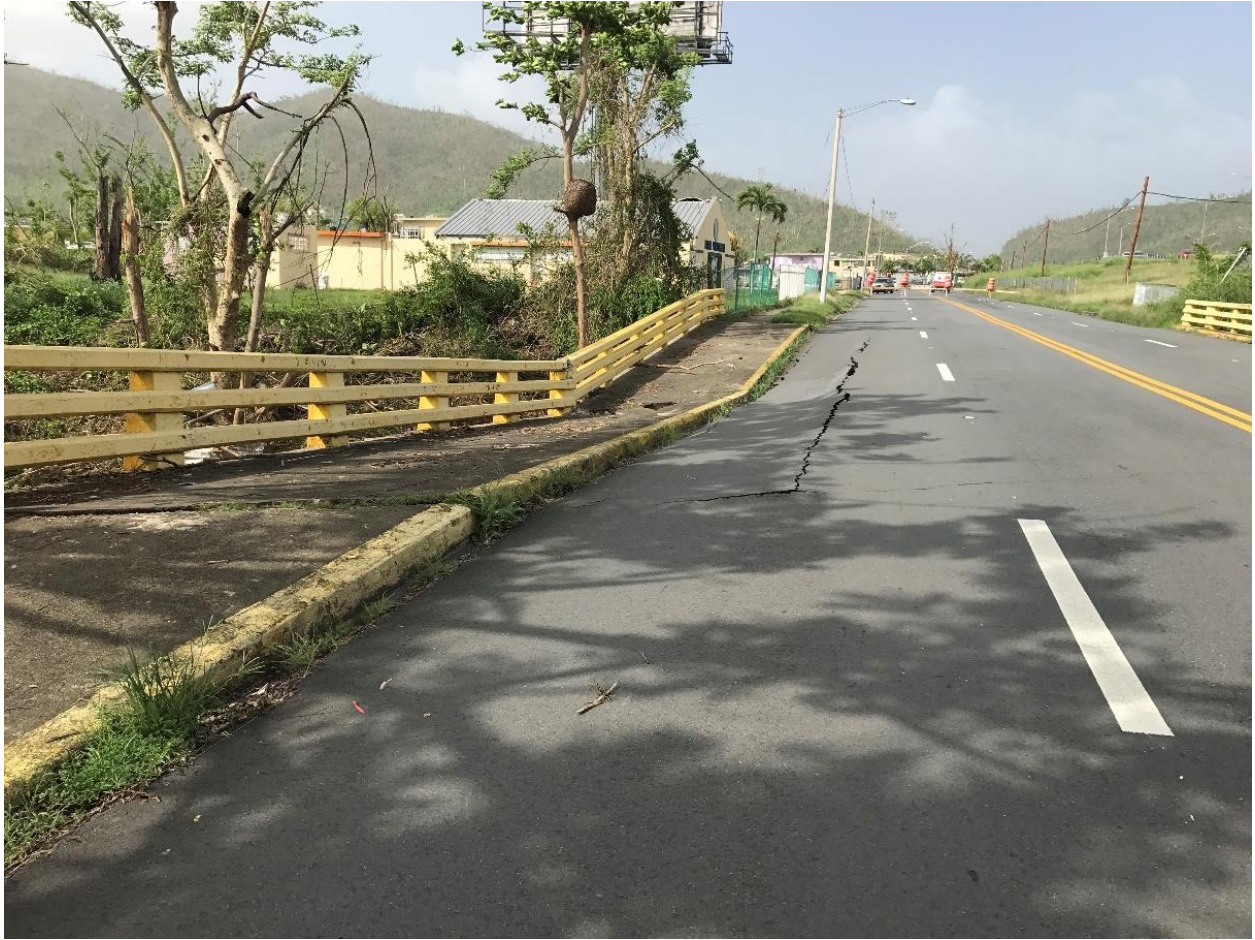
Figure 2-194: Image of damaged Bridge 1453 (source: PRHTA)

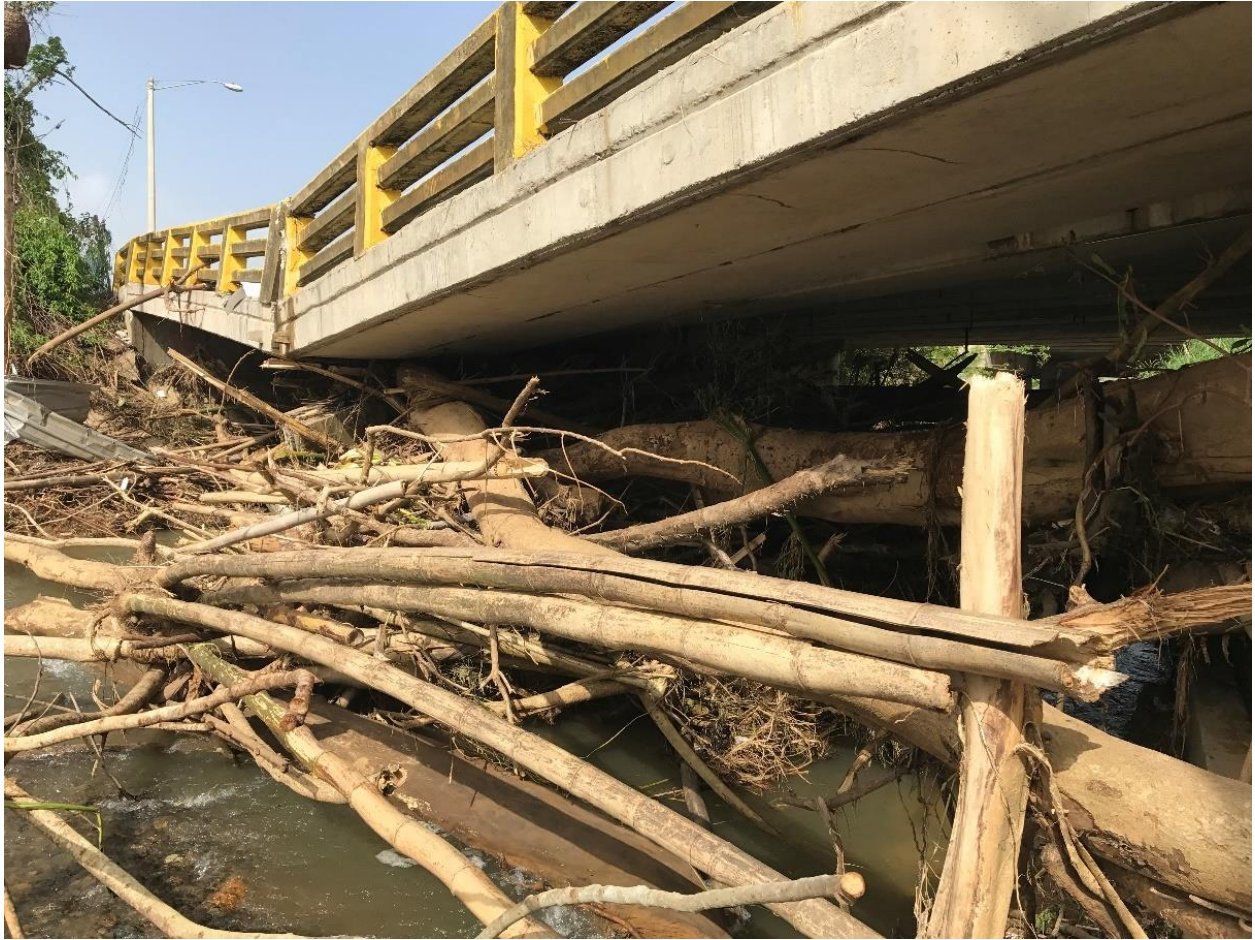
Figure 2-195: Image of damaged Bridge 1453 (source: PRHTA)

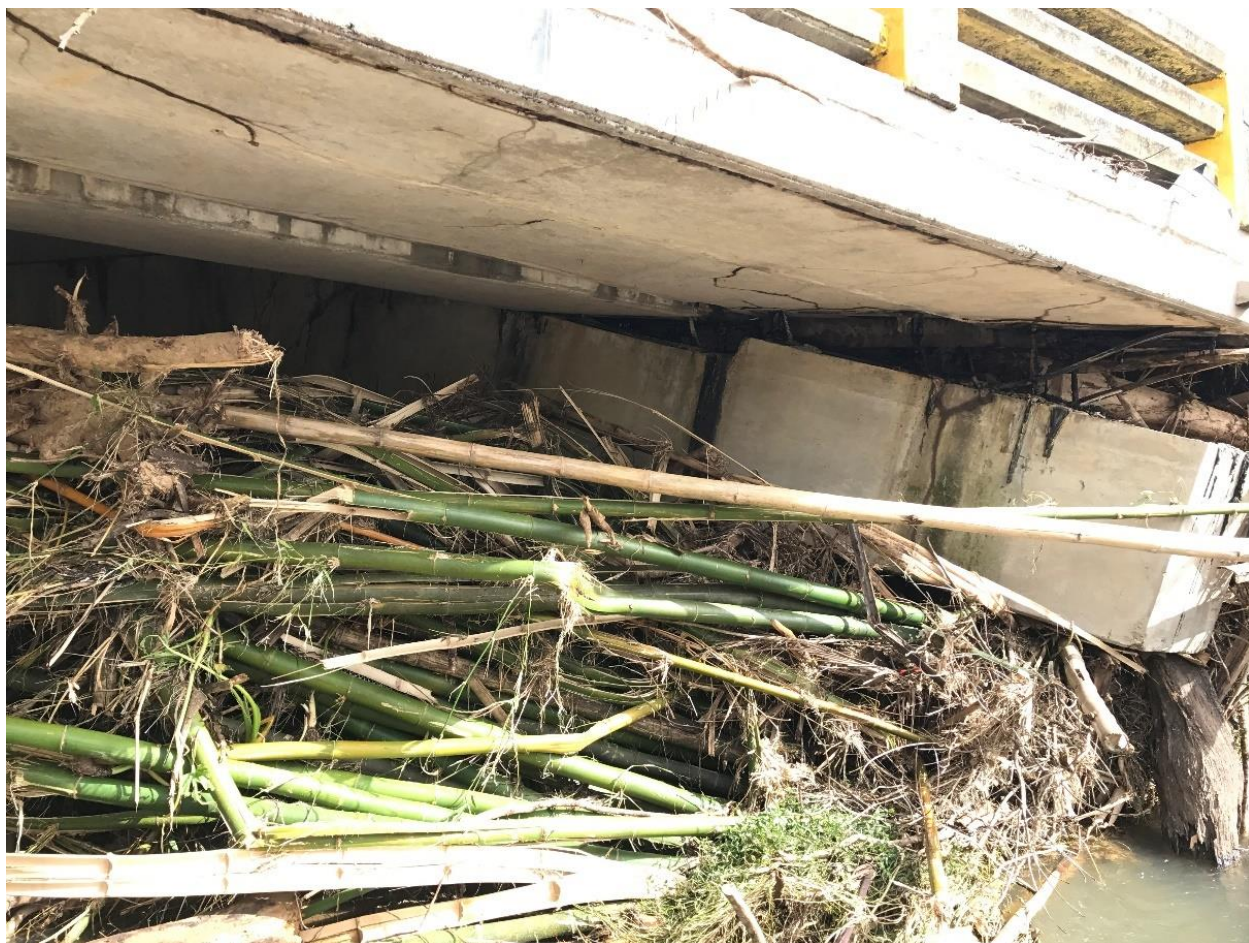
Figure 2-196: Image of damaged Bridge 1453 (source: PRHTA)

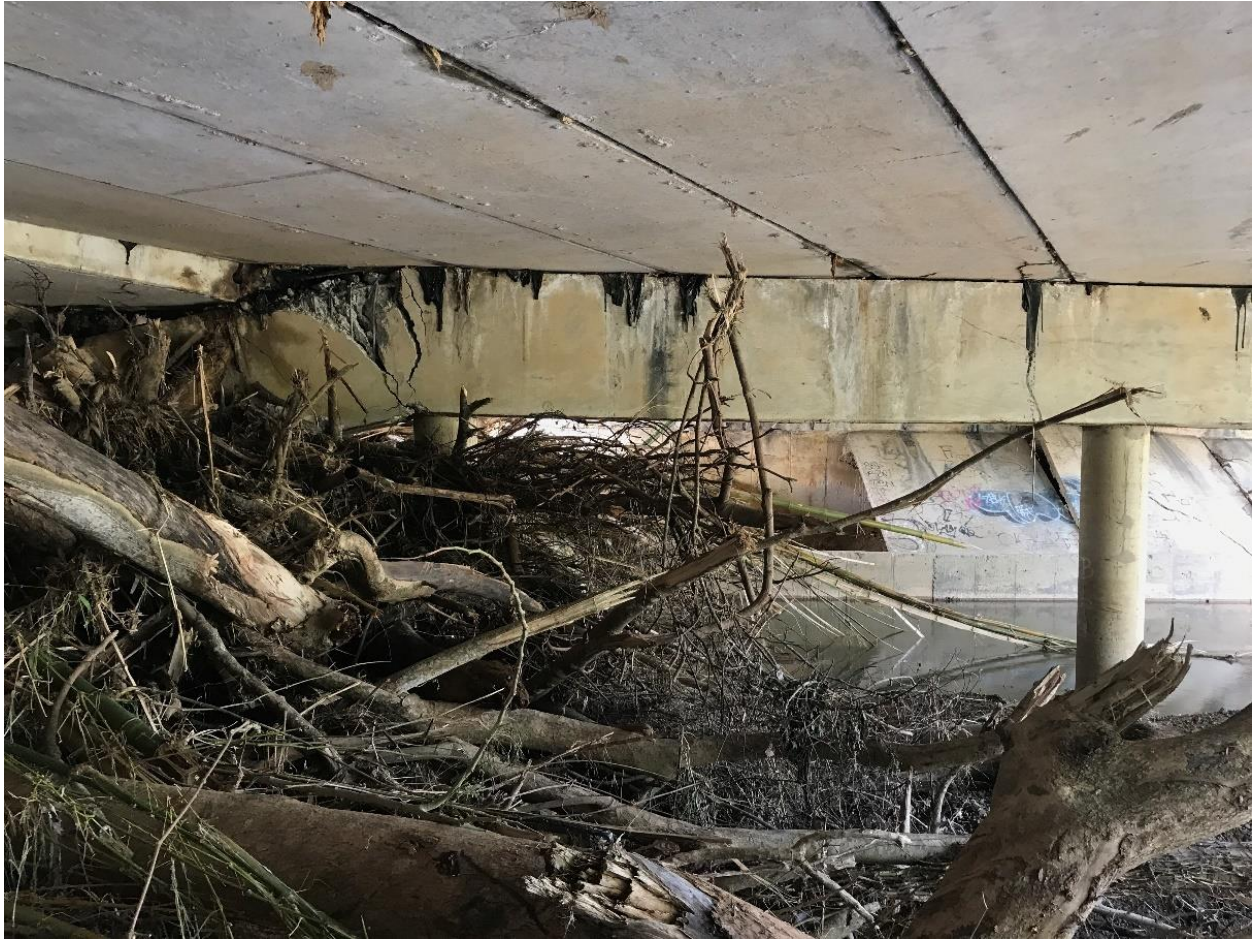
Figure 2-197: Image of damaged Bridge 1453 (source: PRHTA)

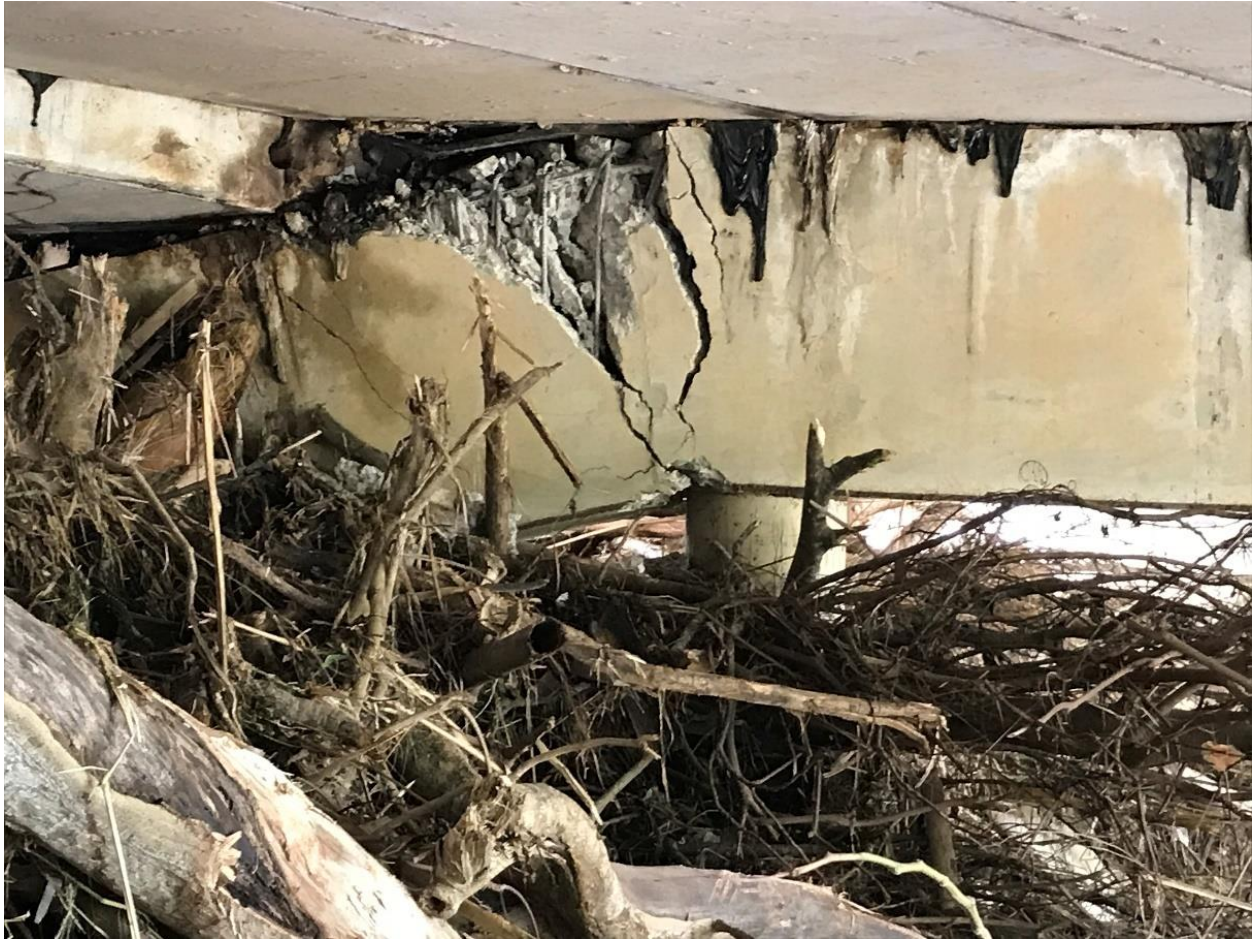
Figure 2-198: Image of damaged Bridge 1453 (source: PRHTA)

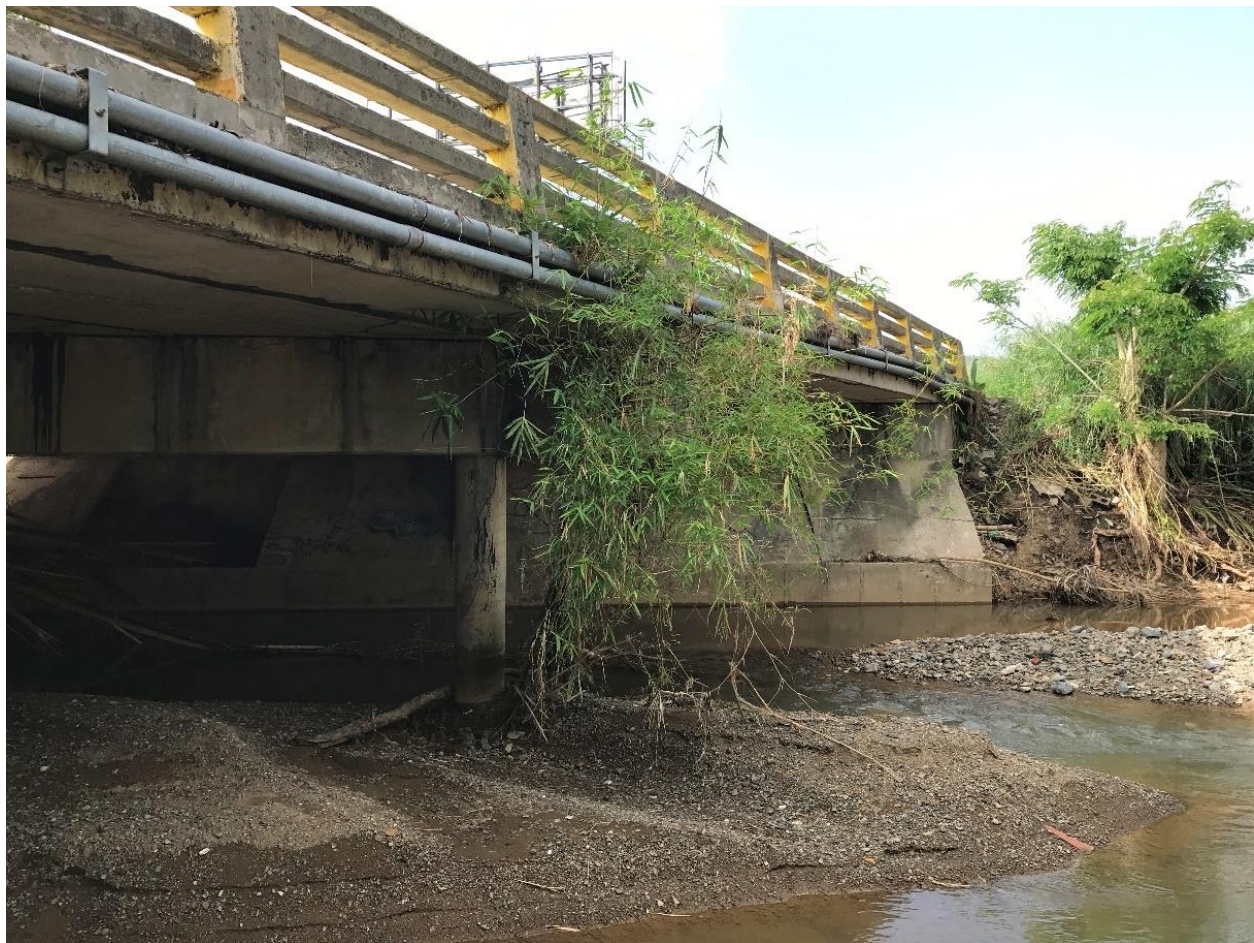
Figure 2-199: Image of damaged Bridge 1453 (source: PRHTA)

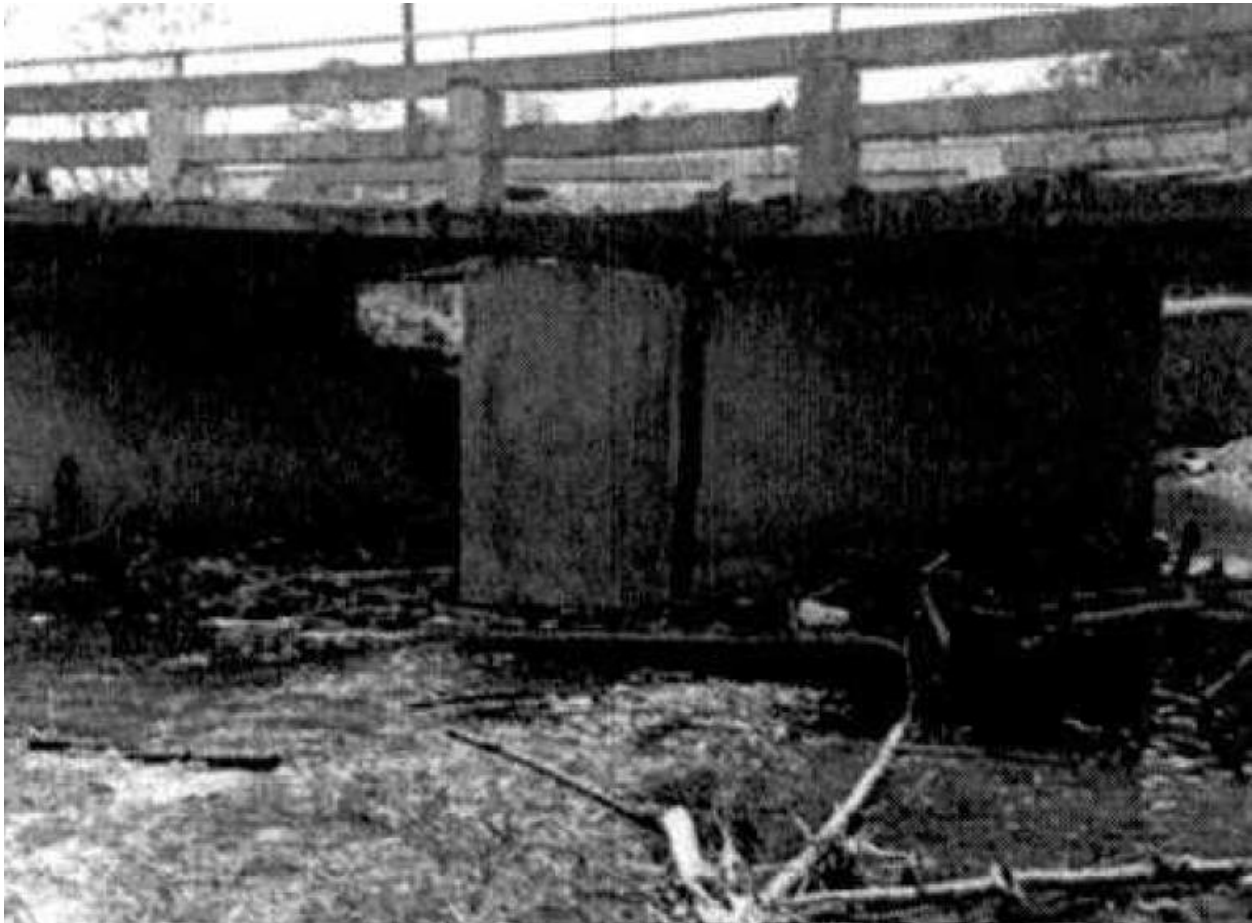
(Extracted from Figure 2-20)

Note: Bridge was not among the bridges identified as collapsed in the PRHTA inventory. Therefore, no additional information was obtained from PRHTA, including inspection reports prior to Hurricane Maria. In the final stages of this project, as a final check was given to the inventory, a closer look was given to the report of the inspection conducted after Maria. In this report, the inspector stated in Spanish that the bridge collapsed and that the piers had settled, causing the bridge to deform. He also indicated that, at one end, the approach roadway had lost fill material, producing a huge pothole.

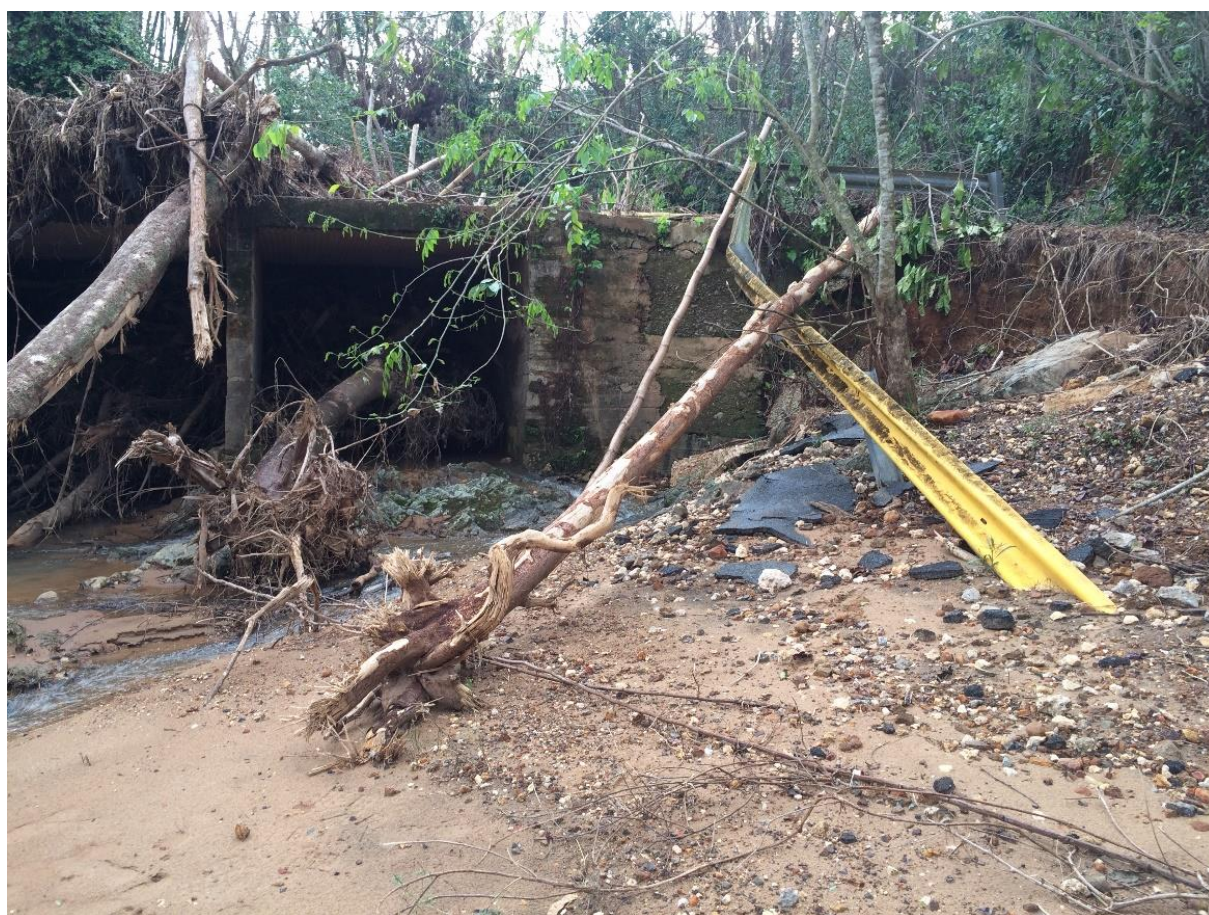
Figure 3-58: Social media image of damaged Bridge 1684 (source: Julia Maldonado)

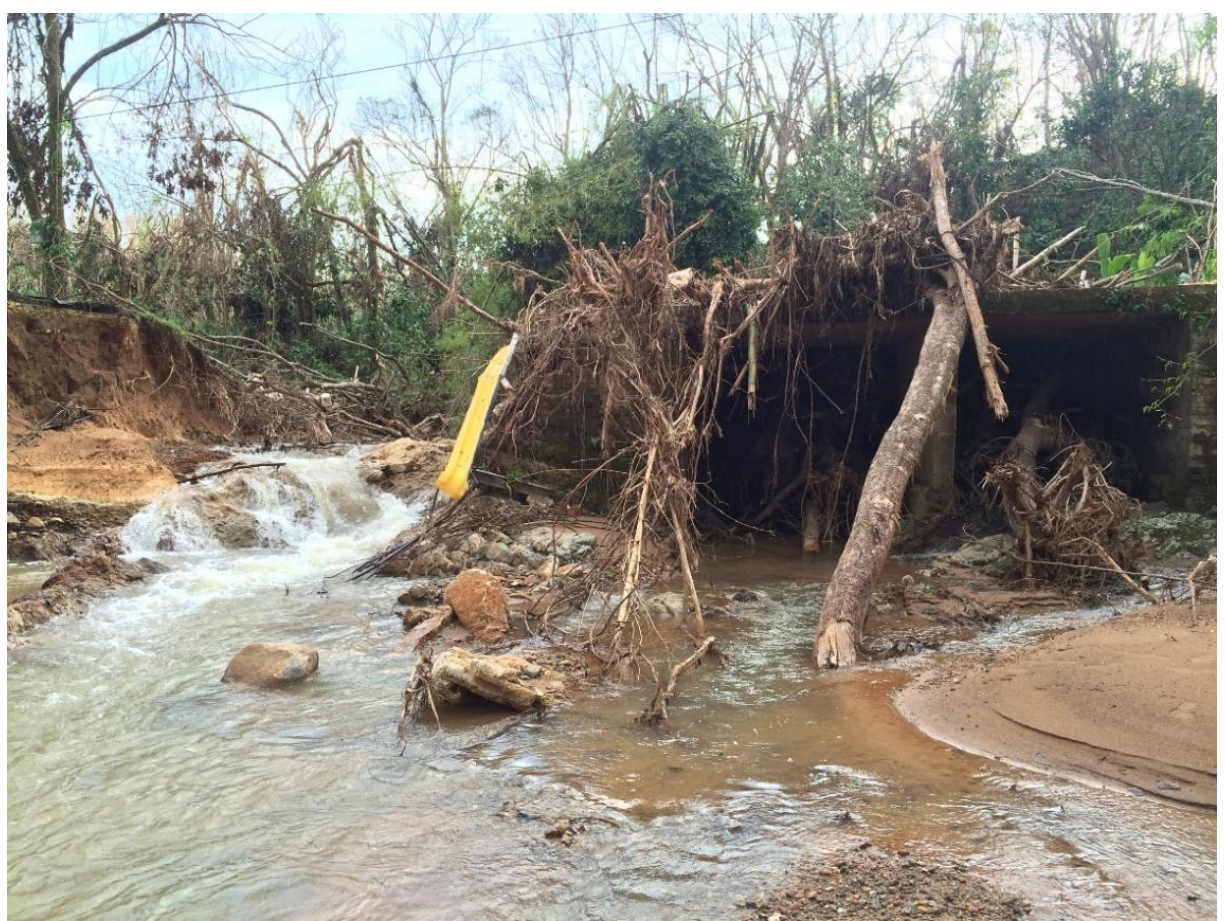
Figure 3-59: Social media image of collapsed approach of Bridge 1684 (source: Julia Maldonado)

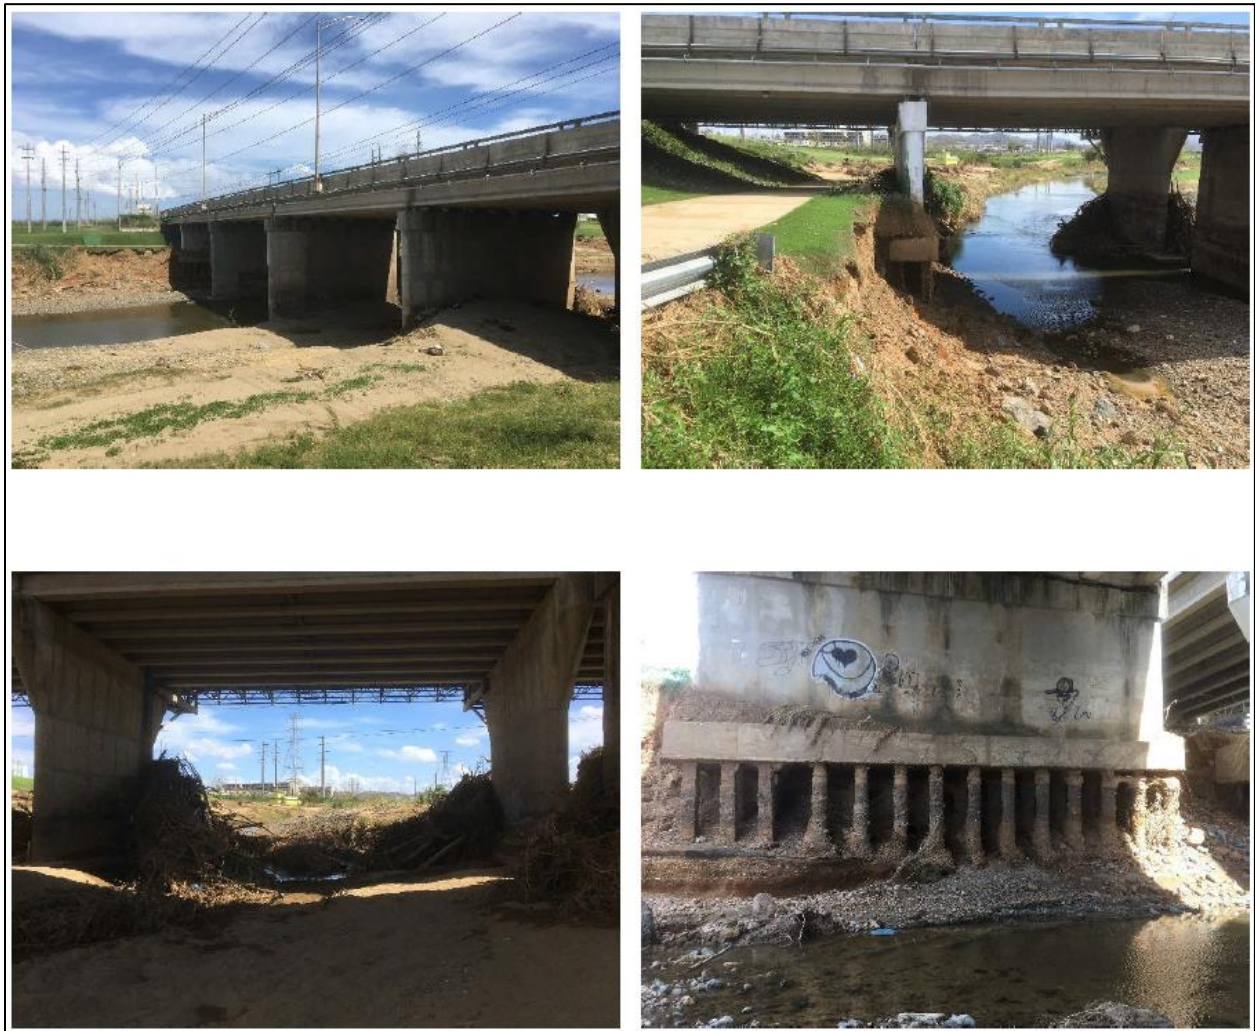
Figure 5-11: Bridge 863 photos from October 4, 2017 inspection (source: PRHTA)

Several bridges were temporarily closed due to scouring problems caused by Hurricane Maria. An example of this is Bridge 863, located in the municipality of Bayamón. One of the piers of its bridge had its piles exposed due to scouring, as shown in Figure 5-11. Other bridges that received media attention due to being in main highways were Bridge 1078 in Juan Díaz and Bridge 1309 in Canóvanas. Further research would have to be conducted to determine the total number of bridges that were closed temporarily due to scouring.

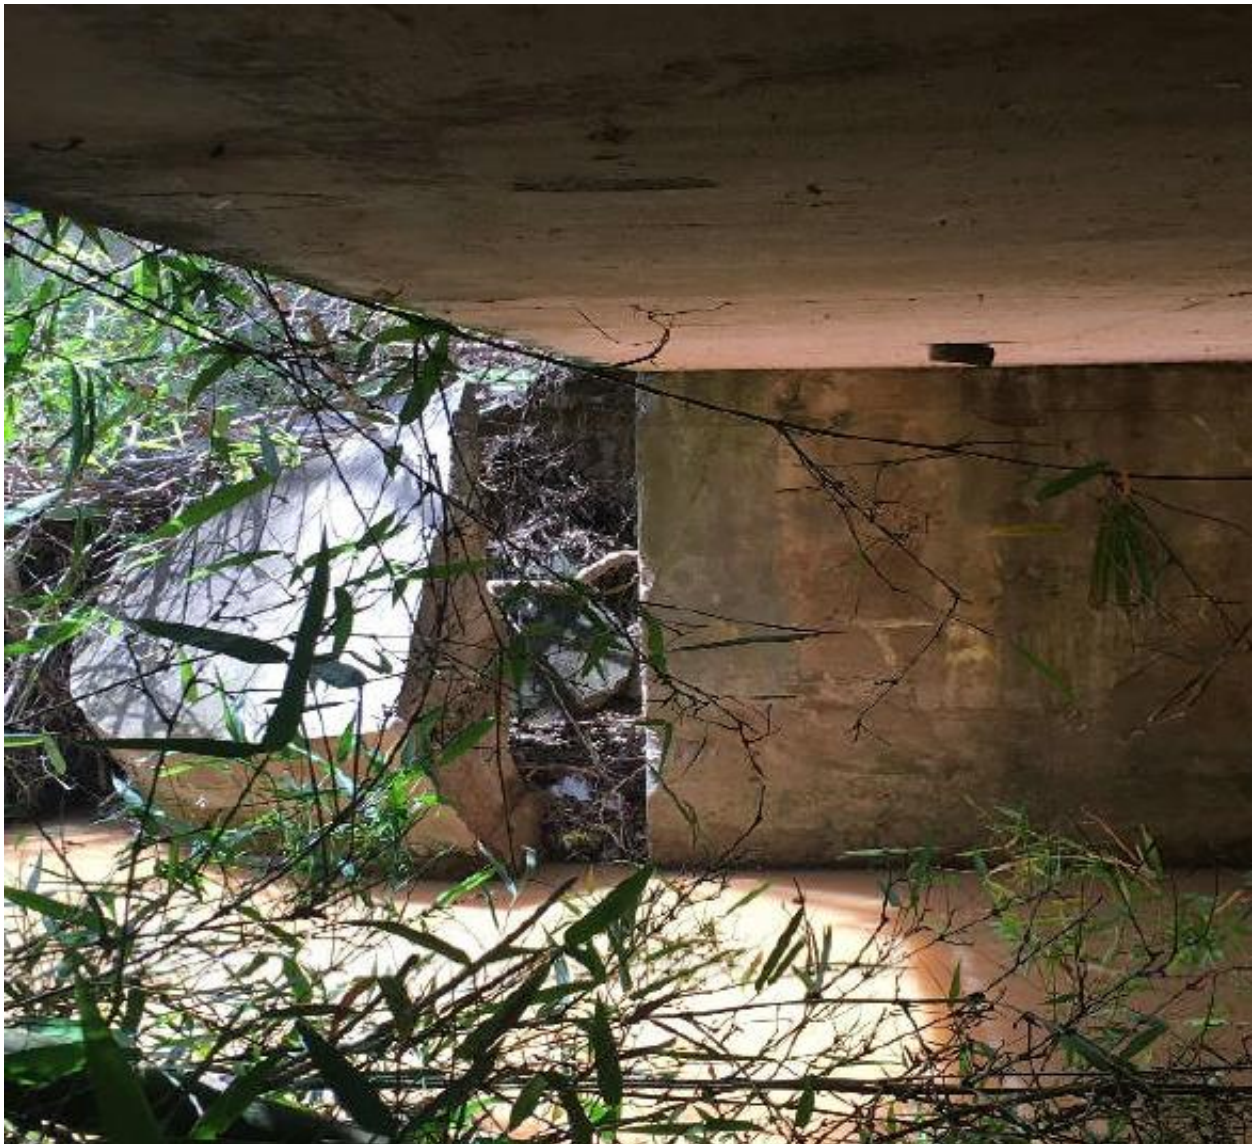
In several inspection reports, problems with wingwalls were indicated. The problems with wingwalls range from the loss of backfill material to complete collapse. An example of a collapsed wingwall is shown in Figure 5-12. Most of the time, the problem with wingwalls did not lead to the closing of bridges. The mechanisms that cause problems with wingwalls are probably related to the ones that lead to approach roadway collapse.

Figure 5-12: Photo of collapsed wingwall of Bridge 1629 taken during October 20,2017 inspection (source: PRHTA)
