# **Development and Validation of Methodologies for Rapid Inspection and Assessment of Fatigue Damage**

FINAL REPORT  
September 2020

Submitted by:  
Sougata Roy, Ph.D., Associate Research  
Professor Department of Civil and Environmental Engineering  
Center for Advanced Infrastructure and Transportation  
Rutgers, the State University of New Jersey  
100 Brett Road  
Piscataway, 08854

External Project Manager  
Jean H. Laird, P.E., Senior Project Engineer  
New Jersey Turnpike Authority (NJTA)  
1 Turnpike Plaza  
Woodbridge, NJ 07095

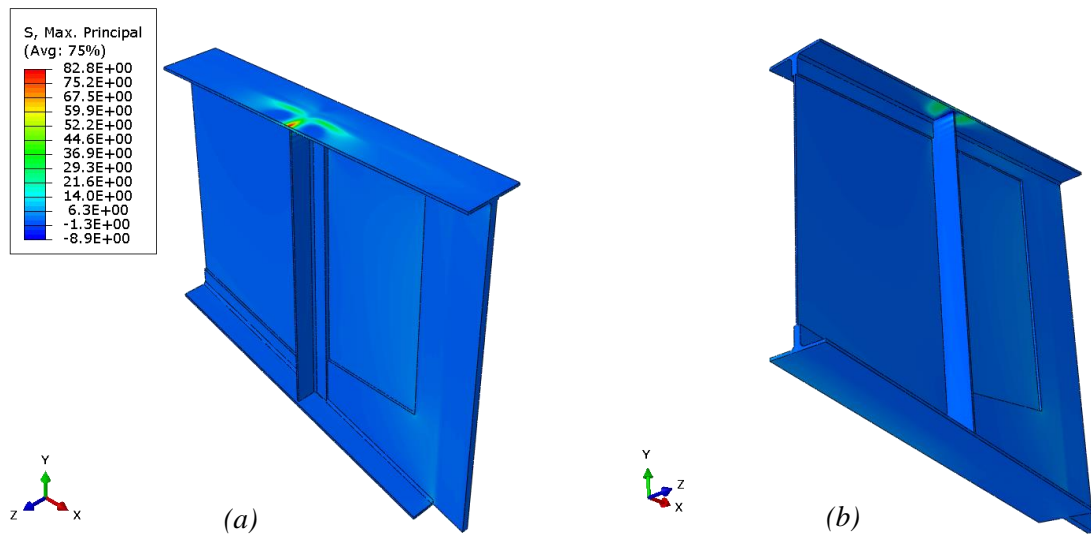
**Figure 3-9** Contour of maximum principal stress in FB4 bracket for load case L3T1: (a) view from top; (b) view from bottom

Contour plots of the maximum principal stress in the top flange of FB4 bracket under S4 are shown in Figure 3-9 for the load case L3T1. Only the FB4 bracket (retained from the original construction) is shown for clarity. The high local stresses occurred due to bending of the top flange under S4 south bearing, as shown in Figure 3-10. The flange of the built-up FB4 bracket is made of two back-to-back  $6 \times 4 \times \frac{1}{2}$  angles, with the 6 in. leg forming the flange. The flange angle leg is subjected to negative moment at the bearing stiffener ( $5 \times 3 \frac{1}{2} \times \frac{3}{8}$  angles with the 5 in. leg protruding), and positive moment away from it. As can be seen, due to the eccentric loading on the south bearing of S4 (since the tandem axle is entirely on the deck south of the expansion joint in load case L3T1), the FB4 is experiencing some twisting deformation. Note that the deformation is shown in Figure 3-10 at 50× magnification.

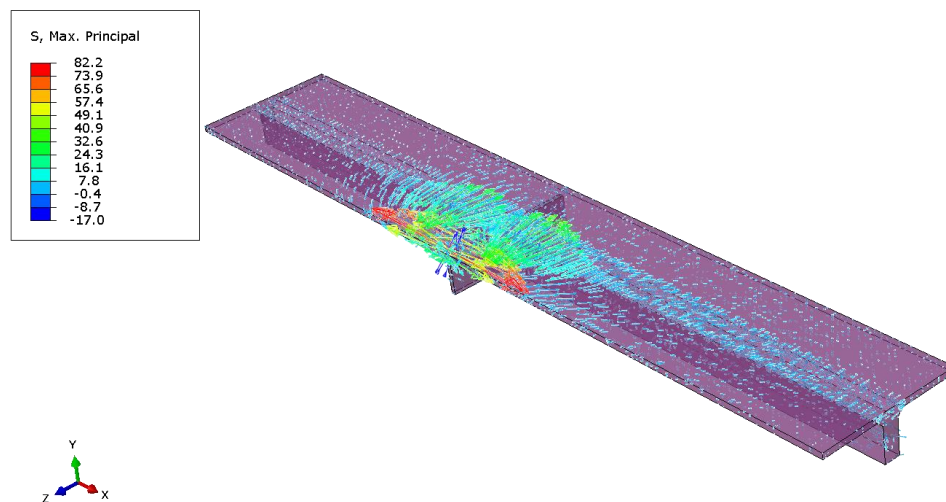
**Figure 3-11 Maximum principal stress field in the top flange of FB4 bracket for load case L3T1**

The maximum principal stress field in the top flange of FB4 bracket is further presented in Figure 3-11 to demonstrate the magnitude and direction. As is evident, the

maxima of principal stress, occurring over the bearing stiffener near the free edge of the flange was primarily along the flange or in the x-direction. Inside the flange, maximum principal stress of smaller magnitude occurred in the transverse direction of FB4, consistent with the bending of the flange like a cantilever supported on the web.

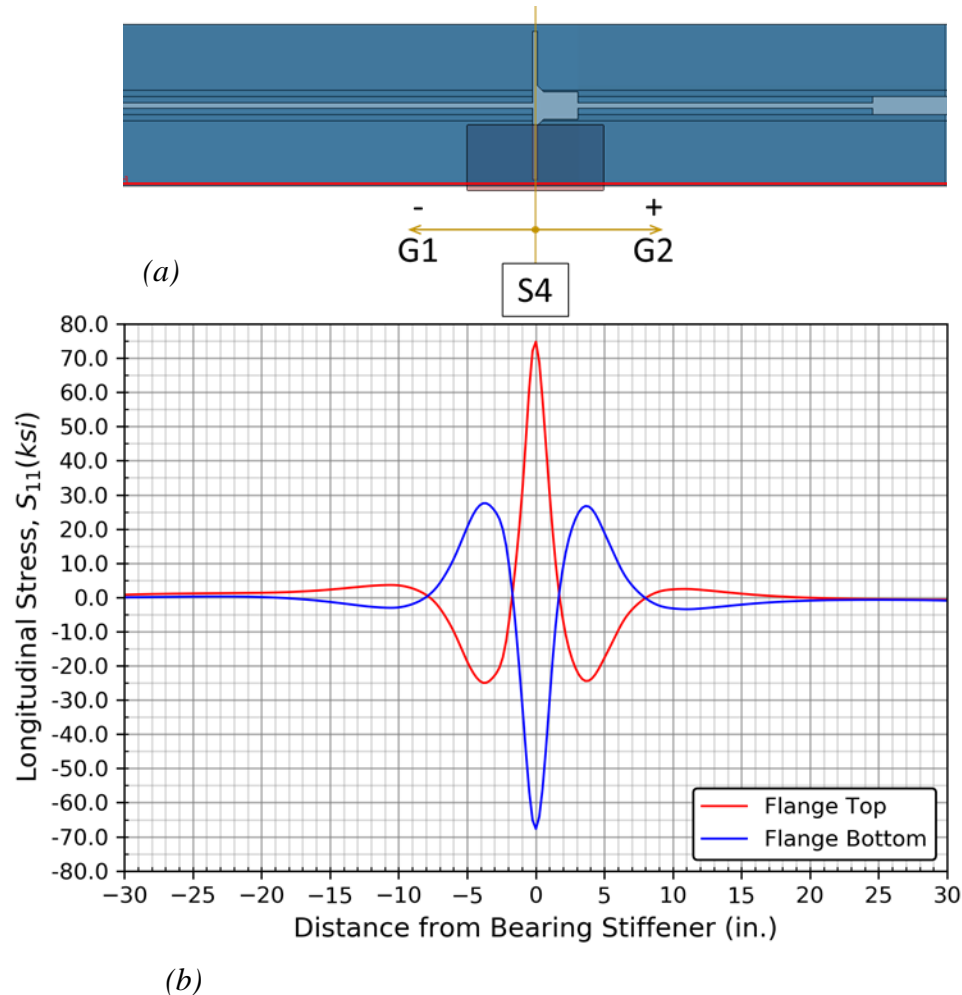
**Figure 3-12 Longitudinal stress in the top flange of FB4 bracket for load case L3T1: (a) plan view of top flange showing path and origin; (b) plot of longitudinal stress along path**

The plot of longitudinal stress  $S_{11}$ , along longitudinal paths on the top and the bottom of the flange (on the same vertical plane, adjacent to the free edge) towards the south side or the loaded span are shown in Figure 3-12. The plot is prepared with the centerline of the bearing stiffener protruding leg (considered as the centerline of the bearing stiffener) as origin, which also coincided with the centerline of S4. The distances are considered positive and negative respectively towards G2 and G1. The stresses were consistent with the bending behavior presented earlier. Stresses of almost equal magnitude and opposite signs were noted on the top and the bottom path, suggesting predominantly flexural deformation of the floor beam flange under the S4 bearing. The floor beam flange (protruding leg of the angle) experienced reverse flexure, with concave deformation over the bearing stiffener angle, rapidly changing to convex deformation under the bearing

footprint. The maximum tensile stress on top of the flange, occurring at the centerline of the bearing stiffener, is about 75 ksi (assuming elastic behavior), which significantly exceeded the yield strength of the material, assumed 36 ksi for the carbon steel that is specified in the original bridge plans. The maximum tensile stress at the bottom of the flange is about 25 ksi, which occurred at about 4 in. from the stiffener centerline. Note that the bearing is  $10\frac{1}{2}$  in. wide and the bearing retaining bolts are located  $2\frac{1}{2}$  in. from the centerline of the bearing stiffener. The tensile stress in the flange at the bolt holes is about 20 ksi. Considering stress concentration, the local stress at the edge of the hole likely exceeded the yield stress of the material (assumed 36 ksi).

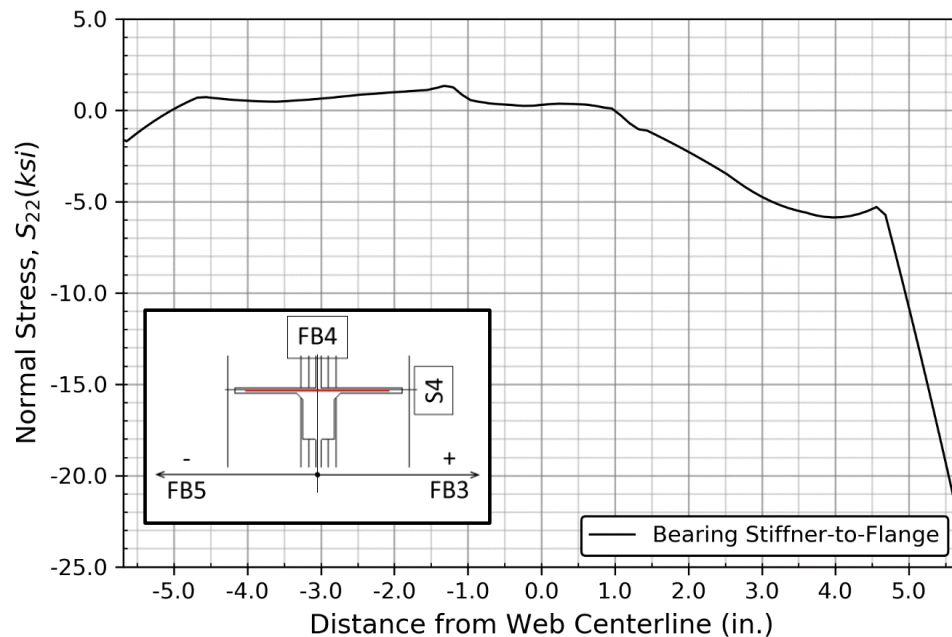
**Figure 3-13 Vertical stress along path at soffit of FB4 top flange and the centerline of bearing stiffener under S4 for load case L3T1**

The variation of vertical stress (stress in the Y or 2-2 direction),  $S_{22}$  at the bearing stiffener-to-flange interface is presented in Figure 3-13. The stresses are determined on a path along the centerline of the protruding leg of the bearing stiffener angle. The plot is prepared with respect to the centerline of FB4 as origin. The distances are considered positive and negative respectively towards south and north, i.e., towards FB3 and FB5. The south bearing stiffener under the loaded S4 bearing experienced bilinear compressive stress distribution that increased at a flatter rate up to about  $4\frac{1}{2}$  in from the centerline of the floor beam web and then at a much rapid rate. The maximum compressive stress occurring at the edge of the bearing stiffener was about 22 ksi. The stress at the north bearing stiffener-to-top flange interface under the unloaded S4 bearing was insignificant. The north bearing stiffener, however, experienced tensile stresses as the floor beam twisted due to the eccentric loading.

As presented in Figure 3-13, that bearing stiffener under S4 bearing experienced compressive bearing stress range of 22 ksi at the stiffener edge. When the stiffener was milled to bear, this stress range was well within the yield strength of the material (assumed 36 ksi) and was unlikely to contribute to fatigue crack growth. However, when the stiffener was welded to the floor beam flange, this compressive stress range in the presence of tensile welding residual stresses would effectively be tensile and could lead to fatigue crack growth through the stiffener-flange weld throat. Although this mode of cracking was not noted in the weld-repaired stiffener, since the demand for the crack growth from the weld toe into the flange (discussed in the previous paragraph) was more severe, branching of the crack parallel to the flange after initiating at the weld toe was noted. Fatigue racking through the throat of the stiffener-to-flange weld near the stiffener edge was noted for the bearing stiffener under S3 within the 1971 widened section with welded fabrication, where the stiffeners were welded to the flange.

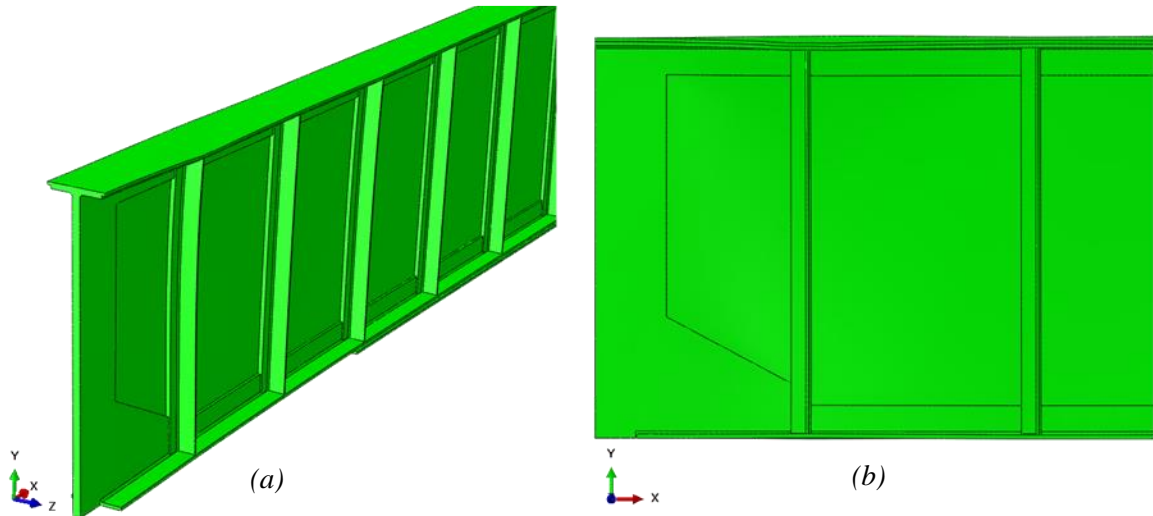
**Figure 3-14 Deformation of FB4 interior for load case L3T3 (50×):**  
**(a) isometric view; (b) south elevation**

The flange was subjected to deformation concave down at the bearing stiffener ( $5 \times 3\frac{1}{2} \times \frac{3}{8}$  in. angles with the 5 in. leg protruding), and convex up away from it.

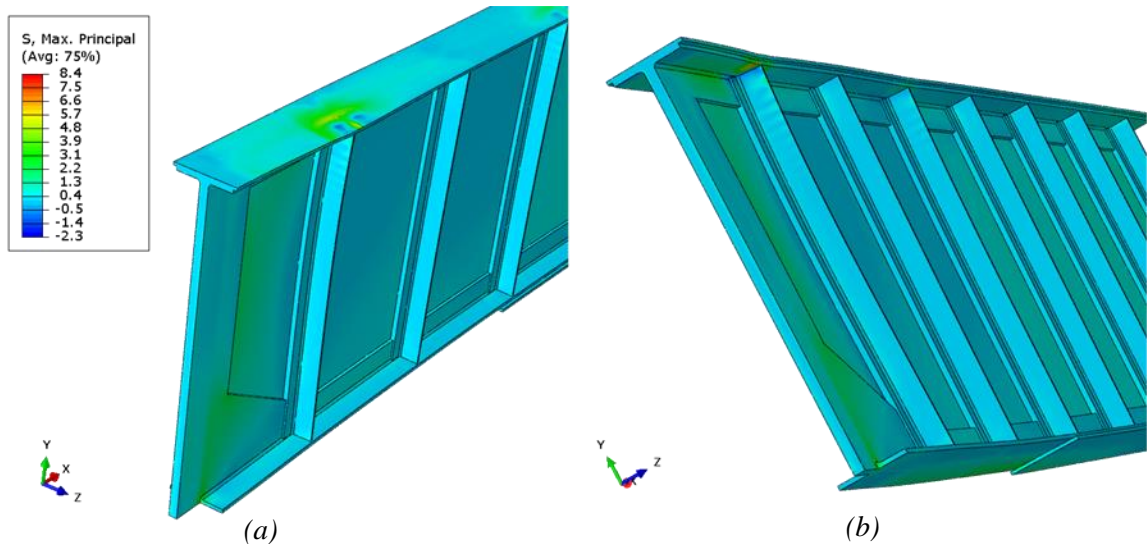
**Figure 3-15 Contour of maximum principal stress in FB4 interior for load case L3T3: (a) view from top; (b) view from bottom**

The maximum stress in FB4 flange under S5 occurred in load case L3T3. Contour plots of the maximum principal stress in FB4 for this load case are shown in **Error! Reference source not found.**. Only the part of the floor beam between G2 and G3 is shown for clarity. The deformation of the floor beam at 50× magnification is shown in Figure 3-14. Local bending of the flange under the bearing for S5 was noted that resulted in the maximum flange stresses. The response of the floor beam flange was similar to that under S4. The deformation was localized only under the south bearing, since the entire tandem was on the south side of the expansion joint (see Figure 3-8) and some twisting of the floor beam was noted due to this eccentric loading. The flange of the floor beam between G2 and G3 was built up of two back-to-back  $6 \times 6 \times \frac{3}{4}$  inch angles and a  $14 \times \frac{5}{8}$  in. cover plate.

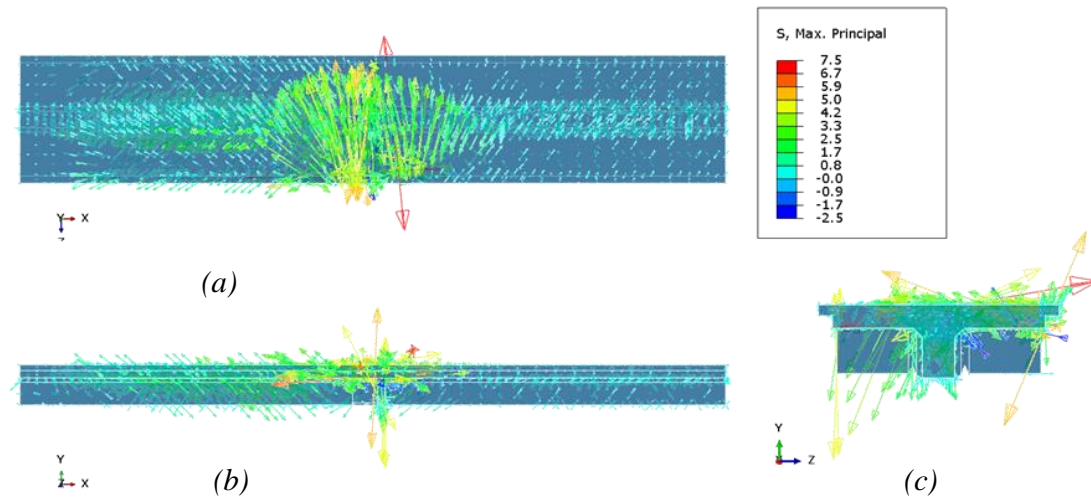
**Figure 3-16** Maximum principal stress field in top flange of FB4 interior for load case L3T3: (a) plan view; (b) elevation view; (c) section view

The direction and magnitude of maximum principal stress in the top flange of FB4 between G2 and G3 is presented in Figure 3-16. Compared the distribution of principal stress under S4 as presented earlier, the stresses under S5 are more complex. Looking at the distribution of principal stresses in three orthogonal views (in X, Y, and Z –directions), it is evident that the maxima of principal stress is not oriented along the flange, but in the transverse direction at an angle. Maximum principal stress of comparable magnitude was also observed in the longitudinal direction (X or 1 direction), but at an angle with the flange plane. This complex distribution of maximum principal stresses under the S5 bearing

suggests existence of high shear stresses between the bearing stiffener and the flange, and the local flange bending was predominantly in the transverse direction. High maximum principal stress was also observed in the vertical direction (Y or 2 direction) at the bearing stiffeners under the S5 bearings.

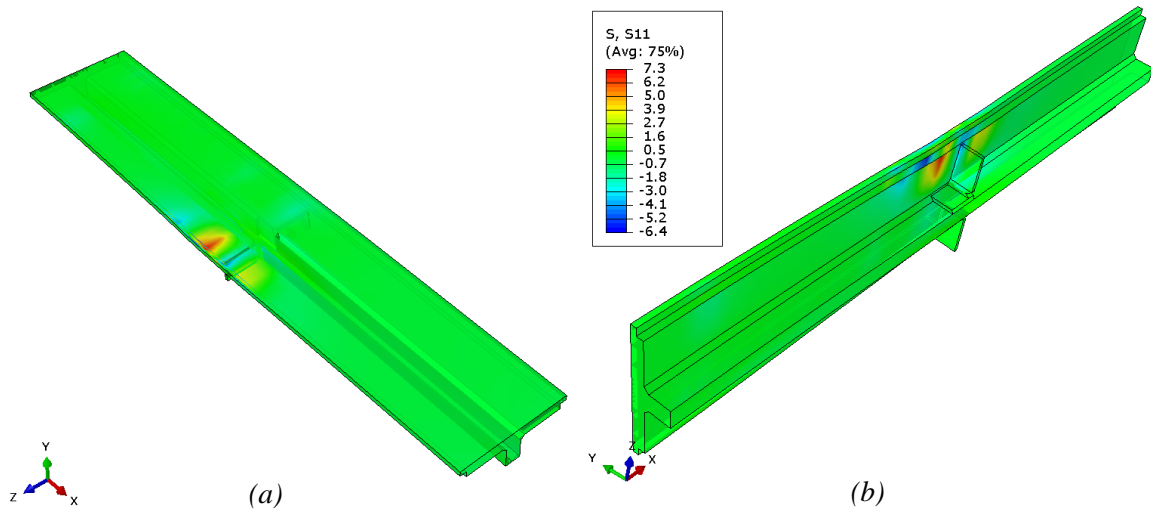
**Figure 3-17** Contour of longitudinal stress in the top flange of FB4 interior for load case L3T3: (a) view from top; (b) view from bottom

The contour plot of longitudinal stress  $S_{11}$  in the floor beam flange adjacent to S5 bearing is presented in Figure 3-17. Variation of longitudinal stress along longitudinal paths on the top of the flange plate and the bottom of the connection angle (on the same vertical plane, adjacent to the protruding leg of the bearing stiffener angle) towards the south side or the loaded span is shown in Figure 3-18. The plot is prepared with the centerline of the bearing stiffener protruding leg (considered as the centerline of the bearing stiffener) as origin, which also coincided with the centerline of S5. The distances are considered positive and negative respectively towards G3 and G2. The variation of longitudinal stresses were consistent with the bending behavior presented earlier. Stresses of almost equal magnitude and opposite signs were noted on the top and the bottom path,

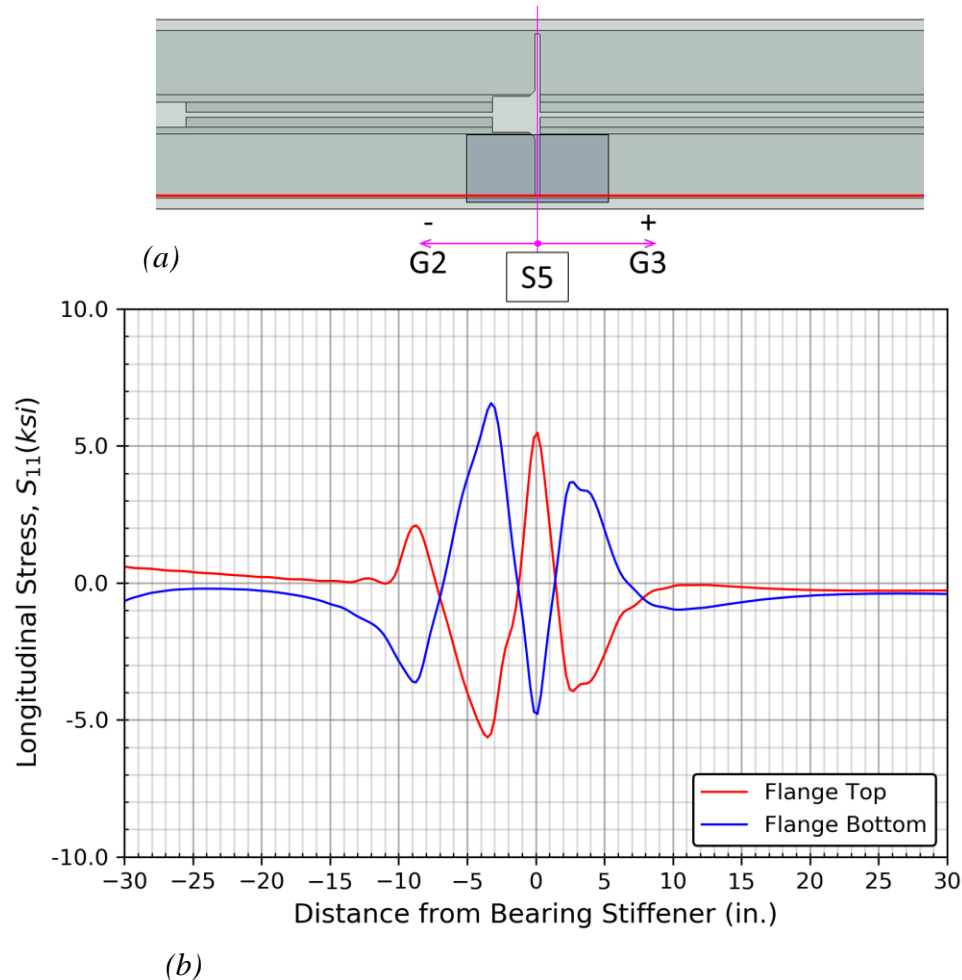
**Figure 3-18 Longitudinal stress in the top flange of FB4 adjacent to S5 for load case L3T3: (a) plan view of top flange showing path and origin; (b) longitudinal stress along top and bottom paths**

suggesting flexural deformation of the floor beam flange in the longitudinal direction under S5 bearing. The floor beam flange experienced reverse flexure, with negative moment (concave down deformation) over the bearing stiffener angle, rapidly changing to positive moment (convex up deformation) under the bearing footprint. The response was unsymmetric with respect to the bearing stiffeners, with the response to the west being slightly higher than the east. This is also evident from the contour plot of  $S_{11}$  presented in Figure 3-17. The maximum tensile stress on bottom of the connection angle leg, occurring at about 3.5 in. west of the bearing stiffener, was about 6.5 ksi. The maximum tensile stress at the top of the flange was about 5 ksi. Note that the bearing was  $10\frac{1}{2}$  in. wide and the bearing retaining bolts were located  $2\frac{1}{2}$  in. from the centerline of the bearing stiffener angle. The tensile stress in the flange at the bolt holes was about 4 ksi.

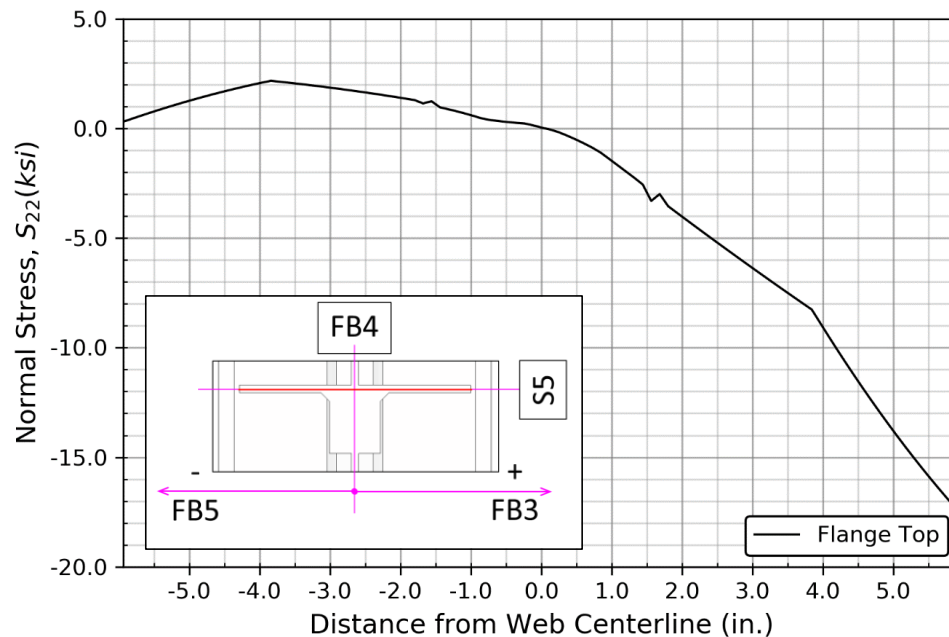
**Figure 3-19 Vertical stress along path at soffit of FB4 top flange along centerline of bearing stiffener under S4 for load case L3T3**

The variation of vertical stress (stress in the Y or 2-2 direction),  $S_{22}$  at the bearing stiffener-to-flange interface is presented in Figure 3-19. The stresses are determined on a path along the centerline of the protruding leg of the bearing stiffener angle. The plot is prepared with respect to the centerline of FB4 as origin. The distances are considered positive and negative respectively towards south and north, i.e., towards FB3 and FB5. The south bearing stiffener under the loaded S5 bearing experience compressive stress that increased almost linearly away from the centerline of the floor beam web. The north bearing stiffener was subjected to tensile stresses as the floor beam flange twisted due to the eccentric loading. The tensile stress increased up to about 4 in. from the centerline of the floor beam web and then decreased to almost zero. The maximum tensile stress was about 2 ksi.
