Bridge Deck Surface Profile Evaluation for Rapid Screening and Deterioration Monitoring

FINAL REPORT
September 2022

Submitted by: Adriana
C. Trias-Blanco
Assistant Professor

1. Report No. CAIT-UTC-REG52	2. Government Accession No.	3. Recipient's Catalog No.	
4. Title and Subtitle Bridge Deck Surface Profile Evaluation for Rapid Screening and Deterioration Monitoring		5. Report Date September 2022	6. Performing Organization Code CAIT/Rowan University

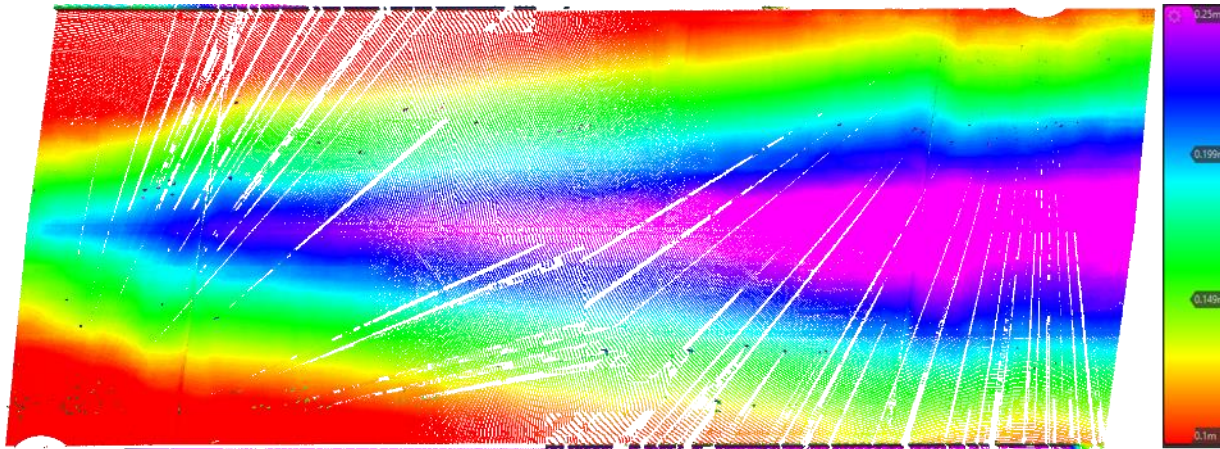
Figure 39. Structure 18G0701 - Elevation map.

Structure 18G0701 is a newly constructed deck. It can be seen from Figure 39, Figure 43, and Figure 44 that the deck has proper slope for drainage on both the longitudinal and transverse directions. It is important to highlight that some low points were found along the deck as seen in Figure 43, this can be areas of concern in the long term. The plan view presented on Figure 41 indicates the location of the longitudinal and transverse section within the deck. Figure 40, presents an RGB view of the deck's top surface.

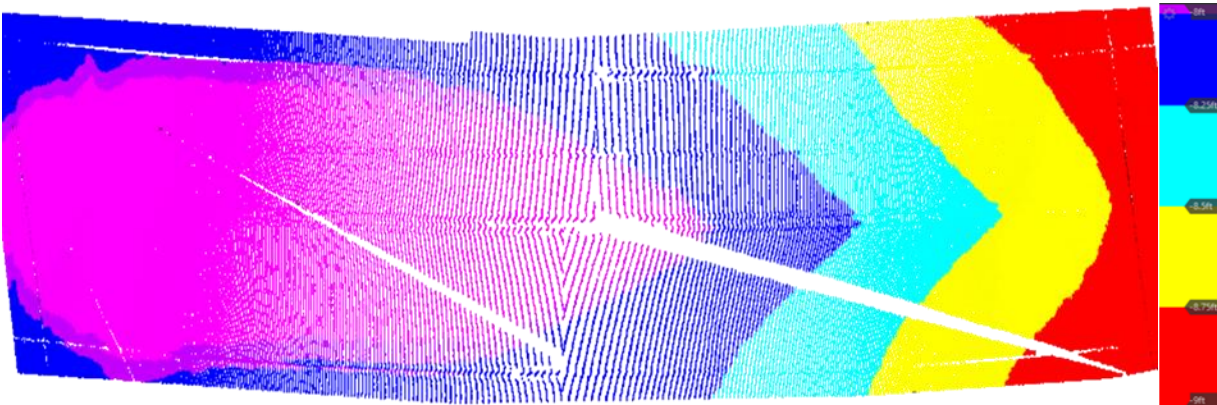
Figure 45. Structure 0821155 - Elevation map.

Structure 0821155 is a newly constructed structure. It can be seen from the left side of Figure 45 and Figure 49, the presence of a flatter region, which can be an area of concern if the long term. The transverse cross section slope of the deck is approximately 1.4%, slightly below the recommended 2%, this was estimated from the data found on Figure 50. Figure 46, presents an RGB view of the deck's top surface.

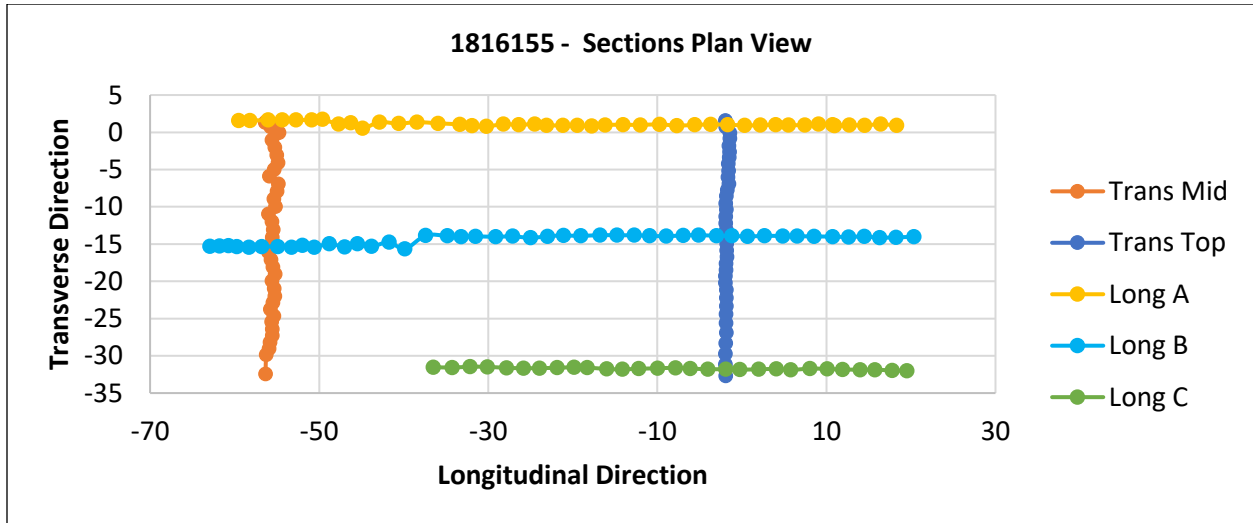
Figure 65. Structure 1816155 - Sections Plan View.

Structures 1816154 and 1816155 will be compared in this section, since these structures were included on this project as a case study presented by NJDOT. The twin bridges originally presented different levels of deck condition (3 for 1816155, and 6 for 1816154) which was a concern since the structures see the same level of traffic and have same dimensions of their structural components. Figure 58 and Figure 63 show the elevation maps of the top surface of the structures. Both structures present a longitudinal slope of approximately 2.3%, which can be estimated from Figure 61 and Figure 66. Structure 1816154 presents a transverse slope between 1 and 1.3% (see Figure 62), while structure 1816155 presents a uniform transverse slope of 1.3% (see Figure 65).
