# Performance Determination of Precast Concrete Slabs Used for the Repair of Rigid Pavements

Final Report  
October 2014

**Reza S. Ashtiani, Ph.D.**  
Assistant Professor  
University of Texas at El Paso  
El Paso TX 79902

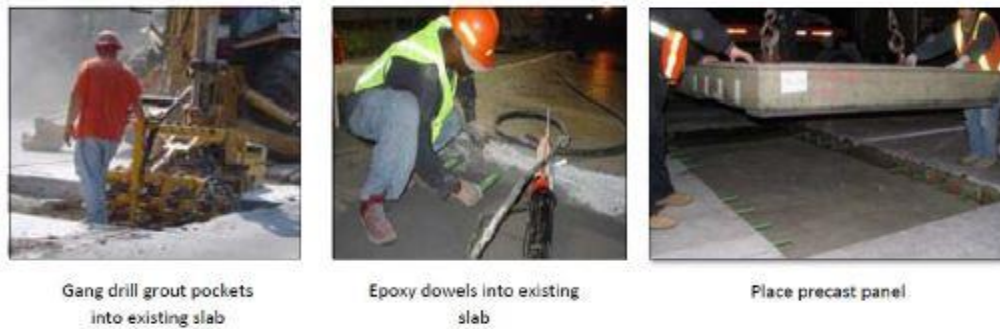
Fort Miller Super-Slab load transfer mechanism consist in connecting the existing concrete slab with steel dowels to the precast repair panel. The precast concrete repair panel has to be fabricated with dowel sleeves on bottom of the panel. Accurate configuration for the sleeves and the load transfer dowels has to be arranged in order for correct installation. Grout ports are provided as well to grout the dowels after placing the precast concrete panel. The process is shown in Figure 2 and Figure 3 [4].

Figure – 2 Preparation of Existing Slab and Installation of Precast Repair Panel [4]

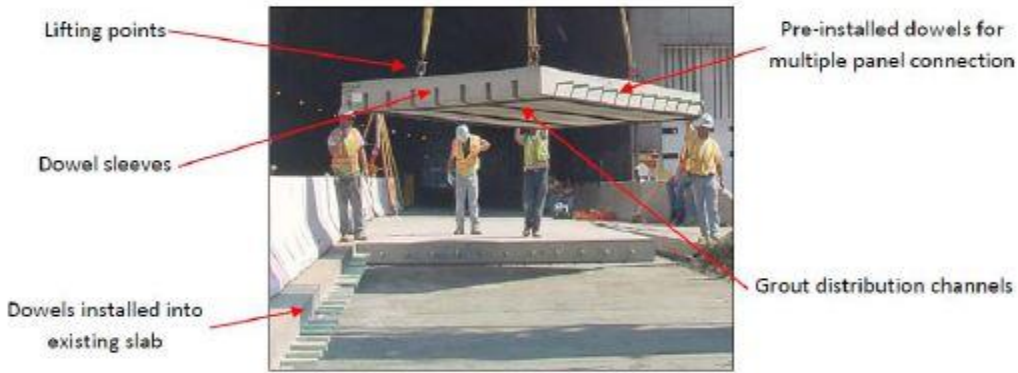
Base course material has to be compacted and a 3/4-inch-thick-layer of fine mineral material aggregate needs to be spread over the base. Specialized grading equipment to screeds the base surface needs to be used for accuracy. The bedding is injected under the panel once the base is prepared, and once dowels are placed in the correct position. Channels under the precast panel are provided for proper distribution of the bedding grout. Figure 4 illustrates the procedure of installing a precast concrete panel.

**Figure – 4 Installation of Precast Concrete Panel [4]**

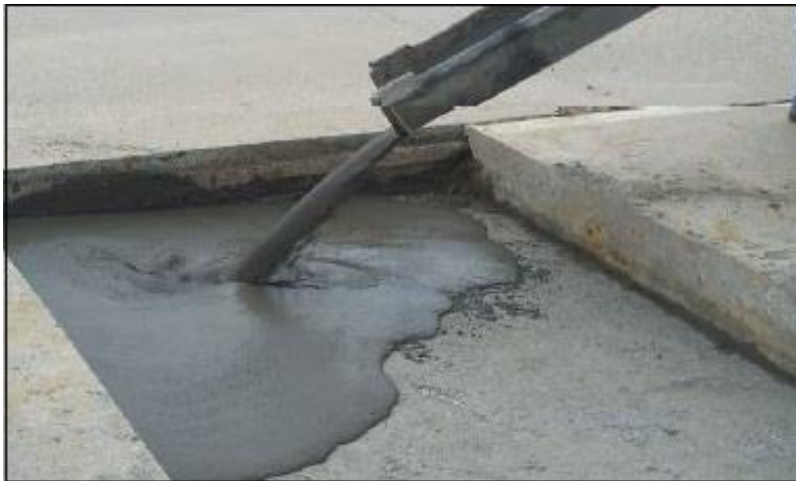
Flowable fill is employed for the base preparation. Flowable fill is a mixture containing Portland cement, water, fly ash, fine mineral aggregate and ½-inch or smaller coarse mineral aggregate. The flowable fill is mixed and delivered to the job site in ready mix truck. Subsequently, after a well compaction is performed in the base layer, the flowable fill is placed above to guarantee complete panel seating and leveling.

**Figure – 6 Flowable Fill Being Place [5]**

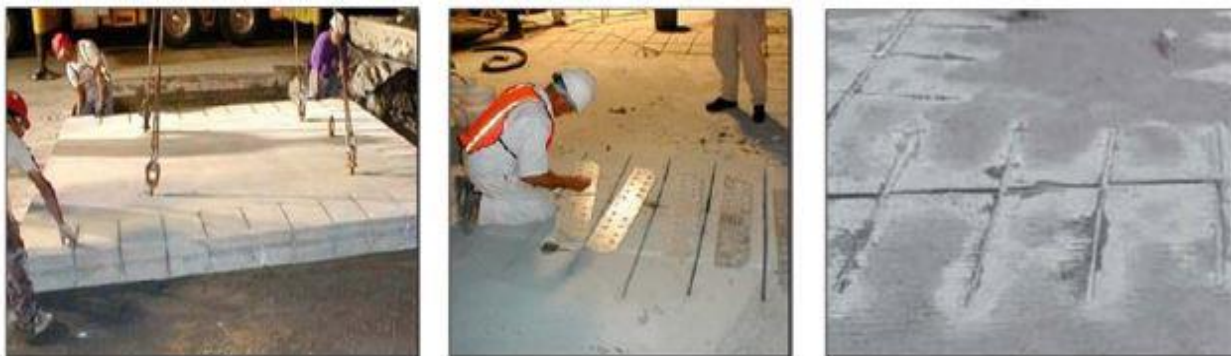
The load Transfer is handle by utilizing specially manufactured fiberglass ties as load transfer mechanisms (Figure 7) [6]. Once the precast panel is placed the fiberglass ties are installed. The ties are inserted and grouted to connect the existing and the repair concrete slab. In Figure 8 the installation

process for the fiberglass ties is illustrated.

Figure – 8 Fiberglass Tie Installation [6]

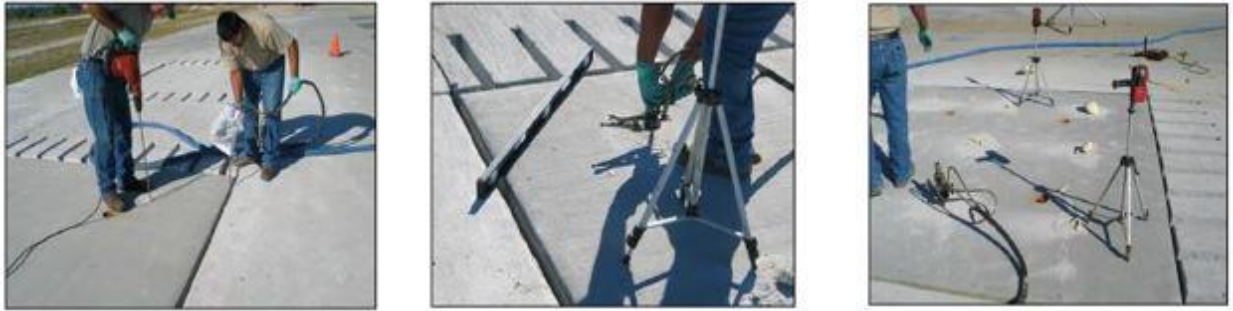
The base preparation technique for the URETEK Method is a process where HDP foam is injected through the precast concrete panel using 5/8-inch diameter drill holes. Generally the holes are spaced uniformly through the repaired section. Several full-depth portholes are made to facilitate the foam distribution. The URETEK base preparation relies on control chemical expansion. Once HDP foam is injected through the drill holes, precise leveling equipment is used to ensure the material does not spread beyond the desired area. Upon injection, the HDP immediately expands to lift, re-support and accurately realign concrete repair slabs. Voids underneath the repair concrete slab are quickly filled and the expansion of the HDP gently raises the slab as desired. The HDP quickly cures into a strong and stable base material.

Deep injection of HDP foam is an alternative technique to use the URETEK method. This alternative technique requires drilling portholes several feet into the sub-grade. HDP foam is then injected into the sub-grade filling all voids or fissures while compressing and densifying the soil. The Injection of the HDP foam forces the precast concrete repair panel to raise upward as it is injected. In order to achieve an accurate leveling, precise leveling equipment is used to align the slabs. Figure 9 show from left to right the portholes drilling, injection of HDP foam and leveling equipment.

**Figure – 9 URETEK Method Installation Technique [3]**

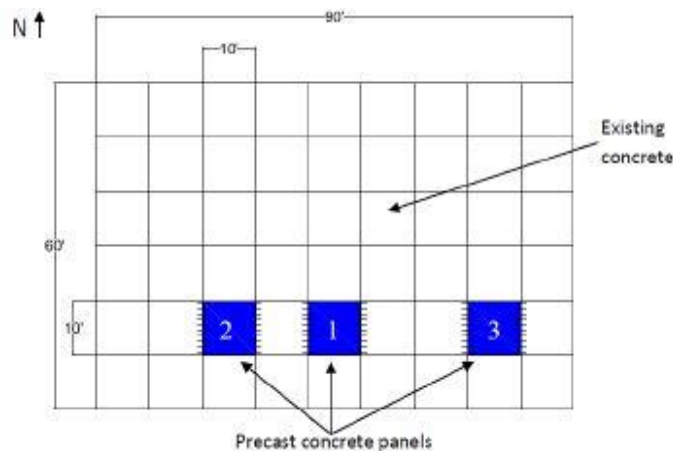
Three pre-cast concrete panels were installed using different techniques for comparison purposes in the analysis. Conventional HDP foam, HDP foam deep injection and flowable fill were the pre-cast installation techniques used for slab #1, Slab #2, and Slab #3, respectively. The base preparation and concrete mix design were also different for each panel. Figure 11 shows a top view of the existing concrete slab and location of the repair sections for each precast concrete slab.

Figure – 11 Precast Concrete Panels Locations [3]

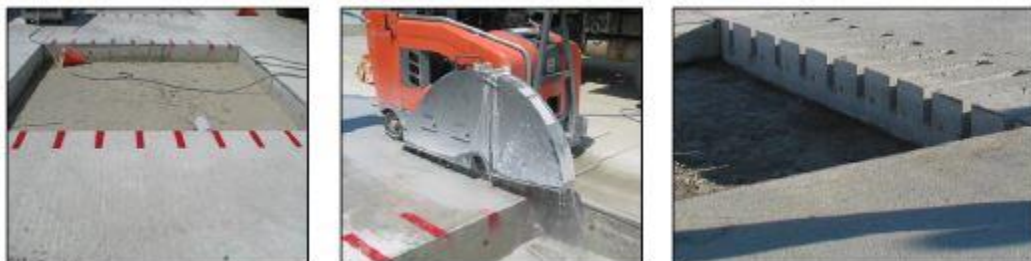
Slots were sawed in the existing concrete slab for a correct assembling of the load transfer mechanisms. The existing slab modifications were done using a walk-behind concrete saw for the cutting of the perimeter portion of the dowel sleeves. A jackhammer was used to chisel and to remove the inner portion of the cutout sleeves. The slab removal procedure described was implemented for the three precast slab installations. The figure 13 displays the procedure.

Figure – 13 Dowel Slots Sawing Process [3]

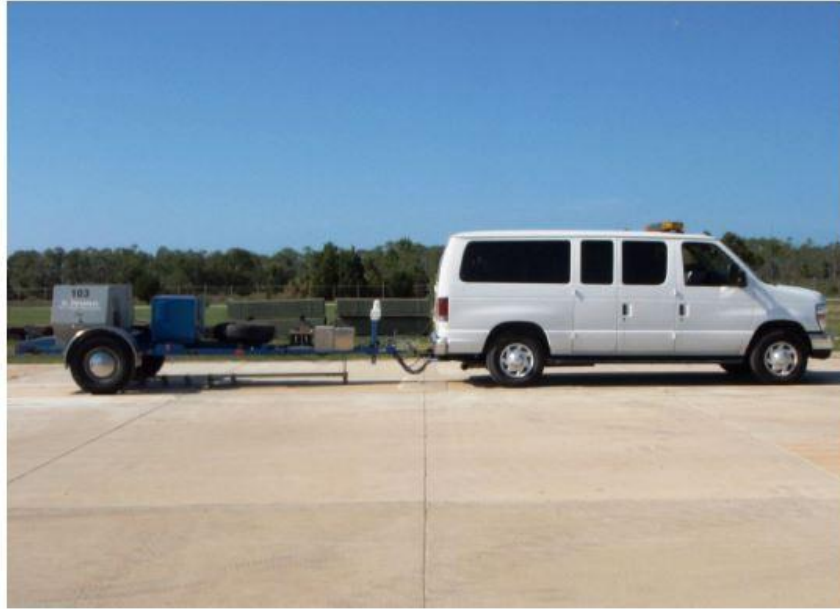
A Heavy Weight Deflectometer (HWD) is a non-destructive test used to back-calculate the modulus of pavement components including the subgrade. The device is widely used by highway engineers for an evaluation of the structural capacity of pavements layers. The load levels for a HWD device range from 6,500 to 54,000lbf (30-240kN). The plastic deformation resulting from the drop of the load is measured at the two sides of the joints that are being evaluated. A series of sensors known as geophones are place in several radial distances for measuring of the plastic deformation. The back-calculation is then perform by measuring the deflection basin and varying the set of modulus until a match between the computed and measured deflection is obtain. The best match has to be select for a higher accuracy. Figure 19 shows the HWD equipment.

Figure – 19 Heavy Weight Deflectometer [3]

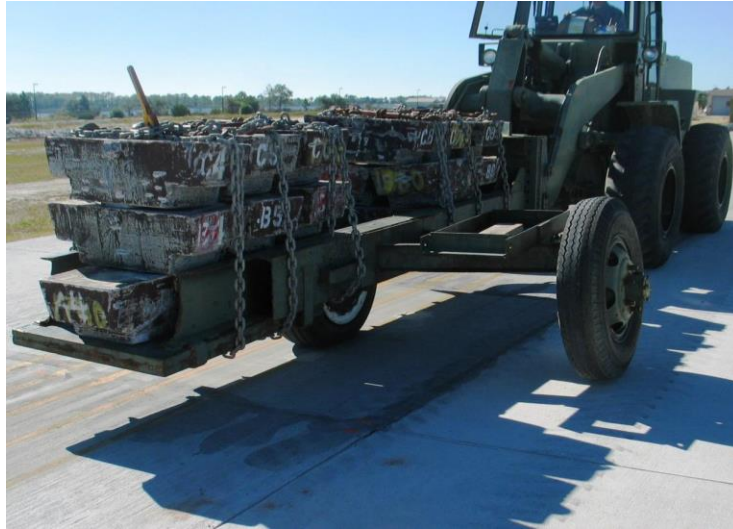
The F – 15 load cart carries 35,200 lbs. on a single wheel, approximately a tire pressure is 315 psi. The load represents one-half of the F – 15 aircraft main loading gear. The F – 15 loading cart was used to induce damage by accelerated loading repetition in the repair section for evaluation purposes. Figure 21 illustrated an accelerated loading in a repair section using the F – 15 load cart.

**Figure – 21 Loading Cart F-15 [3]**

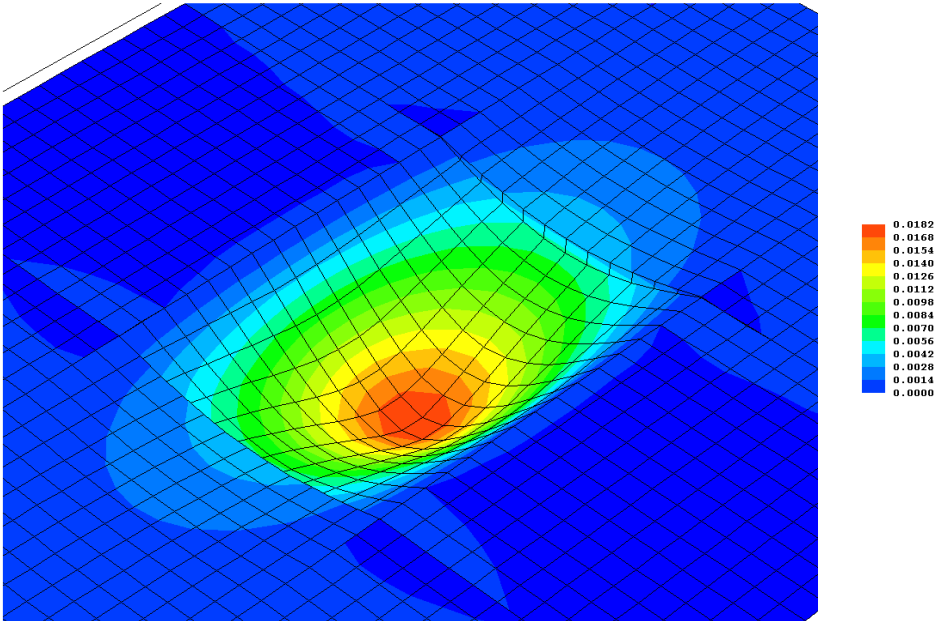
LTE<sub>x</sub>; therefore, the parameter of LTE<sub>x</sub> had to be taken as another variable for the experiment analysis. Figure 23 represents the contour plots of the plastic deformation for case (a) having an LTE<sub>x</sub> of 100% and case (b) having an LTE<sub>x</sub> of 90%.

Case (a)

Case (b)

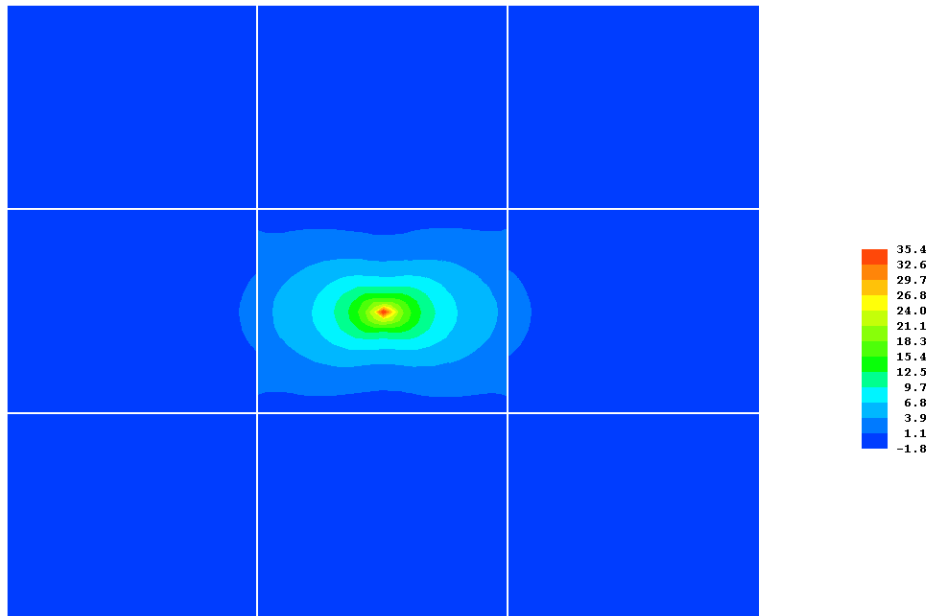
The distribution of shear stresses at the top of concrete slabs and the distribution of vertical stresses at the top of the base layer resulted from a finite element analysis were evaluated separately. The evaluation was performed by plotting the corresponding distress developed on each region of the pavement structure when the HWD test was performed. The  $LTE_x$  and modulus of elasticity values were assume as 90 percent and 5,000,000 psi, respectively.

Figure – 26 Vertical Stresses at the Top of the Base Layer,  $LTE_x=90\%$  and  $E_c=5000$  ksi

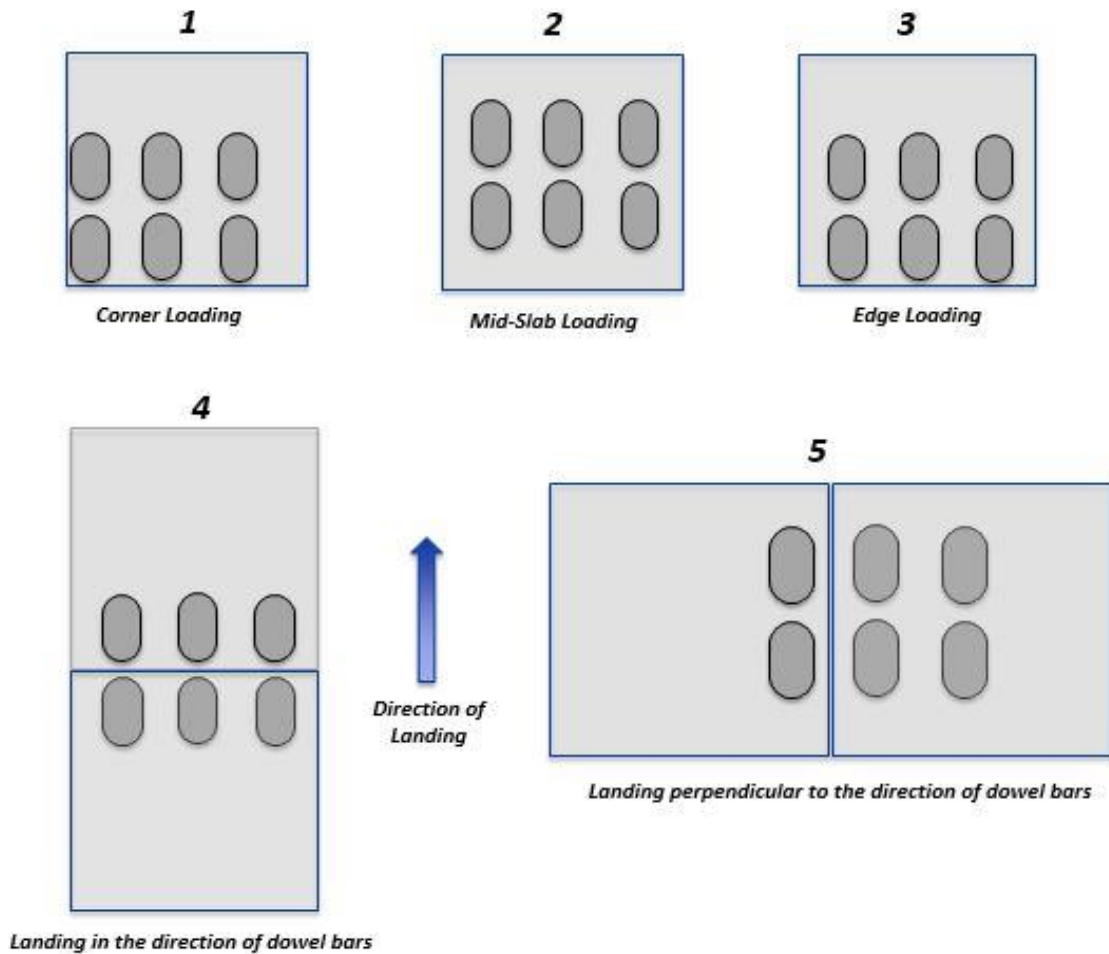
concrete repair panel scenario with the worst distresses. Figure 28 illustrates the five different scenarios.

**Figure – 28 Scenarios for Loading Position of a C – 17 aircraft [3]**

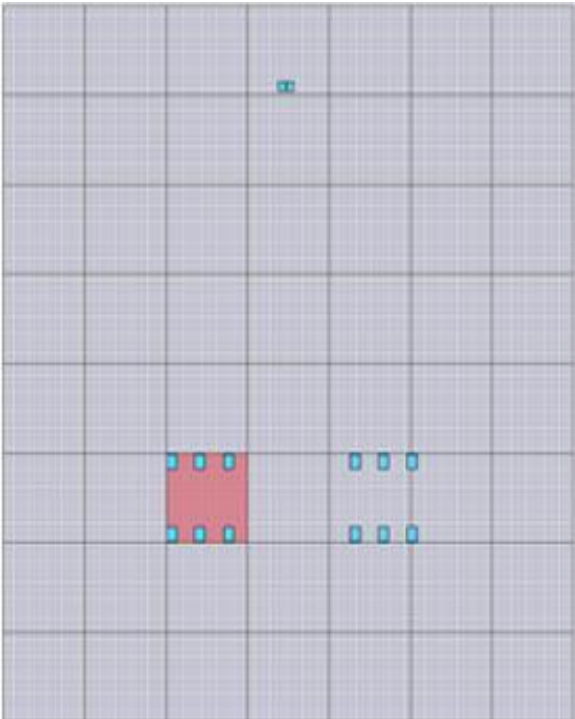
The deformation in the entire concrete slab, existing slab and repair section, was measured and plotted. Figure 29 simulates the deflection caused by a stationary C – 17 aircraft. The static C – 17 aircraft was simulated with the position as the scenario #1 from the loading positions described in Figure 28. This is since the corner loading position resulted in the case with the most deformation. Corner loading position in the concrete slab is described in Figure 29. The highlighted red square in the left bottom part of the figure is the concrete repair panel positioning six C – 17 aircraft landing wheels in the corner position. The other dots in the figure represent the location of the entire landing gear. The six dots in the bottom right are the parallel six landing wheel of the airplane and the two top dots in the figure are the frontal part of the aircraft.

**Figure – 29 Corner Loading Position [3]**

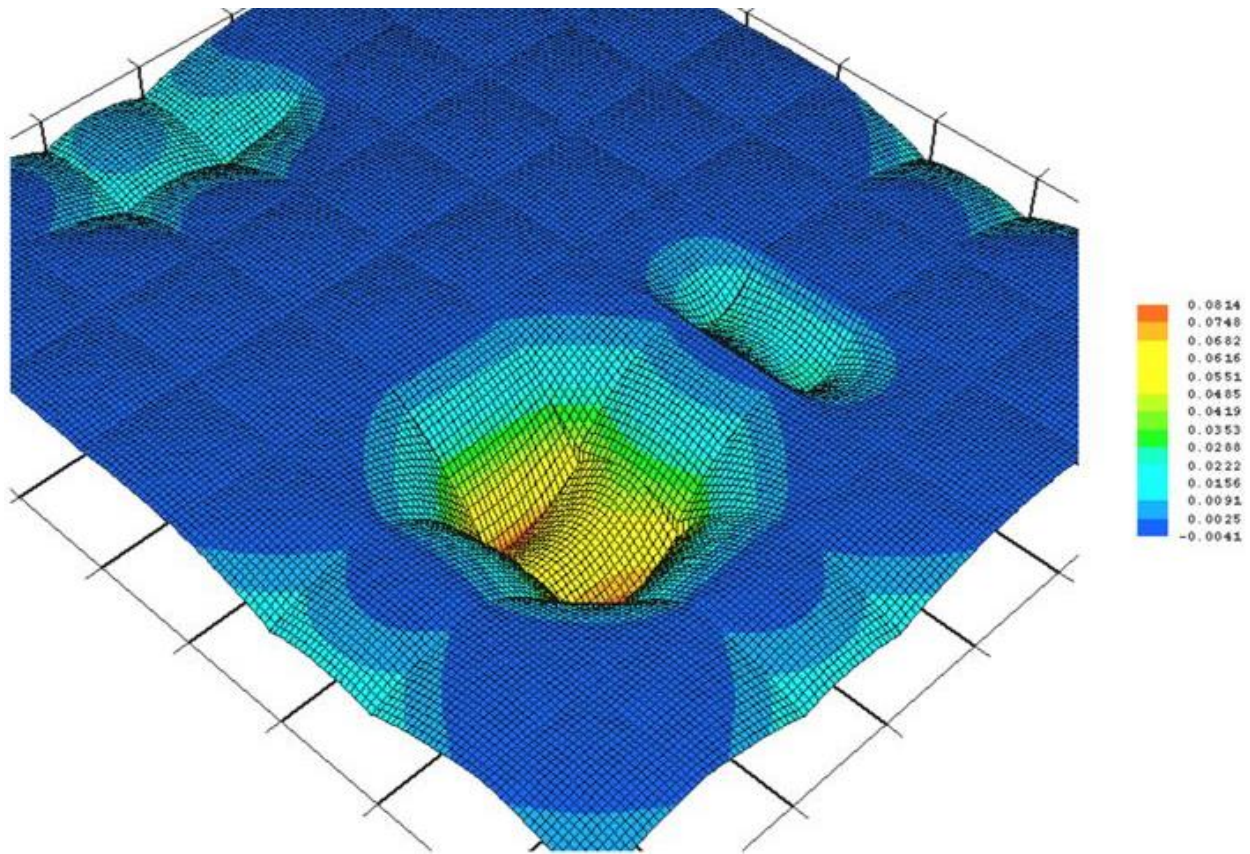
The maximum deformation occurred where the concrete repair panel was installed. The maximum deformation obtained was 0.0814 in. Notice that the minimum deflection was not zero since the simulation took into account the temperature variations. During daytime the temperature at the top of the slab is greater than at the bottom causing the top part to expand while the bottom tends to contract. The curling concept is shown in this analysis; therefore, the deflection where no loading was applied was 0.041 in. The results for the deformation are shown in Figure 30.

**Figure – 30 Deflection cause by C – 17 landing in Panel #1**

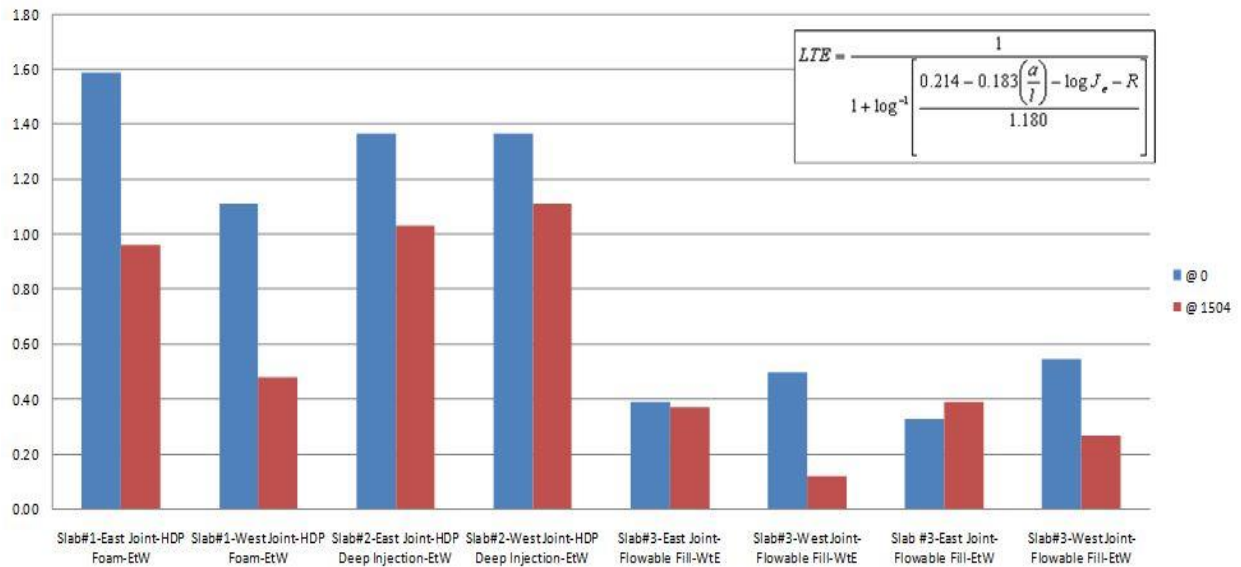
an F – 15 load cart. The results shown in figure 35 describe the analysis for initial joint stiffness and for the joint stiffness after 1504 load applications without the consideration of thermal stresses. The equation used in the analysis is also shown in the figure. The results show that slab #2 installed with HDP deep injection performed better than all the rest after 1504 loads application. The decrease in load transfer efficiency before and after the 1504 load application was not as notable in Slab #2 as in the rest of the slabs; therefore, slab #2 outperformed the rest of the slabs tested.

Figure – 35 Initial Joint Stiffness vs Terminal Joint Stiffness

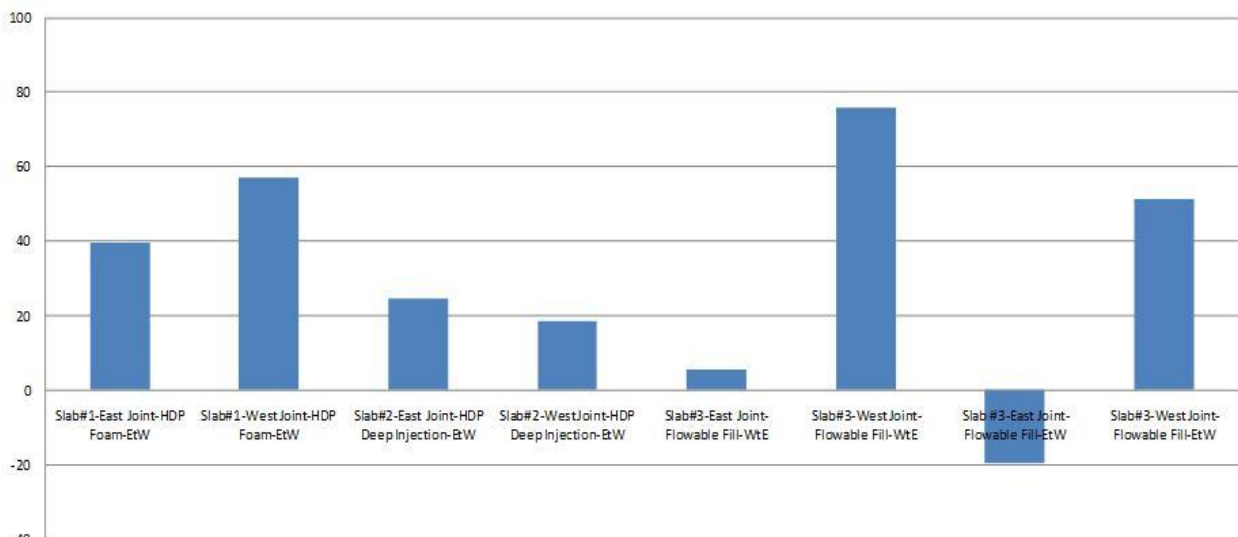
Figure – 36 Loss of Joint Stiffness After 1504 load Applications

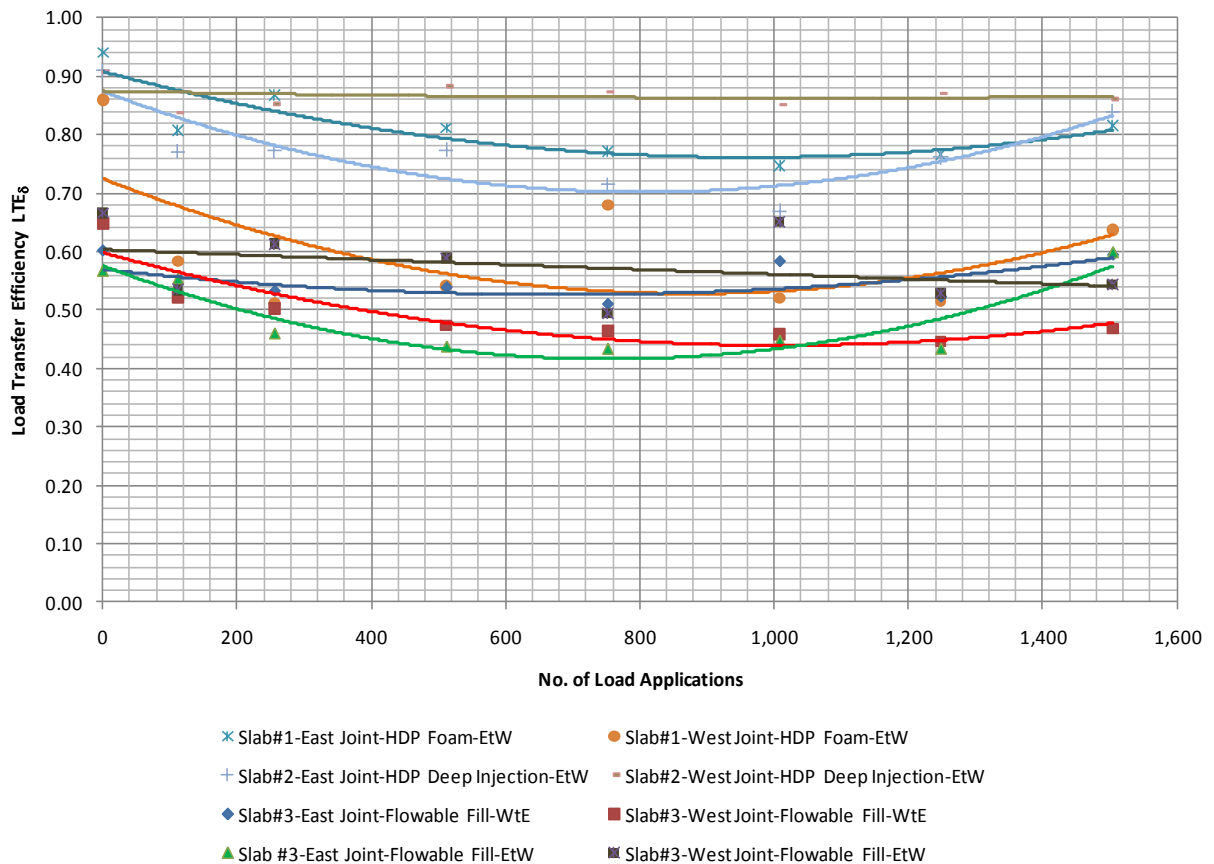
An HWD test was performed to obtain the  $LTE_{\delta}$  based on deflection ( $LTE_{\delta}$ ) without considering the temperature distresses in the analysis. The  $LTE_{\delta}$  was measured directly from the plastic deformation caused by the HWD test. The HWD was placed at each side of the joints and the plastic deformations were recorded for each scenario. The plastic deformations were recorded after 0, 112, 256, 512, 752, 1008, 1248 and 1504 applications of an F – 15 load cart. Subsequently, the  $LTE_{\delta}$  for each case was calculated and a graph was created to represent the trends of the  $LTE_{\delta}$  for several scenarios. Equation 3 describe in Section 4.4 was used to calculate the  $LTE_{\delta}$  for each variation in scenarios and loading intervals. Figure 37 illustrates eight different scenarios in which the  $LTE_{\delta}$  was determined for the three slabs installed. The  $LTE_{\delta}$  exact values are available in Appendix A for the eight scenarios. Another set of deflection-based load transfer efficiencies ( $LTE^*$ ) values were calculated using Equation 5 for comparison purpose. The performance trends were similar as when Equation 3 was used. Slab #2 still performed better than the rest of the slabs. The results are available in Appendix A.

Figure – 37  $LTE_{\delta}$  Neglecting Temperature Variation Distresses

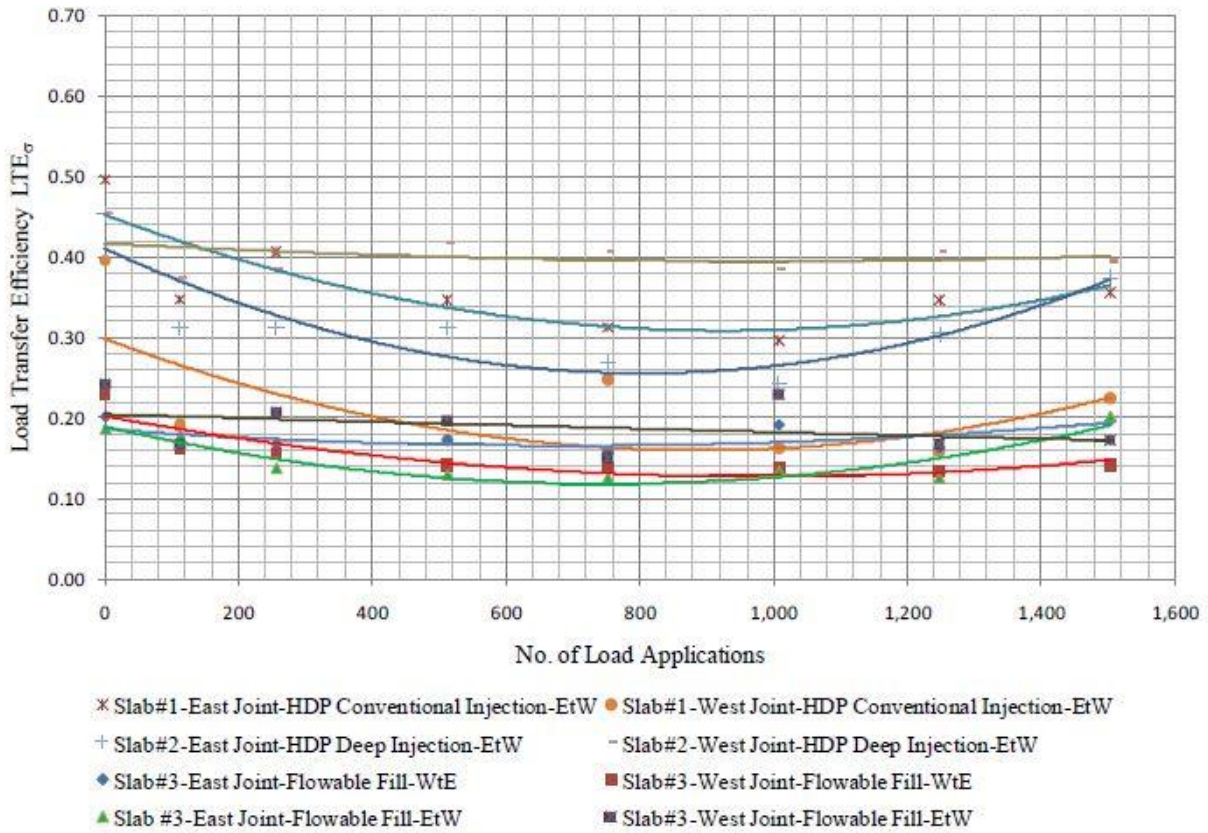
Load Transfer based on stress was analyzed only for accumulation of load applications. The analysis was previously performed and reported in the Practice Protocol for Repair Damaged Runways using Precast Concrete Slabs done by AFRL and AFCESA [3]. Figure 38 displays the results for  $LTE_{\sigma}$  applying a regression analysis for a better understanding of load accumulation. The  $LTE_{\sigma}$  was calculated using Equation 6.

**Figure – 38  $LTE_{\sigma}$  Neglecting Temperature Variation Distress**

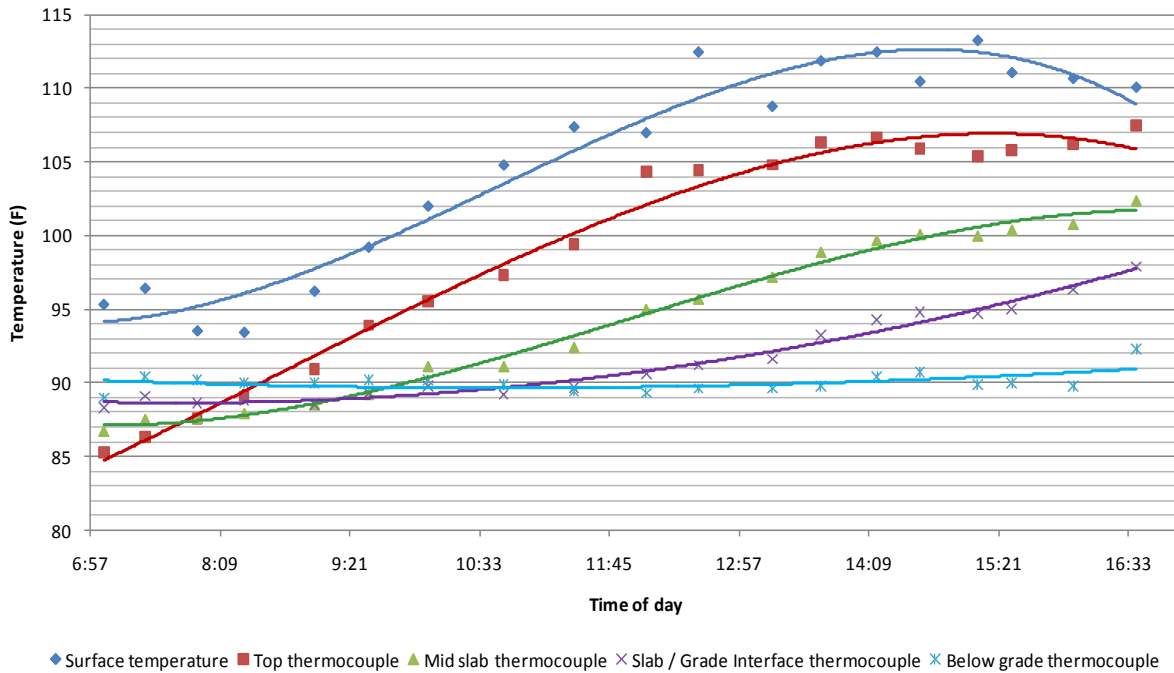
Figure – 39 Slab #1 Temperature Variations vs Time

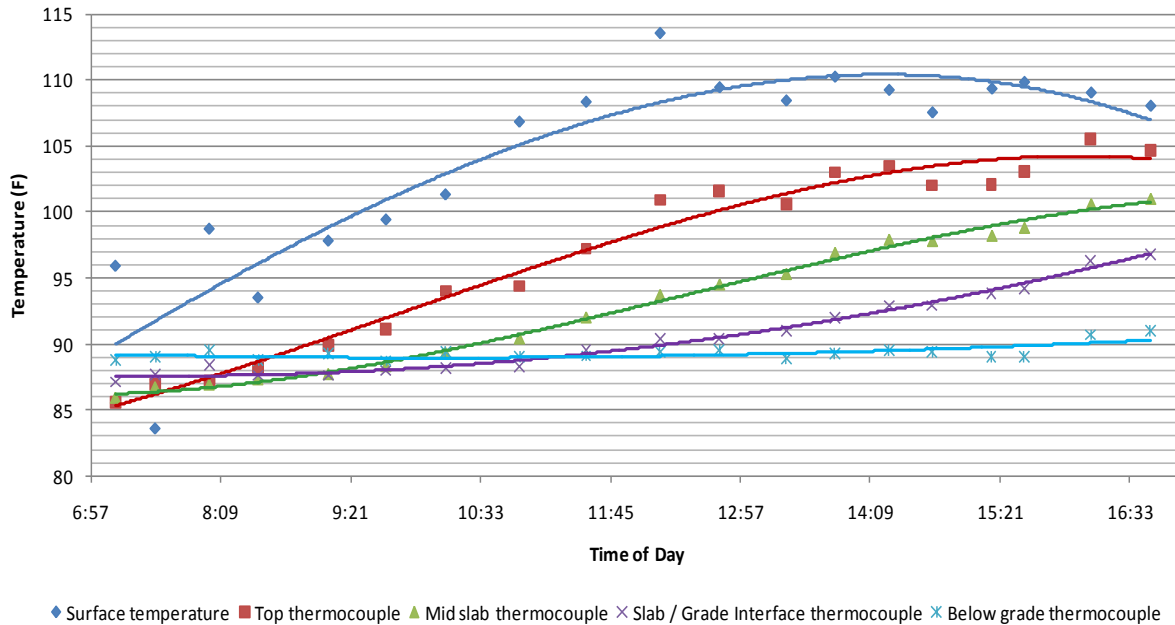
**Figure – 40 Slab #2 Temperature Variations vs Time**

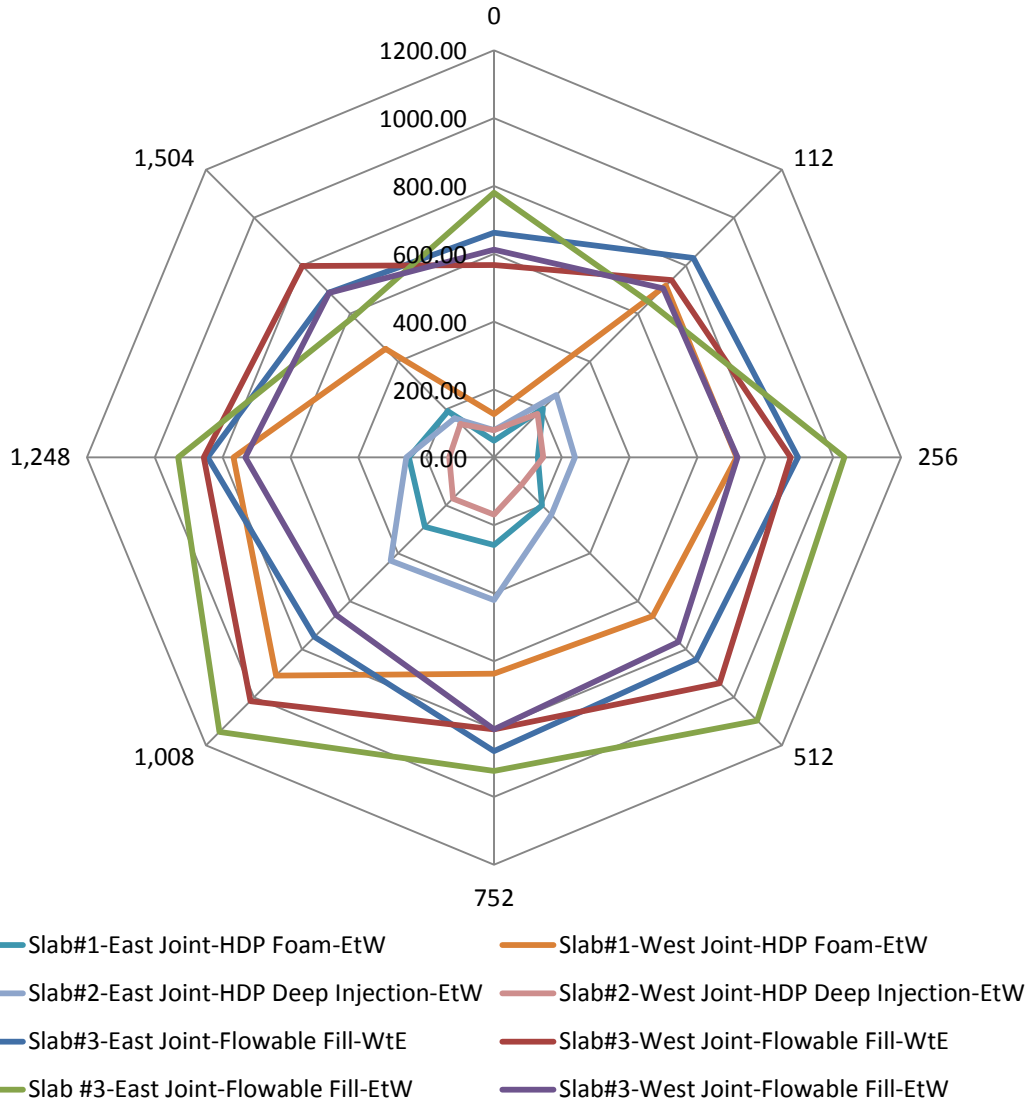
**Figure – 46 Deformation Energy Analysis for Un-aged Concrete Slabs (8 Cases)**
