Evaluation of Bridge Scour Monitoring Methods

FINAL REPORT
March 2002

Dept. of Civil & Environmental Engineering
Center for Advanced Infrastructure & Transportation (CAIT)
Rutgers, The State University
Piscataway, NJ 08854-8014

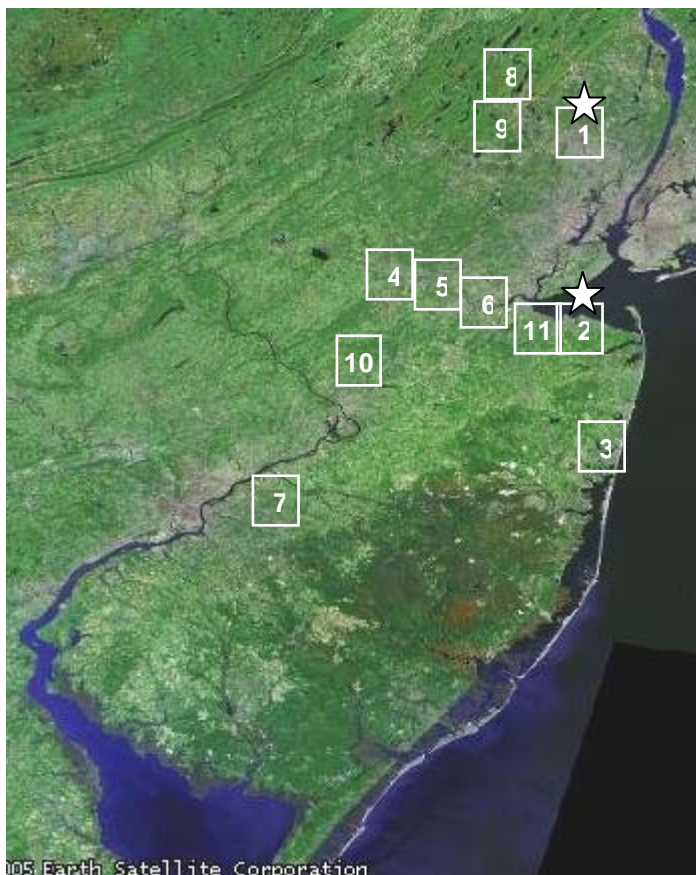
1. *Route 46 Bridge Passaic River over Dundee Lake
2. *Route 35 Matawan Bridge
3. Route 70 Bridge Manasquan River
4. Route 18 Raritan River Bridge
5. U.S. 1 Raritan River Bridge
6. New Jersey Turnpike Raritan River Bridge
7. Interstate 295 Rancocas Creek Bridge
8. Route 80 Passaic River Bridge
9. Route 46 Passaic River Bridge at Fairfield
10. Route 27 Millstone River Bridge
11. Route 35 Cheesequake Bridge

* indicates instrumented bridges.

Figure 4. Aerial Map of New Jersey with bridge sites considered for study (Earth Satellite Corp. 2005).

The area where the study was performed includes the State of New Jersey. The bridges that are investigated are on the following rivers: Matawan, Manasquan, Passaic, Rancocas Creek, and Raritan. Figure 4 illustrates the location of bridges that were inspected in this study for possible instrumentation for scour detection. Table 2 gives more detailed information about the bridges that were investigated.

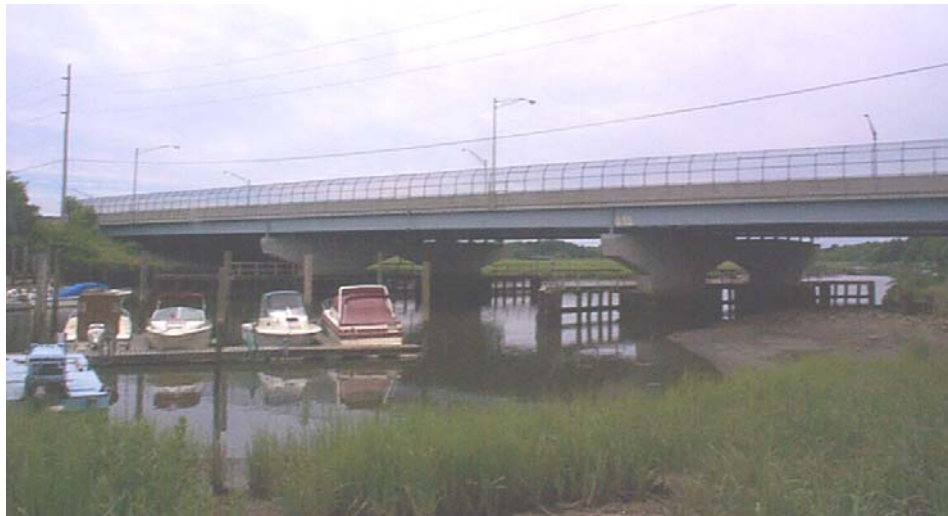
Figure 5. Matawan Bridge North Elevation.

Route 35 crosses Matawan Creek in the town of Aberdeen, Middlesex County, NJ about 15 miles East of Rutgers University's New Brunswick Campus (Figure 6). The three-span, continuous steel girder bridge crosses a stream width of 100 ft. Matawan Creek is the sole outlet of the nearby tidal salt marsh. The foundation is composed of driven piles with cast in place concrete pier caps. The bridge was constructed in 1987.

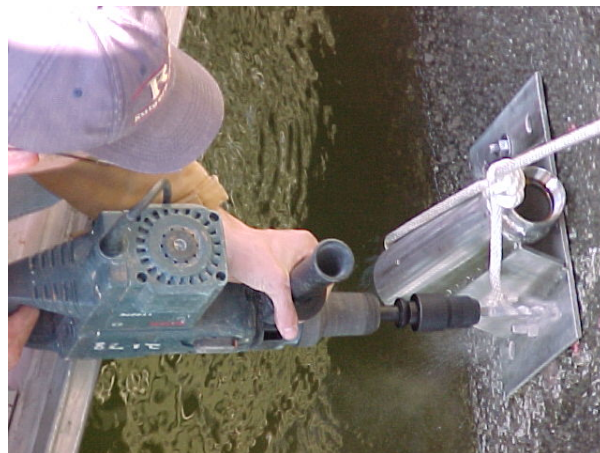
Figure 10. Installation of the stainless steel sonar frame during low tide stage.

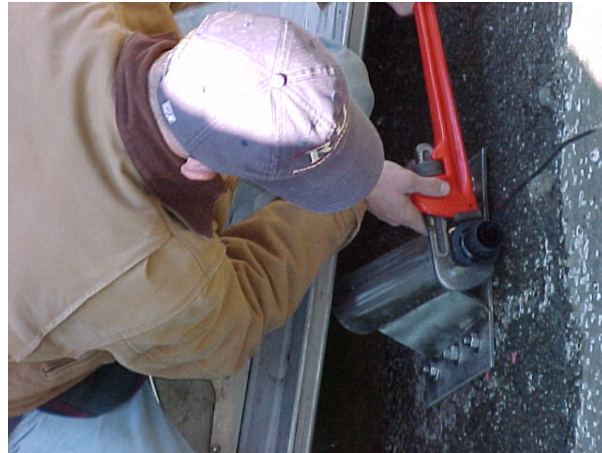
Figure 11. Placing sonar in stainless steel conduit

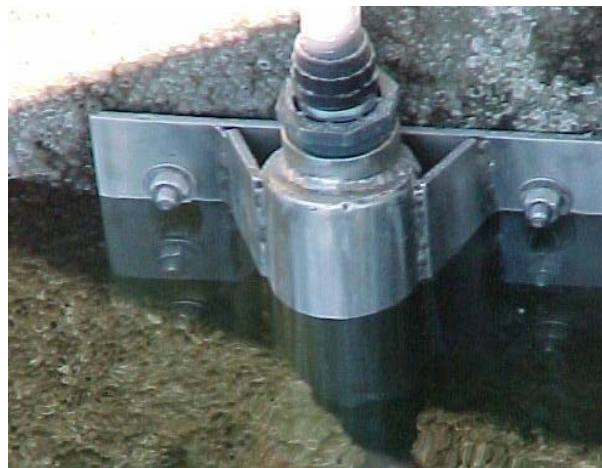
Figure 12. Sonar mounting plate as tide rises.

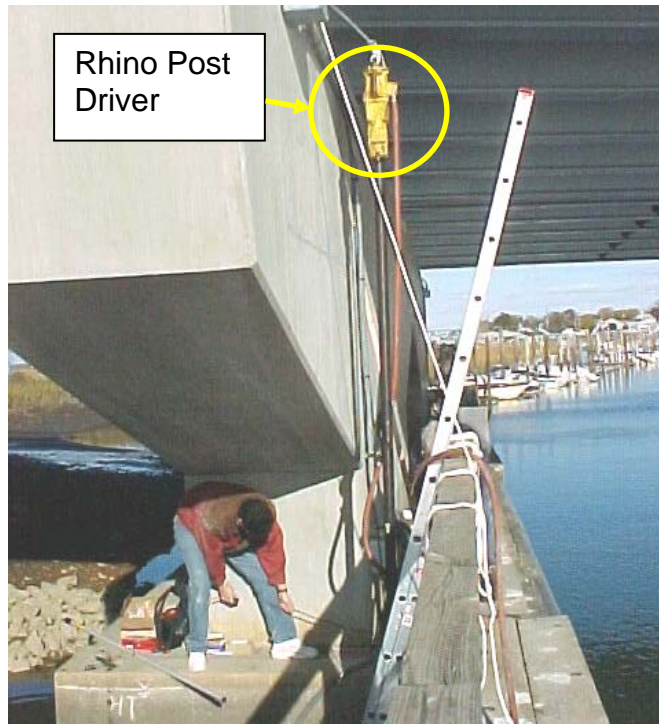
Figure 13. The Rhino™ Post Driver on top of the steel pipe to drive the stainless steel MSC pipe into riverbed.

The rigid stainless steel MSC heavy-duty post is about 8 ft long with a cone tip and threaded fitting end. In addition, threaded steel pipes and couplers were needed as part of the driving rig. The actual magnetic collar was guided up the post with a loop of rope before the final placement. The pipes were threaded into the MSC fitting, to be removed after driving. The Rhino post driver was placed atop the steel pipe, and the MSC setup was positioned.

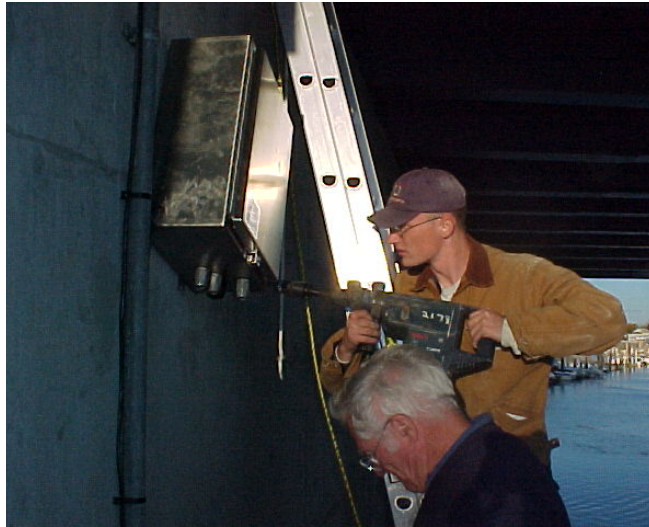
Figure 15. Installation of datalogger by Rutgers and ETI staff.

With most of the instruments installed, the control box was connected with the incoming conduits (Figure 15). The stainless steel enclosure was outfitted with moisture seals and closure clamps to prevent equipment damage. After reviewing the 100-year-flood stage data, it was determined that the box needed to be placed 10 ft above the ledge of the pier cap to ensure data collection during a severe flood condition. After all, the highest magnitude scour would occur during a flood that could also destroy equipment and critical data.

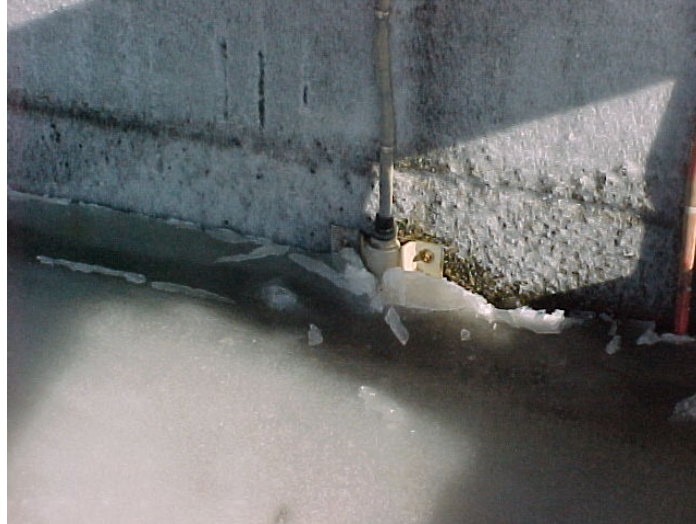
Figure 18. Sonar surrounded by ice. Matawan Bridge, Feb 2000.

The bridge site was visited regularly after installation. The site visits were to ensure proper protection of the equipment. During a Mid-winter trip, 4 inch thick ice flows bearing against the sonar mounting plate, were observed (Figure 18). Although the ice formation did not cause any physical damage to the Sonar unit, data disturbance during sonar data collection was observed.

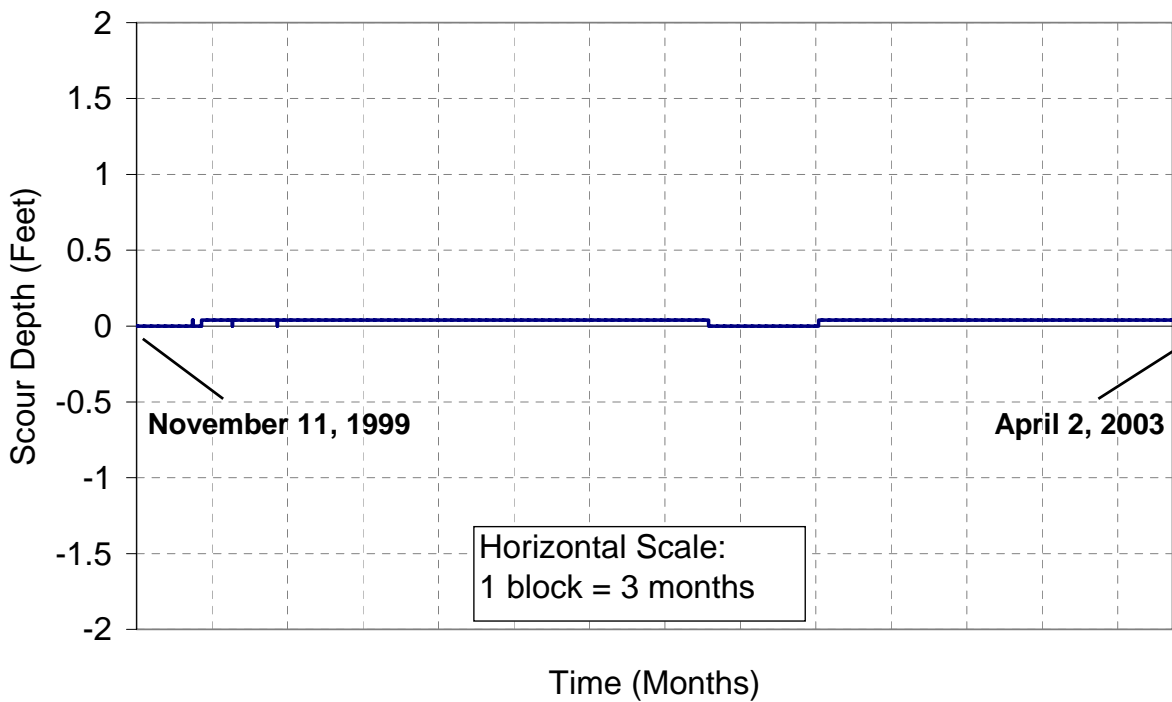
Figure 20. Matawan Bridge Magnetic Sliding Collar Data.

It can be observed from the sonar and MSC depth change plots of Figure 19 and Figure 20 that the Matawan Bridge does not have scour activity. The streambed elevation did not change by more than 0.3 feet in the nearly four years of observation. The only concern for scour would be for extreme flood events, for example 100 year flood or hurricane storm surge.

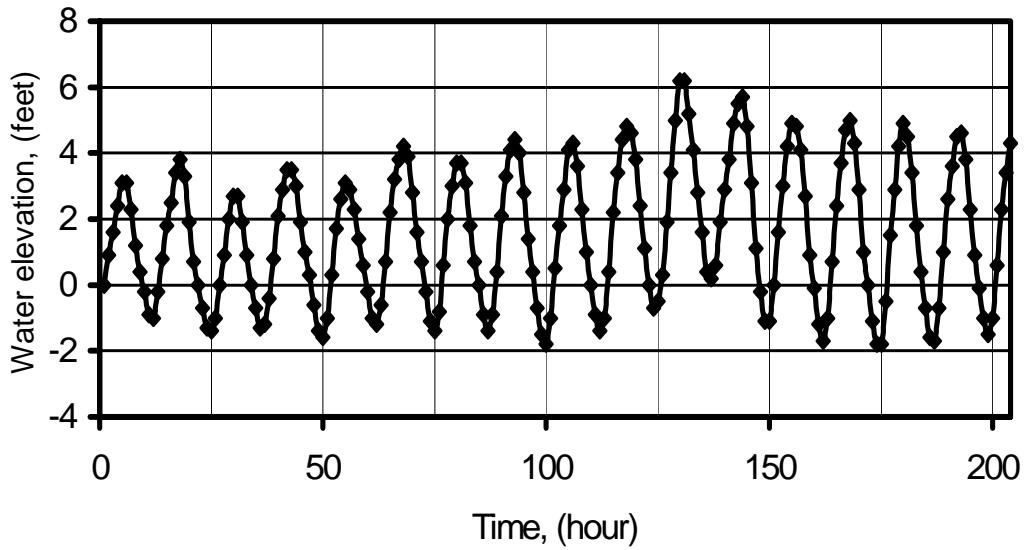
Figure 21. Typical Tide versus Time data for Matawan Bridge collected using stage sensor.

Figure 21 shows a sample of the regular tidal flow at Matawan. The tidal ebb and flow seems to have no effect on the soil at the pier. The lack of any appreciable scour activity also indicates that Matawan Creek is not a major rainfall drainage path.

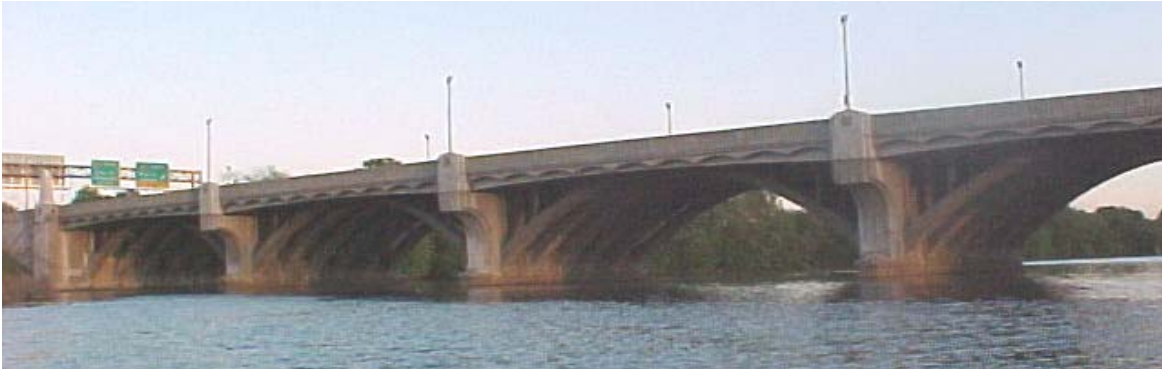
Figure 22. Route 46 Passaic Bridge at Elmwood Park, North Elevation.

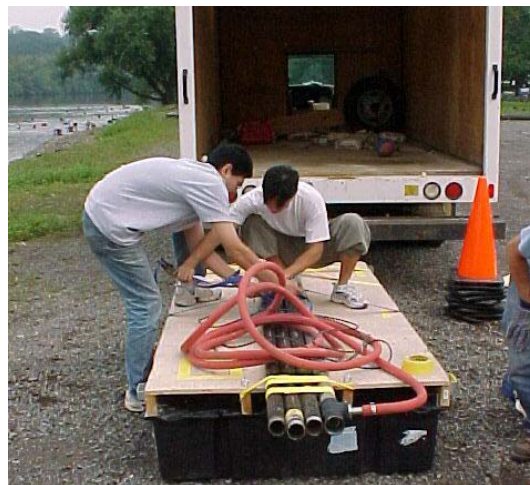
Figure 29. Floating platform used for instrumentation of Route 46 Passaic Bridge.

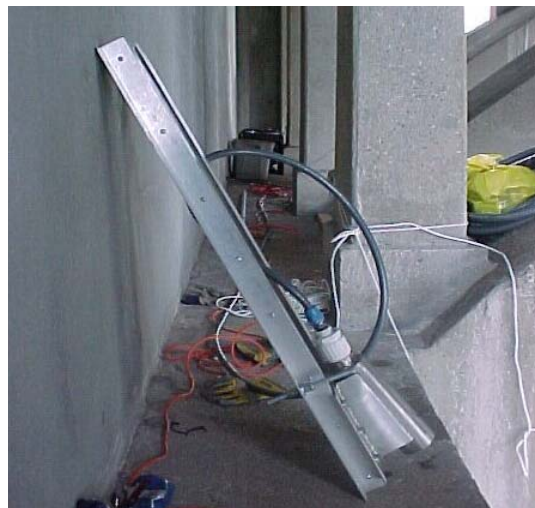
Figure 31. Sonar mounting frame.

Due to the deep-water conditions, an aluminum frame was constructed to install the sonar under the water. Using this frame, the sonar device was installed above water while having the transducer head immersed (Figure 31).

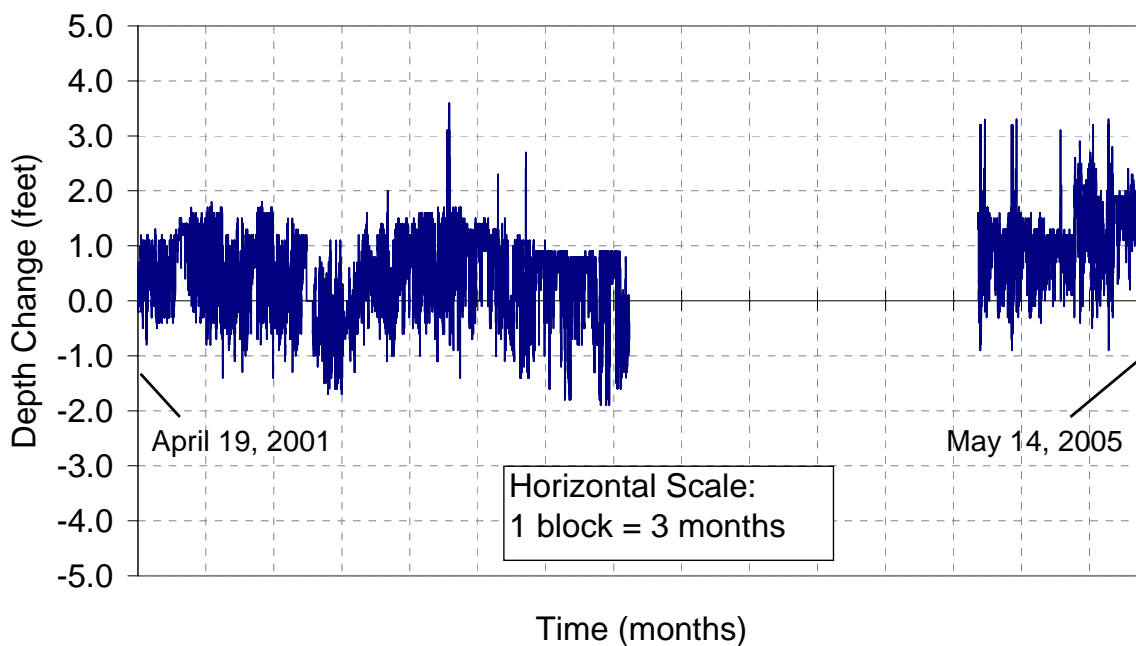
Figure 32. Hourly Scour Data for Route 46 Passaic River Bridge.

Twenty-three months of data have been collected from the Route 46 Bridge (Figure 32 through Figure 34). Note: Data from 9/23/01 through 2/5/03 was lost; however, most of the sonar data for this period was recovered from backup sources.

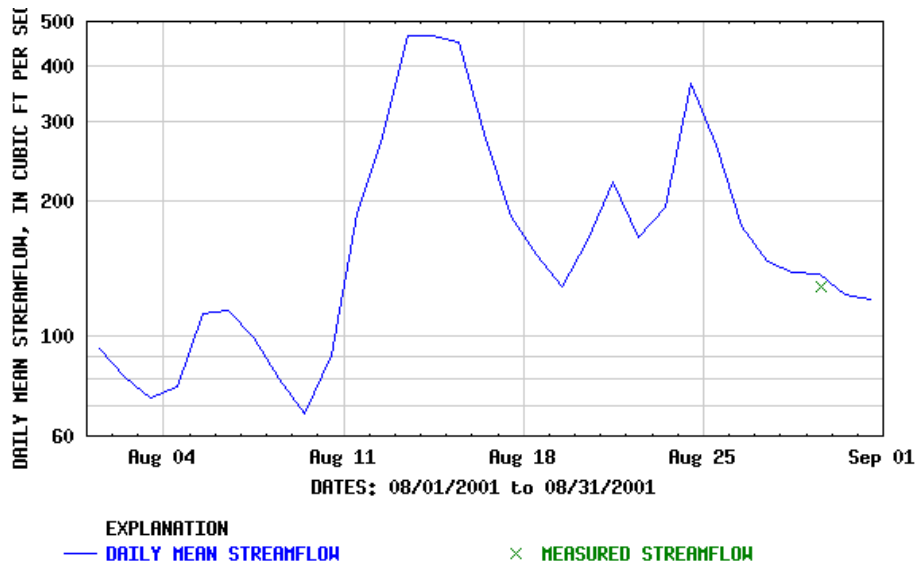
Figure 36. USGS Passaic River stream flow data upstream of Route 46 Passaic River Bridge, August 2001 (www.usgs.gov).

The amount of delay for rainfall to affect the stream flow for the Passaic River can be observed from Figure 36 and Figure 37. For example, a heavy rain on 8/12/01 of more than 1 inch causes an increased flow from 8/12 to 8/16. The weather and stream flow information is useful to verify the data and understand the hydraulic delay properties of the watershed.

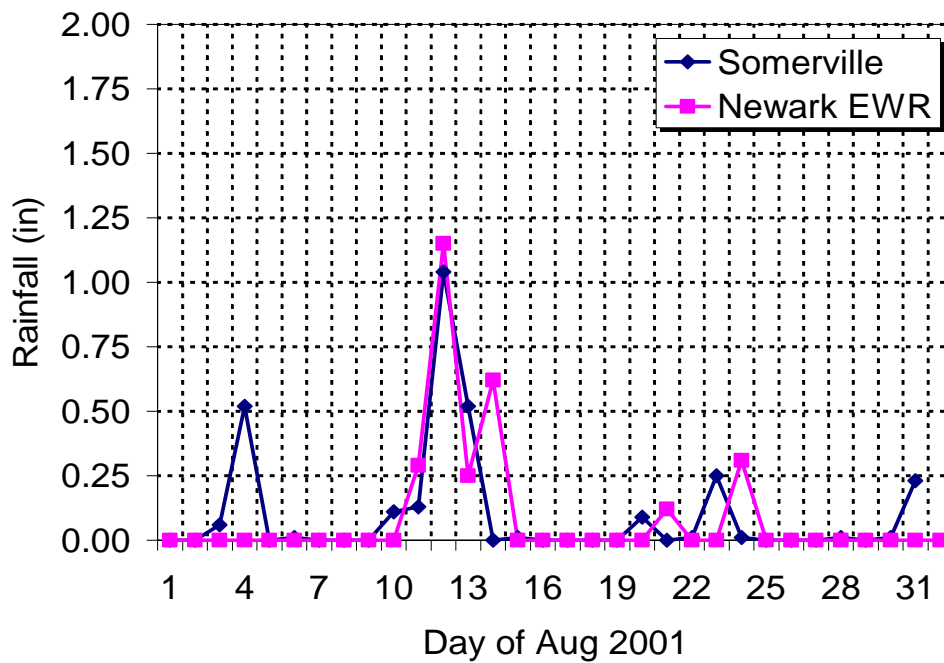
Figure 37. National Weather Service Rainfall Data for New Jersey (<http://www.noaa.gov>).

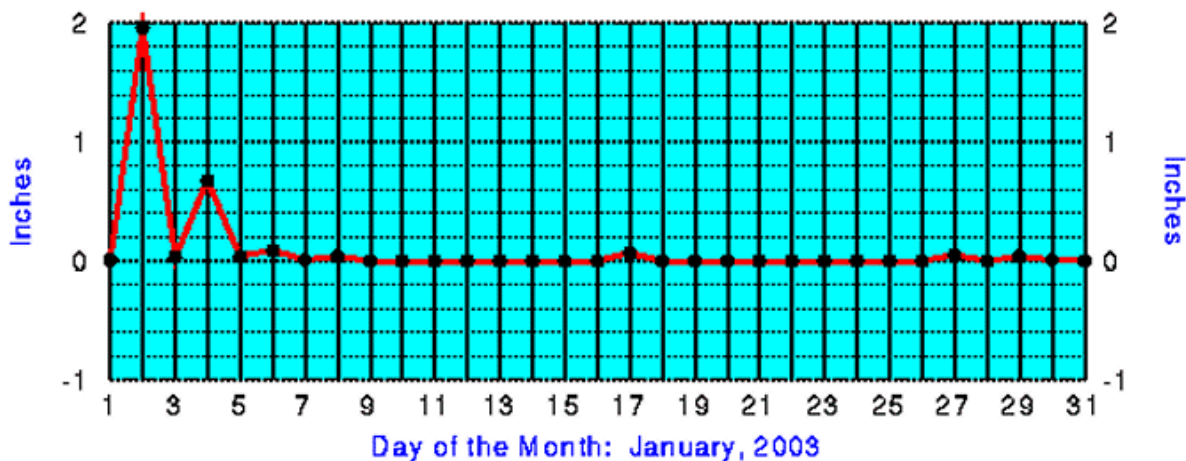
Figure 38. Precipitation Data for nearby Passaic Bridge, January 2003. Courtesy: National Weather Service NOAA (www.noaa.gov).

The following two plots provide another example of a rain condition that led to a scour event at the Passaic Bridge. Figure 38 shows the daily rainfall at Newark International Airport (EWR) for January 2003. A heavy day of rain occurs on 1/2/03 followed by a scour event detected by the Passaic sonar sensor (Figure 39). All depth change measurements are relative to the elevation of the streambed when the system was first initialized. Figure 39 shows no scour activity using the MSC system, while the sonar records a depth change of -1 foot. The likely explanation is that the sonar is showing the scour of soil that was re-deposited at the pier since the last scour event. The MSC will only detect a scour event that is greater than the previous event. The reference elevation for the Passaic Bridge is -16.8 feet.

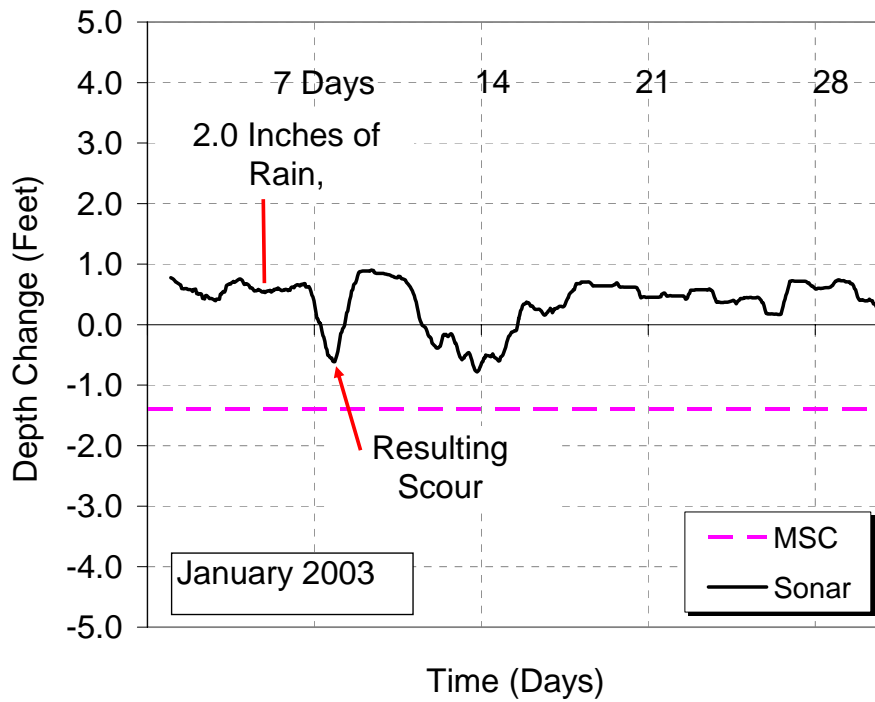
Figure 39. Passaic Bridge Scour Event January 2003.

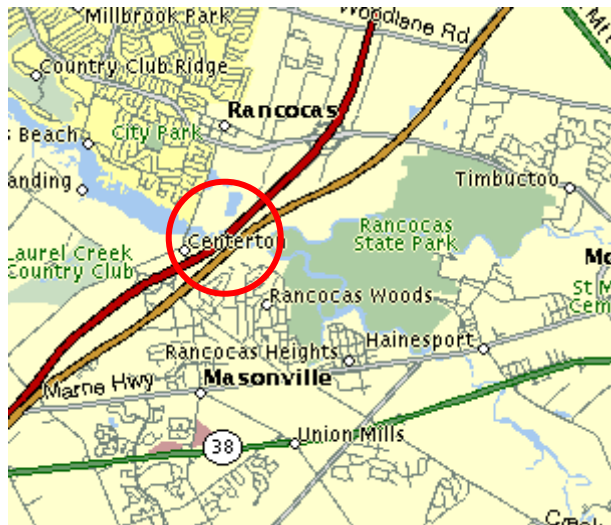
Figure 44. Interstate 295 Rancocas Creek Bridge, Burlington County, NJ.

Rancocas Creek at the Interstate 295 Bridge (Figure 44) is a wide river with accompanying marshes. The soil type is primarily silty and fine to medium grained sands. The flow is tidal, being located 5 miles from the Delaware River in Burlington County, NJ. Portable sonar inspections of the piers show little, if any, scour effects. Furthermore, the remote location of the bridge would make installation and maintenance difficult.

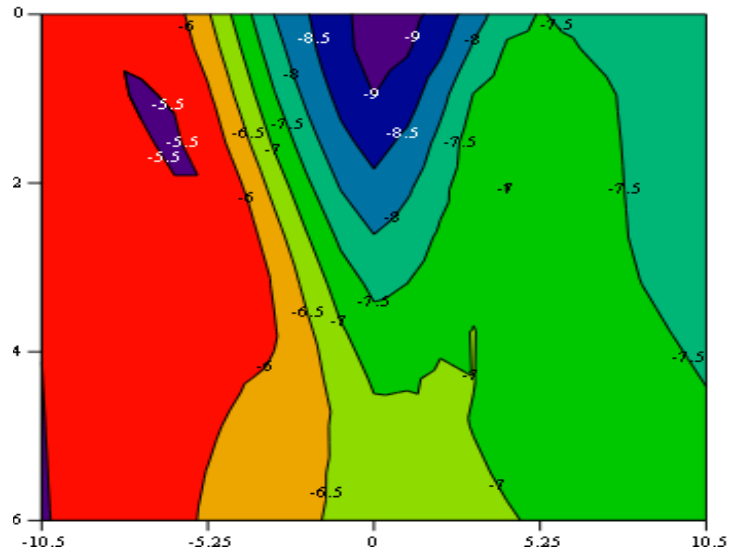
Figure 47. Contour plot of scour depth in front of the pier of Route 46 Passaic River Bridge, Fairfield, NJ.

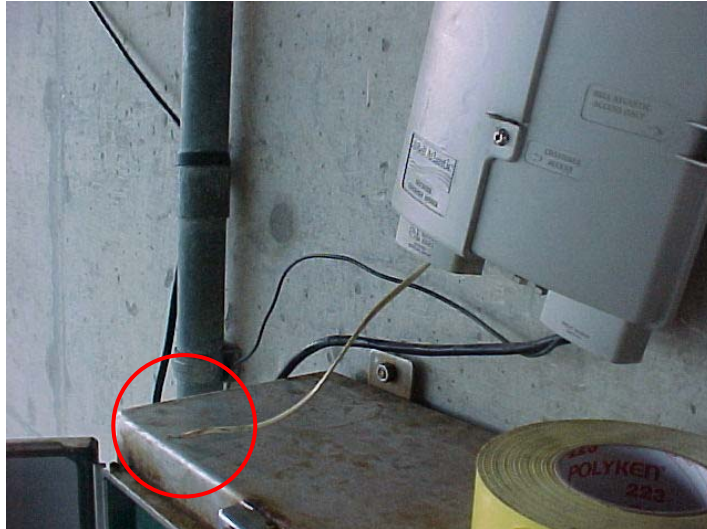
Figure 51. Matawan Bridge Vandalism. Aug 2001. Severed telephone cable and dismantled telephone box

On a typical summer weekend fishermen used the piers at Matawan Bridge for crab trapping. Often they secure their trap lines to the bridge fender and the instrumentation conduits. Repair included providing additional wall anchors for conduits, extensive wire ties, and remounting the telephone box with new anchors (Figure 53).

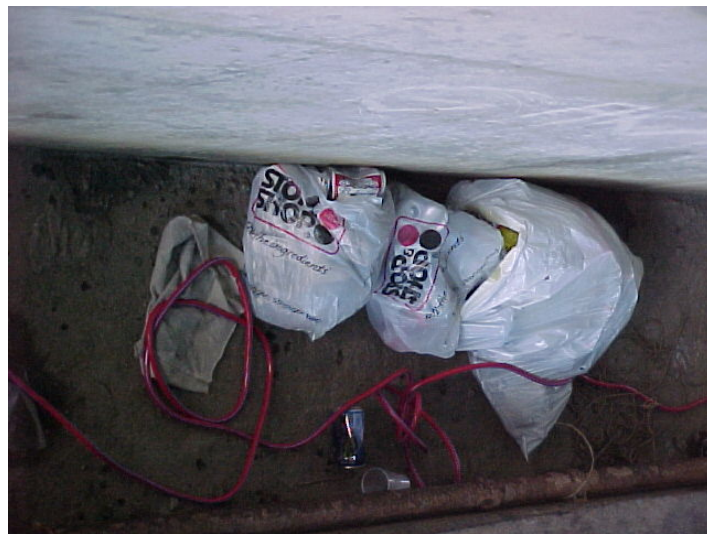
Figure 52. Matawan Bridge Litter, Aug 2001. Trash from local crab fisherman.

The chances of vandalism are high when the instrumentation is near high public foot traffic. On August 24, 2001 a routine call placed to the Matawan Bridge would not connect. A subsequent follow up trip to the bridge revealed that the telephone system box and cable were severed (Figure 51 and Figure 52). Apparently the conduit was pulled down, cutting the connection. The original installation date was November 1999.

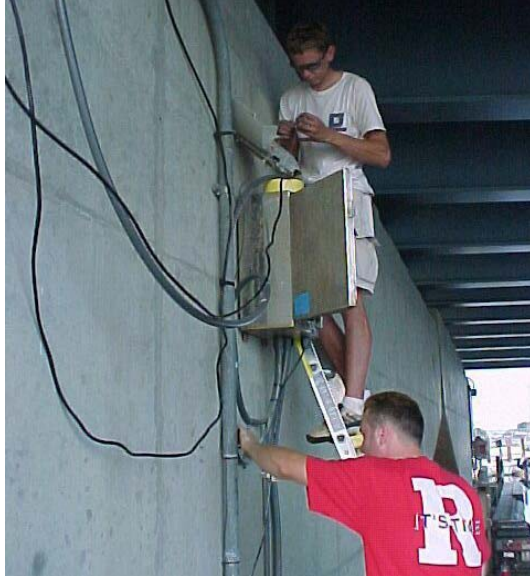
Figure 53. Matawan Bridge Repairs. Aug 2001.
