Inorganic Protective Coatings and Fiber Reinforced Polymers Demonstration Project: Route 47 Wildwood Drawbridge Bridge House Rehabilitations

FINAL REPORT October 2008

Submitted by Dr. P. N. Balaguru, Principal Investigator Jeremy Brownstein, Graduate Assistant

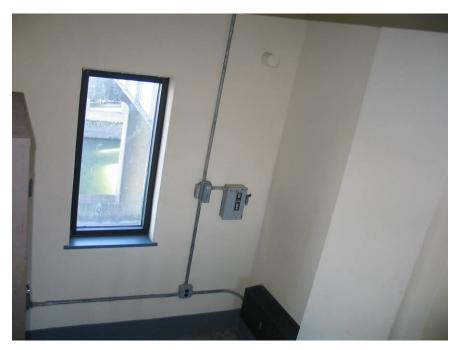
Figure 3 - Finished Inside Surface Including Treatment Around Window (North Tower)

On the following pages, Figures 1-6 show some of the work that was done. Figures 1 and 2 show the outside of the North Tower. Figures 3 and 4 illustrate work that was carried out inside the North Tower. Figures 5 and 6 illustrate work done inside the South Tower.

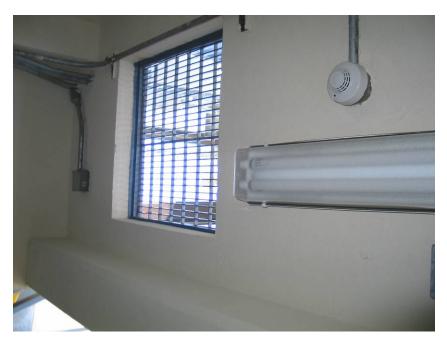
Figure 4 - Details Near Fixtures (North Tower)

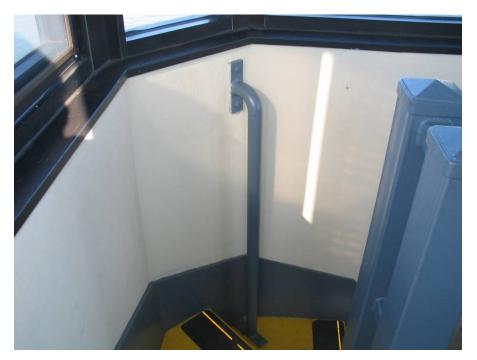
Figure 5 - Details Near Steps (South Tower)

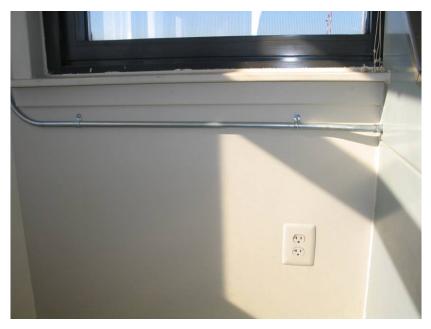
Figure 6 - Details Near a Large Window (South Tower)
