FINAL REPORT

**EVALUATE THE CONTRIBUTION OF THE MIXTURE
COMPONENTS ON THE LONGEVITY AND
PERFORMANCE OF FC-5**

FDOT Contract No. BDS15 977-01

**Thomas Bennert, Ph.D.
Center for Advanced Infrastructure and Transportation (CAIT)
Rutgers University
100 Brett Road
Piscataway, NJ 08854**

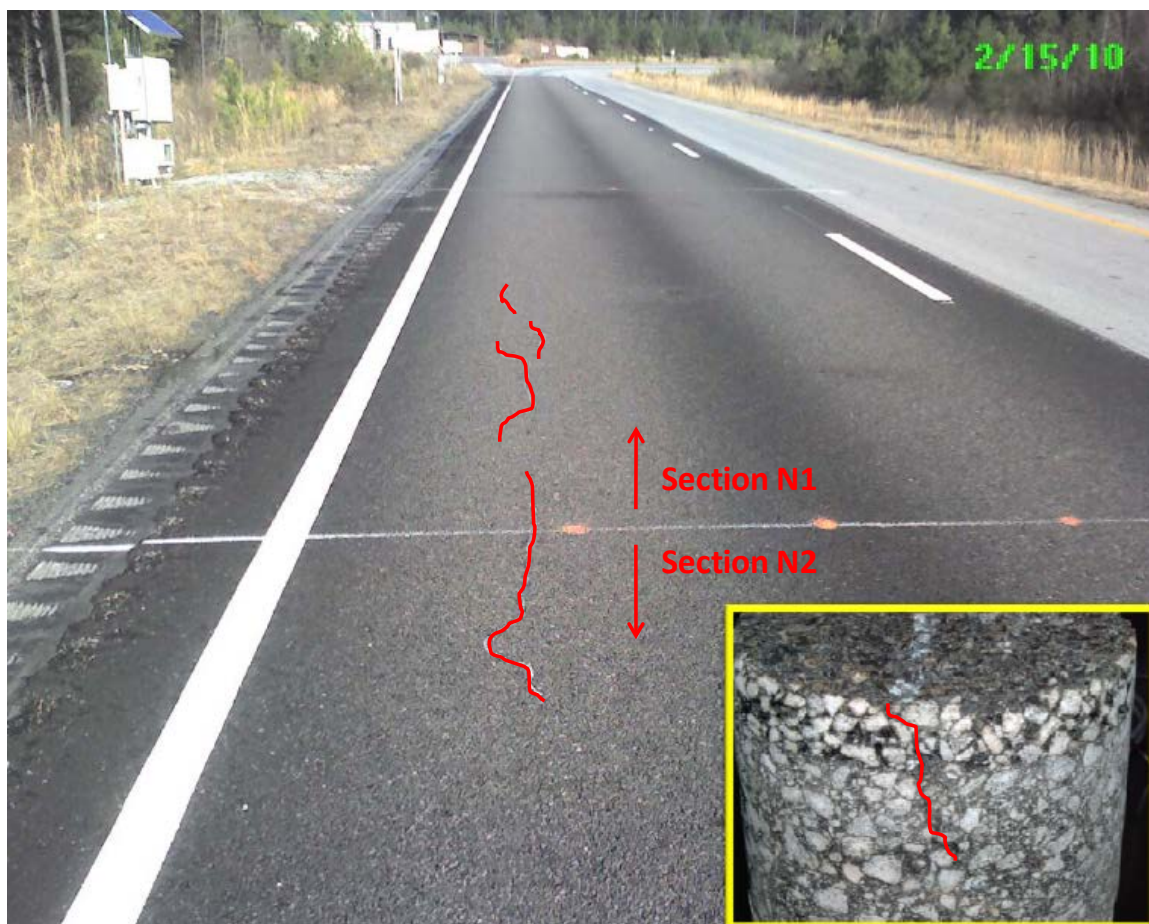
Figure 1.1 - Top-down Cracking at the NCAT Test Track for FDOT's FC-5 Mixtures

1. The OGFC layer on Section N1, in which a heavier tack coat was applied, performed better than that of Section N2, in which a conventional tack coat was used.
2. While both sections had cracking, the level of severity and the area of severe cracks were greater in Section N2 than Section N1.
3. It was recommended that to help resist cracking in OGFC layers, heavier tack coats be used.

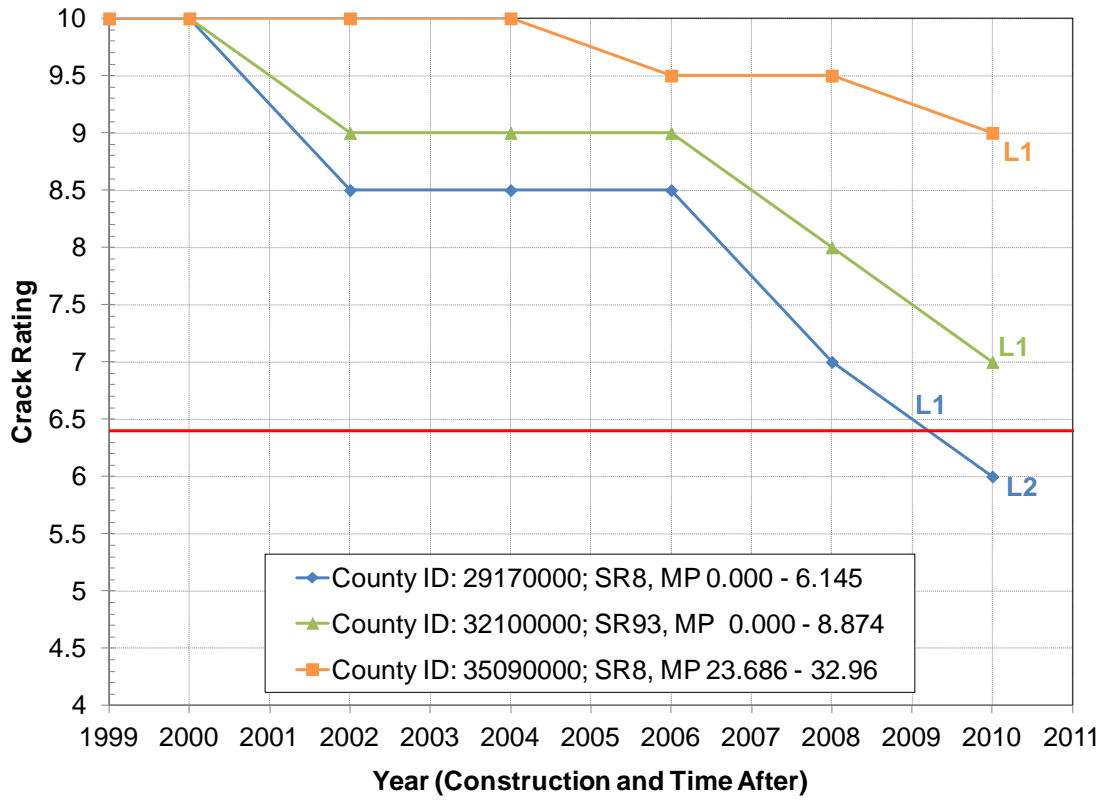
Figure 3.4 – FC-5 Cracking and Raveling Performance in District 2

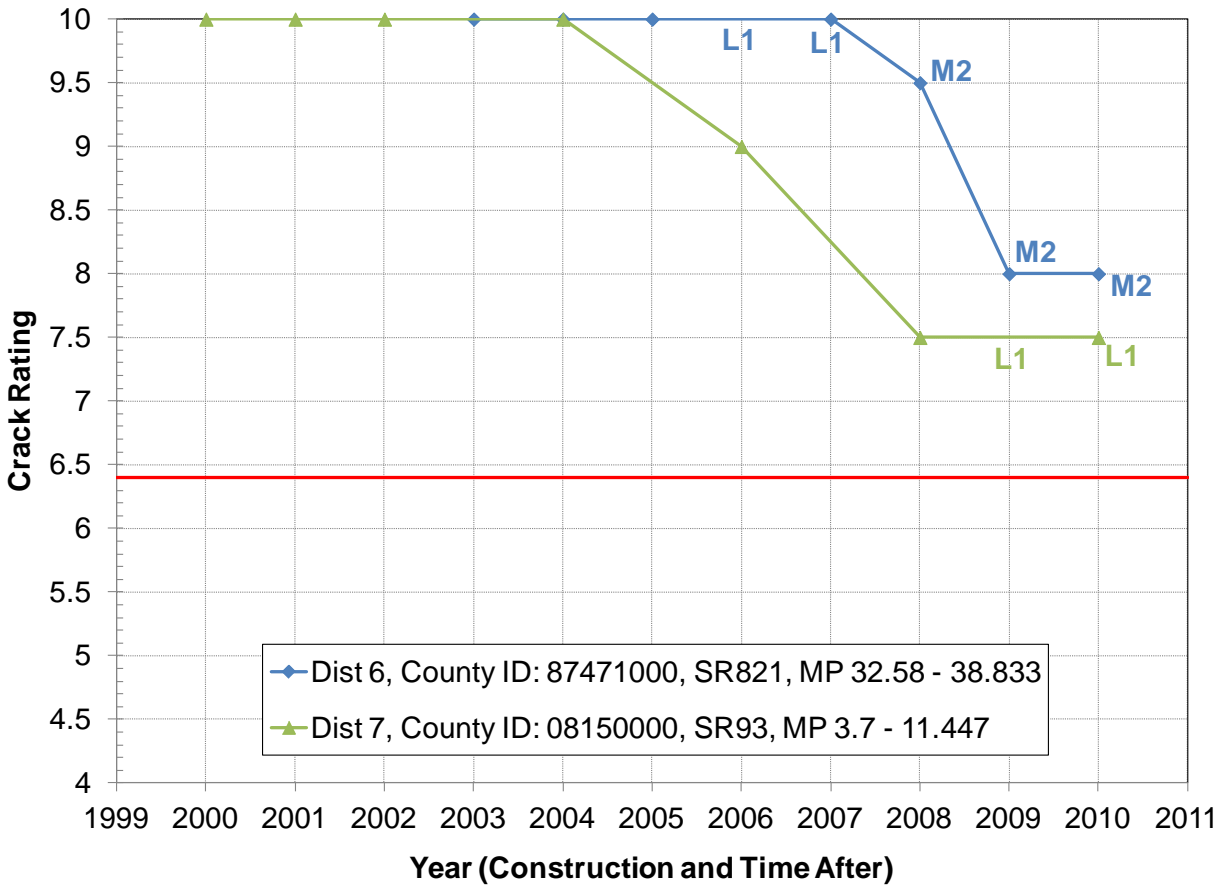
Figure 3.8 - FC-5 Cracking and Raveling Performance in District 6 and 7

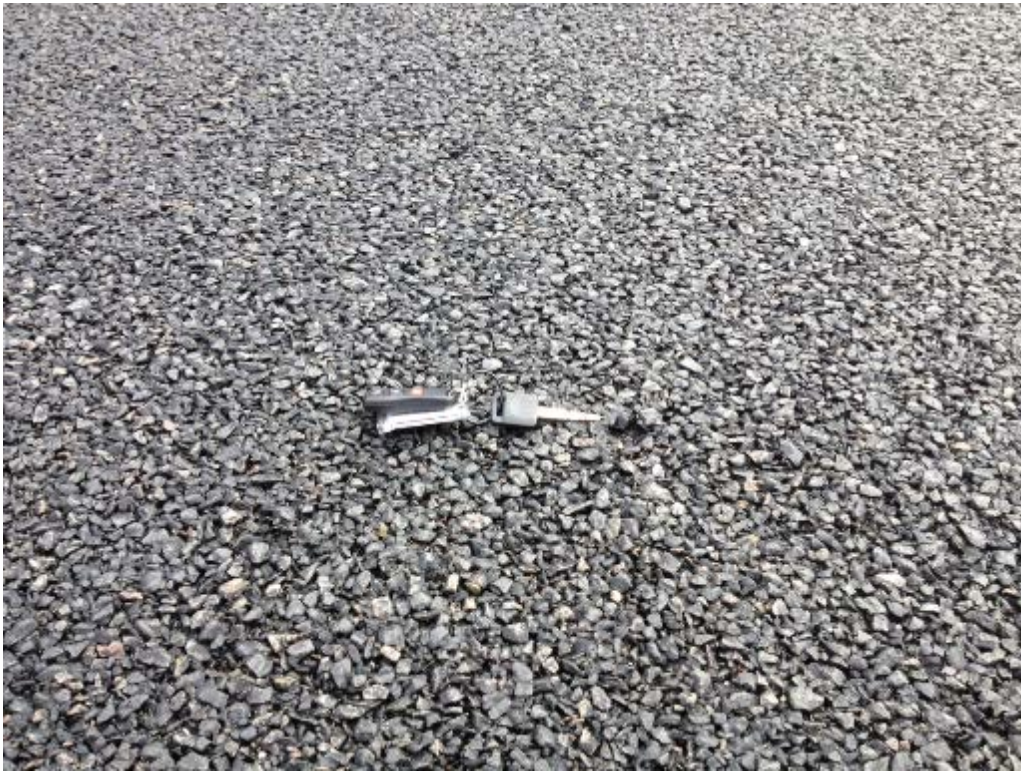
Figure 3.14 - Aggregate Pop-out on SR-20

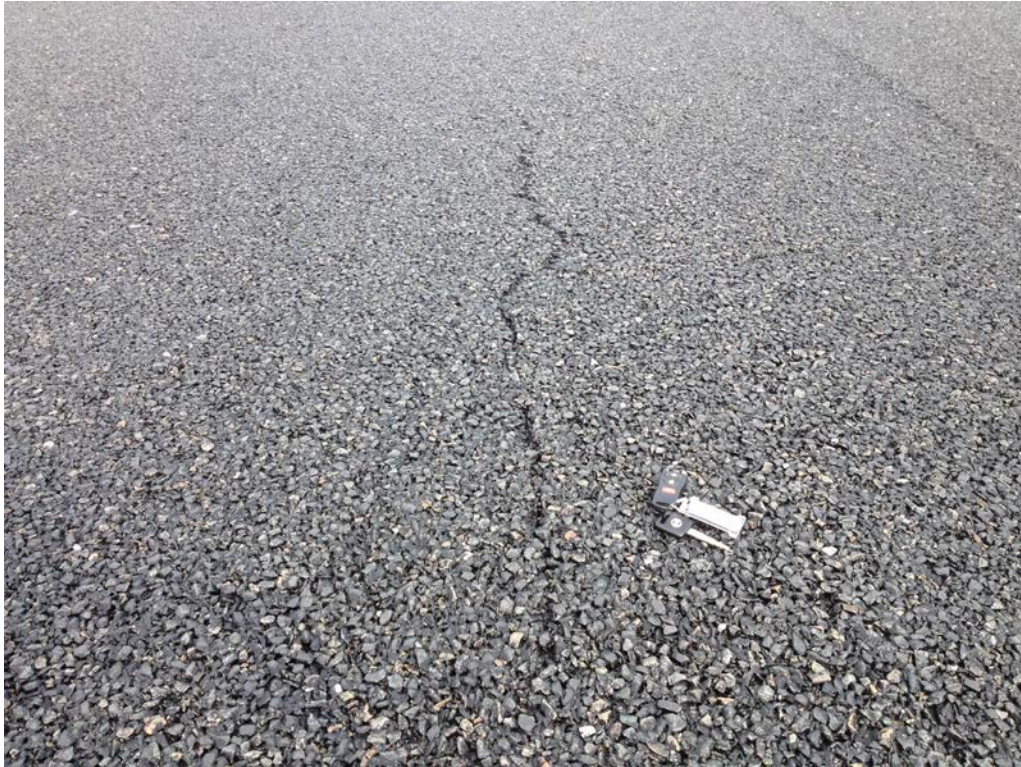
longitudinal cracks were observed within this section. The cracks were not continuous and were observed sporadically over the entire project. Typically, the longitudinal cracks were 4 to 6 ft in length (Figure 3.15) and observed within the wheelpath. There did not appear to be any production or construction issues that caused the distresses. Visually (and this can be observed in Figure 3.14), the FC-5 appeared to be slightly under-asphalted. Not only had the asphalt binder been worn away from the pavement surface by the action of tires, but the aggregates visible under the surface appeared to have very thin asphalt films.

Figure 3.15 - Longitudinal Crack on SR-20

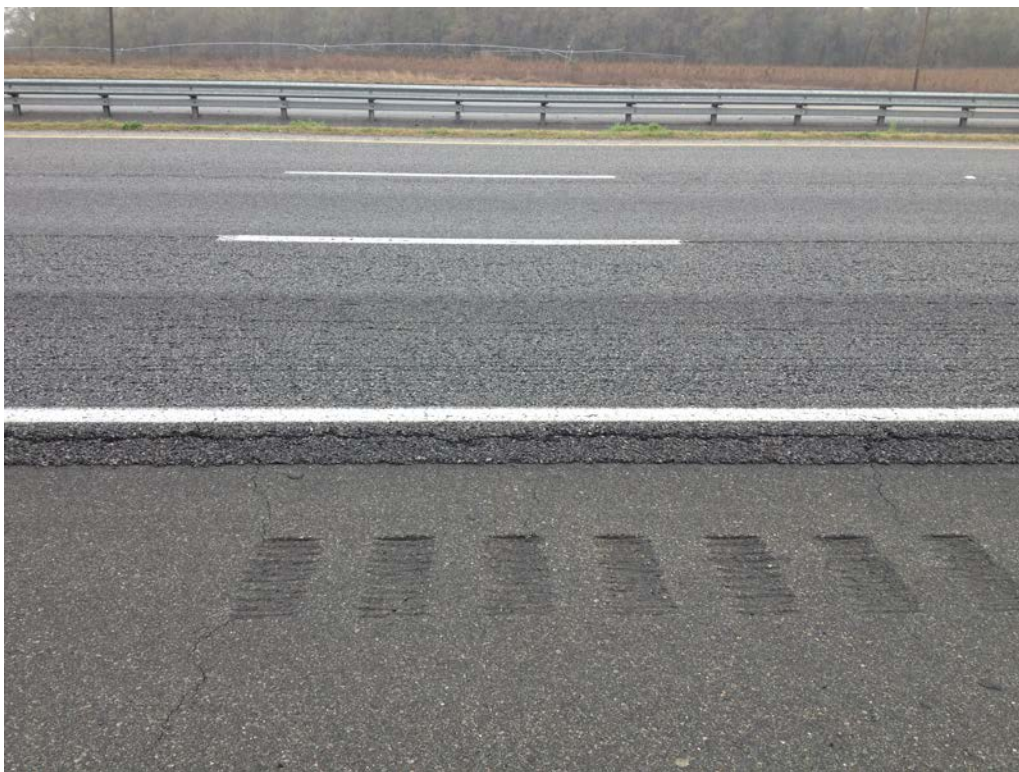
Another section evaluated on I-75 in Hamilton County was in the northbound lanes between Mile Posts 461 and 462, which was last resurfaced in 1998. It was evaluated because of rutting, cracking and raveling. As shown in Figure 3.16, the outside lane was experiencing rutting. It was not discernible whether the rutting was limited to the FC-5 layer or whether the rutting resulted from issues in an underlying layer. Cracking was observed within the wheelpaths. These cracks had an appearance similar to fatigue cracks and were low severity. A significant amount of raveling had also occurred within the wheelpaths (Figures 3.17 and 3.18). It was unclear from the visual examination of the pavement what caused the issues; however, the probable cause was from an underlying layer. It did not appear to be a materials issue with the FC-5. One possibility is that stripping had occurred in an underlying layer.

Figure 3.16 - Rutting on I-75 in Hamilton County (MP461-462)

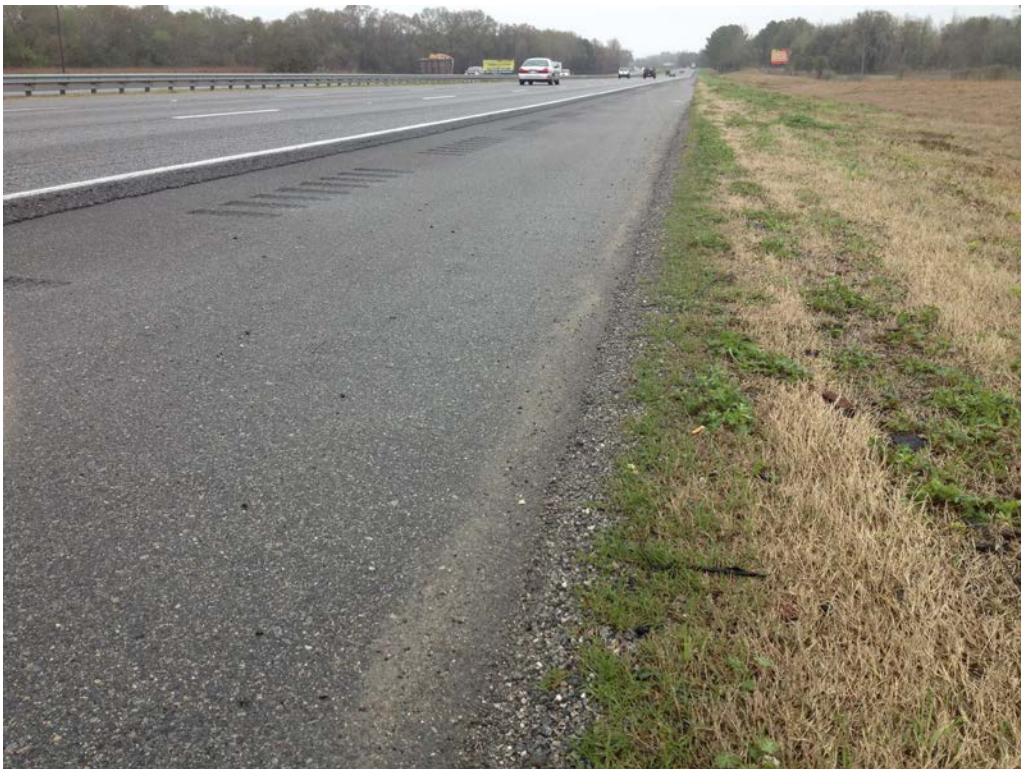
Figure 3.18 - Raveled Aggregates on Shoulder, I-75 Hamilton County (MP 461-462)

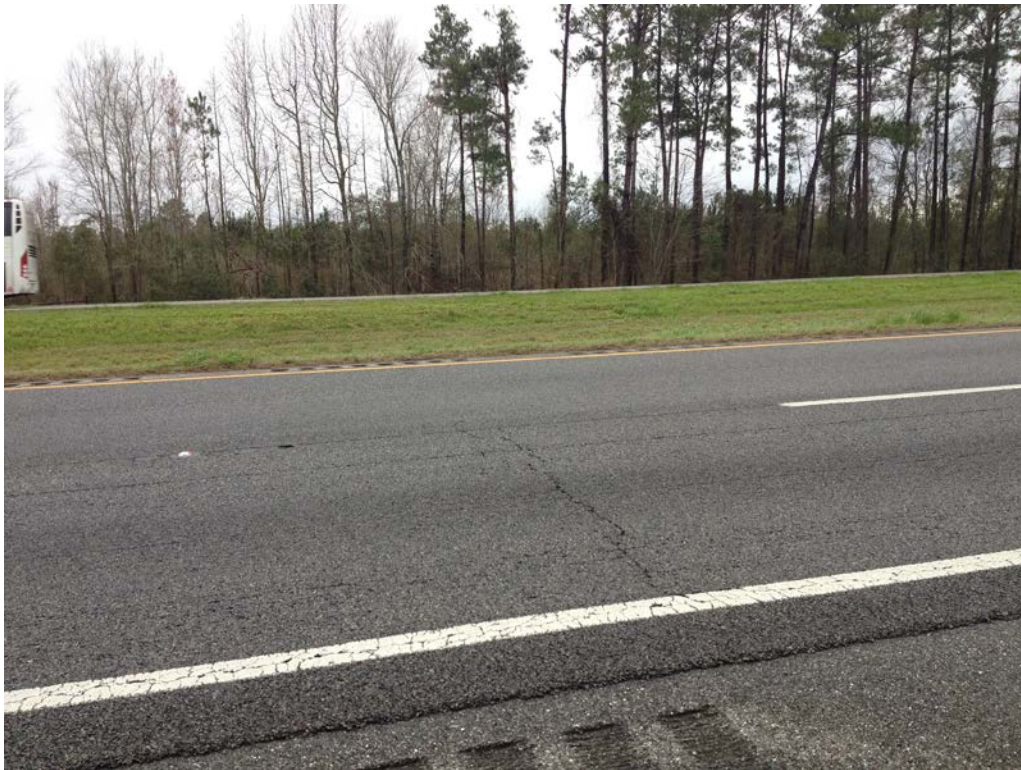
The final section evaluated on Day 2 was on I-10 in Jefferson County, w between Mile Posts 229 and 230. Within this section of roadway, which was last resurfaced in 1999, transverse cracks were observed within the FC-5 mix (Figure 3.19). The spacing and shape of the transverse cracks indicate that they were likely reflected upwards from an underlying concrete pavement. Additionally, in some locations, diagonal cracks had reflected to the surface from broken slabs (Figure 3.20). These distresses were not deemed to be FC-5 material related distresses.

Figure 3.19 - Transverse Crack on I-10 (MP 229-230)

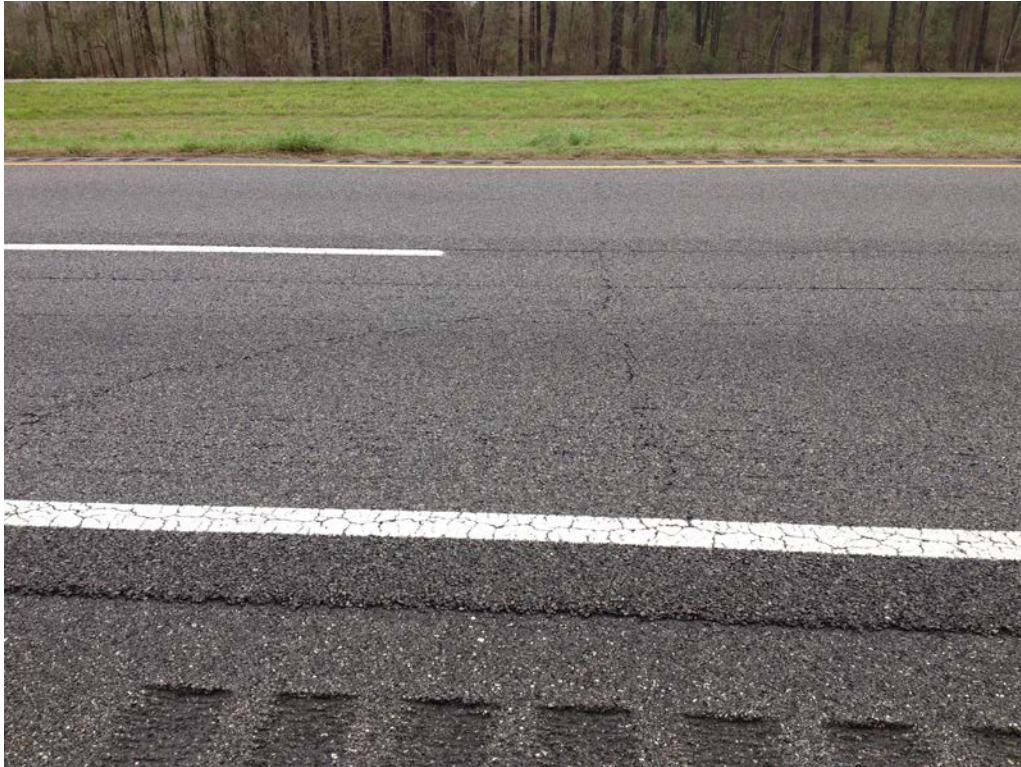
Figure 3.20 - Transverse Cracking on I-10 (MP 229-230)

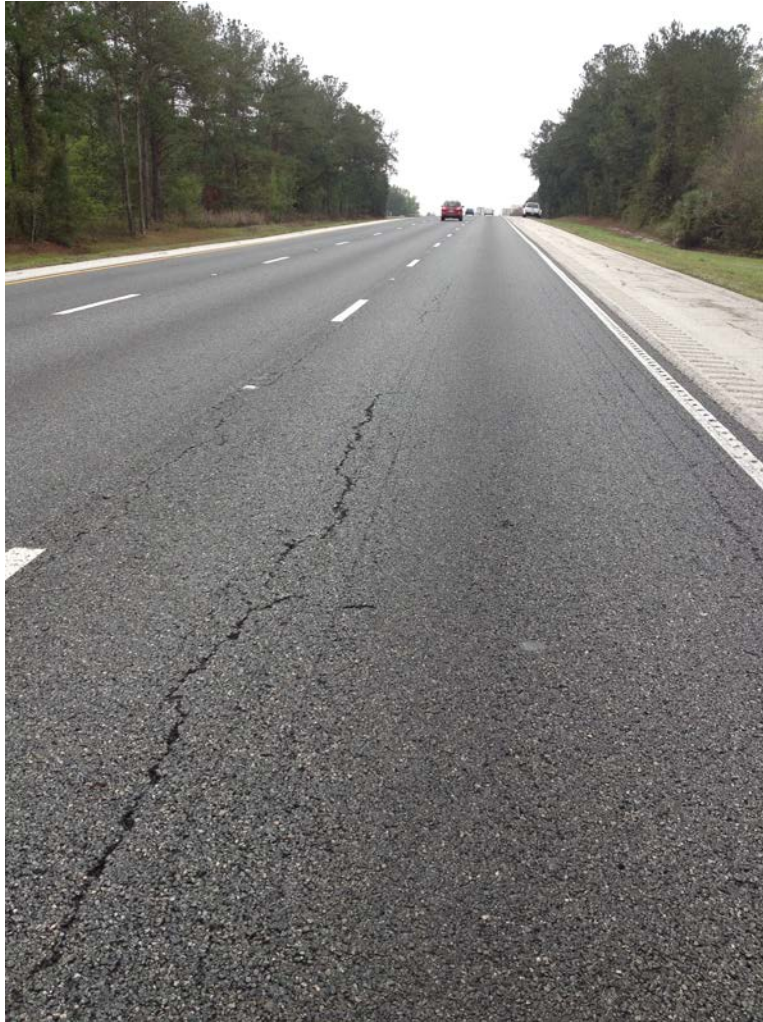
Figure 3.21 - Longitudinal Crack on I-75 in Marion County

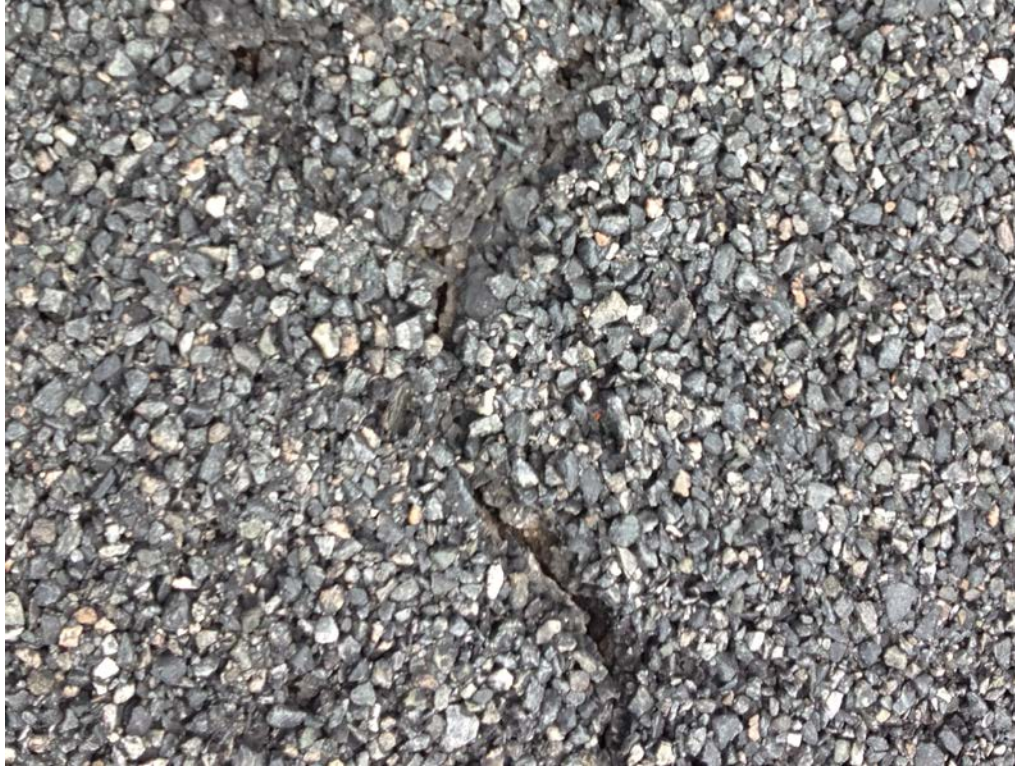
Figure 3.22 - Close-up of Longitudinal Crack on I-75 in Marion County

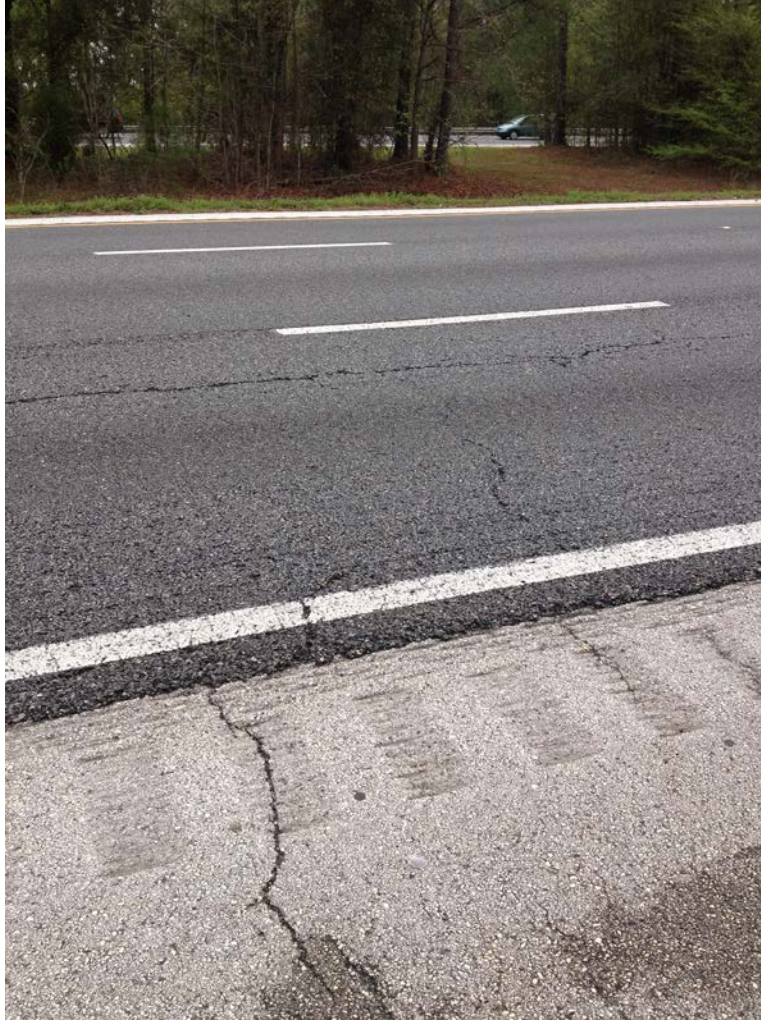
In addition to the longitudinal cracks, transverse cracks were observed in some locations. These transverse cracks appeared to begin at the longitudinal crack and extend into the shoulder (Figure 3.23). Raveling was observed within the section. Within some areas, the raveling would be considered moderate severity, especially within the wheelpath. It was unclear if the longitudinal or transverse cracking was material related. However, it is assumed that the cracking was caused by an issue within underlying layers. This was assumed because of the transverse cracks that extended into the shoulder.

Figure 3.23 - Transverse Crack on I-75 in Marion County

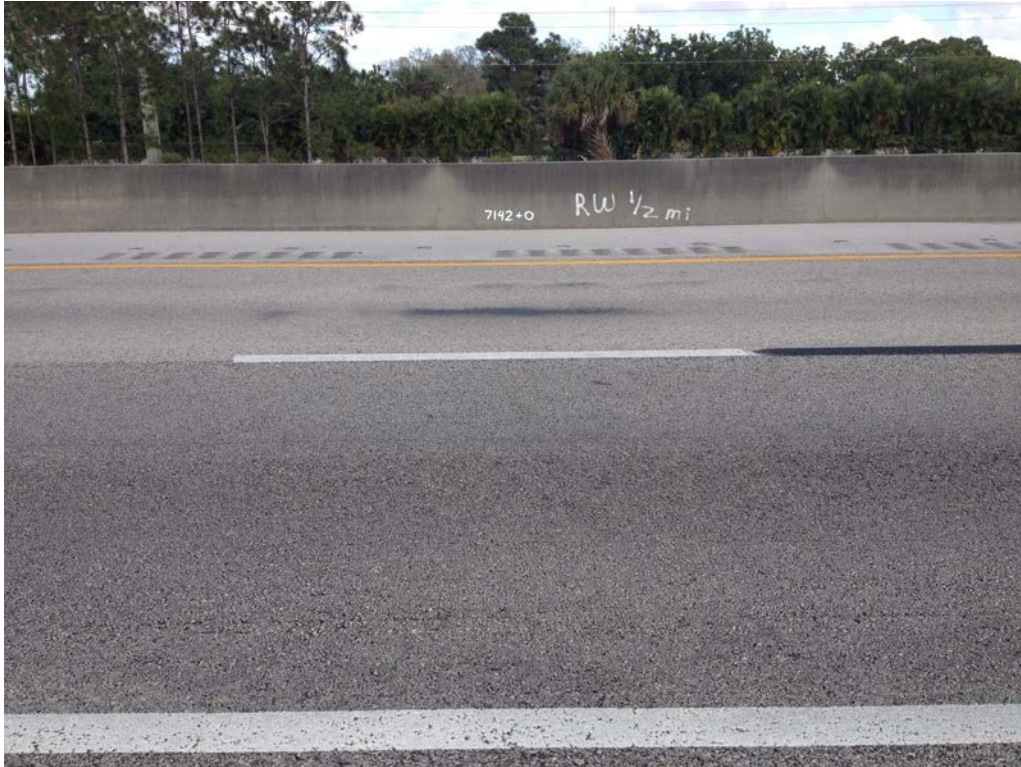
The second and last section evaluated on the third day was just north of Exit 133 on the Florida Turnpike. This section was in Martin County, and was previously resurfaced in 2008. Flushing was observed on the inside lane (Figure 3.24). The flushing was observed within the wheelpath. Typically, the flushed areas were about 8 to 10 ft long and as wide as the wheelpath. Additionally, flushed spots were observed at approximately equal spacing down the pavement that suggested that their occurrence was construction related. Maurice McReynolds indicated that the haul time from the nearest asphalt plant was approximately 1 hour. The flushed areas could have been caused by draindown occurring during transportation of the mix. Raveling was also observed, but was low severity.

Figure 3.24 - Flushed Area on Florida Turnpike near MP 133

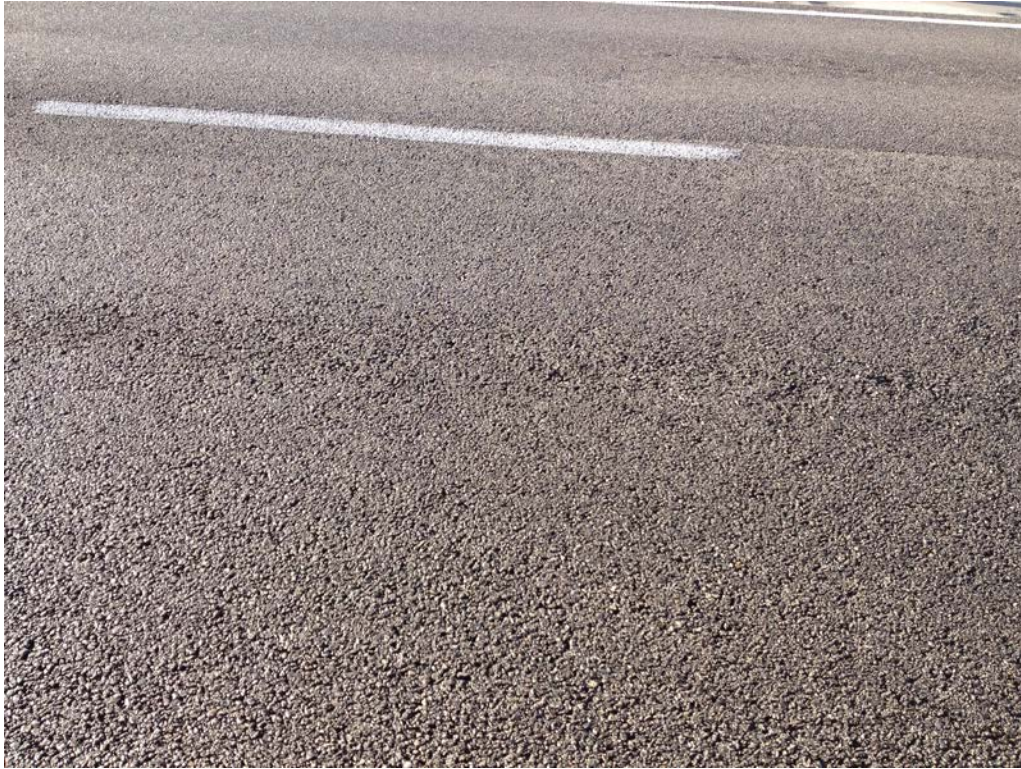
The first section evaluated was in the northbound direction of I-75 in Broward County near Mile Post 30, which was resurfaced in 2011. Within this section, raveling was observed between the wheelpaths (Figure 3.25). Occurrence of the raveling was cyclical and may have been construction related.

Figure 3.25 - Raveling on I-75 in Broward County near MP 30

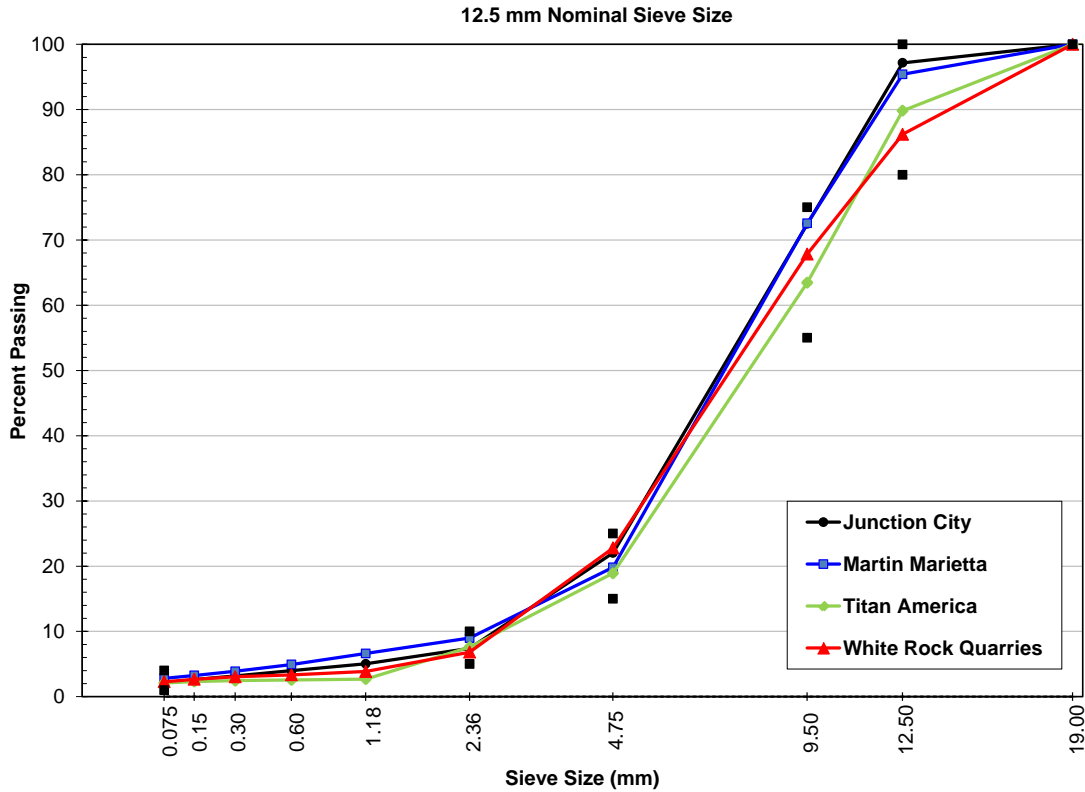
Figure 5.1 - Gradation Used for FC-5 Research Study

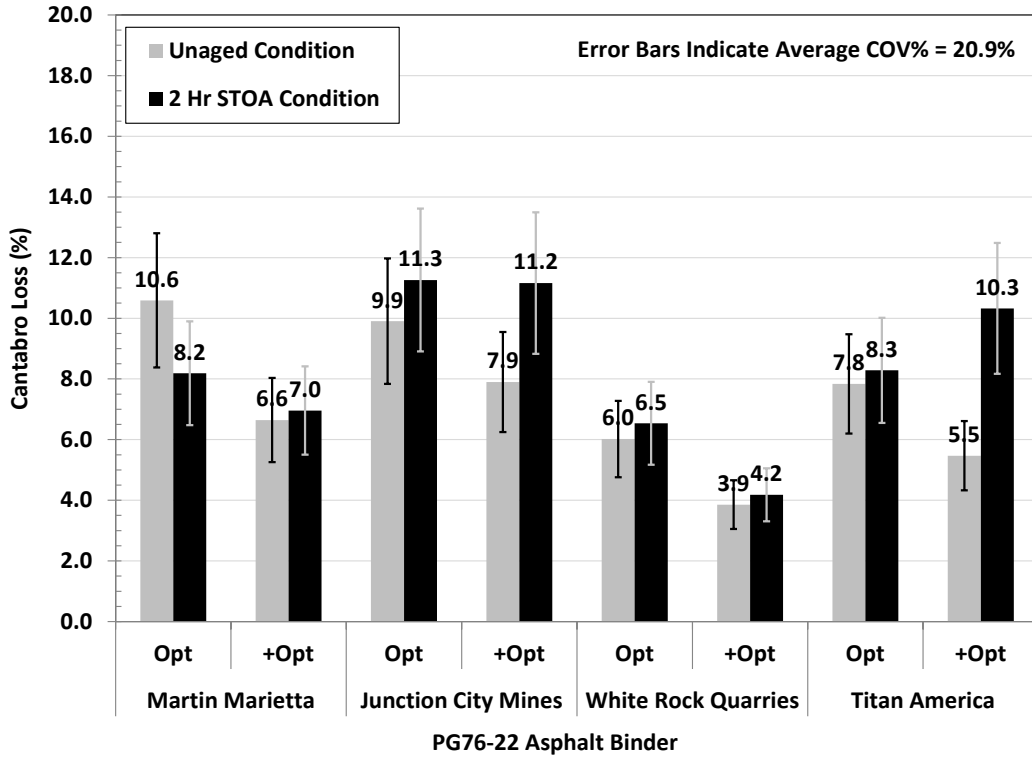
Figure 5.4 - Cantabro Abrasion Loss Results for FC-5 Mixtures with PG 76-22 Asphalt Binder

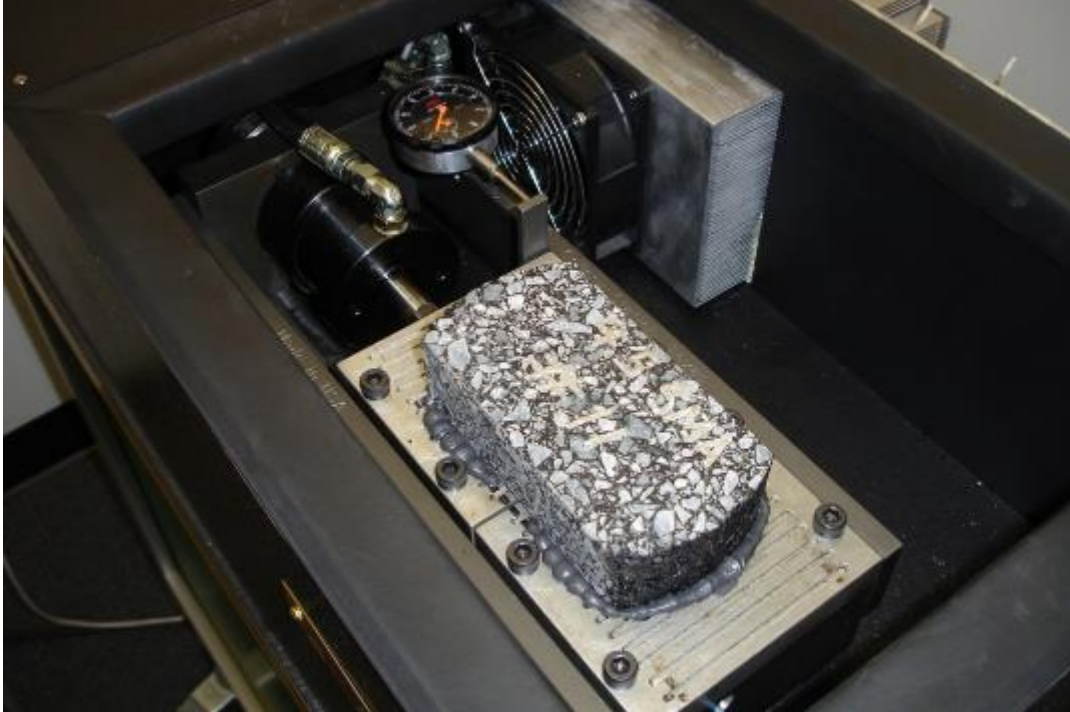
Figure 6.5 – Overlay Tester Device Used for Fatigue Cracking Assessment

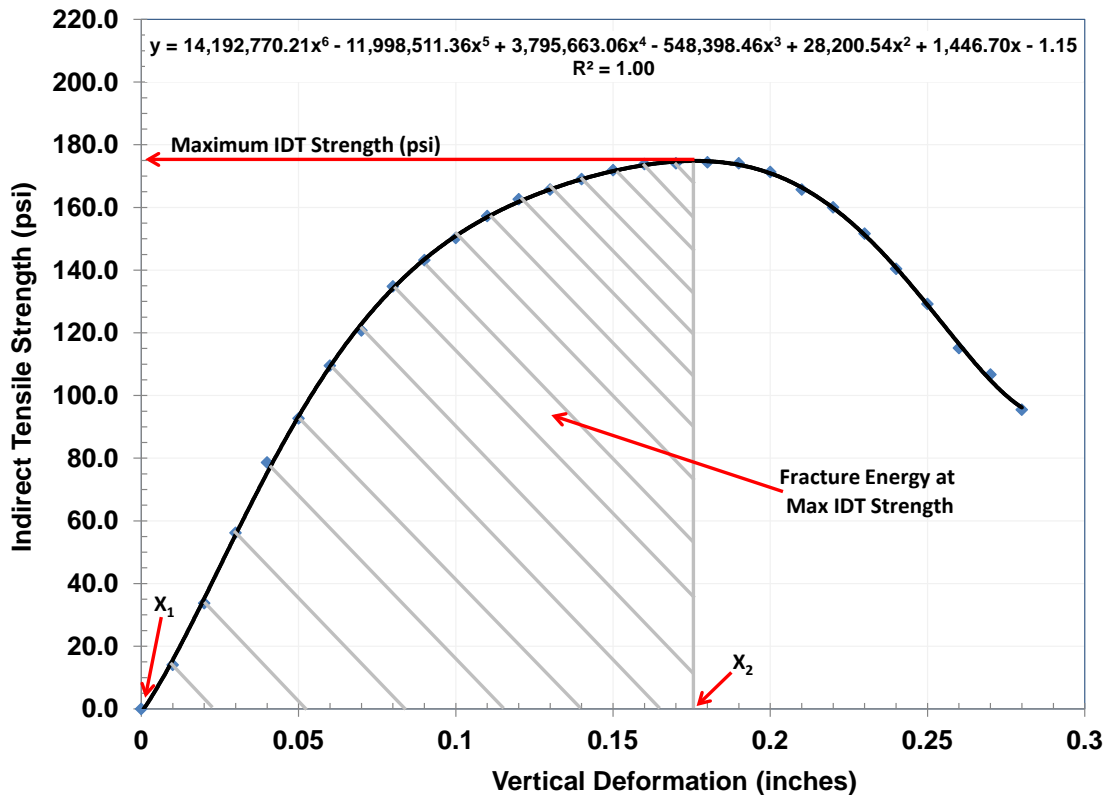
Figure 6.10 – Schematic of Determining FE at Maximum IDT Strength

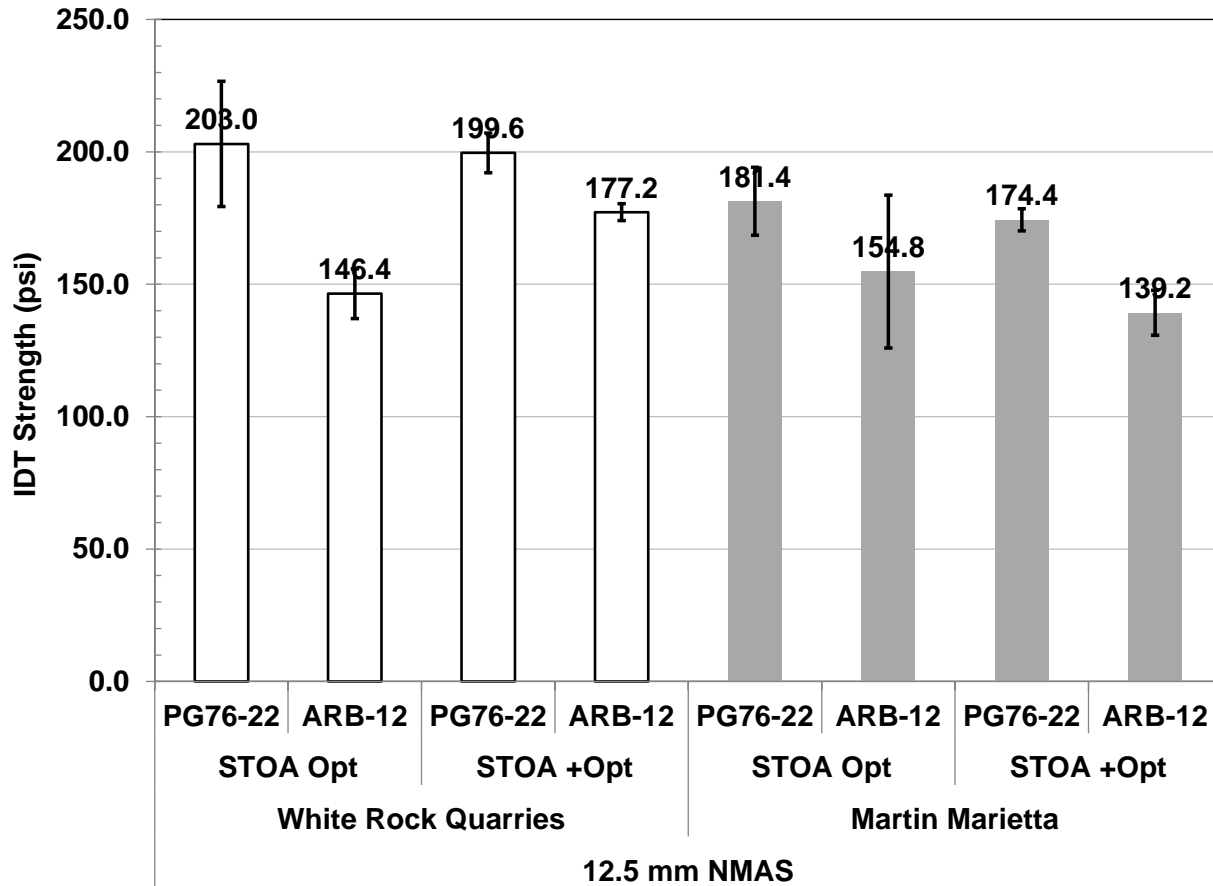
Figure 6.12 – IDT Strength for 12.5 mm NMAS FC-5 Mixtures – Short-Term Aged

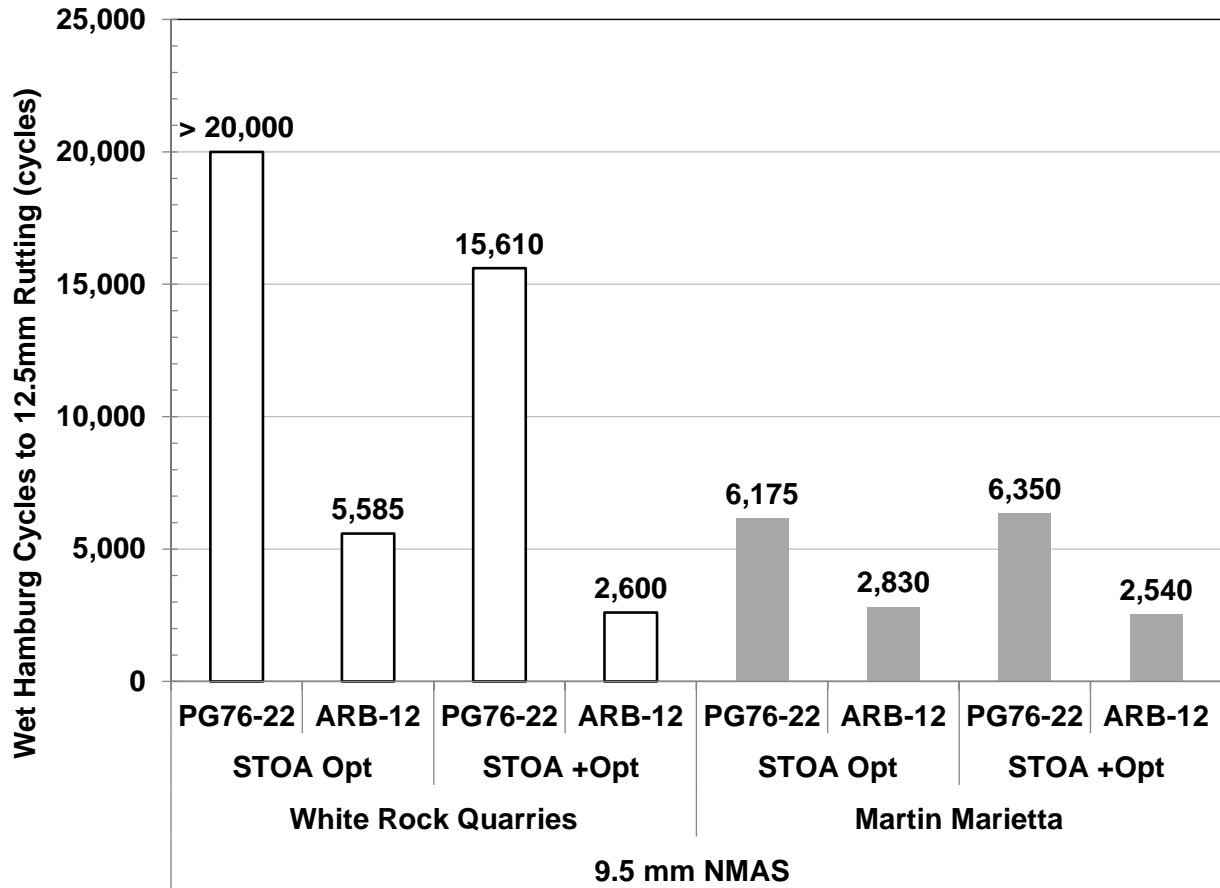
Figure 6.16 – Wet Hamburg Wheel Track Test Results for 9.5 mm NMAS Mixtures – Short-Term Aged – Cycles to 12.5 mm Rutting

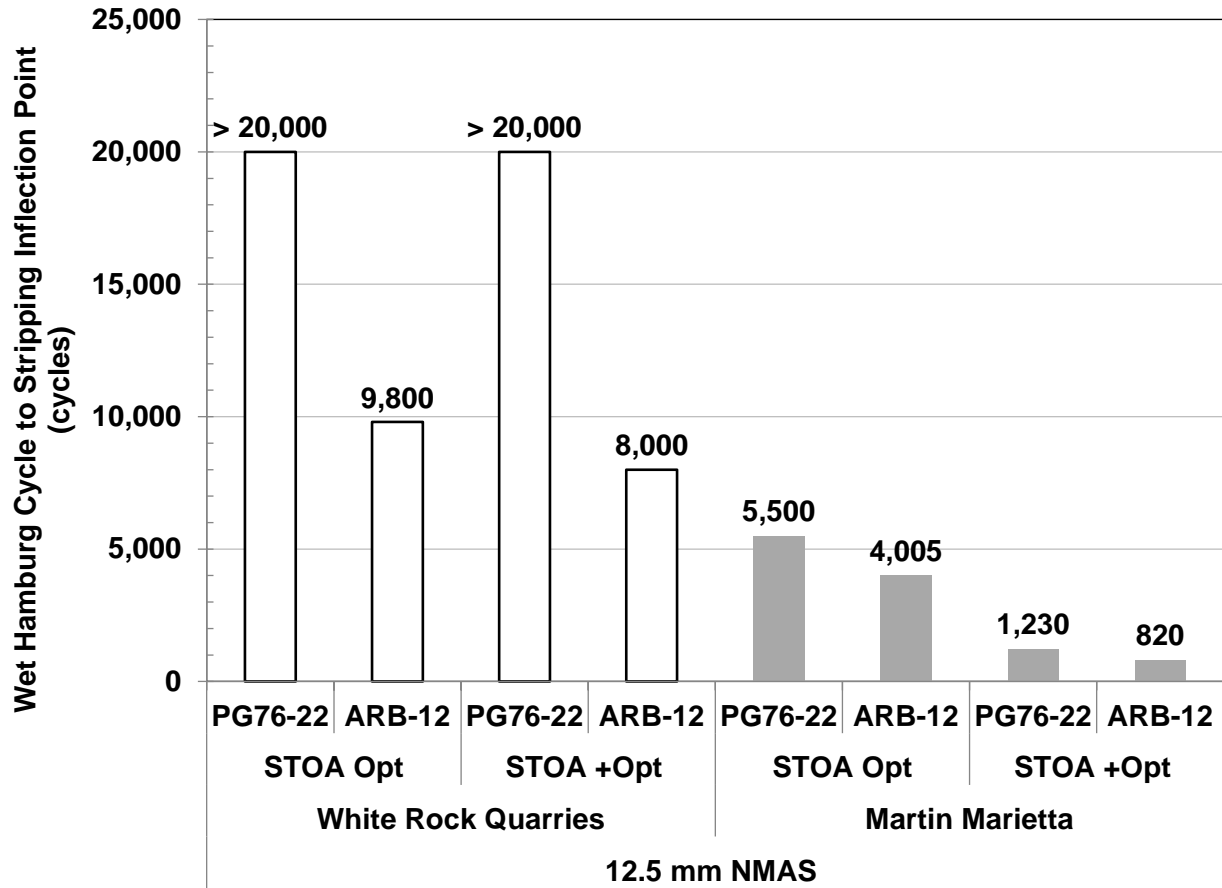
Figure 6.19 - Wet Hamburg Wheel Track Test Results for 12.5 mm NMAS Mixtures – Short-Term Aged – Cycles to Stripping Inflection Point (SIP)

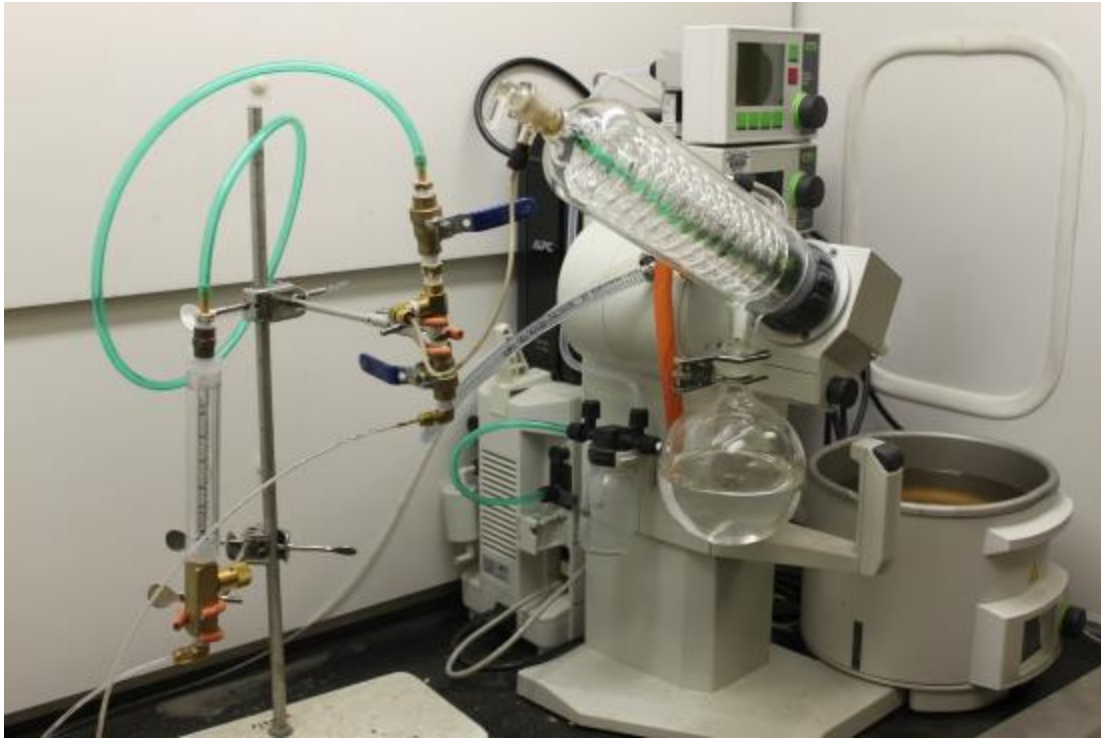
Figure 6.20 – Asphalt Binder Recovery Equipment at Rutgers University (Rotavap System)

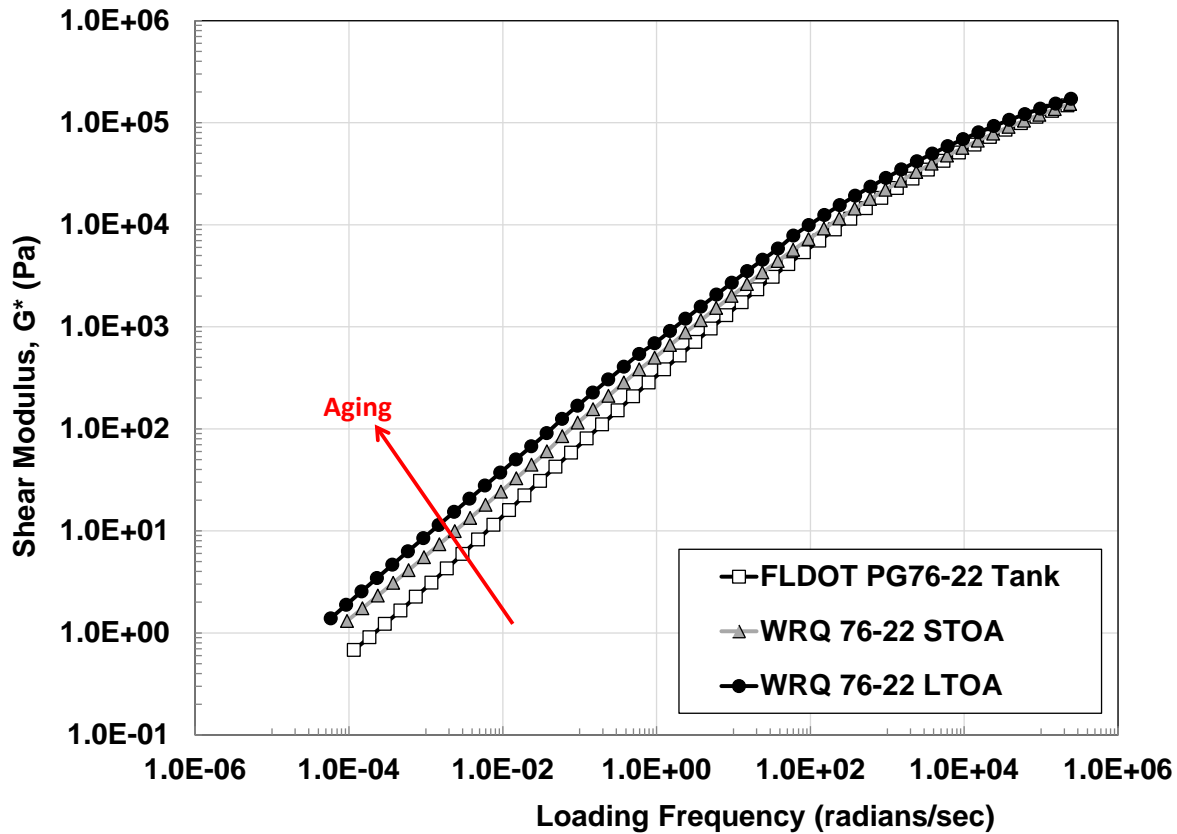
Figure 6.21 – Shear Modulus (G^*) Master Stiffness Curves of Tank, STOA, and LTOA Condition PG 76-22 Asphalt Binder

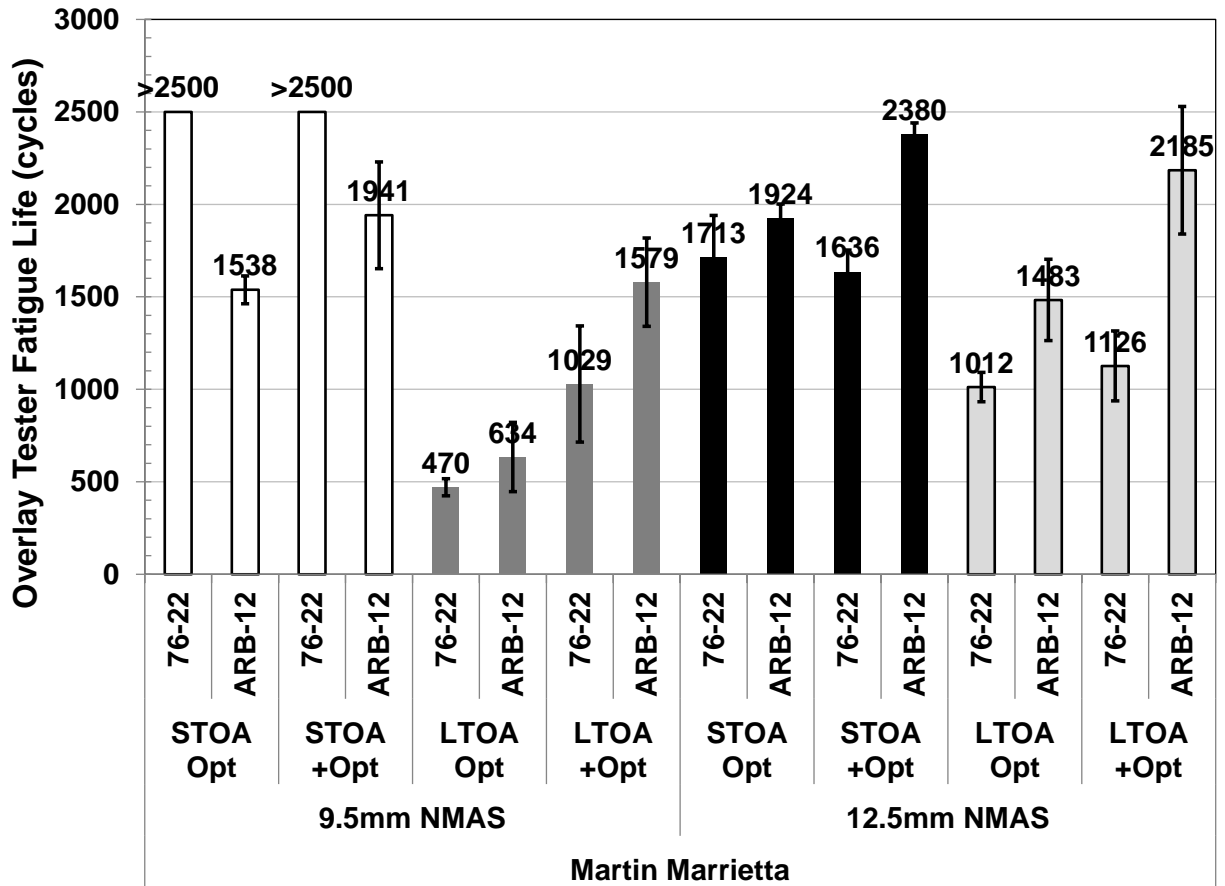
Figure 6.23 – Overlay Tester Results for Martin Marietta FC-5 Mixtures – Short-Term and Long-Term Oven Aged Conditions
