FINAL REPORT

**EVALUATE THE CONTRIBUTION OF THE MIXTURE
COMPONENTS ON THE LONGEVITY AND
PERFORMANCE OF FC-5**

FDOT Contract No. BDS15 977-01

**Thomas Bennert, Ph.D.
Center for Advanced Infrastructure and Transportation (CAIT)
Rutgers University
100 Brett Road
Piscataway, NJ 08854**

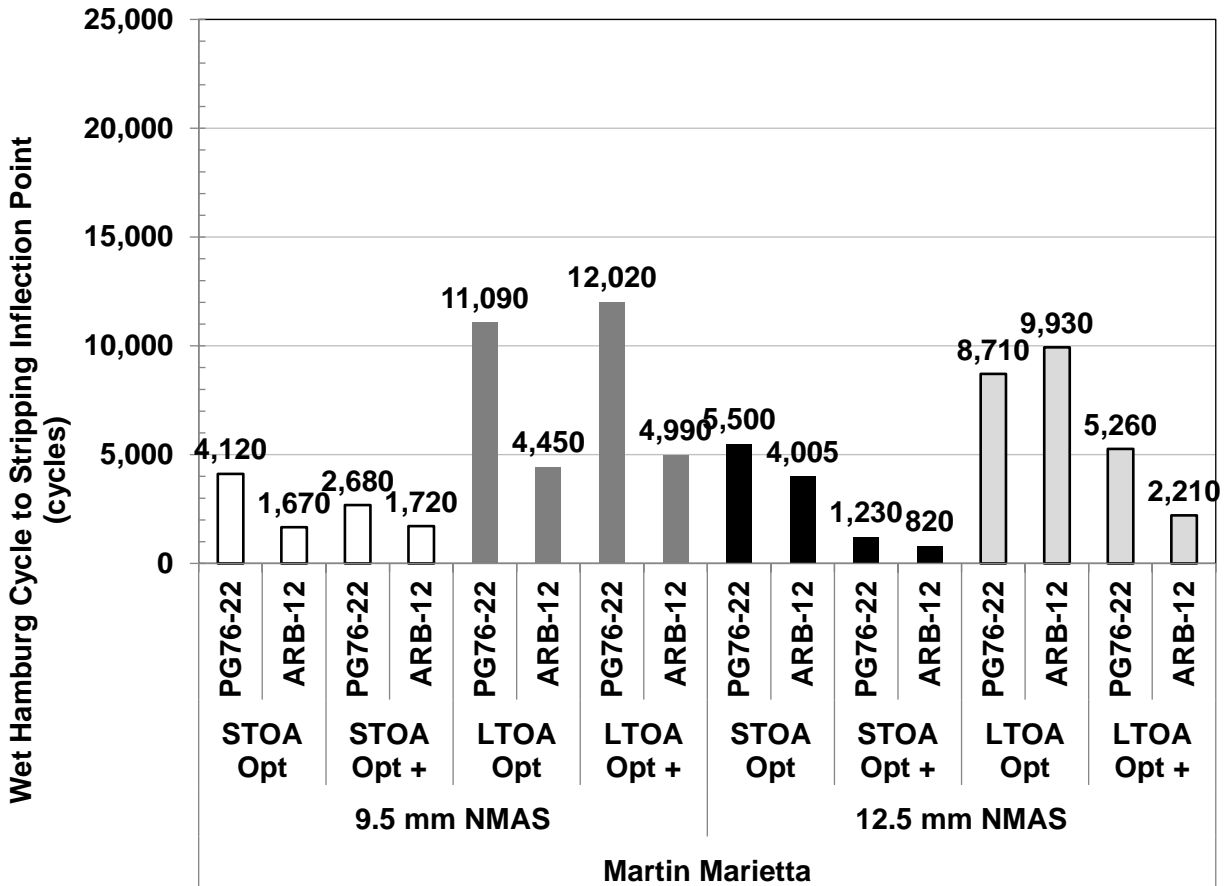
Figure 6.33 – Wet Hamburg Wheel Track Testing for Martin Marietta FC-5 Mixtures – Stripping Inflection Point (SIP) – Long-Term Aged Conditions

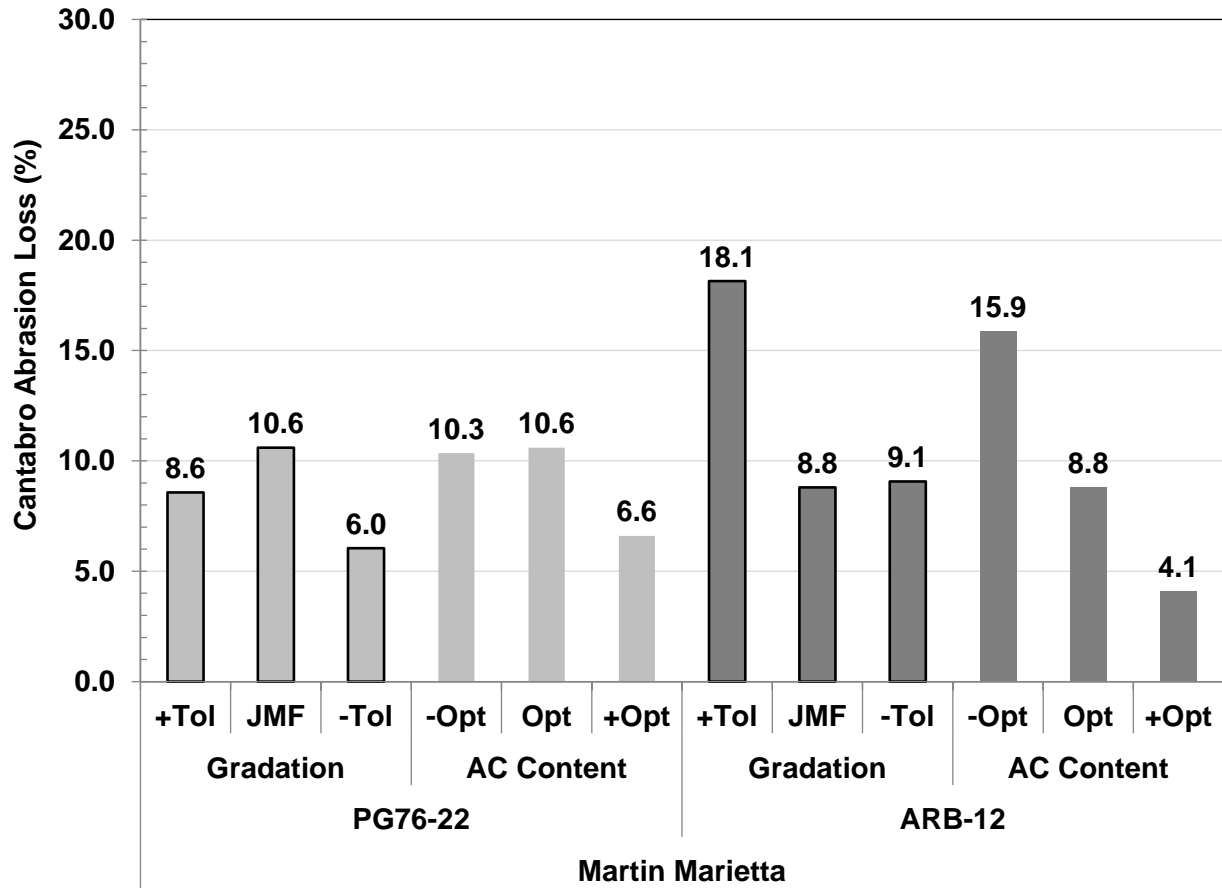
Figure 7.3 – Cantabro Abrasion Loss Results Due to Changes in Production Tolerances – Martin Marietta

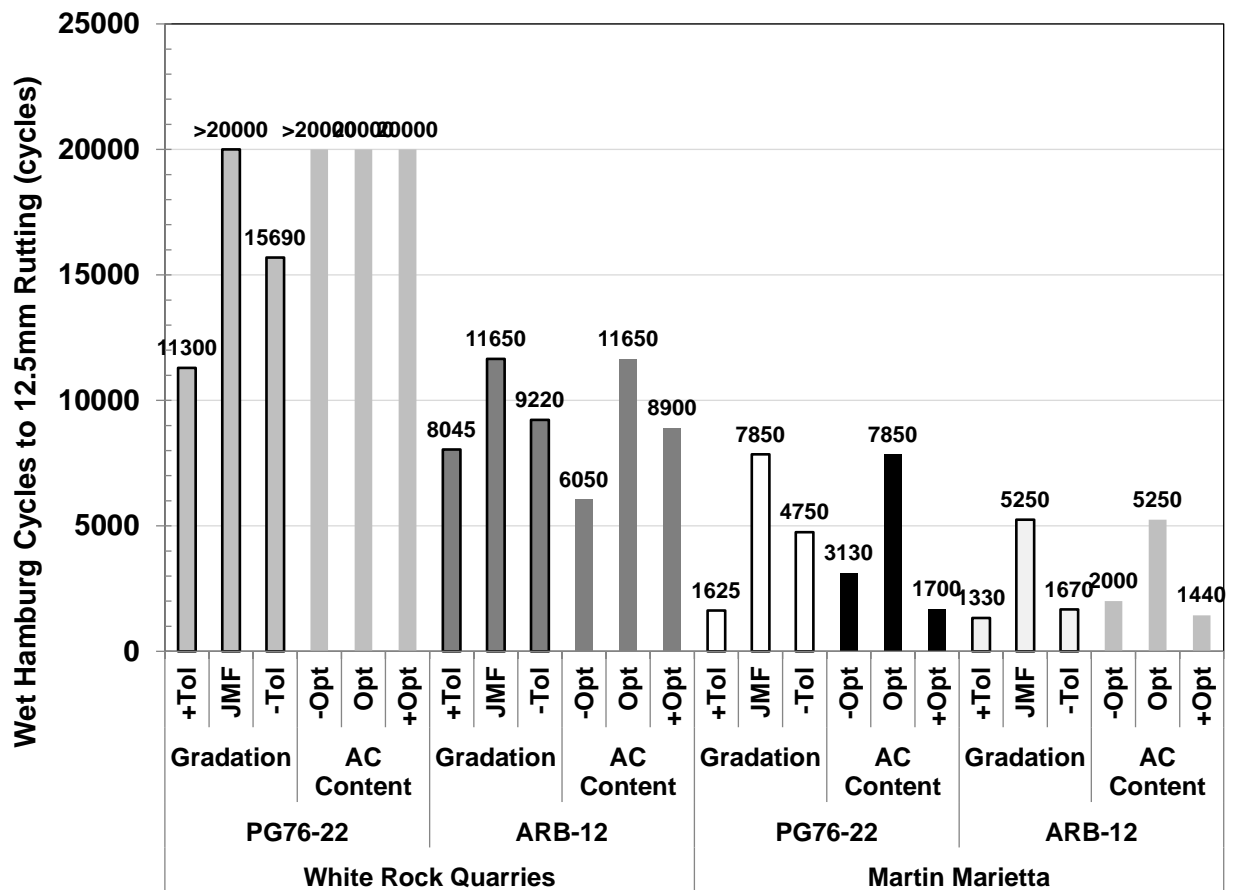
Figure 7.9 – Wet Hamburg Wheel Track Test Results Due to Changes in Production Tolerances – Cycles to 12.5 mm Rutting

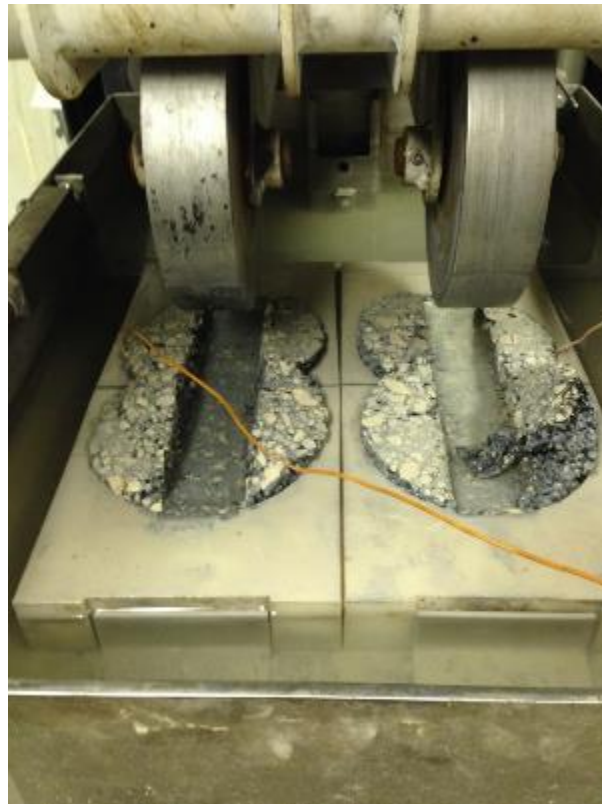
Figure 8.2 – Failed 9.5 mm NMAS FC-5 Specimens with ARB-12 Asphalt Binder
