Fiber optic monitoring methods for composite steel-concrete structures based on determination of neutral axis and deformed shape

FINAL REPORT

January 2014

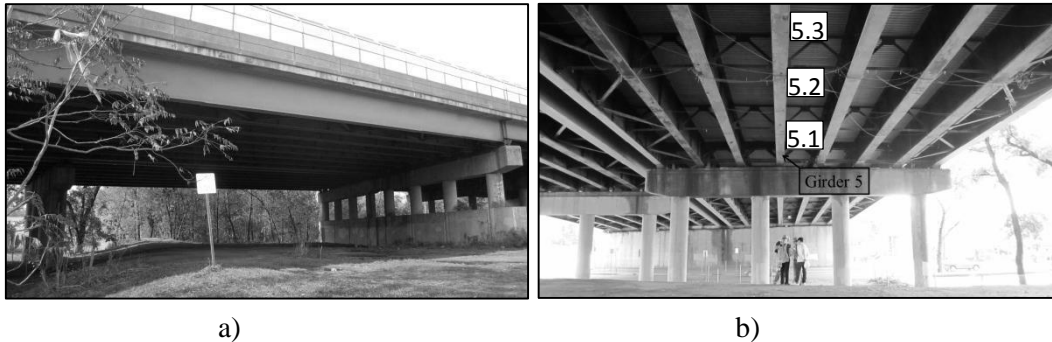
Figure 1. Span 2 of US202/NJ23: a) North and southbound. b) Supports at south end of southbound span.

The US202/NJ23 highway overpass located near Wayne in New Jersey represents a typical structure frequently found across The United States, see Figure 1. It was built in 1984 and is now part of the Long Term Bridge Performance (LTBP) Program put forth by the Federal Highway Administration. North and southbound traffic is carried by two separate structures; each structure is comprised of four simply supported spans, with eight steel girders carrying a concrete slab. The focus of this research is on one of these spans, Span 2, carrying southbound traffic on four lanes. The steel girders are built-up sections with varying flange thickness and varying girder lengths (~32- 40 m or ~105-131 ft.), resulting in a skewed span.

The neutral axis at three cross-sections (see Figure 1) was studied under dynamic events (when large vehicles pass over the bridge). This probabilistic procedure has been carried out for every measurement session, evaluating the mean and standard deviation; the results are shown in Figure 4. This cross-section shows healthy behavior, the neutral axis does not vary significantly over time and the mean is close to the theoretically expected value.

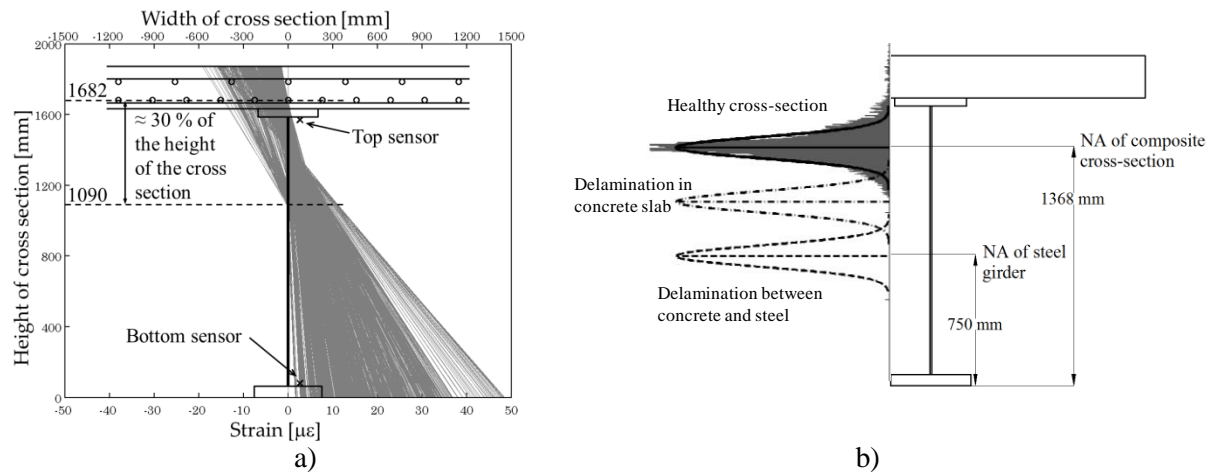
Figure 2. a) Strain diagram over the height of the cross-section during one event from strain measurements at the top and bottom sensor taken at 250Hz. b) Histogram from approximately 60 events. The mean is close to the theoretical location of the neutral axis. If there is delamination in the cross-section the neutral axis location will move.

The deformed shape is a consequence of straining the structure and it is defined by the centroid line of the beam after the deformation. It is well known that the curvature distribution in a deformed beam equals the second derivative of the deformed shape. Thus, any unusual change in global structural behavior that affects the strain (and curvature) also affects the deformed shape. Assuming linearity and the validity of Bernoulli's hypothesis uniaxial curvature can be determined from two strain measurements (e.g. as the slope of the strain diagram presented in Figure 2a).

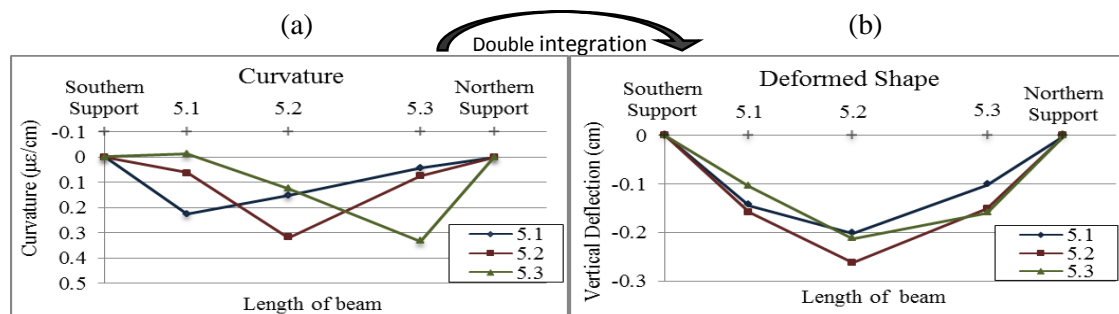
Figure 3. a) Curvature distributions due to passage of a truck; b) deformed shapes calculated by double integration of curvatures using trapezoidal rule.

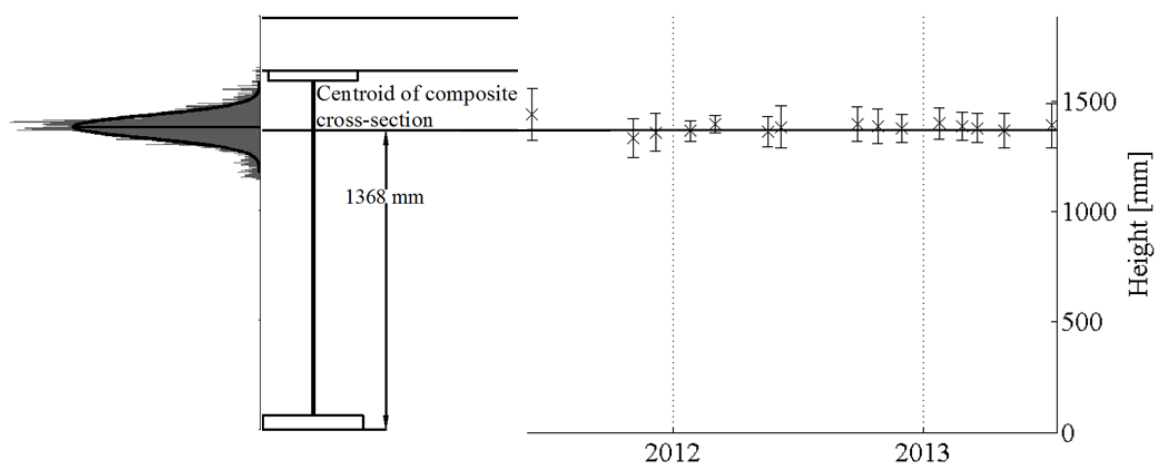
Figure 4. Long-term monitoring of the neutral axis location. The mean for each measurement session along with one standard deviation. This cross-section shows healthy behavior with the mean close to the theoretical location of the neutral axis.

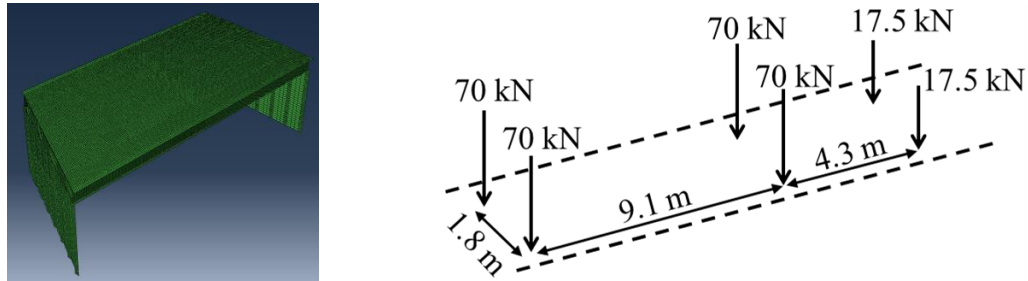
Figure 5. Numerical model of the study span of US202/NJ23 and the simulated load pattern.

A numerical model of span 2 of the US202/NJ23 was created in order to verify that the variation of the location of the neutral axis is a consequence of the dynamic event. The model was created in the analysis software ABAQUS, see Figure 5 (Dassault Systemes 2011). The model is built with S4R shell elements which are 4-node general-purpose shell, reduced integration elements with hourglass control and finite membrane strains (Dassault Systemes 2011). The model was used to study the neutral axis location under dynamic truck loading. A typical truck load was created with a system of six moving point loads, representing a truck with three axels. The magnitude of each force and the distance between forces was based on an AASHTO truck (AASHTO 2012), see Figure 5.

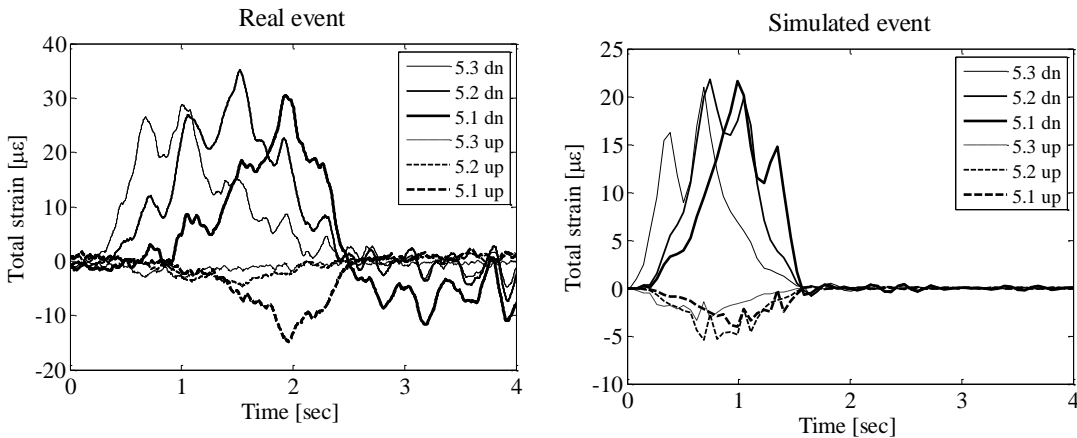
Figure 6. Dynamic event: total strain at location 5.1, 5.2, and 5.3 under the real event and simulated event.

Figure 6 shows the strain at locations 5.1, 5.2, and 5.3 during a truck passage as well as the response of the numerical model at the same location during the passage of the simulated load. It is important to note that events observed on the real structure are subject to a large range of uncertainties related to the loading conditions. In particular the load magnitudes are unknown and vary from truck to truck, the location of the load is unknown, i.e. which lane the truck is driving on, and the number of trucks on the bridge at any given time is also uncertain. Since the simulated truck moves on the lane located above Girder 5 and its speed is different from the real load, direct quantitative comparison of strain values is not possible. However, strain responses shown in the figure are qualitatively similar, and this, in general, validates the model. Our assumption is that as long as the structure is in the linear regime the magnitude of the strain is not of importance. However, what does matter is the time dependent characteristic of the event which has been captured well in the simulation.

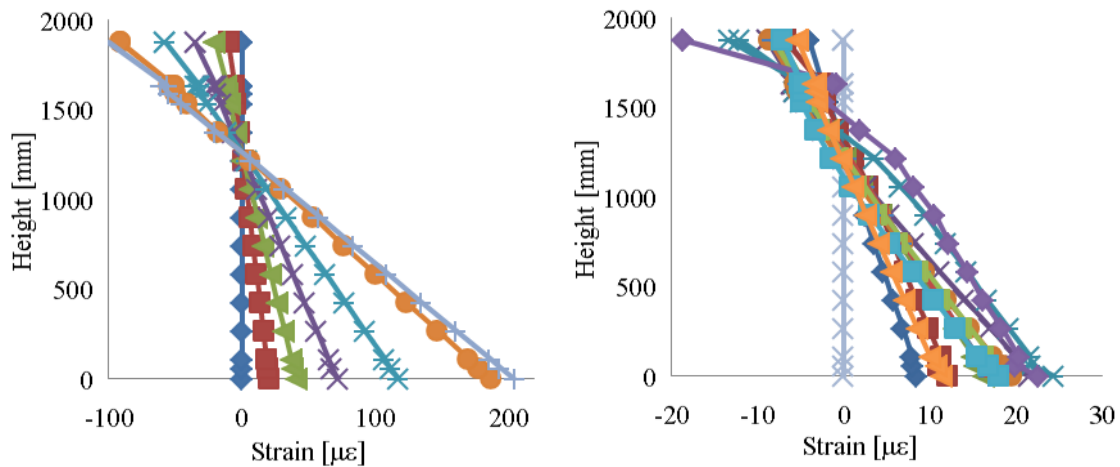
Figure 7. Strain diagram from numerical model. a) Dead load applied to the structure, the neutral axis is constant. b) Dynamic event applied to the structure, the neutral axis varies.

Figures 7a and 7b show the strain diagram at location 5.2 as the result of numerical simulation due to the dead load and during the simulated dynamic event, respectively. Under dead load the neutral axis location is constant, although discontinuities are observed between the concrete slab and the steel girder when the strain magnitudes increase. During the simulated dynamic event the neutral axis is observed to vary over the height of the cross-section. These are important results, as they correlate well with observations made on the real structure, and demonstrate that the neutral axis moves due to dynamic actions.

The location of the neutral axis obtained from the numerical simulation, however, does not coincide with the theoretically obtained values or the observations in the field. This could be mitigated by changing the Young's modulus in the numerical model, but unreasonably high Young's moduli are required to reach the target value and further investigation is needed to fully explain this discrepancy.

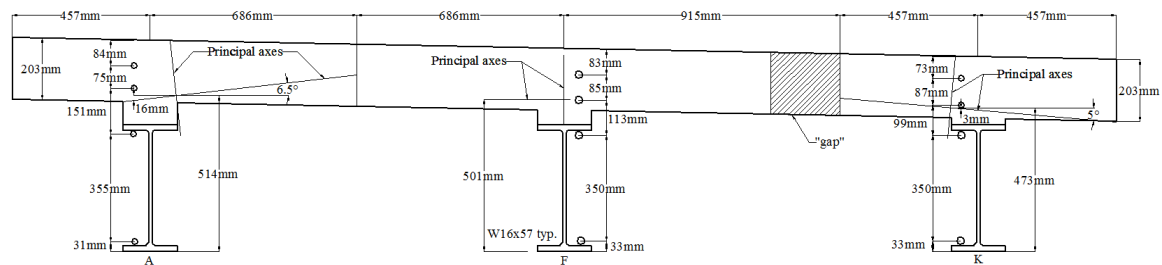
Figure 8. Cross-section of the test structure. Three steel girders supporting a concrete slab. Four strain sensors are installed in three cross-sections. Location A has delamination, location F is healthy, and location K has a crack.

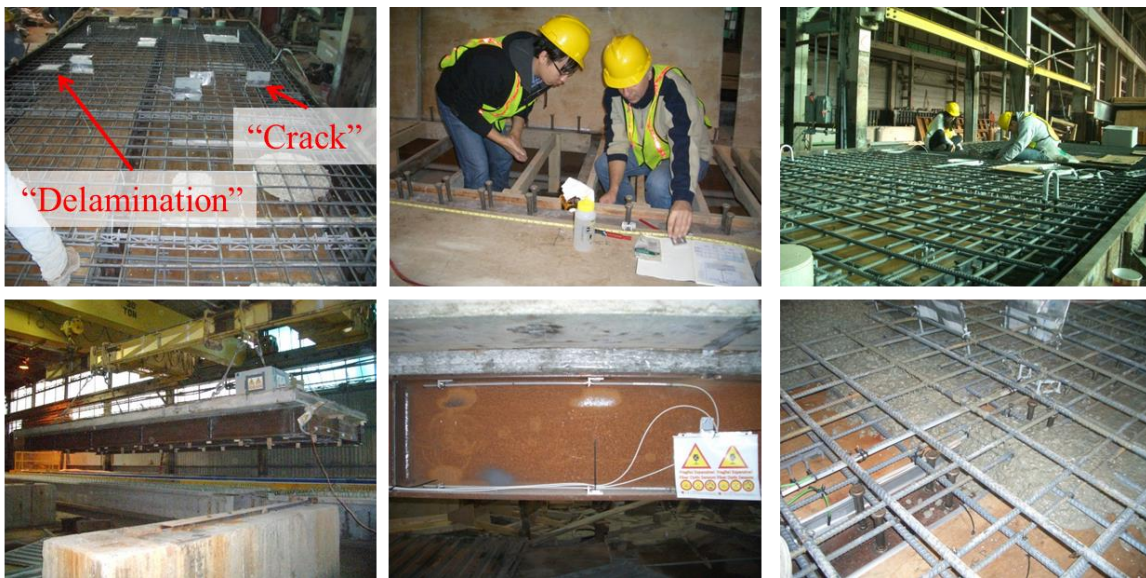
Figure 9. Test structure. The artificial damage is created by placing plastic sheets in the concrete. The sensors are surface mounted on the steel flanges and embedded in the concrete.

Figure 9 shows the rebar cage before pouring of the concrete with labels pointing to the artificially delaminated and cracked locations. It also shows the installation of the steel and concrete sensors as well as the structure after the curing of the concrete. After the sensors were installed and the concrete had reached sufficient strength, the structure was transported to the Rutgers University Livingston Campus. The structure was tested both with static and dynamic loading. Measurements were taken using the fiber-optic sensors. Additionally, LVDT's were installed at the sensor locations A, K, and F during the static testing for comparison with deflection calculations. The dynamic tests were used to calculate the location of the neutral axis. Figure 10 shows the test structure with the test load on it.

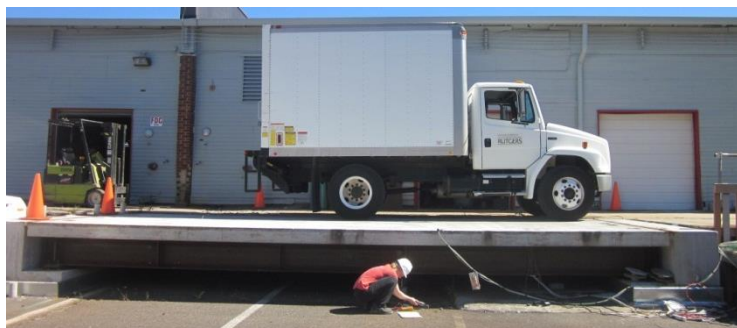
Figure 10. Test structure with test load. The photo is taken during static testing.

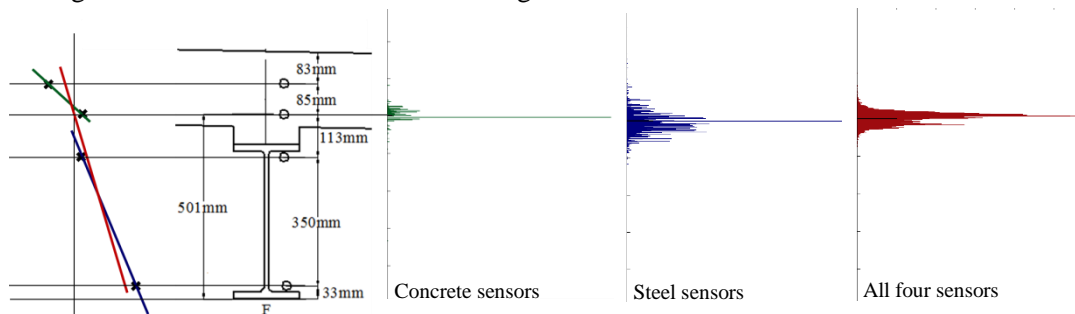
Figure 11. Recorded dataset from concrete and steel sensors separately, and from all four sensors together. On the left, a potential scenario is illustrated where studying different combination leads to different conclusions. On the right the histograms for the healthy location.

Four dynamic tests were conducted as follows. The truck was backed up on to the structure and then driven off as quickly as possible in an effort to create a similar load as the real structure experiences under traffic loading. The data set was studied in three different ways using the concrete sensors, the steel sensors, and all four sensors. This is illustrated in Figure 11, where the strain diagram on the left shows how by analyzing different groups of sensors results in different conclusions regarding location of neutral axis (and structural behavior in general). In particular, for the example shown in the figure, analysis of the concrete sensors only might lead to the conclusions that the neutral axis is high, and analysis of the steel sensors only might lead to the conclusion that the neutral axis is low. However, the analysis of all sensors (by finding the best fit through all the points) might lead to the conclusion that the neutral axis is located at the centroid. Understanding which combination gives the most accurate conclusion is crucial for accurate assessment of the data. The histograms to the right of the figure are obtained from the healthy location (F), during the four dynamic tests and the results are summarized in Table 1, along with the results from the other two (damaged) locations (delaminated A and cracked K). Figures 12 and 13 show the histograms from the steel sensors for damaged locations A and K.

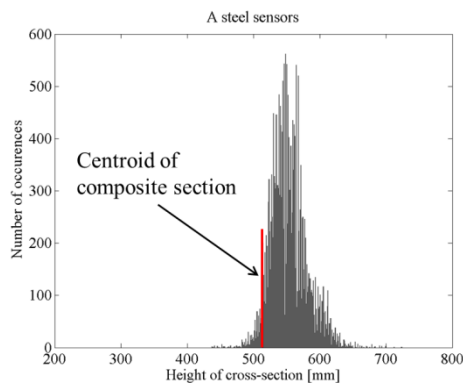
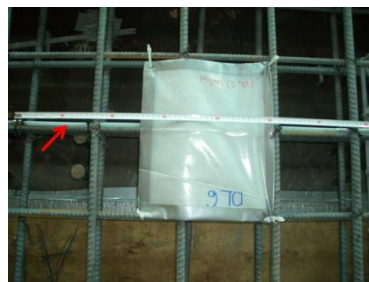
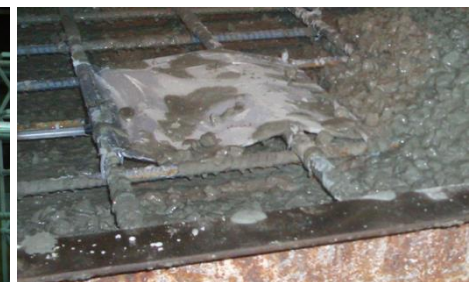
Figure 12. Delamination is created by placing a plastic sheet horizontally in the concrete. Photos show the sheet and the sensor installed next to it. The histogram is from the measurements of the steel mounted sensors from the delaminated cross-section.

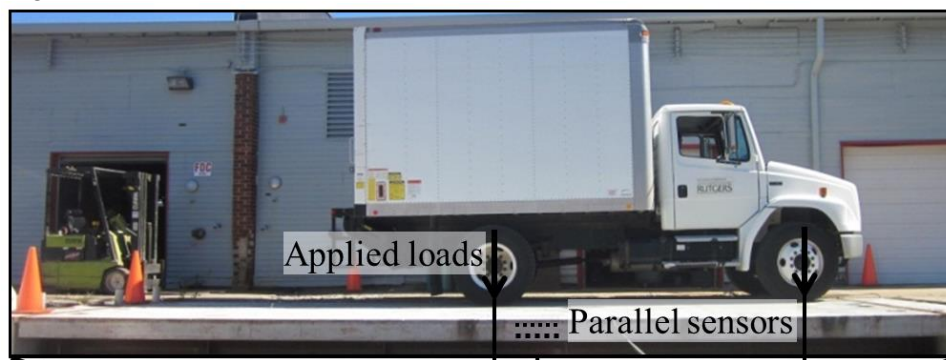
Figure 14. Static test. The truck applies two point loads to the structure. The corresponding curvature diagram is shown. The solid line represents the linear theory of beams and the dashed line corresponds to the measured value at midspan. The three integration rules: Trapezoidal, Rectangular I, and Rectangular II are shown below.

Figure 14 shows the truck and the scale model during the testing. The solid line in the figure represents the curvature diagram due to the truck load according to the linear theory of beams, whereas the dashed line represents the curvature diagram measured by the parallel sensors at the center of the span. Three integration rules were used to evaluate the double integral of the curvature. These are Trapezoidal rule, Rectangular rule I, and Rectangular rule II. The difference between the three rules is illustrated in Figure 14.

The Trapezoidal rule estimates the area as two triangles lying within the dashed lines, Rectangular rule I defines a rectangle that covers half the length of the beam, assuming that the curvature at the end of the beam is zero, and Rectangular rule II defines a rectangle that covers the whole length of the beam. The Trapezoidal rule and Rectangular rule I give the same result in this study, since only one curvature measurement is available along the length of the beam (they would be different if more sensors were installed along the structure). Rectangular rule II was added in this study to compensate for the lack in instrumentation.

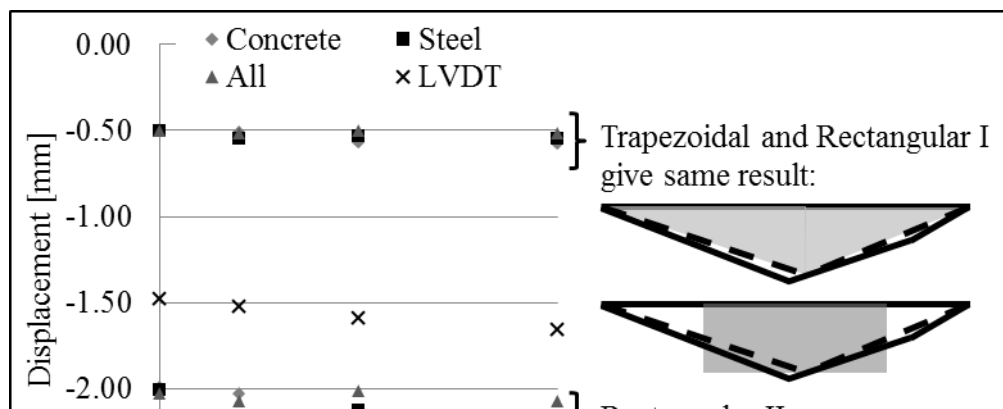
Figure 15. Displacements calculated by double integration using the Trapezoidal rule, Rectangular rule I, and Rectangular rule II for three sensor combinations, concrete, steel, and all. The LVDT measurements lie between the two estimations.

The dataset was studied in three ways, using the concrete sensors and steel sensors separately and using all four sensors together. Figure 15 shows the results from location F, with the three different datasets, the three integration rules, and the independent measurements made with the LVDTs. The results confirm that in this case the Trapezoidal rule and Rectangular rule I give the same estimation of the displacement. They underestimate the displacement compared with the LVDT measurements. Rectangular rule II on the other hand overestimates the magnitude of the displacement. The range between the values calculated with the concrete sensors, steel sensors, and all four sensors varies between 0.01-0.07 mm for the Trapezoidal rule and Rectangular rule I and 0.02-0.26 mm for Rectangular rule II.
