Using Information at Different Spatial Scales to Estimate Demand to Support Asset Management Decision Making

FINAL REPORT
July 2019

1. Report No. CAIT-UTC-NC 6	2. Government Accession No.	3. Recipient's Catalog No.	
4. Title and Subtitle Using Information at Different Spatial Scales to Estimate Demand to Support Asset Management Decision Making		5. Report Date July 2019

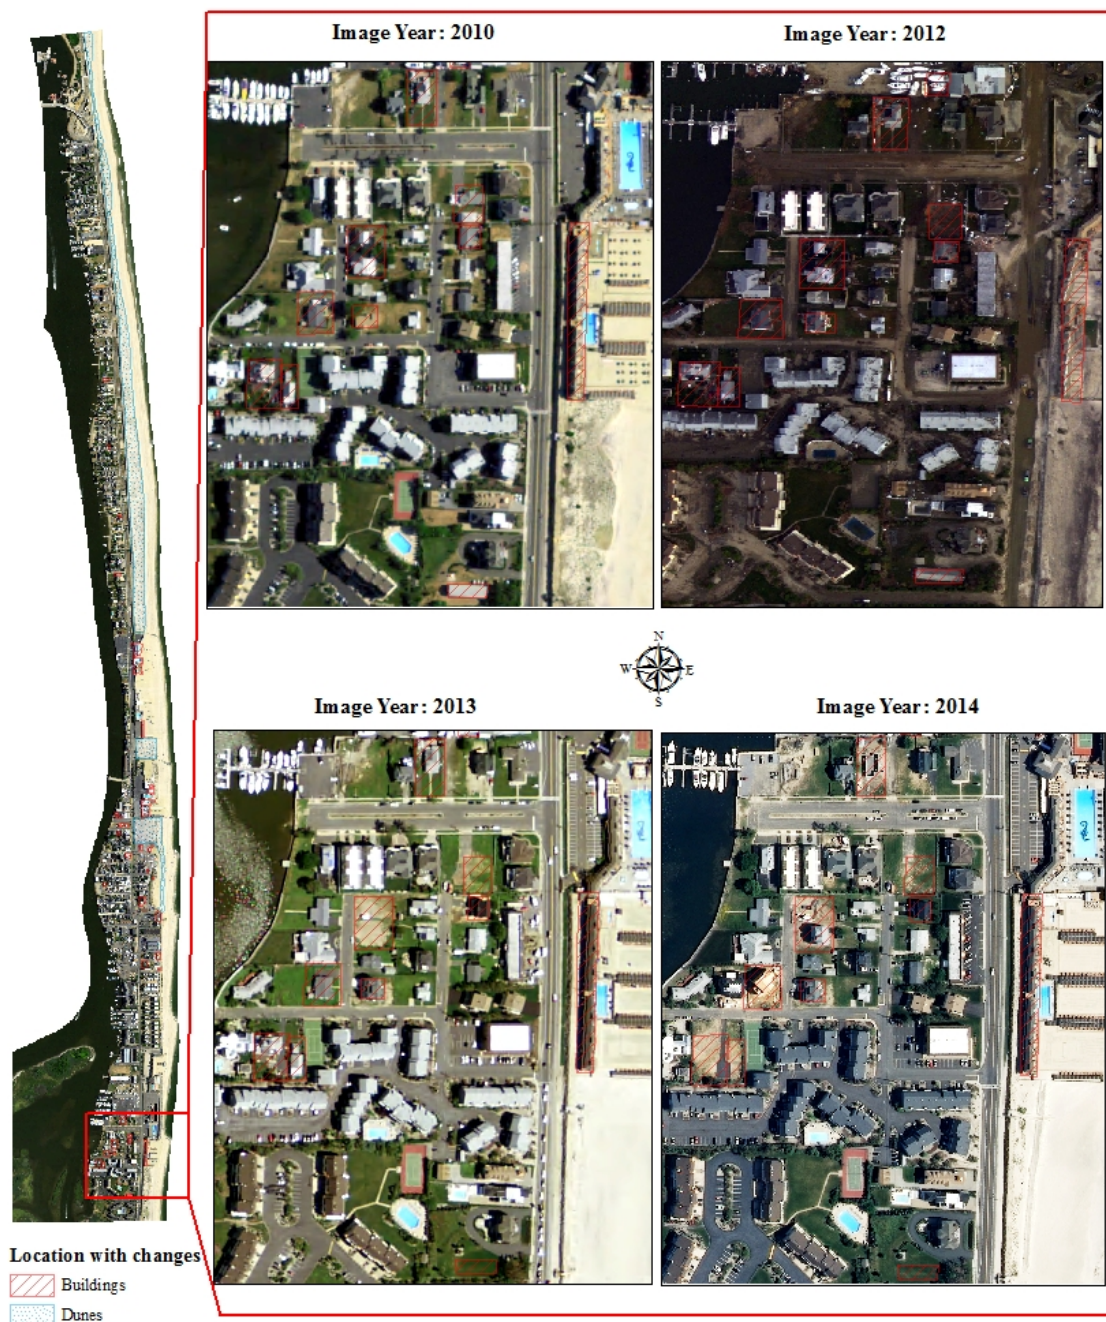
Figure 8: Visually identifiable changes in buildings (2010-2014) after Hurricane Sandy impact in 2012.

These images are visually inspected to detect change and identify the locations with differential land use including man-made and natural features through overlaying them one above another in ArcGIS software and by swiping the target image over the base imagery, and identifying the changes. Figure 8 shows the full view of the study area with damaged building locations (shown in red) and natural dunes (shown in blue) in the image on the left. The inserts show highlights of a specific section where the images for buildings differed from the earlier image. This figure represents a large view and specific years, 2010, 2012, 2013 and 2014 showing the changing situation in the field. In the case of buildings, the difference could only be detected if the property was fully destroyed or demolished for rebuilding and after the space has been occupied again in the observed time interval.

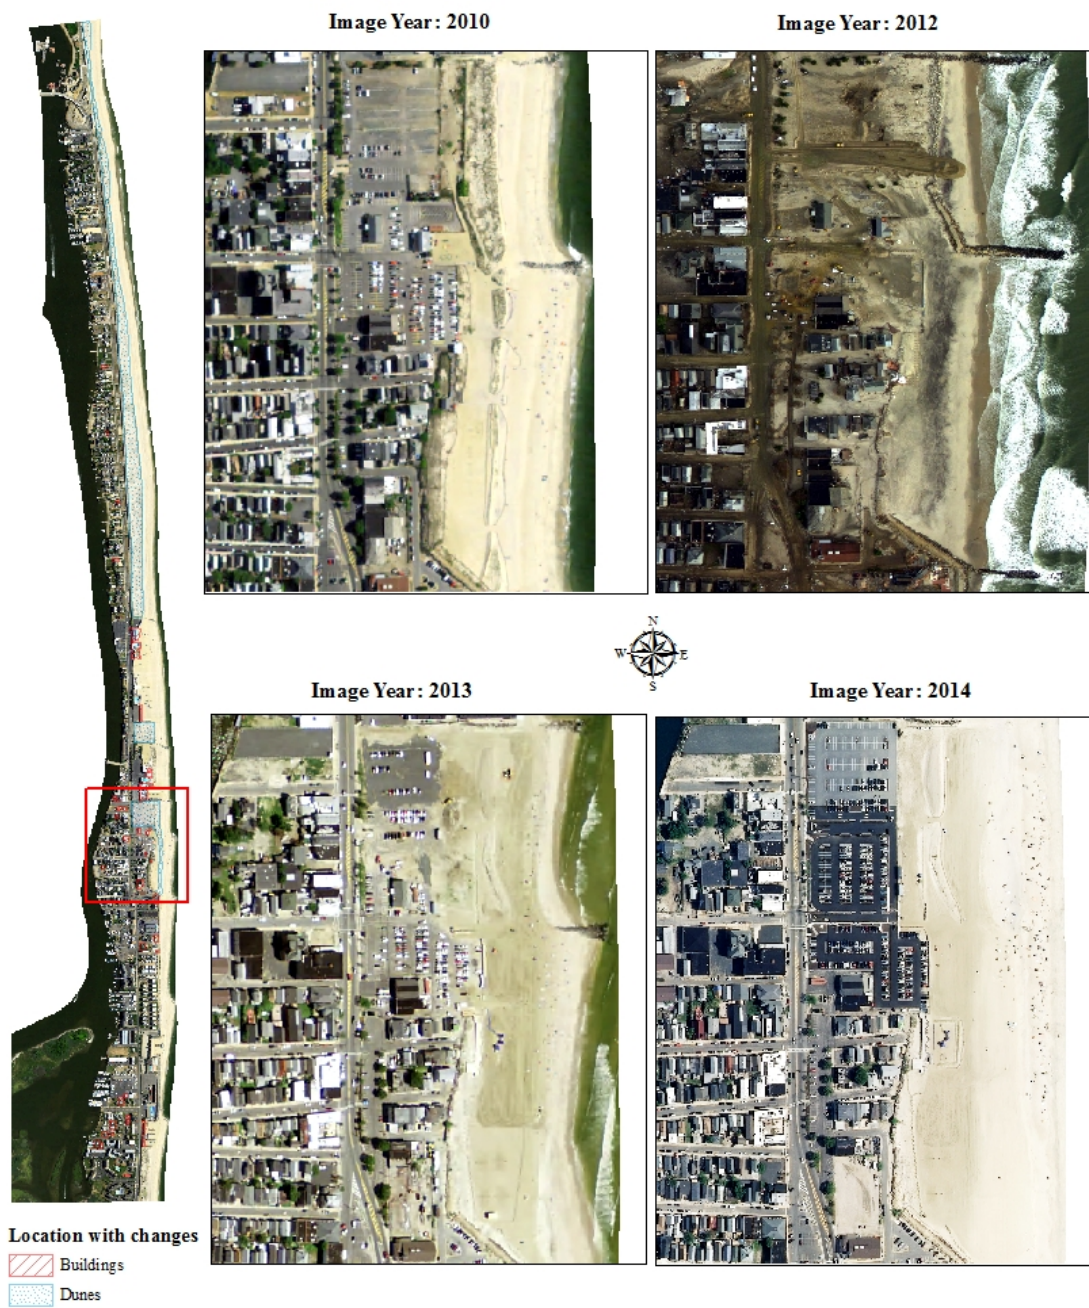
Figure 9: Visually identifiable changes in dunes after Hurricane Sandy between 2010 and 2014.

Figure 9, like Figure 8, shows the full view of the study area with damaged building locations (shown in red) and natural dunes (shown in blue) in the image on the left, and the

insert images focus on the dunes. From imagery the change in natural features like continuation of sandy dunes can be identified clearly. In the case of the sandy dunes that protect Sea Bright naturally, it is found that in Hurricane Sandy the dunes had been damaged in several places, which had not been repaired until 2014. Figure 9 shows snap shots of the dunes in 2010, 2012, 2013 and 2014, capturing this situation.

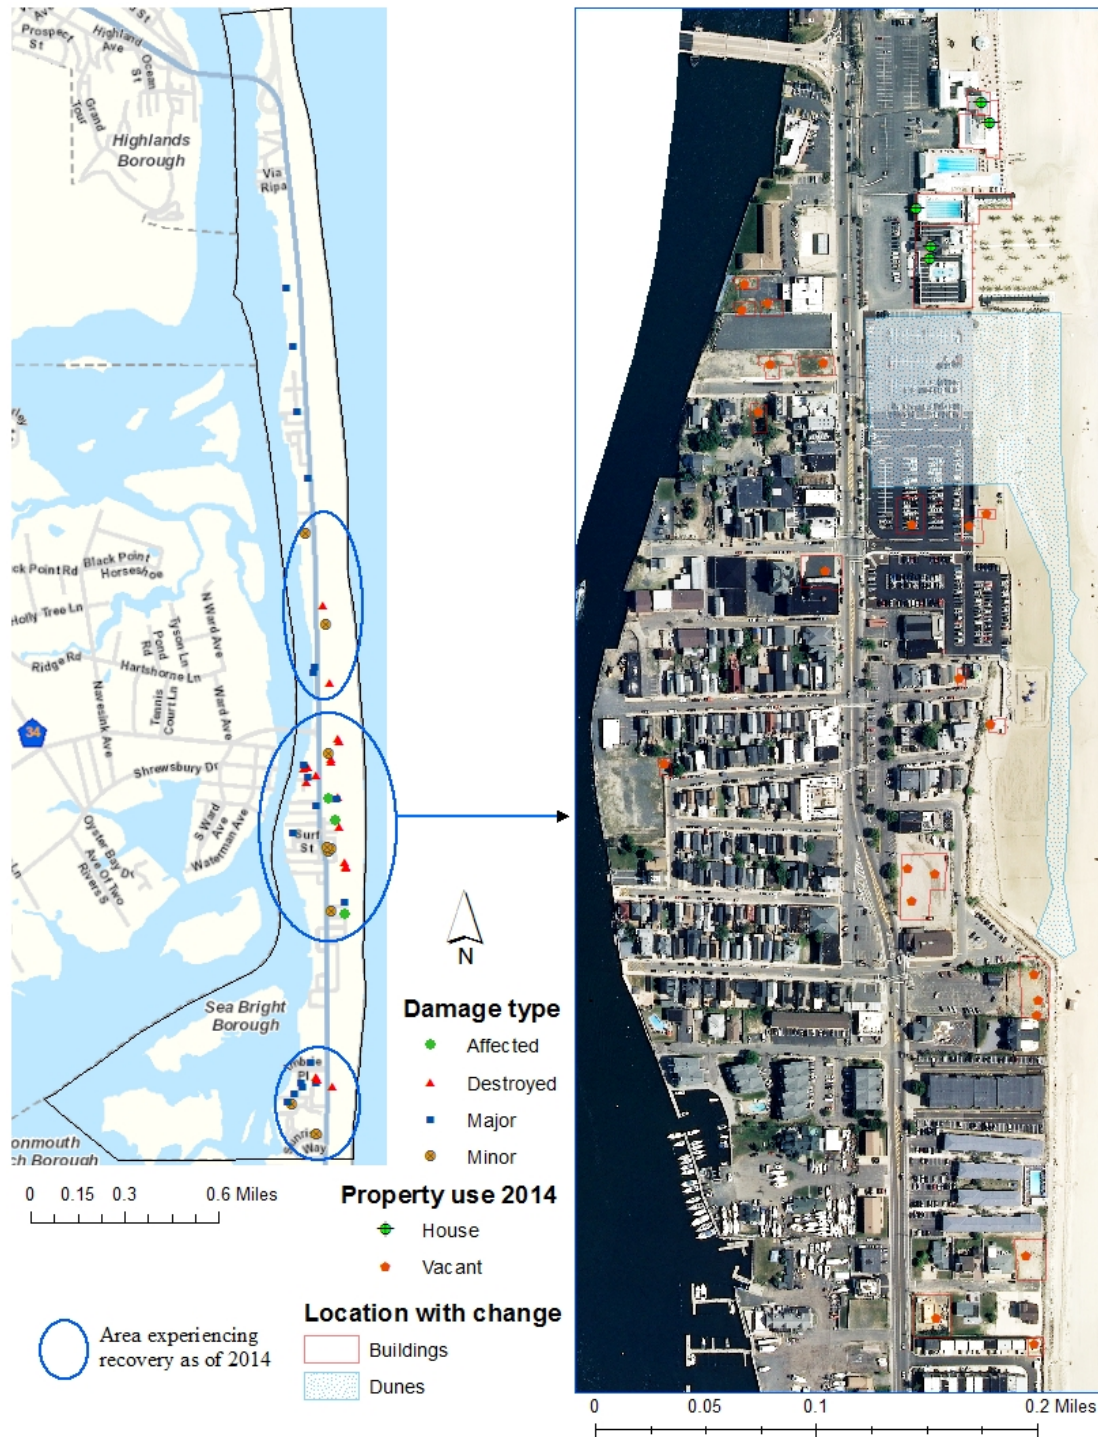
Figure 10: Location of 48 damage points that showed change in different time until 2014 after Hurricane Sandy, concentration identifies the area experiencing housing recovery.

Chronologically, comparing the building structures from site images, it is found that 48 points had some change. Among them, in Hurricane Sandy, 18 locations were destroyed fully, 18 had major damage, 9 had minor damage and 3 buildings were affected in that disaster. Up to 2013 there was little activity on the destroyed properties with only four properties rebuilt. This number increased to seven in 2014, and the rest were still vacant plots. In 2013 eight major damaged plots were found vacant where building structures existed earlier. This number increased to 16 with two of those previous vacant location had houses reconstructed in 2014. The minor damaged sites also experienced demolition, for example, in year 2014, seven of these locations were found to be unoccupied. Affected buildings are not an exception in this scenario where three such plots were bare land in 2014. The damage sites going through reconstruction, and demolition with their damage condition in Hurricane Sandy are shown in Figure 10. From this figure it can be concluded through visual observation that the south part of Sea Bright area was still going through the recovery process in 2014 considering the number of unoccupied plots and change in use patterns from previous.
