Using Information at Different Spatial Scales to Estimate Demand to Support Asset Management Decision Making

FINAL REPORT
July 2019

16. Abstract Quantifying disaster recovery is important to be able to match resources to needs. The research explores the use of survey data, FEMA assessment data, aerial photographs and LIDAR data in the context of recovery from 2012 Hurricane Sandy in Sea Bright, New Jersey. The data cover the period 2010 to 2015. Each of the data sources differ in terms of completeness, resolution, accuracy, coverage and the time period in which it was collected. Using spatial analysis, the analysis found that different data sources gave similar estimates for recovery for the entire borough. More careful analysis of specific plots using data from different sources found that the redevelopment was slow and, in some cases, stagnant when the damage was extensive or demolition required. This report documents the sources of the data, presents a framework for data analysis and presents Sea Bright as a case study. These methods show promise and document the value in periodic analysis of publicly available data from different sources to document recovery. There are furthe

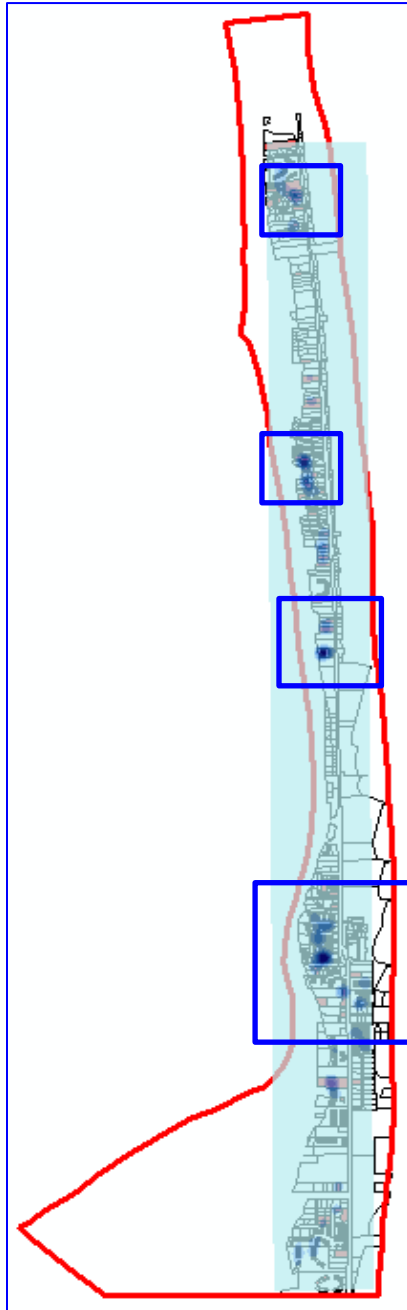
Figure 6: Findings from Kernel density analysis showing distribution of estimated damage from survey, scaling damage to the study area

Based on the damage estimates in survey responses, kernel density analysis is done in ArcGIS to create a continuous surface surrounding damage concentration. Here damage cost in dollars are the count or quantity to be spread across the landscape. Kernel calculates a magnitude per unit area using a kernel function to fit a smoothly tapered surface to each point or polyline. Figure 6 maps the result of such analysis. The analysis considered the 180 responses located in the study area, so the outcome is not very representative. The map highlights the area with more damage concentration based on people's perception. From this map it is clear that the south part of Sea Bright has more damage estimates than north part.

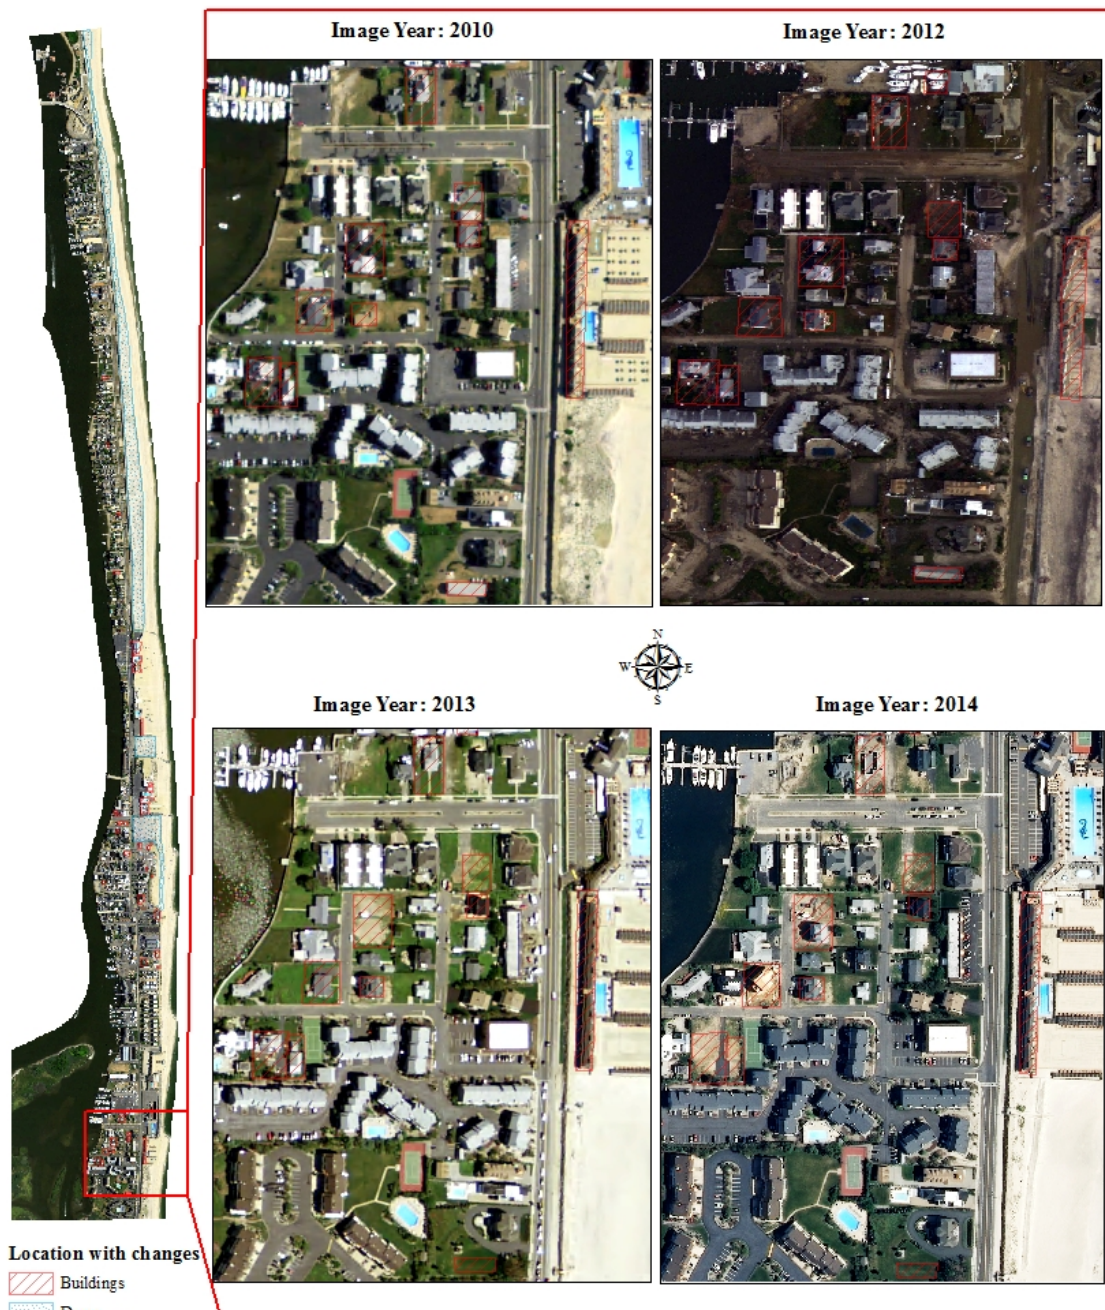
Figure 8: Visually identifiable changes in buildings (2010-2014) after Hurricane Sandy impact in 2012.

These images are visually inspected to detect change and identify the locations with differential land use including man-made and natural features through overlaying them one above another in ArcGIS software and by swiping the target image over the base imagery, and identifying the changes. Figure 8 shows the full view of the study area with damaged building locations (shown in red) and natural dunes (shown in blue) in the image on the left. The inserts show highlights of a specific section where the images for buildings differed from the earlier image. This figure represents a large view and specific years, 2010, 2012, 2013 and 2014 showing the changing situation in the field. In the case of buildings, the difference could only be detected if the property was fully destroyed or demolished for rebuilding and after the space has been occupied again in the observed time interval.

Figure 9, like Figure 8, shows the full view of the study area with damaged building locations (shown in red) and natural dunes (shown in blue) in the image on the left, and the

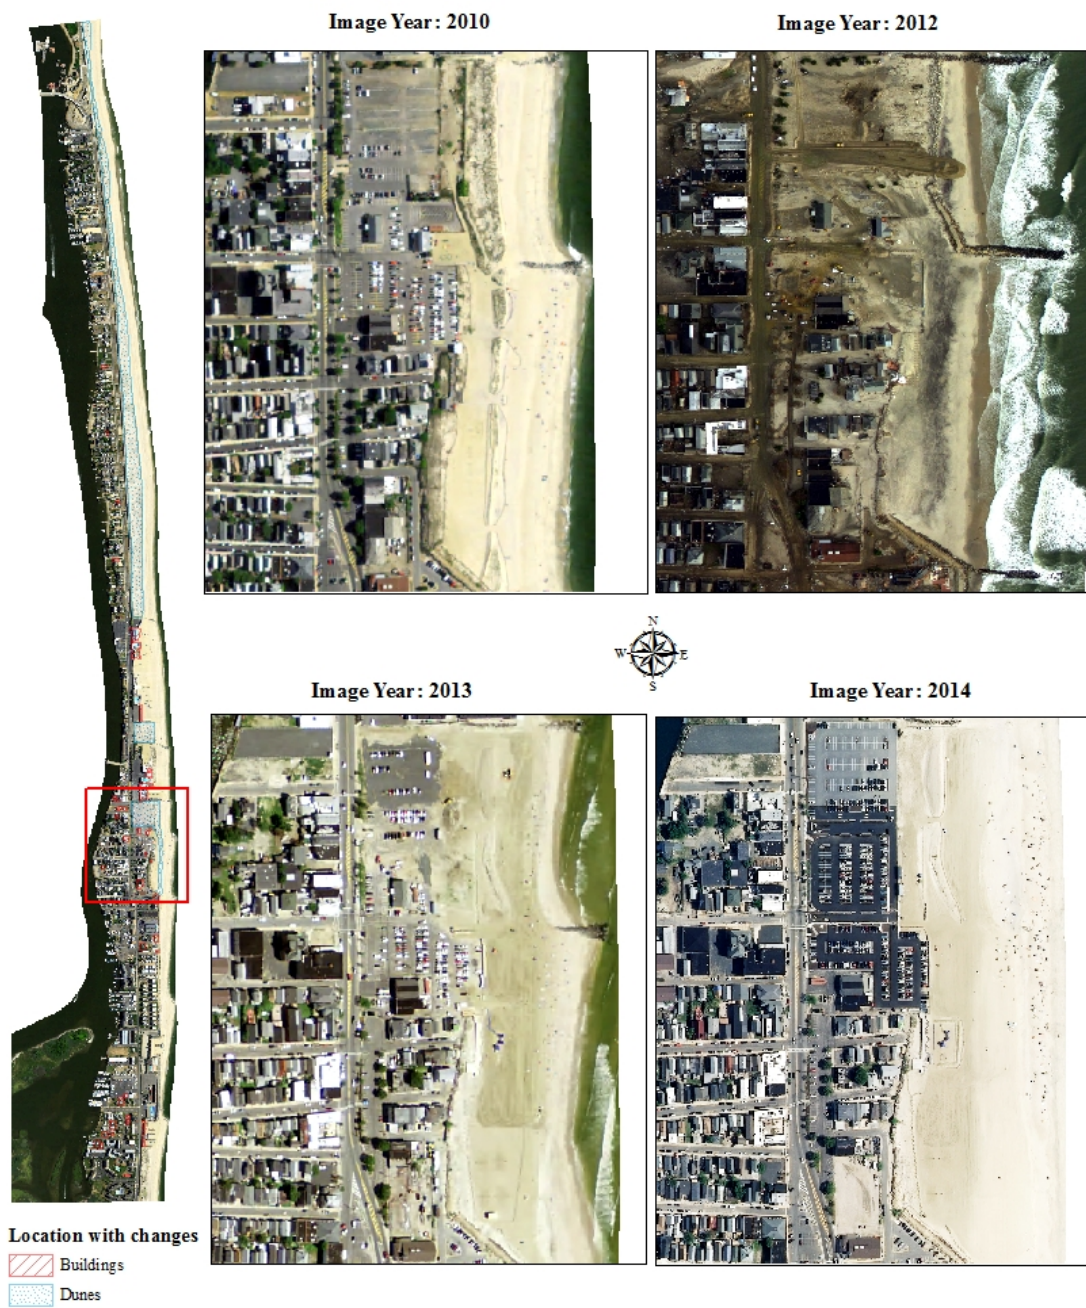
Figure 9: Visually identifiable changes in dunes after Hurricane Sandy between 2010 and 2014.

insert images focus on the dunes. From imagery the change in natural features like continuation of sandy dunes can be identified clearly. In the case of the sandy dunes that protect Sea Bright naturally, it is found that in Hurricane Sandy the dunes had been damaged in several places, which had not been repaired until 2014. Figure 9 shows snap shots of the dunes in 2010, 2012, 2013 and 2014, capturing this situation.

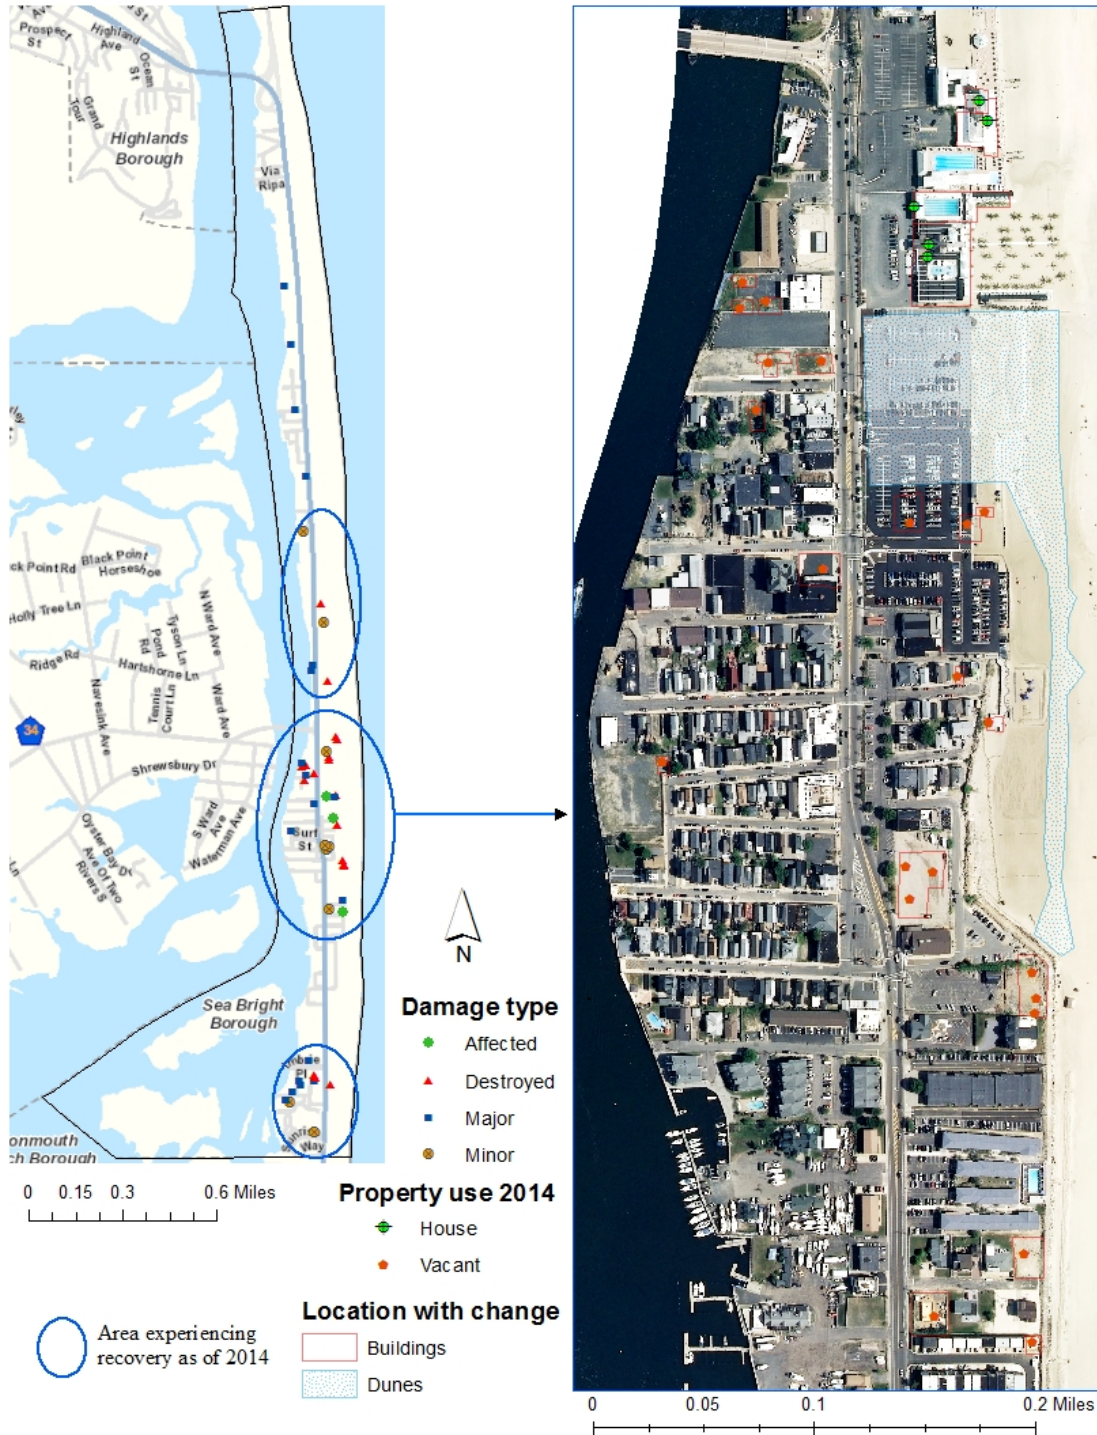
Figure 10: Location of 48 damage points that showed change in different time until 2014 after Hurricane Sandy, concentration identifies the area experiencing housing recovery.

Chronologically, comparing the building structures from site images, it is found that 48 points had some change. Among them, in Hurricane Sandy, 18 locations were destroyed fully, 18 had major damage, 9 had minor damage and 3 buildings were affected in that disaster. Up to 2013 there was little activity on the destroyed properties with only four properties rebuilt. This number increased to seven in 2014, and the rest were still vacant plots. In 2013 eight major damaged plots were found vacant where building structures existed earlier. This number increased to 16 with two of those previous vacant location had houses reconstructed in 2014. The minor damaged sites also experienced demolition, for example, in year 2014, seven of these locations were found to be unoccupied. Affected buildings are not an exception in this scenario where three such plots were bare land in 2014. The damage sites going through reconstruction, and demolition with their damage condition in Hurricane Sandy are shown in Figure 10. From this figure it can be concluded through visual observation that the south part of Sea Bright area was still going through the recovery process in 2014 considering the number of unoccupied plots and change in use patterns from previous.

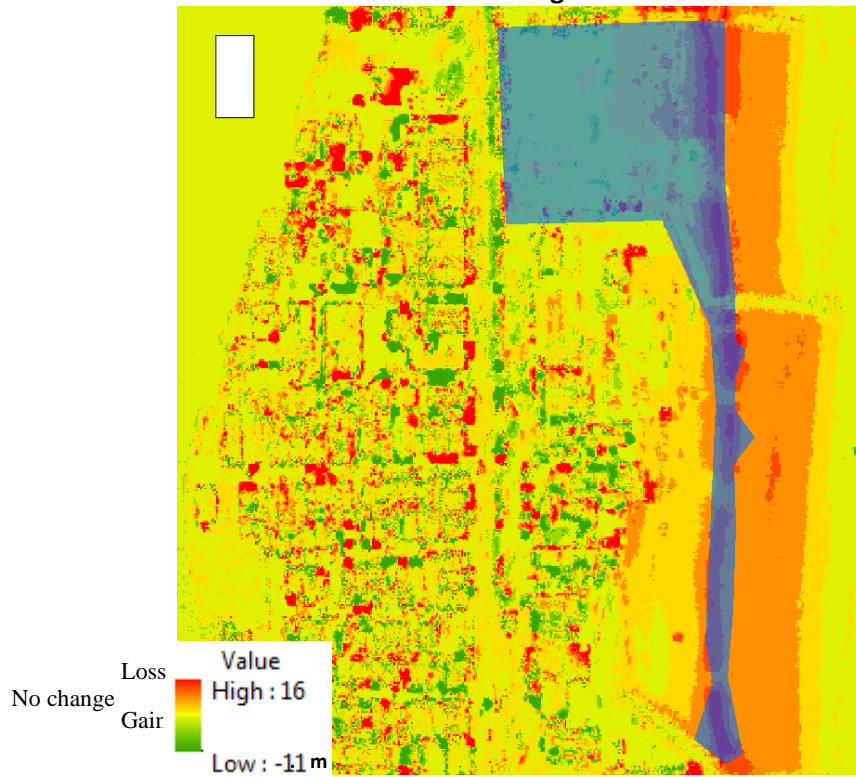
Figure 11: Change detection in dunes pre and post Sandy using LiDAR data.

covered in surface creation. The surface models created from pre and post sandy elevation are used to find out the location with differential change in elevation identifying loss or gain in elevation as an indicator of damage or debris accumulation in the area. To determine this change, the analysis tool 'change detection map' in QTM software is used to create a continuous surface showing elevation difference. These maps are useful in visually identifying the areas with gain or loss in elevation due to impact of Hurricane Sandy. This type of LiDAR data analysis is effective in damage estimation of an area considering its physical properties. Figure 11 and Figure 12 respectively shows the visual interpretation from LiDAR data analysis of elevation change detection in pre and post Hurricane Sandy in natural dunes and building structures. Changes are color coded by from a low of -11 meters to a high of +16 meters.
