Evaluation of Pothole Patching Materials

FINAL REPORT
February 2001

Dept. of Civil & Environmental Engineering
Center for Advanced Infrastructure & Transportation (CAIT)
Rutgers, The State University
Piscataway, NJ 08854-8014

New Jersey
Department of Transportation
Division of Research and Technology
and
U.S. Department of Transportation
Federal Highway Administration

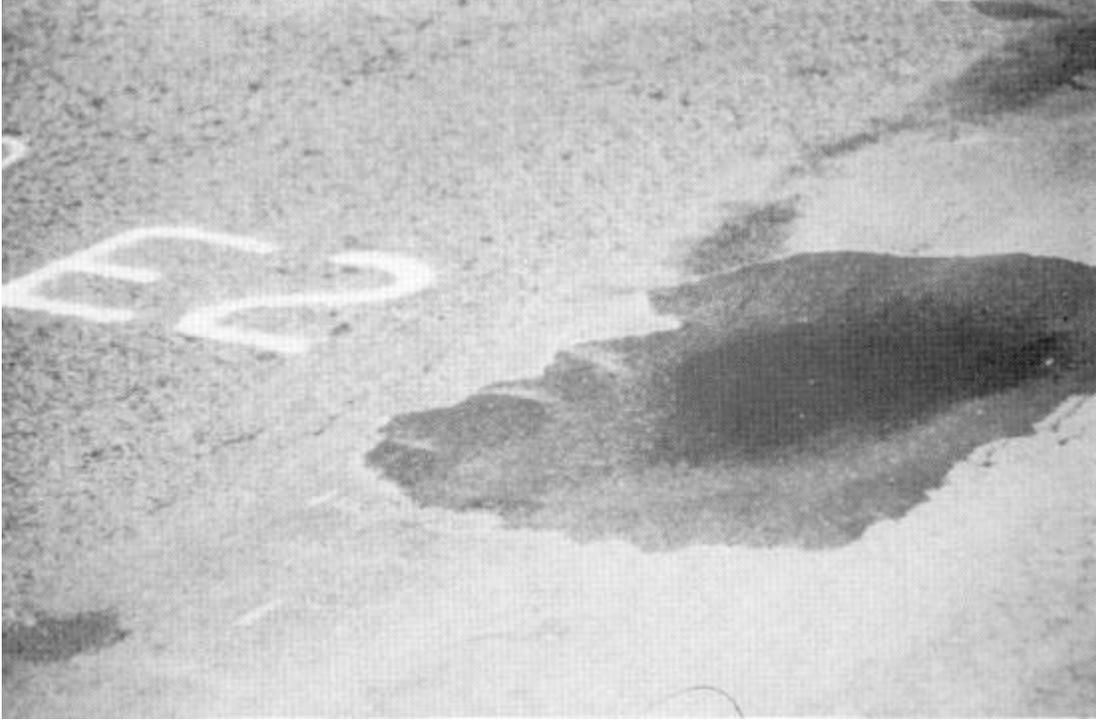
Figure 1. Bleeding Distress ⁽³⁾

In Table 4 ⁽²⁾, in-service problems and failure mechanisms in cold-mix patching materials are presented. Some examples of distress types are shown in Figures 1-5 ⁽³⁾.

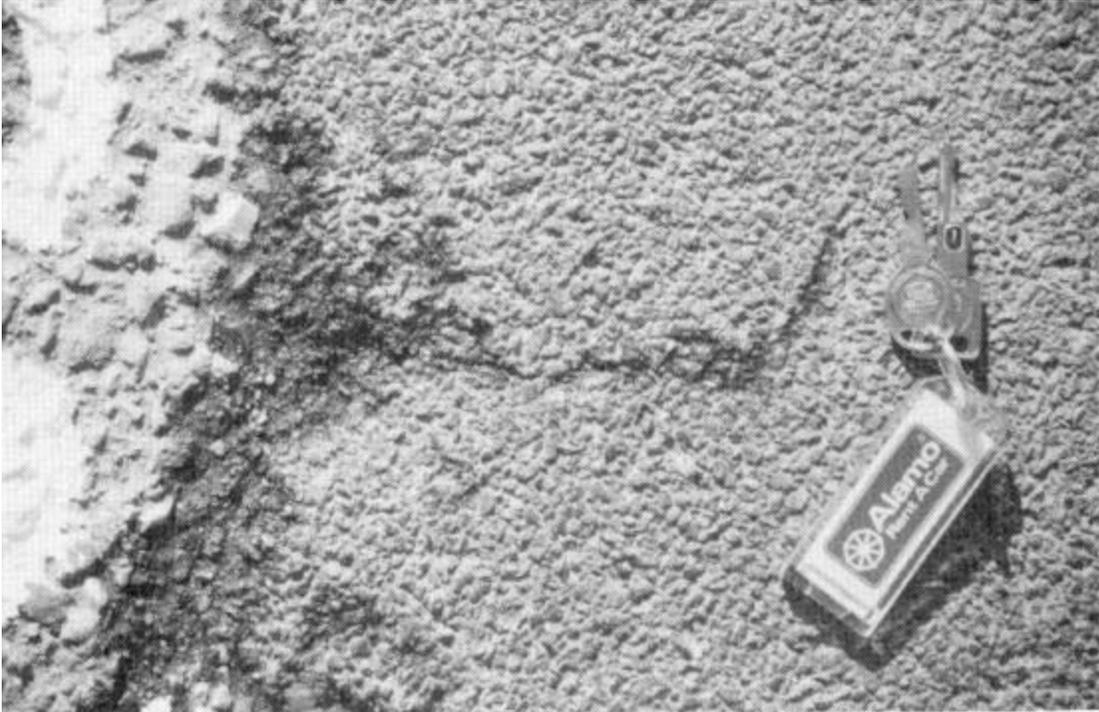
Figure 2. Cracking Distress ⁽³⁾

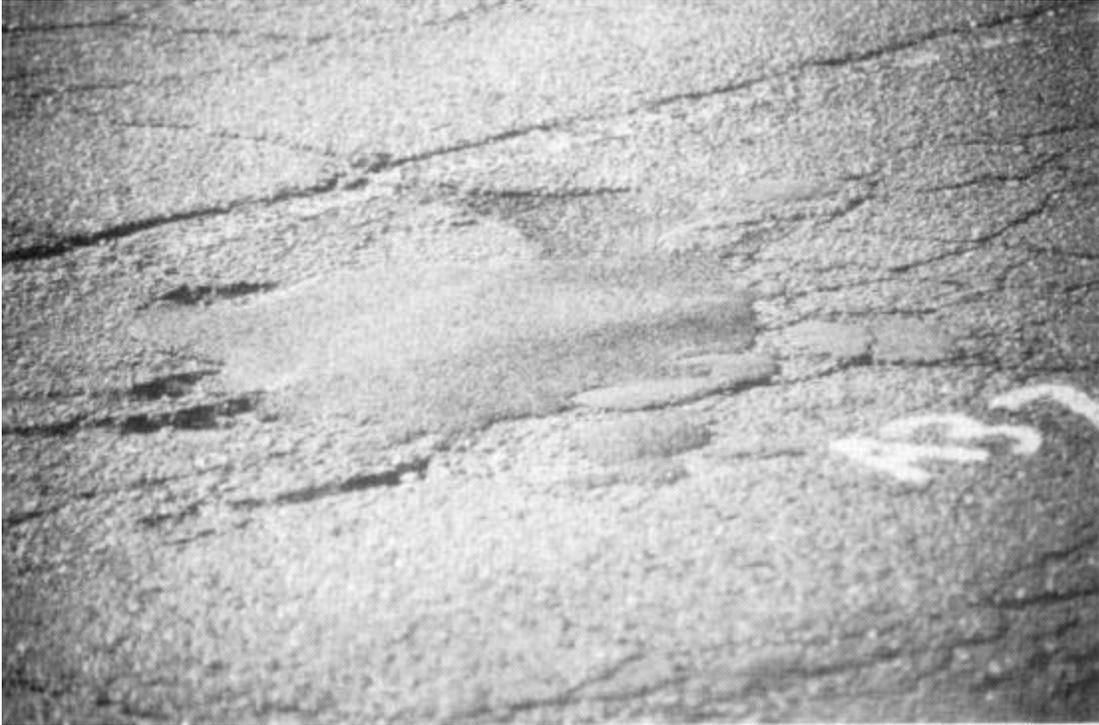
Figure 3. Edge Disintegration Distress ⁽³⁾

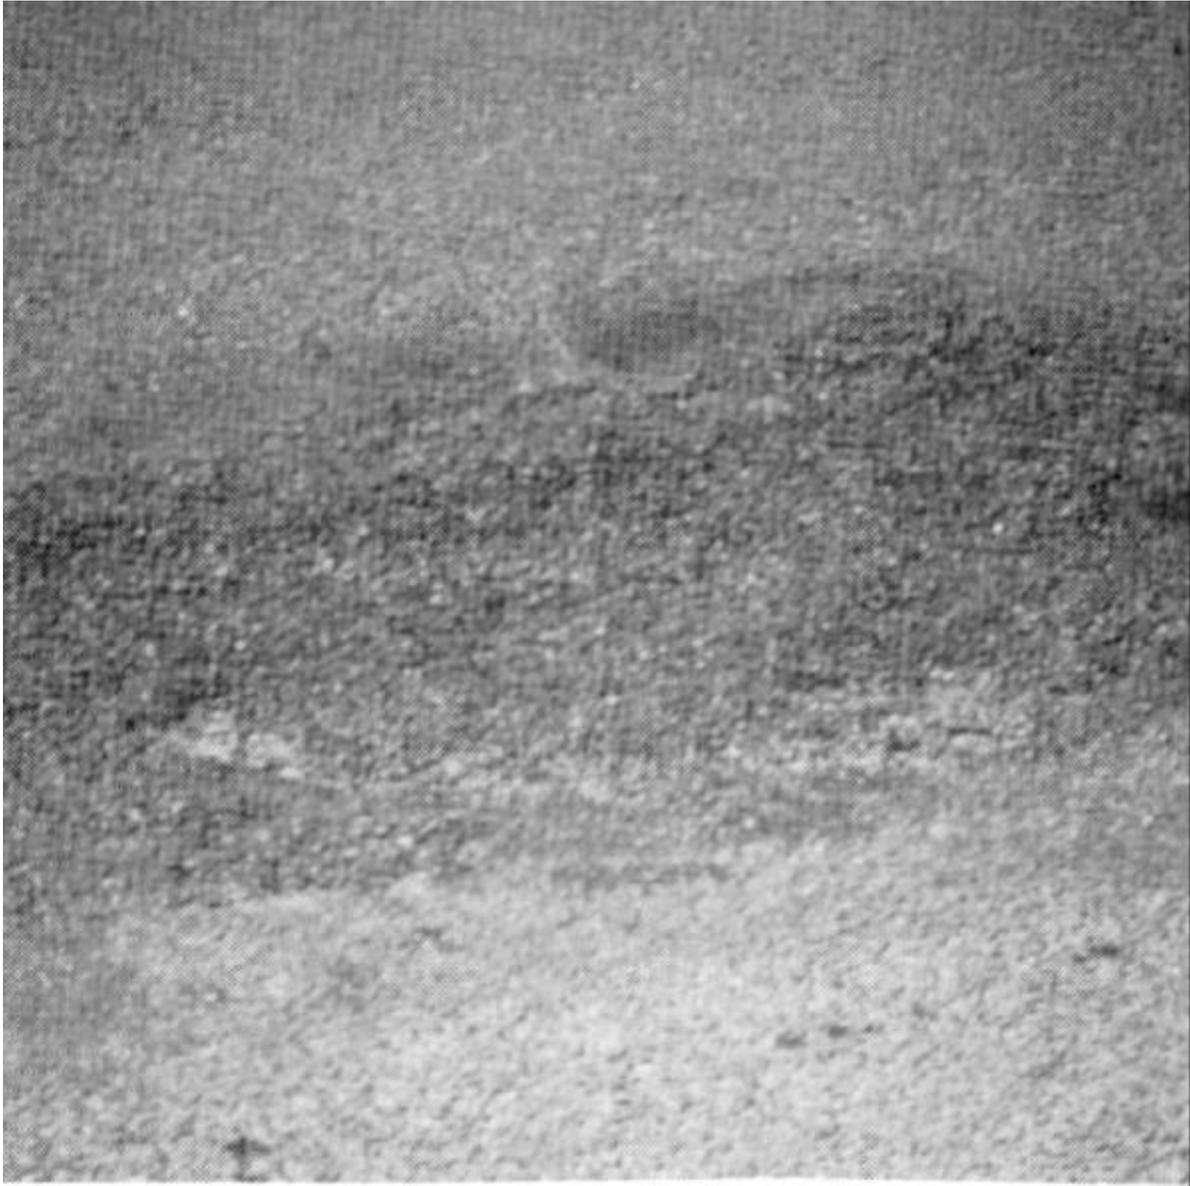
Figure 4. Raveling Distress ⁽³⁾

3. *Raveling* can be described as a progressive loss of aggregate from the surface of the repair. It is basically the product of poor aggregate interlock and inadequate cohesion within the mix. Poor compaction may also contribute to raveling as it reduces cohesion. Most factors that cause shoving may also contribute to raveling.

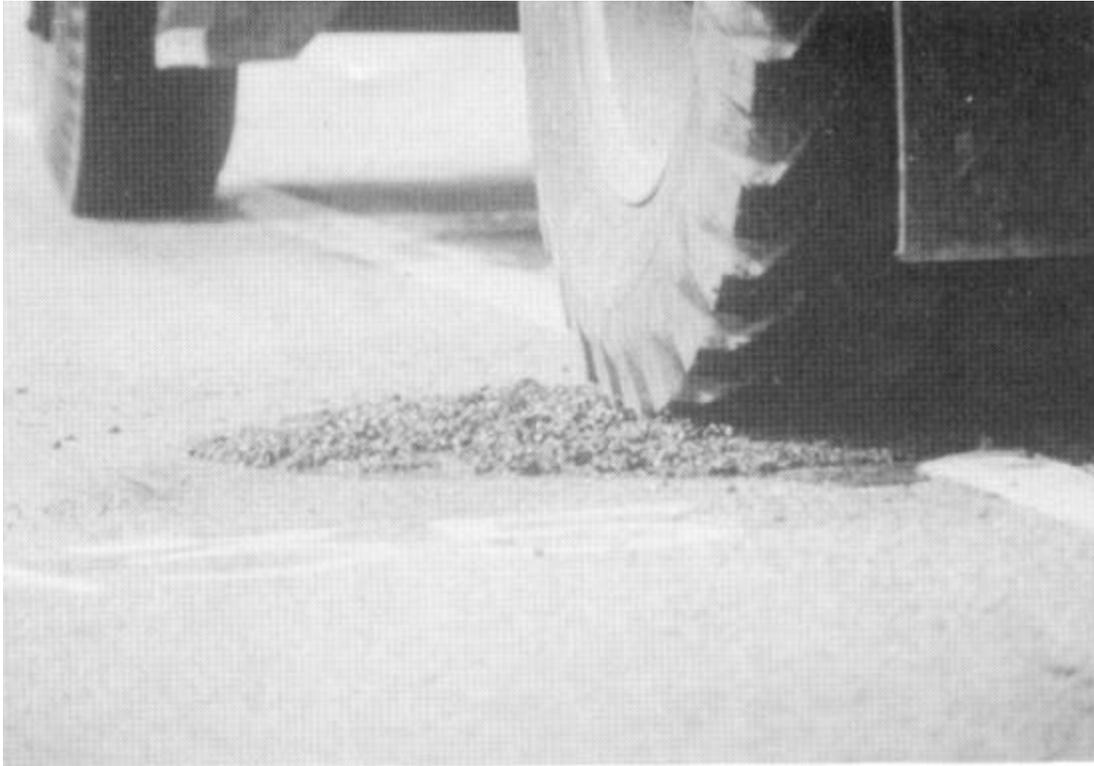
Figure 7. Throw-and-Roll Repair Method: Compaction of Material Using the Wheels of a Truck on Site⁽⁵⁾

In the "throw and roll" method the material is first placed into the pothole (which may or may not be filled with water or debris). The material is then compacted using track tires to allow for a tighter patch for traffic. The remaining is crown between 3 and 6 mm (0.125 and 0.25 in). The maintenance crew moves to the next pothole and the repair is open to traffic as soon as maintenance workers and equipment are clear.

In figures 6 to 11 ⁽⁵⁾ photographs regarding patching repair techniques and equipment are presented.

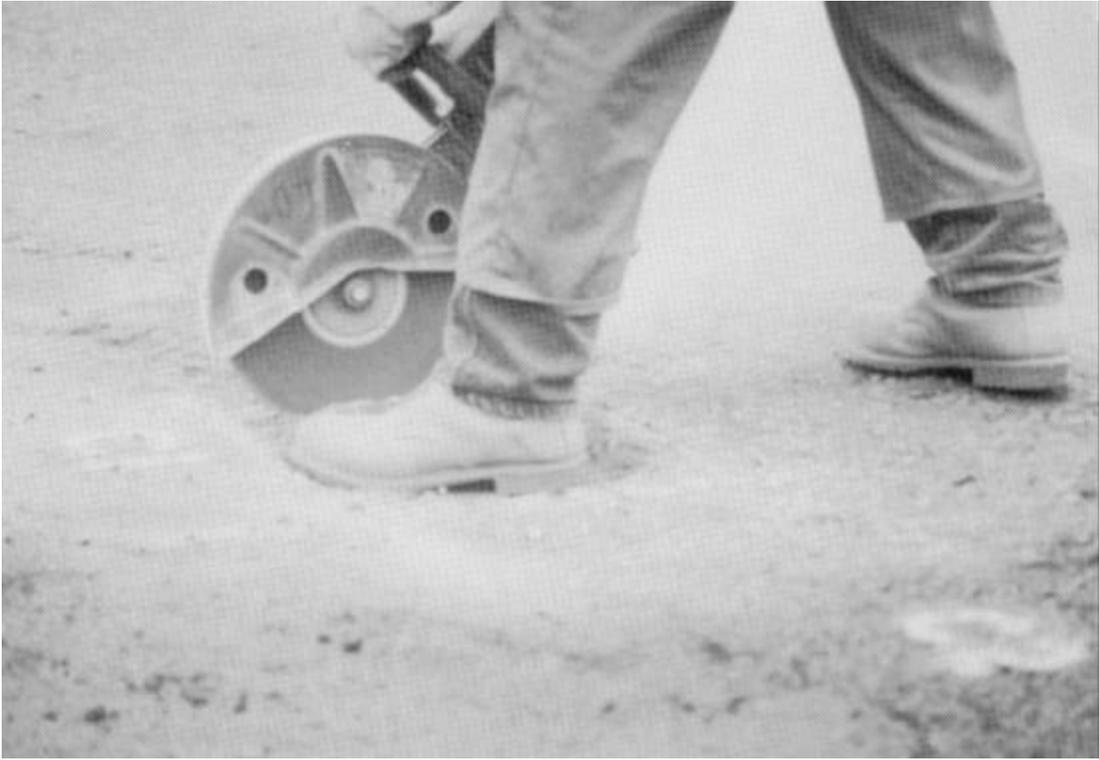
Figure 8. Semi-permanent Method of Pothole Repair: Saw-Cutting of Edges ⁽⁵⁾

In the semi-permanent method, the water and debris are first removed from the pothole. The sides of the patch area are then squared up until vertical sides exist in reasonably sound pavement and the mixed is placed. The patch is then compacted by using a device smaller than the patching area and the repair is opened to traffic as soon as the maintenance workers and equipment are clear.

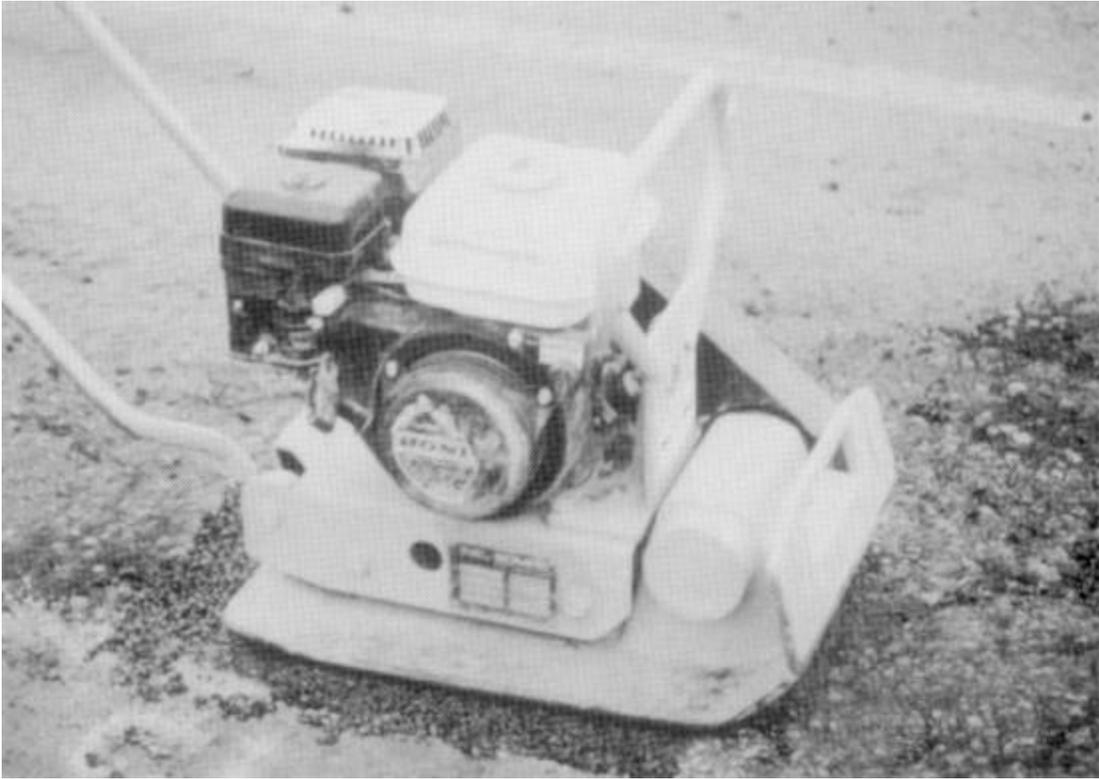
**Figure 9. Semi-permanent Method of Pothole Repair:
Compaction Using a Mobile Vibratory Plate Compactor ⁽⁵⁾**

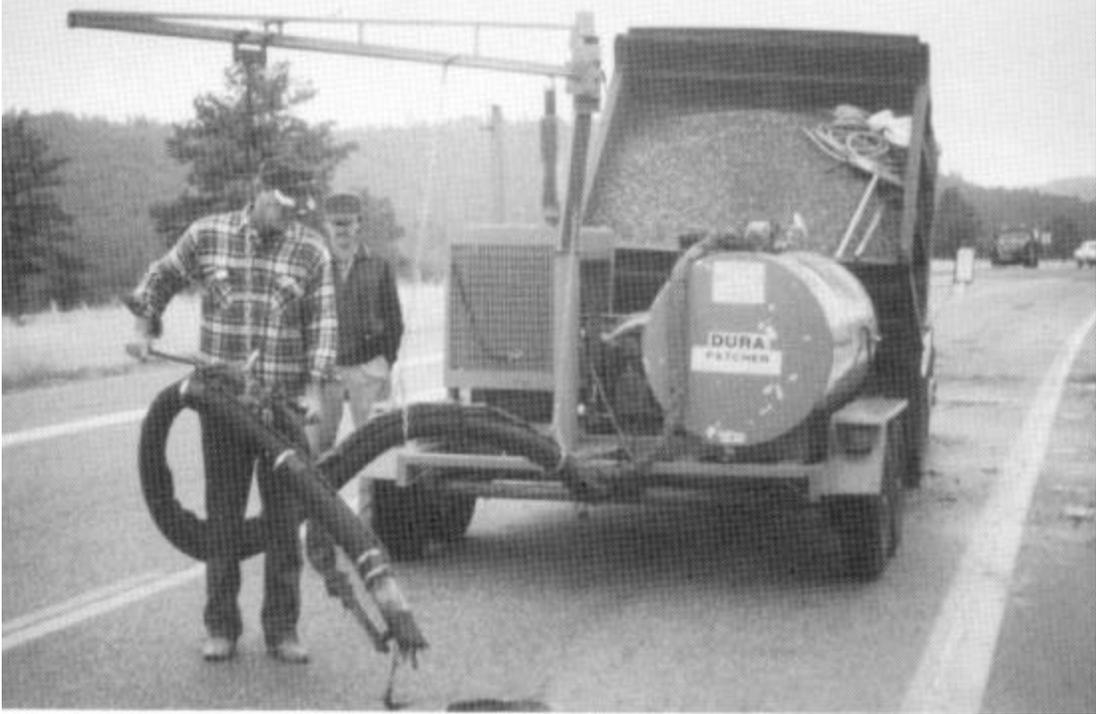
Figure 10. Spray Injection Method of Pothole Repair ⁽⁵⁾

In the spray injection method the water and debris are first removed from the pothole and a tack coat of binder is sprayed into the pothole on the sides and bottom. The asphalt and aggregate are then blown into the pothole and the patched area is then covered by an aggregate layer. The repair is finally opened to traffic as soon as the maintenance workers and the equipment are clear.

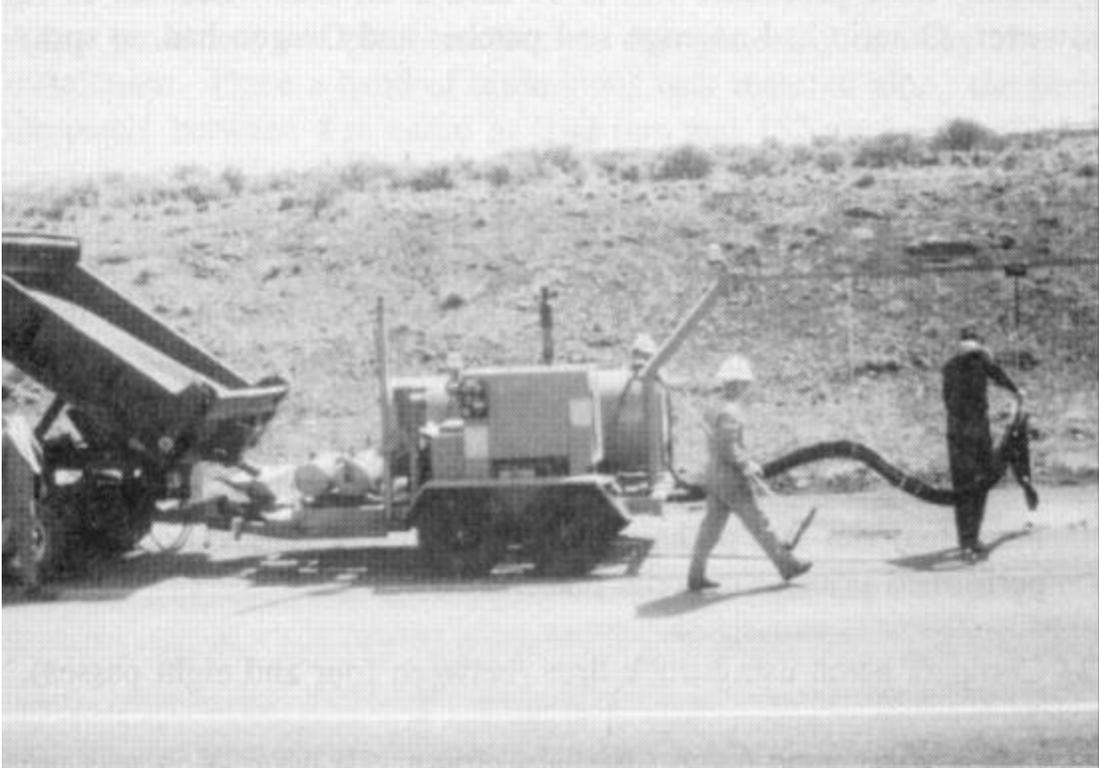
Figure 11. Spray Injection Method of Pothole Repair ⁽⁵⁾
