Implementation of Weigh-in-Motion (WIM) Systems

FINAL REPORT
February 2009

1. Report No. FHWA-NJ-2009-001	2. Government Accession No.	3. Recipient's Catalog No.	
4. Title and Subtitle Implementation of Weigh-in-motion (WIM) Systems		5. Report Date February 2009

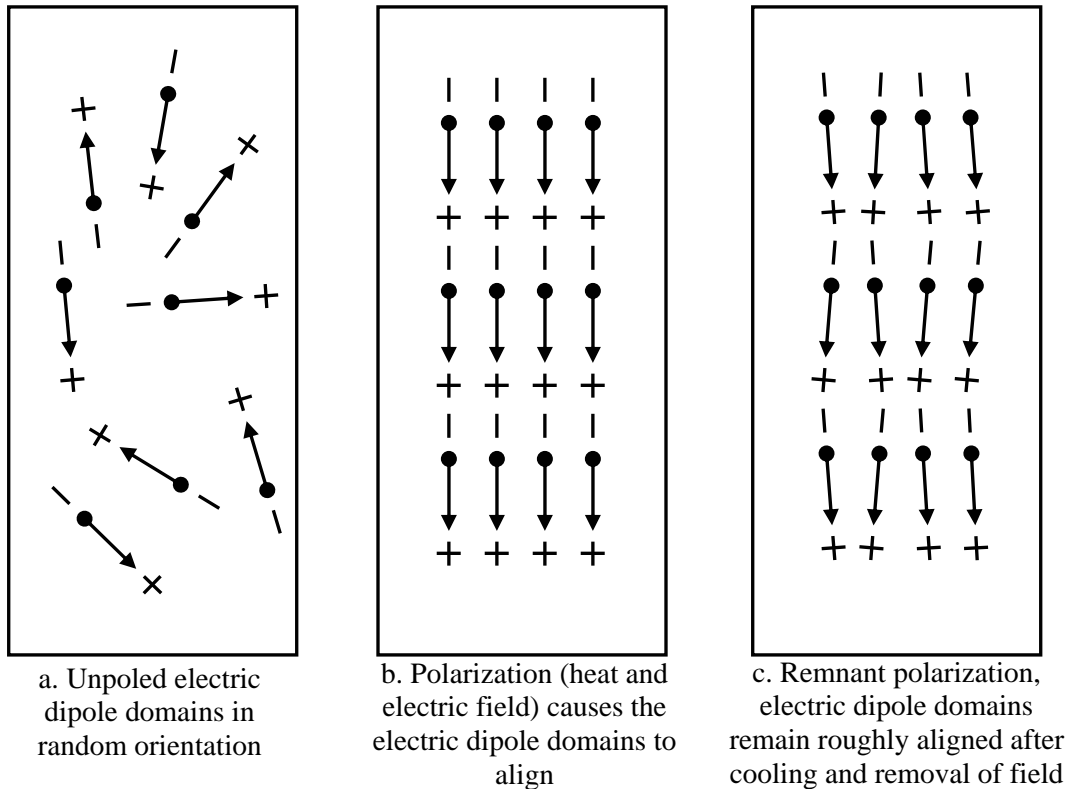
Figure 1 Diagram detailing the poling process and remnant polarization.

Piezoelectric; the word is derived from the Greek “Piezin“, which means to squeeze or press. Thus piezoelectricity is really “pressure electricity.” Piezoelectric implies that the material has a crystalline structure, quartz for example commonly found in watches exhibits piezoelectric properties. Ceramic materials such as PZT (Lead Zirconate Titanate) are crystalline, but the crystals are very tiny. PZT is a piezoelectric material through a combination of chemical effects, physical effects, and geometry. Unlike quartz, PZT starts with powdered crystals which get melted together and solidify into a block so it is not just a single crystal, but numerous small ones. Once the block is formed it is still not a piezoelectric material, its all scrambled, think of it in terms of magnetism with pluses and minuses more or less it is an equal balance but by aligning the charges a block of ceramic (containing all these tiny crystals) can be “poled” Figure 1a. Poling is done with heat, pressure, and exposing the material to a strong voltage/electrostatic field Figure 1b. When the material cools it retains this internal electrical alignment, as shown in Figure 1c. However, exceeding the materials’ remnant polarization properties thermal, mechanical, or electrical will cause its polarization to degrade.⁷

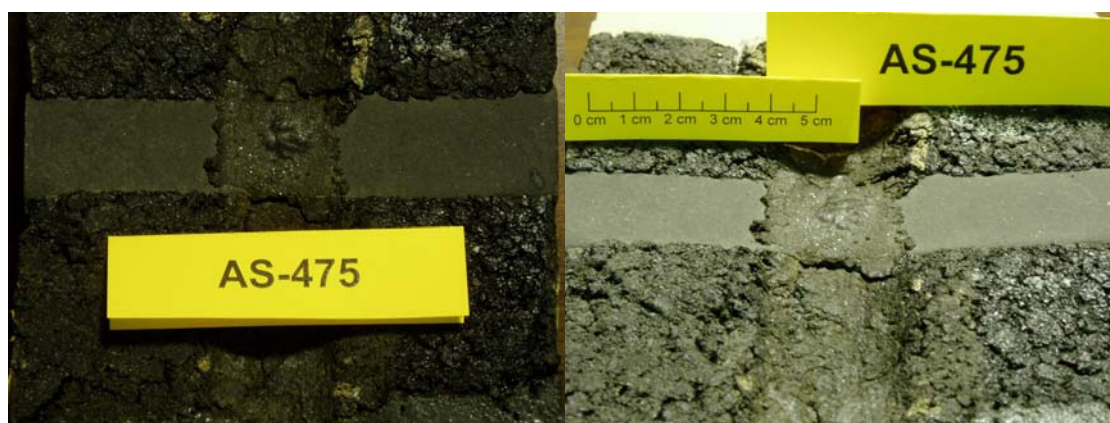
Figure 13 Photograph of APA Test rutting results of AS 475.

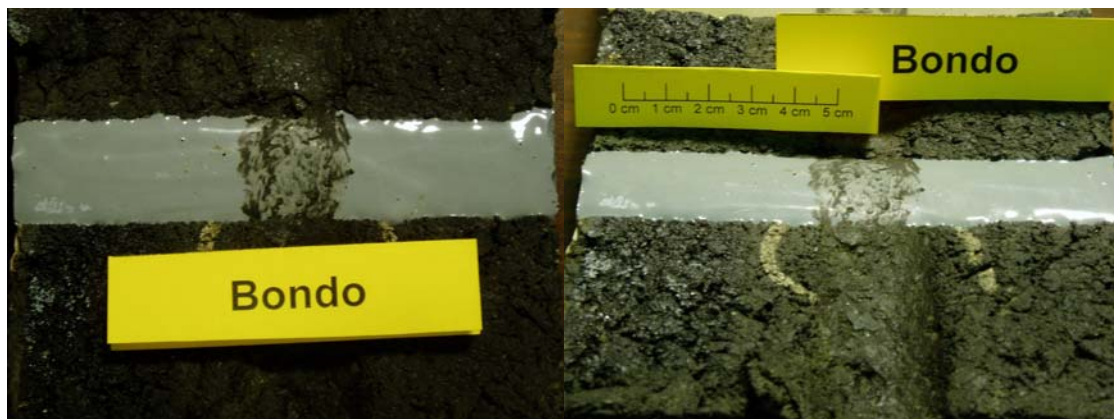
Figure 17 Photograph of APA Test rutting results of Bondo 7084.

Product:	BONDO 7084
Properties	
Pot Life	17-25 minutes
Initial Cure	45 minutes
Traffic Ready	1 hour
Final Cure	1 hour
Viscosity	Unknown
Compressive Strength	Unknown
Tensile Strength	17.2 MPa (2500 psi)
Adhesive/Bond/Shear Strength	13.8 MPa (2000 psi)
Mixing Ratio	1:1 by volume
Flash Point	Not Available, assume >93°C (>200°F)
Other Observations	Bondo 7084 is very thick and extremely difficult to work with , rigidity may cause issues if the road ruts, however there was no delamination in APA tests.
Measured Delamination from 20,000 Cycle APA Test	0 mm (0in)
	0.69 mm (0.027 in)
Type of Delamination	None / Asphalt Cracking

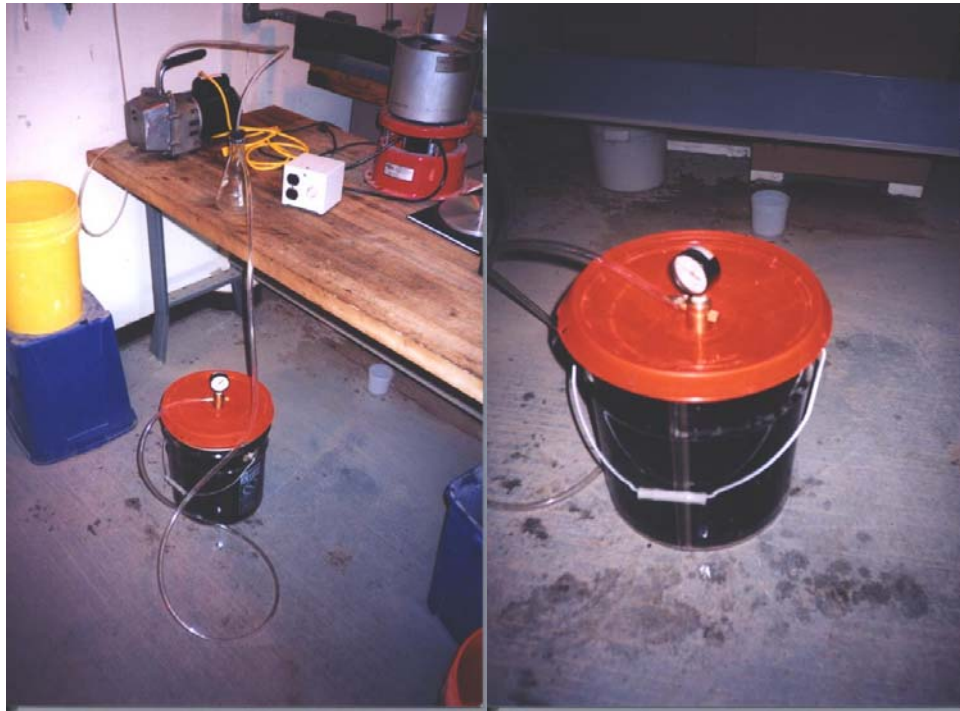
Figure 19 Photograph of vacuum container with vacuum pump and gage.

The test consisted of saturating the samples to between 55%-80%. To achieve this level of saturation, vacuum saturation was used. The pump and vacuum gage from the Rice test were used with a 5 gallon container to create the vacuum container. A vacuum of 100 kPa (15 psi) was achieved within the container. All testing was conducted at room temperature.

The vacuum container, as shown in Figure 19, was then filled with water to a level that when the sample was placed in the container the sample was completely covered by approximately 2.54 cm (1 in) of water. Salt was then added to the water, as shown in Figure 20, and the solution was then mixed well to form a brine solution to mimic the harshest field conditions. For example, during winter months when salt is frequently used on the roadway this can significantly degrade asphalt bonding. Normally, durability testing is done with distilled water but this approach was meant as a torture test to accelerate potential damage.

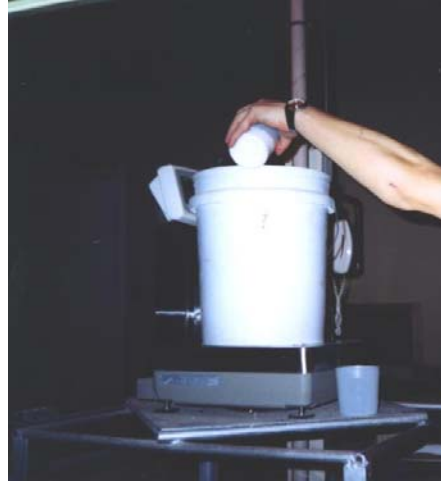
Figure 20 Addition of salt to form brine solution to ensure test would be performed under worst case environmental effects.

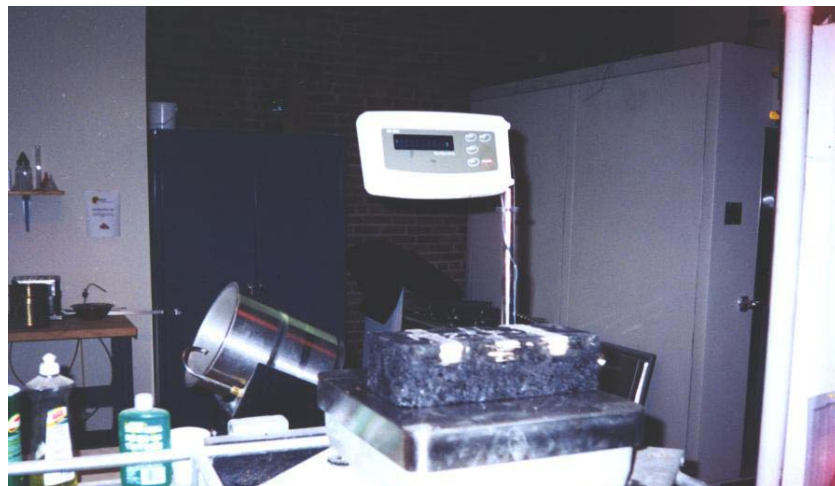
Figure 21 Weighing of samples to determine saturated surface dry (SSD) weight.

The saturated surface-dry mass of each sample was determined and is shown in Figure 21. Each brick was then subjected to vacuum conditioning for 15 minutes. The vacuum was then removed and the samples were allowed to sit in the solution for another 5 minutes. The samples were then removed from the vacuum container and the saturated surface-dry mass was re-measured and compared to the original measurement. The saturation for two HMA bricks was 62% and for the HMA third brick it was 66%. Therefore, within an acceptable tolerance of 55-80% according to T-283, all the samples had roughly the sample level of saturation and the testing was continued.²⁹

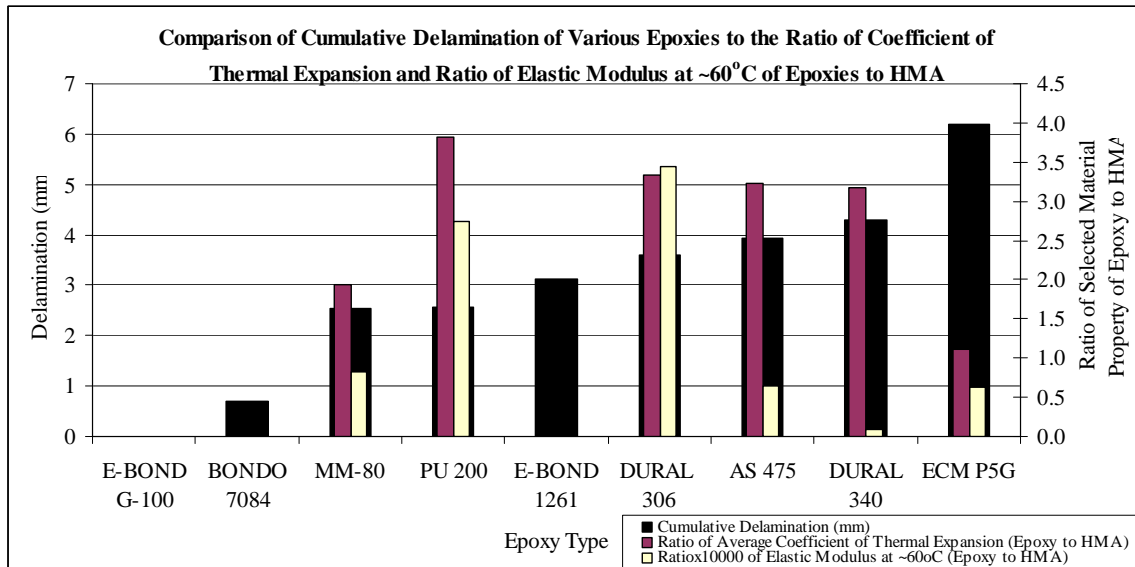
Figure 27 Comparison of cumulative delamination of various epoxies to the ratio of Coefficient of Thermal Expansion and ratio of Elastic Modulus at $\sim 60^{\circ}\text{C}$ of epoxies to HMA.

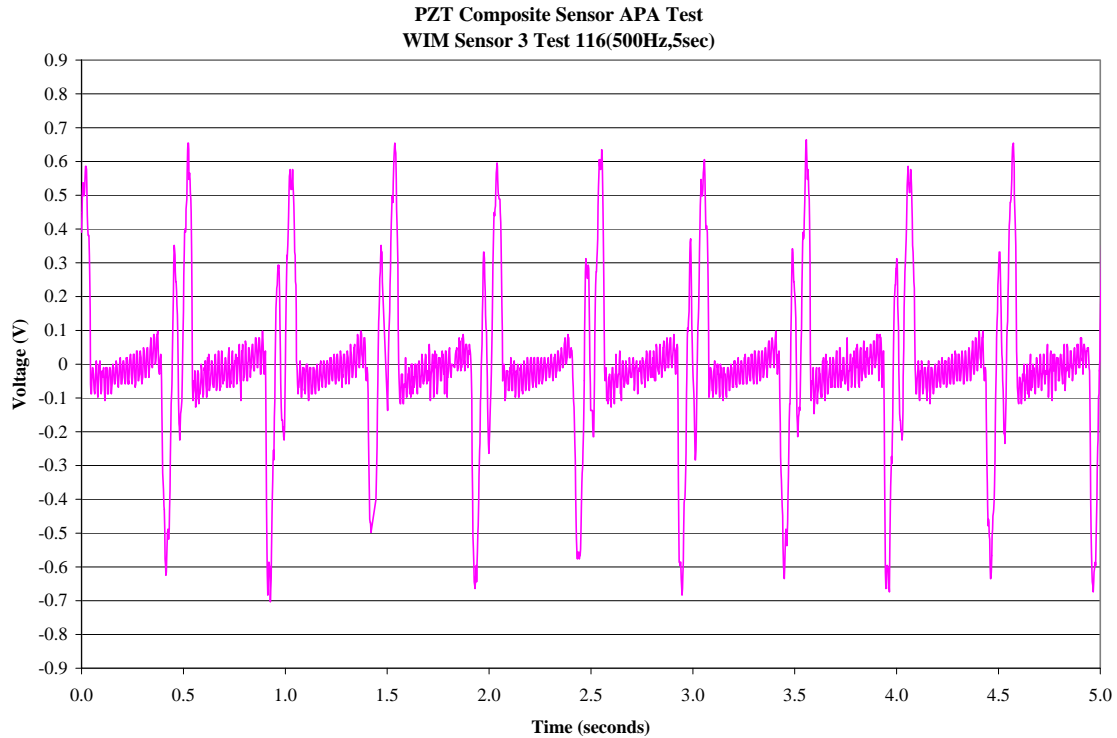
Figure 29 APA testing of fourth prototype sensor, sensor assembly three (WIM3).

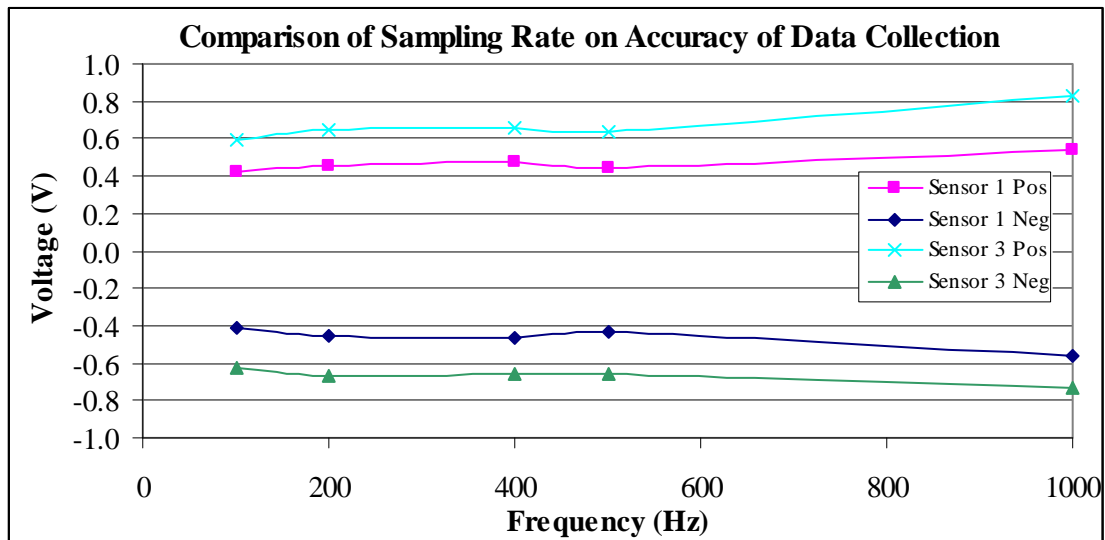
Figure 30 Comparison of sampling rate on the voltage output.

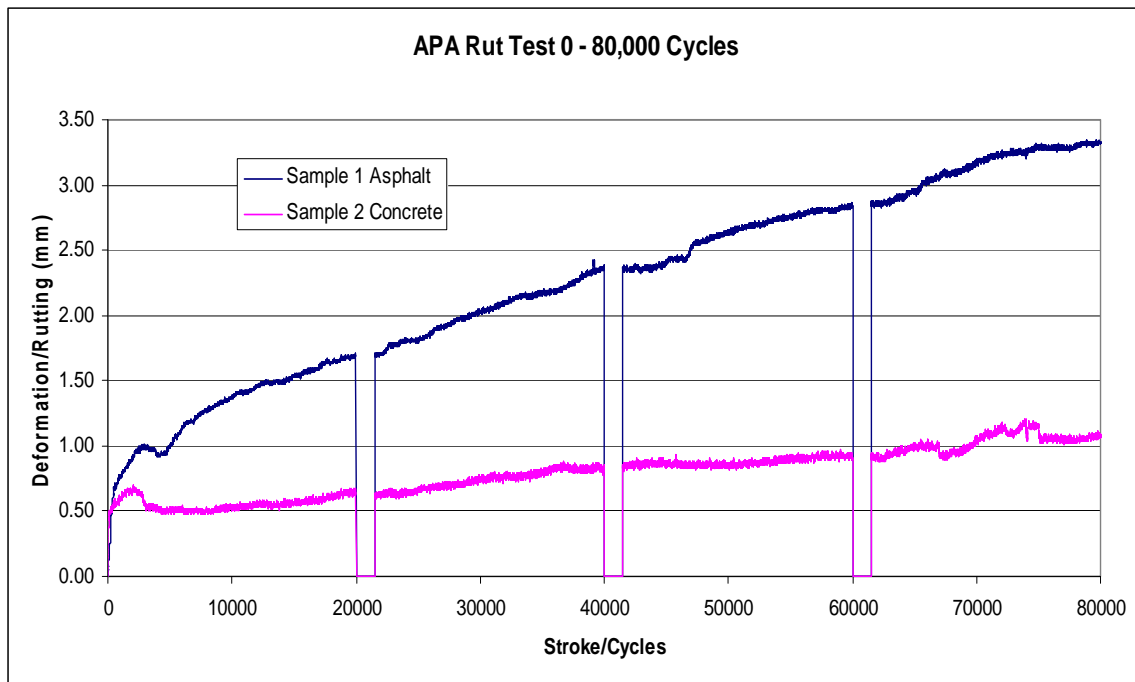
Figure 34 Graph of combined rut data from APA test 0 thru 80,000 cycles.

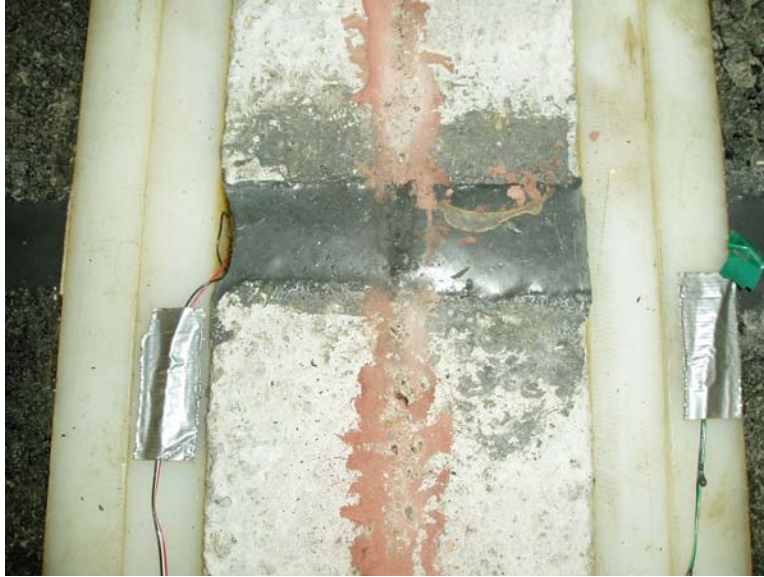
Figure 36 Rutting of concrete sample after 100,000 cycles.

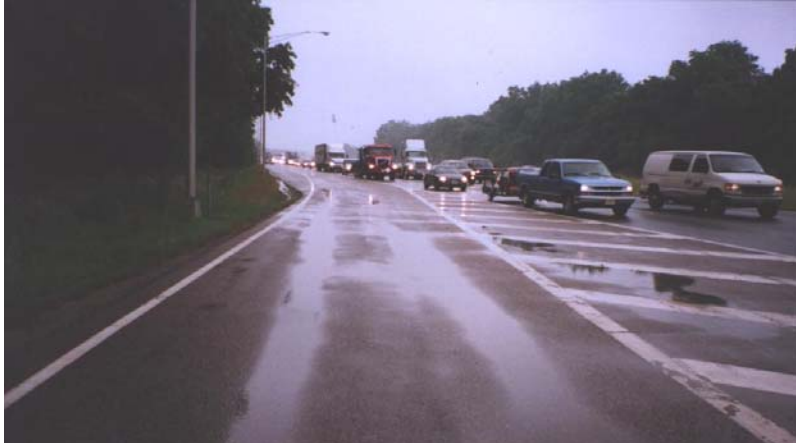
Figure 54 Field observation of water ponding in the wheel paths.

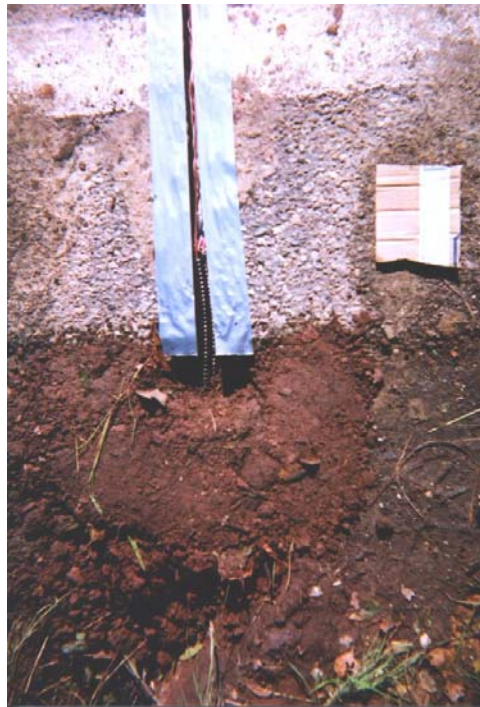
Figure 60 Photograph of the groove with the wires and plastic conduit ready for epoxy infiltration.

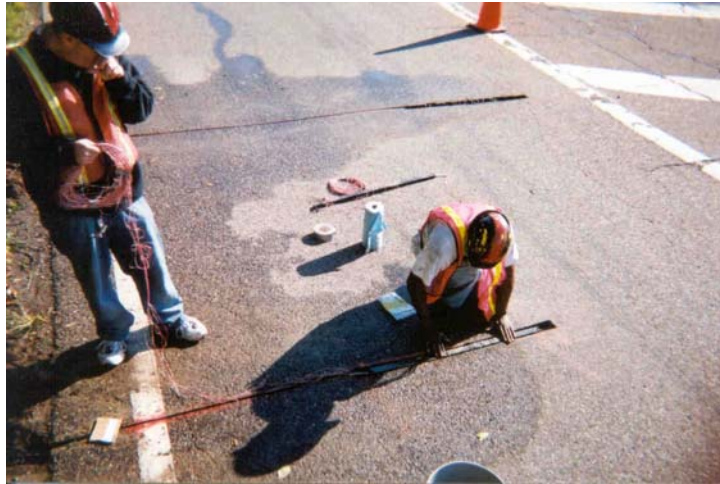
Figure 61 Photograph of ceramic-polymer composite sensor assembly being placed in groove at the Route 287 weigh station.

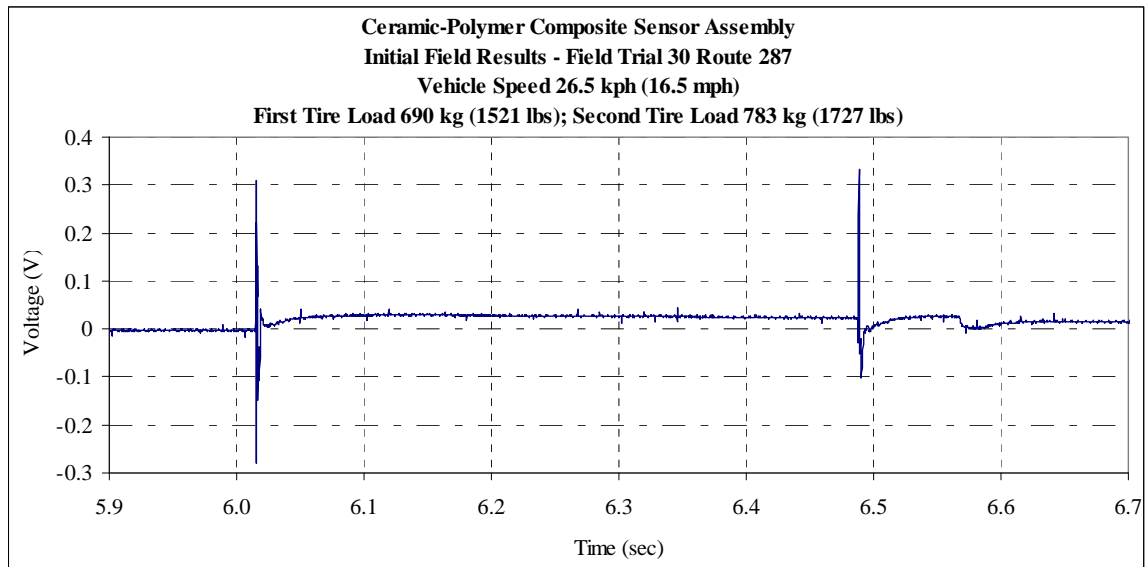
Figure 65 Ceramic-polymer composite sensor assembly initial field trial Rt. 287 results at 26.5 kph (16.5 mph).

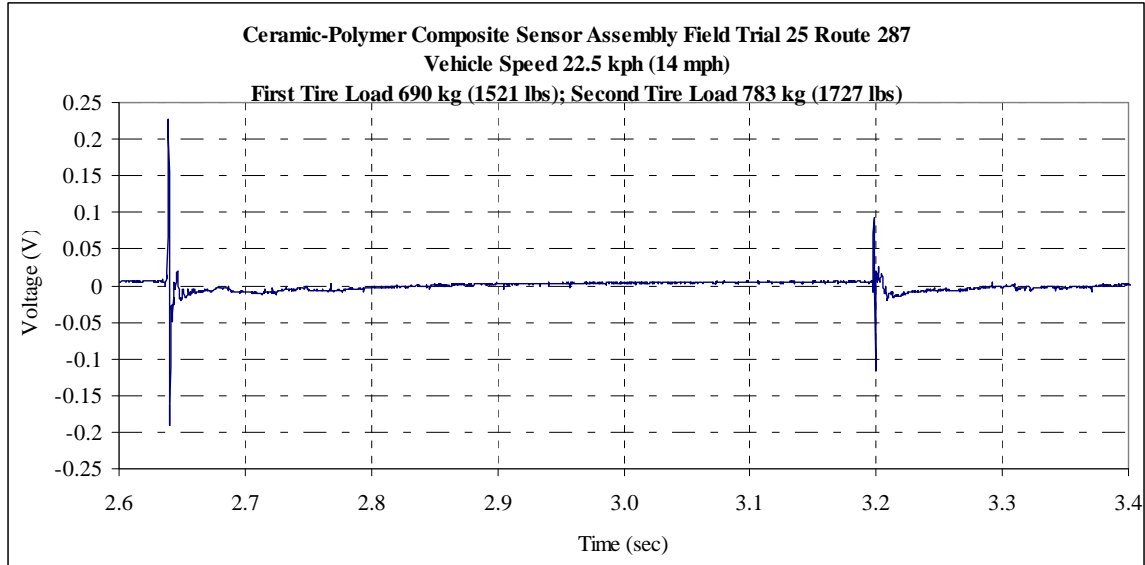
Figure 69 Ceramic-polymer composite sensor assembly field trial Rt. 287 results after winter season at 22.5 kph (14 mph).

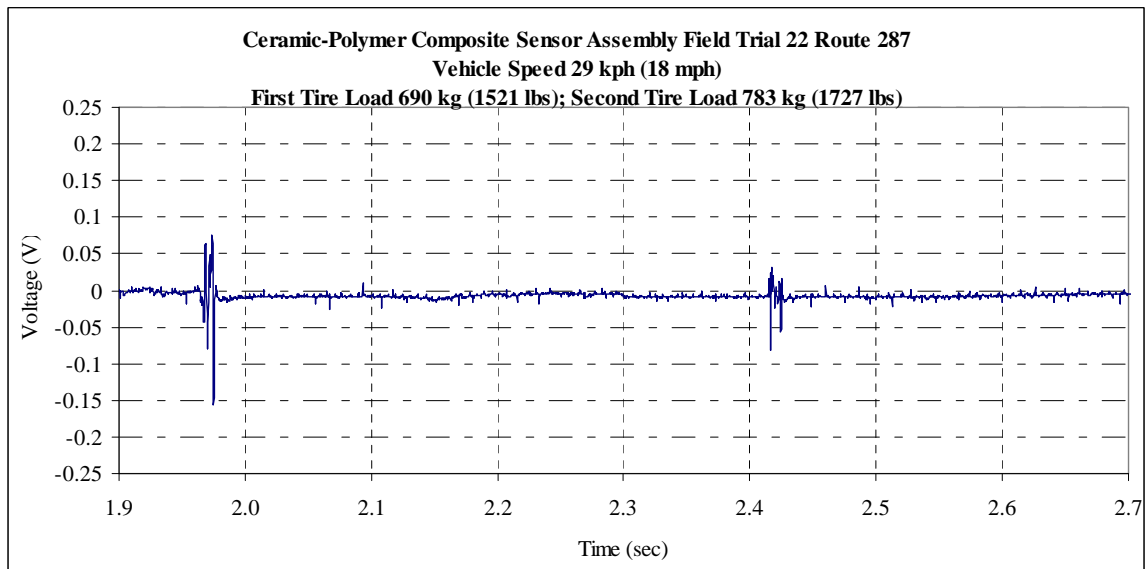
Figure 70 Ceramic-polymer composite sensor assembly field trial Rt. 287 results after winter season at 29 kph (18 mph).

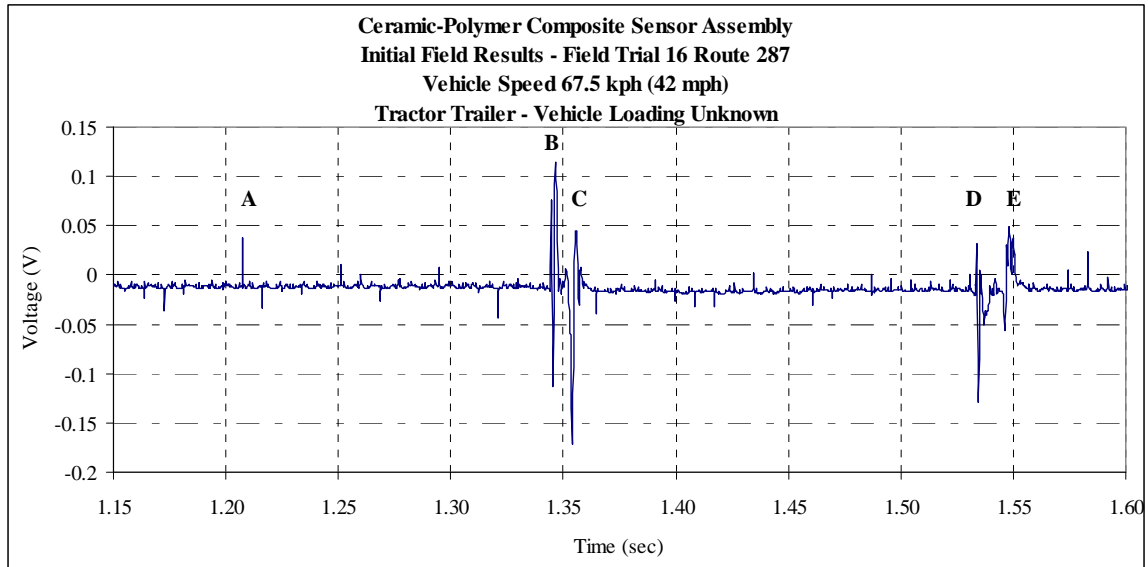
Figure 72 Ceramic-polymer composite sensor assembly field trial Rt. 287 results of tractor trailer loading, after winter season at 67.5 kph (42 mph).

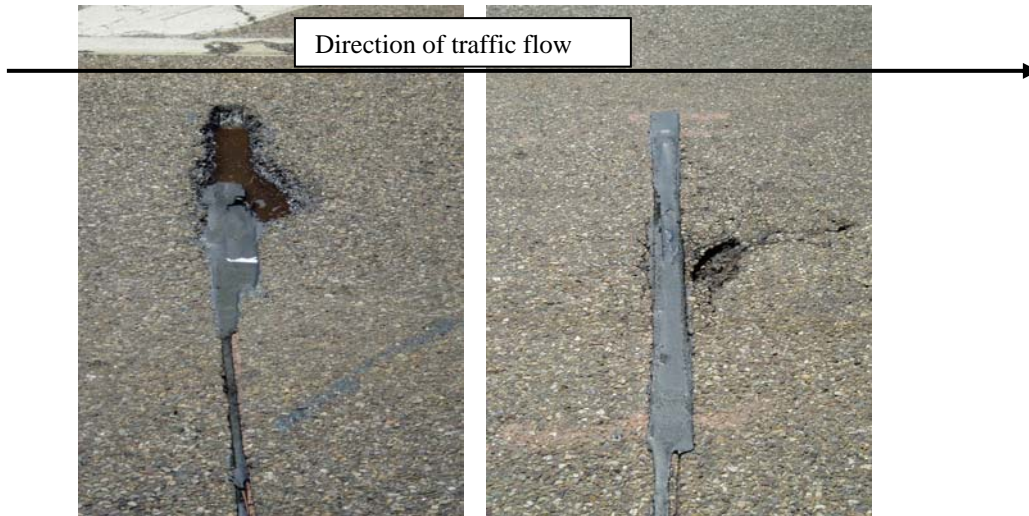
Figure 76 Failure of sensor assemblies; outside of lane (left) and inside of lane (right).
