Cost-effective Bridge Decks for Improved Durability and Extended Service Life – Experimental Testing and Performance Analysis of a Corrugated Core Bridge Deck with Structural Adhesive Bonding

FINAL REPORT

June 2023

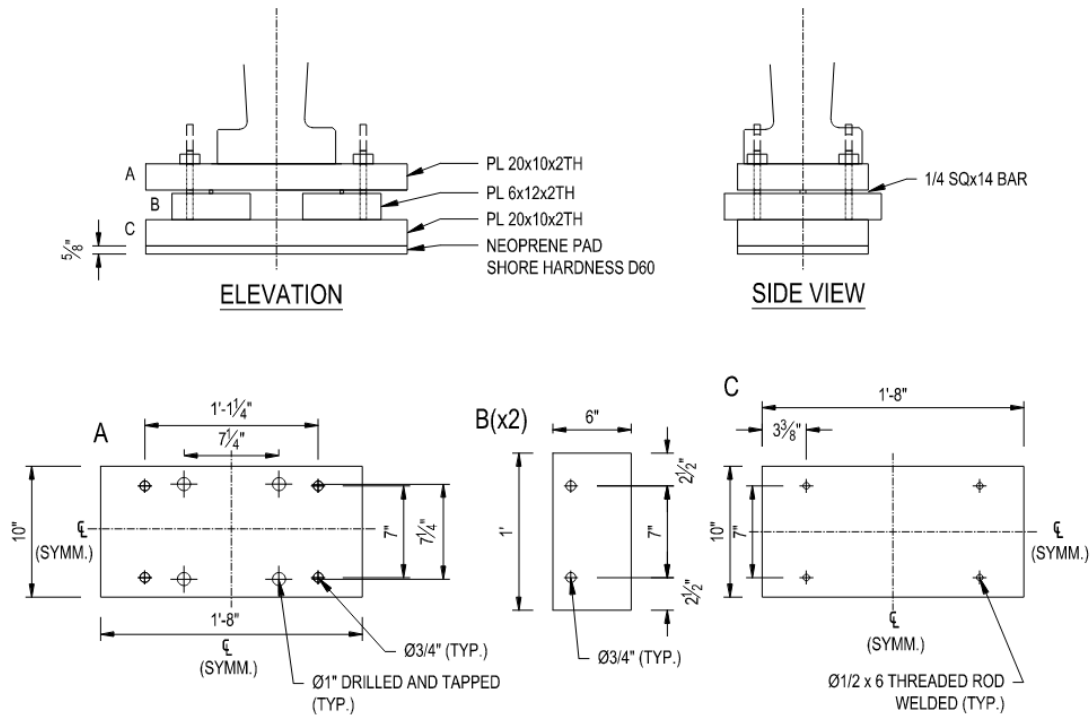
Figure 3 Details of loading pad (1inch =2.54 cm)

To ensure uniform distribution of the load from the actuator onto the deck, a loading pad was employed. The LRFD BDS tire contact area was simulated using three 2-inch-thick plates arranged in a stack, with dimensions of 10"×20". A rubber pad, 1/2" thick, was affixed to the bottom of the loading block. The bottom plate was provided with four threaded rods welded to its surface at the four corners, which extended through the other plates and finished with nuts at the top. The details of the loading pad are shown in Figure 3.

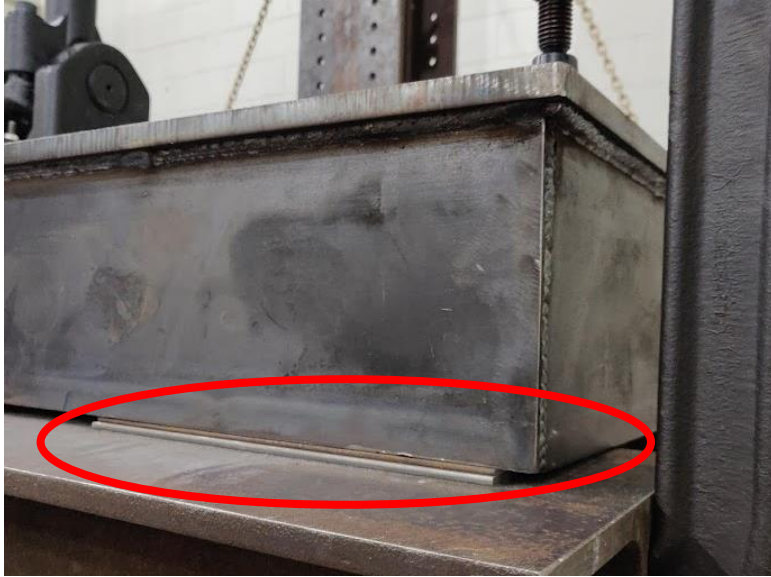
Figure 4 Shims to support deck edge

Significant bowing of the edge plates was noted in the deck specimen as delivered, resulting in the specimen being primarily supported at the corners. Additionally, distortion of the supporting beam top flange led to partial support at the longitudinal edge, which deviated from the intended boundary condition. Shims were strategically placed along the longitudinal edges to ensure support solely by the edge plates onto the support beams. Figure 4 and Figure 5 illustrate the deck after the shims were added, highlighting the previous contact area. Furthermore, large C-clamps were affixed to the corners and center of the deck on both sides to prevent any movement during cyclic testing. A fence, fabricated out of welded angle pieces, was placed around the loading pad and clamped to the deck plate edge, to prevent the loading pad from “walking” out of position (Figure 6). The actuator was restrained in alignment by an angle member bolted to the back of the actuator and to the loading frame columns (Figure 7). Out of plane rocking of the loading frame during cyclic loading was braced by heavy duty pretensioned chains bolted to the loading frame and to the laboratory floor.

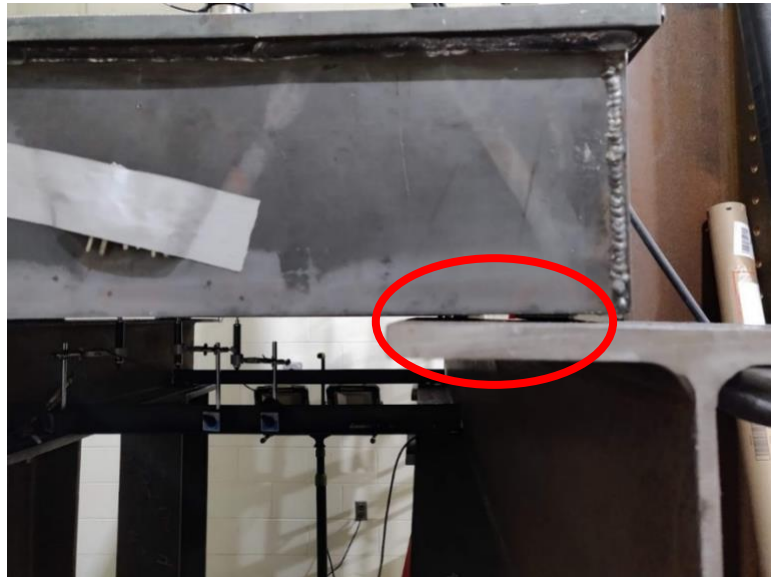
Figure 5 Straight-on view of shims

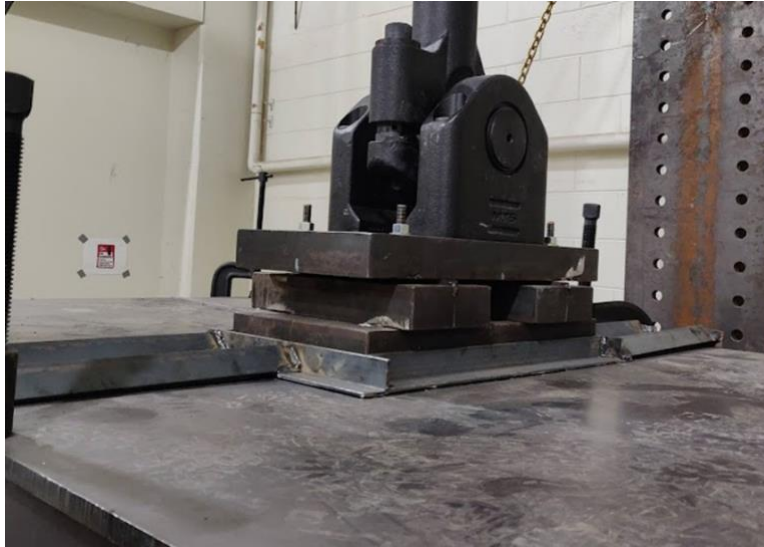
Figure 6 Loading pad with fence around

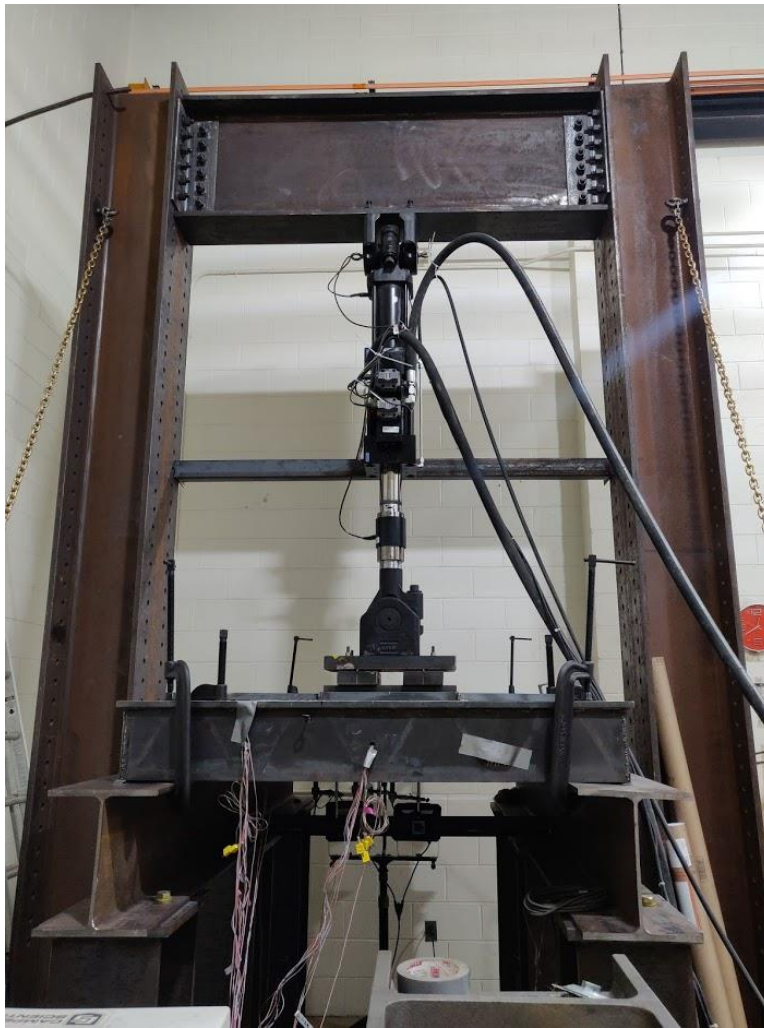
Figure 7 Overall test setup – end view

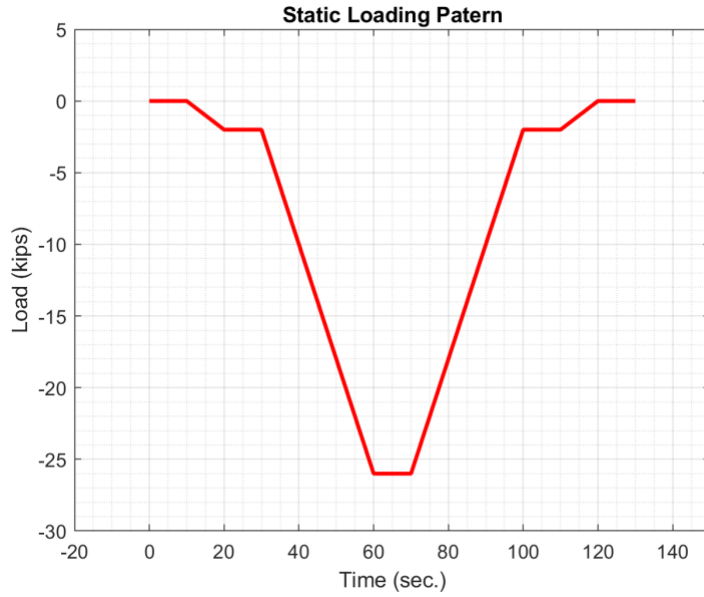
Figure 14 Static Loading Pattern

The loading pattern for the static test followed a stepped pattern shown in Figure 14. The loading profile for the static test was as follows: monotonically load the actuator to 2 kips in 10 seconds; hold for 10 seconds; monotonically increase to 26.0 kips in 30 seconds; hold for 10 seconds; monotonically decrease to 2 kips; hold for 10 seconds; and finally unload the actuator.

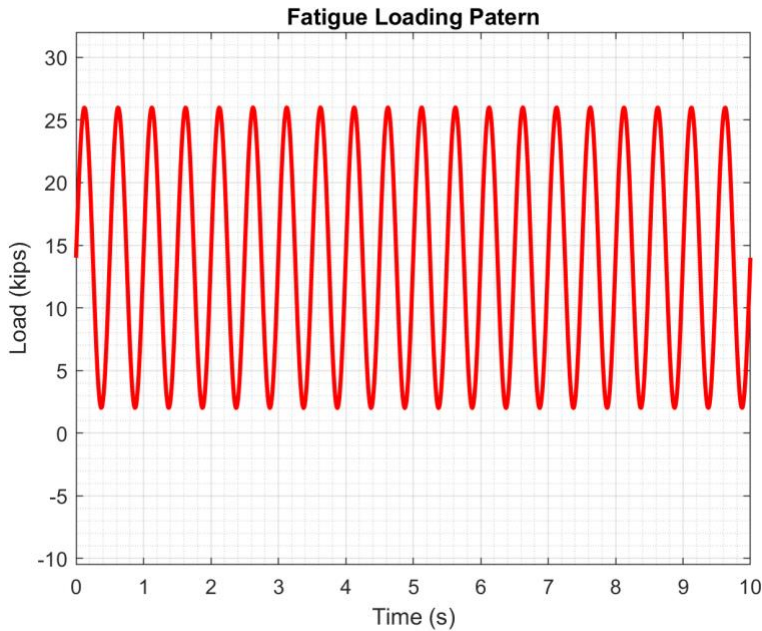
Figure 15 Fatigue Loading Pattern

The minimum and maximum load for the fatigue test were also set as 2 and 26 kips, respectively. The fatigue testing was carried out under sinusoidal loading at a frequency of 2 Hz, as illustrated in Figure 15 Fatigue Loading Pattern for a 10 second interval. The fatigue test was conducted around the clock, except for routine maintenance. Throughout the testing period, the fatigue test was inspected and monitored five times each day, or approximately every 30,000 cycles (or 60,000 cycles overnight).

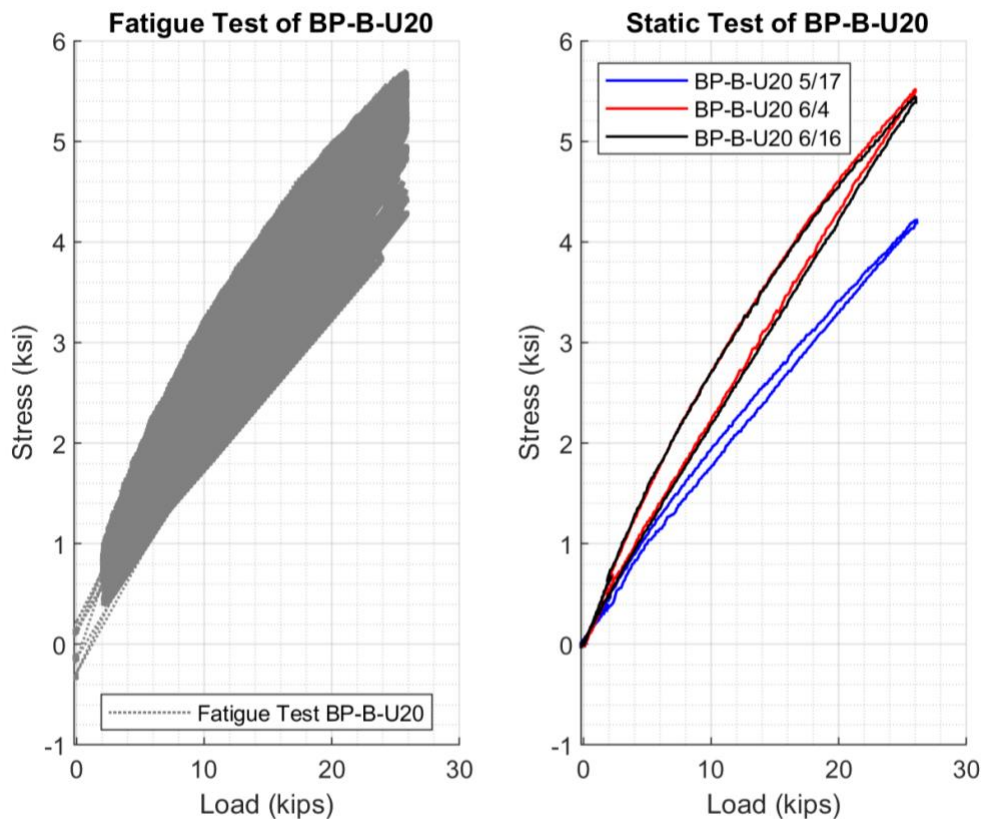
Figure 16 Fatigue and static test results of BP_B_U20

Figure 16 shows the static and the fatigue test measurements made by the uniaxial strain gauge BP_B_U20, which was positioned in the middle of the deck on the underside of the bottom plate and was oriented in the longitudinal direction of the specimen. This gauge was provided to measure the longitudinal flexural stresses at the soffit of the deck.

The strain gauges exhibited a slight deviation from linearity and displayed hysteresis in their response. This non-linear hysteretic behavior raises concerns regarding the integrity of the adhesive bond between the deck plate and the corrugated core. The deck was supported in a way that caused the main response in the transverse direction. As the fatigue testing progressed, the longitudinal stress response of the deck increased, indicating a potential compromise in the transverse load transfer within the deck. This deterioration was likely attributed to the weakening of the adhesive bond between the core and the deck plate. However, it is worth noting that the response eventually stabilized, as demonstrated by the nearly identical results observed in the second and third static tests.

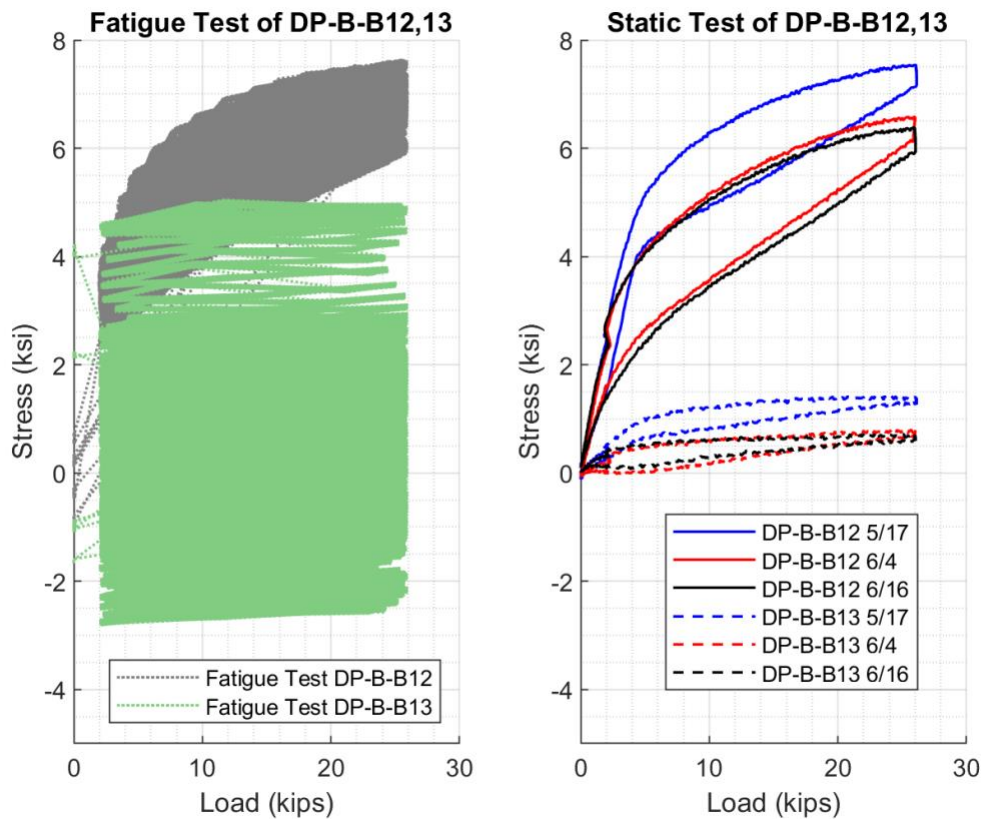
Figure 17 Fatigue and static test results of DP_B_B12,13

Figure 17 presents the measurements obtained from the biaxial gauge positioned at the center of the deck, on the underside of the top plate. The gauge arms, labeled as B12 and B13, were aligned in the transverse and longitudinal directions, respectively.

The gauge displayed a significant nonlinear and hysteretic response. In both directions, the measurements from the first test (5/17) were significantly higher than those from the other two tests (6/4 and 6/16). This suggests that between one and three million cycles of testing, the condition of the deck changed significantly. While the significant nonlinear and hysteretic behavior could be due to the behavior of the adhesive connection between the corrugated core and the deck

plate, the performance of the strain gauge is also in doubt. A cyanoacrylic glue, with an operating temperature of approximately 200°F, was used to attach the strain gauge to the deck plate prior to its attachment to the core. The adhesive connection between the deck plate and the core was heat cured at temperatures above 275°F after the installation of the deck plate. This exposure to high temperatures likely impacted the bond between the strain gauge and the deck plate, resulting in the observed response. However, the non-linear and hysteresis behavior observed in the uniaxial gauge installed on the soffit of the deck after the fabricated deck was installed in the laboratory indicates that some of this behavior can be attributed to the adhesive connection between the deck plate and the core. Nevertheless, the gauge response remained consistent across three trials for each test and between the tests conducted after 3 and 5 million cycles. The deck plate primarily experienced loading in the transverse direction, spanning between the crest of the corrugations, as evidenced by the higher response of the biaxial gauge arm in the transverse direction.

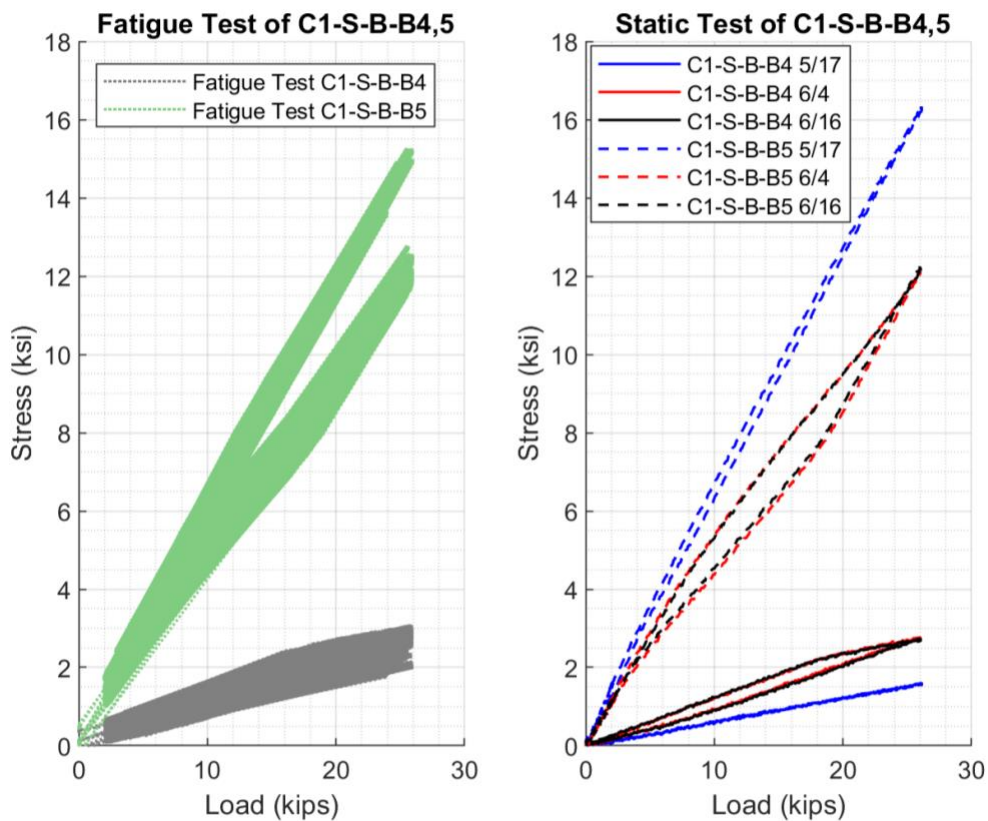
Figure 18 Fatigue and static test results of C1_S_B_B4,5

Figure 18 displays the biaxial gauge C1_S_B_B4,5 positioned at the lower end of the southern slope of the first corrugation in the deck, situated north of the deck centerline. The gauge arm B5 was aligned with the incline (the transverse direction), while the gauge arm B4 was aligned with the longitudinal direction of the deck.

The response of gauge C1_S_B_B4 remained consistent and linear across the first static test and then the stress increased with a sign of nonlinear response. On the other hand, gauge B5 initially displayed primarily linear behavior with a slight presence of hysteresis during the first static test.

In subsequent static tests, the response of B5 remained mostly linear but reduced significantly, with consistent results observed between the tests conducted after 3 and 5 million cycles in both gauges (B4 and B5). The hysteresis in the response also increased during these two tests. The response of this gauge also suggests a change in the deck condition during the 3 million cycles of fatigue testing. It is worth noting that this gauge was positioned near the welded connection between the core and the bottom plate and captured the stresses in the corrugation slope. The observed hysteresis in its response was likely due to the condition of the adhesive connection between the core and the deck plate. The decrease in gauge response and the increase in hysteresis can be attributed to the deterioration of the adhesive connection between the core and the top plate, resulting in a change in stiffness and reduced stress on the corrugations.

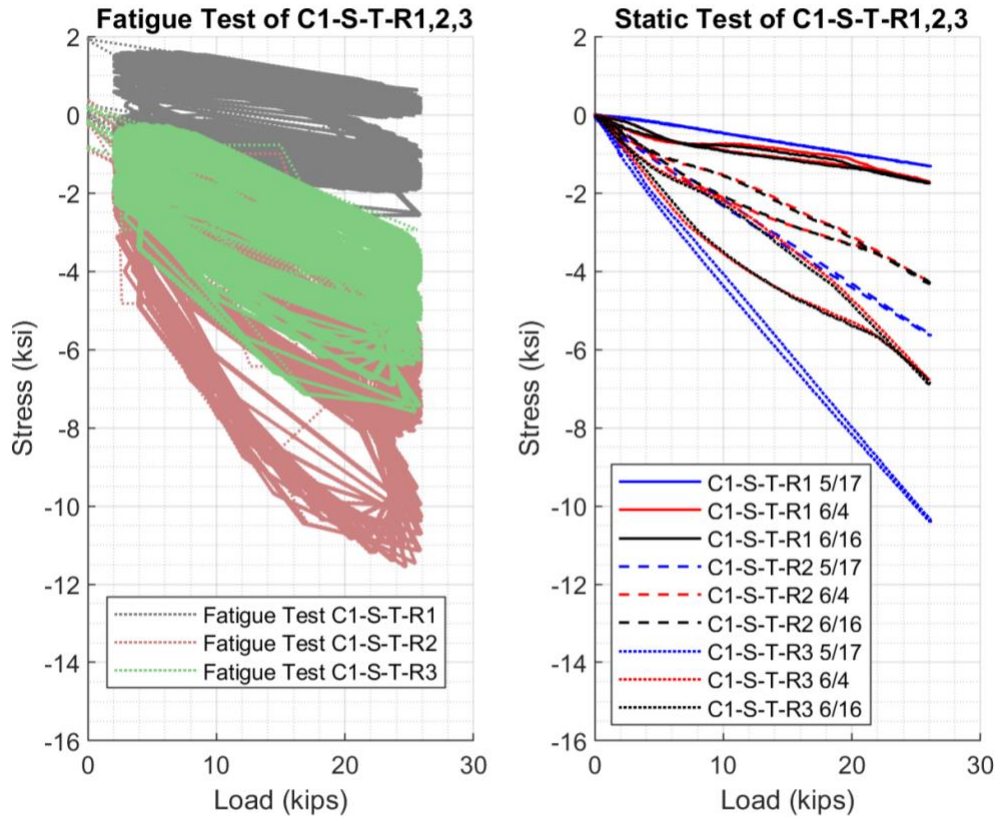
Figure 19 Fatigue and static test results of C1_S_T_R1,2,3

The gauge C1_S_T_R1,2,3 was positioned at the upper part of the first corrugation, located to the north of the deck centerline. Arm R1 was aligned with the longitudinal direction of the deck, while arm R3 was oriented in the transverse direction along the corrugation slope. Arm R2 was positioned at a 45-degree angle between R1 and R3. The measurements from this gauge are plotted in Figure 19.

The stresses experienced by this gauge were compressive throughout the test. The stresses along the slope of the corrugation (R3) were larger in magnitude compared to the stresses in the longitudinal direction of the deck, consistent with the predominantly one-way response of the deck in the transverse direction. The responses of R1 and R3 in the first static test were mostly linear and showed minimal hysteresis. However, as fatigue testing progressed, the response of R3 decreased significantly in magnitude and exhibited hysteresis. On the other hand, the response of R1 increased in magnitude without showing hysteresis. The response of the deck during static tests at 3 and 5 million cycles remained consistent, indicating that the deck condition changed during the 1 to 3 million cycles of testing. The decrease in response along the corrugation suggests a deterioration of the adhesive connection between the core and the deck plate during fatigue testing, affecting the transfer of transverse loads. However, this degradation seemed to stabilize after 3 million cycles of testing.

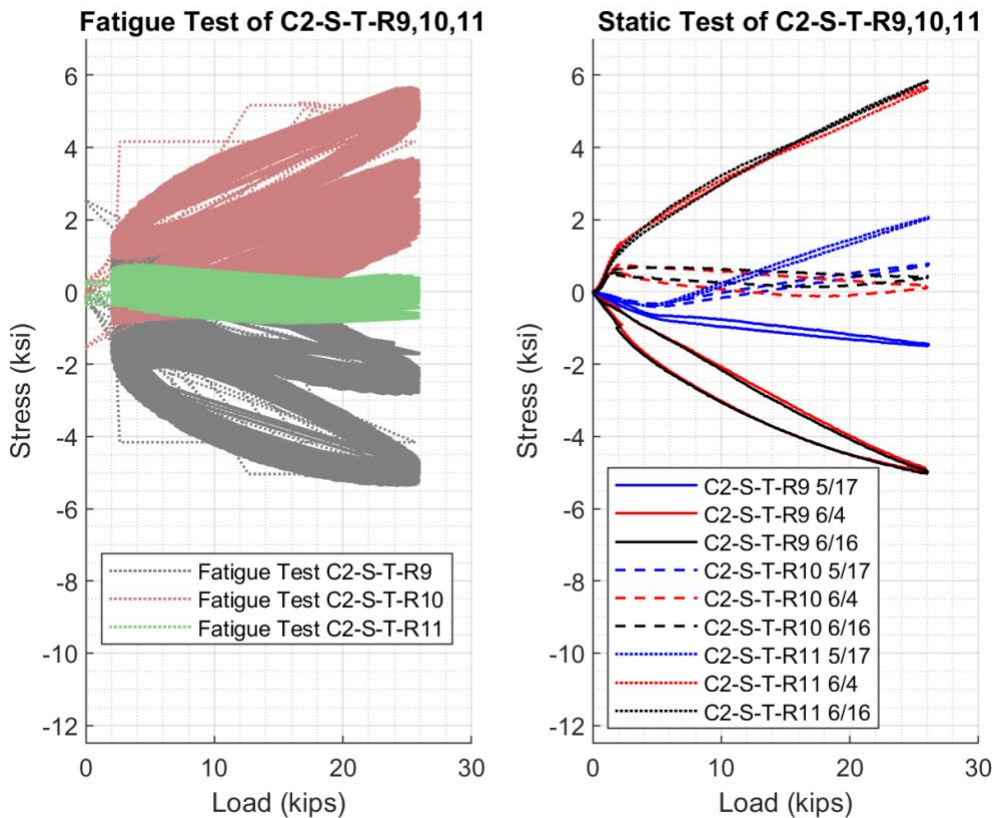
Figure 21 Fatigue and static test results of C2_S_T_R9,10,11

Figure 21 displays the response of gauge C2_S_T_R9,10,11. Positioned on the upper edge of the south side of corrugation C2 incline, it was directly opposite to C2_N_T_R6,7,8 on the north side. The gauge arm R9 was aligned with the longitudinal direction of the deck, R11 was oriented along the corrugation in the transverse direction, and R10 was positioned diagonally between the two arms.

The strain gauge, with its R9 arm aligned longitudinally, displayed a compressive response, while the arm R11, aligned transversely, exhibited tensile response. Notably, the R11 arm achieved larger values compared to R9. Both arms exhibited hysteresis, particularly during the tests conducted on 6/4 and 6/16. Considering the configuration of the specimen, the gauges C2_S_T_R9,10,11 and C2_N_T_R6,7,8, should experience tensile and compressive stresses, respectively. However, the graphs show the opposite. The northern gauge is acting primarily in tension, and the southern gauge is acting primarily in compression. This could be due to local out-of-plane bending of the corrugated core. As the deck was loaded, the northern side of the corrugation stretched in tension, and the southern side was compressed. The stress on the southern side increased greatly between the initial test and the following tests. This suggests that more tension was experienced as the adhesive between the deck plate and the corrugation began to deteriorate. As the fatigue testing progressed to 3 million cycles, both responses increased in magnitude, suggesting a deterioration of the adhesive connection between the core and the deck plate.

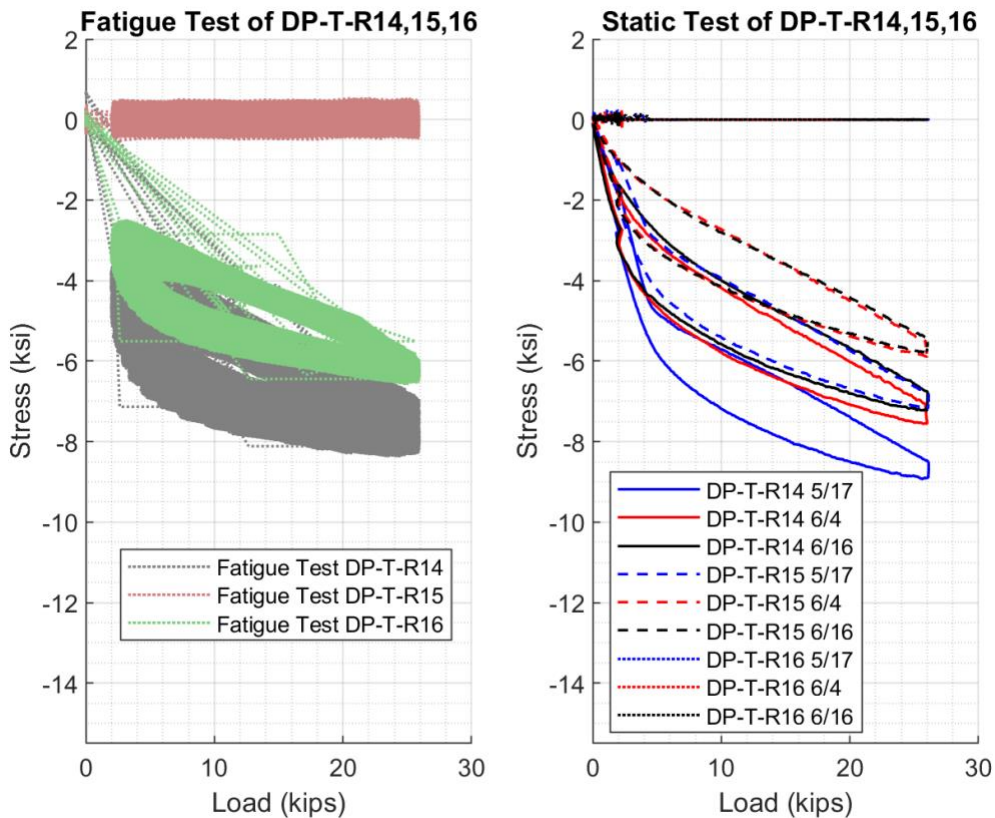
Figure 22 Fatigue and static test results of DP_T_R14,15,16

Figure 22 illustrates the behavior of the gauge DP_T_R14,15,16. This gauge was positioned at the deck center on top of the top deck plate. Arm R14 was aligned in the transverse direction relative to the deck specimen, while arm R16 is oriented longitudinally. Additionally, arm R15 was situated diagonally between these two orientations.

The gauge DP_T_R14,15,16 exhibited a nonlinear hysteretic response across all three static tests, with a noticeable jump at the maximum load. This response could be due to damage to the gauge, as it was located directly beneath the loading pad. The jump at the maximum load could suggest a slip phenomenon occurring during the loading process. The presence of slip could account for the observed hysteresis as the deck was loaded and unloaded. This behavior was consistent as the gauge response dropped at the same load for all three static tests. A similar response of the gauge across all static testes would imply that the gauge was not damaged.

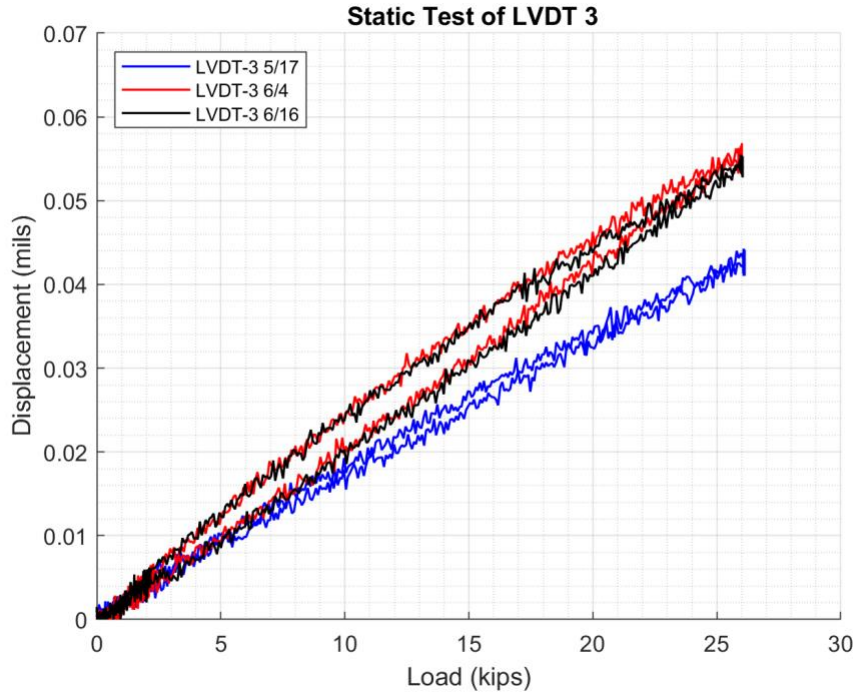
Figure 26 Static test results of LVDT 3

Three LVDTs were positioned beneath the deck that were exclusively employed during the static tests. The measurements from these LVDTs exhibited similar patterns. An increase of approximately 0.01 mils in displacement was observed between the initial and the subsequent tests. Ideally, the LVDT-measured displacement should be the loading divided by the deck stiffness. As the loading remained constant while the displacement increased, the stiffness of the deck specimen must have decreased between 5/17 and 6/4. This reduction in stiffness could be attributed to the deterioration of the adhesive connections between the core and the deck plate. The degradation of these adhesive connections would lead to a decline in the transverse flexural stiffness of the deck, causing an increase in vertical displacement. Figure 24, Figure 25, and Figure 26 showed the response of the three LVDTs.
