FATIGUE PERFORMANCE OF VARIABLE MESSAGE SIGN & LUMINAIRE SUPPORT STRUCTURES
Volume II – Fatigue Testing and Failure Analysis of Aluminum Luminaire Support Structures

FATIGUE TESTING AND FAILURE ANALYSIS OF ALUMINUM LUMINAIRE SUPPORT STRUCTURES

Final Report

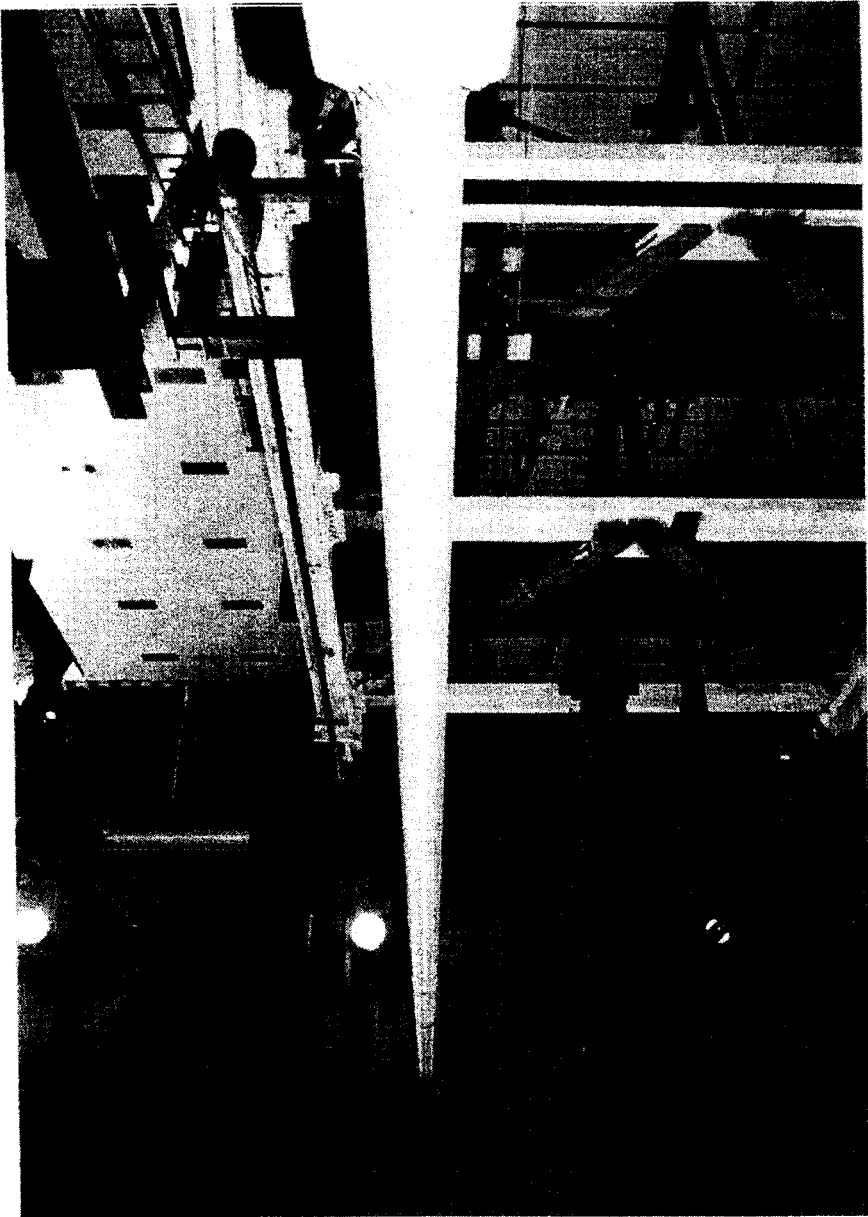
Figure 3-1 is a transformer base that was cracked alongside Route 147. In the event of an impact by a motorist, these bases are intended to break off at the tabs on the bottom where they bolt to their foundation. These breakaway tabs would seem to be the location of some of the failures since they are designed to be the weak link in the transformer base, however none of the bases appeared to fracture there. A video of the failure site taken by Hapco the next morning provided a means to view some of the failures [14].

Figure 3-1 Cracked Transformer Base from Route 147.

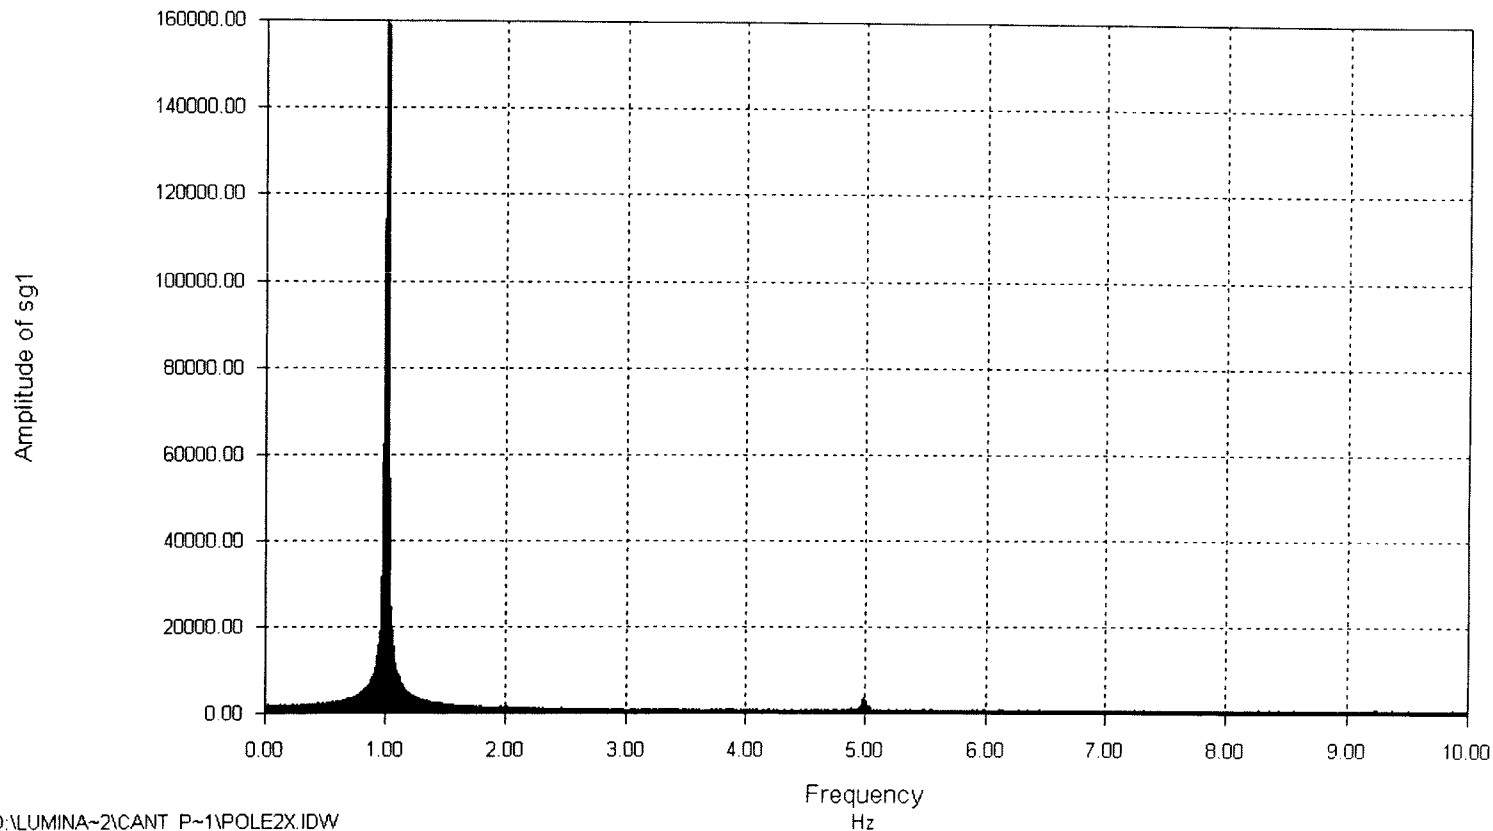
Figure 3-6 Natural Frequency of Cantilevered Support

A Fast Fourier Transform was performed on data from a strain gage while the support standard oscillated at its second mode natural frequency. As was mentioned before, the first mode of the cantilevered support standards is twisting of the pole and is not relevant to fatigue. The natural frequency in the second mode was 1.02 cycles/s (Figure 3-6). Finite element analysis indicated a second mode frequency of 1.04 cycles/s. As with the stiffness this is an excellent agreement.

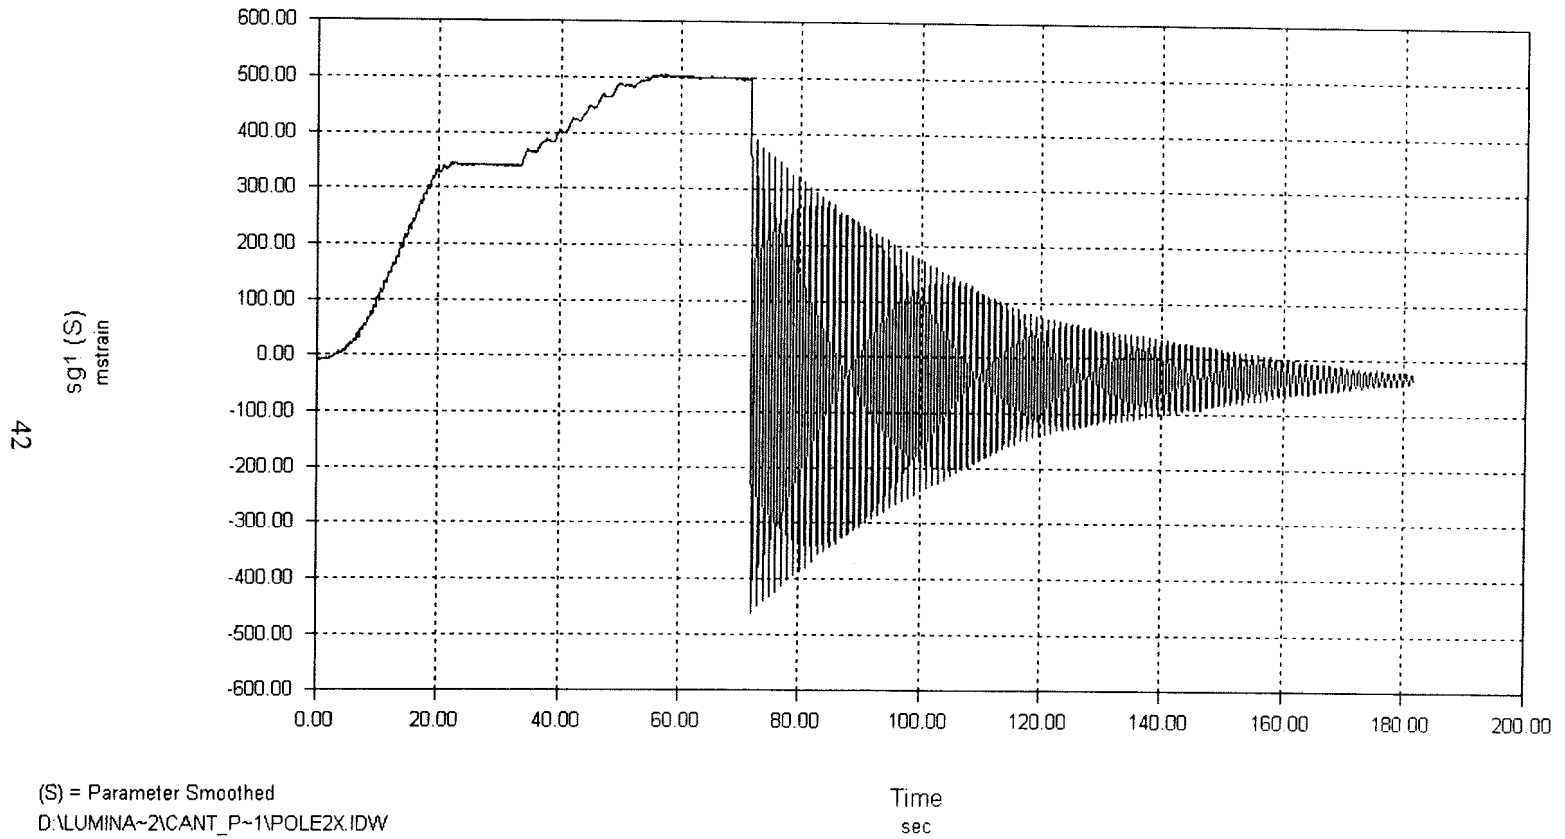
Figure 3-7 Damping of Cantilevered Support with No Damper

damping of the cantilevered support standard was calculated with and with out the damper attached. Figure 3-7 shows the decay of motion in a strain gage when the damper was not installed. This plot represents the motion of the cantilevered support standard in its second mode. Without a damper the percent of critical damping is 0.40 percent.

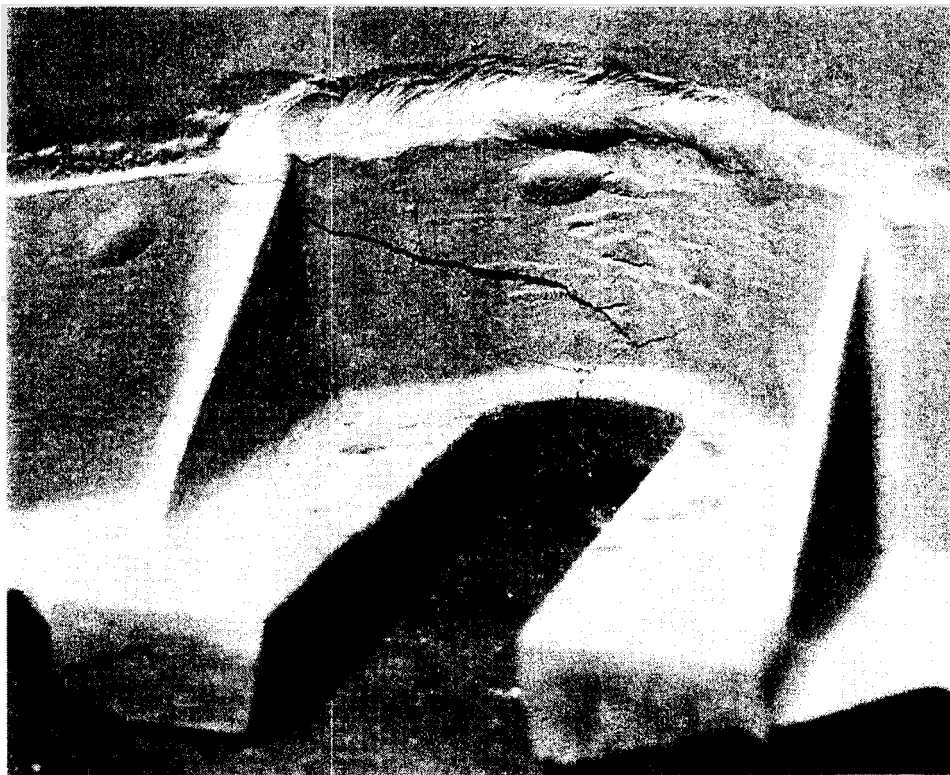
Specimen S-6 developed cracks in two places. The first crack started to form in the side of the transformer base wall opposite the access hole (Figure 3-14). After the test this crack was cut out and a definite change in thickness was noticed in the transformer base wall (Figure 3-15). The thinner wall was caused by excess grinding on the side of this transformer base. There may have also been an attempt at a weld repair in the base metal of this transformer base. Apparently there was a surface defect in this base. Instead of discarding it a repair was attempted and this was the origin of the first fatigue crack. The second crack in this base originated at the back of the finger tabs that are used to bolt the structure to its foundation (Figure 3-16). This crack appeared to originate out of the radius at the back of the finger tabs.

Figure 3-15 Cross Section of Transformer Base Wall of Specimen S-6

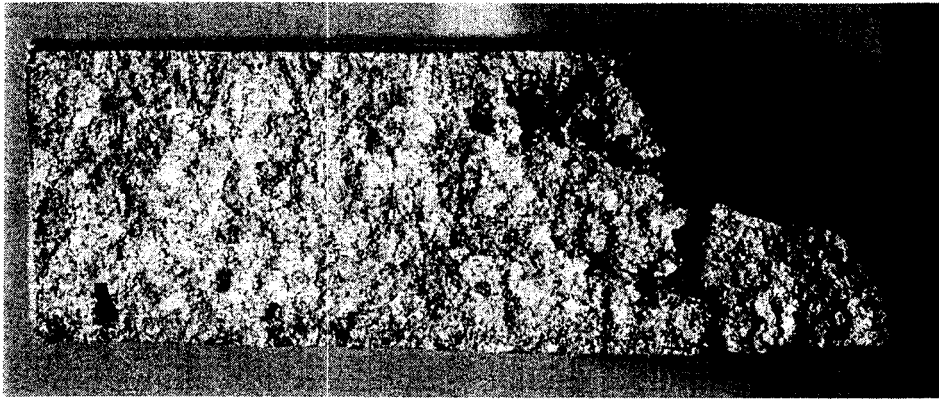
Figure 3-16 Fatigue Crack in Finger Tabs of Transformer Base of Specimen S-6

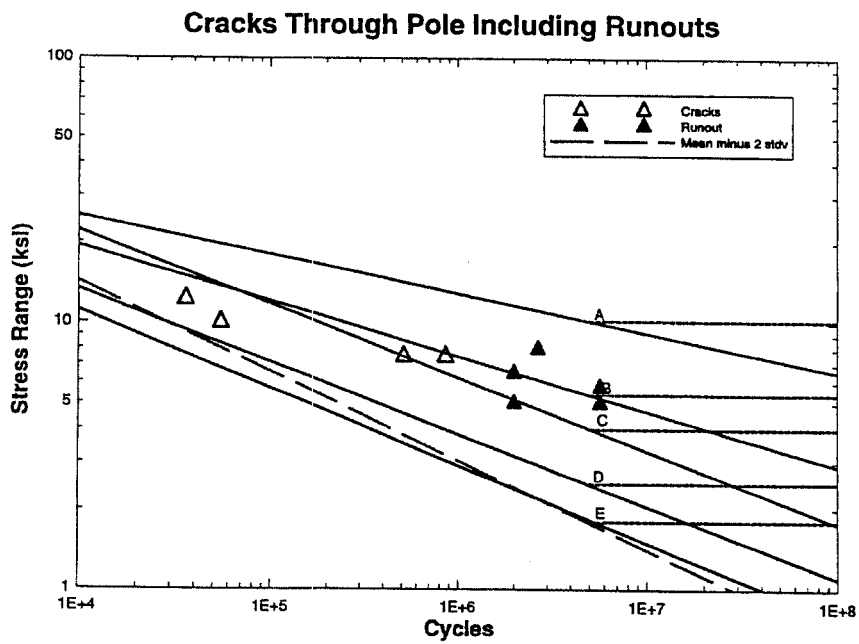
Figure 3-20 S-N Curve for Through-Thickness Cracks Including the Runouts.

There are two methods for plotting crack data on an S-N curve. One is to include the runouts in the mean minus two standard deviations calculations and the other is to leave them out. Different researchers prefer one to the other and it is not clear which is more "correct". The thing that is clear is that not including the runouts in the computation results in more conservative values for the mean minus two standard deviations calculation. Both methods are presented here for comparison of the impact on the final decision of the detail category. Figure 3-19 and Figure 3-20 show an S-N plot of the through-thickness fatigue crack data not including the runouts and including them in the mean minus two standard deviations calculation, respectively. As can be seen from comparing the two plots the mean minus two standard deviation is more conservative when the runouts are not included, however in this data set the fatigue strength of the detail is equal to Category E regardless of weather the runouts are included or not.

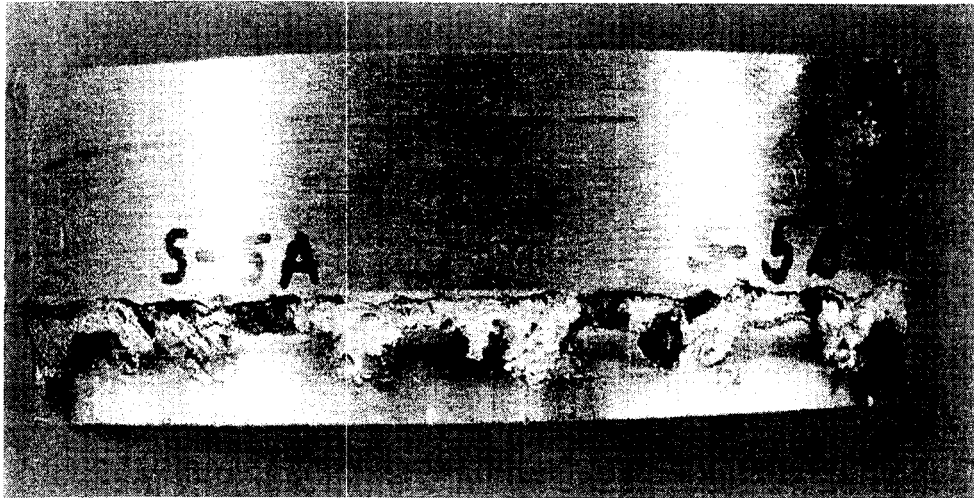
Three of the seven cracks were formed in a manner that must be compared to Category F, the category for shear stress on the weld. Two of these poles exhibited a failure that was caused by a crack that started at the weld root and quickly propagated upward to intersect a very shallow crack at the weld toe (Figure 3-21). When these specimens were cycling in the fatigue test there was no way to know the crack was forming in a different manner, however after the testing the cracks were cut open and then it was obvious. Figure 3-21 shows that the effective weld size in some locations along the tube was a small as a quarter inch. This weld is supposed to be a seven sixteenth inch weld. If this weld is made correctly the nominal stress range in the tube wall should be 1.75 times greater than the shear stress range on the fillet leg. However, if the weld is made with the effective weld size as is indicated in Figure 3-21 the shear stress range on the fillet leg becomes equal or even greater than that in the tube wall. This causes a ΔK at the weld root higher than that at the weld toe which is why the root crack quickly propagated up to intercept the toe crack before it went through thickness. This lack of fusion that causes the effective weld size to be reduced is a quality control issue that needs to be addressed.

Figure 3-21 Typical Fatigue Crack that Propagates from Behind the Weld Leg.

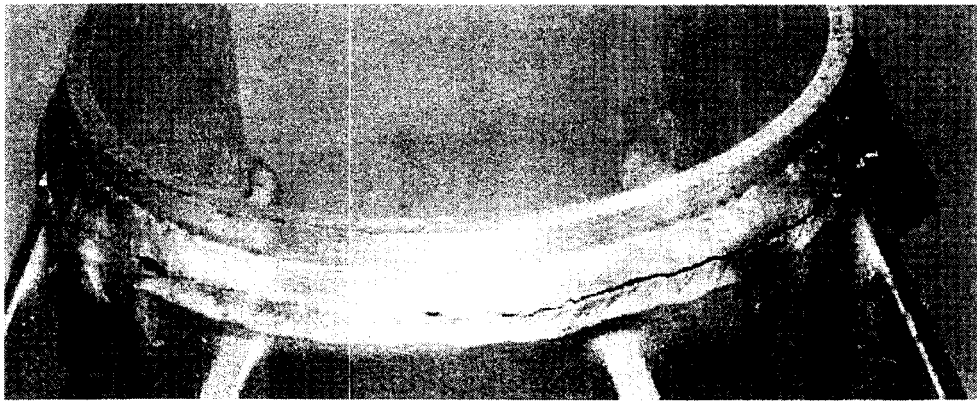
Figure 3-22 shows a typical fatigue crack that propagated from the weld root through the weld throat. This type of crack is also cause by a shear stress range on the weld. The weld throat represents the weakest plane through the weld and is where a crack will form is one is going to propagate through the weld metal.

Figure 3-22 Typical Fatigue Crack that Propagates Through the Weld Throat

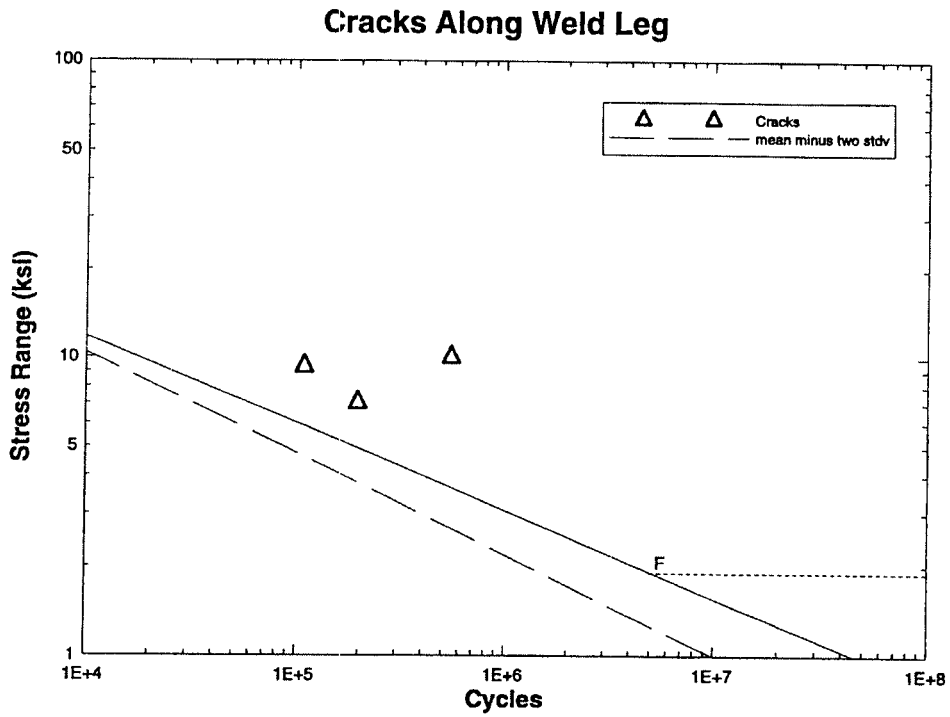
Figure 3-23 S-N Curve for Shear Stress Range Induced Cracks

Figure 3-23 shows an S-N plot of the shear-induced cracks compared to category F. As can be seen in this figure when the cracks are shear induced the detail has a fatigue strength below Category F.

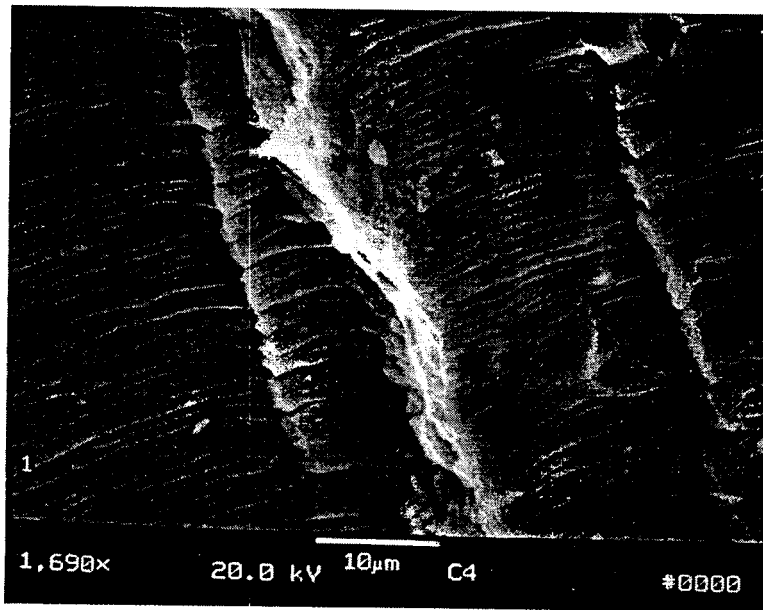
Upon completion of the fatigue test cracks from specimens C-2 and C-4 were cut open and examined under a scanning electron microscope. These two specimens were chosen because they were tested at 51.7 MPa (7.5 ksi) and 84 MPa (12.2 ksi), respectively. These stress ranges were originally thought to be close to what the stress range was when the failures occurred on Route 147. Figure 3-24 and Figure 3-

25 show striations from a fatigue crack generated in specimen C-4 during the fatigue test and a support standard that failed on Route 147, respectively. As can be seen in these figures the striations from the fatigue test are closer together, which indicates a lower stress range. It is not clear what the exact stress range was in the support standards on Route 147, but it appears to have been greater than 84 MPa (12.2 ksi). There were no specimens tested at a stress range higher than 84 MPa, therefore a closer comparison of striation spacing cannot be made.

Figure 3-24 Striations in Specimen C-4.

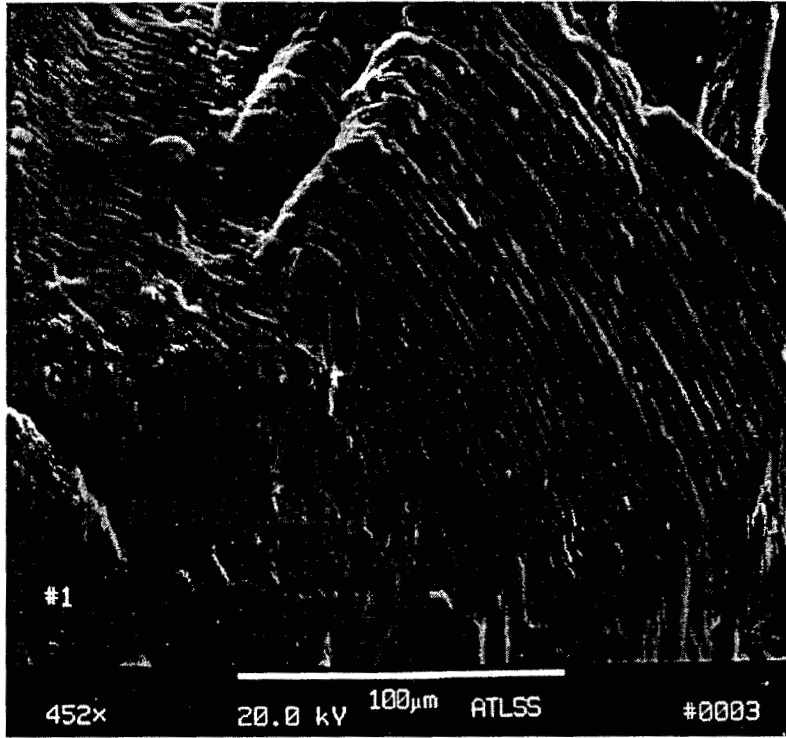
Figure 3-25 Striations from Cracked Pole on Route 147.
