# Unmanned Aerial Vehicle Augmented Bridge Inspection Feasibility Study

FINAL REPORT

August 2017

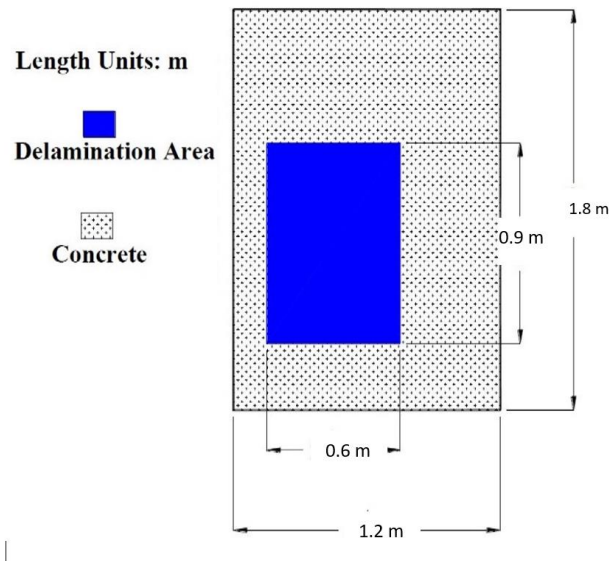
The research team also used the deck to investigate thermal delamination detection using an FLIR E8 thermal camera, E003. For this experiment, the FLIR E8 was mounted on the 3DR Iris, which maxed out the payload, making it only able to fly a short distance off the ground for a short period of time, which is why the slab was not mounted on the girders of the small bridge. A smaller thermal camera was not available (Dorafshan 2017b). Even with this limitation, this experiment shows that it is possible with additional time and effort to detect subsurface (delaminations) and surface (cracks). A 0.6 m (2 ft) by 0.9 m (3 ft) plastic sheet inclusion was embedded in the deck during construction to simulate a delaminated region (see Figure 3.5). The research team monitored the bridge deck when the deck was still hot from the day and ambient temperature was dropping (deck temperature was roughly 25°C (70°F) on average. The thermal image is shown in Figure 3.6. The delaminated region was detectable as a cold region in the thermal image. However, there are other cold regions not associated with the depicted delamination in Figure 3.5, which had severe cracking in those areas that could also be identified visually. These cracks effectively altered the surface, which caused faster heat loss than the surrounding sound concrete, and they presented comparatively colder spots. This small experiment proved that using thermal imagery for surface and subsurface defect detection is feasible, however, it was not the focus moving forward.

*Figure 3.5 The Plan and Elevation View of the Deck and its Delamination, (E003)*

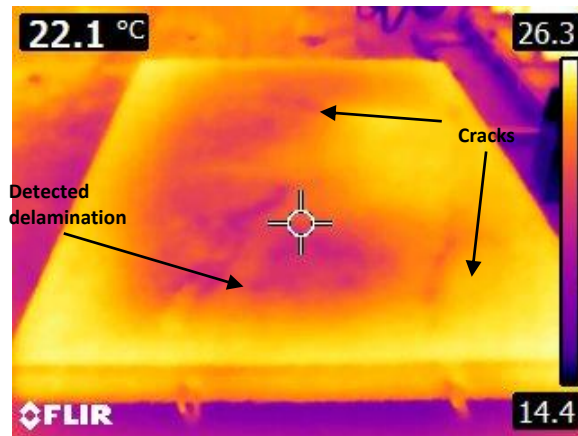
*Figure 3.6 Captured Thermal Image, E003*

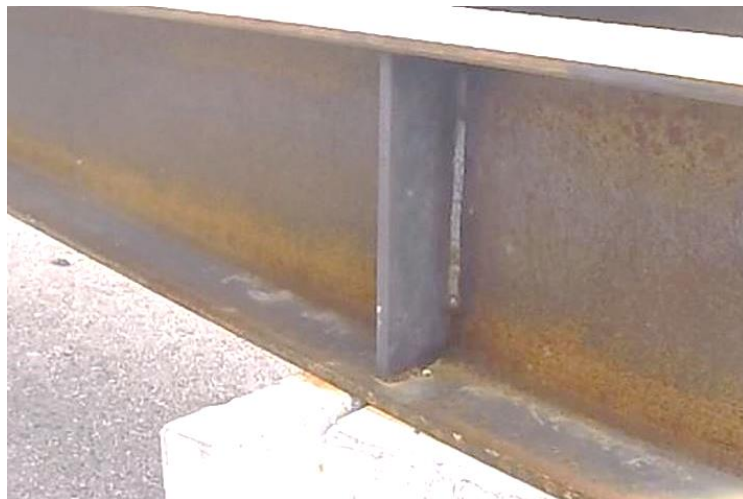
conditions (Otero 2015). In addition to corrosion on the girders, the weld quality of the web stiffeners was observable in real-time using the optical zoom feature (Figure 3.8). The camera the research team used for this inspection was a GoPro Hero 4, which is not ideal for scientific and accurate imagery due to its focal length and fish eye effect (see rounded edges of objects in corners of Figure 3.7). However, GoPro cameras are very popular for UASs due to their small size and light weight. Better cameras are likely to produce better results.

*Figure 3.8 Visual Weld Inspection on the Small Bridge, E004*

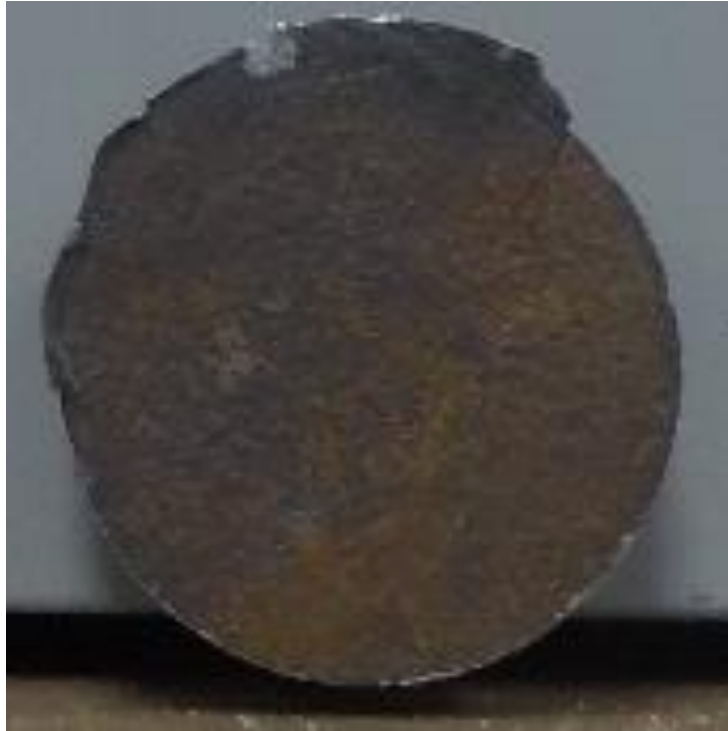
The maximum camera distance for the GoPro camera in the Normal condition was 20 cm (8 in.), which is shown in Figure 4.2. The GoPro pictures, taken in the Bright condition, were not satisfactory because light reflections in the pictures washed out the crack. Even though the GoPro camera captured the fatigue crack at 20 cm (8 in.) in the Normal lighting condition, it is not recommended to use the GoPro Hero 4 camera for fatigue crack inspection.

*Figure 4.2 Normal Condition, 20 cm (8 inches), GoPro, Fatigue Crack Visible*

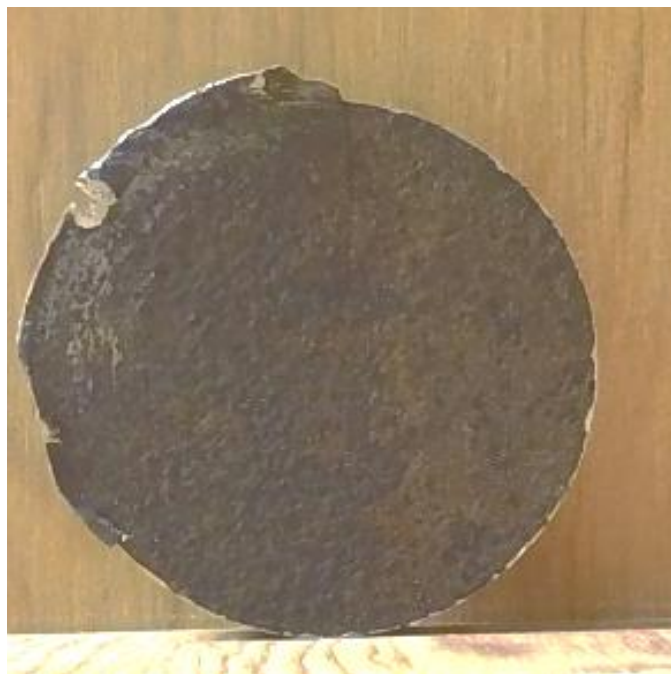
The DJI Mavic has an onboard camera which was used to take the pictures, E007. The crack was not visible in the images taken in the Dark condition without exposure adjustment, however, the DJI Mavic camera can be adapted manually to low-light by increasing the exposure in real time. When the camera exposure was manually optimized to perform in the Dark condition, the crack was visible in the images with a 15 cm (6 in.) camera distance, as seen Figure 4.3. In the Normal condition, the crack was visible in the image taken at 20 cm (8 in.) away from the test-piece. In the Bright condition, the maximum camera distance to see the crack visually was 25 cm

(10 in.) as seen in Figure 4.4. The required camera distance to detect the crack was 15 cm (6 in.) or less for the Dark condition, 20 cm (8 in.) or less for the Normal condition, and 25 cm (10 in.) or less for the Bright condition. The camera distance could be increased to 35 cm (14 in.) in the Normal condition and 40 cm (16 in.) in the Bright condition without the crack becoming undetectable.

*Figure 4.3 Dark Condition, 15 cm (6 inches), DJI Mavic, E007*

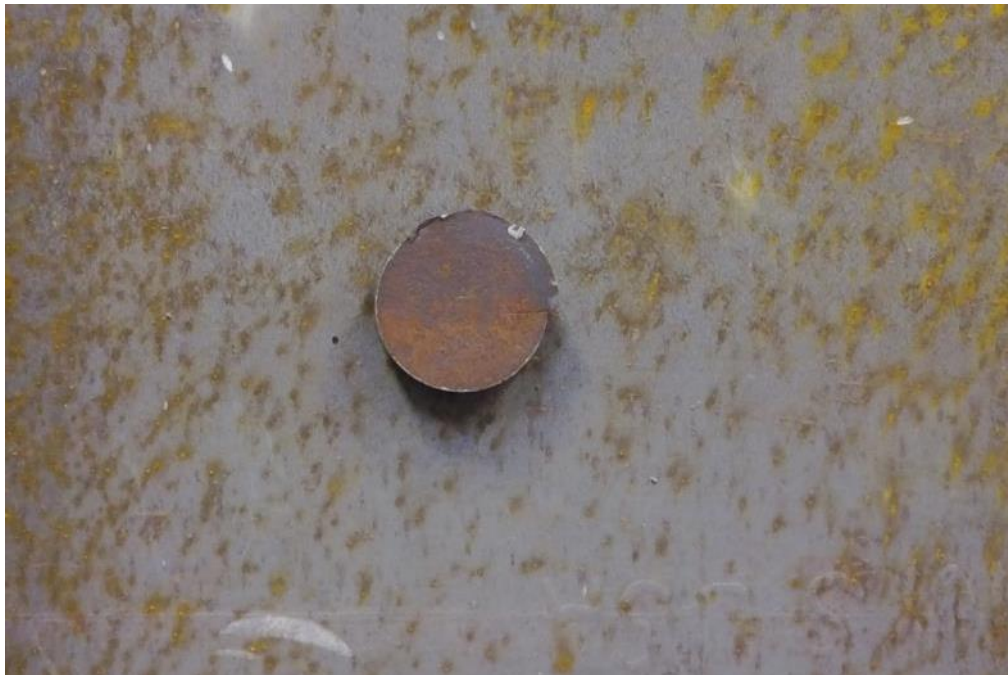
The performance of the DJI Mavic was evaluated in two scenarios: the Normal lighting condition with the test-piece attached on a horizontal steel beam approximately 3 m (10 ft) from the ground and the Dark condition with the test-piece attached to the roof frame, E010. Figure 4.7 shows the image of the test-piece taken by this UAS in the Normal condition. The obstacle avoidance in the UAS does not allow the pilot to get closer than 60 cm (24 in.). However, the UAS was very stable in the GPS-denied condition without turning on the obstacle avoidance feature. The sonar altitude hold feature was used to stabilize the UAS so the pilot could get approximately as close as 20 cm (8 inches) to the test-piece while the camera was at 2X zoom. The crack is clearly visible in the captured image when viewed on a desktop. In addition, the crack was visible during

*Figure 4.7 Photo of the Test-Piece Taken by DJI Mavic in the SMASH Lab, Normal Condition, E010*

The image processing results were successful on the images taken by the DJI Mavic in the SMASH lab. The image shown previously in Figure 4.7 was processed by the proposed LoG filter. In the final image, the fatigue crack was detected along with the edges of the test-piece, as seen in Figure 4.19. In practice, the edges of the test-piece do not exist and the algorithm will detect only the fatigue crack along with some surface clutter. The LoG algorithm was able to detect the majority of the crack length in this figure.

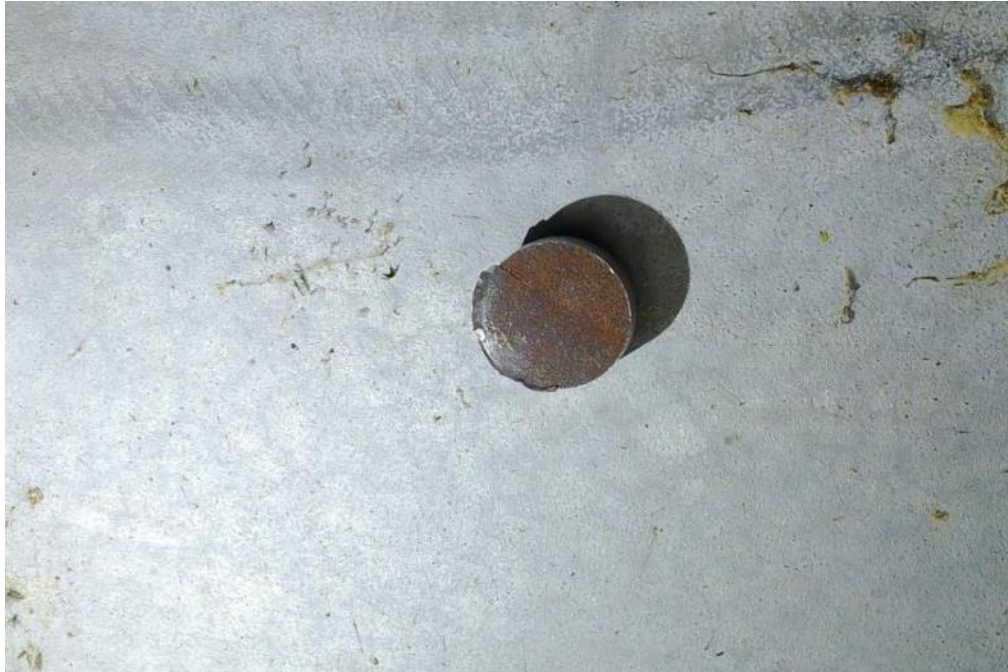
*Figure 4.16 Photo of the Test-Piece Taken by DJI Mavic, UWRL Bridge, Bright Condition, Normal Camera Angle, E012*

taken during the UWRL bridge inspection, previously shown in Figure 4.16. The edges of the test-piece and its shadow border were picked in the final image, and most of the crack's length was also detected. Additional filtering can remove the detected edges from the test-piece and shadow edges.

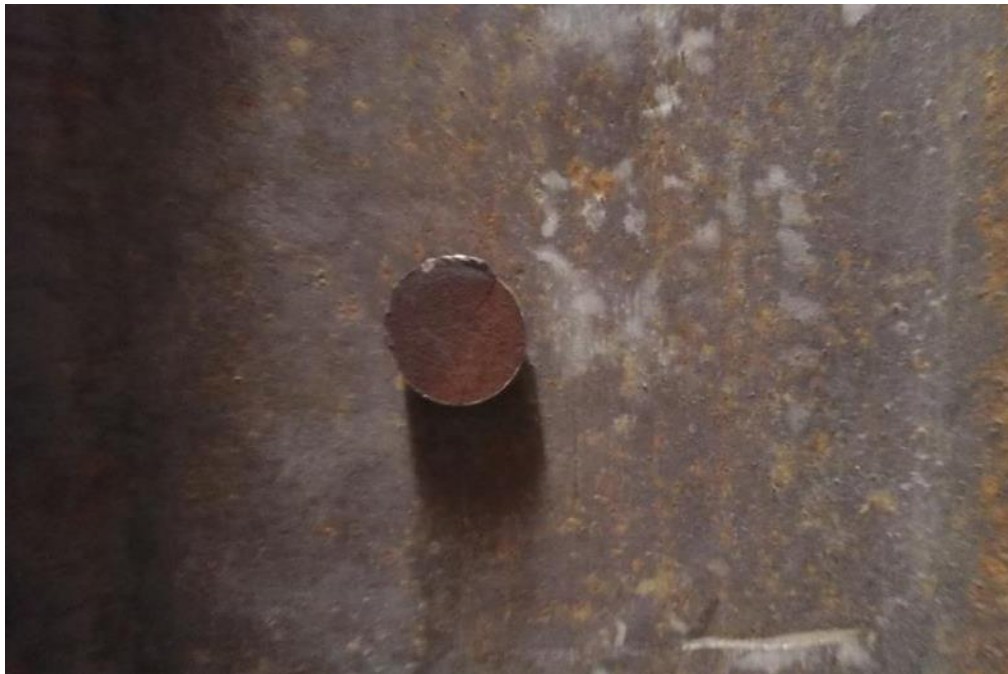
*Figure 4.17 Photo of the Test-Piece Taken by DJI Mavic, UWRL Bridge, Dark Condition, Normal Camera Angle, E012*

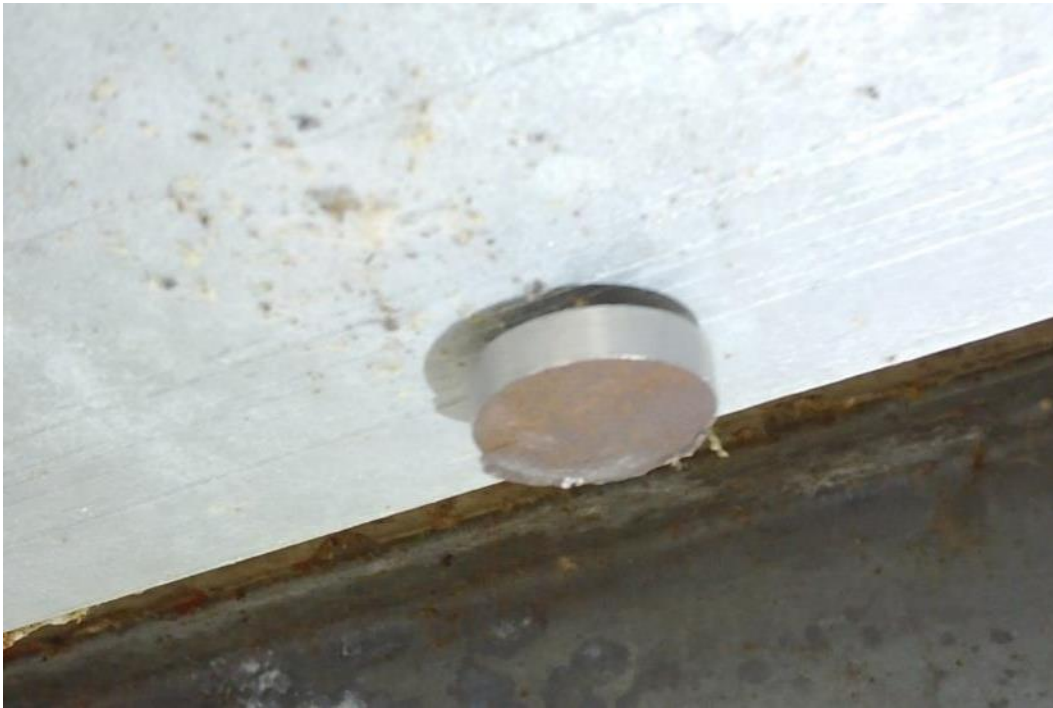
review the captured images on a bigger monitor to see the fatigue crack. One of these images is shown in Figure 4.18. This image is significant considering that the tilt-angle of the camera on the DJI Mavic is limited to 30 degrees.

*Figure 4.18 Photo of the Test-Piece Taken by DJI Mavic, UWRL Bridge, Bright Condition, Oblique Camera Angle, E012*

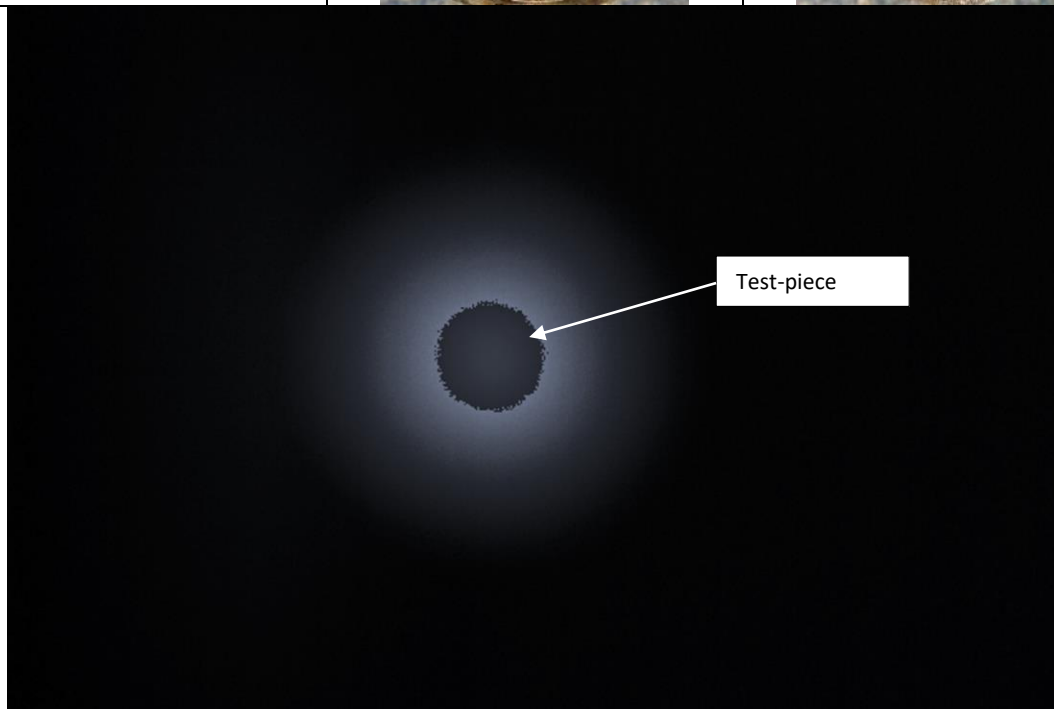
The first thermal camera was a FLIR SC 640 with 1°C sensitivity. The research team selected this camera because it had similar sensitivity to conventional thermal cameras compatible with most commercial UASs, E015 and E016. Figure 4.21 and Figure 4.22 show the thermal images taken from the first and second test-piece, respectively, while they were losing heat. As seen in the thermal images, fatigue crack detection was not achieved with this method.

*Figure 4.21 Thermal Image from the First Test-Piece, Passive, E015*

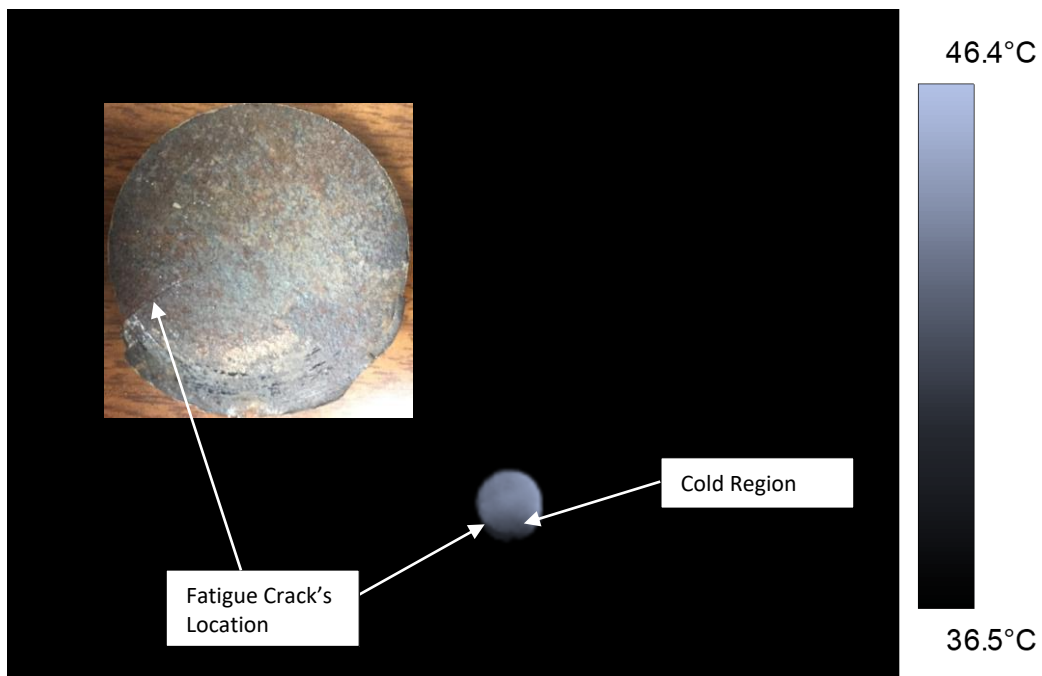
Figure 4.23 Thermal Image of the Side A of Test-Piece 1, 75 cm (30 in) Camera Distance, E017

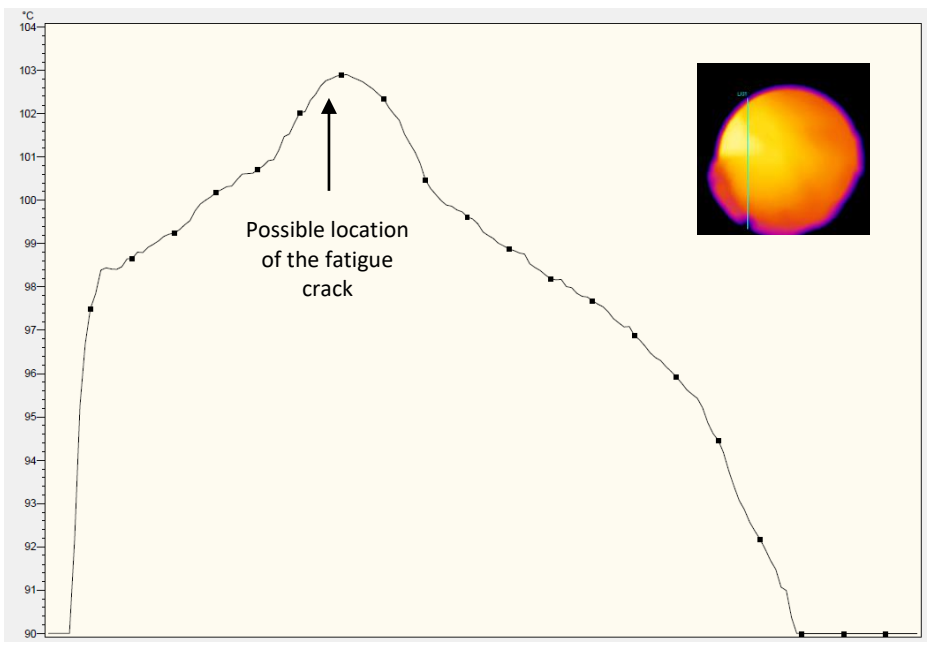
Figure 4.26 Temperature Along the Profile Line for the Side A of Test-Piece 1, 5 cm (2 in) Camera Distance, E019

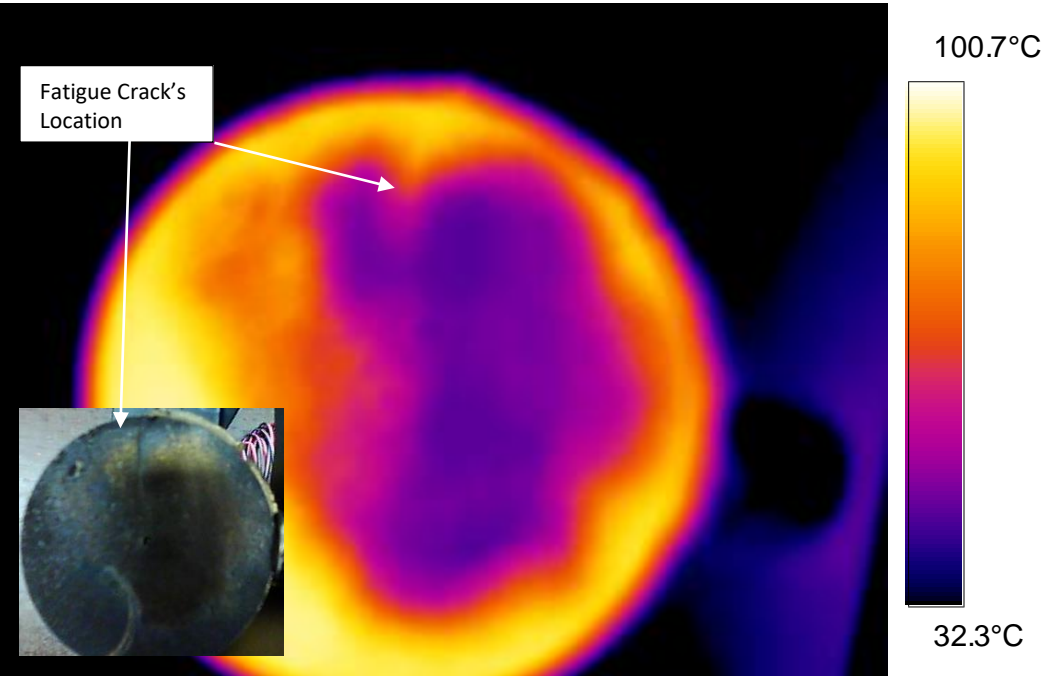
Figure 4.27 Thermal Image of the Side B of Test-Piece 1, 5 cm (2 in) Camera Distance, E019

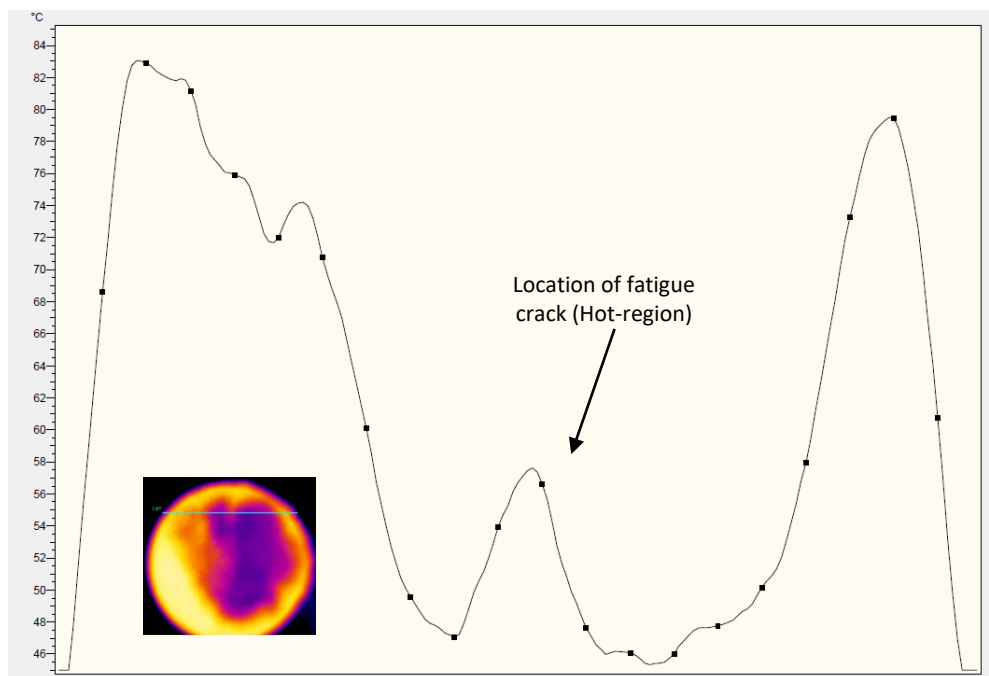
Figure 4.28 Temperature Along the Profile Line for Side B of Test-Piece 1, 5 cm (2 in) Camera Distance, E019

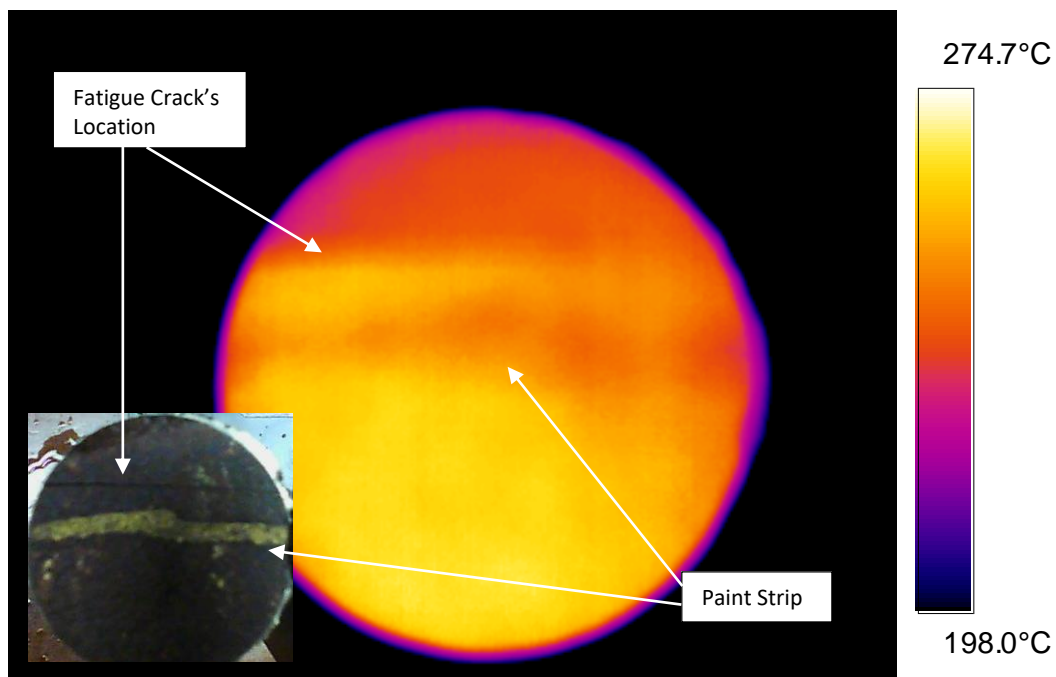
Figure 4.29 Thermal Image of the Side A of Test-Piece 2, 5 cm (2 in) Camera Distance, E020

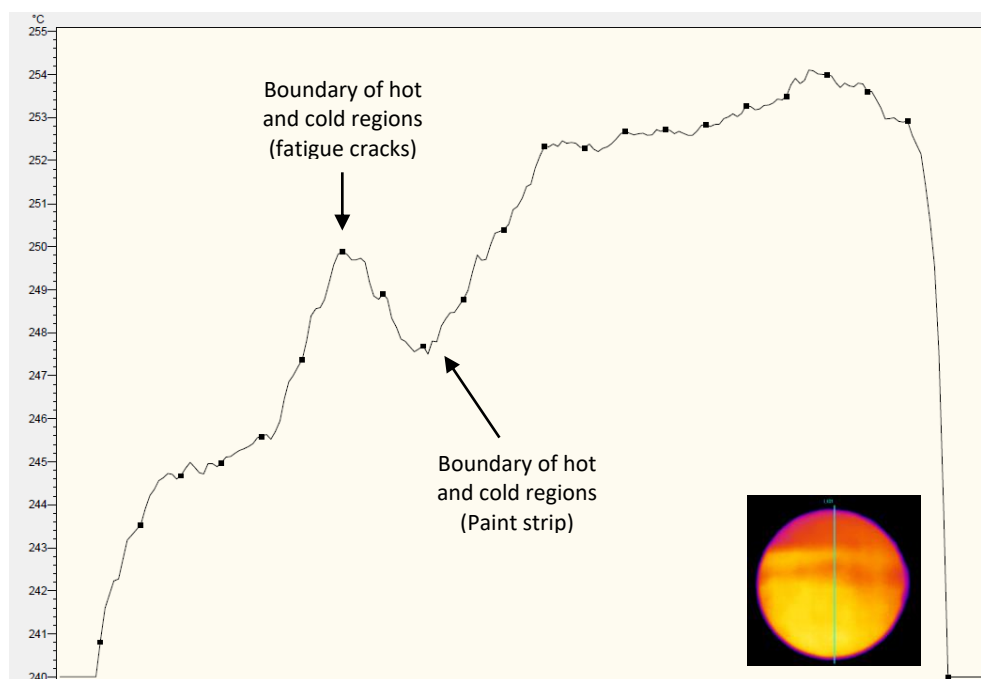
Figure 4.30 Temperature Along the Profile Line for Side A of Test-Piece 2, 5 cm (2 in) Camera Distance, E020

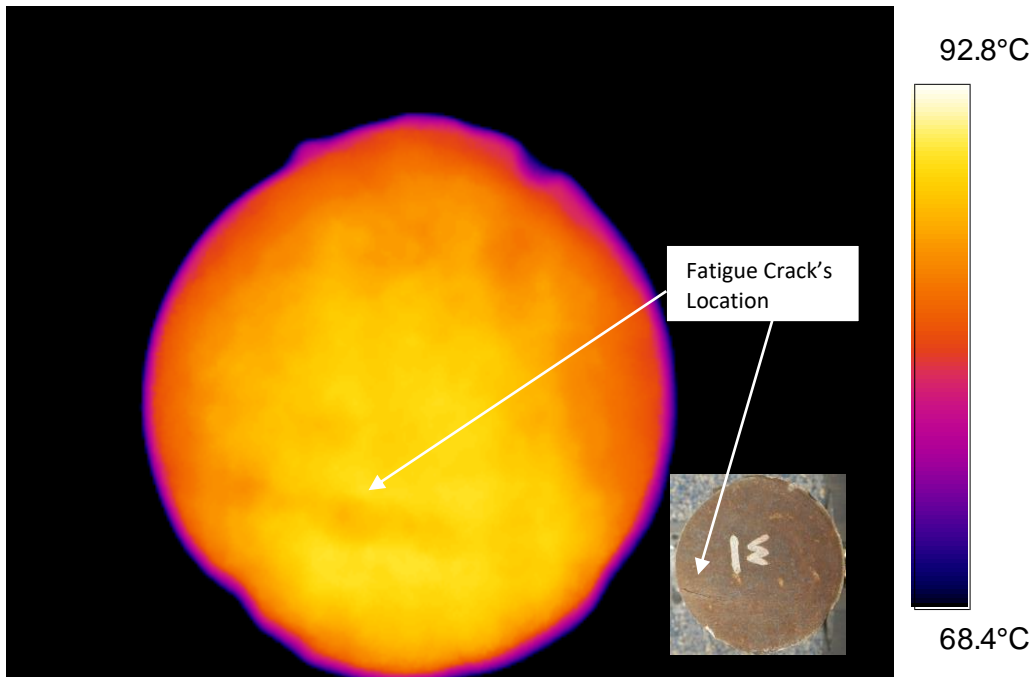
Figure 4.31 Thermal Image of the Side B of Test-Piece 2, 5 cm (2 in) Camera Distance, E020

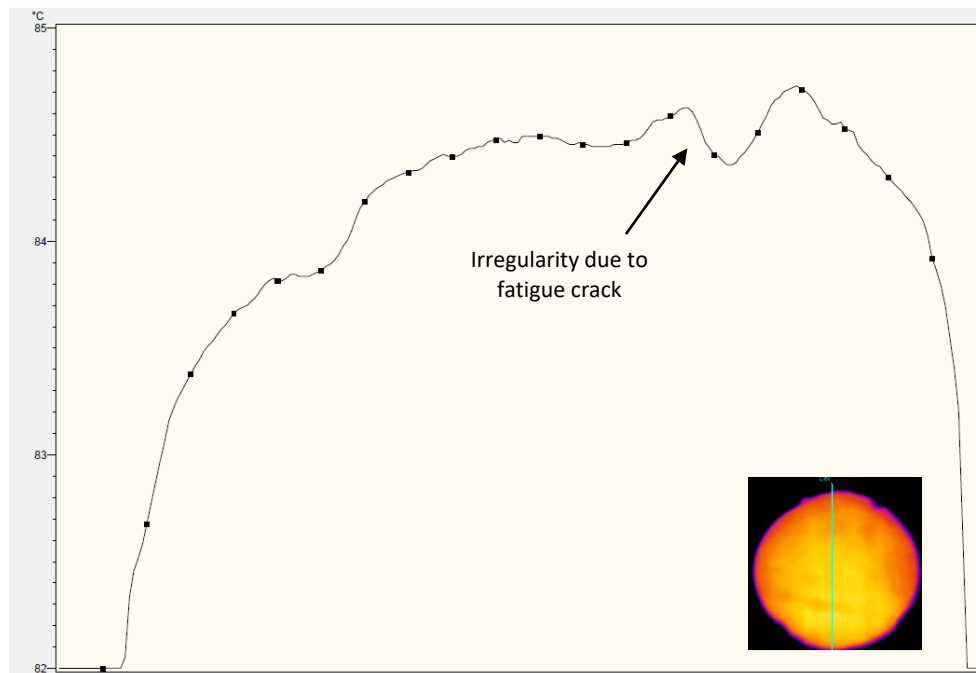
Figure 4.32 Temperature Along the Profile Line for the Side B of Test-Piece 2, 5 cm (2 in) Camera Distance, E020

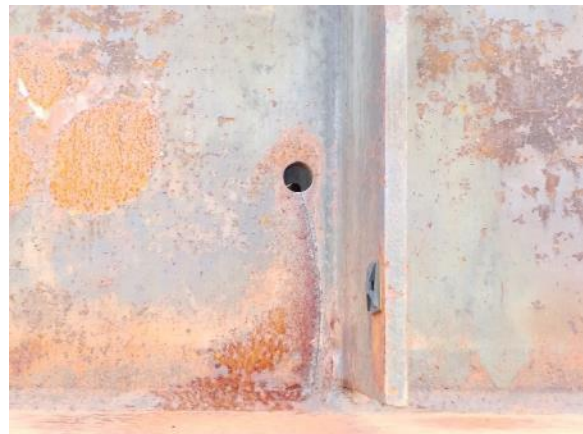
Figure 6.10 Fatigue crack in the railroad bridge: (a) DJI Mavic image, (b) Samsung Tablet image, (c) Visual image from the thermal camera, and (d) thermal image from the thermal camera using passive thermography

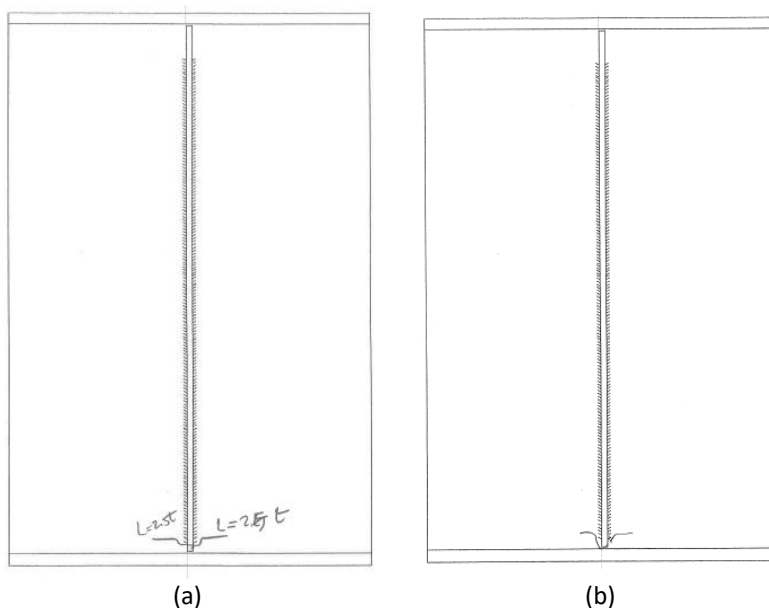
of the cracks were the same in both inspections. Figure 6.16a and Figure 6.16b show the postmortem and realtime reports based on the DJI Mavic images, respectively. As seen, both inspections reported two fatigue cracks located on bottom-right of the weld, Figure 6.17a, and bottom-left of the weld, Figure 6.17b.

Figure 6.16 Reports on a girder specimen based on the DJI Mavic image: (a) postmortem report and (b) realtime report

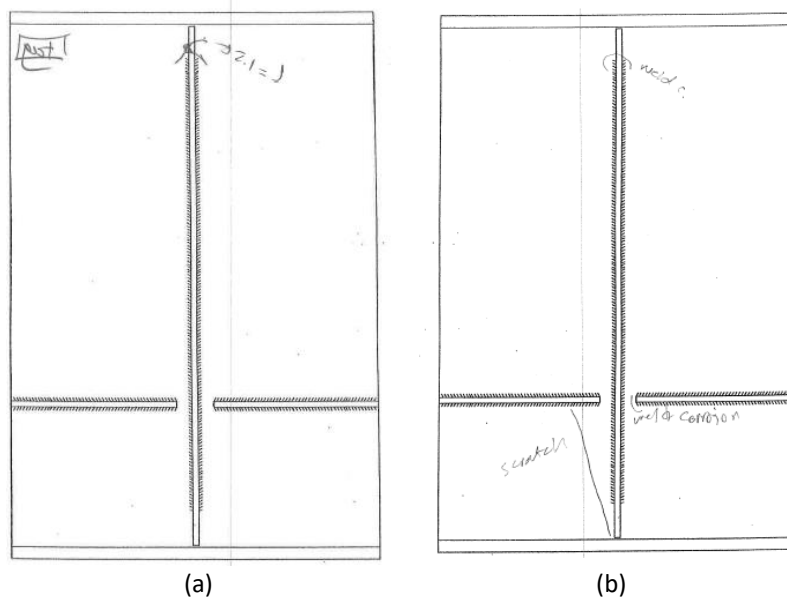
cracks after the postmortem inspection, two were previously reported in realtime. One specimen was reported crack-free according to the realtime inspection, with a weld notch on the top, see Figure 6.18b. After the postmortem inspection, however, the inspector detected three fatigue cracks on it, see Figure 6.18a. The inspector reported two fatigue cracks on the top-right, see Figure 6.19a, and one fatigue crack on the top-left, see Figure 6.19b, which were not reported in realtime. The bottom-left rust did not confuse the inspector in realtime or in the postmortem inspections. Figure 6.19c shows the rust.

Figure 6.18 A girder specimen inspection using the DJI Mavic images: (a) postmortem report and (b) realtime report

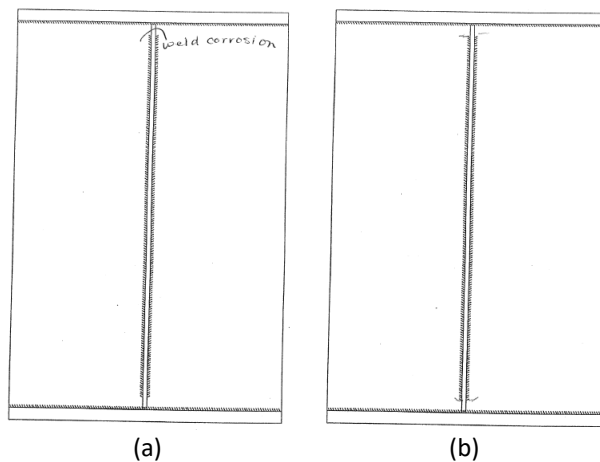
Figure 6.21 Realtime inspection results for a specimen with different number of reported cracks (a) the DJI Mavic and (b) the DJI Inspire

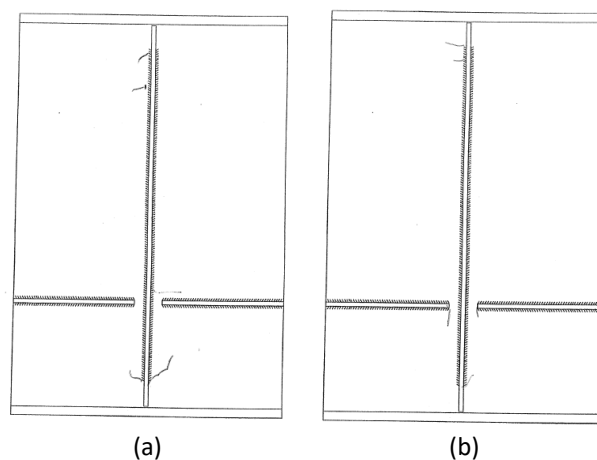
In the DJI Mavic inspection, 5 out of 18 specimens were reported as crack-free, while this number was reported to be 2 for the inspection using the DJI Inspire. The inspector reported 32 and 14 cracks during realtime and postmortem inspections. There were 6 cases where the inspector reported more cracks in the DJI Mavic images than the DJI inspire images. An example is the specimen shown in Figure 6.20a and 6.20b realtime inspection reports based on the DJI Mavic and the DJI inspire pictures, respectively. The inspector reported fewer fatigue cracks in the DJI Mavic images than the DJI Inspire images in 7 specimens, for instance specimen shown in Figure 6.21 **Error! Reference source not found.** a ich was reported to be crack-free in the DJI Mavic pictures, see. However, the inspector reported four fatigue cracks while doing the inspection using the DJI Inspire, see Figure 6.21b. Finally, the inspector reported the same amount of cracks in 5 specimens. However, the locations of the detected cracks were only similar in two specimens. In 4 specimens, the inspector reported inconsistent results, shwon in Figure 6.22a and Figure 6.22b for the DJI Mavic and DJI Inspire inspections, respectively.

Figure 6.22 Realtime inspection results for a specimen according to images from (a) the DJI Mavic and (b) the DJI Inspire

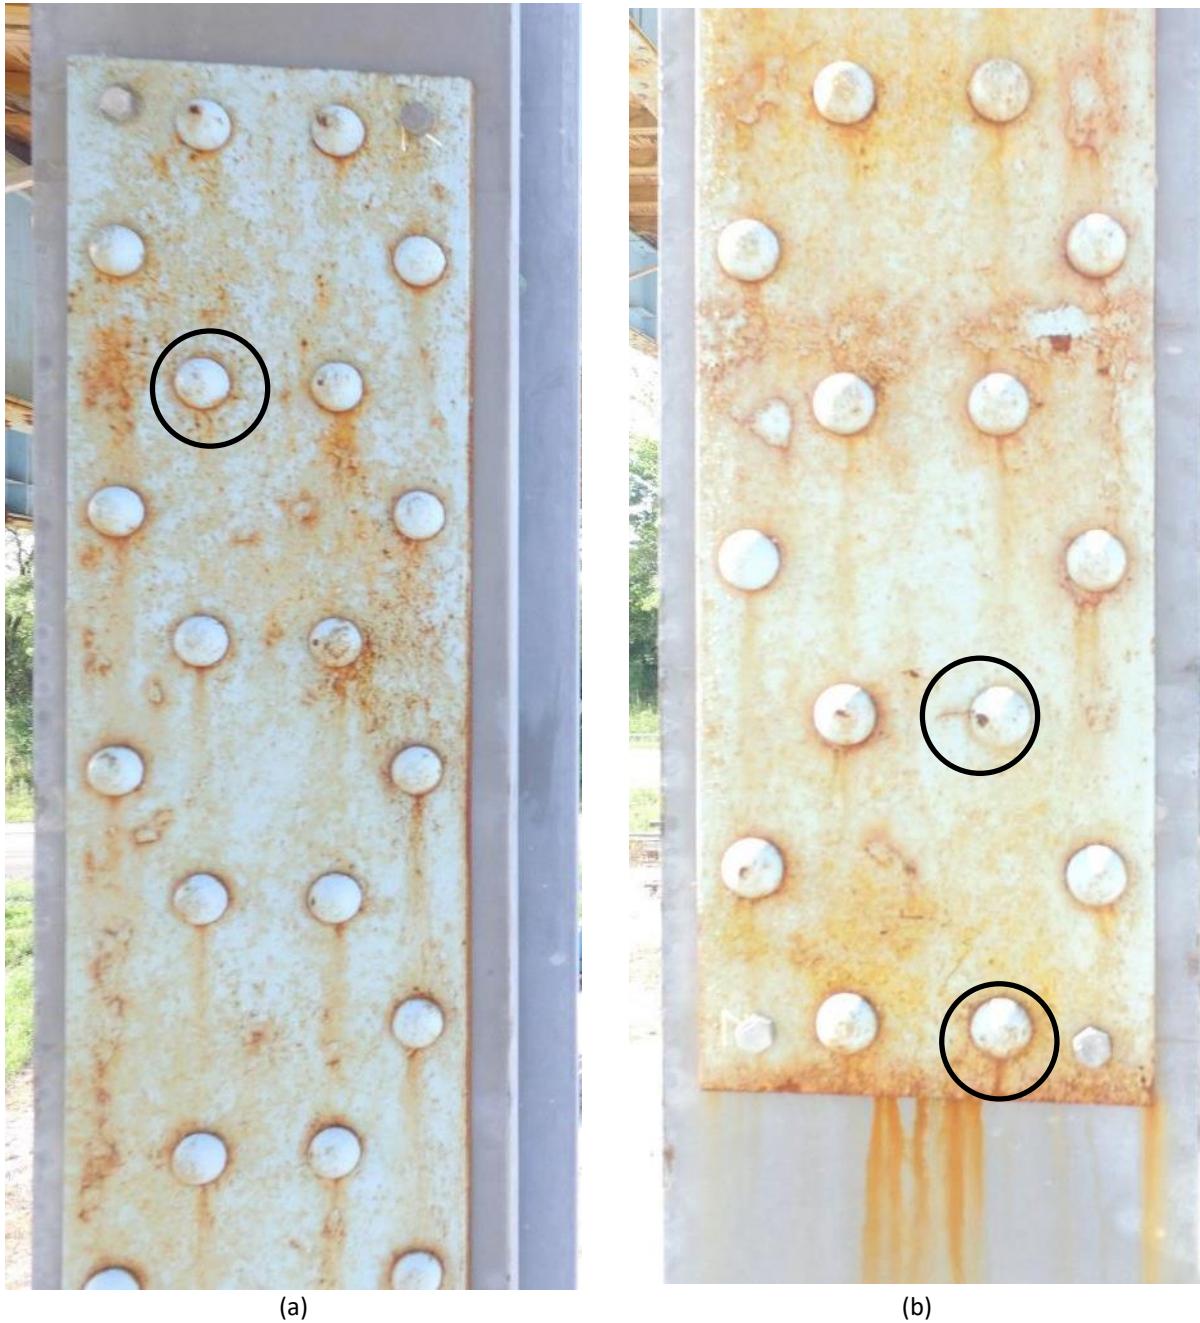
The inspector reported five cracks while inspecting the specimen in Figure 6.25 and reported six cracks after reviewing inspection images. Figure 6.26a shows the crack on the third row from the top of the specimen, and Figure 6.26b shows fatigue cracks on row 25 and row 27 from the top.

*Figure 6.26 Images of the riveted cover plate specimen (a) reported crack on row 3 and (b) reported cracks on row 25 and 27*

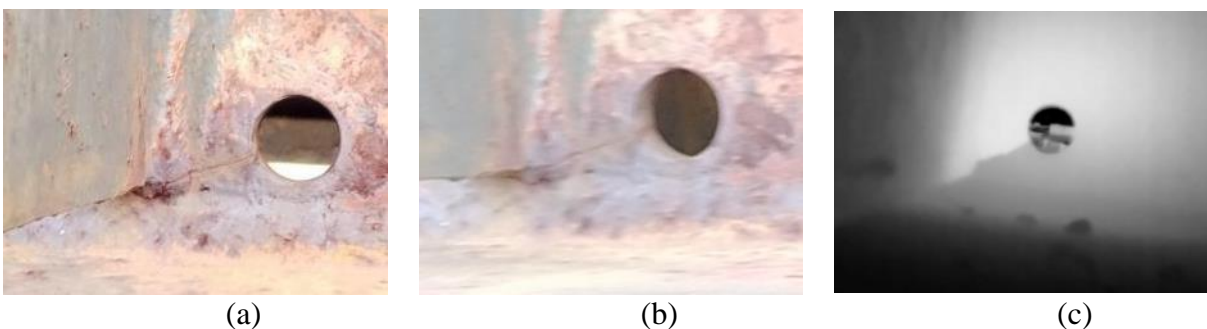
The fatigue cracks in the railroad bridge structure were longer and wider than the ones in the POD frame. In many cases, the fatigue cracks have led to fracture. Some cracks had holes at the end to reduce the stress and stop propagation. The research team inspected the railroad bridge using visual and thermal cameras in addition to the DJI Mavic. The visual camera was the 13 MP built-in Samsung tablet camera. For the thermal inspection, the inspector used active thermography by heating the fatigue cracks up to approximately 200°F. Figure 6.28a shows the Samsung tablet

image from one of the fatigue cracks in this structure. Figure 6.28b shows an image from the same crack taken by the DJI Mavic during the UAV inspection of the railroad. The crack was not as visible in the tablet image, but was still recognizable. Figure 6.28c shows a thermal image of the fatigue crack while it was losing heat. The temperature gradient was 23°F when the image was taken. As seen, the presence of the fatigue crack disrupted surface temperature contribution.

*Figure 6.28 Known fatigue crack in the railroad bridge: (a) tablet image, (b) DJI Mavic image, and (c) thermal image*
