Improving Transportation Infrastructure Resilience against Hurricanes, other Natural Disasters, and Weathering: Part I - Analysis of failure of transportation signs due to Hurricane Maria

Volume 1

FINAL REPORT
June 2022

Transportation Infrastructure Research Center – TIRC
Polytechnic University of Puerto Rico
377 Ponce de Leon Ave, San Juan, PR 00918

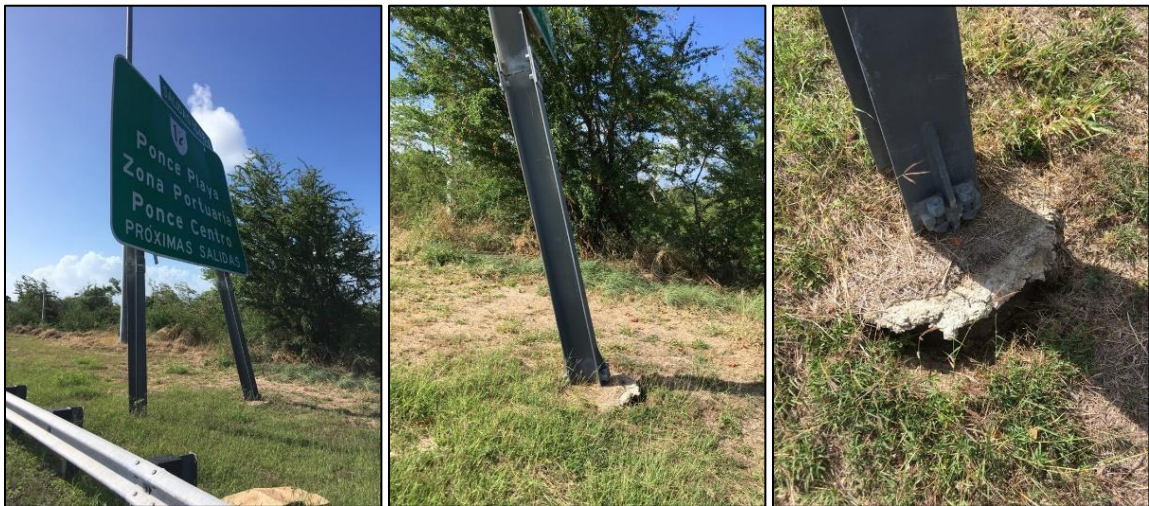
Figure 4.2: Foundation failure of Sign 6

Foundation failure occurs when none of the structural members on top of the foundation initially failed under the wind loads, but one or more of the posts overturns. The overturn could be due to the foundation not being deep enough, to the foundations not being adequately constructed, to the soil being significantly weakened due to the heavy rainfall of a hurricane, or to a combination of these factors. Sign 6, presented in Figure 4.2, was a case of foundation failure in which one of the posts started to overturn. Meanwhile, Sign 5 was another case of foundation failure in which the structure collapse due to the overturning of both posts, as presented in Figure 4.3.

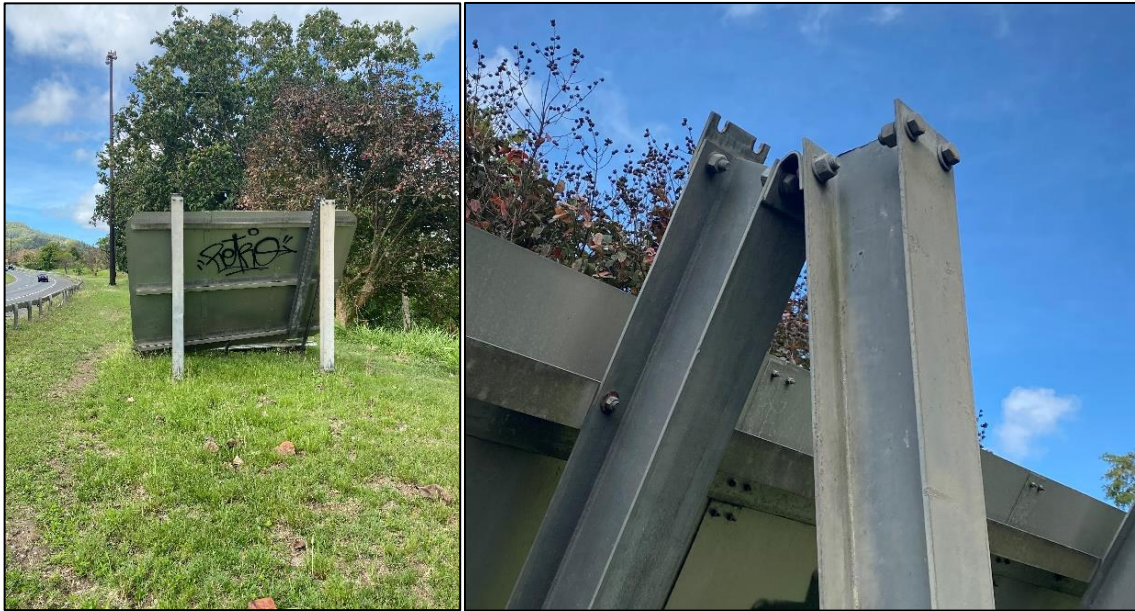
Figure 4.4: Slotted fuse plate slippage failure of Sign 9

During this project it was found that, sometimes, a fuse plate different from the one shown in Figure 2.15 is used. Instead, a slotted fuse plate is employed. Plate slippage occurs when the bolts holding the slotted fuse plate together to the upper and lower part of the post are loosened, probably due to the effects of cyclic loading caused by the wind or the frictional resistance being exceeded. Once this slotted fuse plate is loosened, the upper post is only being supported by the hinge plate, which eventually causes the hinge plate to bend. This was the mode of failure of Sign 9, shown in Figure 4.4. Notice in this figure that the slotted fuse plate is undamaged, while the hinge plate is bend.

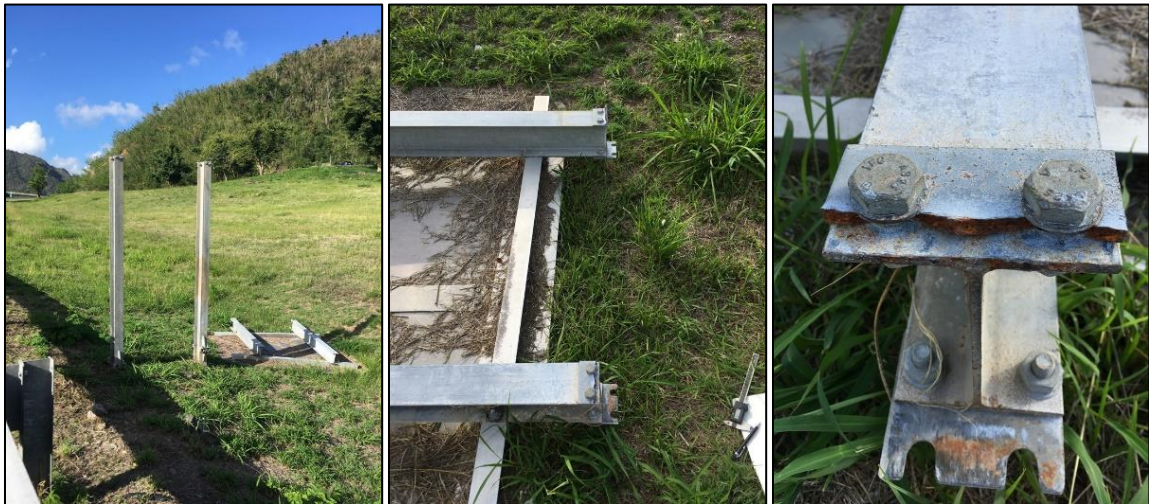
Figure 4.5: Slotted fuse plate slippage failure of Sign 7

Similarly, Sign 7 was another case of slotted fuse plate slippage, as shown in Figure 4.5. This time, the hinge plate was ruptured, probably because the upper beams are shorter than the lower beams.

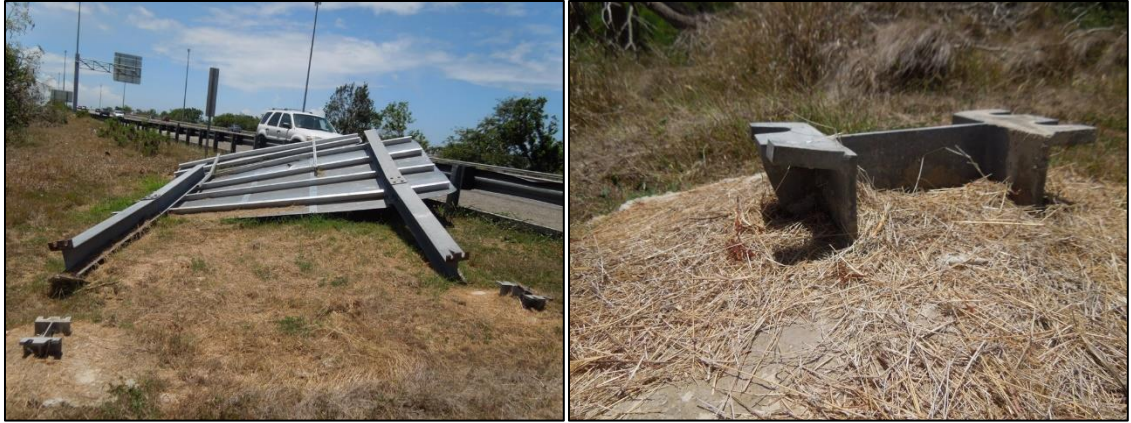
Figure 4.7: Slippage failure at the base of Sign 4

Another case of slippage failure at the base of the posts was Sign 4, as shown in Figure 4.7. It can be noticed in the figure that the breakaway base support is partially deformed.

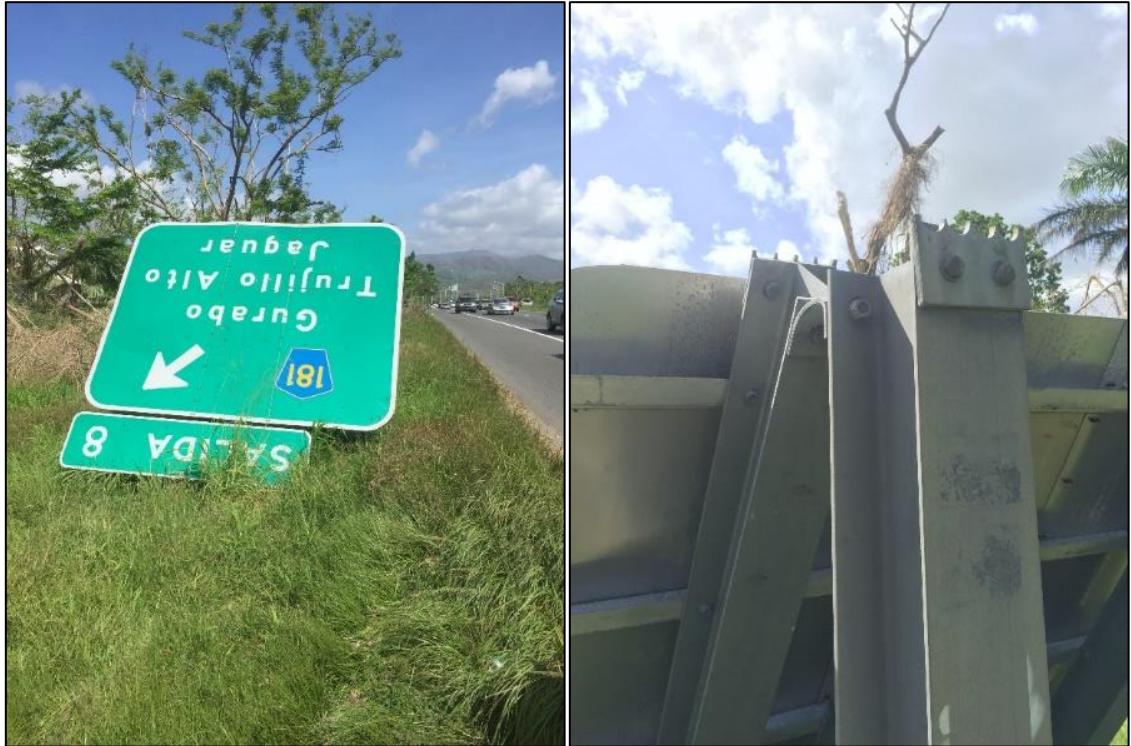
Figure 4.8: Fuse plate rupture of Case 2

Fuse plate fracture occurs when the wind loads on the sign cause the fuse plate to fail in tension, which eventually leads to the bending of the hinge plate, like the case shown in Figure 4.8. It was determined that this mode of failure has a mechanism that allows the estimation of wind speed. Therefore, they were selected as case studies. As previously mentioned, three cases of fuse plate fracture were documented as the three red markers depicted in Figure 4.1 and denoted as Cases 1, 2, and 3 in Table 4.1. It can be noted in Figure 4.1 that the three case studies were at some point located in the right front quadrant of the hurricane, which is the quadrant with the strongest winds. The three case studies are discussed in more detail in the following chapter.

Case 2, as shown in Figure 5.9 (and previously shown in Figure 4.8), was also a guide sign supported by dual W10x33 posts of galvanized steel and a smaller exit number sign attached to the main sign. The sign was located on highway PR-30 at km 7.8, at coordinates $18^{\circ}14'58.21''\text{N}$, $65^{\circ}58'5.16''\text{W}$ (see Figure 5.10). Figure 5.11 shows relevant field measurements taken of the sign structure.

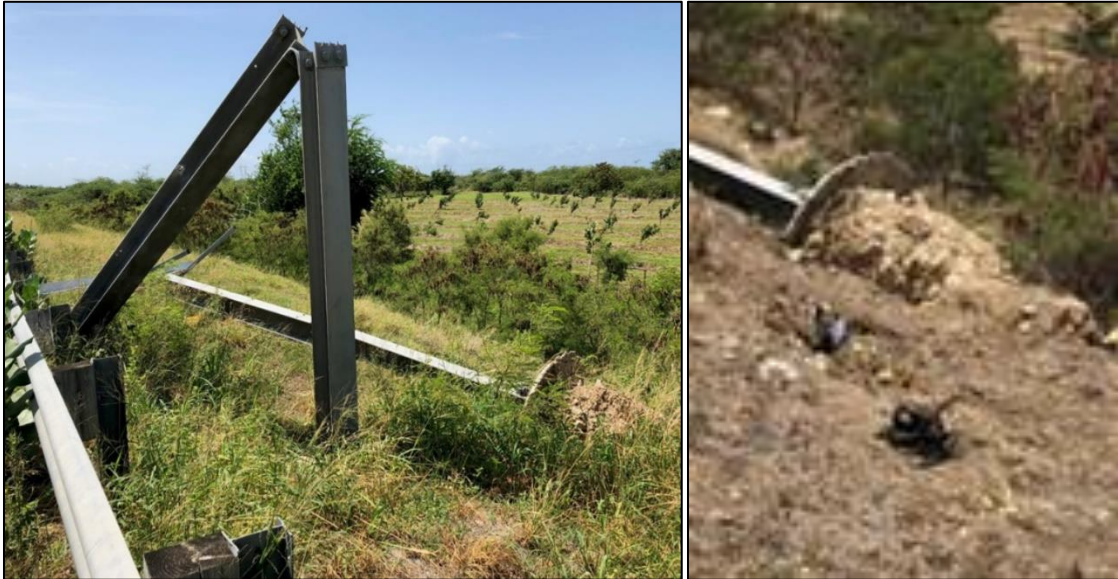
Figure 4.9: Undetermined mode of failure of Sign 8

Sign 8, demonstrated a combination foundation failure and fuse plate rupture, as shown in Figure 4.9. It is probable that one of the posts had a foundation failure that lead to the other post having fuse plate rupture.

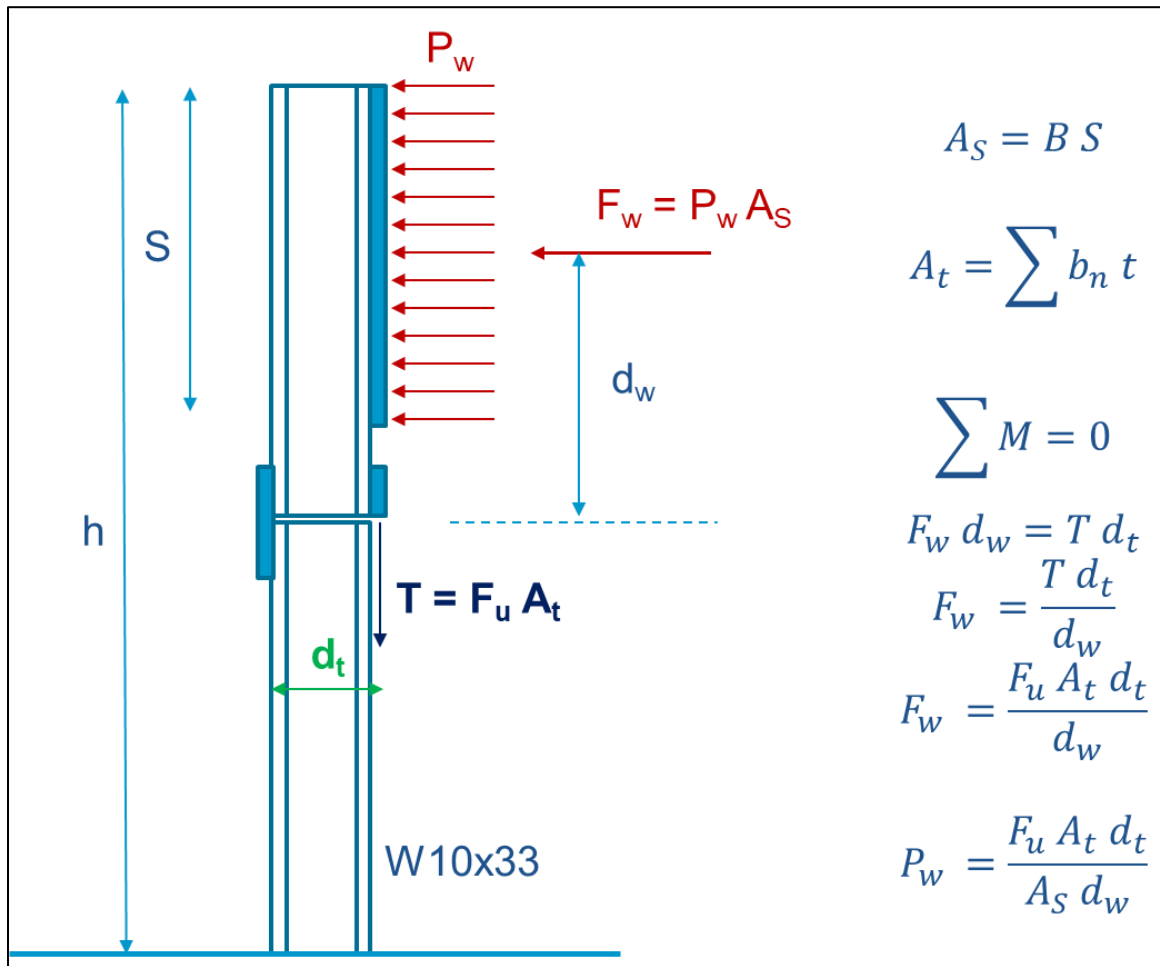
Figure 5.1: Failure model for determination of wind speed

The model adopted for the failure mechanism consists in a static moment equilibrium about the hinge plate, between the wind pressure over the sign (which produces the overturning moment), and the tension stresses on the fuse plate (which produced the restoring moment). This model, presented in Figure 5.1, is consistent with the model of other authors (Pfeifer, 1993; Paulsen, Pfeifer, Holloway, & Reid, 1995). The nomenclature for this model is as follows:

For the model, the flexural capacity of the hinge plate was disregarded, even though it remained connected. The gravitational load of the different elements was also disregarded.

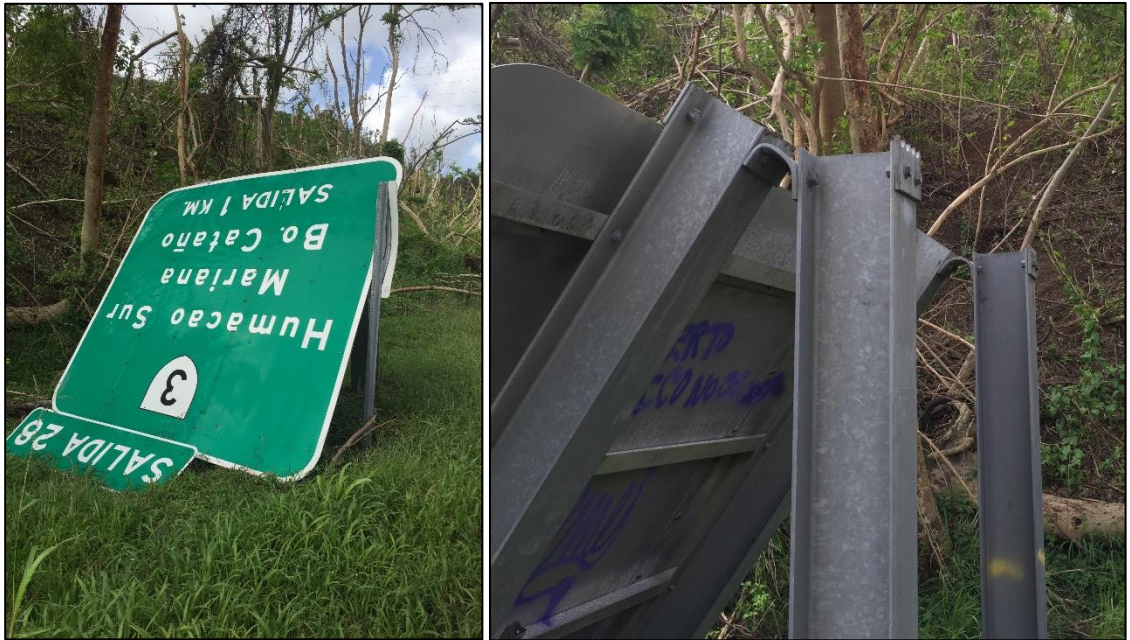
Figure 5.2: Case 1

Case 1, as shown in Figure 5.2, was a guide sign supported by dual W10x33 posts of galvanized steel. The main sign had attached a smaller exit number sign. The sign was located on highway PR-30 at km 28.3, at coordinates 18°8'10.53"N, 65°49'40.19"W (see Figure 5.3). Figure 5.4 shows relevant field measurements taken of the sign structure.

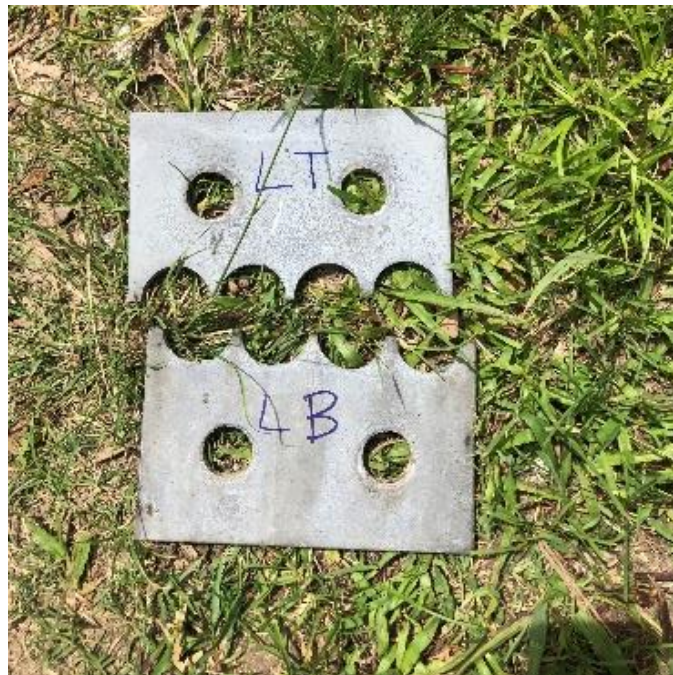
Figure 5.5 Fuse plate retrieved from Case 1

For this case, the two rupture fuse plates were retrieved from the posts, one of which is shown in Figure 5.5. Afterwards, the rupture fuse plates were carefully measured to determine the total tension area in the rupture plane (A_t); including both plates, it was estimated that $A_t = 1.6763 \text{ in}^2$.

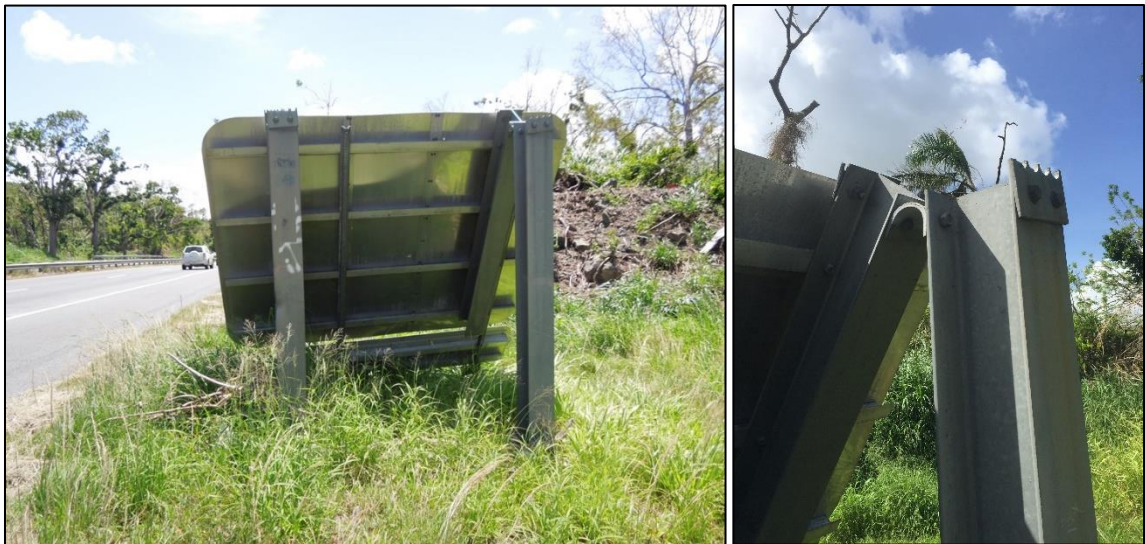
Figure 5.9: Case 2

For this case, the two rupture fuse plates were not retrieved. The fuse plates were carefully field measured to determine the total tension area in the rupture plane (A_t); including both plates, it was estimated that $A_t = 1.414 \text{ in}^2$. It was assumed that the plates were made of the same steel of Case 1 with an ultimate strength of $F_u = 63,963 \text{ psi}$.

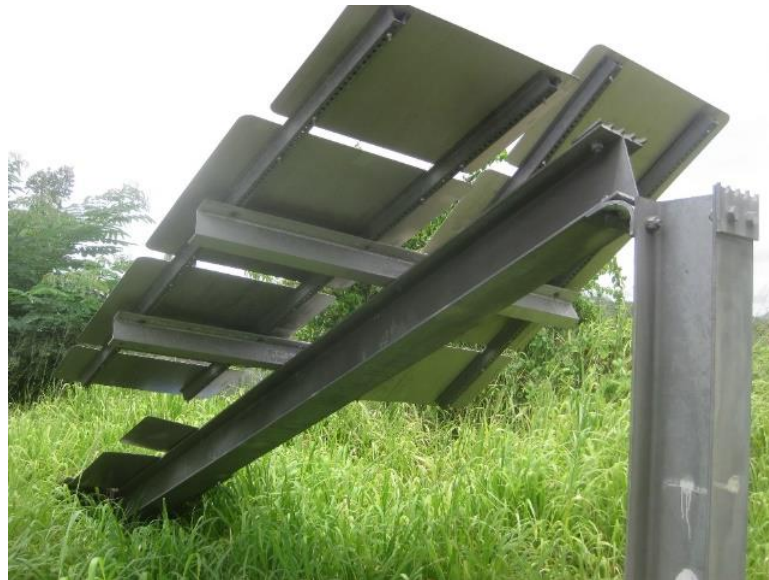
Figure 5.14: Case 3

Case 3, as shown in Figure 5.14, consisted of a single W10x33 posts of galvanized steel supporting eleven small signs of assorted sizes. The structure was located on highway PR-1 at km 31.4, at coordinates $18^\circ 15' 56.68''\text{N}$, $66^\circ 2' 21.25''\text{W}$ (see Figure 5.15). Figure 5.16 shows relevant field measurements taken of the structure.

For this case, the rupture fuse plate was retrieved from the post. Afterwards, the rupture fuse plates were carefully measured to determine the tension area in the rupture plane (A_t); it was estimated that $A_t = 0.75 \text{ in}^2$.

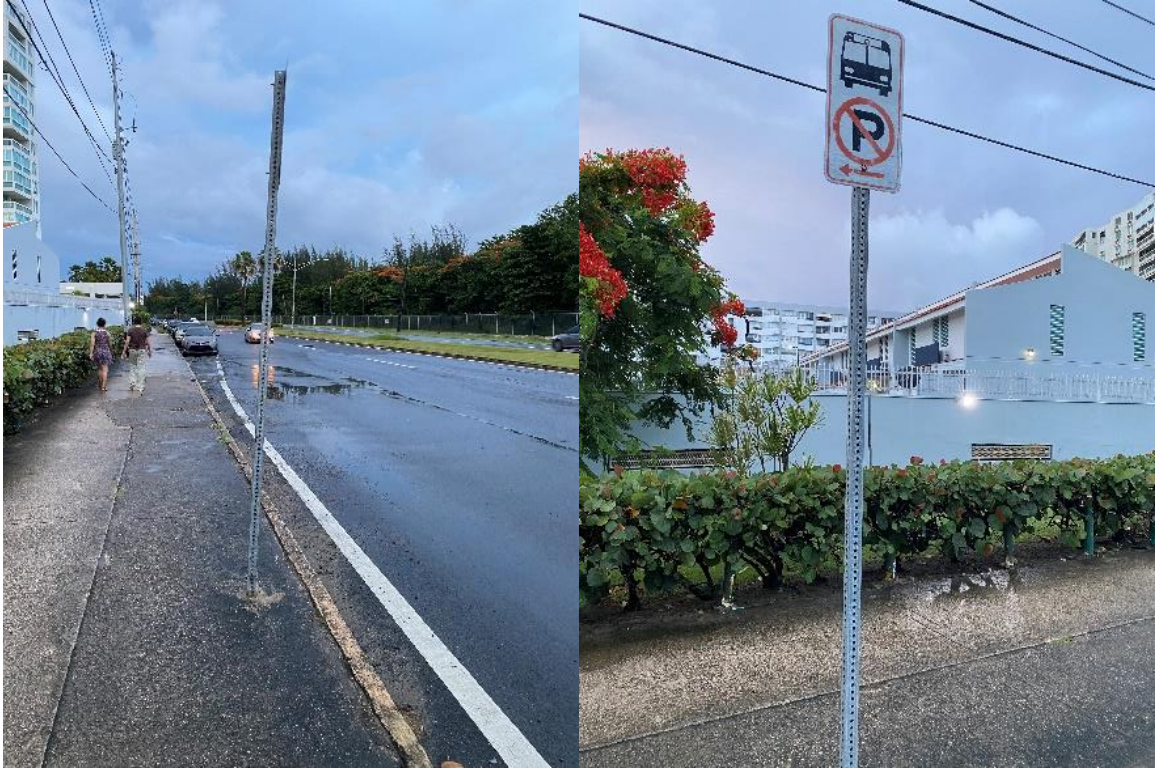
Figure 4.1 shows SQ1's square post bended with respect to its base post. Figure 4.2 shows the areas surrounding SQ1. It can be noticed that is close to the north coast (less than 1,000 ft), while it has the Luis Muñoz Marín Airport to the south and east, and the San Jose Lagoon to the southwest.

Figure 4.1: Front and side views of SQ1

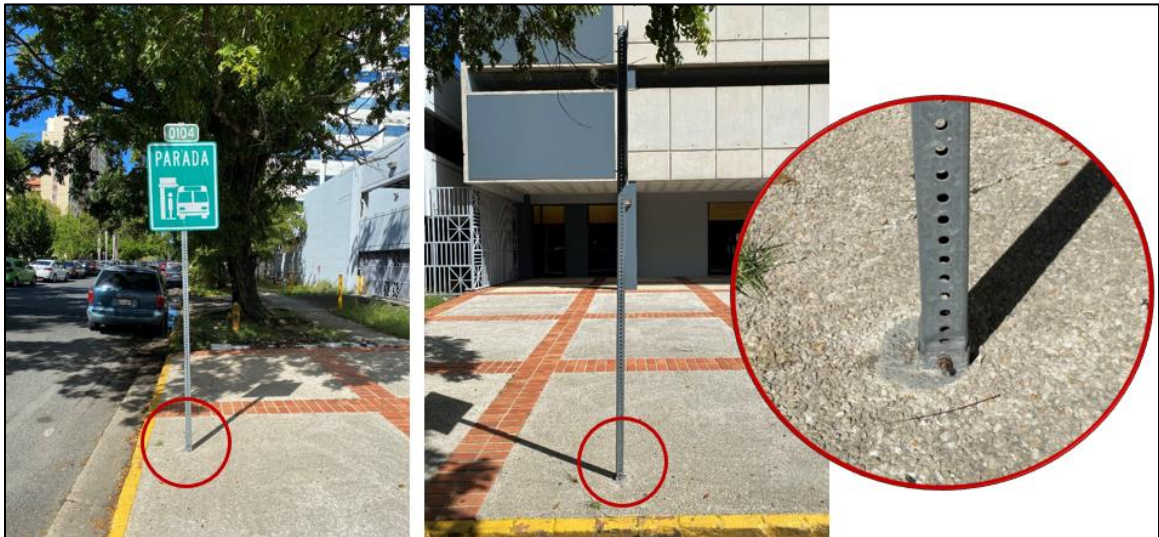
- Two posts exhibited plasticization at the base. An example of this is shown in Figure 4.3. At first it was considered that Hurricane Maria caused these, but through Google Map's Street View, it was determined that the posts already presented this damage in 2016, prior to Maria's arrival.
- A few posts were out of plum due to construction defects. The base post appeared to have been improperly installed, as shown in an example presented in Figure 4.4.
- A few cases did not appear to have the base post required by the PRHTA (refer to Figure 2.13, Figure 2.14, and Figure 2.15). Figure 4.5 presents an example where the base post is not visible.

Figure 4.3: Square exhibiting plasticization at the base

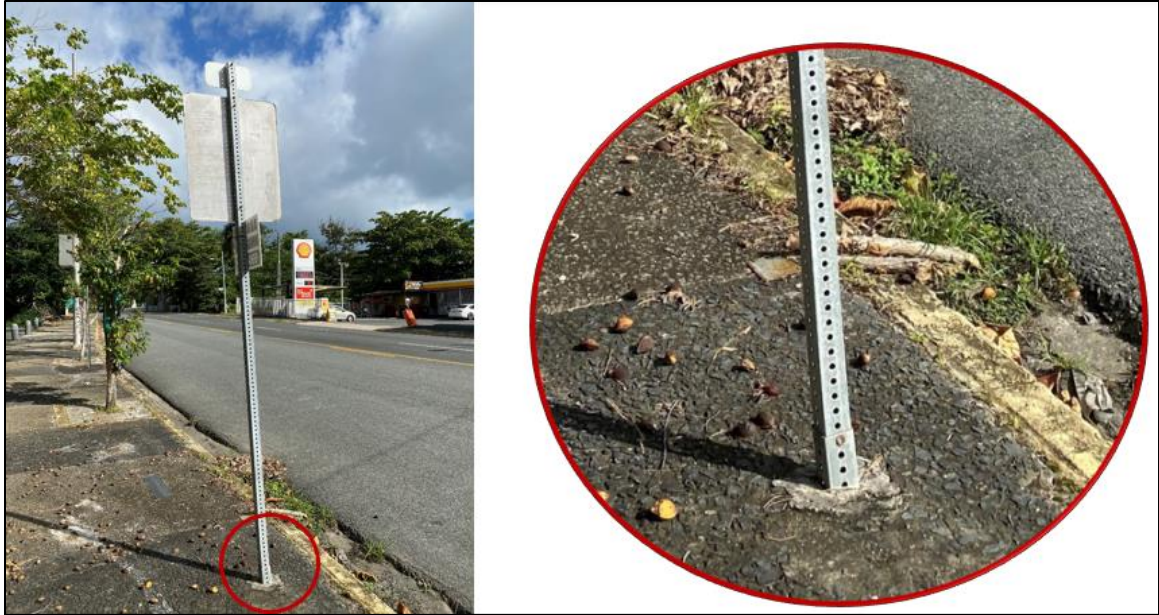
Figure 4.4: Out of plumb square tube due to construction defect

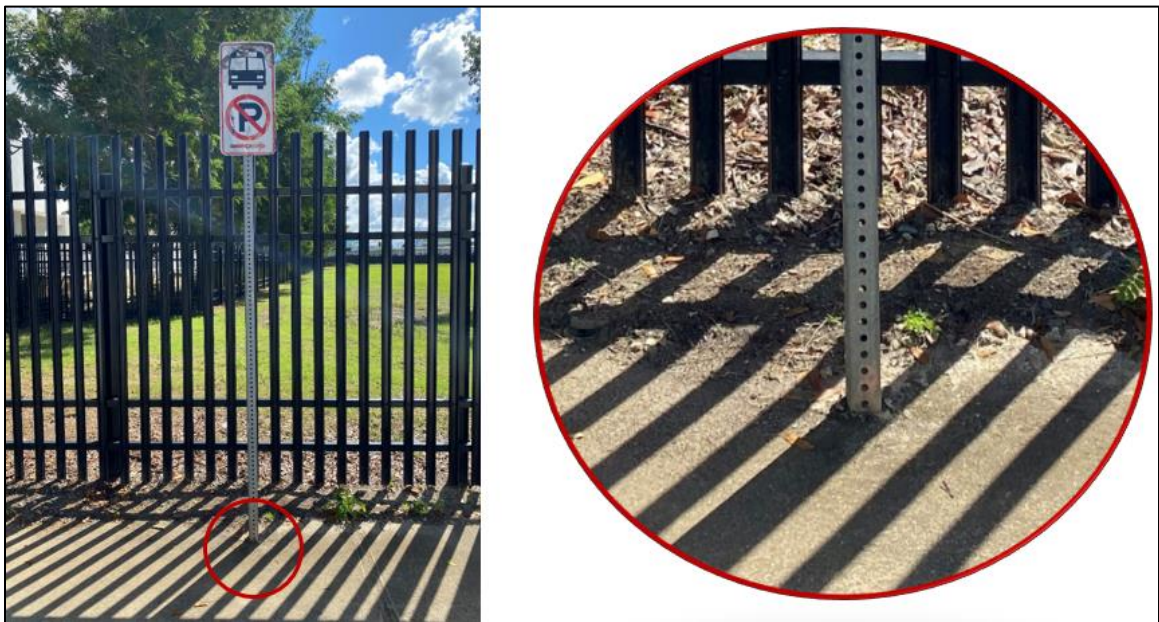
Figure 4.5: Top post without a visible base post

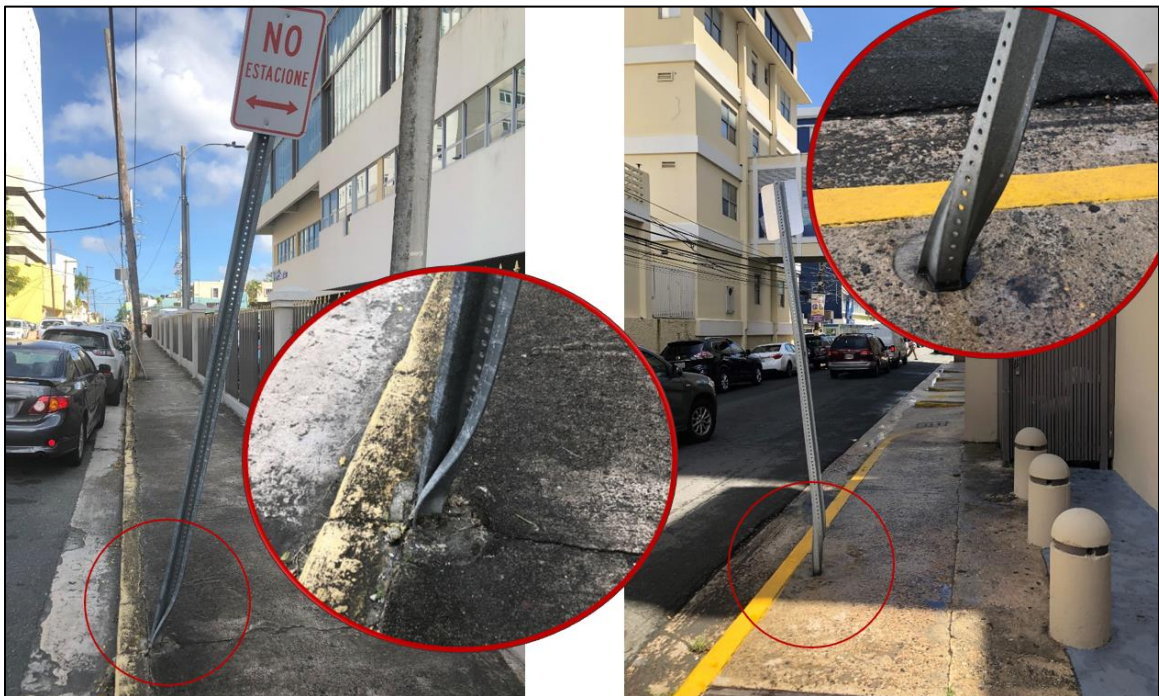
- Permanent twisting deformation: In this mode of failure, the top post twisted near its base, as it can be seen in the examples shown in Figure 4.10. This was the most predominant mode of failure observed. Several posts were found facing the wrong direction due to the deformation (see example in Figure 4.11). In other instances, the sign panel was lost (see example in Figure 4.12). In some cases, the deformation was so severe, that it led to the collapse by post fracture (see example in Figure 4.13). This mode of failure is furthered discussed in Chapter 6, as one of the failed signs was taken as a case study. In that chapter, theories on the mechanism that causes the twisting are offered.

Figure 4.10: Examples of permanent twisting deformation

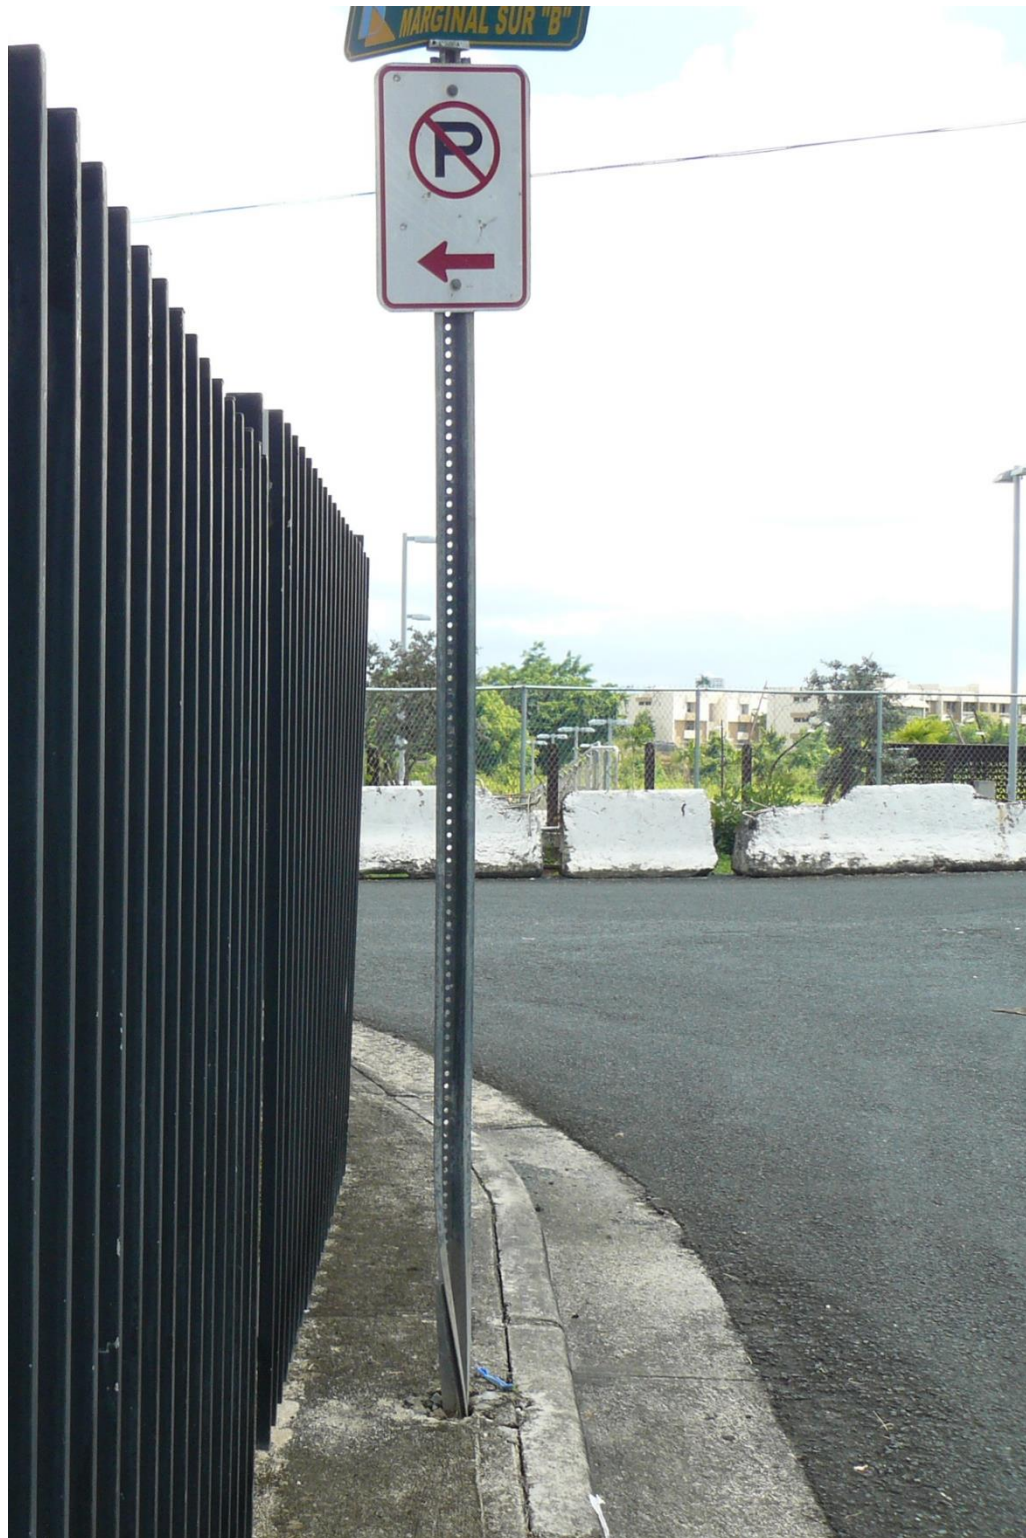
Figure 4.11: Sign facing wrong direction due to permanent twisting deformation

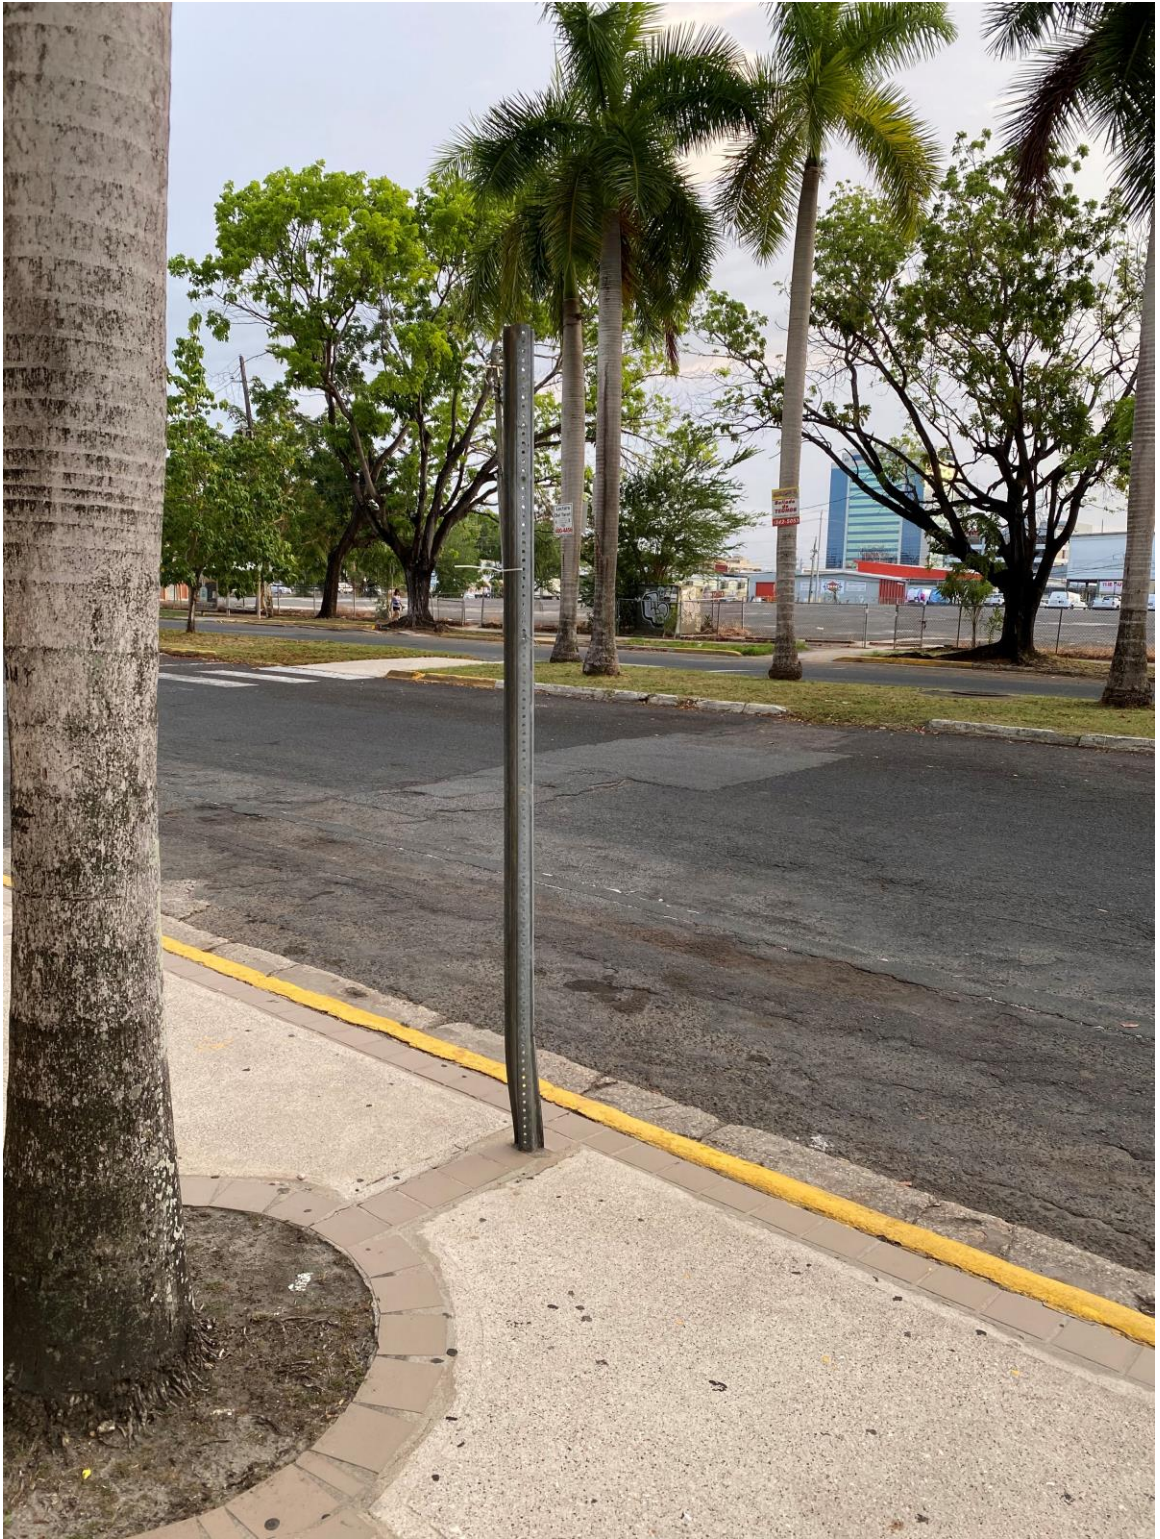
Figure 4.12: Permanent twisting deformation post that lost sign panel

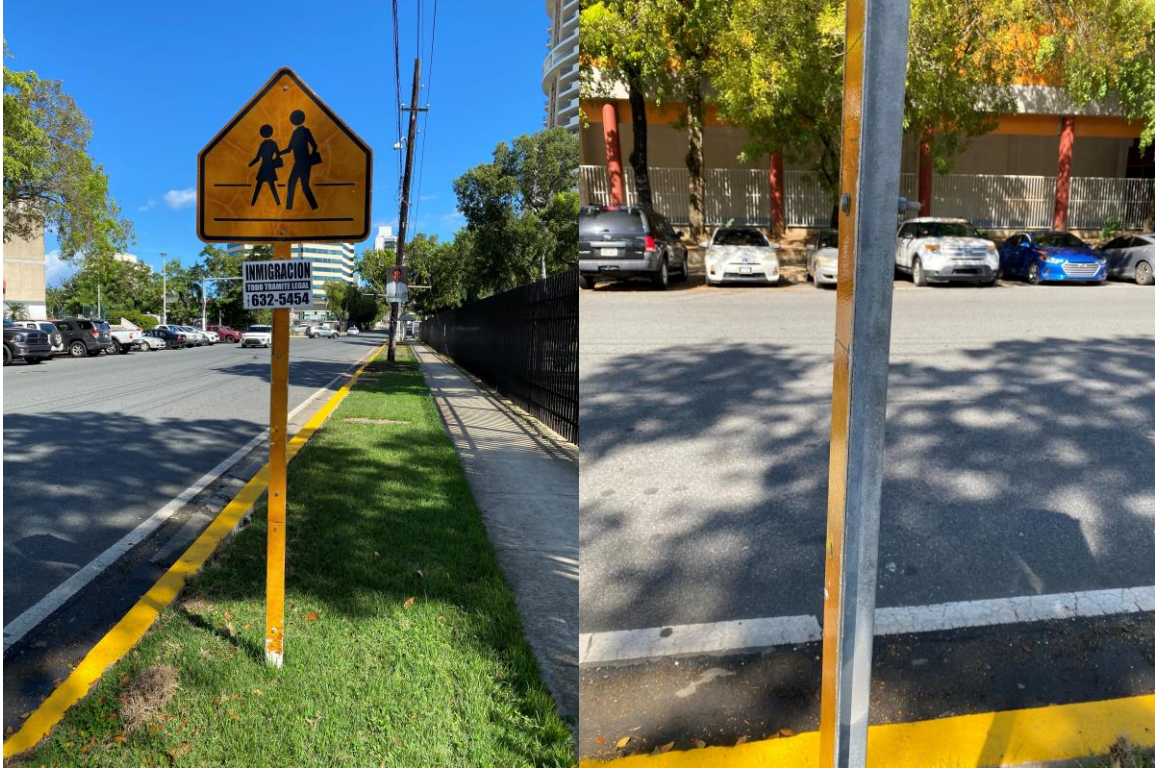
- Some cases did not appear to have the top post to base post connection as required by the PRHTA, (refer to Figure 2.20 and Figure 2.21). An example of this is shown in Figure 4.17.
- Figure 4.18 shows a U-channel post with a reflective plastic cover. This post behaved is located in a street segment of about 500 ft where five other signs failed. The reflective plastic cover may have contributed to avoid permanent twisting deformation.

Figure 4.18: U-channel with plastic reflector

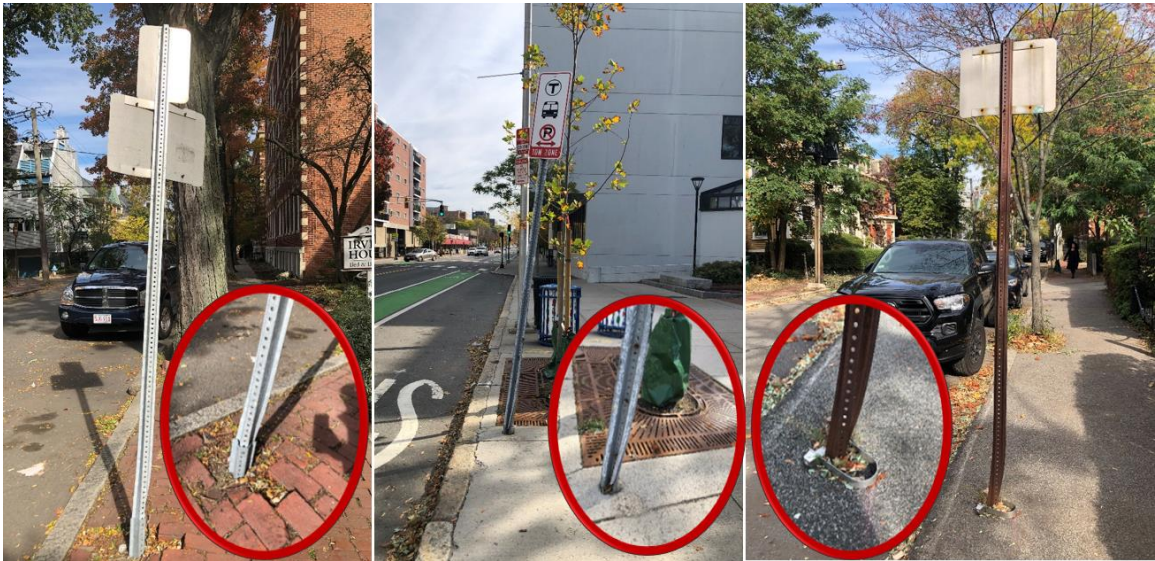
The permanent twisting deformation in U-channel posts has also been observed in other parts in the United States with lower basic wind speeds. As an example, Figure 4.19 shows three posts with permanent twisting deformation in Cambridge, MA. These, together with the other cases of permanent twisting deformation that were found to have occurred before Hurricane Maria in Puerto Rico suggest that the U-channel is very susceptible to this type of failure.

Figure 4.19: Permanent twisting deformation in U-channels in Cambridge, MA

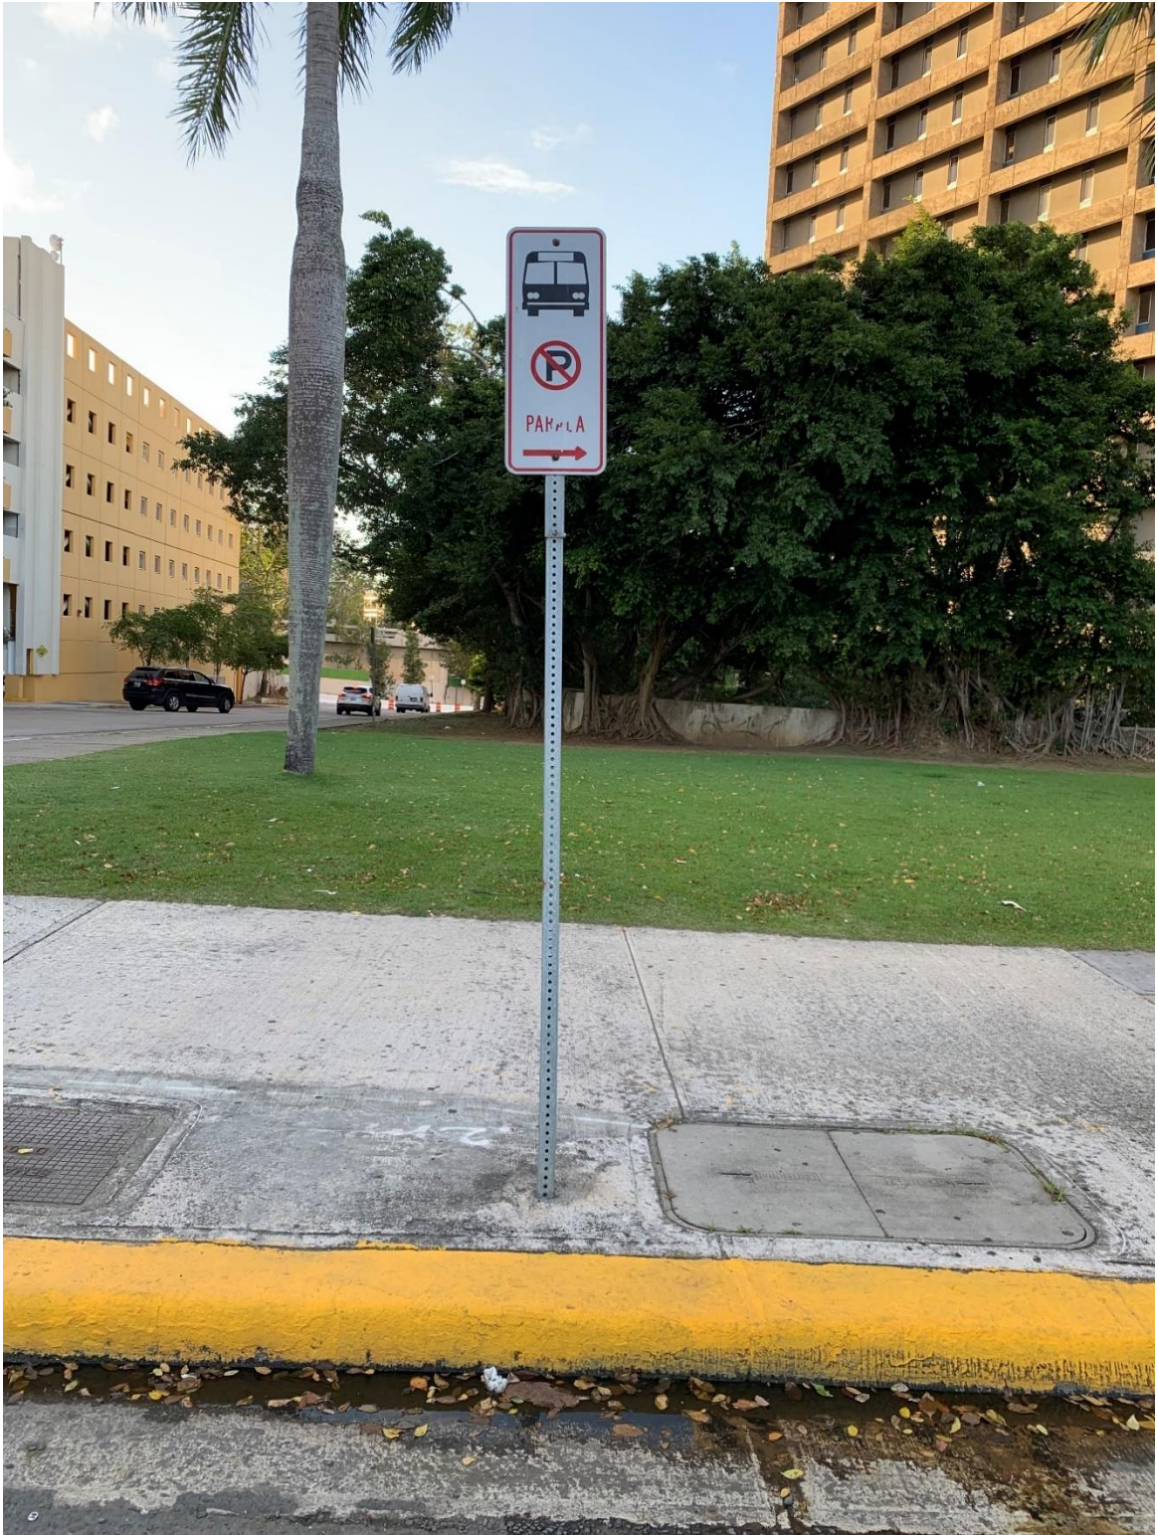
The first case study evaluated was sign with a square tube that experienced bending in the plastic range due to the winds of Hurricane Maria. For this project, this structure was identified as SQ2 in Table 4.1, which indicates the sign's location. The sign is located in an urban area, as shown in see Figure 5.1. Figure 5.2 presents a front view of the case study itself. Figure 5.3 shows a side view in which the bending failure can be appreciated.

Figure 5.2: Case Study 1 front view

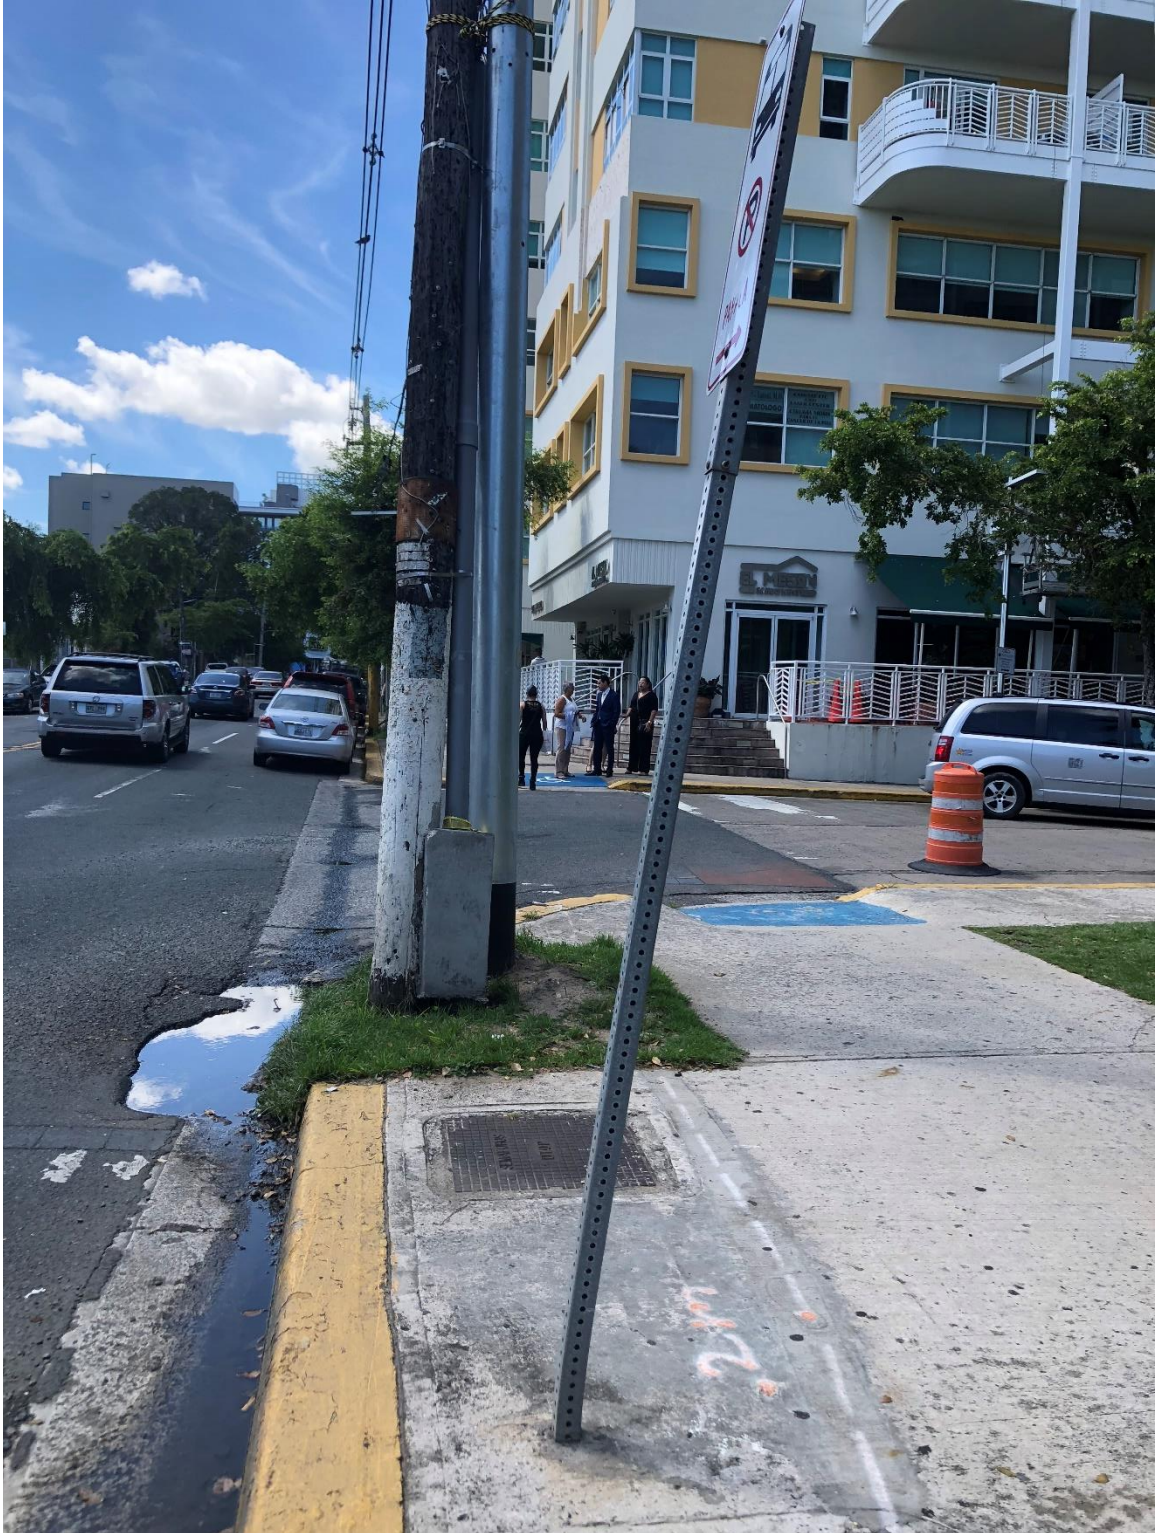
Figure 5.3: Case Study 1 side view
