Improving Transportation Infrastructure Resilience against Hurricanes, other Natural Disasters, and Weathering: Part I - Analysis of failure of transportation signs due to Hurricane Maria

Volume 1

FINAL REPORT
June 2022

Transportation Infrastructure Research Center – TIRC
Polytechnic University of Puerto Rico
377 Ponce de Leon Ave, San Juan, PR 00918

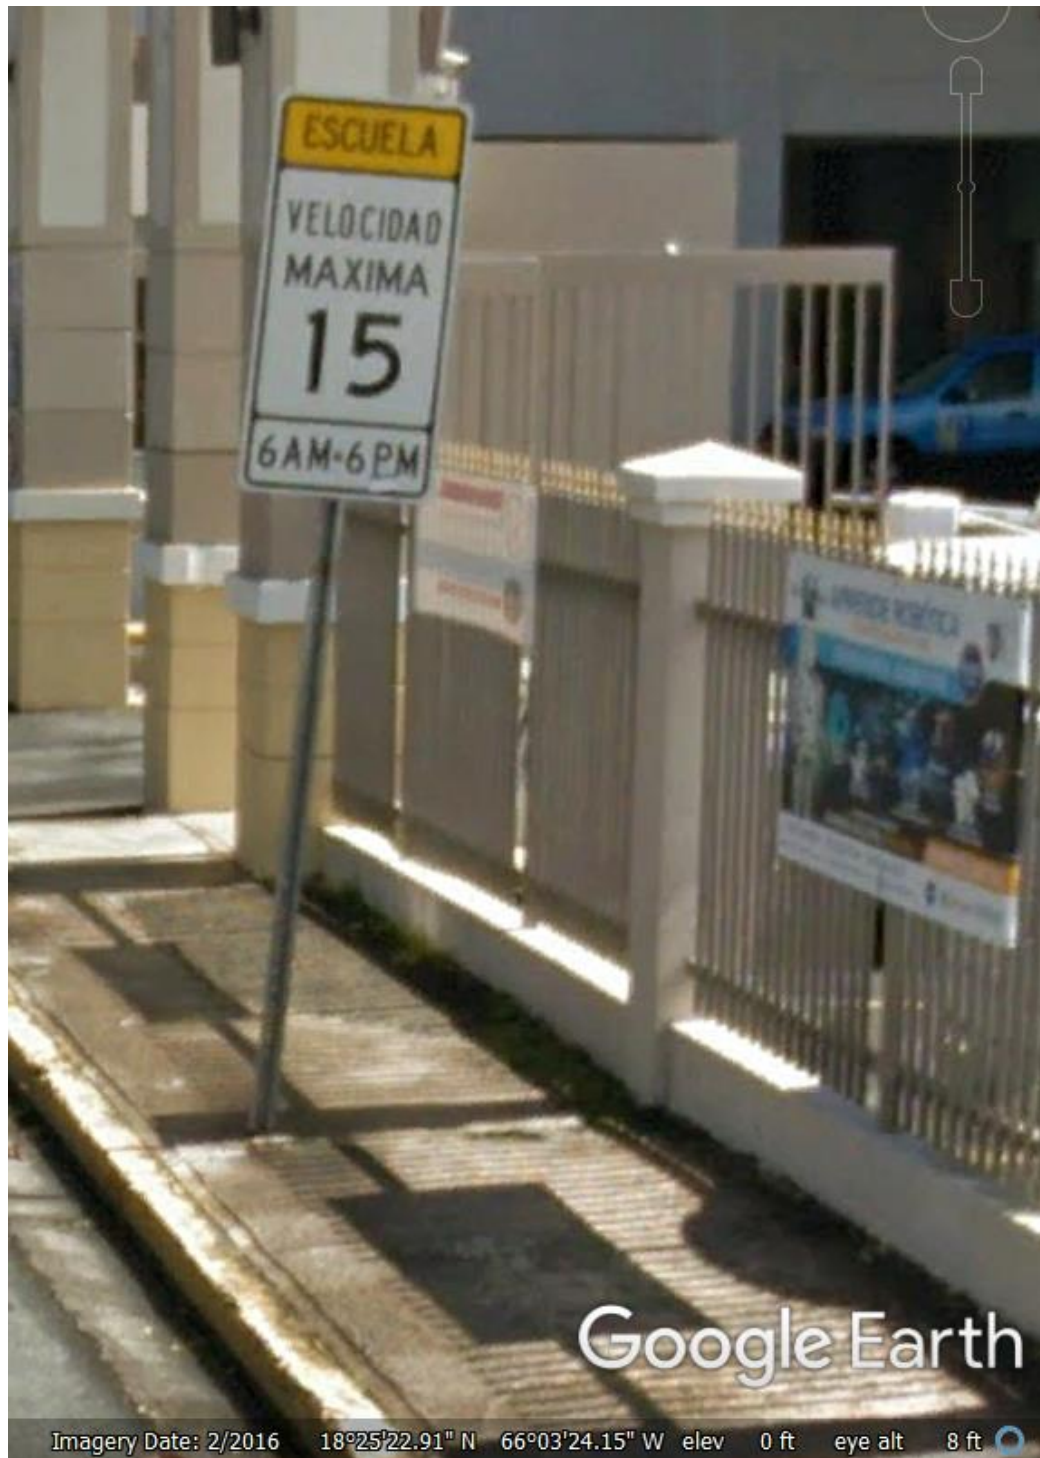
View. It can be seen that the post supported a School Zone Speed Limit sign panel. Although the post appears to have been somewhat tilted, the post does not exhibit permanent twisting deformation.

Figure 6.2: Case Study 2 before Hurricane Maria

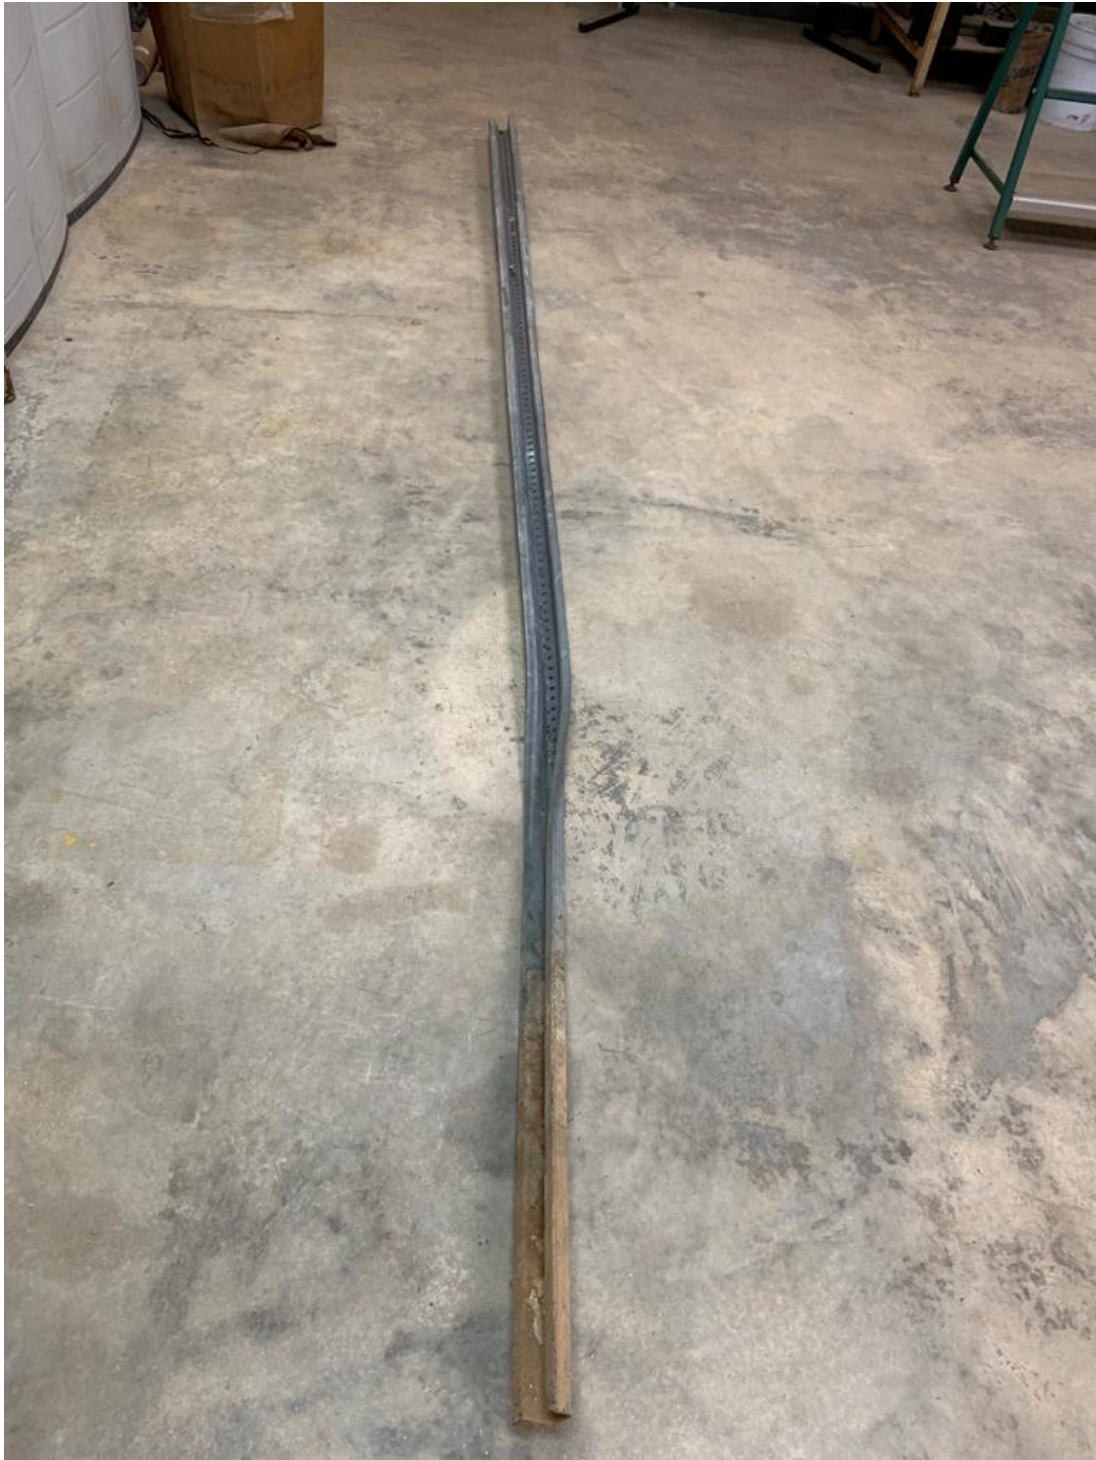
The post was eventually uninstalled and left on the sidewalk, where it was recovered by PUPR, as shown in Figure 6.5. This allowed the taking of measurements, as well as the extraction of samples to conduct laboratory tests, as it will be explained later.

Figure 6.5: U-channel post assembly at laboratory

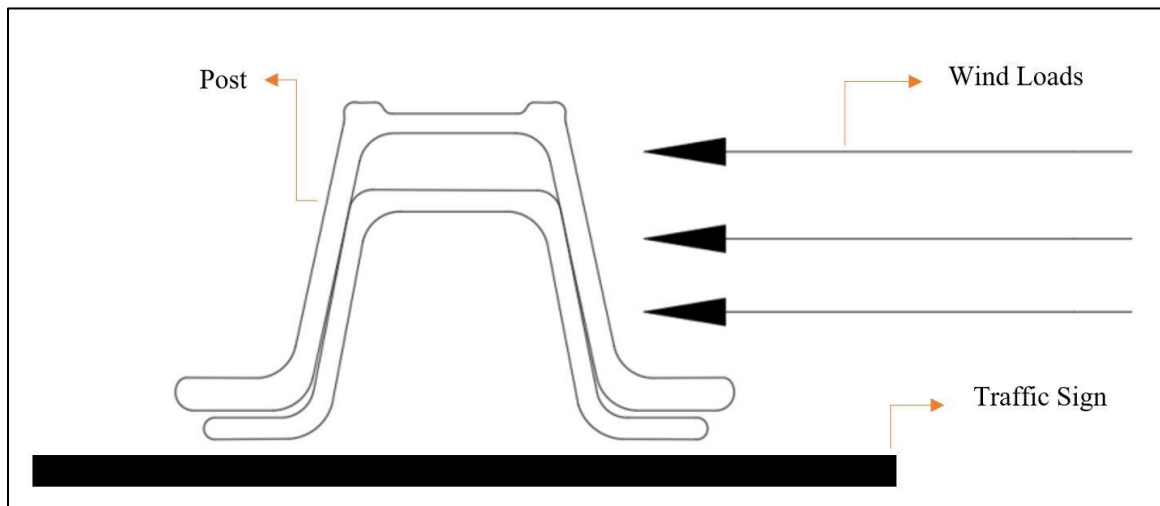
Figure 6.10: Wind loads applied in the parallel to the sign panel

The hypothesis considered for Case Study 2 is based on how the post is affected when the wind has a direction parallel to the sign panel, as shown in Figure 6.10. The analysis considers the possibility that the wind applied along the post produced a failure due to lateral torsional buckling. Since the post has a permanent deformation without rupture, it is considered that the failure was due to plastic yielding. Therefore, a non-linear plastic analysis was conducted.

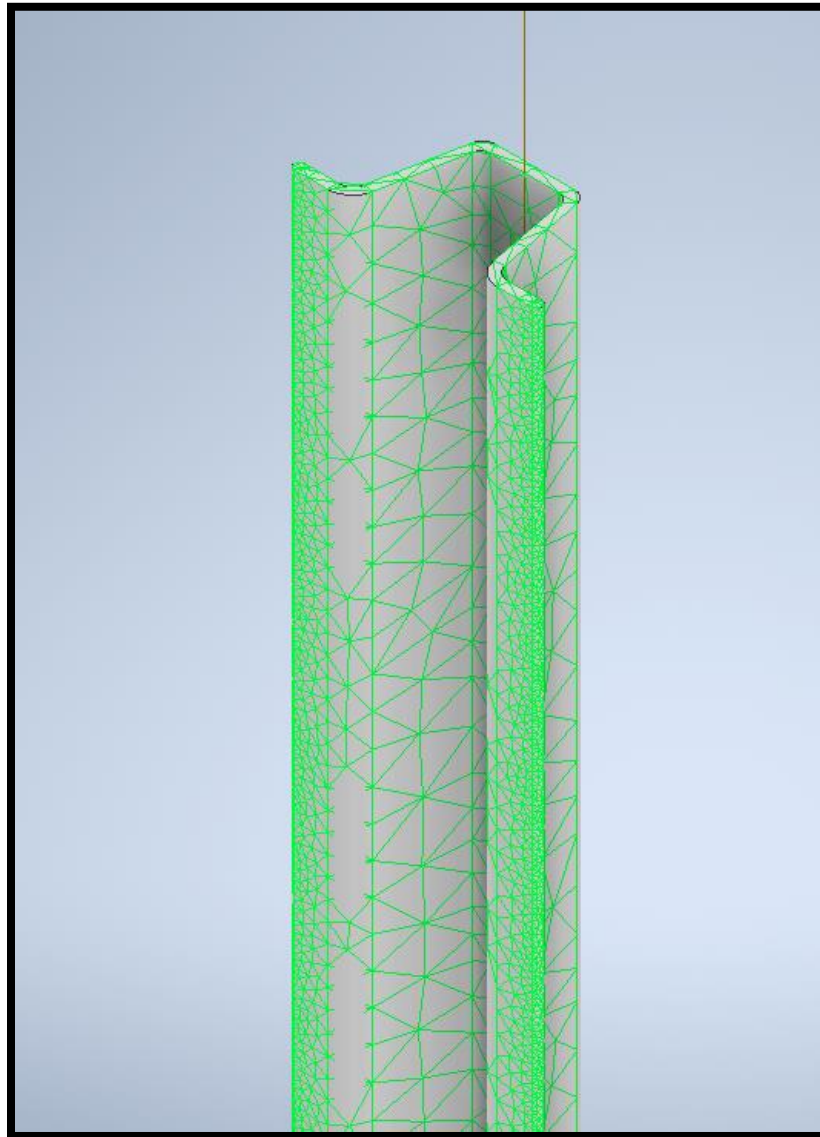
Figure 6.11: Mesh generated for U-Channel

Similar to the Case Study 1, a finite element model was developed using Autodesk's Inventor software, as shown in Figure 6.11. The model disregarded the presence of what should have been the base post. The model had the cross-sectional dimensions of what

should have been the top post, (Section 2 in Figure 6.7). The post was modeled with a total height of 12.25 ft, with the bottom 2ft restricted from displacing, to simulate the segment of the post that was underground.

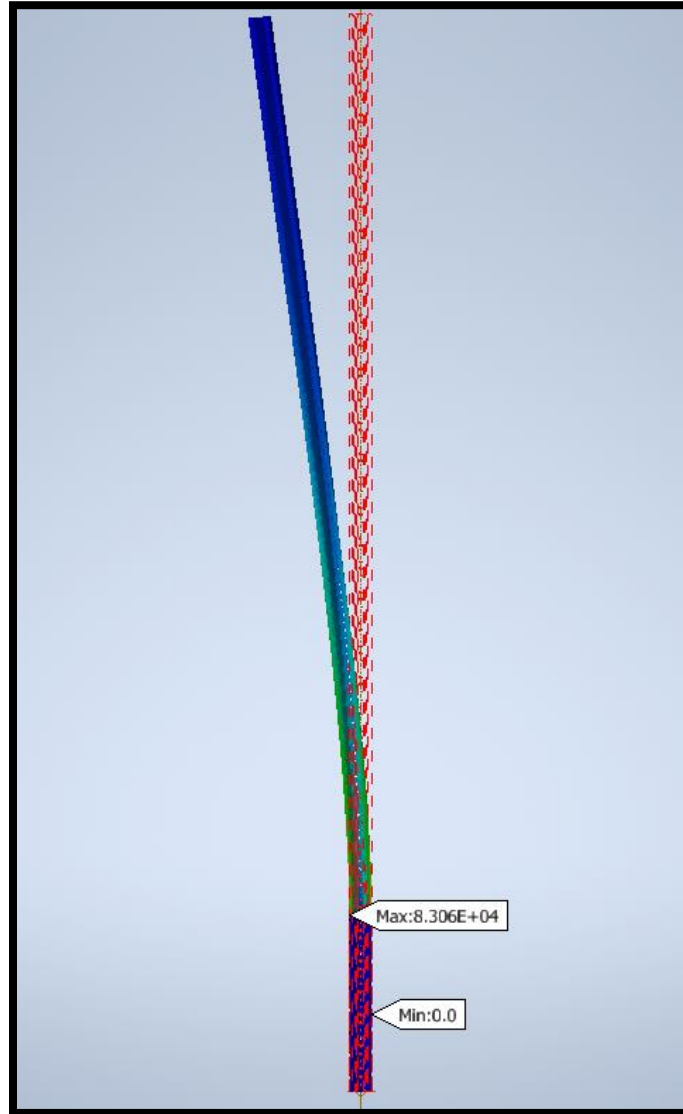
Figure 6.12: U-channel deformation under applied wind loads

A lateral pressure load was applied to the side of the post. It was found that with a load of 2 psi, the FE model exhibited a combination of deflection and twisting similar to the behavior of Case Study 2. This lateral pressure produced a stress of 83.07 ksi at the support, as shown in Figure 6.12. This value is close to the yield stress determined in the

tension tests. Therefore, it was assumed that a higher load would lead the post to have permanent and irreversible damage.

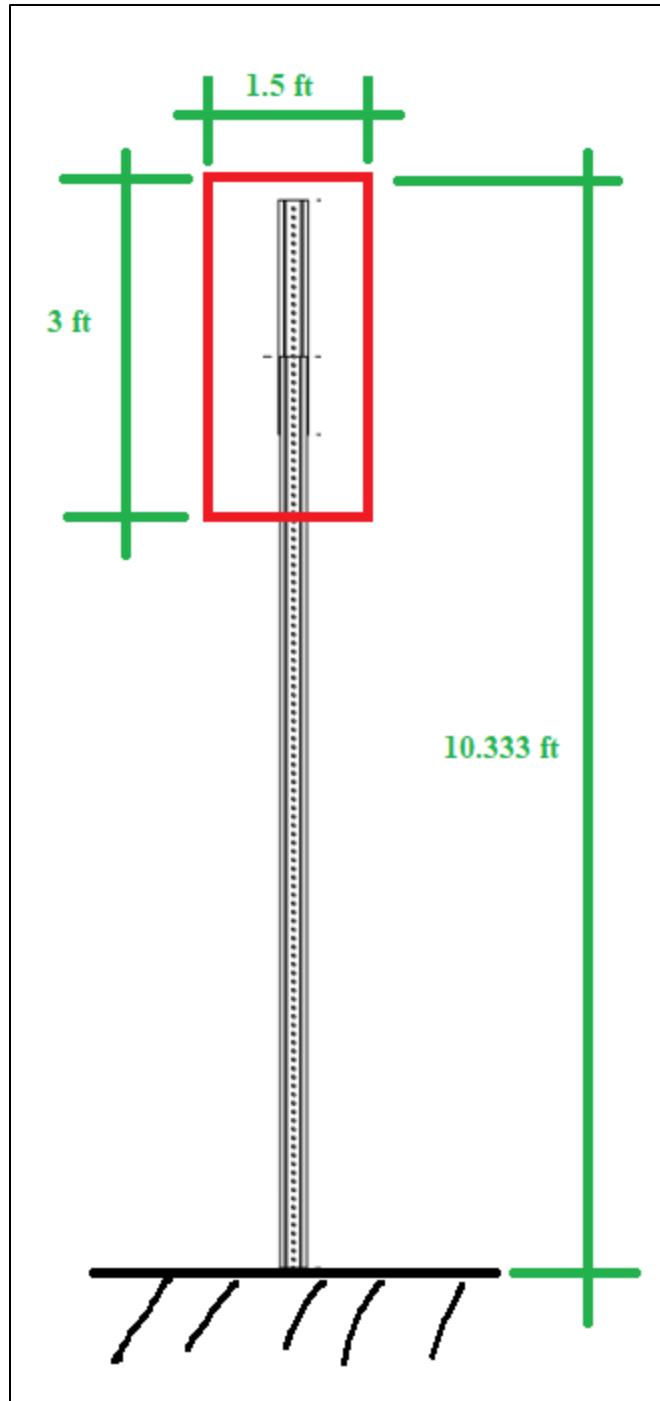
Figure 6.14: Case Study 2 geometry

- Given that then sign panel was not available, its dimensions were estimated using Google Street View. It was estimated that the sign panel had a height of 3ft and a width of 1.5 ft, as shown in Figure 6.14. Also, the top edge of the sign was 1” higher than the top end of the post. The net force coefficient (C_f) was calculated according to the ASCE’s Case A, as discussed in Section 2.4. A value of $C_f = 1.80$ was obtained.

Again, this estimate is very conservative. The failure bending moment obtained by Rhee, Nevill & Lombardo (2022) was 1.28 times larger than the yield bending moment. If that were the case for Case Study 2, the gust wind speed would increase to 147 mph.

These results demonstrate that it is possible that the permanent twisting deformations documented in U-channels for this project were caused by lateral torsional buckling. Still, further research needs to be conducted to reach a definite conclusion, as a combination of flexural and torsional forces may have caused the permanent twisting deformation due to changes in wind direction and eccentricity (Rhee, Nevill, & Lombardo, 2022).

- Phased out U-channels should be from use in small traffic signs. They should be eliminated from the standard drawings of the PRHTA, and failed and damaged posts should be replaced with square tubes. U-channels may still be used for mile markers.
- Evaluate increasing the size of square tubes from 2-in by 2-in with gauge 14 to 2.5-in to 2.5-in with gauge 12. This will represent an increase in cost of this type of structure, but it would increase their resiliency, which could be more economical eventually.
- Improve control during construction to reduce the possibility of small traffic signs not having foundations that do not meet the requirements of the PRHTA.

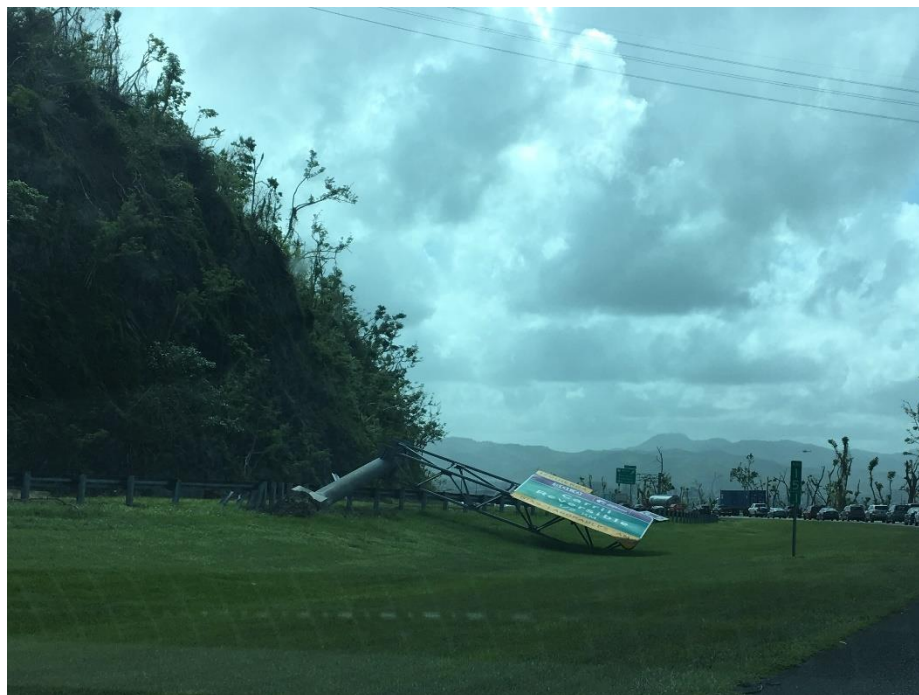
Figure 1-5: Example of Overhead Cantilever Sign Failure due to Hurricane Maria

to Puerto Rico. During Hurricane Maria, some of these structures suffered different types of damages. They were exposed to lateral loads of intense winds that exceeded their capacity, resulting in the total or partial collapse of some of them. A collapse example is shown in Figure 1-5.

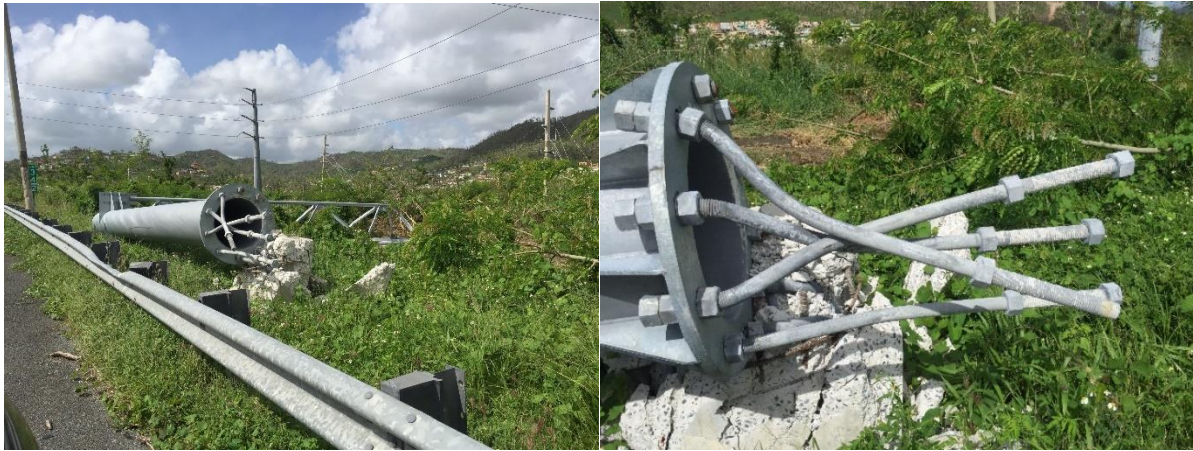
Figure 4-1: Collapsed Cantilever Sign in PR-30 Highway

Figure 4-1 and Figure 4-2 show the total collapse of two cantilever traffic sign located on PR-30 highway, near Yabucoa. These cases allowed to identify failures on the foundation pedestal, with the anchor bolts experiencing large deformations, shear failure, and being place outside the

confinement provided by the stirrups. These preliminary findings suggested that a comprehensive graphical documentation of the pedestal was recommended for further field visits.

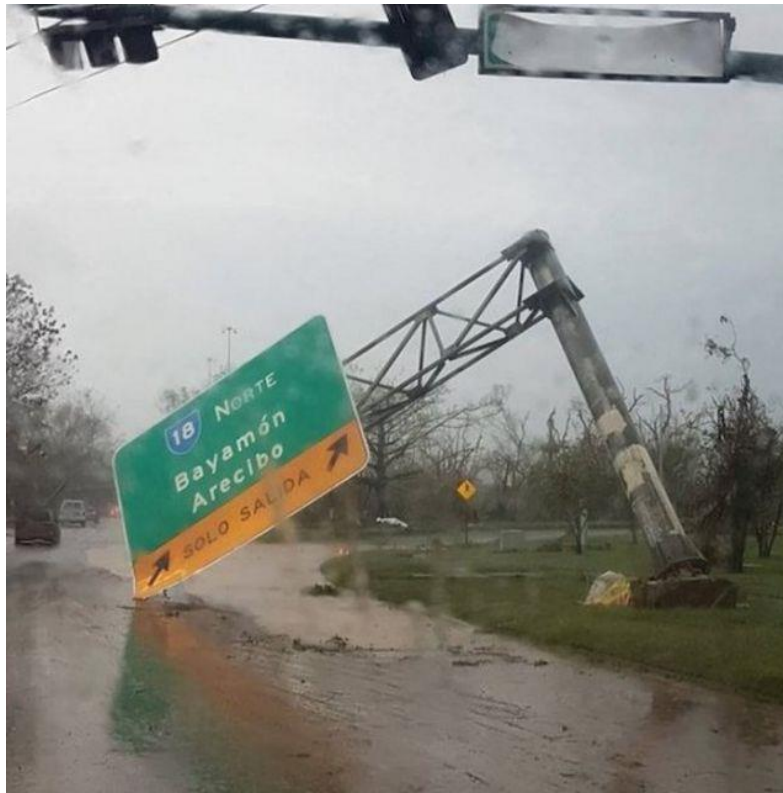
Figure 4-6: Overhead Cantilever Traffic Sign Collapse on PR-17 (Lima, 2017)

Local and global news outlets were reviewed, searching for articles describing damages to the transportation infrastructure in general, and to the traffic signs in particular. One case study was obtained this way, reported by journalist Jay Fonseca in the newspaper *El Nuevo Día*. The sign was located in PR-53 Highway, near Salinas. A BBC Mundo news report presented a case depicted in Figure 4-6, which resulted in one of the cases identified in the preliminary tours in PR-17.

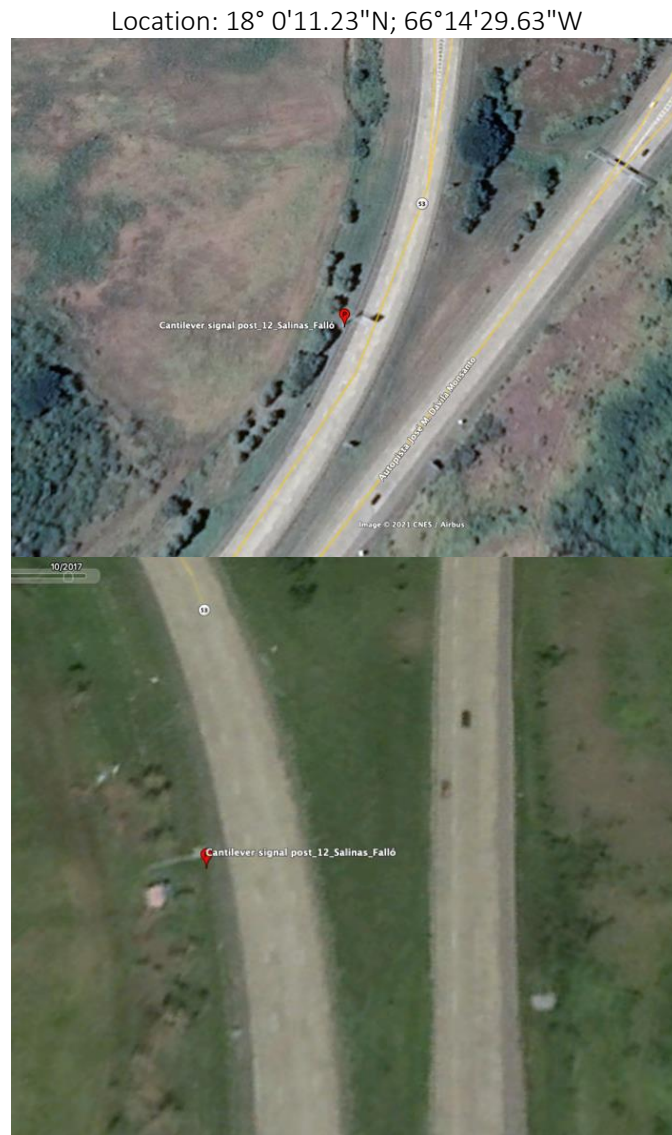
Figure 4-7: Cantilever Sign Post 12 Located in Salinas (Picture1 (12/2016), Picture 2 (10/2017))

Images in Figure 4-7 were obtained from the research carried out using the program Google Earth Pro, which works with the historical image analysis method, comparing those presented by the 10/2017 program with those of 12/2016. The inspected sign showed a foundation rotation/twisting failure. For this case (as presented in further chapters), samples of the materials were extracted to perform laboratory testing of their mechanical properties.

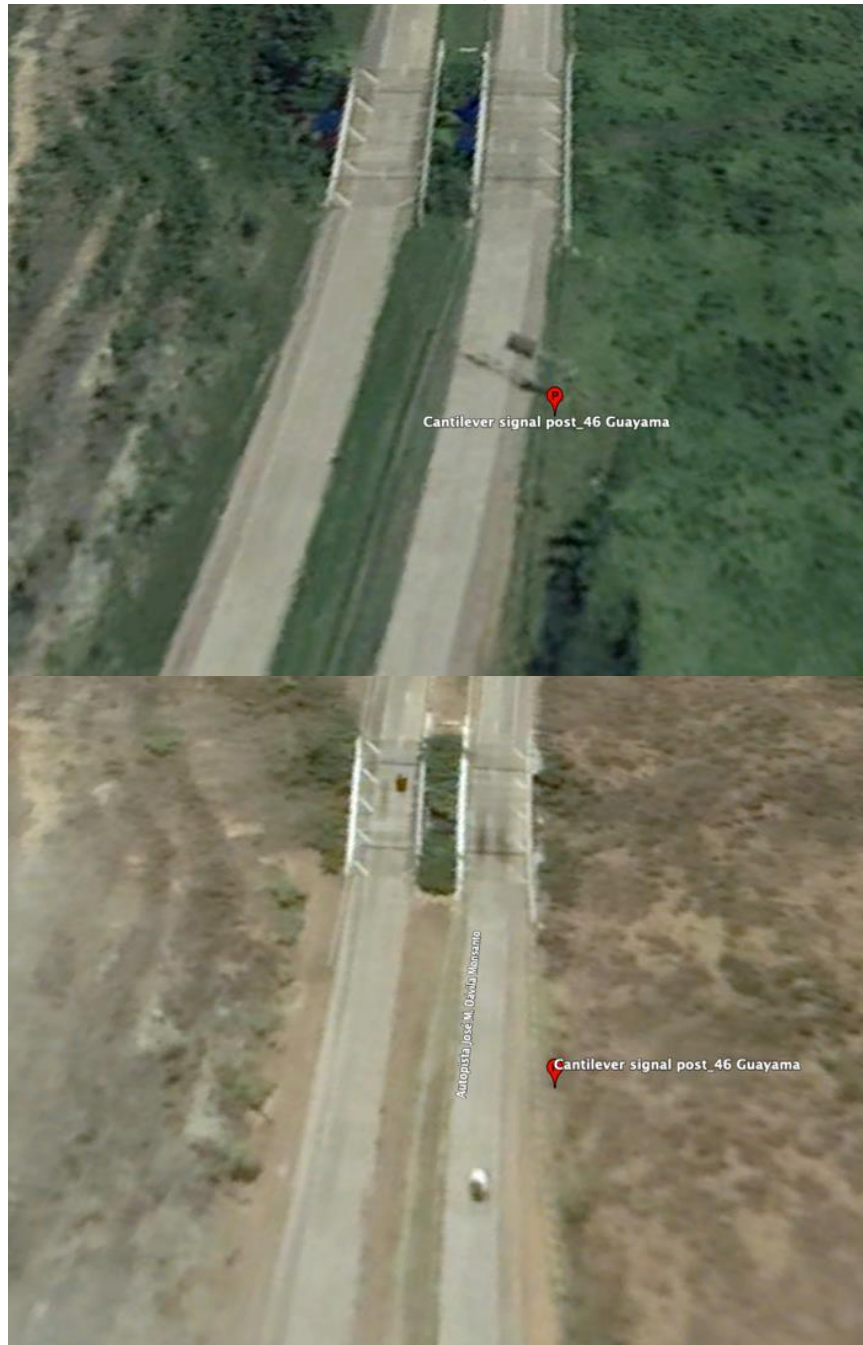
Figure 4-8: Cantilever Sign Post 46 Located in Guayama (Picture 1: 10/2017, Picture 2: 1/2019)

Images in Figure 4-8 were obtained from the research carried out using the program Google Earth Pro, which works with the historical image analysis method, comparing those presented by the 1/2019 program with those of 10/2017. Apparent structural collapse, the sign appeared to be removed from the site.

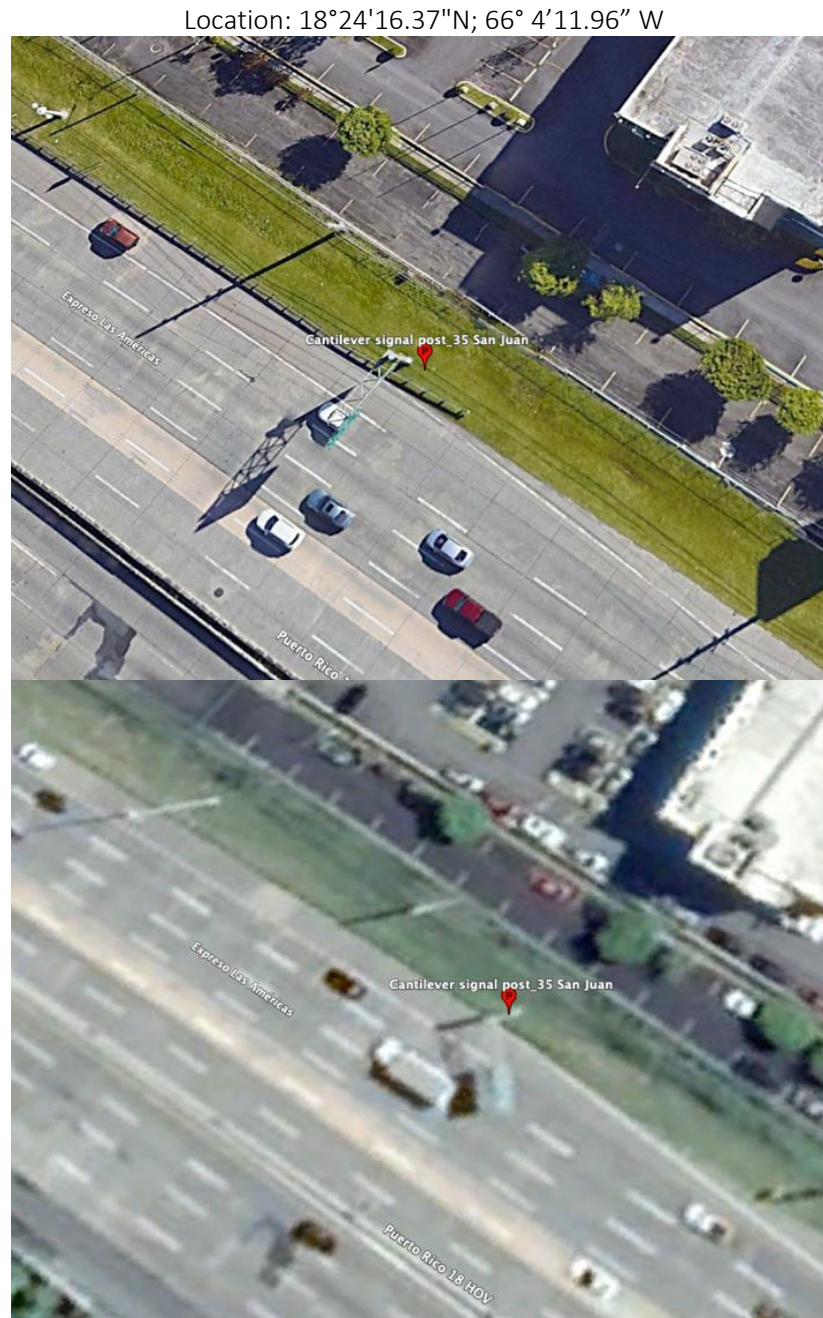
Figure 4-9: Cantilever Sign Post 35 located in San Juan (Picture 1: 4/2016, Picture 2: 1/2020)

Photos in Figure 4-9 were obtained from the research carried out using the program Google Earth Pro, which works with the historical image analysis method, comparing those presented by the 1/2020 program with those of 4/2016. Located on PR18- N @ Km 2.80. The Cantilever sign rotated approximately 30 degrees. The concrete base could not be seen because it was covered in dirt like most of the steel bolts.

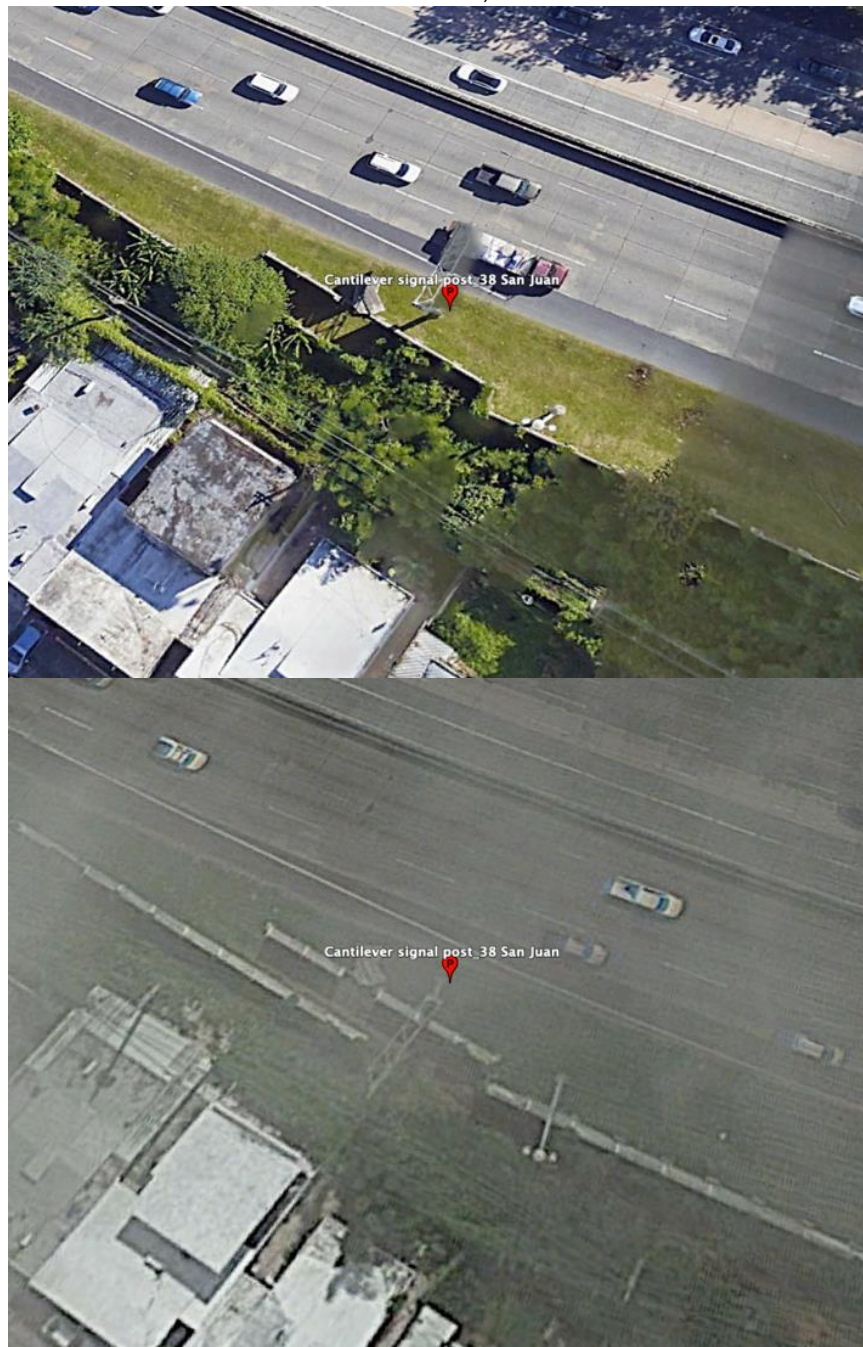
Figure 4-10: Cantilever Sign Post 38 Located in San Juan. (Picture 1: 4/2016, Picture 2: 4/2018)

Images in Figure 4-10 were obtained from the research carried out using the program Google Earth Pro, which works with the historical image analysis method, comparing those presented by the 4/2018 program with those of 4/2016. Located on PR18 Km 3.0 the Cantilever sign rotated 180 degrees, and the soil around the base failed allowing the base to rotate.

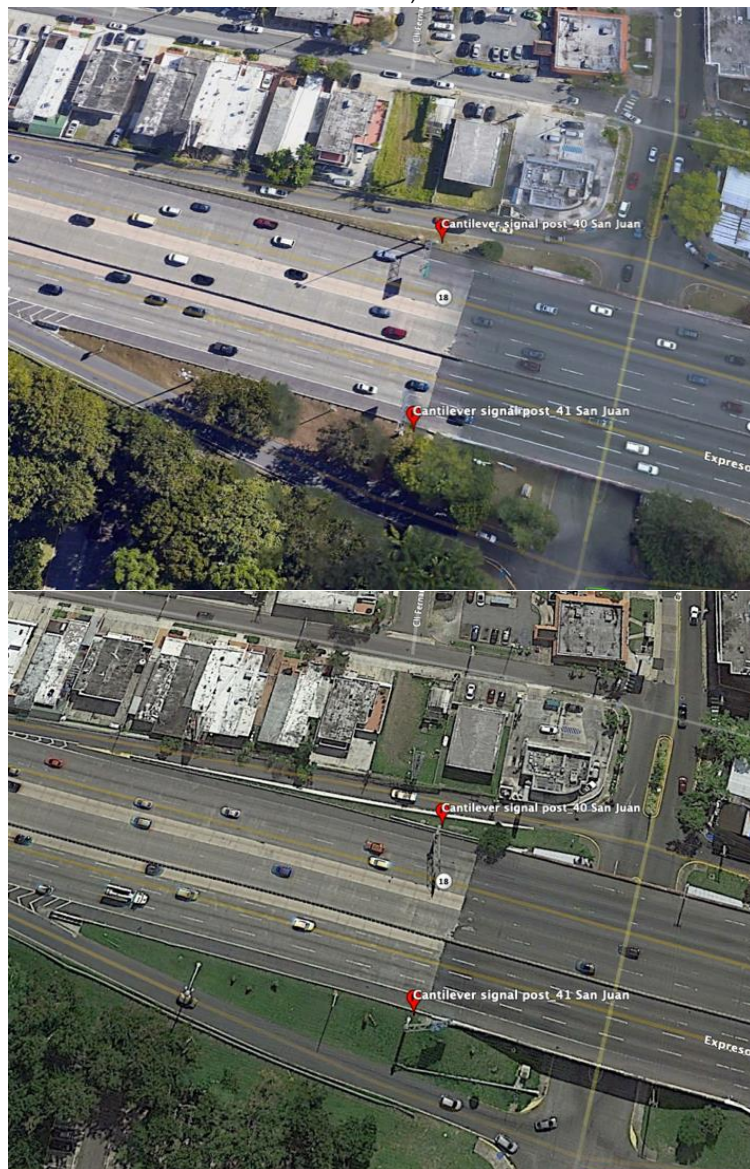
Figure 4-11: Cantilever Sign Post 40 and 41 located in San Juan. (Picture 1: 4/2016, Picture 2: 4/2018)

Photos in Figure 4-11 were obtained from the research carried out using the program Google Earth Pro, which works with the historical image analysis method, comparing those presented by the 4/2018 program with those of 4/2016. They show two cantilever traffic signs. The base of the post identified as P-40 rotated approximately 15 degrees and the base suffered damage from loss of cover and cracking. The P-41 cantilever sign base rotated approximately 70 degrees and the concrete base suffered damage from loss of cover and cracking exposing the anchor bolts.

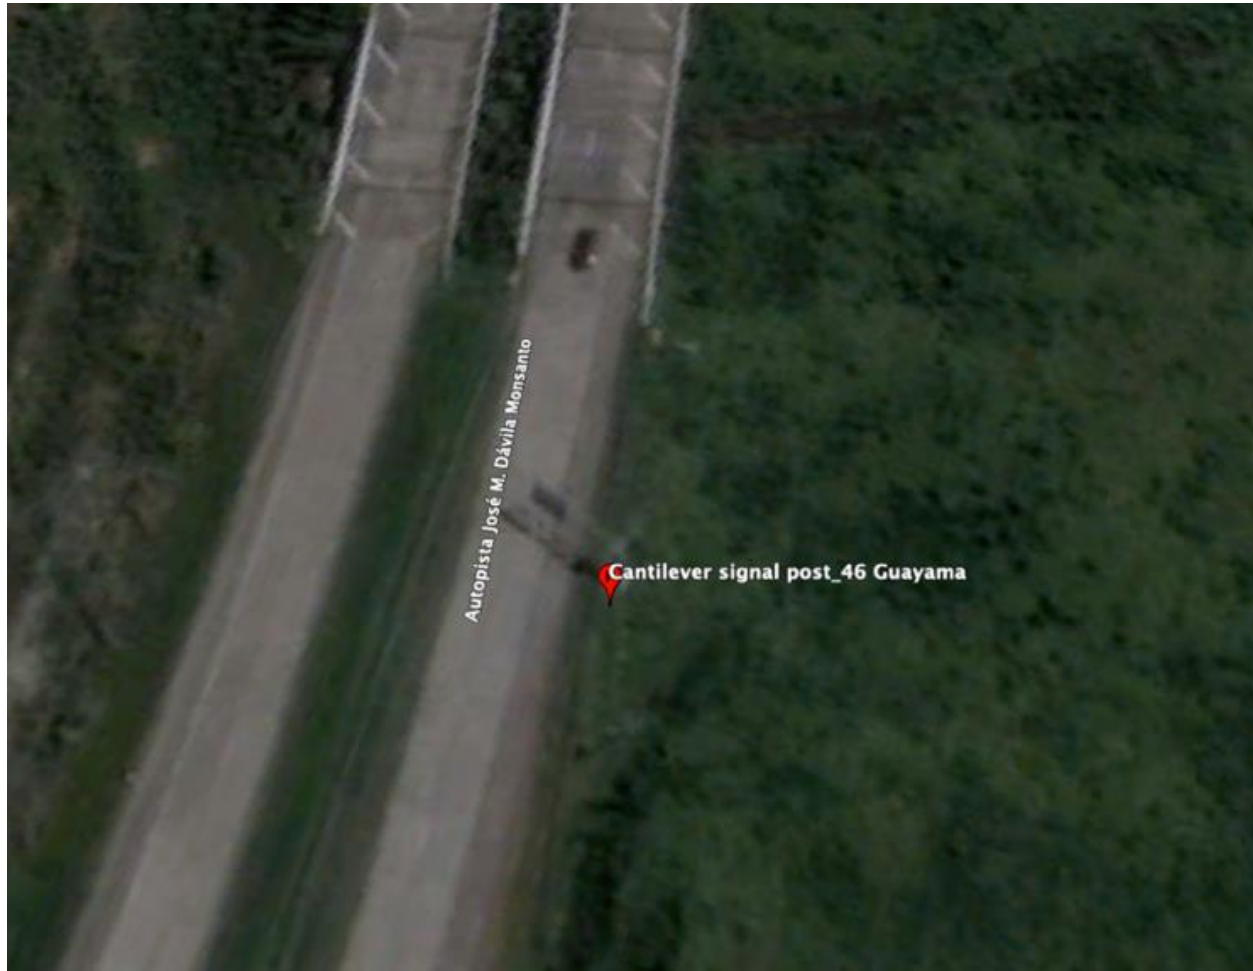
Figure 4-12: Cantilever Sign Post 46 Located in Guayama (Picture 1: 10/2017)

Figure 4-12 were obtained from the research carried out using the program Google Earth Pro, which works with the historical image analysis method, using the image from 10/2017 where the base of the pole identified as P-46 shows a rotation of approximately 20 degrees.

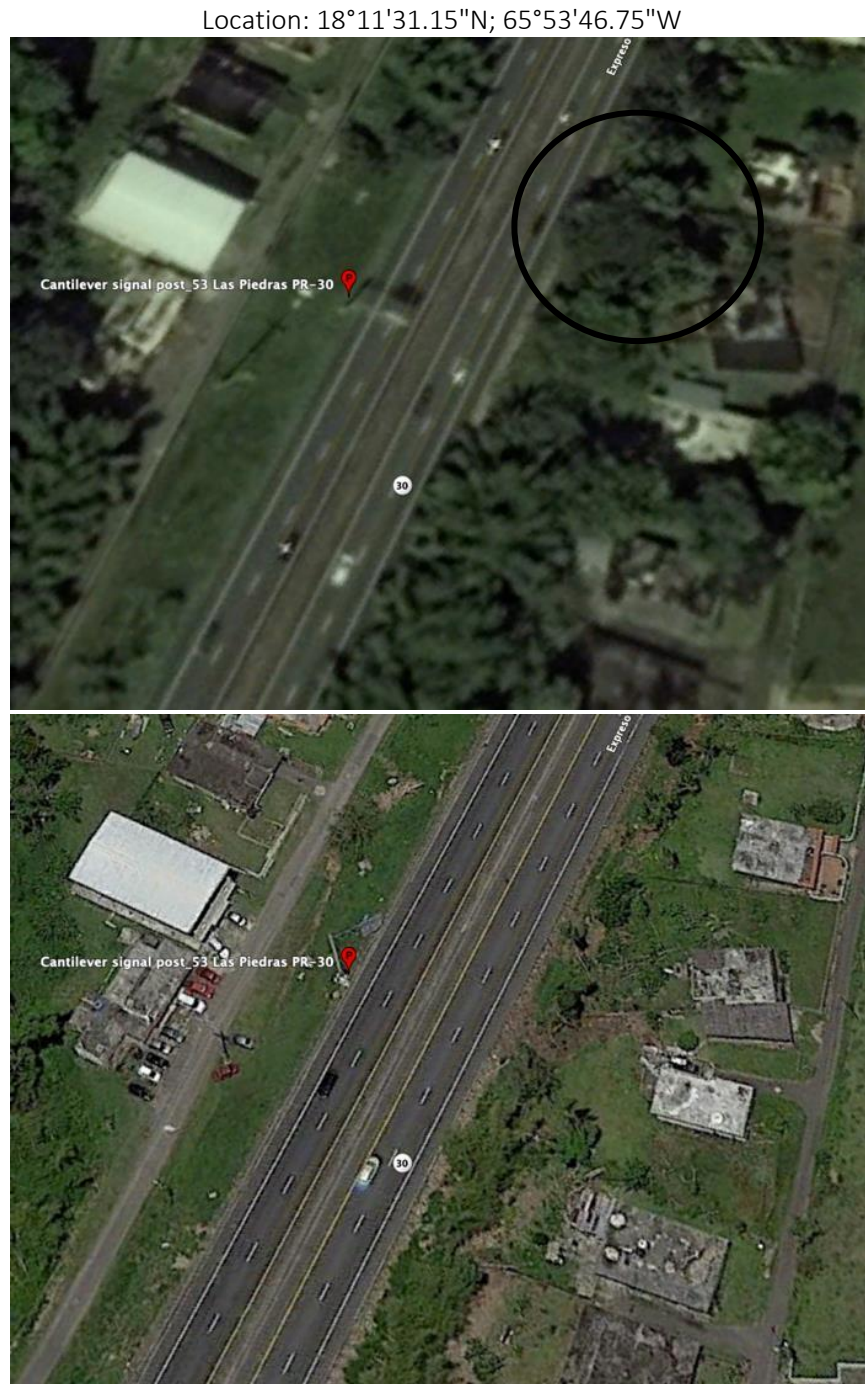
Figure 4-13: Cantilever Sign Post 53 Located in Las Piedras (Picture 1: 11/2016, Picture 2: 4/2018).

Images in Figure 4-13 were obtained from the research carried out using the program Google Earth Pro, which works with the historical image analysis method, comparing those presented by the 4/2018 program with those of 11/2016. This allows to identify a change in position of the post indicating a possible collapse.

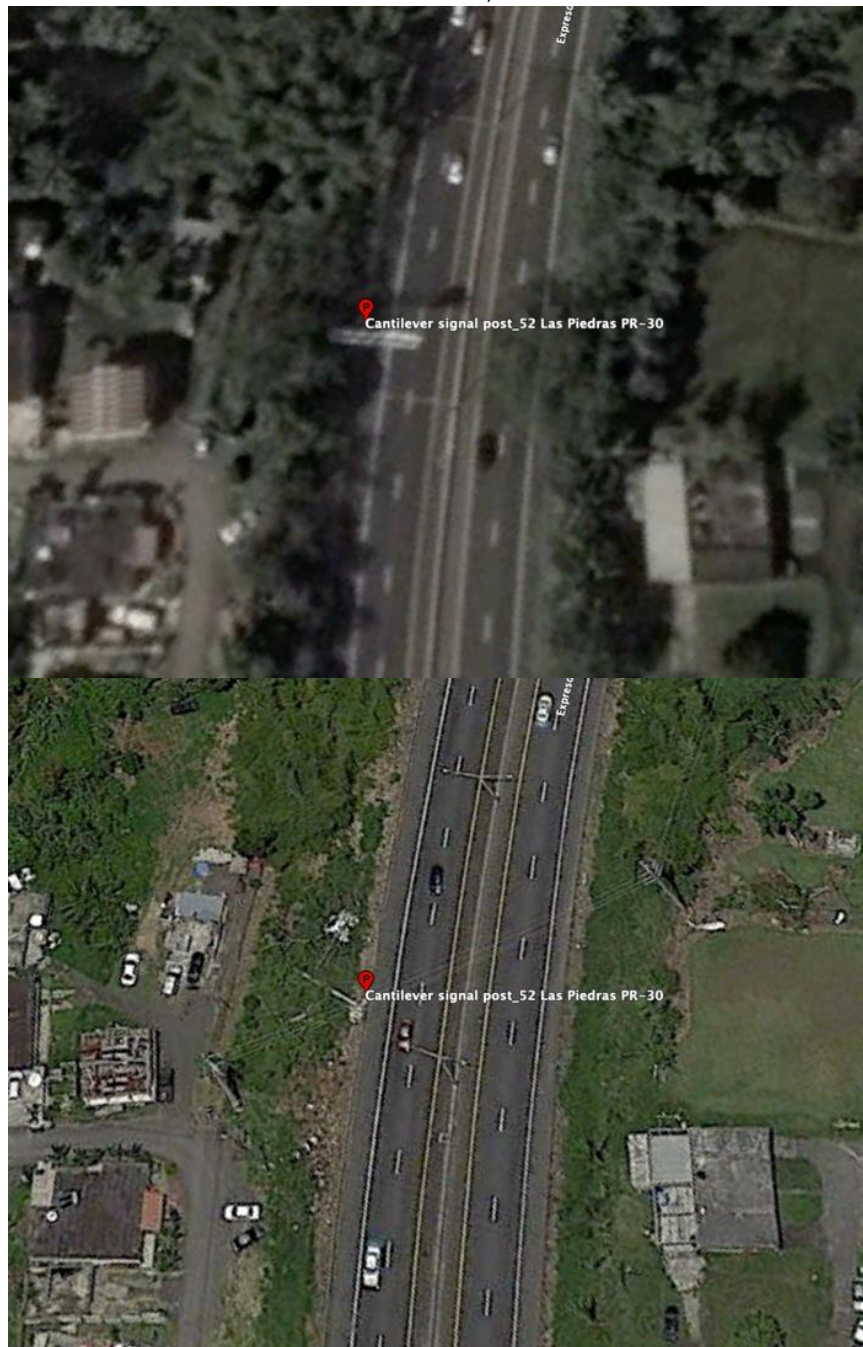
Figure 4-14: Cantilever Sign Post 52 Located in Las Piedras (Picture 1: 1/2014, Picture 2: 4/2018)

Images in Figure 4-14 were obtained from the research carried out using the program Google Earth Pro, which works with the historical image analysis method, comparing those presented by the 4/2018 program with those of 1/2014. This allows to identify a change in position of the post indicating a possible collapse.

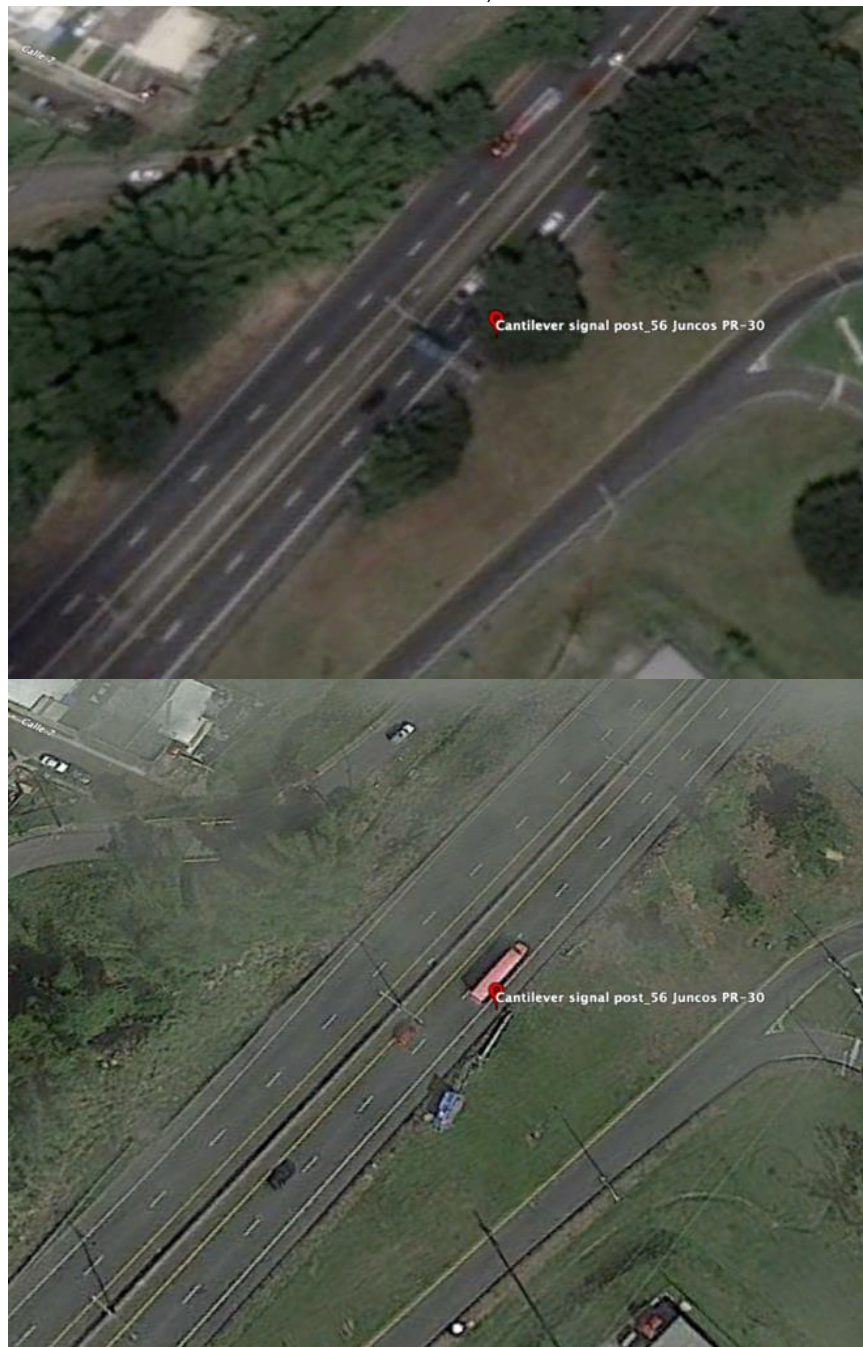
Figure 4-15: Cantilever Sign Post 56 Located in Juncos (Picture 1: 10/2016, Picture 2: 4/2018)

Photos in Figure 4-15 were obtained from the research carried out using the program Google Earth Pro, which works with the historical image analysis method, comparing those presented by the 4/2018 program with those of 10/2016. This allows to identify a change in position of the post indicating a possible collapse.

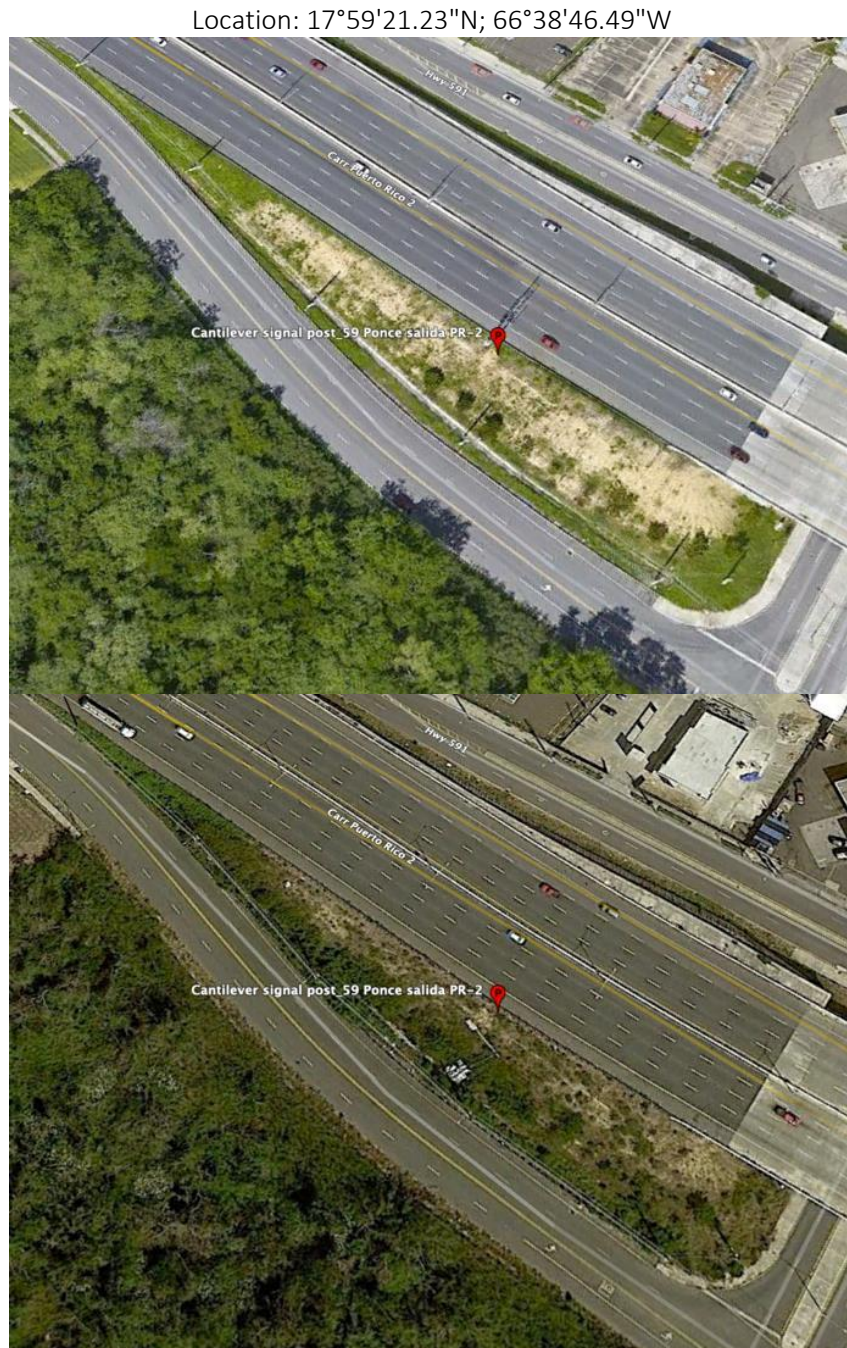
Figure 4-16: Cantilever Sign Post 59 Located in Ponce (Picture 1: 4/2016, Picture 2: 4/2018)

Photos in Figure 4-16 were obtained from the research carried out using the program Google Earth Pro, which works with the historical image analysis method, comparing those presented by the 4/2018 program with those of 4/2016. This allows to identify a change in position of the post indicating a possible collapse.
