Improving Transportation Infrastructure Resilience against Hurricanes, other Natural Disasters, and Weathering: Part I - Analysis of failure of transportation signs due to Hurricane Maria

Volume 1

FINAL REPORT
June 2022

Transportation Infrastructure Research Center – TIRC
Polytechnic University of Puerto Rico
377 Ponce de Leon Ave, San Juan, PR 00918

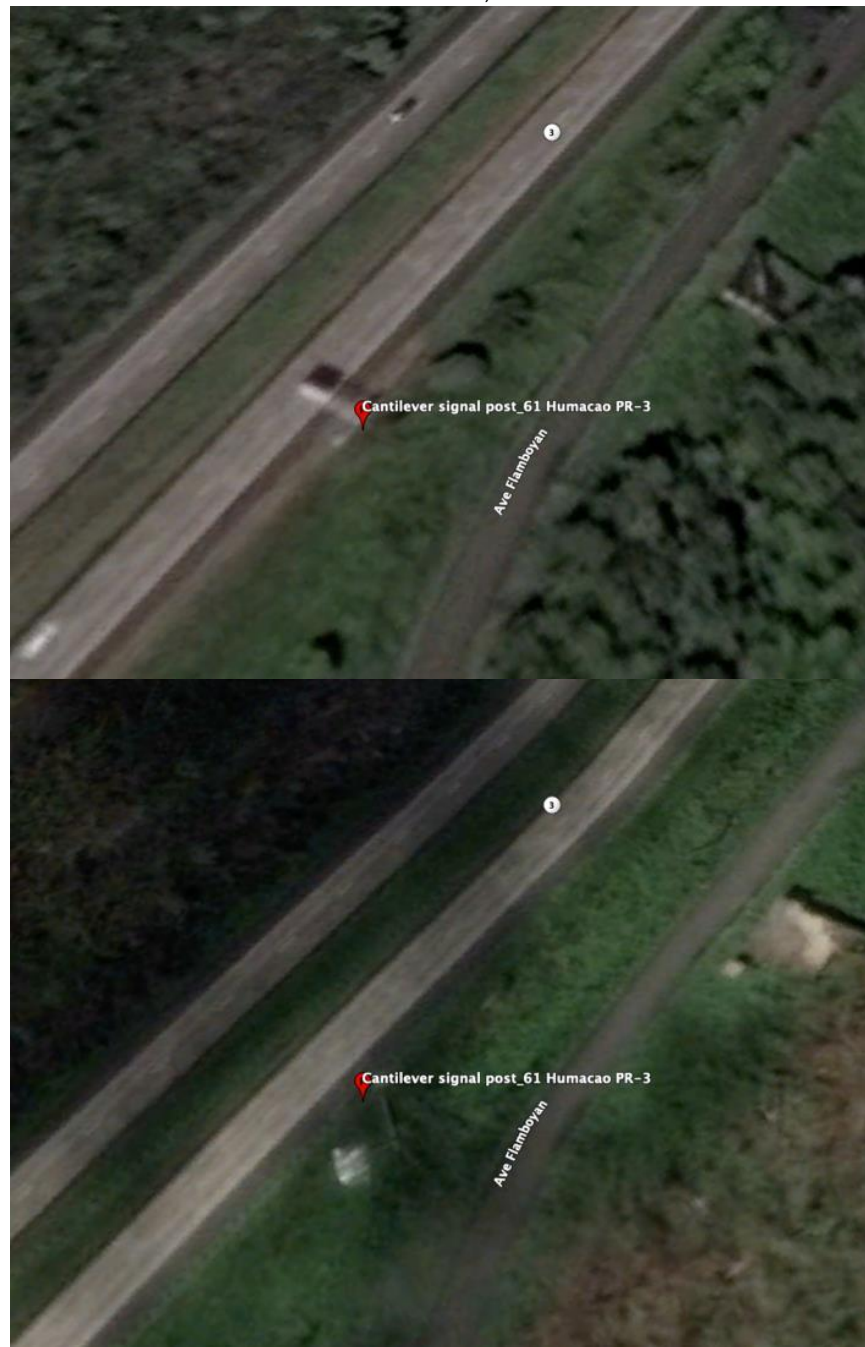
Figure 4-17: Cantilever Sign Post 61 Located in Humacao (Picture 1: 12/2016, Picture 2: 10/2017)

Images in Figure 4-17 were obtained from the research carried out using the program Google Earth Pro, which works with the historical image analysis method, comparing those presented by the 10/2017 program with those of 12/2016. This allows to identify a change in position of the post indicating a possible collapse.

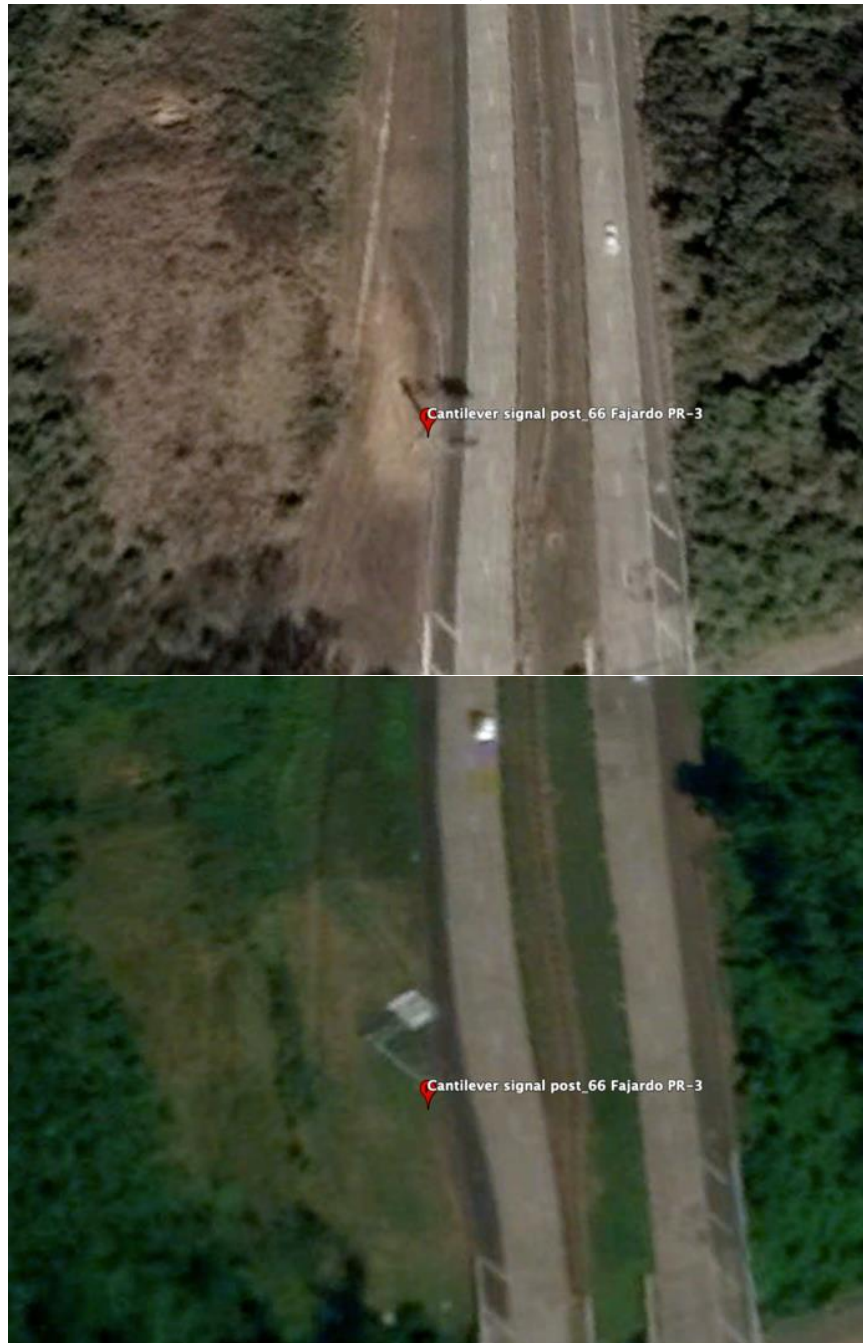
Figure 4-18: Cantilever Sign Post 66 Located in Fajardo (Picture 1: 2/2017, Picture 2: 1/2018)

Photos in Figure 4-18 were obtained from the research carried out using the program Google Earth Pro, which works with the historical image analysis method, comparing those presented by the 1/2018 program with those of 2/2017. This allows to identify a change in position of the post indicating a possible collapse.

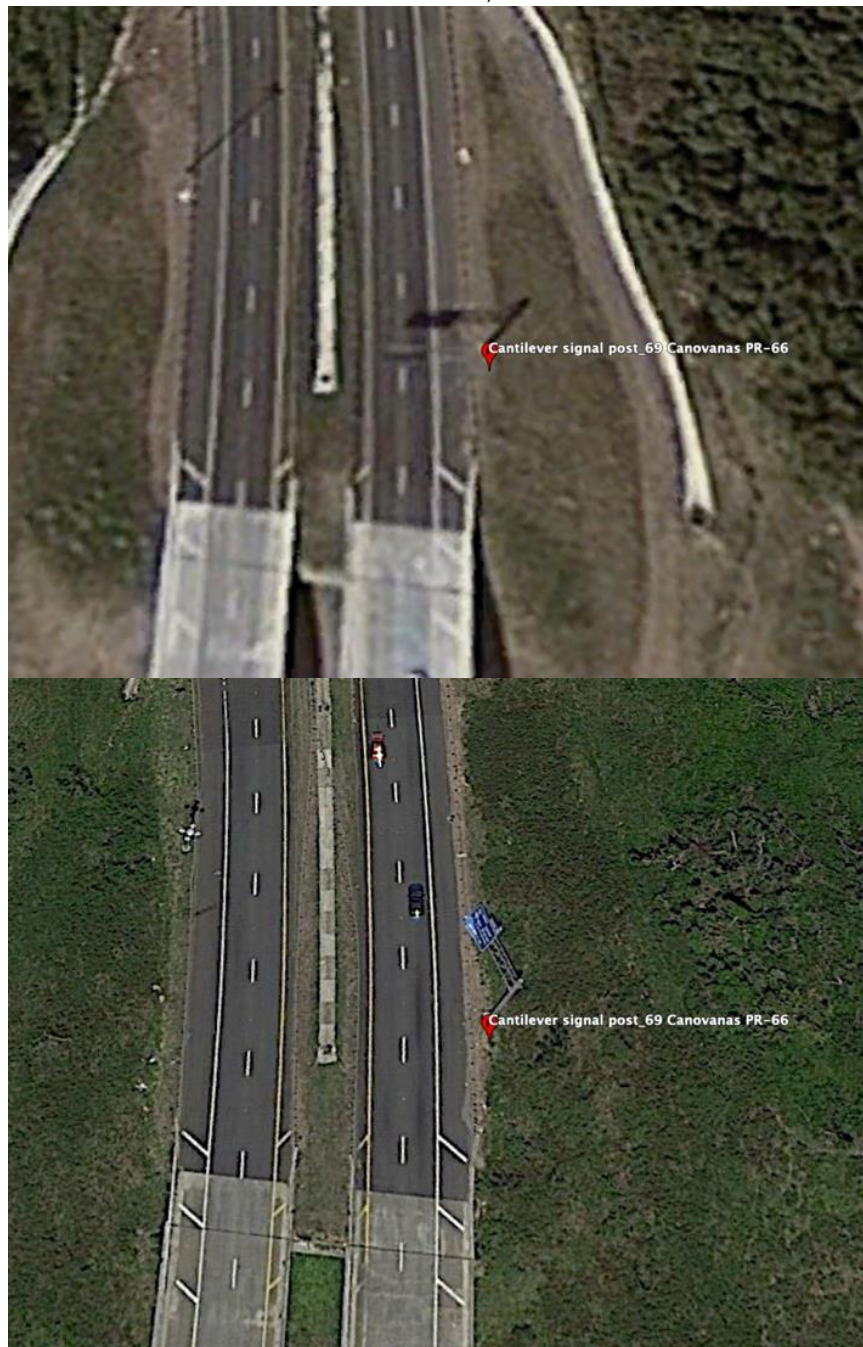
Figure 4-19: Cantilever Sign Post 69 Located in Canóvanas (Picture 1: 3/2013, Picture 2: 4/2018)

Images in Figure 4-19 were obtained from the research carried out using the program Google Earth Pro, which works with the historical image analysis method, comparing those presented by the 4/2018 program with those of 3/2013. This allows to identify a change in position of the post indicating a possible collapse.

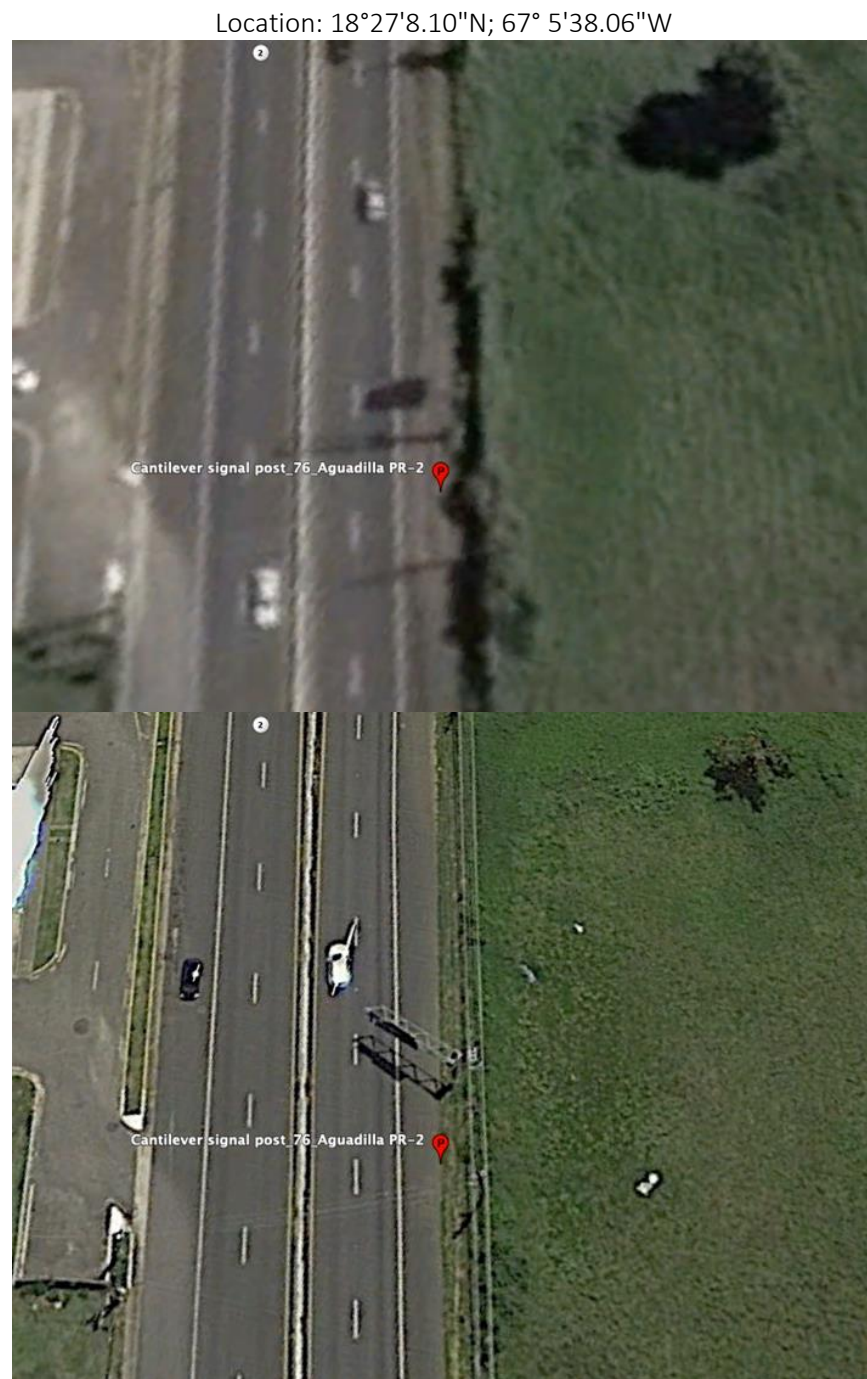
Figure 4-20: Cantilever Sign Post 76 Located in Aguadilla (Picture 1: 2/2017, Picture 2: 4/2018)

Images in Figure 4-20 were obtained from the research carried out using the program Google Earth Pro, which works with the historical image analysis method, comparing those presented by the 4/2018 program with those of 2/2017. Cantilever sign foundation failure at P-76 in PR 2_Aguadilla. The Cantilever sign rotated approximately 30 degrees.

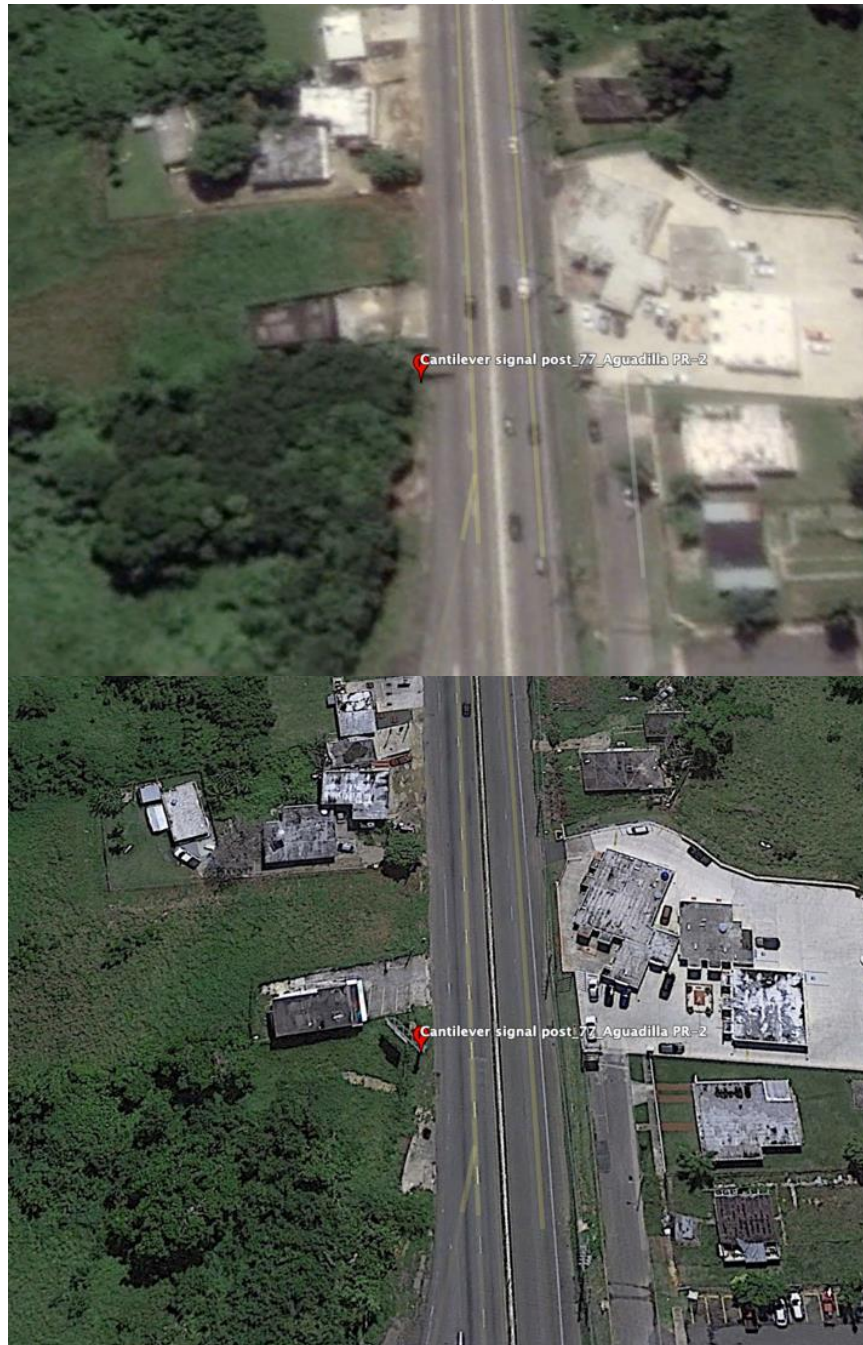
Figure 4-21: Cantilever Sign Post 77 Located in Aguadilla (Picture 1: 9/2016, Picture 2: 5/2018)

Images in Figure 4-21 were obtained from the research carried out using the program Google Earth Pro, which works with the historical image analysis method, comparing those presented by the 5/2018 program with those of 9/2016. Cantilever sign foundation failure at P-77 in PR 2_Aguadilla. The Cantilever sign rotated approximately 270 degrees.

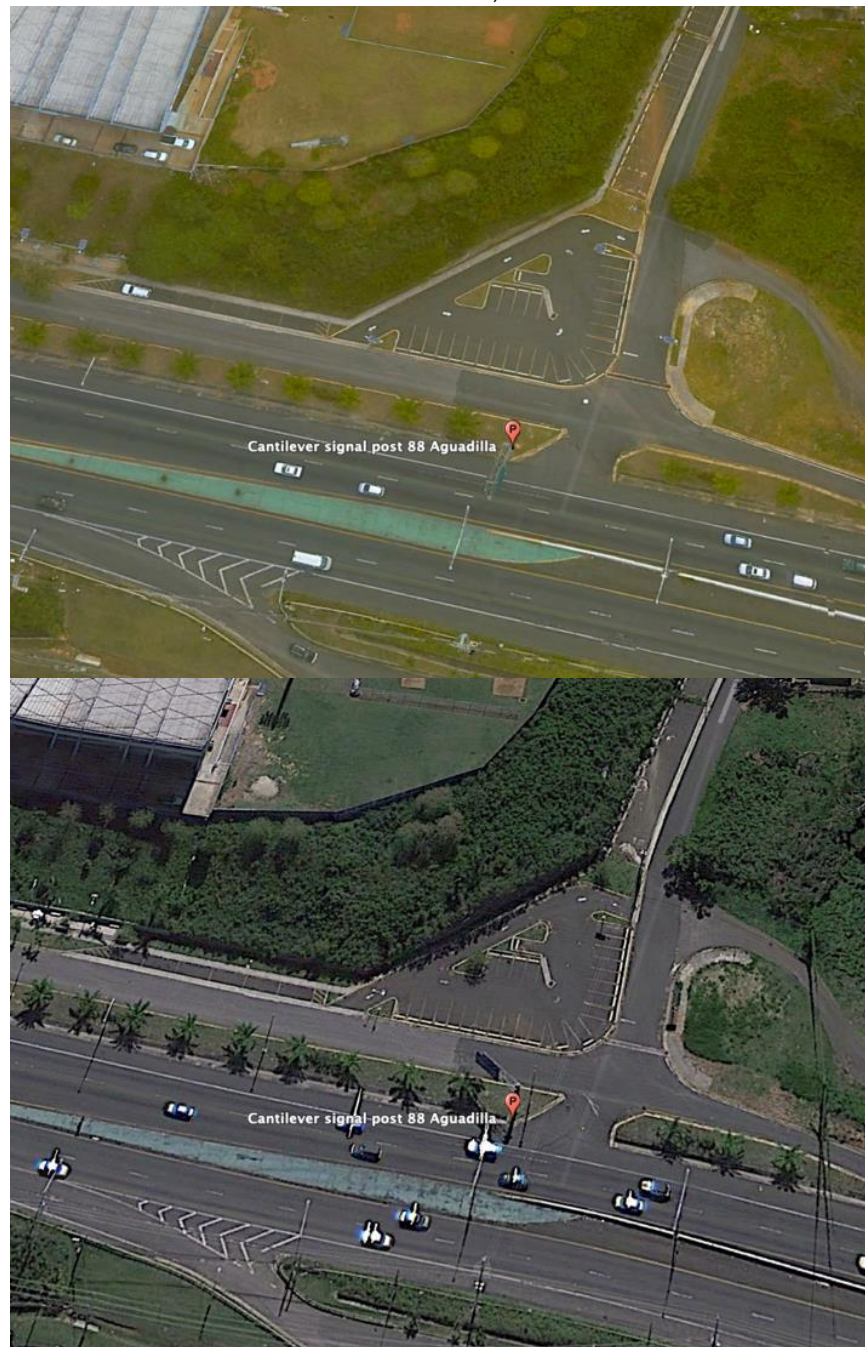
Figure 4-22: Cantilever Sign Post 88 Located in Aguadilla (Picture 1: 3/2016, Picture 2: 5/2018)

Photos in Figure 4-22 were obtained from the research carried out using the program Google Earth Pro, which works with the historical image analysis method, comparing those presented by the 5/2018 program with those of 9/2016. Cantilever sign foundation failure at P-88 in PR 2_Aguadilla. The Cantilever sign rotated approximately 100 degrees.

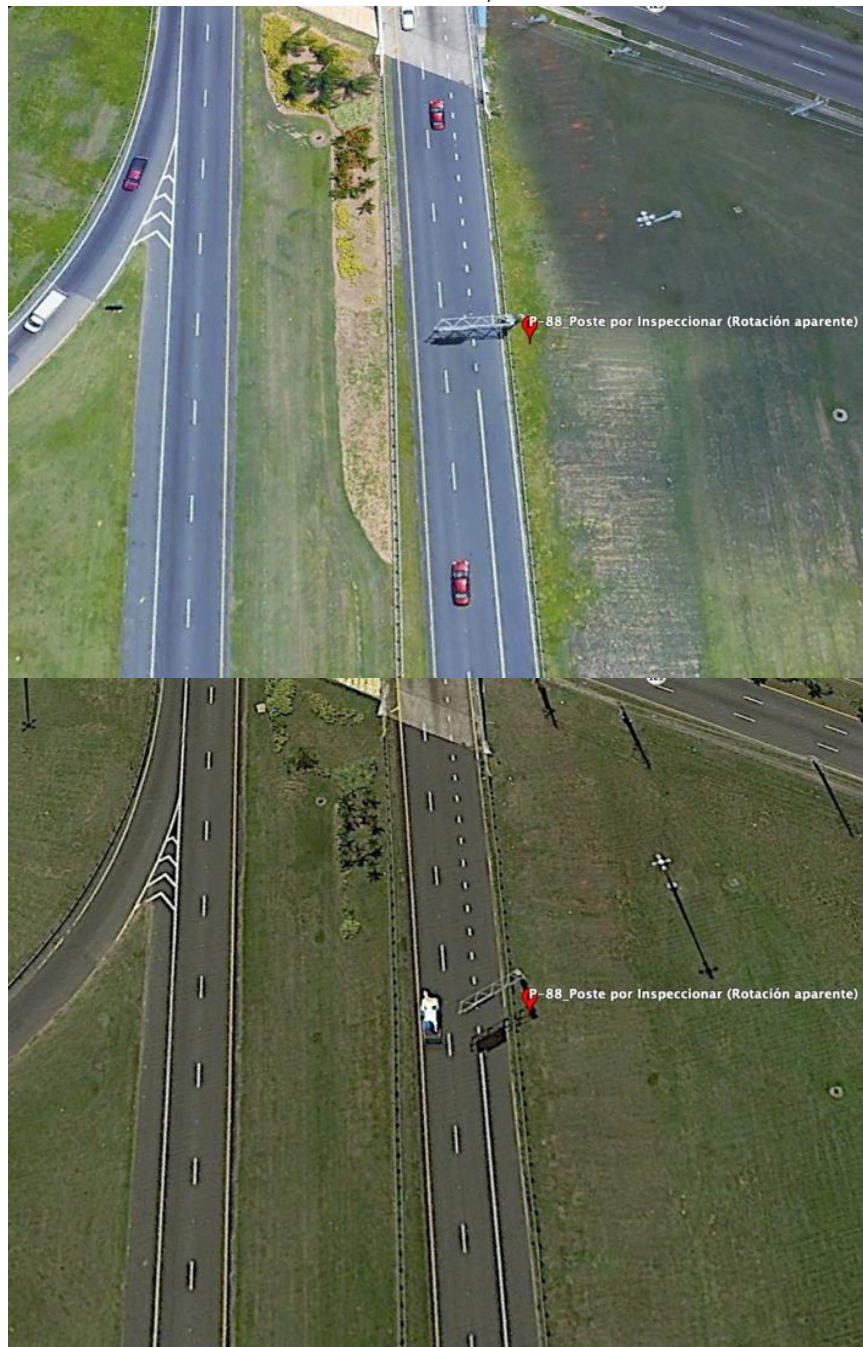
Figure 4-23: Cantilever Sign Post 88 Located in Arecibo (Picture 1: 3/2016, Picture 2 4/2018)

Photos in Figure 4-23 were obtained from the research carried out using the program Google Earth Pro, which works with the historical image analysis method, comparing those presented by the 4/2018 program with those of 3/2016. Cantilever sign foundation failure at P-88 in PR 22_Arecibo. The Cantilever sign rotated approximately 20 degrees.

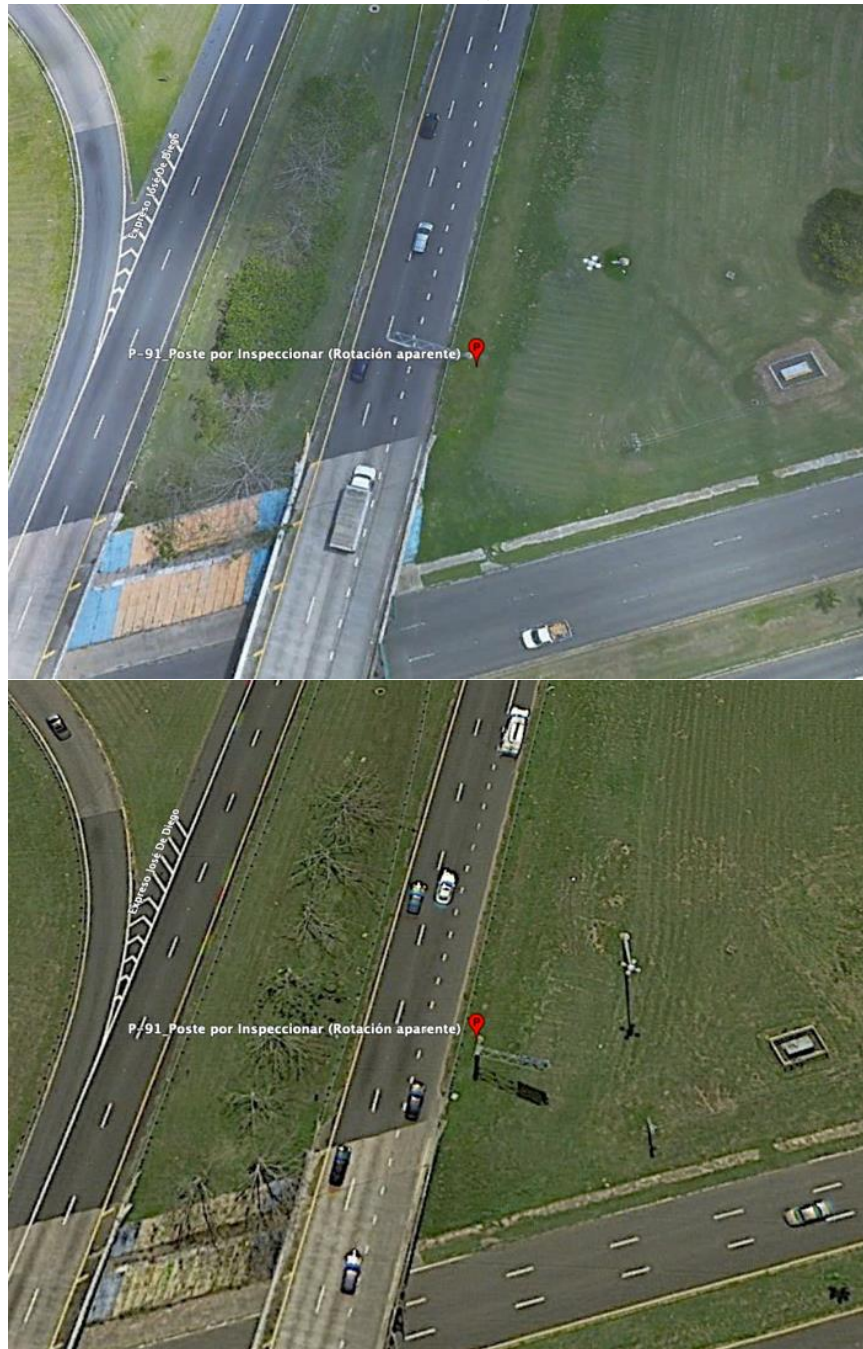
Figure 4-24: Cantilever Sign Post 91 Located in Arecibo (Picture 1: 3/2016, Picture 2: 4/2018)

Photos in Figure 4-24 were obtained from the research carried out using the program Google Earth Pro, which works with the historical image analysis method, comparing those presented by the 5/2018 program with those of 9/2016. Cantilever sign foundation failure at P-91 in PR 52_Arecibo. The Cantilever sign rotated approximately 180 degrees.

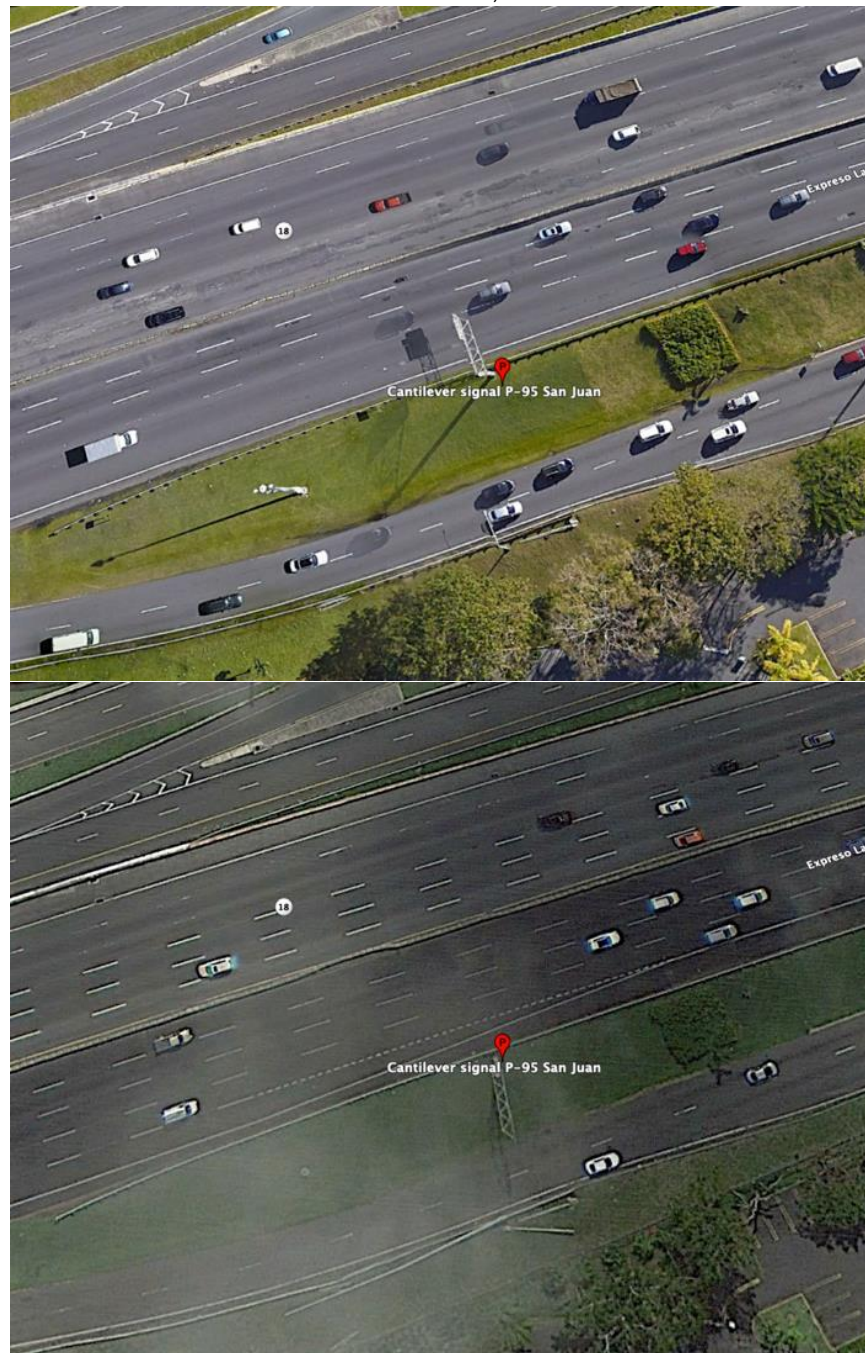
Figure 4-25: Cantilever Sign Post 95 Located in San Juan (Picture 1: 4/2016, Picture 2: 4/2018)

Images in Figure 4-25 were obtained from the research carried out using the program Google Earth Pro, which works with the historical image analysis method, comparing those presented by the 4/2018 program with those of 4/2016. Cantilever sign foundation failure at P-95 in PR 18_San Juan. The Cantilever sign rotated approximately 180 degrees.

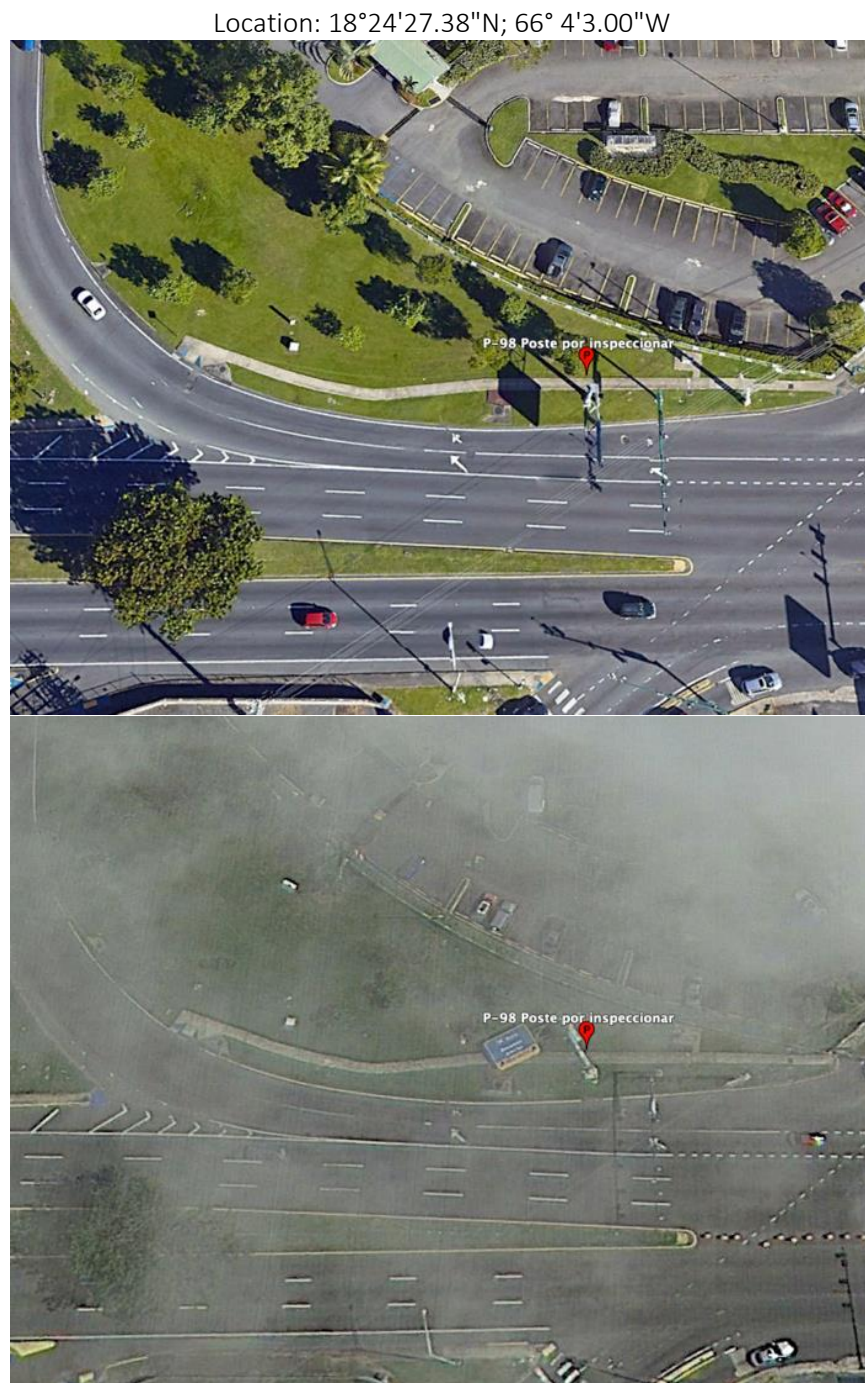
Figure 4-26: Cantilever Sign Post 98 Located in Las Piedras (Picture 1: 4/2016, Picture 2: 4/2018)

Images in Figure 4-26 were obtained from the research carried out using the program Google Earth Pro, which works with the historical image analysis method, comparing those presented by the 4/2018 program with those of 4/2016. This allows to identify a change in position of the post indicating a possible collapse.

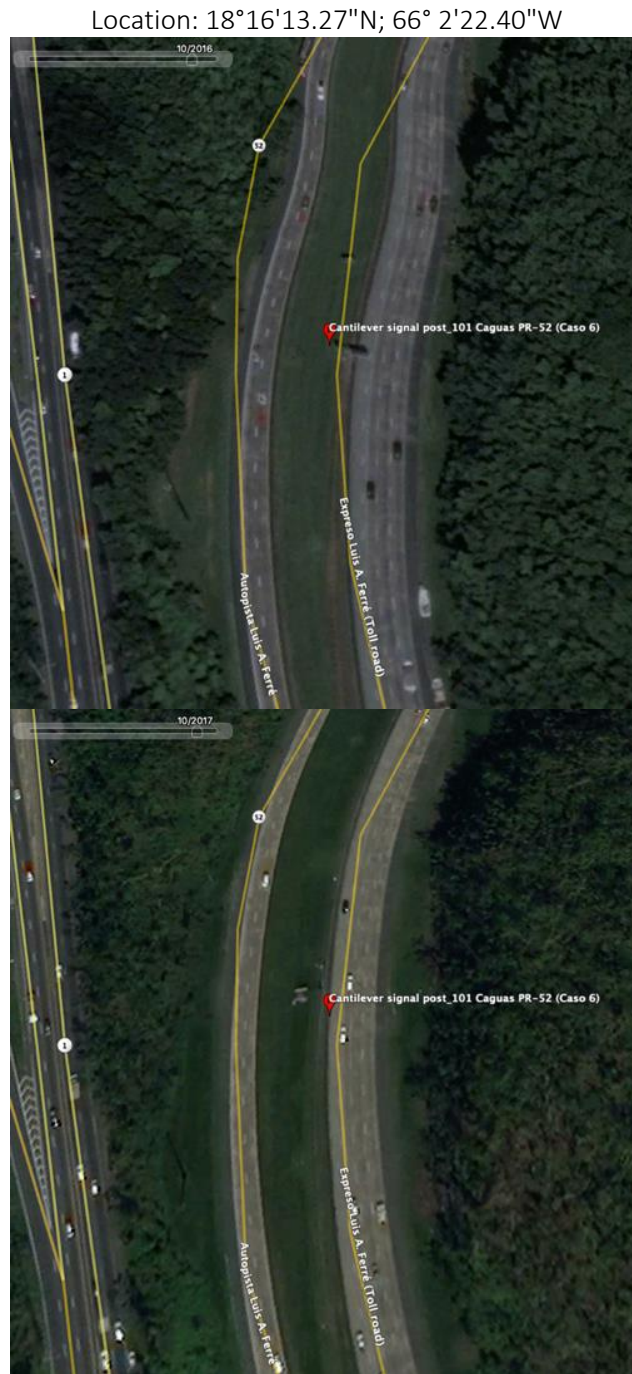
Figure 4-27: Cantilever Sign Post 101 Located in Caguas (Picture 1: 10/2016, Picture 2: 10/2017)

Photos in Figure 4-27 were obtained from the research carried out using the program Google Earth Pro, which works with the historical image analysis method, comparing those presented by the 10/2017 program with those of 10/2016. This allows to identify a change in position of the post indicating a possible collapse.

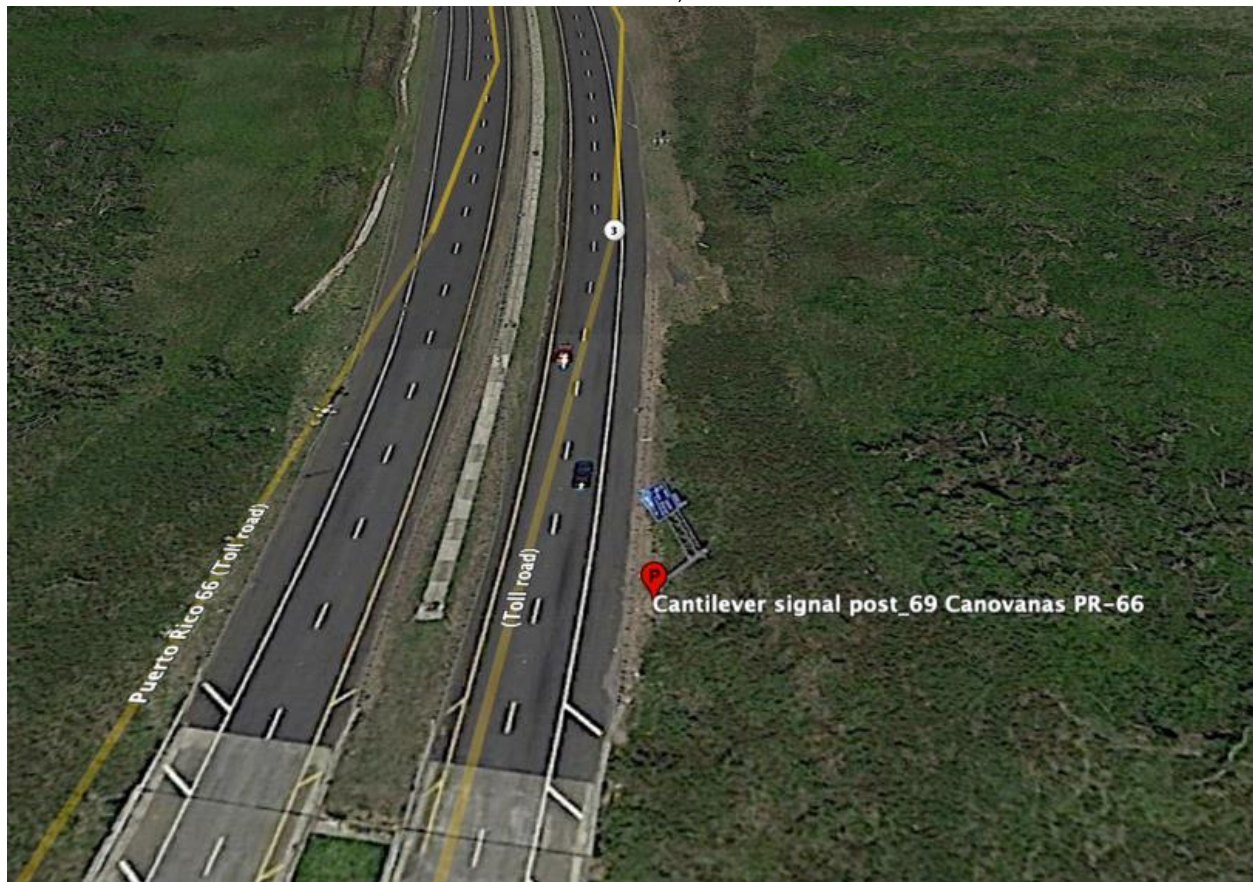
Figure 4-28 Cantilever Sign Post 69 located at Canóvanas (Picture 1: 4/2018)

Figure 4-28 was obtained from the research carried out using the program Google Earth Pro, which works with the historical image analysis method, using the image from 4/2018 where the base of the post identified as P-66. This allows to identify a change in position of the post indicating a possible collapse.

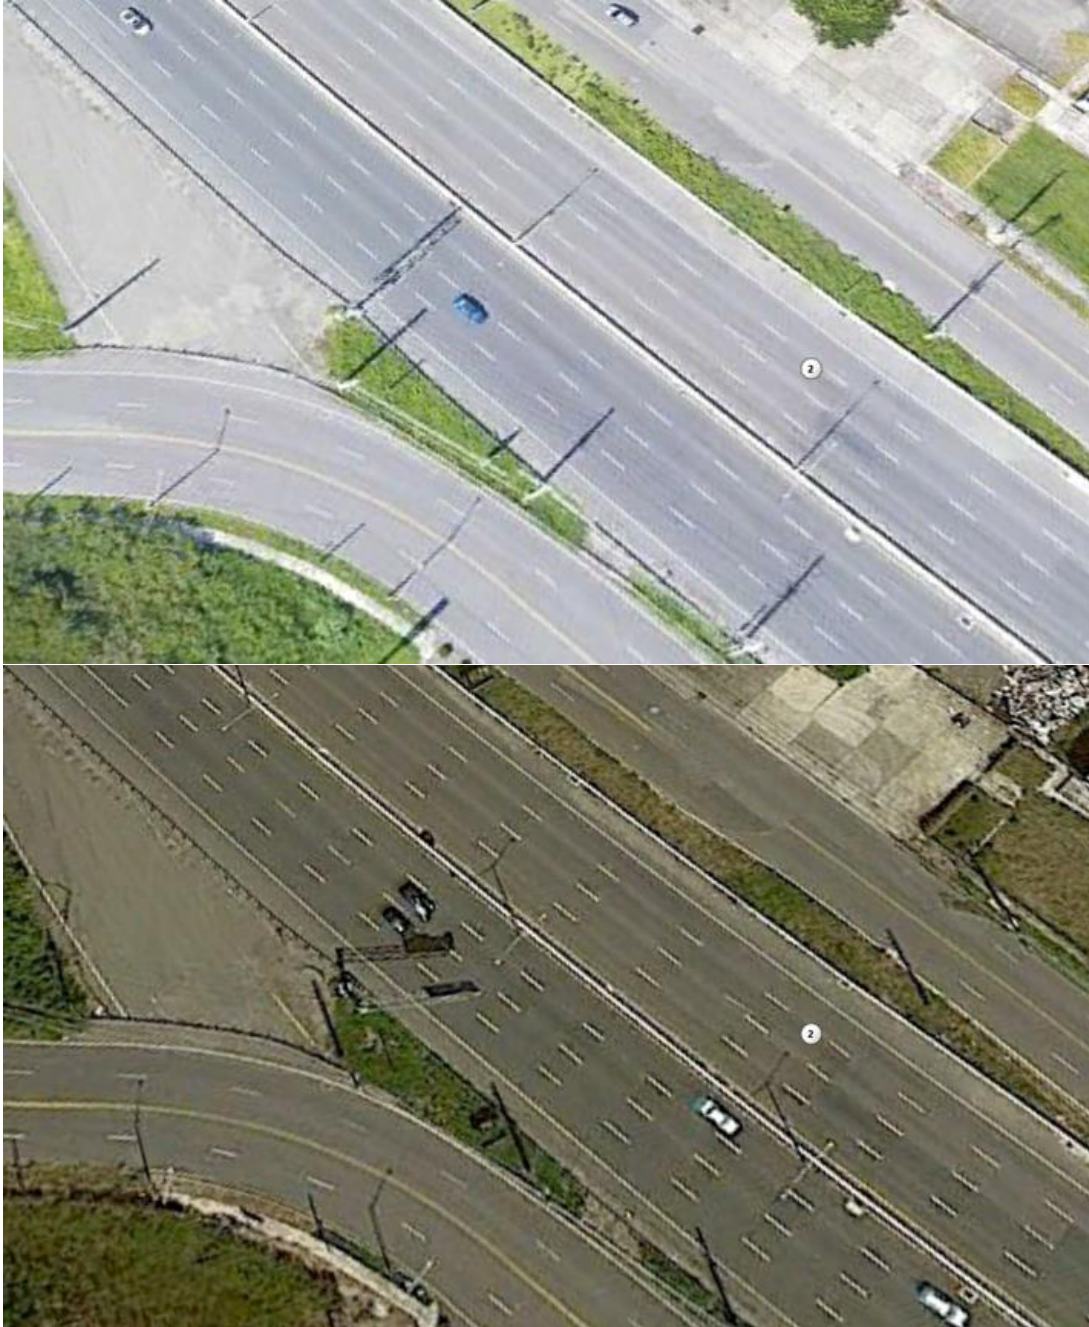
Figure 4-29 Cantilever Sign Post 94 Located in Ponce (Picture 1: 4/2016, Picture: 4/2018)

Images in Figure 4-29 were obtained from the research carried out using the program Google Earth Pro, which works with the historical image analysis method, comparing those presented by the 4/2018 program with those of 4/2016. Cantilever sign foundation failure at P-94 in PR 2_Ponce. The Cantilever sign rotated approximately 120 degrees.

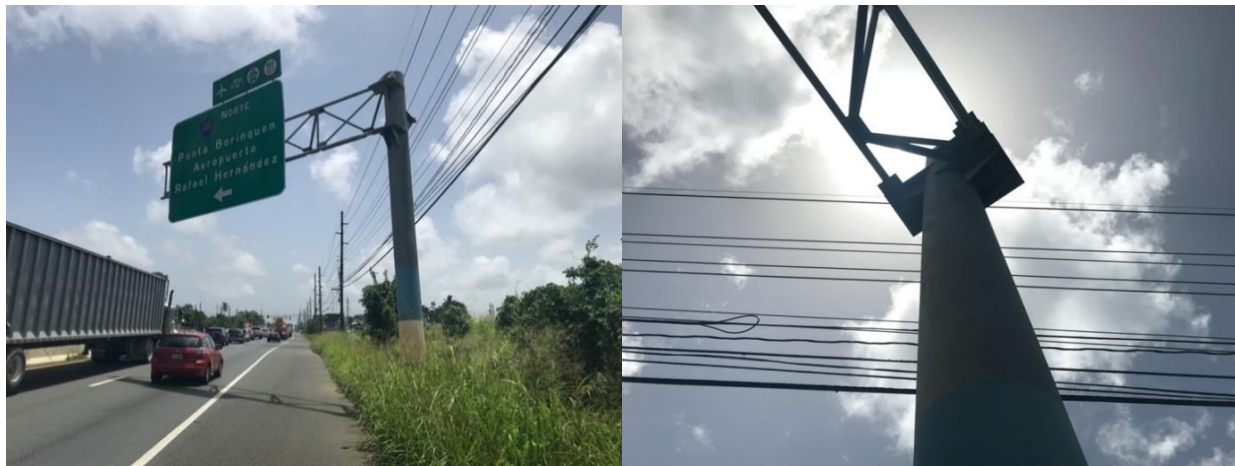
Figure 5-5: Photos Showing the Rotation of the Traffic Sign at P-76 Location: 18°27'8.10"N; 67° 5'38.06"W

Located along the southbound lane of Highway PR-2 in Aguadilla. An image of the traffic sign structure is shown on Figure 5-5. The final position of the traffic sign was rotated about 20 degrees (negative using the right-hand sign convention with respect to a vertical Zenith axis) with respect to the original installation position. The diameter of the drilled shaft that supports this structure was measured to be 30 inches (0.76 m). The visual inspection revealed fractures and detachment of the concrete at the top of the pedestal, below the post base plate, as observed in Figure 5-6; and some stiffeners at the base plate were bent; also the post showed some degree of tilting (out of plumb by about 10 grades of the superstructure with respect to the Zenith).

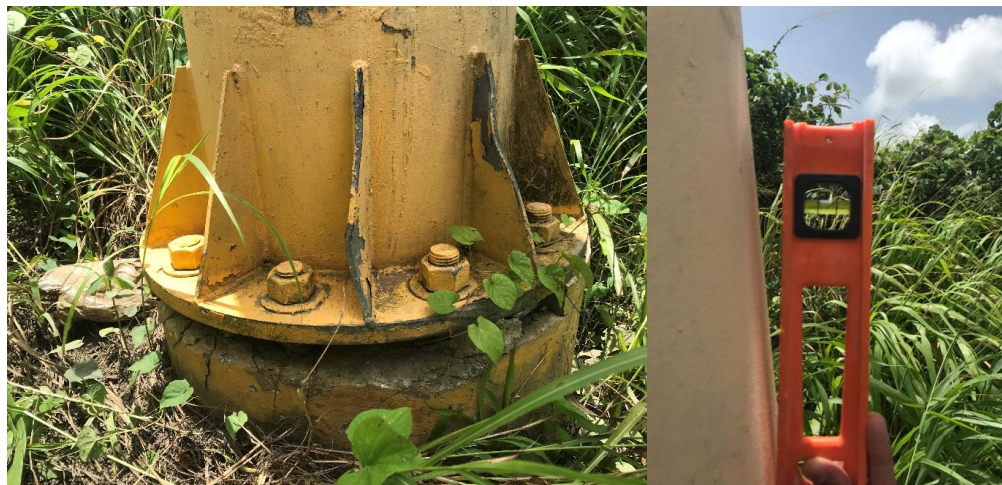
Figure 5-6: Photos of Cantilever Traffic Sign Pedestal Failures and Post Inclination at P-76

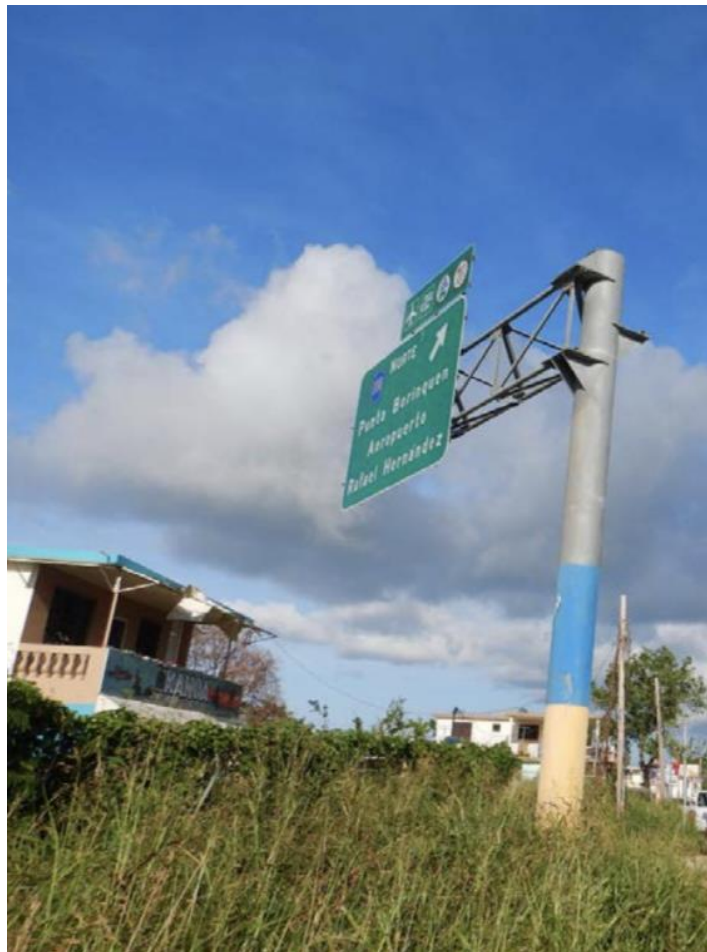
Located along the southbound lane of Highway PR-2 in Aguadilla. The image of the traffic sign structure is shown on Figure 5-7. The final position of the traffic sign was rotated about 100 degrees (measured positive or counterclockwise using the right-hand sign convention with respect to a vertical Zenith axis) with respect to the original installation position. The diameter of the precast cylindrical pedestal that supports this structure was measured to be 30 inches (0.76 m). The visual inspection revealed a deep gap around most of the perimeter circumference between the drilled shaft and the ground. Figure 5-7 shows some tilting of the superstructure with respect to the Zenith.

Figure 5-7: Photo of Cantilever Sign Foundation Failure at P-77 with Location: 18°27'13.01"N; 67° 5'20.87"W

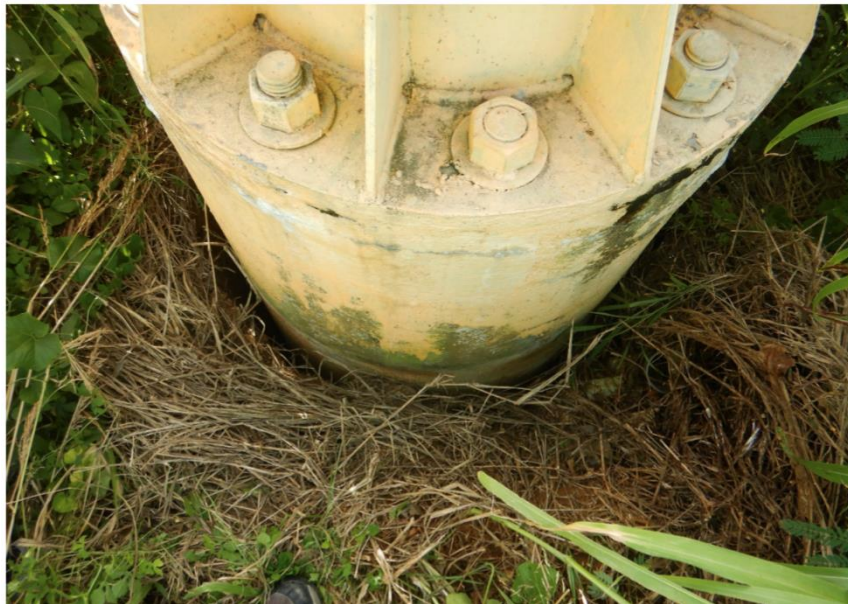
Figure 5-8 and Figure 5-9 show photos of the top of the drilled shaft foundation where the gap formation can be observed. The gap, which likely formed due to the large bending and lateral forces transmitted to the drilled shafts, reduced the contact area between soil and foundation, and thus, the torsional resistance of the drilled shafts.

Figure 5-8: Photo of Drilled Shaft Foundation of Traffic Sign P-77 with Location: 18°27'13.01"N; 67° 5'20.87"W

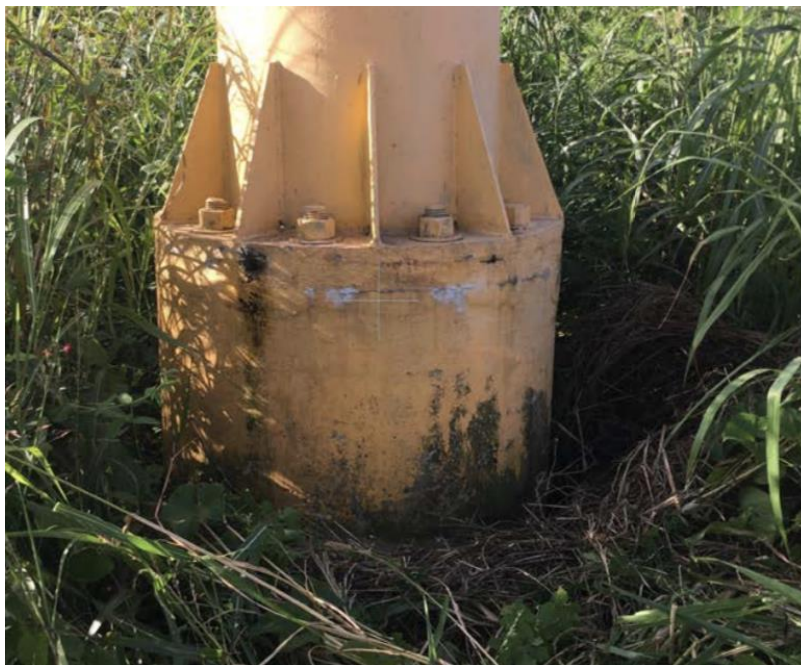
Figure 5-9: Photo of Drilled Shaft Foundation of Traffic Sign P-77

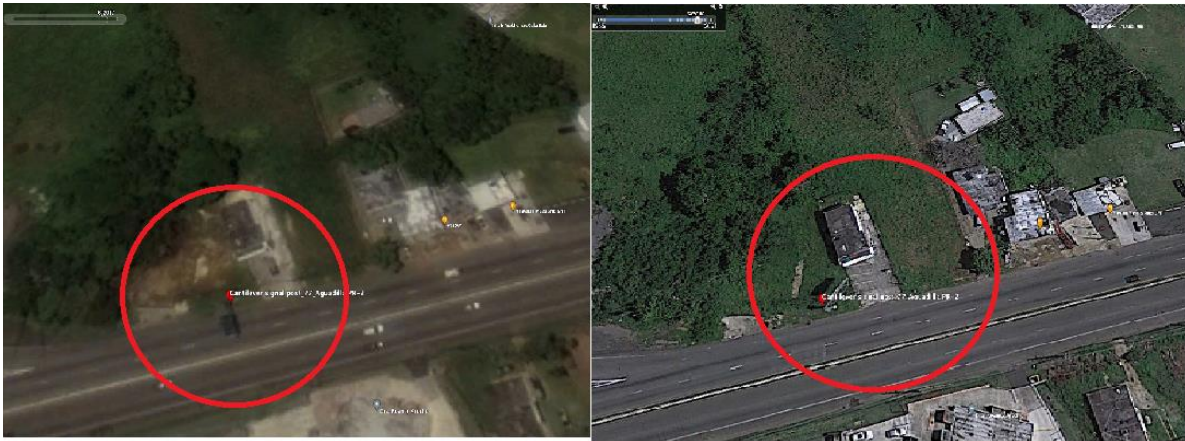
The analysis of this traffic sign showed the validity of using satellite image processing to identify cases. An image of the traffic sign structure is shown in Figure 5-10, and was obtained from the research carried out using the GIS program (Google Earth Pro) that works with the historical image analysis method, comparing those presented by the 4/2018 program with those of 6/2017. In these an apparent rotation of approximately -270 degrees was identified (note that the first field visit estimate was around +100 degrees). At the time of the second field visit, the traffic sign was not found in the identified place. It appears to have been removed from the site for safety reasons, as one can appreciate in Figure 5-11.

Figure 5-10: Photo of Cantilever Sign Soil Foundation Failure at P- 77 Location: 18° 27'13.01"N; 67°5'20.87"W (Photo 1 date: 6/2017, Photo 2 date: 4/2018)

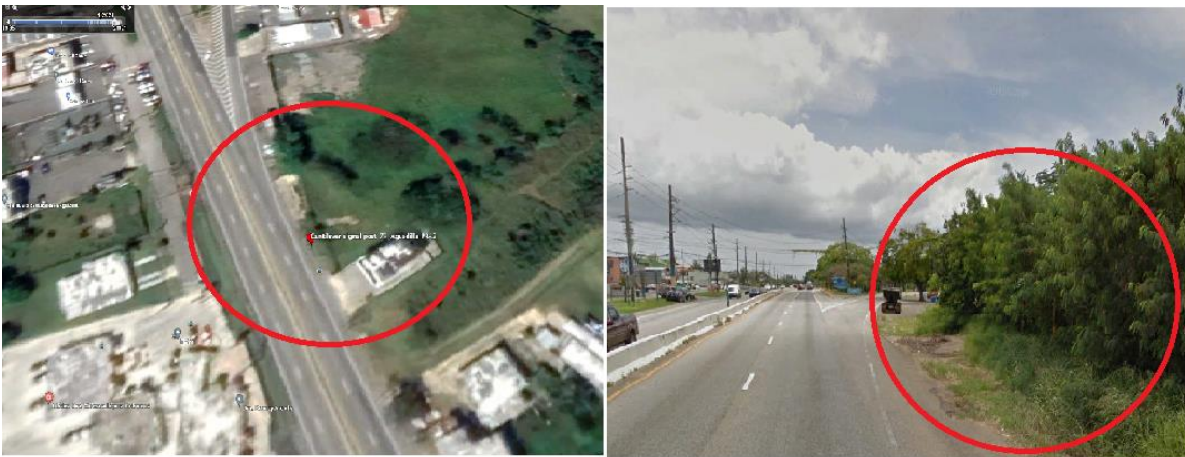
Figure 5-11: Cantilever Traffic Sign P- 77 at the Time of Inspection (Post not in Place)

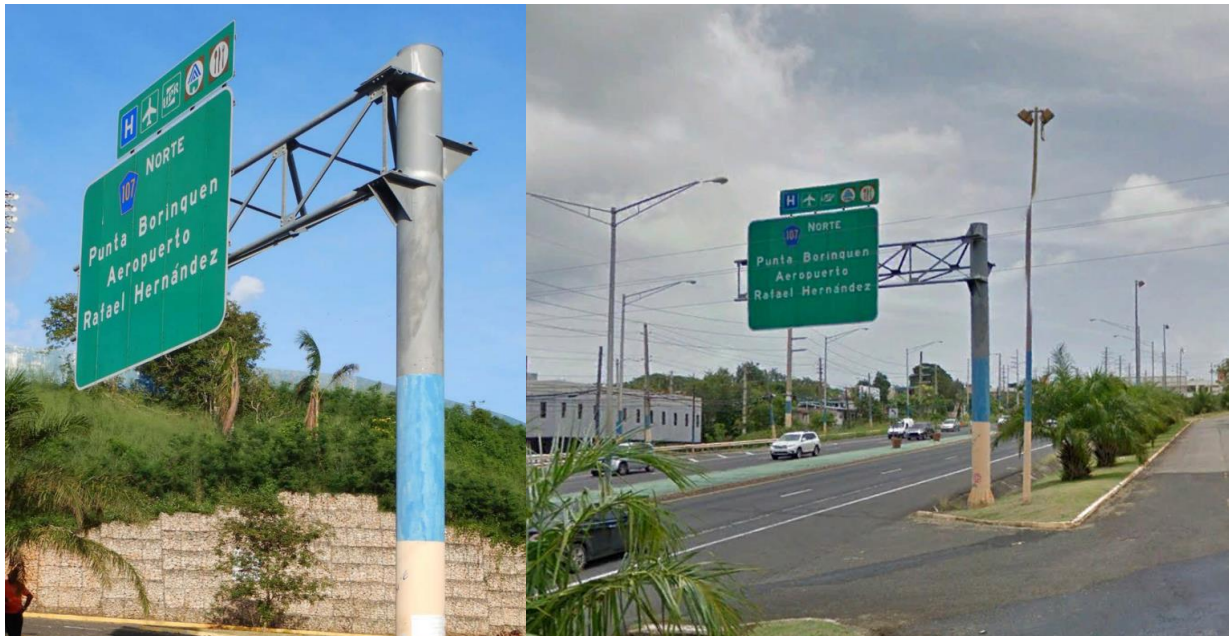
Located at the southwest corner of the Luis A. Canela Marquez Stadium in Aguadilla, along the northbound lane of Highway PR-2. An image of the rotated post-arm traffic sign is shown on Figure 5-12. The diameter of the drilled shaft was approximately 30 inches (0.76 m). The field inspection also revealed a near continuous gap around the circumference of the drilled shaft. In some locations, the gap was as wide as 10 inches. The observed depth of the gap was about 18 inches, as shown in Figure 5-14; however, the bottom of the gap had loose soils, which suggest that minor caving may have filled some of the gap. The post also experienced some tilt (out of plumb) as shown on Figure 5-12. The traffic sign experienced a rotation of about -100 degrees with respect to the zenith and using the right-hand rule sign convention.

Figure 5-12: Photo of Cantilever Sign Foundation Failure at P- 78 Photo Location: 18°26'11.95"N; 67° 8'52.33"W
