Improving Transportation Infrastructure Resilience against Hurricanes, other Natural Disasters, and Weathering: Part I - Analysis of failure of transportation signs due to Hurricane Maria

Volume 1

FINAL REPORT
June 2022

Transportation Infrastructure Research Center – TIRC
Polytechnic University of Puerto Rico
377 Ponce de Leon Ave, San Juan, PR 00918

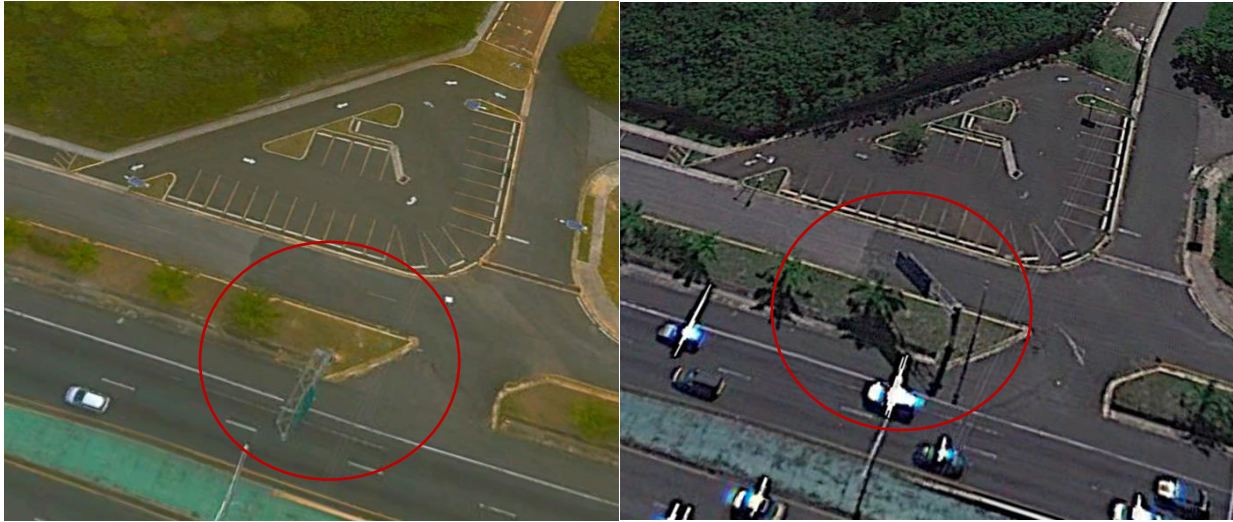
Figure 5-13: Photo of Drilled Shaft Foundation of Traffic Sign at P-78 Photo Location: 18°26'11.95"N; 67° 8'52.33"W.

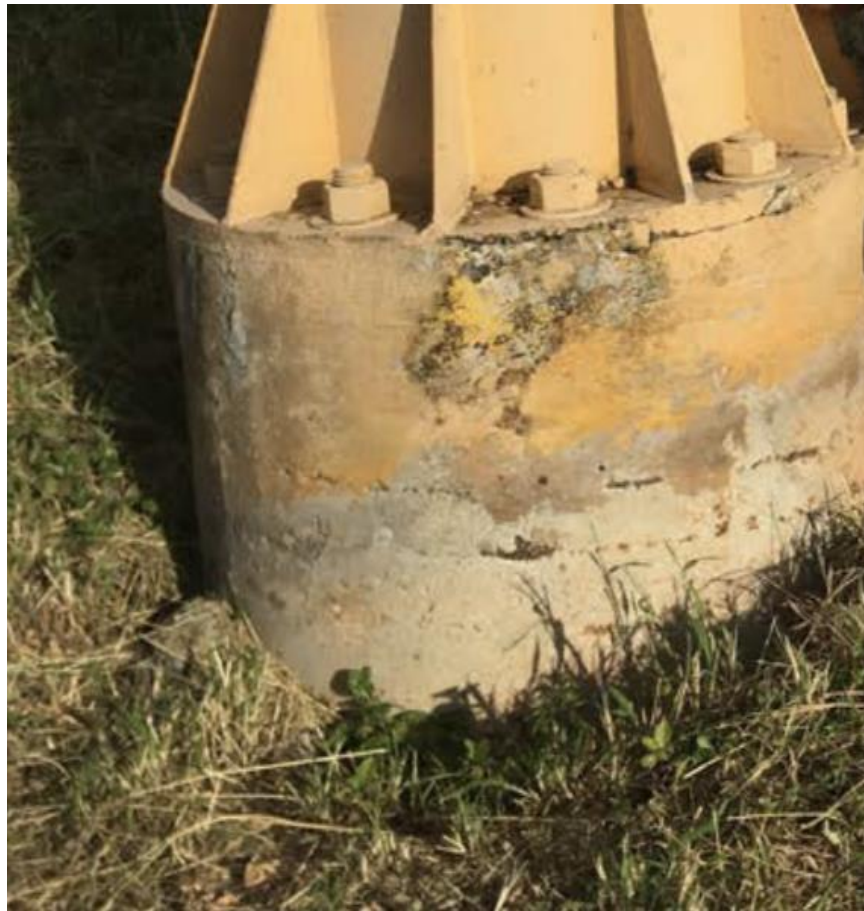
Figure 5-14: Continuous Gap Around the Circumference of the Drilled Shaft

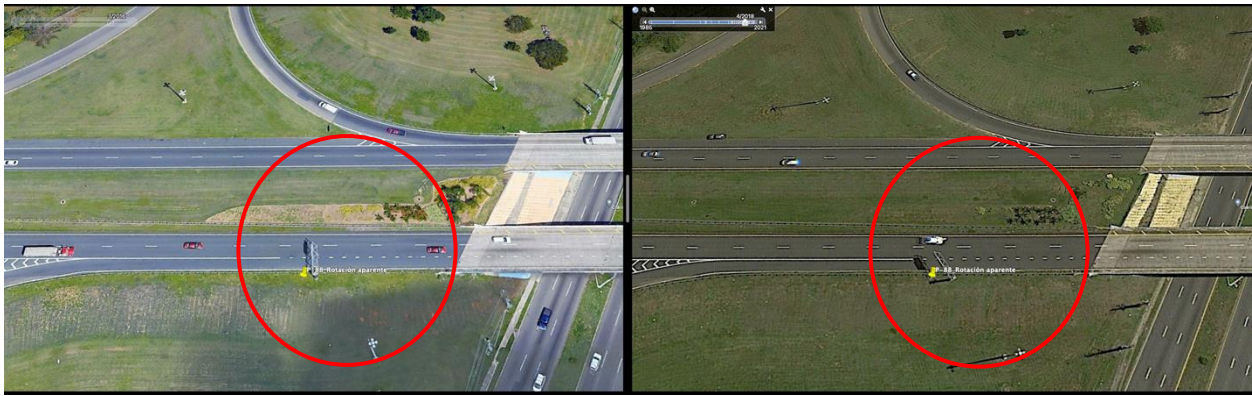
Located along the Highway PR-22 in Arecibo. An image of the traffic sign structure is shown in Figure 5-15, and was obtained from the research carried out using the GIS program (Google Earth Pro) that works with the historical image analysis method, comparing those presented by the 4/2018 program with those of 3/2016. In these an apparent rotation of approximately 20 degrees was identified.

Figure 5-15: Photo of Cantilever Sign Soil Foundation Failure at P-88 Location: 18°27'13.01"N; 66°5'20.87"W (Photo 1 date: 3/2016, Photo 2 date: 4/2018)

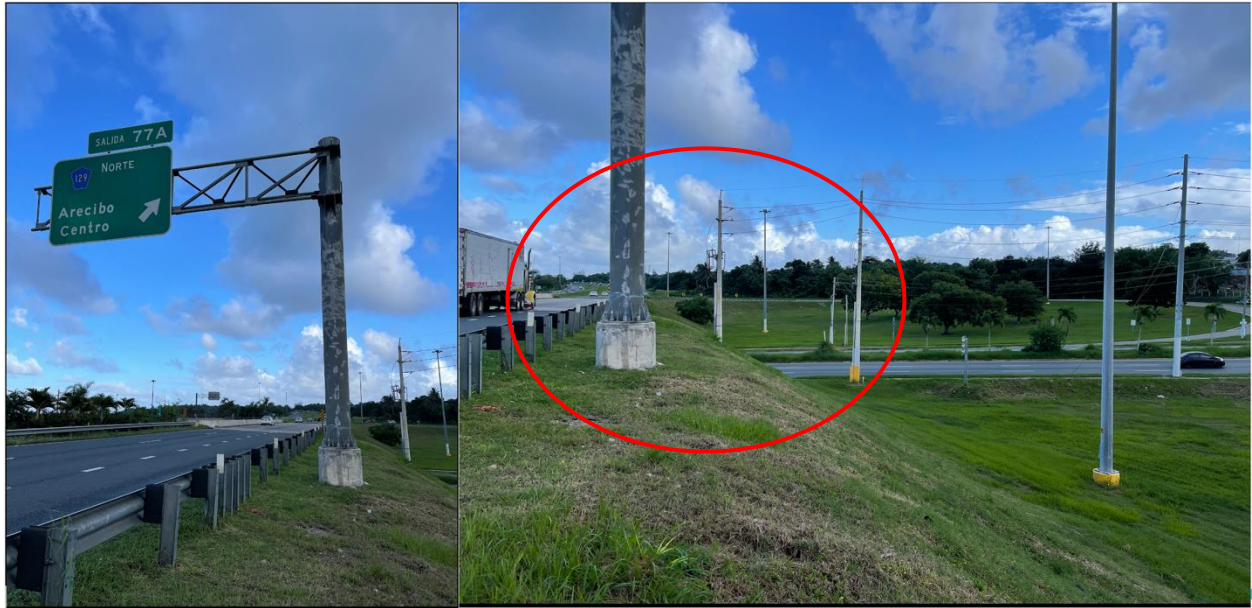
At the time of the field visit no rotation was observed at the base. It appears to have been stabilized and placed in its service position. It was observed that the base of the structure is located at a distance of approximately 2 feet from the beginning of the slope, thus presenting a possible risk of stability in future situations (see Figure 5-16).

Figure 5-16: Cantilever Traffic Sign P-88 at the Time of Inspection

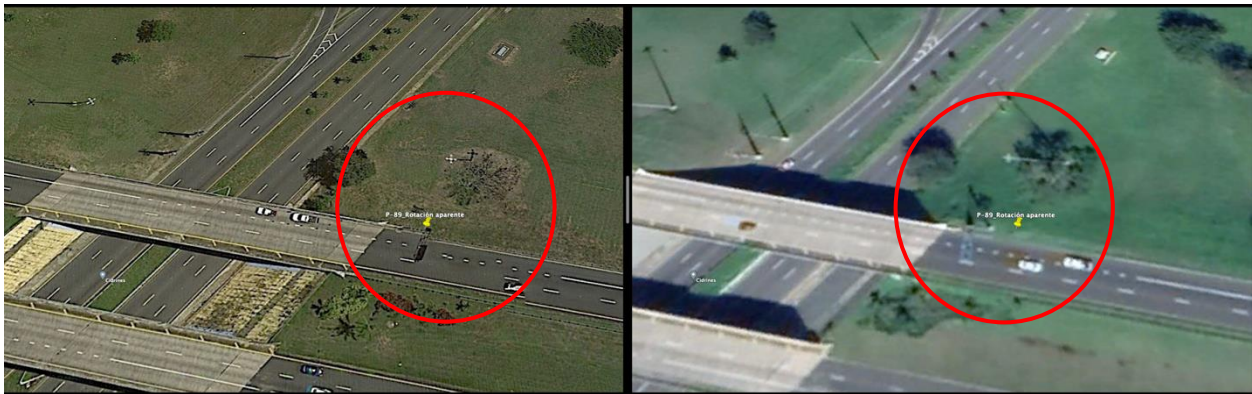
Located along the Highway PR-22 in Arecibo. An image of the traffic sign structure is shown in Figure 5-17, and was obtained from the research carried out using the GIS program (Google Earth Pro) that works with the historical image analysis method, comparing those presented by the 4/2018 program with those of 3/2016. In these an apparent rotation of approximately 15 degrees was identified.

Figure 5-17: Photo of Cantilever Sign Soil Foundation Failure at P-89 Location: 18°27'10.09"N; 66°44'50.21"W (Photo 1 date: 3/2016, Photo 2 date: 4/2018)

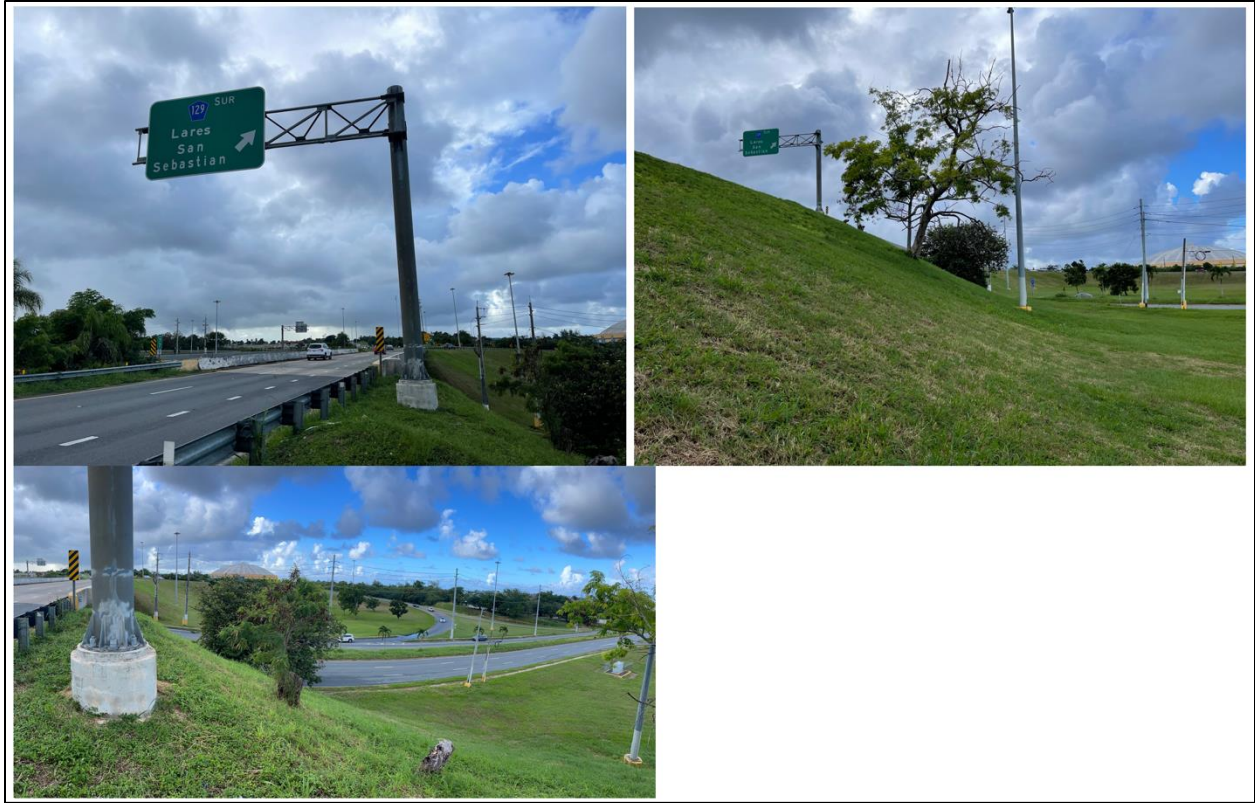
At the time of the field visit no rotation was observed at the base. It appears to have been stabilized and placed in its service position. It was observed that the base of the structure is located just at the beginning of the slope, thus presenting a possible risk of stability in future situations (see Figure 5-18).

Figure 5-18: Cantilever Traffic Sign P-89 at the Time of Inspection

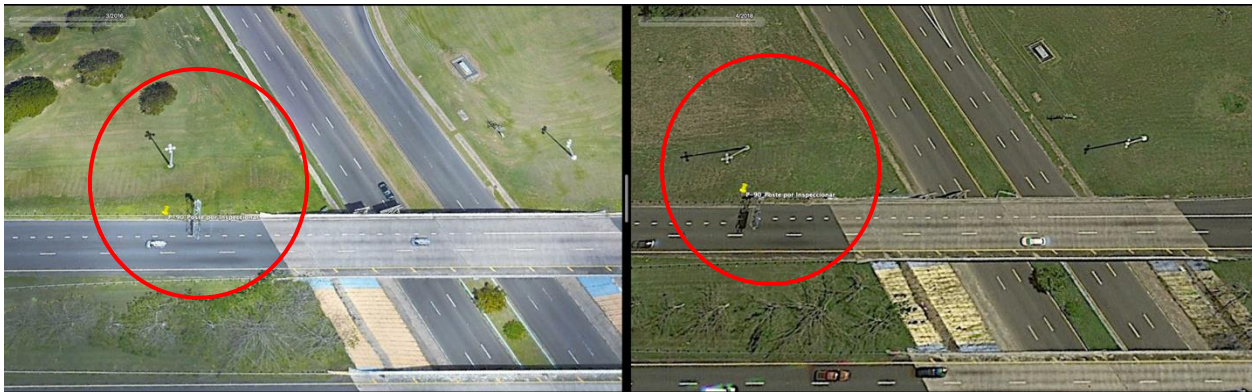
Located along the Highway PR-22 in Arecibo. An image of the traffic sign structure is shown in Figure 5-19, and was obtained from the research carried out using the GIS program (Google Earth Pro) that works with the historical image analysis method, comparing those presented by the 4/2018 program with those of 3/2016. In these an apparent rotation of approximately 10 degrees was identified.

Figure 5-19: Photo of Cantilever Sign Soil Foundation Failure at P-90 Location: 18°27'8.40"N; 66°43'8.03"W (Photo 1 date: 3/2016, Photo 2 date: 4/2018)

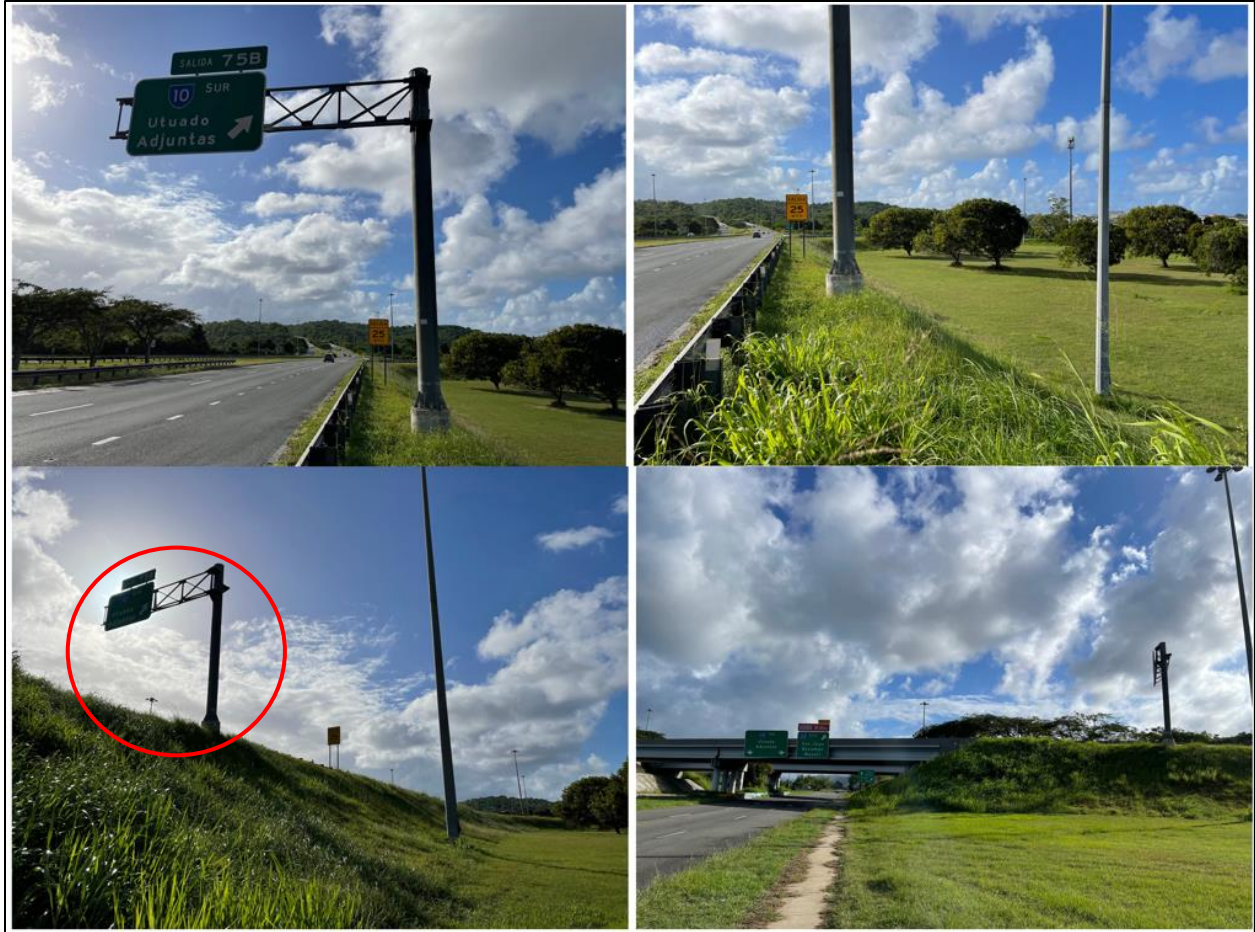
At the time of the field visit no rotation was observed at the base. It appears to have been stabilized and placed in its service position. It was observed that the base of the structure is located just at the beginning of the slope, thus presenting a possible risk of stability in future situations (see Figure 5-20).

Figure 5-20: Cantilever Traffic Sign P-90 at the Time of Inspection

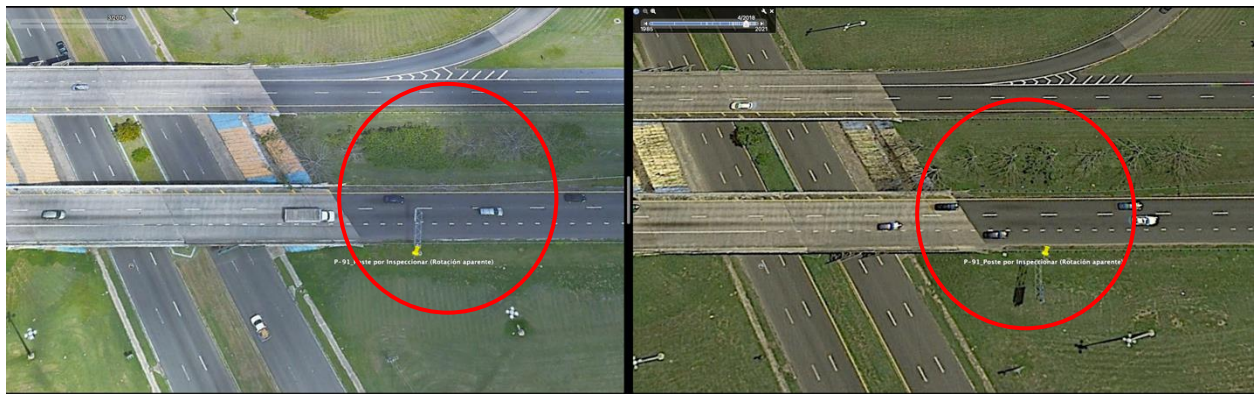
Located along the Highway PR-22 in Arecibo. An image of the traffic sign structure is shown in Figure 5-21, and was obtained from the research carried out using the GIS program (Google Earth Pro) that works with the historical image analysis method, comparing those presented by the 4/2018 program with those of 3/2016. In these an apparent rotation of approximately 180 degrees was identified.

Figure 5-21: Photo of Cantilever Sign Soil Foundation Failure at P-91 Location: 18°27'5.98"N; 66°43'4.13"W (Photo 1 date: 3/2016, Photo 2 date: 4/2018)

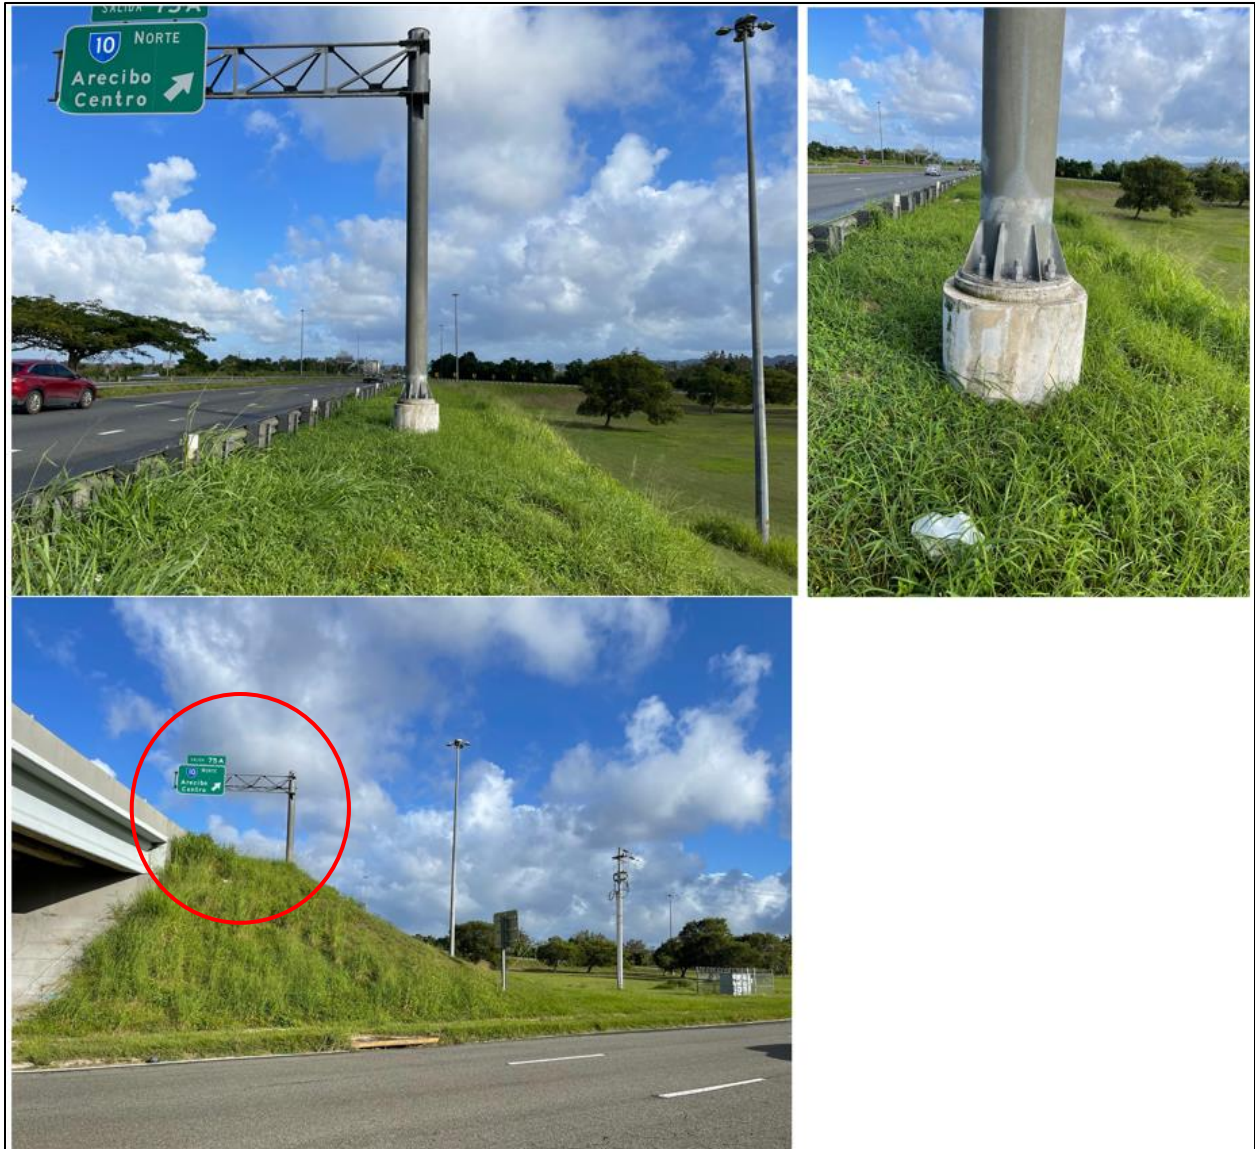
At the time of the field visit no rotation was observed at the base. It appears to have been stabilized and placed in its service position. It was observed that the base of the structure is located at a distance of about 5 ft from the beginning of the slope, thus presenting a possible risk of stability in future situations (see Figure 5-22).

Figure 5-22: Cantilever Traffic Sign P-91 at the Time of Inspection

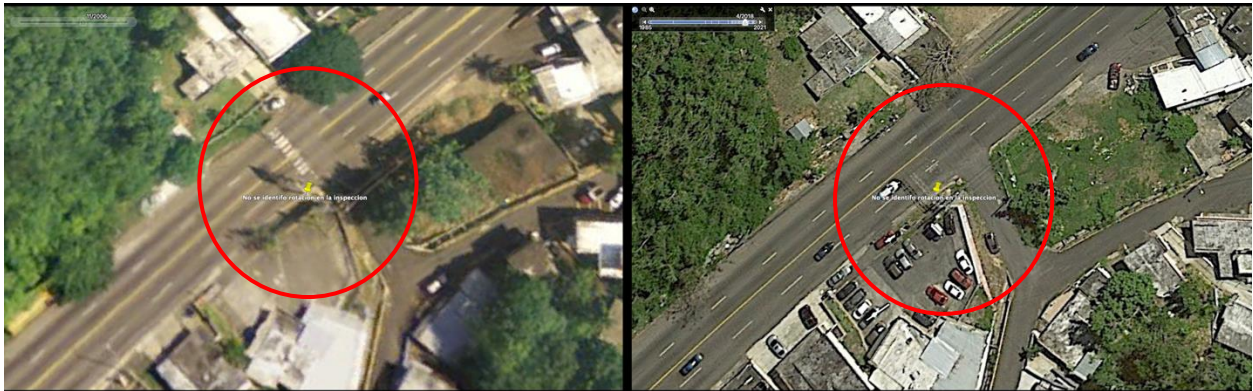
Located along the Highway PR-2 in Barceloneta. An image of the traffic sign structure is shown in Figure 5-23, and was obtained from the research carried out using the GIS program (Google Earth Pro) that works with the historical image analysis method, comparing those presented by the 4/2018 program with those of 11/2006. In these an apparent detachment of sign itself was identified.

Figure 5-23: Photo of Cantilever Sign Failure at P-103 Location: 18°26'8.06"N; 66°32'38.60"W (Photo 1 date: 11/2006, Photo 2 date: 4/2018)

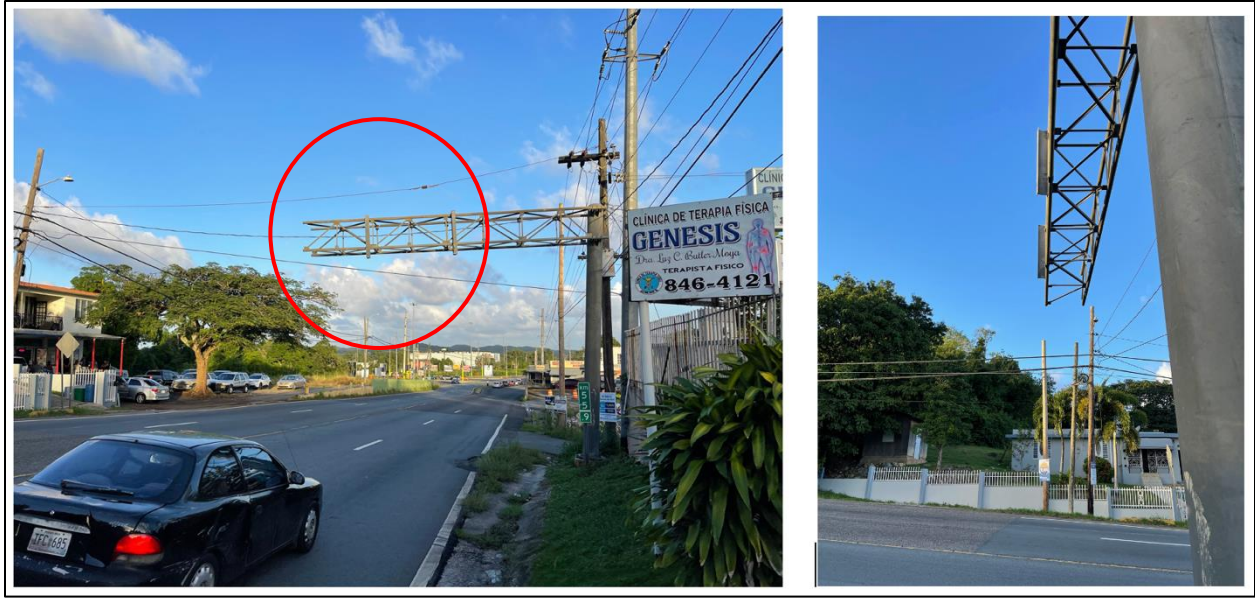
At the time of the field visit it was identified that the sign was not of the type I-B, but since it had experienced damages (detachment of the sign itself) it was documented (see Figure 5-24). This was the only case inspected where the sign itself had apparently blown away.

Figure 5-24: Cantilever Traffic Sign P-103 at the Time of Inspection

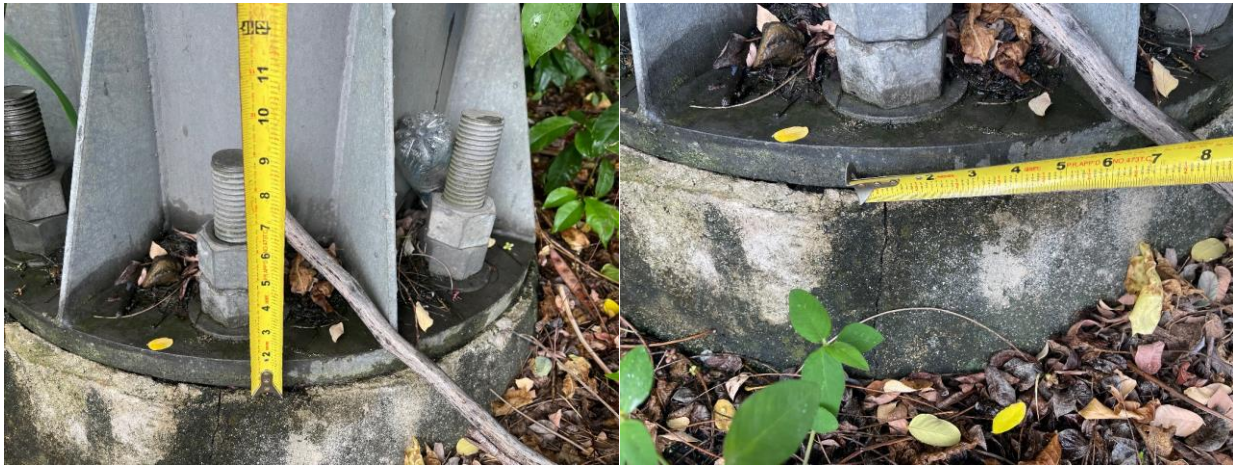
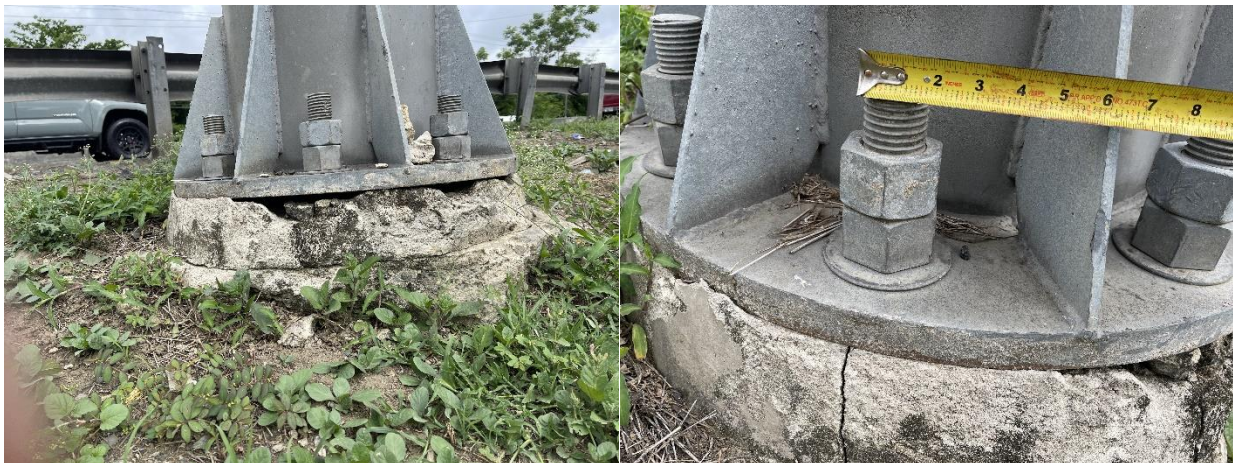
Located along the Highway PR-52 in Caguas, an image of the traffic sign structure base is shown on Figure 5-29 for sign P-16, and Figure 5-26 for sign P-17. Although there was no evidence of post rotation or tilt, the concrete base of both posts showed vertical cracks at anchor bolt location, that appeared to be evidence of bolt lateral movement in the initial stages. Sign P-17 also showed lack of adequate bearing support (that may have been caused by construction defects, or by concrete crushing due to mall posts tilt movements).

Figure 5-25: Photos of Cantilever Traffic Sign Base Condition at P-16. Location: 18.22014722 N; -66.04703611 W.

Figure 5-26: Photos of Cantilever Traffic Sign Base Condition at P-16. Location: 18.45293333N; -66.04458333W

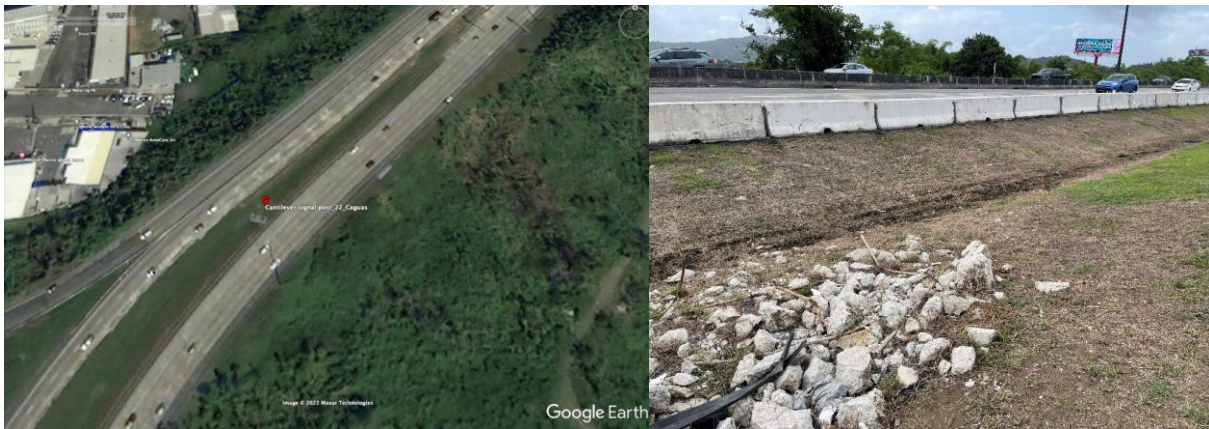
Located along the Highway PR-52 in Caguas, an image of the traffic sign geolocation and the rests of its base foundation structure are shown on Figure 5-27. The sign has been removed at the time of the inspection. The shape of the debris of to the concrete base suggest that large lateral displacement of the anchor bolts due to post torsional rotation took place and trigger the collapse.

Figure 5-27: Photos of Cantilever Traffic Sign Geolocation and Rests of the Post Foundation at P-22. Location: 18.27201944N; -66.03914444W

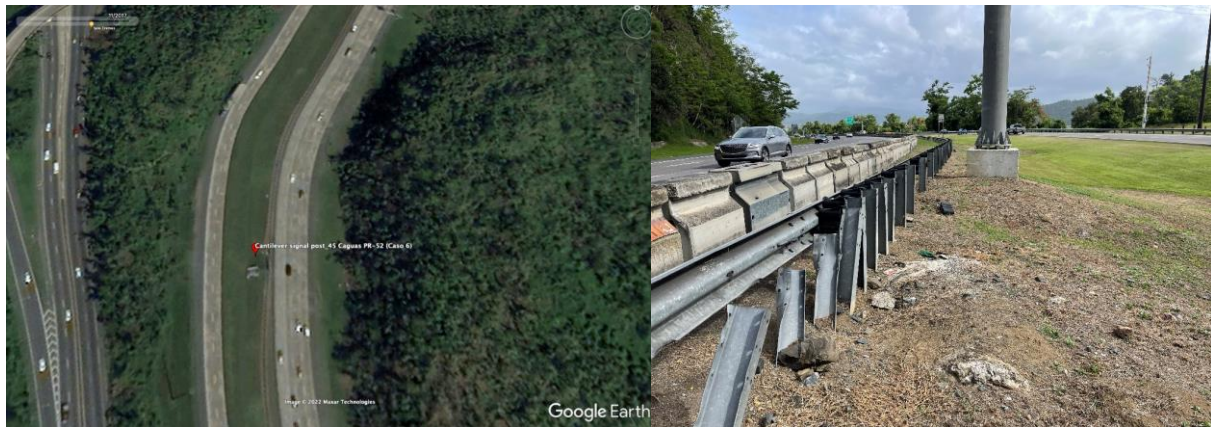
Located along the Highway PR-52 in Caguas, an image of the traffic sign geolocation displaying and apparent collapse, and the rests of a base foundation structure and damaged traffic barriers (apparently due to the collapse) are shown on Figure 5-28. The sign has appeared to have been replaced at the time of the inspection. The absence of soil movement, the shape of the damaged traffic barrier, and the satellite image suggest that a concrete base structural failure could have taken place.

Figure 5-28: Photos of Cantilever Traffic Sign Geolocation, damages to the traffic barrier, and Rests of a Post Foundation at P-45. Location: 18.27035278N; -66.03955556W

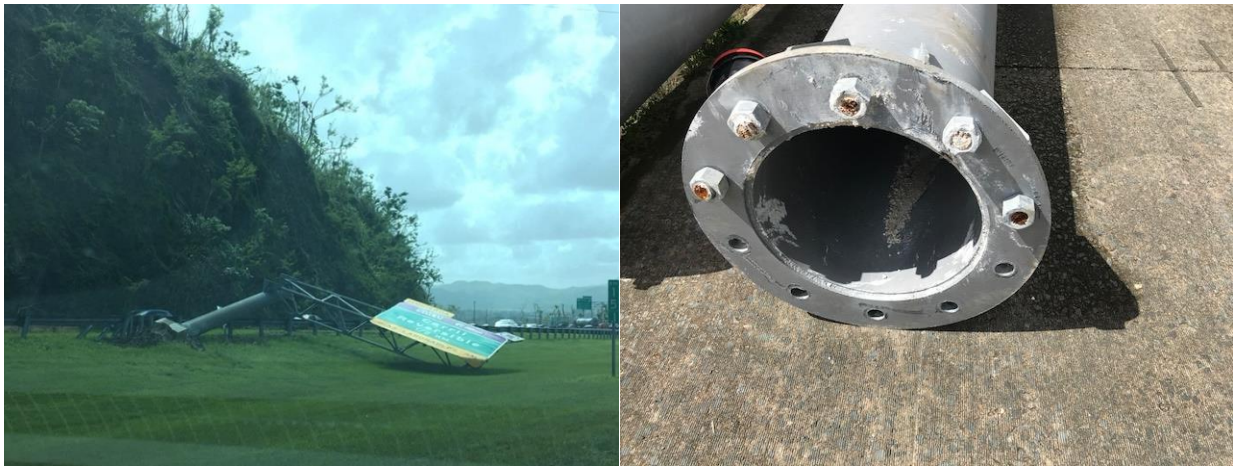
Located along the Highway PR-52 in Caguas, an image of the traffic sign structure is shown in Figure 5-29. The final position of the traffic sign was rotated about a vertical Zenith axis. The post had a square concrete base that presented a foundation overturning failure, causing the collapse of the traffic sign, as observed in Figure 5-29. The sign showed a possible rotation around the vertical zenith axis with bolts shear and or tension failure before flipping to the ground.

Figure 5-29: Photos of Cantilever Traffic Sign Overturning Foundation Failure and Anchor Bolts Shear/Tension Failure at P-52. Location: 18°11'7.35"N; 66° 3'17.55"W

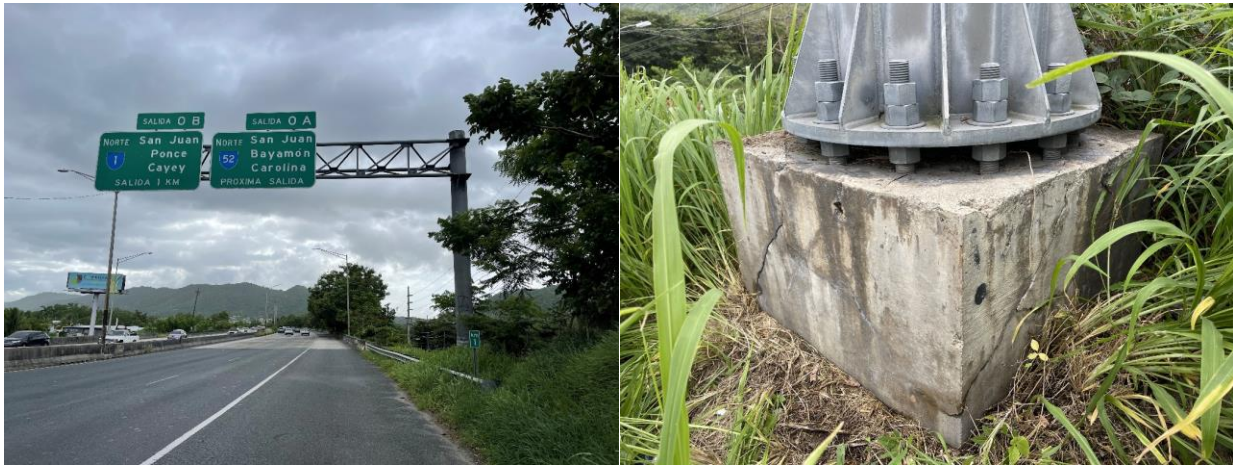
Located along the Highway PR-52 in Caguas, an image of the traffic sign structure and a detail of its base are shown in Figure 5-30. The final position of the traffic sign was not rotated about a vertical Zenith axis, but the anchor bolts lateral movement was large enough to produce wide cracks that were near to produce large spalls on the concrete base, as shown in Figure 5-31.

Figure 5-30: Photos of Cantilever Traffic Sign Location and Anchor Bolts Lateral Movement Producing Cracks on the RC Base at P-58. Location: 18.25564167N; -66.02865278W

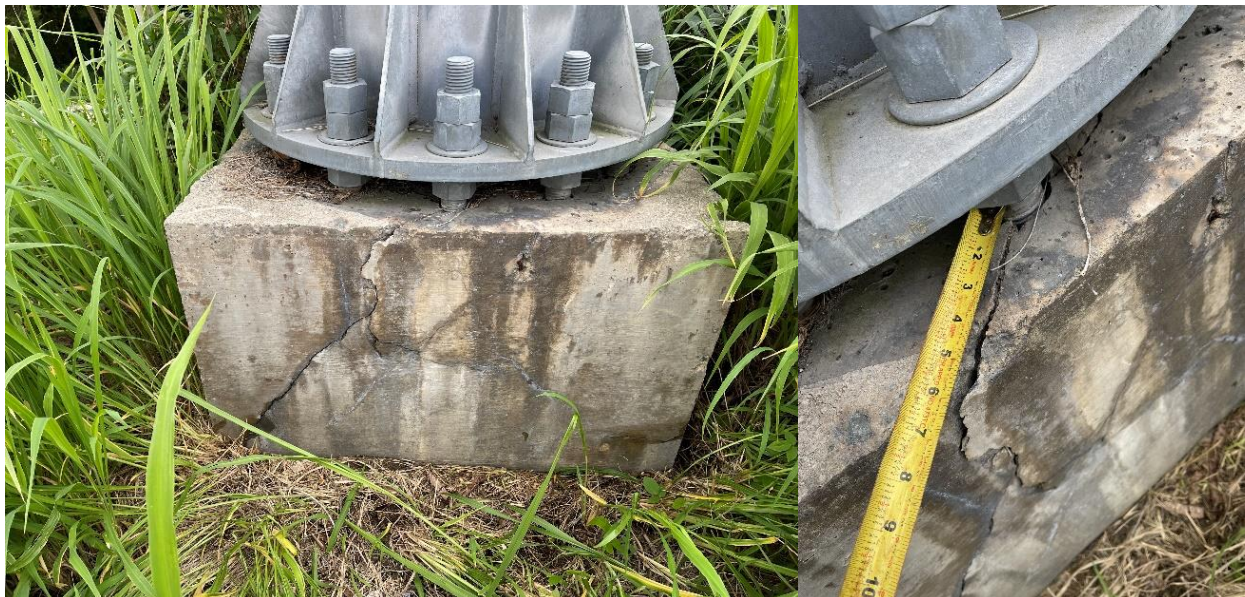
Figure 5-31: Additional Details of RC Base Damages due to Anchor Bolts Lateral Displacements at P-58

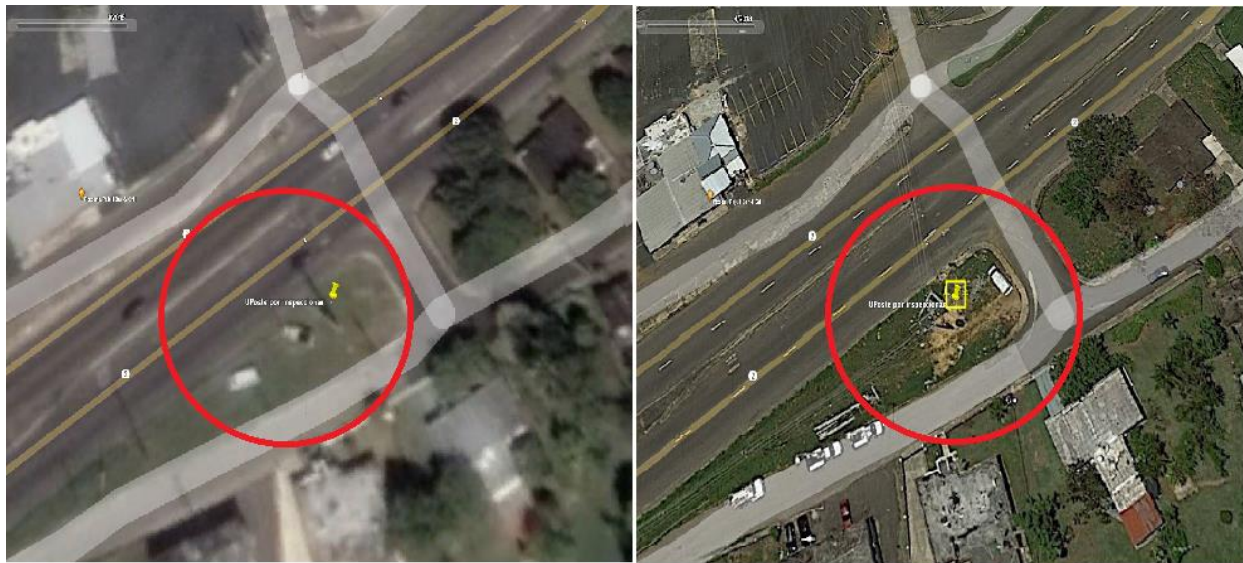
Located along the Highway PR-2 in Camuy. An image of the traffic sign structure is shown in Figure 5-32, and was obtained from the research carried out using the GIS program (Google Earth Pro) that works with the historical image analysis method, comparing those presented by the 4/2018 program with those of 1/2015. In this case a change of situation was identified, with apparent soil and structural foundation failure. At the time of the visit, no traffic sign was found in the area. The perimeter was fenced, so no access was gained to the area to identify rests of past installation.

Figure 5-32: Photo of Cantilever Sign Soil and Structural Foundation Failure at P- 69 Location: 18° 29'18.024"N; 66°48'0.72"W (Photo 1 date: 1/2015, Photo 2 date: 4/2018)

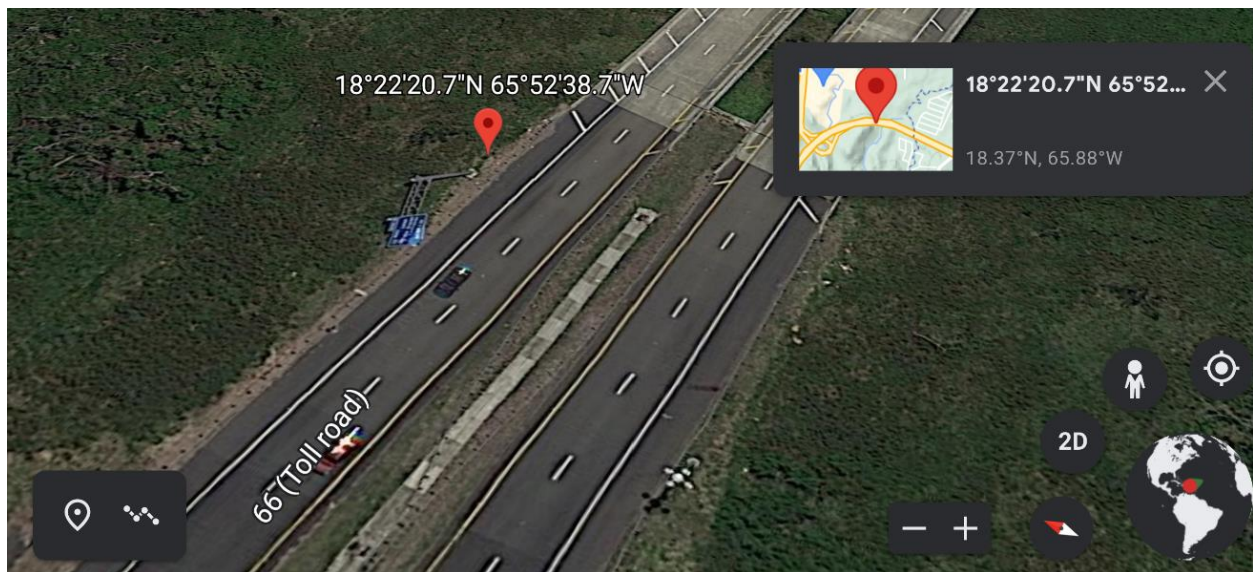
Located along the Highway PR-66 in Canóvanas. An image of the traffic sign structure geolocation and collapsed post is shown on Figure 5-33. The final position of the traffic sign showed a rotation around the vertical zenith axis, and also a rotation about a horizontal axis (leading to a tilt of the post). The visual inspection revealed that the collapsed traffic sign presented anchoring elements with large lateral displacements, bending on the plastic range, and shear fracture; the concrete pedestal presented large fractures and detachments as a consequence of the post torsional rotation (and bolts lateral movement) and post tilt (base plates crushed the concrete), as shown in Figure 5-34 and Figure 5-47.

Figure 5-33: Photo of Cantilever Sign Foundation Structural Failures on the Pedestal at P-106 Location: 18°22'20.65"N; 65°52'38.72"W

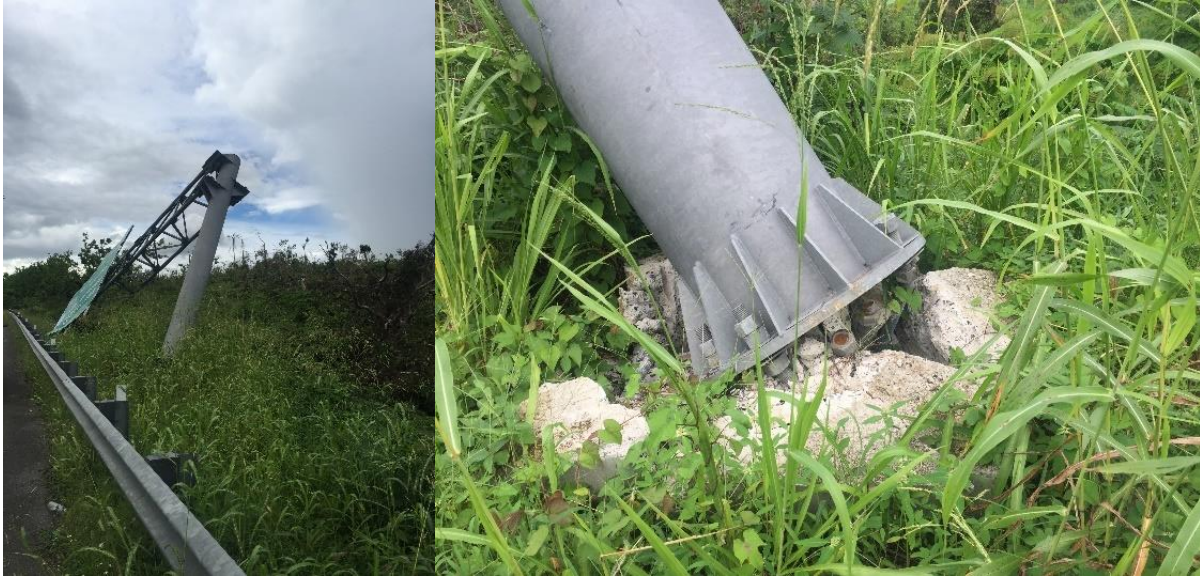
Figure 5-34: Photo of Cantilever Sign Foundation Structural Failures on the Pedestal at P-106

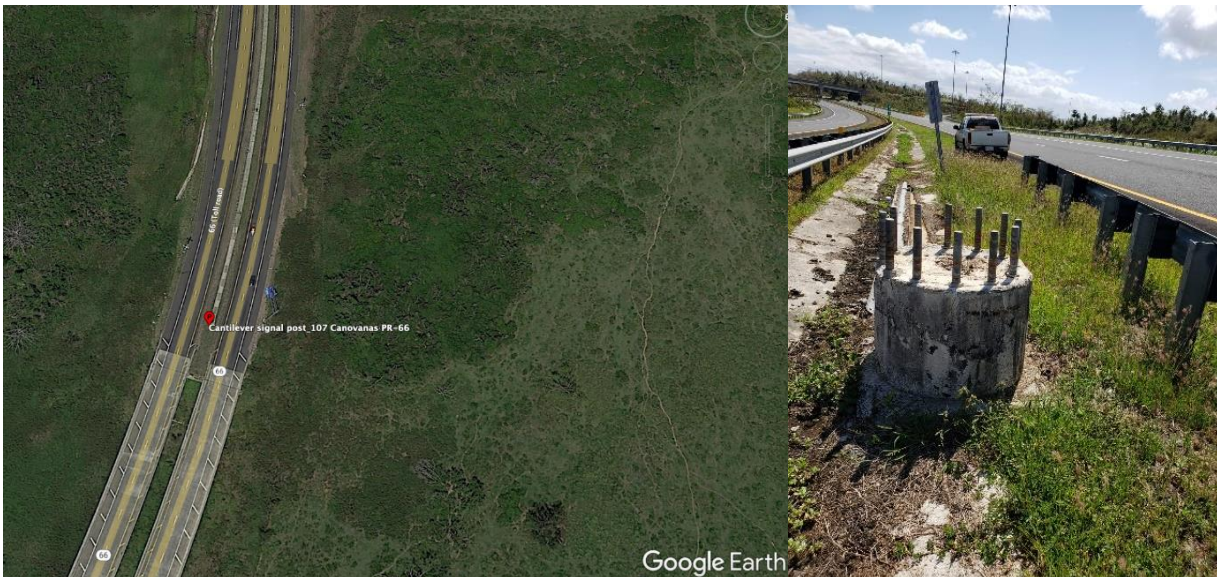
Located along the Highway PR-66 in Canóvanas. An image of the traffic sign structure is presented in Figure 5-36, showing a satellite image of the post indicating foundation rotation, and an image of the remaining post base with the anchor bolts in vertical position, that demonstrate that the sign had experienced torsional rotations due to soil foundation failure. The concrete base exhibit cracks due anchor bolts action. The post and the sign had been removed at the time of the field visit.

Figure 5-36: Photo of Cantilever Sign Foundation Torsional Rotation of the Pedestal at P-107 Location: 18.3603111°N, -65.8938111°W

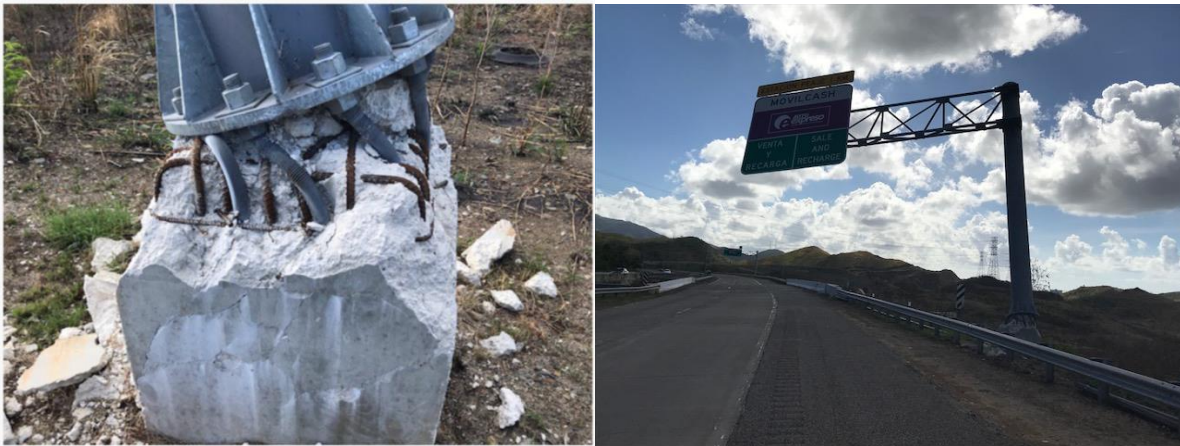
Located along the Highway PR-53 in Guayama. An image of the traffic sign structure is shown on Figure 5-37. The final position of the traffic sign showed a rotation around the vertical zenith axis, and also a rotation about a horizontal axis (leading to a tilt of the post). The visual inspection revealed that the partially collapsed post presented large lateral displacements, bending on the plastic range, and shear fracture of the anchoring elements; the concrete pedestal presented large fractures, detachments, and crushing. One of the anchor bolts was outside the stirrups, lacking the lateral confinement, the others had a large length at the top without lateral confinement (distance between the post base plate and the first stirrup), as displayed in Figure 5-38. The concrete pedestal below the first stirrup presented few damages, in the area not affected by the plate bending. A large distance between the last stirrup and the top of the pedestal could also be appreciated.

Figure 5-37: Photo of Cantilever Sign Foundation Structural Failures on the Pedestal and Sign Position (Partial Collapse) at P-46. Location: 17°59'8.91"N; 66° 8'45.56"W

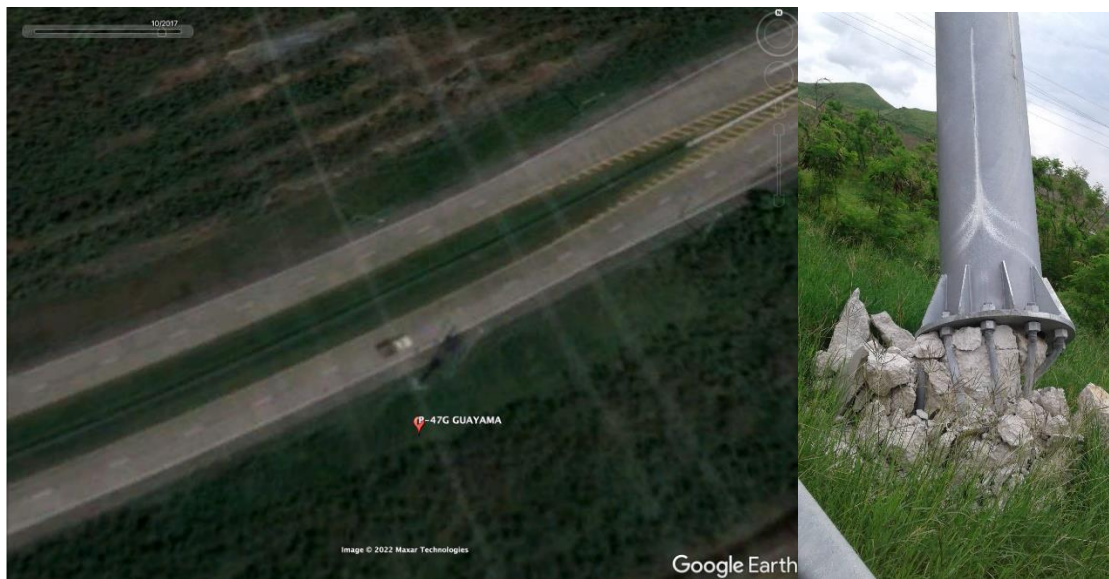
Located along the Highway PR-53 in Guayama. An image of the traffic sign structure location and its out of plumb condition after the hurricane is shown on Figure 5-39. The final position of the traffic sign showed a rotation around the vertical zenith axis, and also a rotation about a horizontal axis (leading to a tilt of the post). During a second visit to the field the sign had been removed. The visual inspection revealed that the partially collapsed post presented large lateral displacements, bending on the plastic range, and shear fracture of the anchoring elements; the concrete pedestal presented large fractures, detachments, and crushing. Several of the anchor bolts were outside the stirrups, lacking the lateral confinement, the others had a very large length at the top without lateral confinement (distance between the post base plate and the first stirrup), as presented in Figure 5-40.

Figure 5-39: Photo of Cantilever Sign Foundation Structural Failures on the Pedestal and Sign Position (Partial Collapse) at P-47. Location: 17.9868529°N, -66.1425048°W

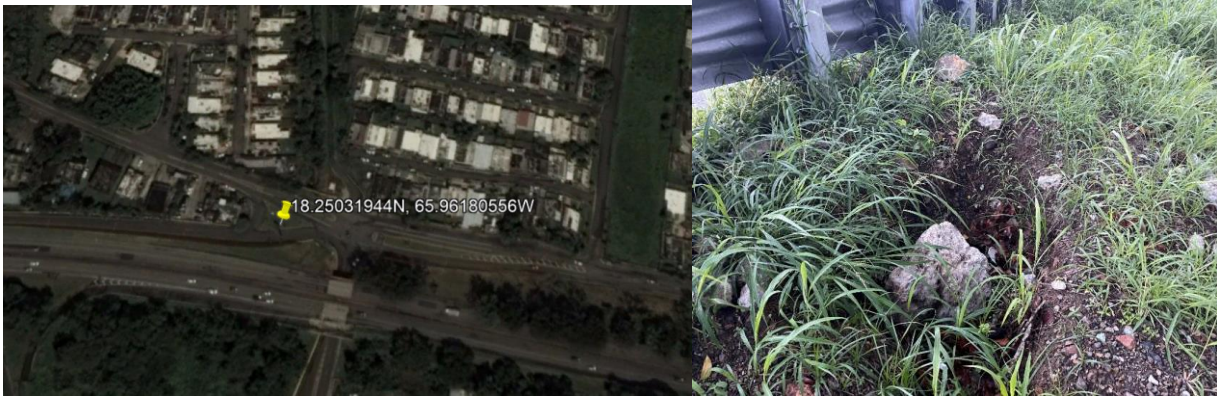
Located along the Highway PR-30 in Gurabo. An image of the traffic sign structure location and the rests of the concrete pedestal are shown on Figure 5-41. At the time of the visit only rests of a concrete pedestal were found. A total collapse due to pedestal structural failure was assumed.

Figure 5-41: Photo of Cantilever Sign Structural Failures on the Pedestal at P-57 Location: 18.25031944°N; 65.96180556°W

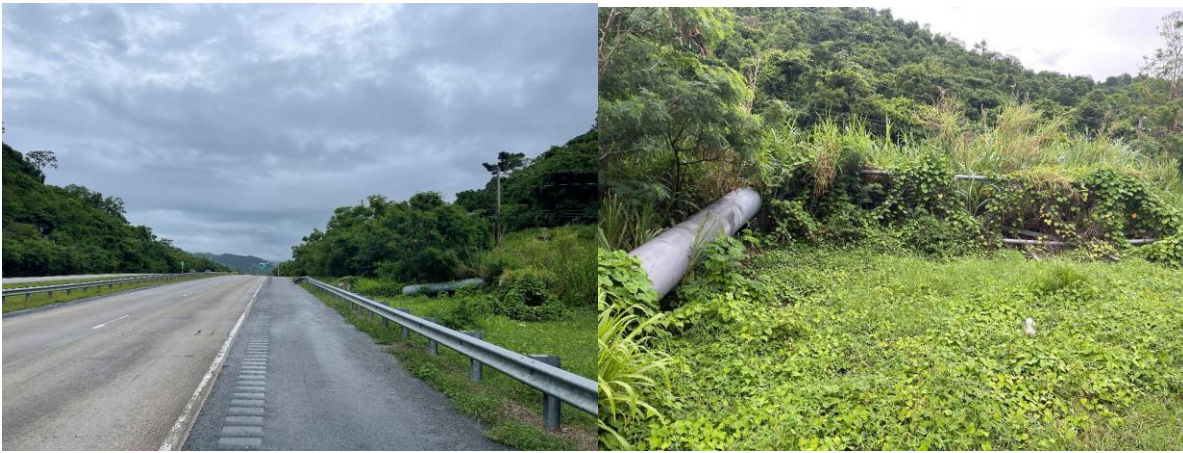
Located along the Highway PR-53 in Humacao. An image of the collapsed traffic sign structure is shown on Figure 5-42. The visual inspection revealed that the collapsed post presented large lateral displacements, bending on the plastic range, and shear fracture of the anchoring elements; the concrete pedestal presented large fractures, detachments, and crushing. One of the anchor bolts was outside the stirrups, lacking the lateral confinement, the others had a large length at the top without lateral confinement (distance between the post base plate and the first stirrup), as displayed in Figure 5-43. The concrete pedestal below the first stirrup presented few damages. A large distance between the last stirrup and the top of the pedestal could also be appreciated.

Figure 5-42: Photo of Cantilever Sign Foundation Structural Failures on the Pedestal and Sign Position (Total Collapse) at P-61. Location: 18.159975°N; 65.79745833° W

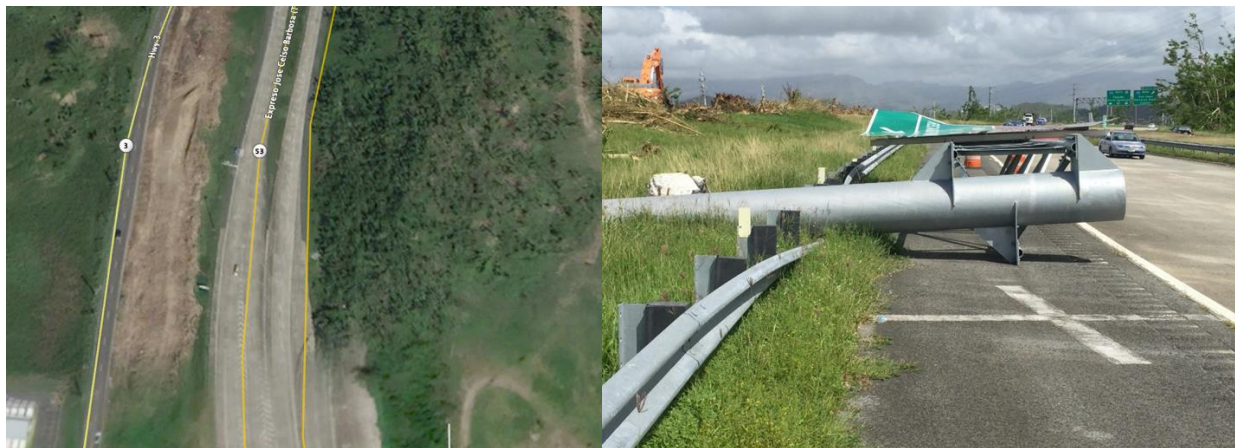
Located along the Highway PR-53 in Humacao. An image of the traffic sign structure is shown on Figure 5-44. The final position of the traffic sign showed a rotation about the vertical zenith axis. The diameter of the pedestal that supports this structure was measured, resulting in a diameter of 35 inches (0.89 m). Visual inspection revealed that the collapsed post presented large lateral deflections and bending on the plastic range of the anchor elements, that also exhibited pullout and shear fracture; the concrete presented fractures and detachments (see Figure 5-45). Some of the anchor bolts were clearly located outside the confinement provided by the stirrups (see Figure 5-45). A large distance between the last stirrup and the top of the pedestal could also be appreciated.

Figure 5-44: Photo of Cantilever Sign Structural Failures on the Pedestal at P-100 Location: 18°7'7.11"N; 65°49'16.812"W
