Improving Transportation Infrastructure Resilience against Hurricanes, other Natural Disasters, and Weathering: Part I - Analysis of failure of transportation signs due to Hurricane Maria

Volume 1

FINAL REPORT
June 2022

Transportation Infrastructure Research Center – TIRC
Polytechnic University of Puerto Rico
377 Ponce de Leon Ave, San Juan, PR 00918

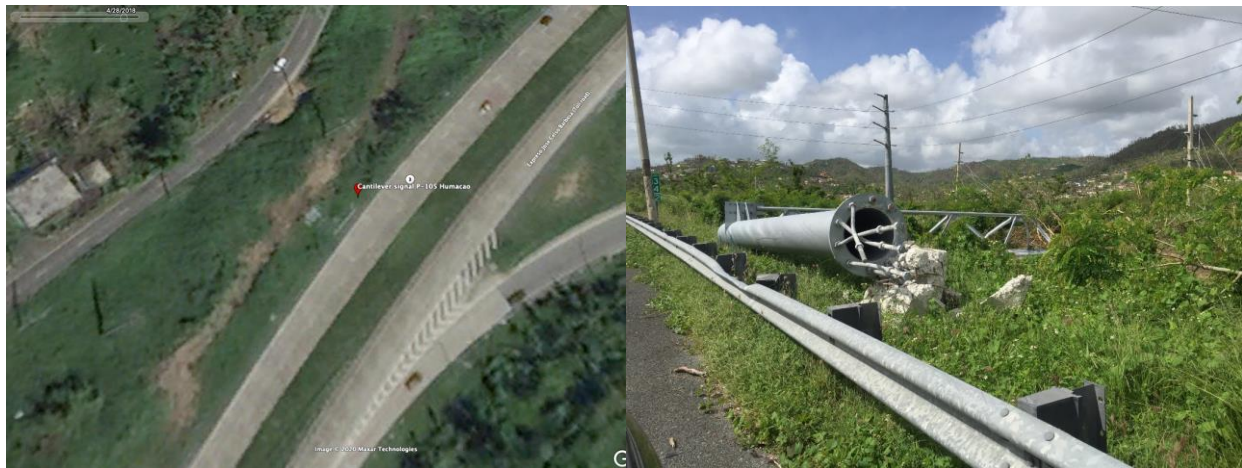
Located along the Highway PR-53 in Humacao. An image of the traffic sign structure is shown on Figure 5-46. The final position of the traffic sign shows a rotation about the vertical zenith axis. The diameter of the pedestal that supports this structure was measured, presenting a diameter of 35 inches (0.89 m). Visual inspection revealed that the collapsed post showed large lateral deflections and bending on the plastic range of the anchor elements, that also exhibited pullout and shear fracture; the concrete presented fractures and detachments (see Figure 5-47). Some of the anchor bolts were clearly located outside the confinement provided by the stirrups. A large distance between the last stirrup and the top of the pedestal could also be appreciated.

Figure 5-46: Photo of Cantilever Sign Structural Failures on the Pedestal at P-105 Location: 18° 7'20.00"N; 65° 49'12.23"W

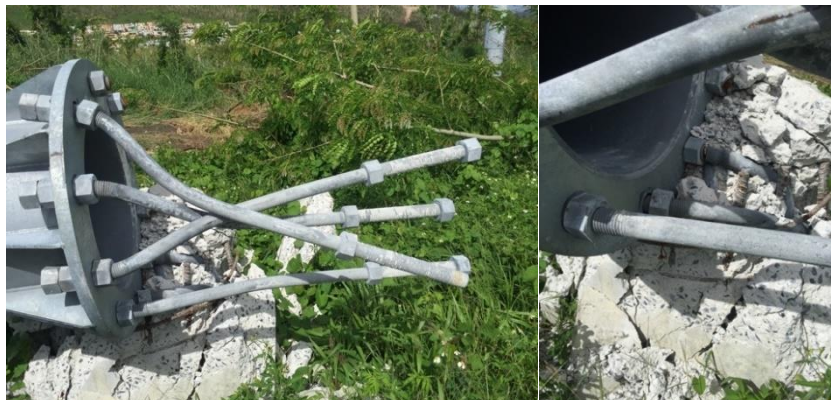
Figure 5-47: Photo on Cantilever Sign Foundation Structural Failure at P-105; Collapsed Post Presented Large Deflections and Bending on the Plastic Range and Shear Fracture of the Anchor Elements

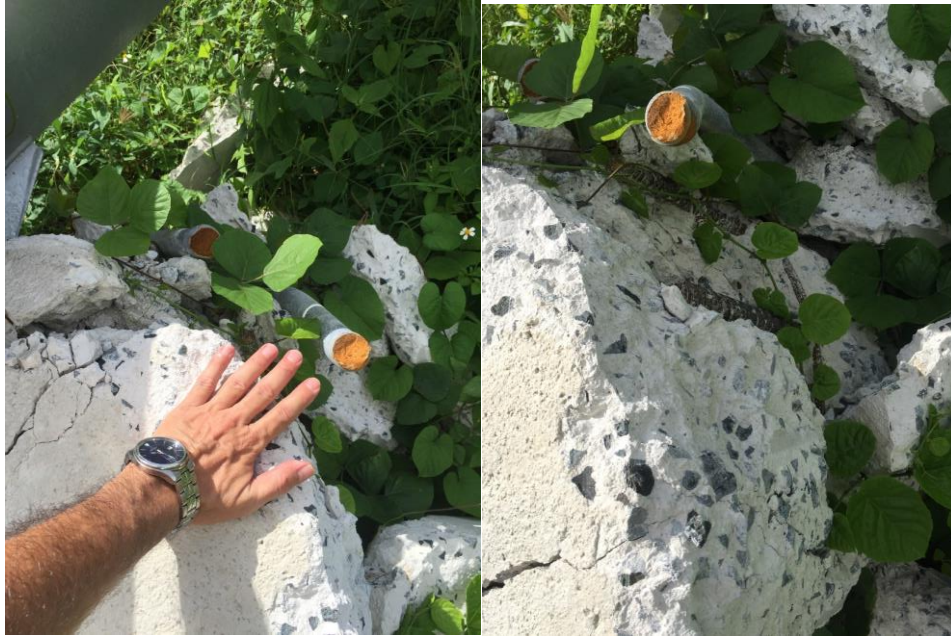
Figure 5-48: Photo on Cantilever Sign Foundation Structural Failure at P-105; Collapsed Post Presented Large Deflections and Bending on the Plastic Range and Shear Fracture of the Anchor Elements, and Fractures and Detachments of the Concrete. Anchor elements outside the confinement provided by Stirrups

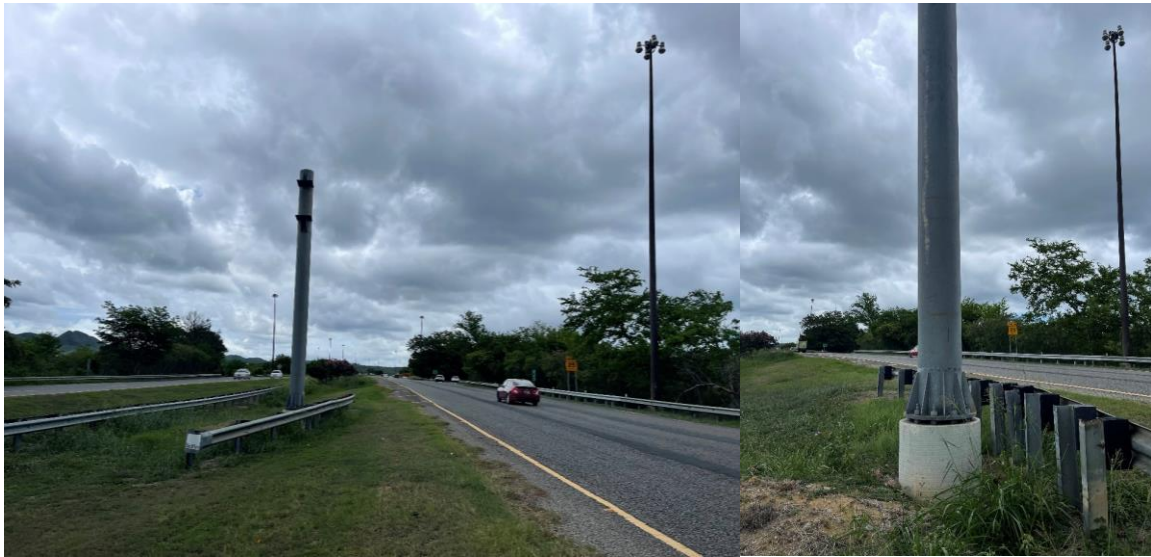
Located along the Highway PR-52 in Juana Diaz. An image of the traffic sign structure is shown on Figure 5-49. The truss and the sign were missing, but the post and the concrete pedestal were in good condition, and no evidence of hurricane impact was found during the field inspection.

Figure 5-49: Photo of Cantilever Sign Missing Truss and Sign at P-6 Location: 18.03189444°N; 66.45465278°W

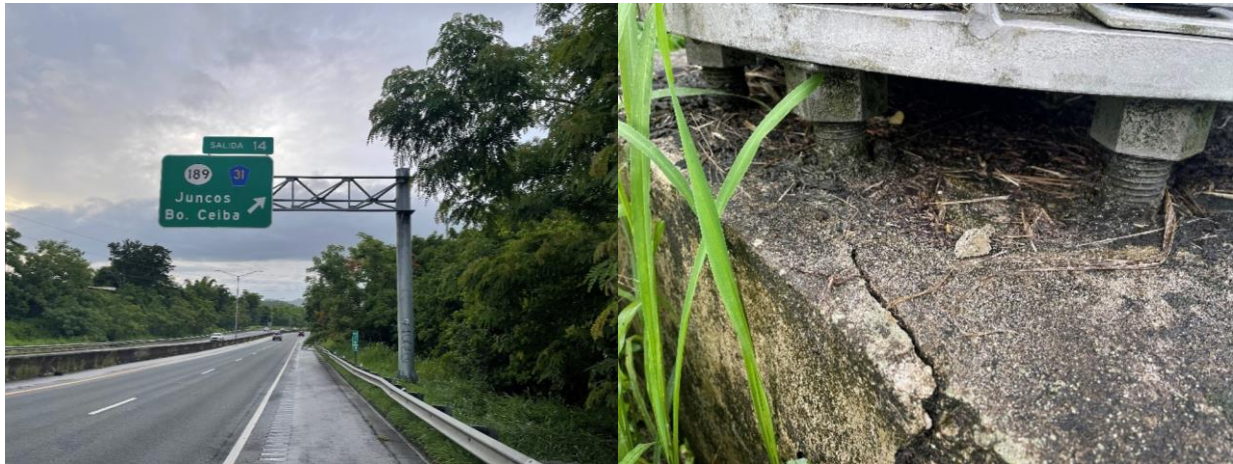
Located along the Highway PR-30 in Juncos. An image of the traffic sign structure is shown on Figure 5-50. The concrete base presented a wide crack that appeared to be produced by the anchor bolt lateral movement.

Figure 5-50: Photo of Cantilever Sign Structural Crack on the Pedestal at P-55 Location: 18.22131389°N; 65.91406944°W

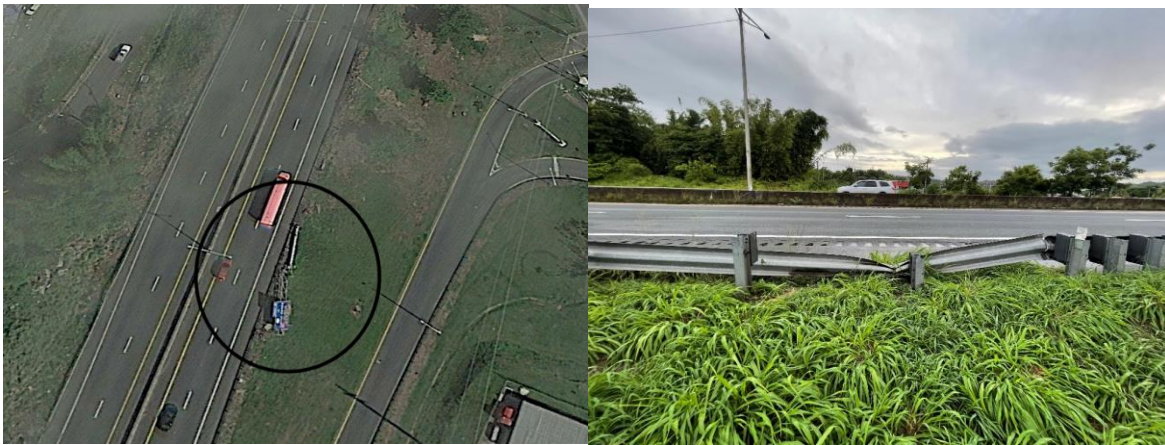
Located along the Highway PR-30 in Juncos. An image of the traffic sign location is shown on Figure 5-51. The image clearly shows that the post experienced a large torsional rotation of more than 90 degrees, and the damaged traffic barriers may be evidence of collapse. At the time of the field visit the post was already removed, but the concrete foundation was found in place, as shown in Figure 5-52.

Figure 5-51: Photo of Cantilever Sign Torsional Rotation and Possible Collapse on the Pedestal at P-56 Location: 18.22426944°N; 65.91595833°W

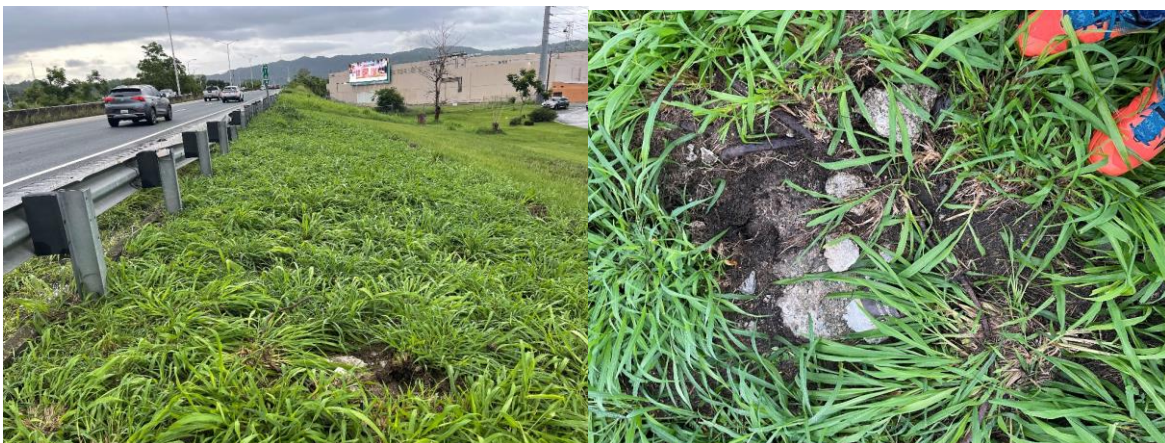
Figure 5-52: Photo of Cantilever Sign Concrete Foundation Rests at P-56

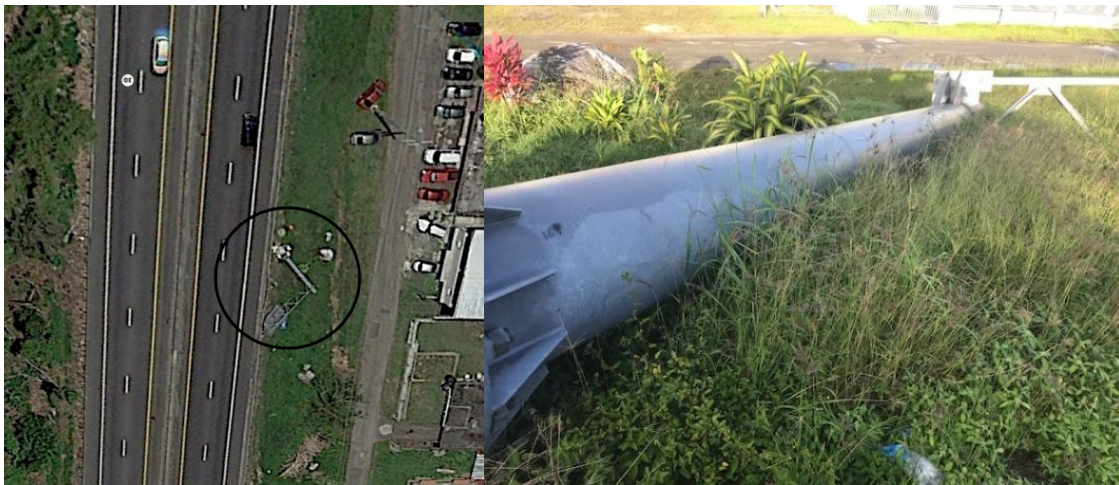
Located along the southbound lane of Highway PR-30 in Las Piedras. An image of the traffic sign structure is shown on Figure 5-53. The final position of the traffic sign showed a rotation around the vertical zenith axis. The diameter of the pedestal that supports this structure was measured to be 35 inches (0.89 m). Visual inspection revealed that the collapsed post presents large lateral deflections and bending on the plastic range of the anchor elements, that also exhibit pullout and shear fracture; the anchor bolts seemed to have been outside of the pedestal lateral confinement; the concrete presented fractures and detachments. (See Figure 5-54).

Figure 5-53: Photo of Cantilever Sign Structural Failures on The Pedestal at P-53 Location: 18°11'31.15"N; 65°53'46.75"W

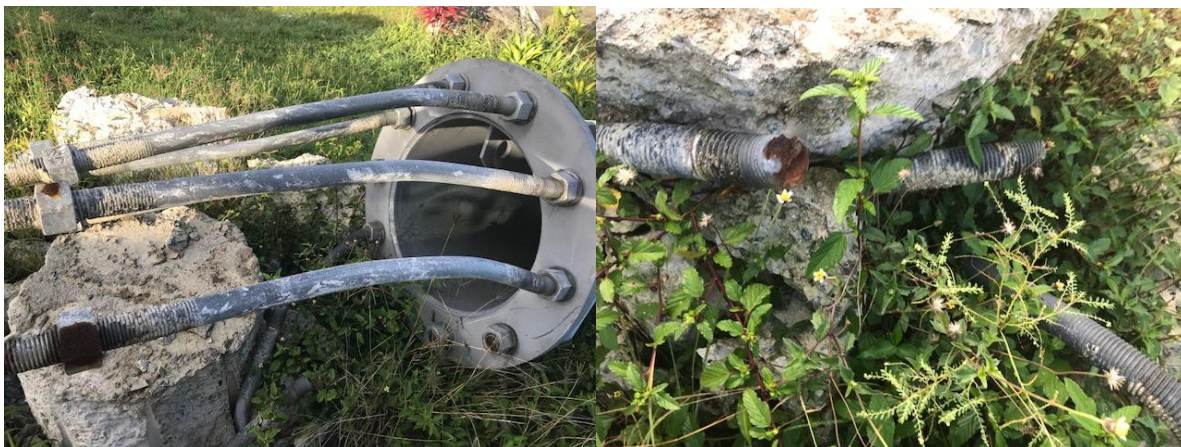
Figure 5-54: Photos of Cantilever Traffic Sign Foundation Structural Pedestal Failure at P-53; with Large Deflections on the Plastic Range, Shear Fracture, and Pullout of the Anchor Elements, and Fractures and Detachments of the Concrete

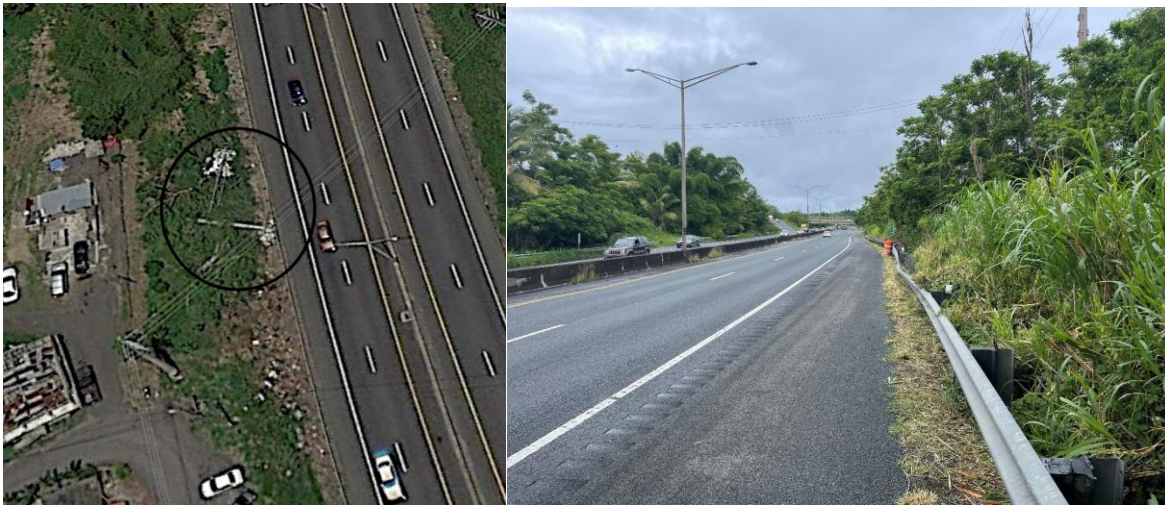
Located along Highway PR-30 in Las Piedras. A satellite image of the traffic sign structure is shown on Figure 5-55. The final position of the traffic sign showed a rotation around the vertical zenith axis and a total collapse. Figure 5-55 also presets that there were impact damages on the traffic barriers, possible due to the collapse of the sign. Due to narrow shoulders and traffic, the site was considered not safe to perform a more detailed inspection, but the post was already removed by the time of the field visit.

Figure 5-55: Photo of Cantilever Sign Collapse at P-66 Location: 18°11'11.10"N; 65°53'28.92"W

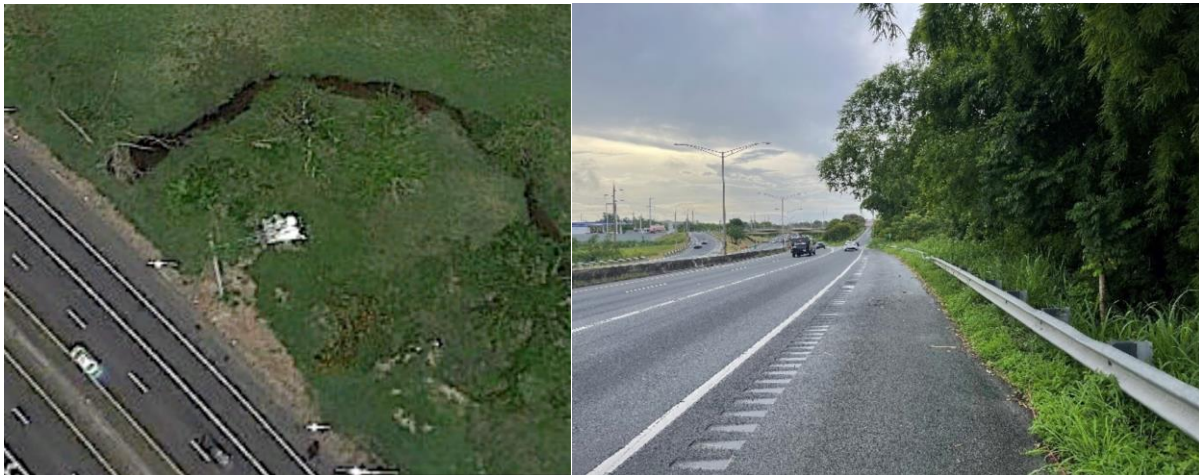
Located along Highway PR-30 in Las Piedras. A satellite image of the traffic sign structure is shown on Figure 5-56. The final position of the traffic sign showed a rotation around the vertical zenith axis and a total collapse. Figure 5-56 also presets that there were impact damages on the traffic barriers, possible due to the collapse of the sign. Due to narrow shoulders and traffic, the site was considered not safe to perform a more detailed inspection, but the post was already removed by the time of the field visit.

Figure 5-56: Photo of Cantilever Sign Collapse at P-99 Location: 18.183386°N; 65.88572°W

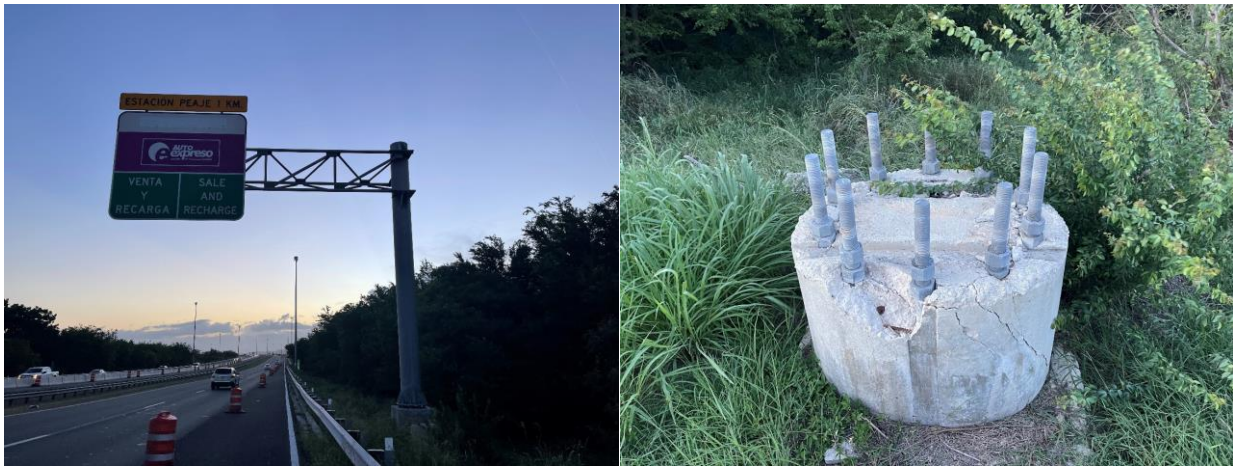
Located along the Highway PR-52 in Ponce. An image of the traffic sign structure is shown on Figure 5-58. Visual inspection revealed the pedestal concrete experienced fractures and initial detachments due to the anchor bolts lateral movement (See Figure 5-58). The position of the first stirrup was not visible. At the time of the visit the post was reinstalled on a new concrete square base.

Figure 5-59: Photo of Cantilever Sign Foundation Structural Damages on the Pedestal at P-4, Damages (Fractures on the Concrete Base) Location: 17.986208°N; 66.6033°W

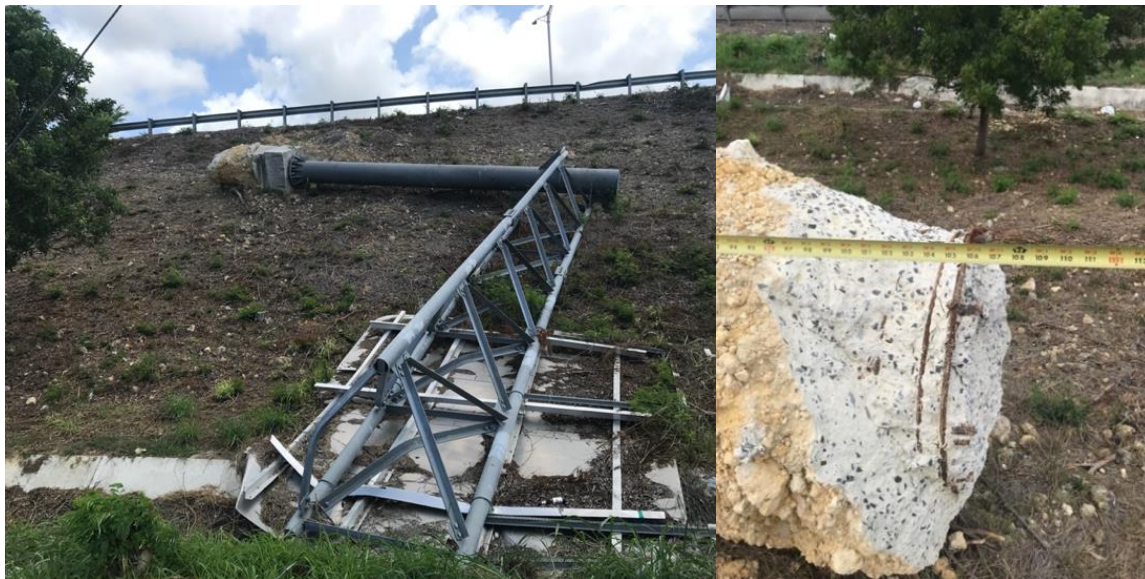
The Cantilever sign showing a foundation failure was located in the south area of the city of Ponce, along the Highway PR-2. It consisted of a square concrete base (pedestal) over a cast in place drilled shaft, that presented a foundation overturning failure, combined with an apparent rotation about the zenith axis before flipping, and a shear fracture of the concrete drilled shaft, as observed in the Figure 5-60. The fracture of the concrete of the drilled shaft was identified at a depth of 107 inches (measured from the top of the pedestal), just where the reinforcing steel of the shaft was discontinued.

Figure 5-60: Photo of Cantilever Sign Foundation Soil and Structural Failure at P-59. Location: 17°59'21.23"N; 66°38'46.49"W

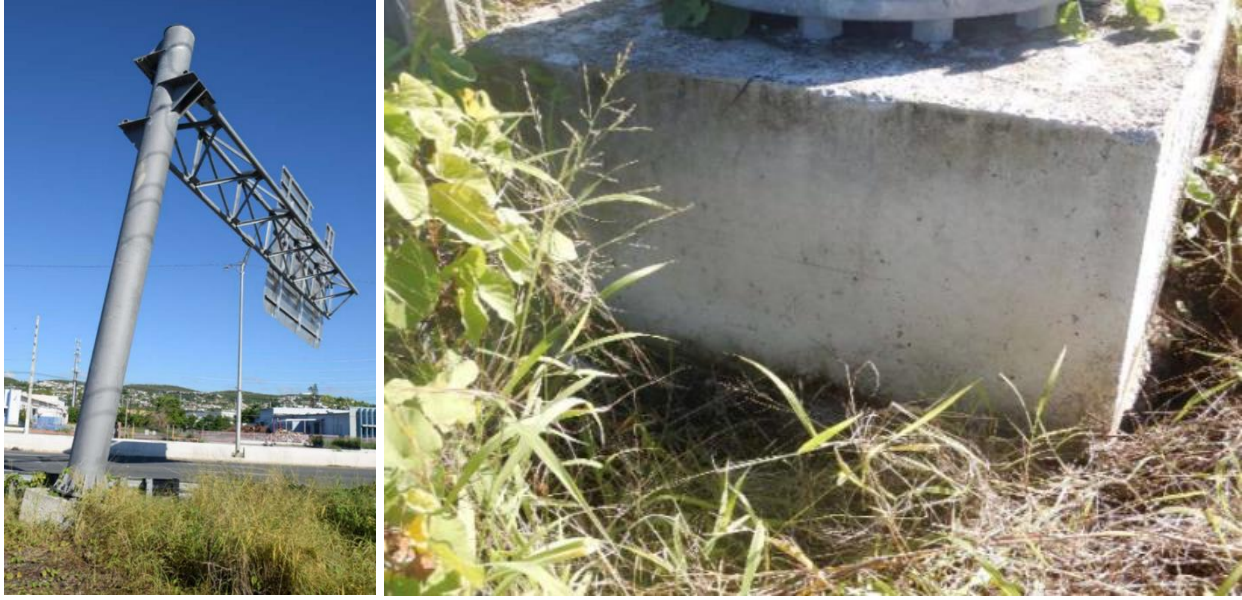
The Cantilever traffic was located just north of the city of Ponce along the southbound lanes of Highway PR-2. An image of the rotated state of this structure is shown on Figure 5-61. The foundation system at this site was not confirmed, as it was only possible to see a square pedestal, as shown in Figure 5-62. The sign was rotated (by about -30 degrees) and a gap between the top pedestal and the surrounding ground was observed, as shown on the images in Figure 5-62, but the concrete pedestal was not damaged, and the anchor bolts did not exhibit noticeable lateral deflections. This behavior leads to the assumptions that its foundation was the same that other exhibiting the same pattern of movement (precast cylindrical drilled shafts).

Figure 5-62: Photo Showing the Rotation of The Traffic Sign and the Foundation Pedestal at P-94

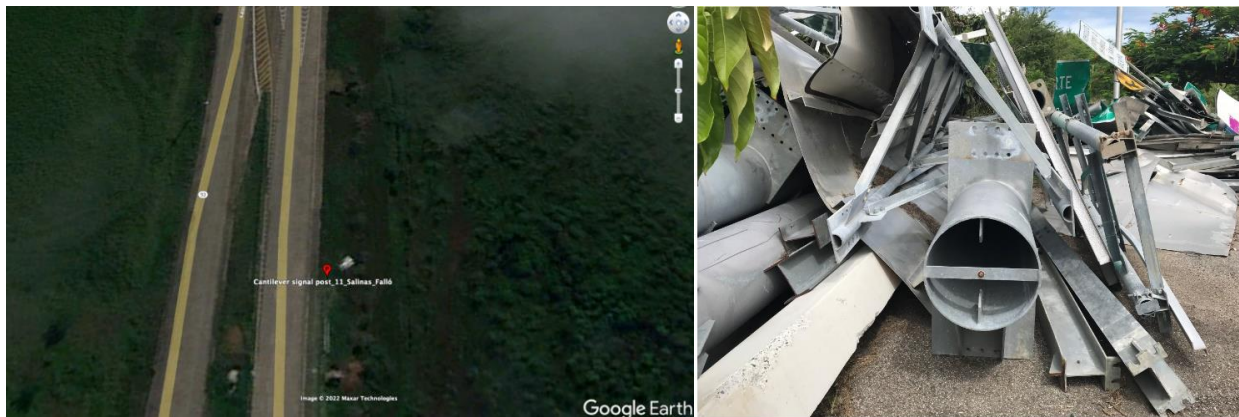
Located along the Highway PR-53 in Salinas. The final position of the traffic sign could not be verified because at the time of the visual inspection the sign structure had been totally removed by the PR DOT. The structure was verified in the yard where it was stored. The diameter of the pole base was 35 inches (0.89 m) (See Figure 5-63). The structure was sound. Through the visual inspection of the elements on the yard, and interview with PR DOT personnel, that recover the sign from PR-53 highway, it was determined that the collapsed post experimented detachment from the pedestal, and that the anchor bolts showed large deflections, bending on the plastic range, and total shear failure due to torsional movement of the base plate, similar to P-12 (presented in next section).

Figure 5-63: Photo of Cantilever Sign Location and Rests Stored at Yard for Id P-11 Location: 18° 0'1.89"N; 66°14'17.05"W

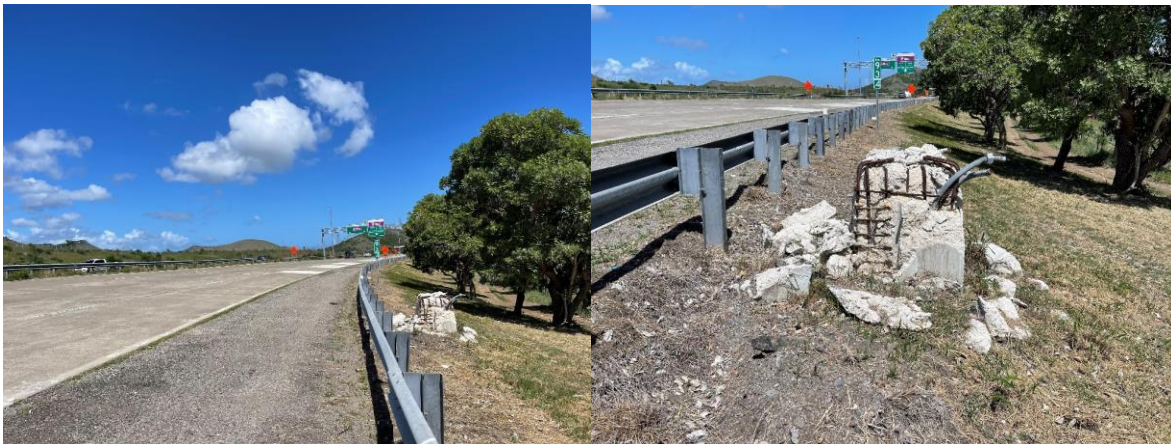
Located along the Highway PR-53, José M. Dávila Monsanto, in Salinas. An image of the remains of the traffic sign structure is shown on Figure 5-64. The traffic sign was removed from the scene and stored on agency property. According to the final position of the anchor bolts of the structure, a rotation of approximately 100 degrees about the vertical zenith axis was observed. Visual inspection revealed that the collapsed post presented large deflection of the anchoring elements with a torsional pattern, leading them to receive permanent deformations and shear fracture. The concrete of the pedestal reflects fractures and detachment due to the high stresses received (See Figure 5-65). A large distance between the last stirrup and the top of the pedestal could also be appreciated, and an anchor bolt outside the stirrups' confinement.

**Figure 5-64: Photo of Cantilever Sign Structural Failures on the Pedestal at P-12 Location: 18° 0'11.23"N;
66°14'29.63"W**

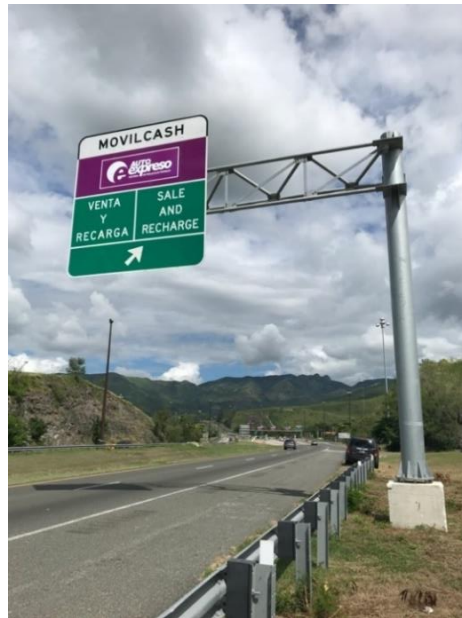
Located along the Highway PR-52 in Salinas. An image of the traffic sign structure is shown on Figure 5-66. The final position of the traffic sign showed a rotation about the zenith vertical axis (Figure 5-67). The visual inspection demonstrated that the post exhibits twisting and plastic deformations in the anchor elements. The internal stresses experienced by the concrete produced fractures and detachments in the pedestal (See Figure 5-67).

Figure 5-66: Photo of Cantilever Sign Structural Failures on the Pedestal at P-15. Location: 18° 1'29.22"N; 66° 14'28.42"W

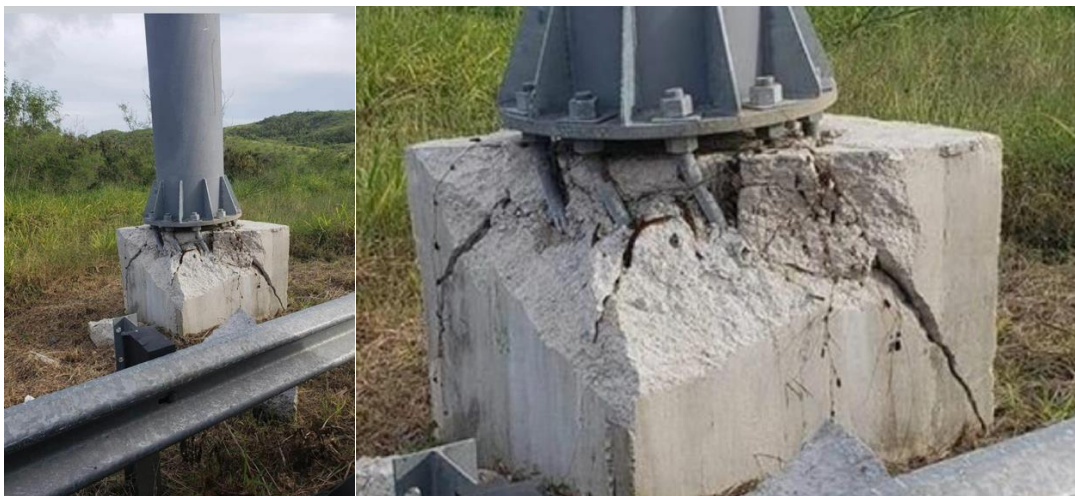
Figure 5-67: Photo of Cantilever Sign Foundation Structural Failure at P-15; Partial Collapse; the Post Presented Large Deflections and Double Bending in the Plastic Range of the Anchoring Elements

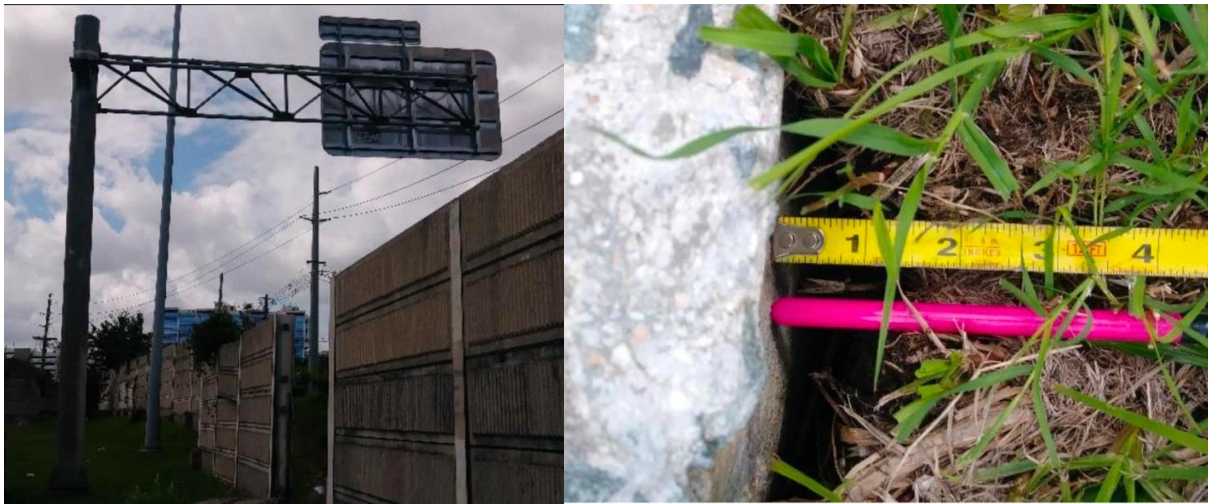
Located along the Highway PR-18 in San Juan. An image of the traffic sign structure is shown on Figure 5-68. The visual inspection showed that the Cantilever sign rotated approximately 180 degrees about the vertical zenith axis. The ground around the base was detached from the foundation approximately 2 in, allowing the base to rotate more freely (See Figure 5-68). Not significant structural damages were found on the pedestal.

**Figure 5-68: Photo of Cantilever Sign Foundation Soil Failure (Torsional Rotation) at P- 33 Photo Location:
18°23'52.03"N; 67° 66° 4'14.19"W**

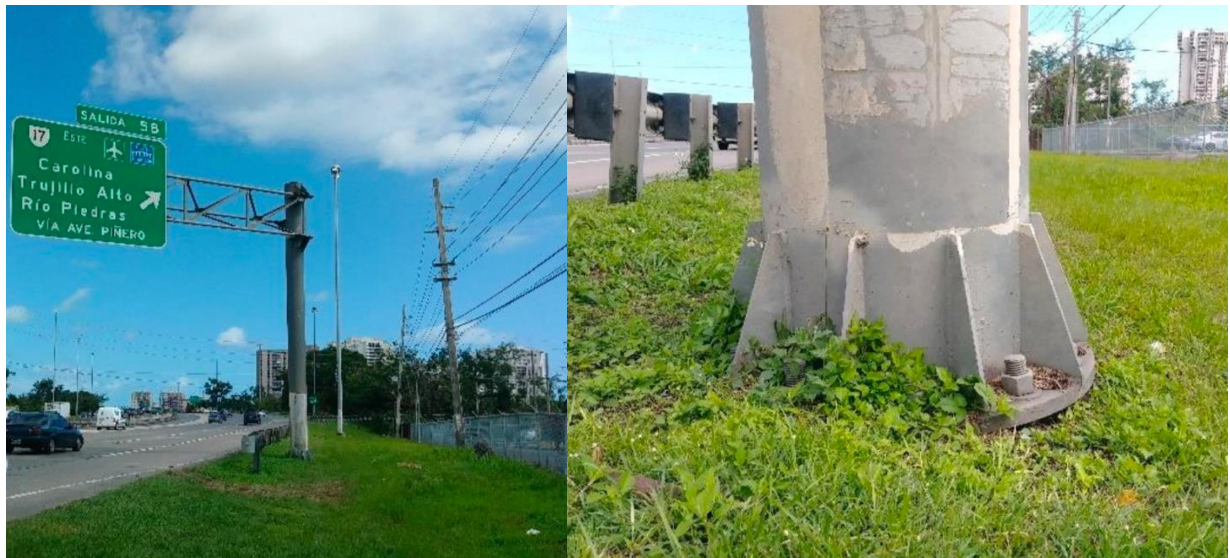
Located along the Highway PR-18 in San Juan. An image of the traffic sign structure is shown on Figure 5-69. The visual inspection revealed that the Cantilever sign rotated approximately 30 degrees about the vertical zenith axis. In addition, the connection of the base to the pedestal did not have the non-shrinkable grout material installed that must be placed between the base plate and the concrete base, to evenly distribute the loads and stresses on the concrete base.

**Figure 5-69: Photo of Cantilever Sign Soil Foundation Failure (Torsional Rotation) at P- 35 Photo Location:
18°24'16.37"N; 66° 4'11.96"W**

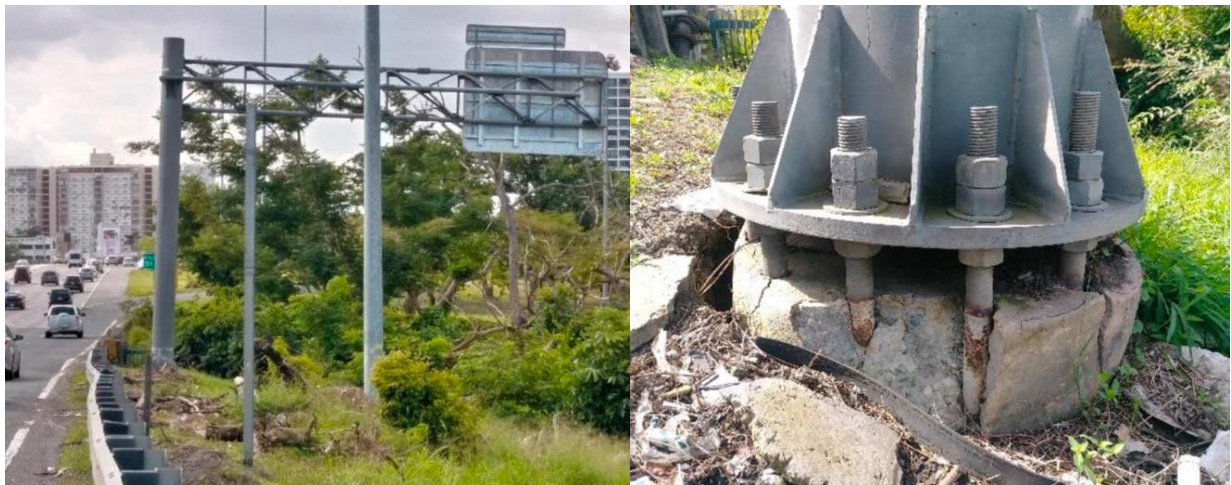
Located along the Highway PR-18 in San Juan. An image of the traffic sign structure is shown on Figure 5-70. During the visual inspection, it was observed that the cantilever sign rotated approximately 180 degrees about the vertical zenith axis, and the concrete base experienced fractures and detachments due to anchor bolts lateral movement. The base did not have installed the non-shrinkable grout material that must be placed between the base plate and the concrete base, to evenly distribute the loads and stresses on the concrete base (See Figure 5-70). The anchors that resulted exposed and corroded. The position of the first stirrup was not visible.

Figure 5-70: Photo of Cantilever Sign Soil Foundation Failure (Torsional Rotation) with Damages to the Pedestal at P- 38
Photo Location: 18°24'5.58"N; 66° 4'16.57"W

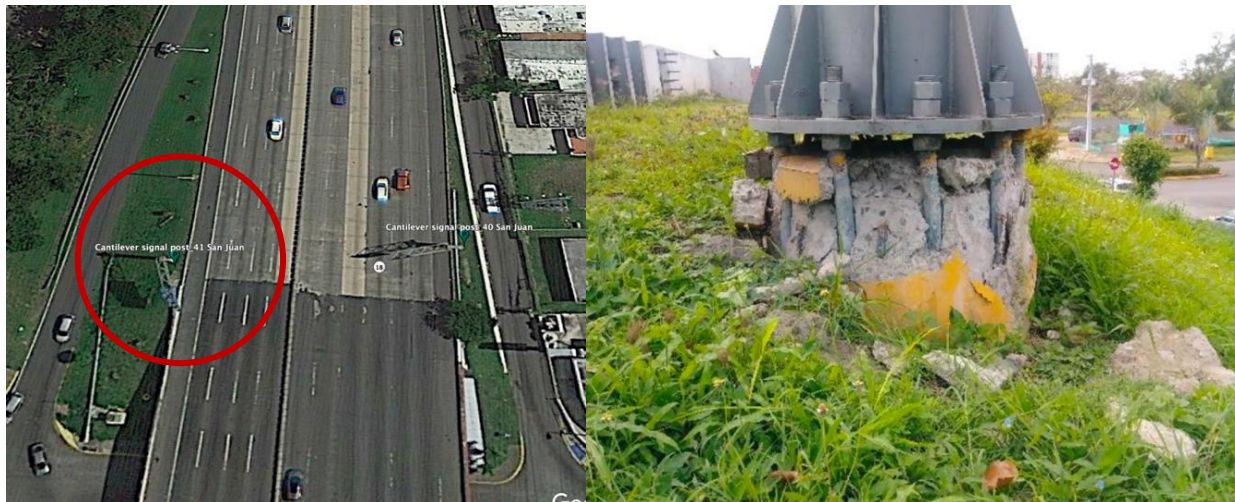
Located along the Highway PR-18 in San Juan. An image of the traffic sign structure is shown on Figure 5-72. The Cantilever sign rotated approximately 70 degrees about the vertical zenith angle, and the concrete base reflected damages (cracks and detachments) due to anchor bolts lateral movement. The bolts had some degree of permanent deformations. In the visual inspection, it was identified that the base did not have the non-shrinkable grout material installed that must be placed between the base plate and the concrete base, to evenly distribute the loads and stresses on the base of concrete (See Figure 5-72). The position of the first stirrup was not visible.

Figure 5-72: Photo of Cantilever Sign Soil Foundation Failure (Torsional Rotation) with Damages to the Pedestal at P- 41
Photo Location: 18°24'47.01"N; 66° 4'13.07"W

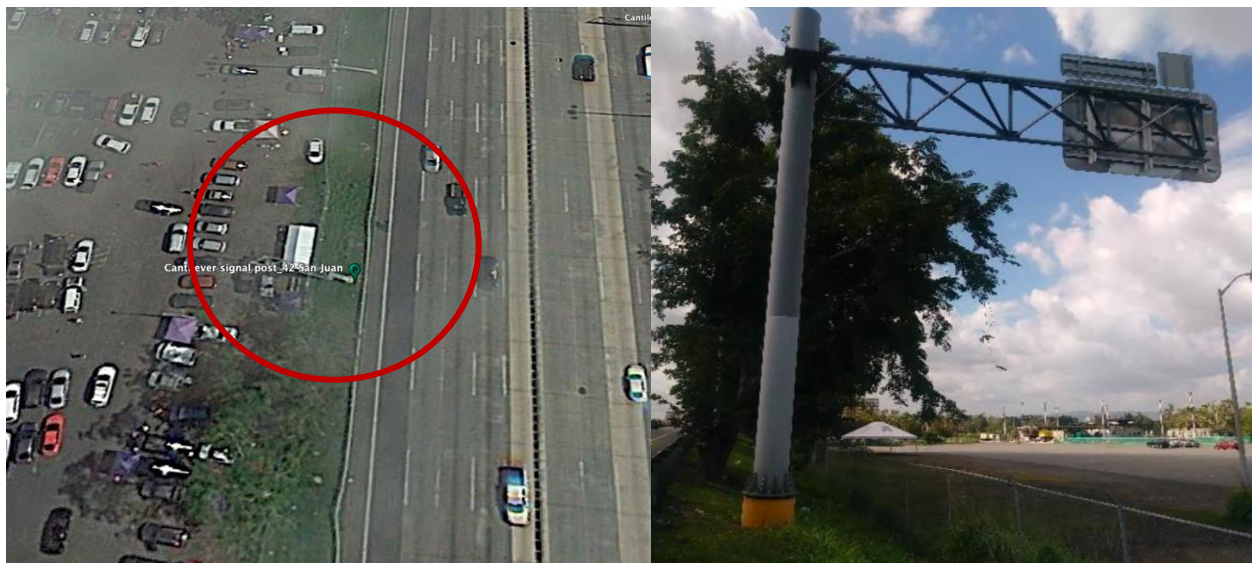
Located along the Highway PR-18 in San Juan. An image of the traffic sign structure is shown on Figure 5-73. The concrete base rotated 90 degrees about the vertical zenith axis, and also reflected an inclination (out of plumb) towards the bottom of the slope. In the visual inspection, it was identified that the base did not have the non-shrinkable grout material installed that must be placed between the base plate and the concrete base, to evenly distribute the loads and stresses on the base of concrete. The base was detached from the ground, creating a gap of around 3.5-4.0 in. This dimension was variable around the perimeter of the cylindrical foundation (See Figure 5-74). The granular fill material or clean sand indicated in the specifications was not identified. It was observed that part of the earth slope had experienced movement downwards (the soil located approximately 0.45 m downslope from the post) (See Figure 5-74).

Figure 5-73: Photo of Cantilever Sign Foundation Failure (Torsional Rotation) at P- 42 Photo Location: 18°24'54.71"N; 66° 4'13.43"W

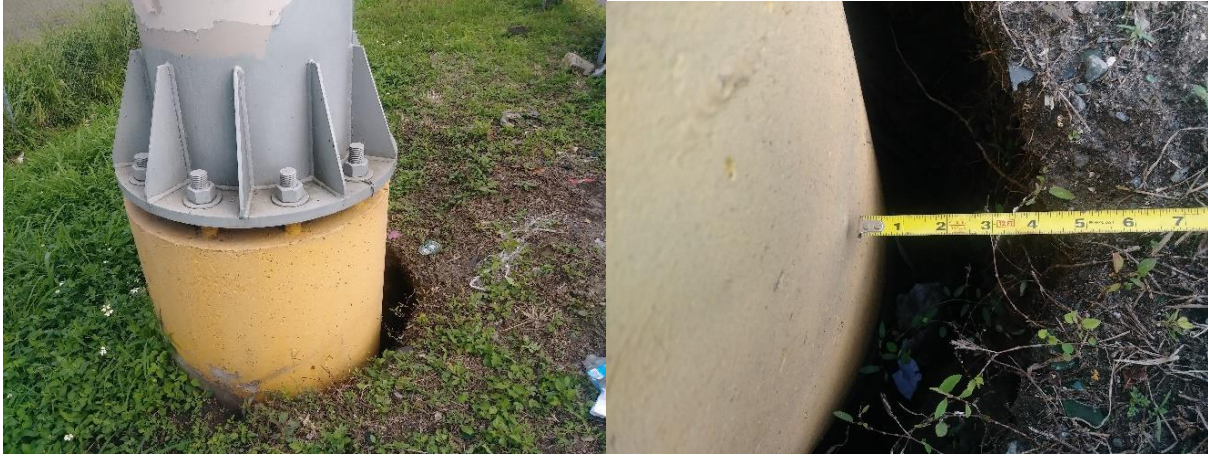
Figure 5-74: Gap Around the Circumference of the Drilled Shaft, and Soil Movement Downhill

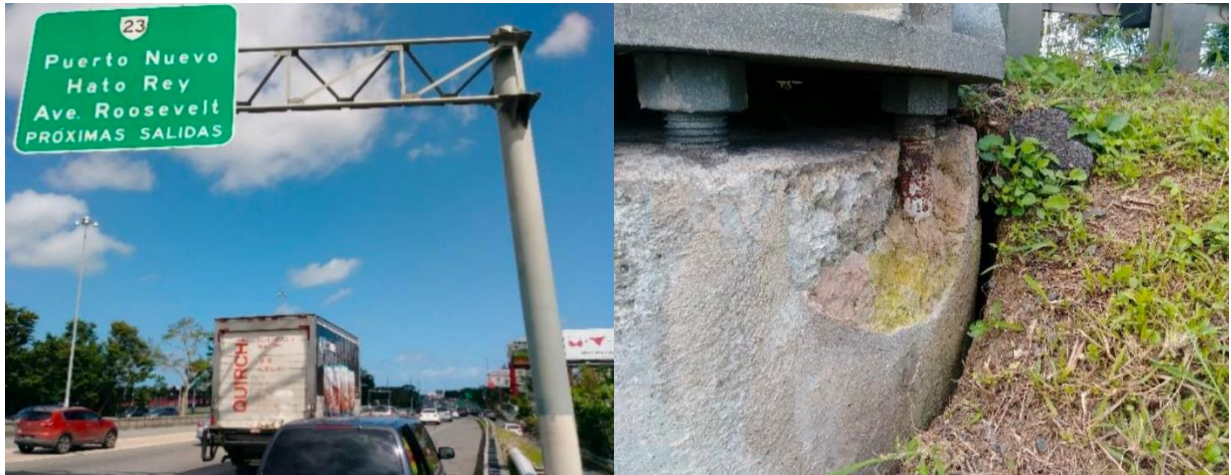
Located along the Highway PR-18 in San Juan. An image of the traffic sign structure is shown on Figure 5-75. The concrete base appeared to have experienced small torsional rotations, there were damages to the concrete base (spall, and exposed and corroded anchor bolt), and there was a gap between the soil and de foundation shaft. Additionally, the base plate did not have the non-shrinkable grout material installed that must be placed between the base plate and the concrete base, to evenly distribute the loads and stresses on the base of concrete.

Figure 5-75: Photo of Cantilever Sign Foundation Failure (Torsional Rotation), Damages to the Concrete Pedestal, and Gap Between Soil and Shaft at P- 43 Photo Location: 18.41788611°N; 66.07006111°W

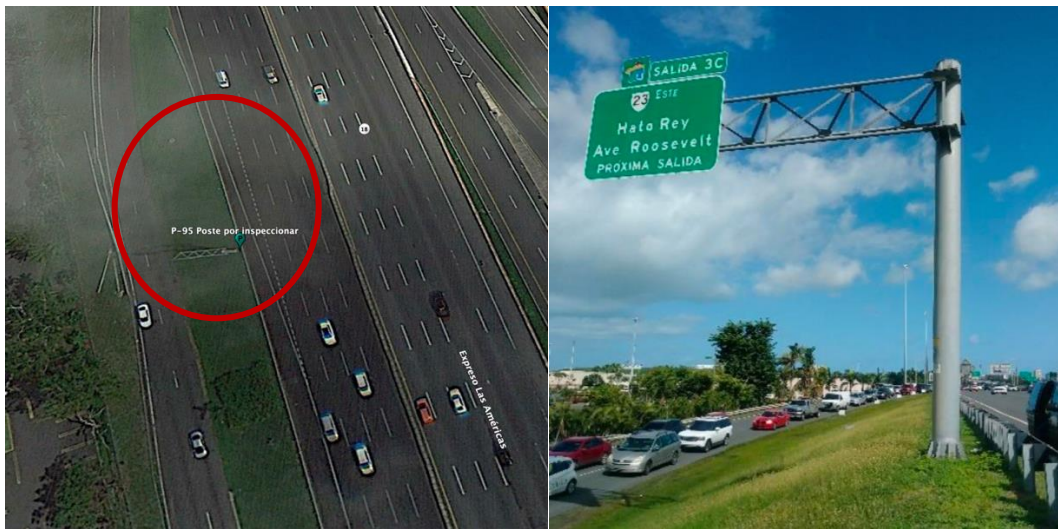
Located along the Highway PR-18 in San Juan. An image of the traffic sign structure is shown on Figure 5-77. The visual inspection revealed that the cantilever sign rotated approximately 180 degrees about the vertical zenith axis and exhibited a loss of contact with the ground along the entire upper circumference of the foundation. Ground detached from the base approximately 2 in around the circumference (See Figure 5-78).

Figure 5-77: Photo of Cantilever Sign Soil Foundation Failure at P- 95 Photo Location: 18°25'25.61"N; 66° 4'20.75"W

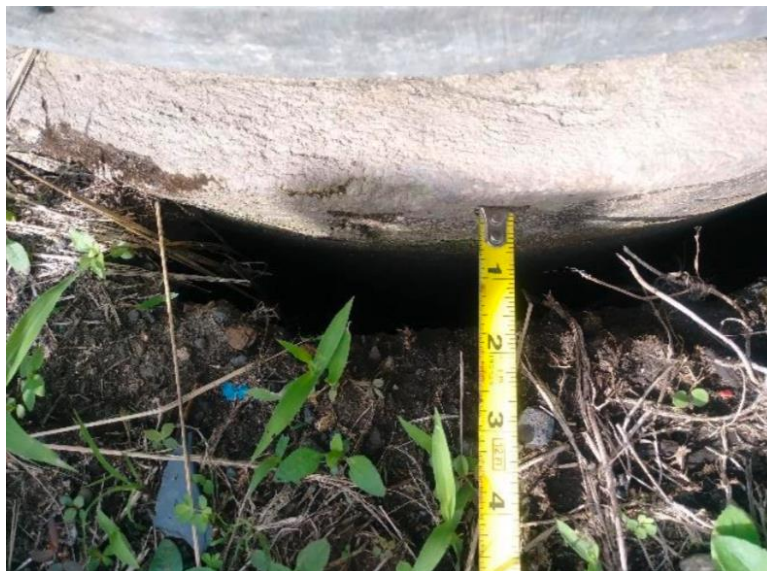
Figure 5-78: Gap Around the Circumference of the Drilled Shaft

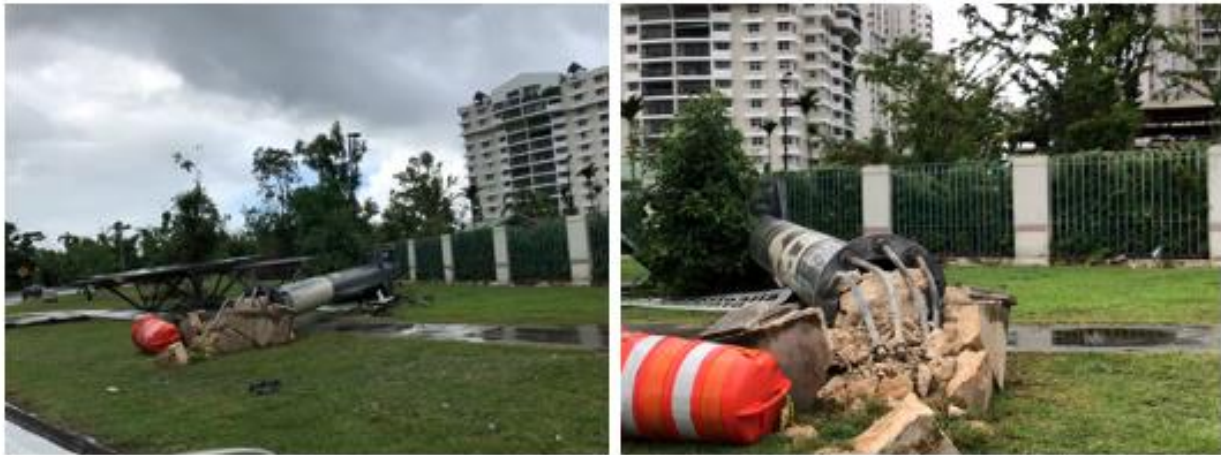
Located along the Highway PR-17 Avenida Jesús T Piñero in San Juan. An image of the traffic sign structure after its removal from the roadway is shown on Figure 5-79. The final position of the traffic sign shows a rotation about the vertical zenith axis, and about a horizontal axis. Visual inspection revealed that the collapsed post presented large lateral deflections and bending on the plastic range of the anchor elements, that also exhibited pullout and shear fracture; some of the anchor bolts seemed to have been out of the pedestal lateral confinement steel reinforcement; the concrete presented fractures and detachments (See Figure 5-79).

Figure 5-79: Photo of a Collapsed Cantilever Sign Foundation due to Structural Failures on the Pedestal at P-98
Location: 18°24'27.38"N; 66° 4'3.00"W

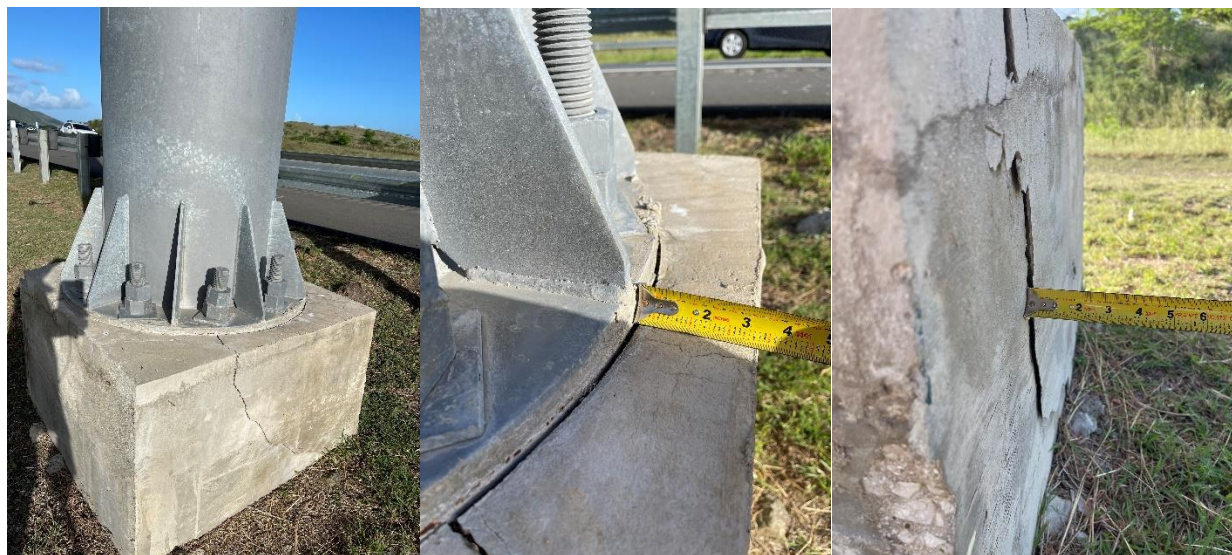
Located along the Highway PR-52 in Santa Isabel. An image of the traffic sign structure is shown on Figure 5-82. The field visit revealed that the pedestal had cracks, as presented in Figure 5-82 and Figure 5-83. These cracks are consistent with the ones produced by anchor bolts and/or base plate movement.

Figure 5-83: Photo of Cantilever Sign Location Pedestal Cracks at P-10

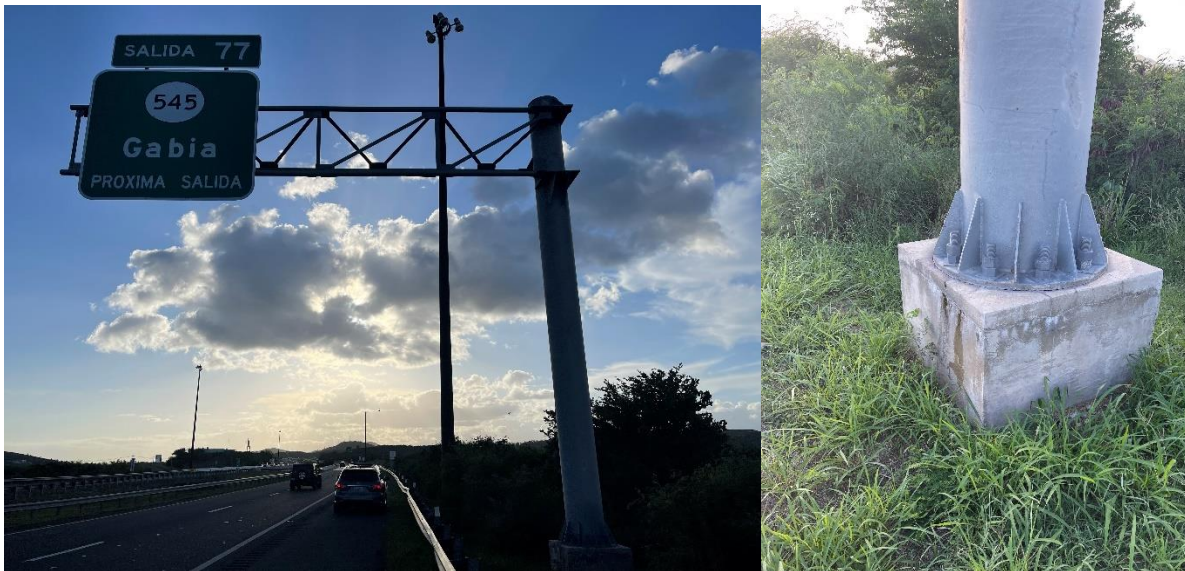
Located along the Highway PR-52 in Santa Isabel. An image of the traffic sign structure is shown on Figure 5-84. The field visit revealed some fine cracks on the pedestal, as presented in Figure 5-84; these cracks appeared to be limited to the top mortar of the concrete base, and could be a result of the construction process, and not necessarily attributed to the wind vibrations. The pedestal also shows efflorescence, water marks, and leakage. At the time of summarizing the findings, this one will not be counted as a wind induced failure.

Figure 5-84: Photo of Cantilever Sign Location and Pedestal Cracks, Efflorescence, Water Marks and Leakage at P-36
Photo Location: 18.01324444°N; 66.38875°W

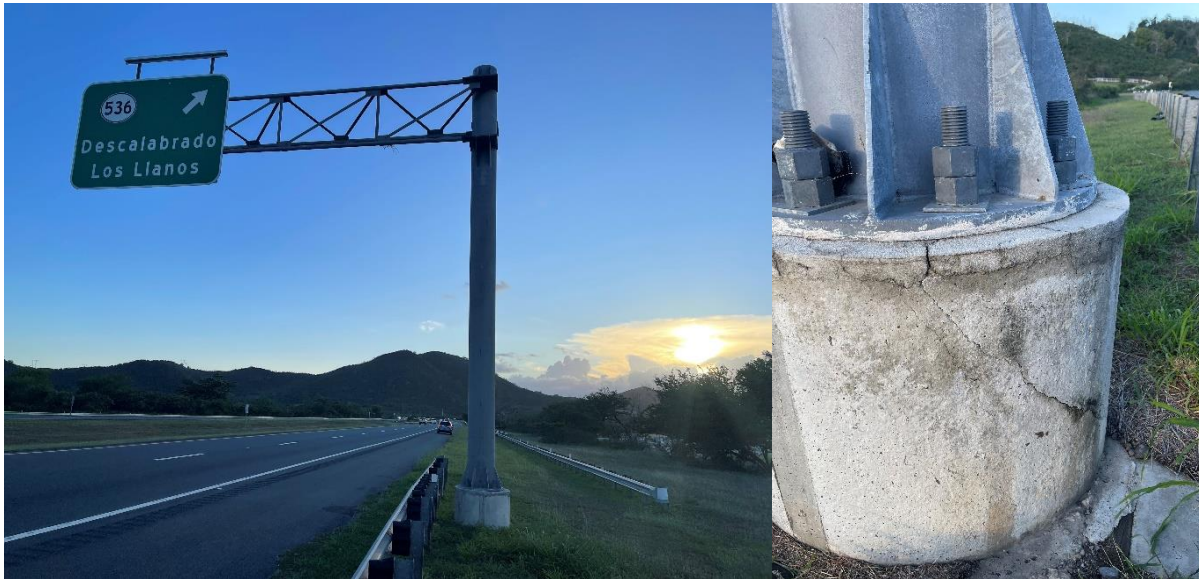
Located along the Highway PR-52 in Santa Isabel. An image of the traffic sign structure is shown on Figure 5-85. The field visit revealed a diagonal on the pedestal, consistent with the ones produced by anchor bolts movement due to wind action (see Figure 5-85).

Figure 5-85: Photo of Cantilever Sign Location and Pedestal Cracks at P-70 Photo Location: 18.0284609°N; 66.4165331°W
