Improving Transportation Infrastructure Resilience against Hurricanes, other Natural Disasters, and Weathering: Part I - Analysis of failure of transportation signs due to Hurricane Maria

Volume 1

FINAL REPORT
June 2022

Transportation Infrastructure Research Center – TIRC
Polytechnic University of Puerto Rico
377 Ponce de Leon Ave, San Juan, PR 00918

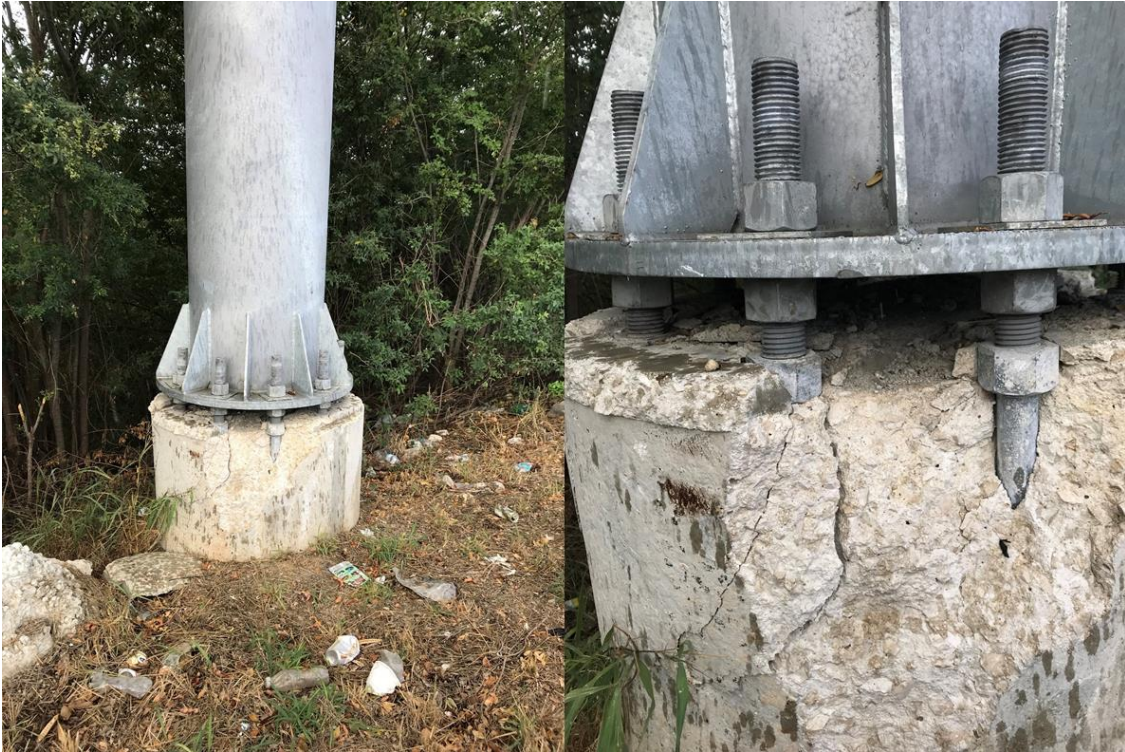
In Figure 6-1, Figure 6-2, and Figure 6-3 one can appreciate the initial stages of pedestal damages due the torsional rotation of the post base plate, presenting cracks and spalls on the concrete triggered by the lateral deflections of the anchor bolts that exerted tension stresses on the concrete. In all these three cases the bolts did not exhibit significant deflections in the plastic regimen.

Figure 6-1: Initial Stages of Concrete Cracks and Spalls due to Lateral Deflections of Anchor Bolts (Sign P-1)

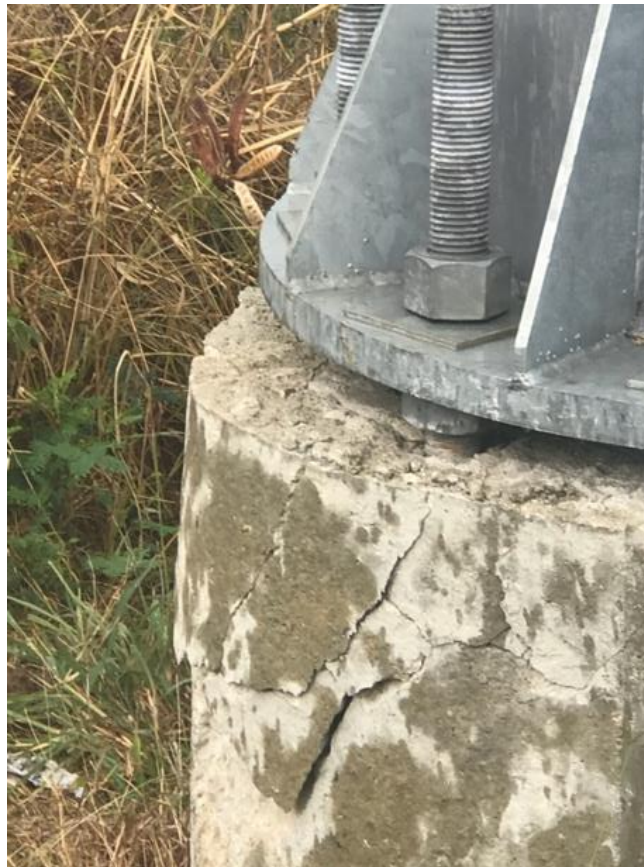
Figure 6-2: Initial Stages of Concrete Cracks and Spalls due to Lateral Deflections of Anchor Bolts (Sign P-3)

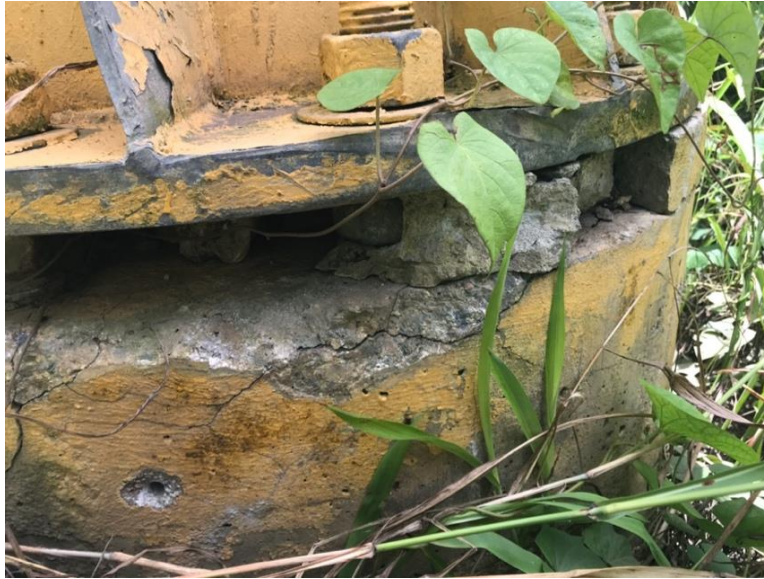
Figure 6-3: Initial Stages of Concrete Cracks and Spalls due to Lateral Deflections of Anchor Bolts (Sign P-76)

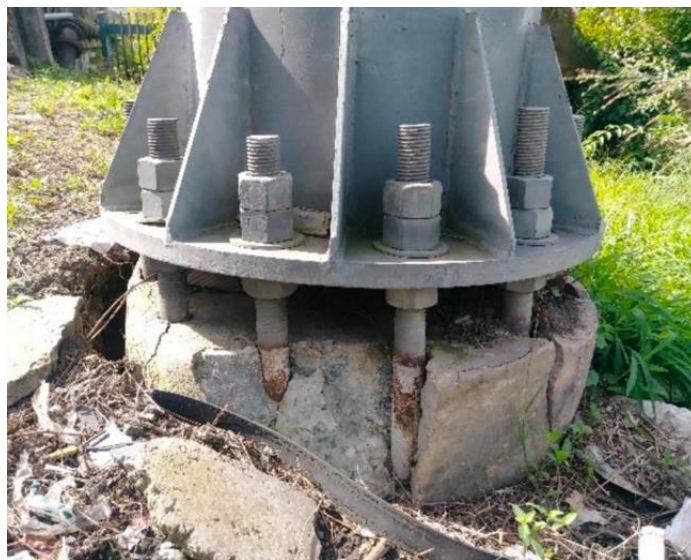
Figure 6-4, Figure 6-5, and Figure 6-6 present more advance situations of pedestal damages due the torsional rotation of the post base plate. In the first two cases the bolts did not exhibit significant defections in the plastic regimen, but in the third one the plastic deformations are present, and the double bending shape of the bolts starts to be identifiable. The large distance between the last stirrup (last lateral support of the anchor bolts) and the base plate also started to be evident.

Figure 6-4: More Advance Stage of Concrete Cracks and Spalls due to Lateral Deflections of Anchor Bolts with Large Unconfined Length (Sign P-38)

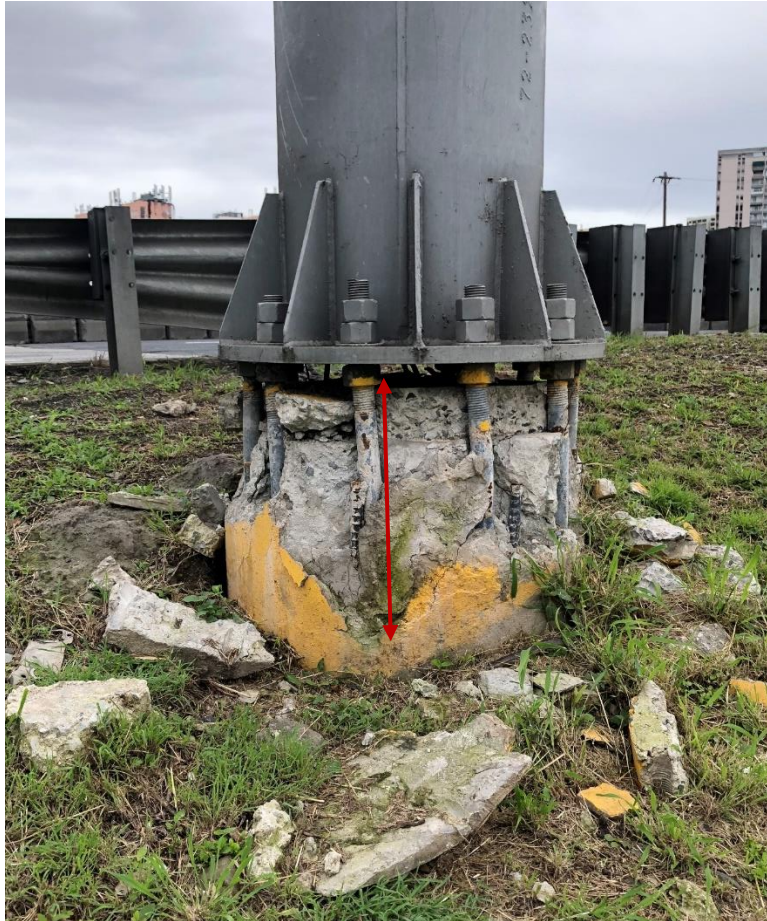
Figure 6-5: More Advance Stage of Concrete Cracks and Spalls due to Lateral Deflections of Anchor Bolts with Large Unconfined Length (Sign P-41)

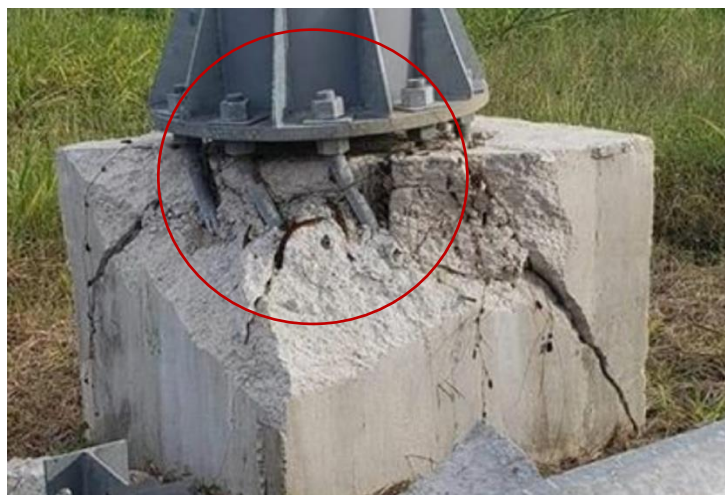
Figure 6-6: More Advance Stage of Concrete Cracks and Spalls due to Lateral Deflections of Anchor Bolts with Large Unconfined Length. Bolts Exhibit Double Bending Shape (Sign P-15)

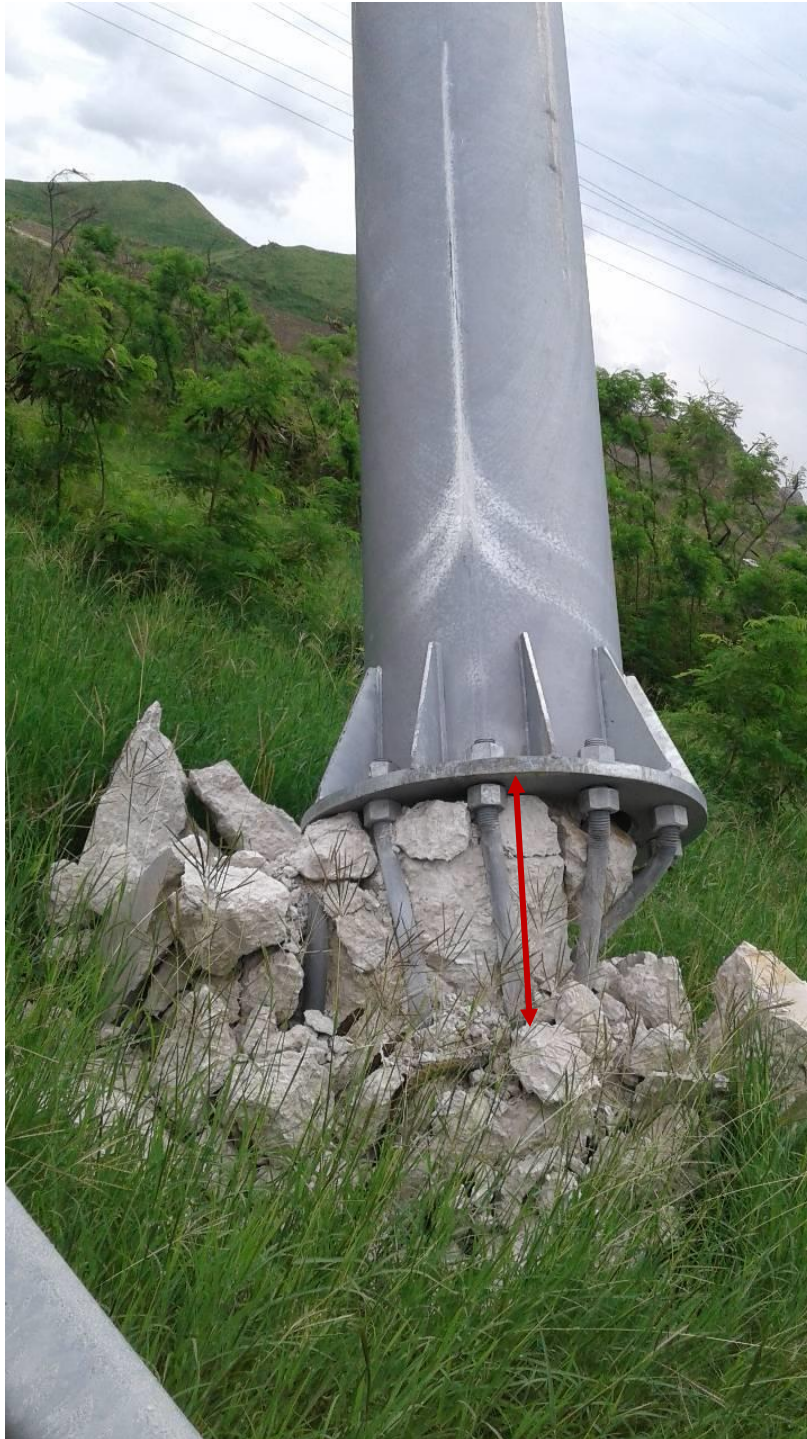
Significantly more advanced situations of damages, presenting extremely large deflections of the anchor bolts on the plastic regimen, large cracks, spalls, and deterioration of the concrete, and partial or total collapse of the traffic sign structure are displayed in Figure 6-7 to Figure 6-11. The images clearly present the double bending of the anchor bolts in the plastic range, and the large distance between the base plate of the post and the first stirrup that provides lateral support to the bolt. The images also show that in some cases the base plate did not only rotate in torsion (about the vertical axis) but also in bending (about the horizontal axis), producing crushing to the concrete, and pull out of the anchor bolts.

Figure 6-8: Large Deflections of Anchor Bolts due to Lack of Lateral Confinement

These damages and failures indicate that the confinement of the anchor bolts is essential to avoid damages. And that the specifications for stirrups separation, separation between the last stirrup and the base plate, and details of the top of the pedestal to avoid these lateral movement is of extremely importance. In several cases, the observed distance between the top stirrup and the base plate did not comply with PRHTA specifications (see Appendix C for details); a strict inspection and quality control during sign installation is also imperative.

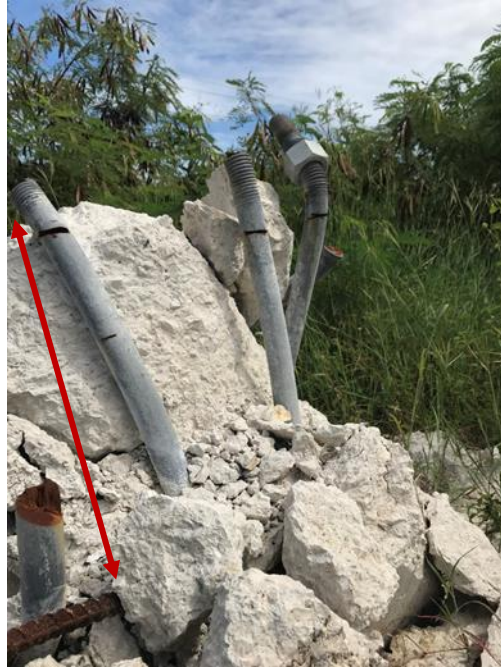
Figure 6-9: Large Deflections of Anchor Bolts due to Lack of Lateral Confinement (Sign P-12)

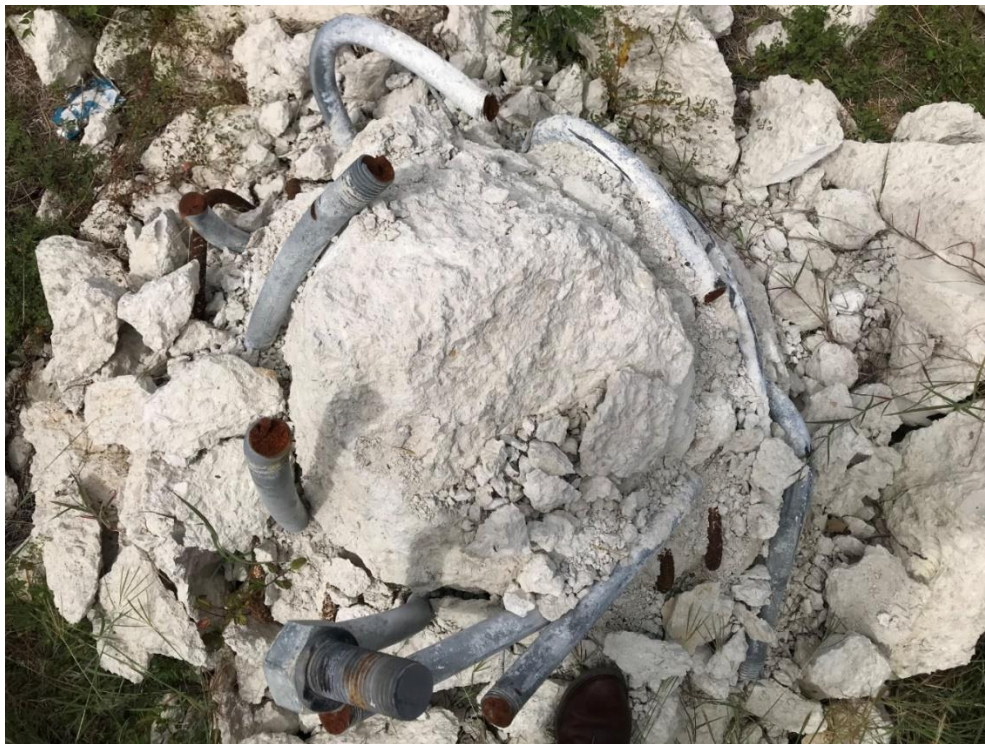
Figure 6-10: Large Deflections of Anchor Bolts due to Lack of Lateral Confinement (Sign P-12)

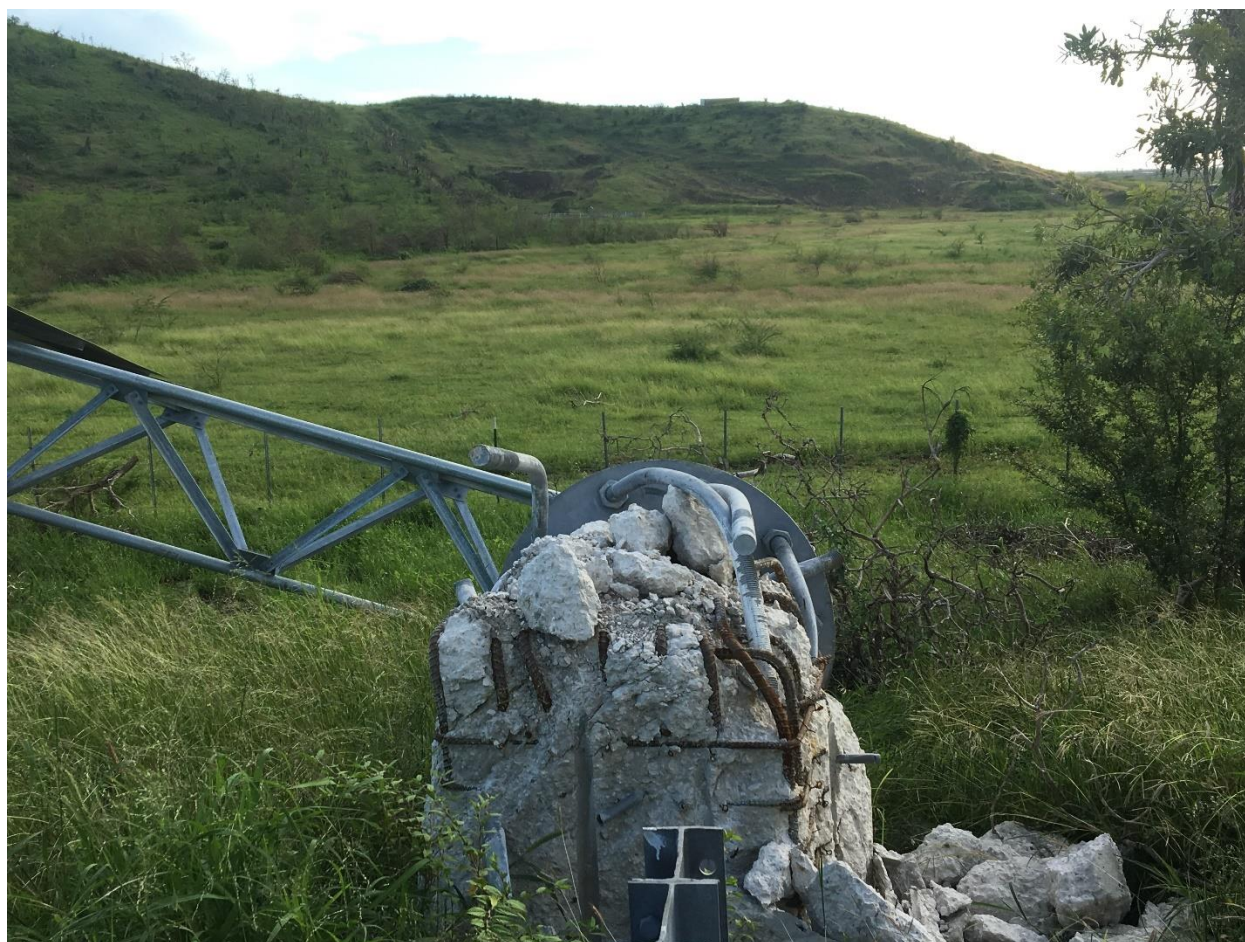
The field inspection also revealed that in several situations the anchor bolts were placed outside the concrete core confined by the stirrups (transverse reinforcement). This condition made these signs more vulnerable. Figure 6-12 to Figure 6-14 are examples of this situation.

Figure 6-13: Some of the Anchor Bolts Outside the Transverse Confinement Steel / Concrete Core (Sign P-100)

The observed location of the anchor bolts strongly suggests that a review of the final proposed design for the foundation of this traffic signs, and a strict inspection and quality control during sign installation are imperative.

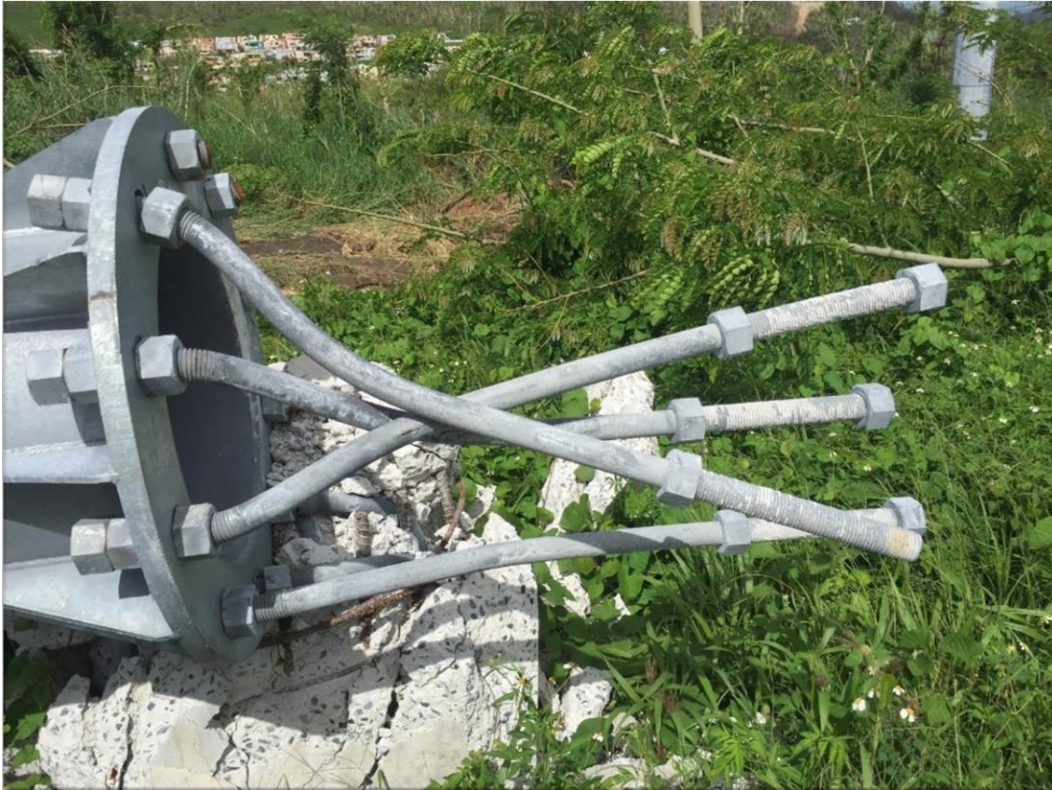
Some of the cases presented anchor bolts clean, with no concrete adhered to its skin, giving the appearance of anchor bolts pull out due to lack of skin resistance or adequate embedment. This situation suggests that a revision of anchor bolts installation to assure proper embedment length and adherence to concrete is required. Figure 6-15 to Figure 6-17 are examples of this condition.

Figure 6-16: Anchor Bolts Pullout (Sign P-105)

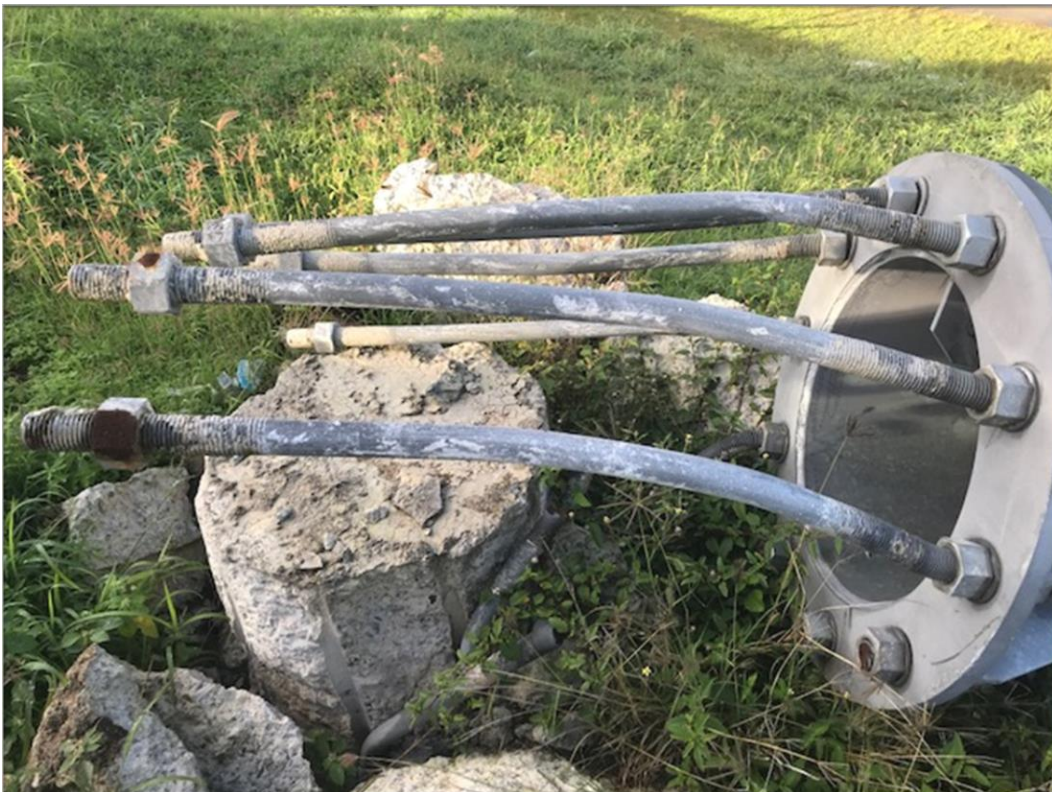
Figure 6-17: Anchor Bolts Pullout (Sign P-53)

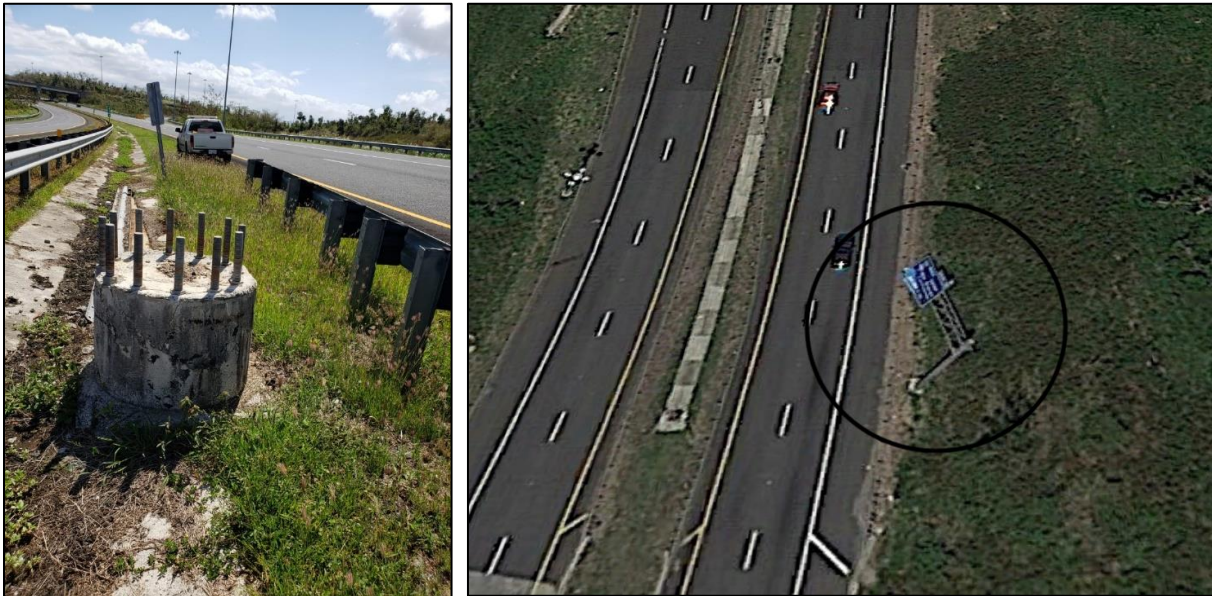
Figure 6-20 and Figure 6-21 present two examples of cylindrical precast concrete bases that rotated about the vertical axis due to torsional shear stresses on the soil-shaft interface produced by the wind forces action on the traffic sign.

Figure 6-20: Cylindrical Precast Concrete Base that Experienced Torsional Rotation. The post was Removed. PR 66 in Canóvanas

This abundant mode of failure strongly suggests that the shaft resistance of these precast concrete cylindrical was not adequate, and a redesign of the foundations is recommended. For instance, one may consider either increasing the embedment length and the diameter of the base, changing the soil compaction requirements and the texture of the finished concrete, or changing the precast concrete base cross sectional shape from circular to square, in order to trigger soil to soil shear resistance instead of soil to concrete shear resistance. Other alternative could be to opt for cast in place concrete bases, which did not exhibit these torsional rotations.

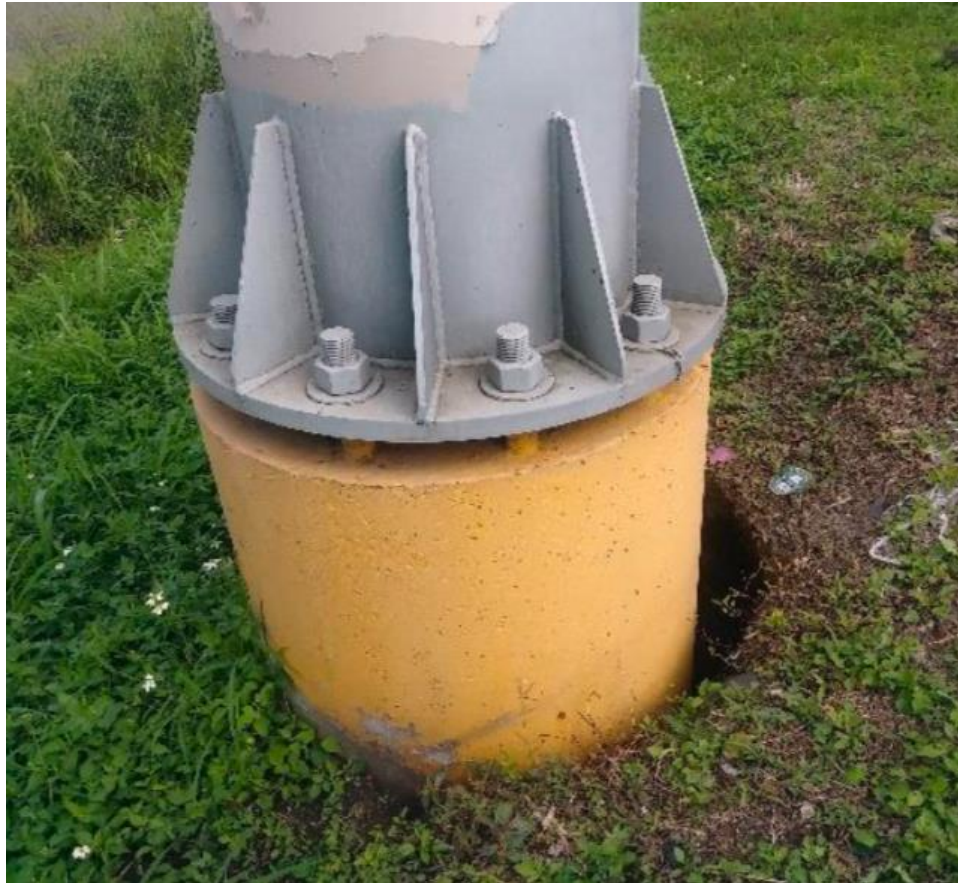
This mode of failure may have been aggravated by lack of proper soil preparation. It was noticed that in some cases the concrete base was detached from the ground, creating a gap between the soil and the foundation in all the perimeter of the cylindrical shaft, as shown in Figure 6-22. Also, in these cases that presented the gap, the granular fill material or clean sand indicated in the specifications was not identified during the visual inspection. Although not related to this mode of failure, it was identified that several of the post bases did not have the non-shrinkable grout material installed that should be placed between the base plate and the concrete base, to evenly distribute the loads and stresses on the base of concrete, as can be observed in Figure 6-22.

Figure 6-22: Gap Between the Soil and the Cylindrical Precast Concrete Base that Experienced Torsional Rotation. PR 18 in San Juan.

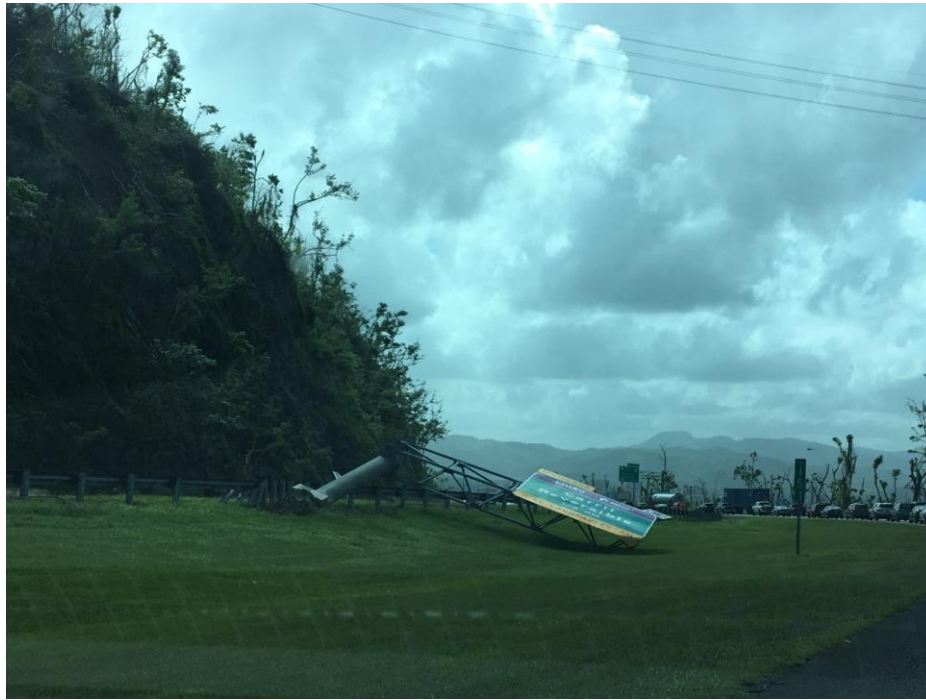
Figure 6-23 shows one of the three cases observed with this type of failure, where the base (foundation) experienced torsional rotation and collapsed by overturning. One of the other cases occurred on a more pronounced slope and is presented in the following section. The fact that there were only two cases observed in flat or not pronounced slope suggests that the overturning mode of failure was not a common problem, and not general recommendations and observations were drawn for this case.

Figure 6-23: Foundation that Experienced Torsional Rotation and Overturning. PR 52 in Caguas.

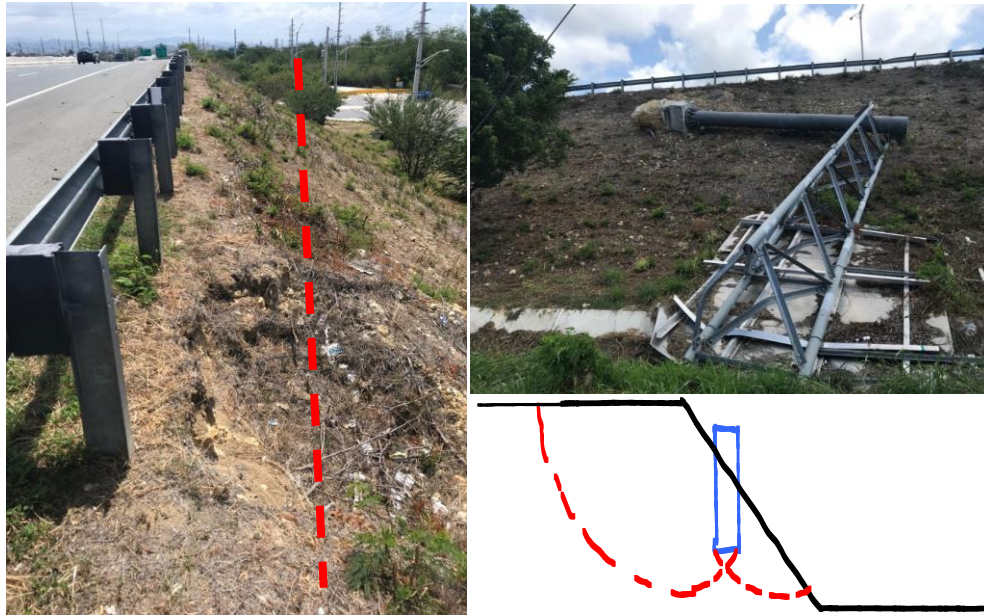
Figure 6-24 presents the other case observed that experienced this type of failure, where the base experienced torsional rotation and collapsed by overturning, but this one occurred on a pronounced slope.

As presented in section 6.1.4, the pedestal presented lack of required length (depth) of the longitudinal and transverse steel reinforcement, that produced a shear torsional failure of the shaft.

Figure 6-24: Foundation that Experienced Torsional Rotation and Overturning on a Pronounced Slope. PR 2 in Ponce.

But the shape of the soil failure suggests that there were also foundation length embedment problems. No special design details and construction plans were obtained for the case of signs on slopes from the PR DOT; This strongly suggest that this type of sign location needs special design requirements, to assure enough embedment length that allows the proper soil passive action, considering the soil discontinuity and lack of confinement downhill.

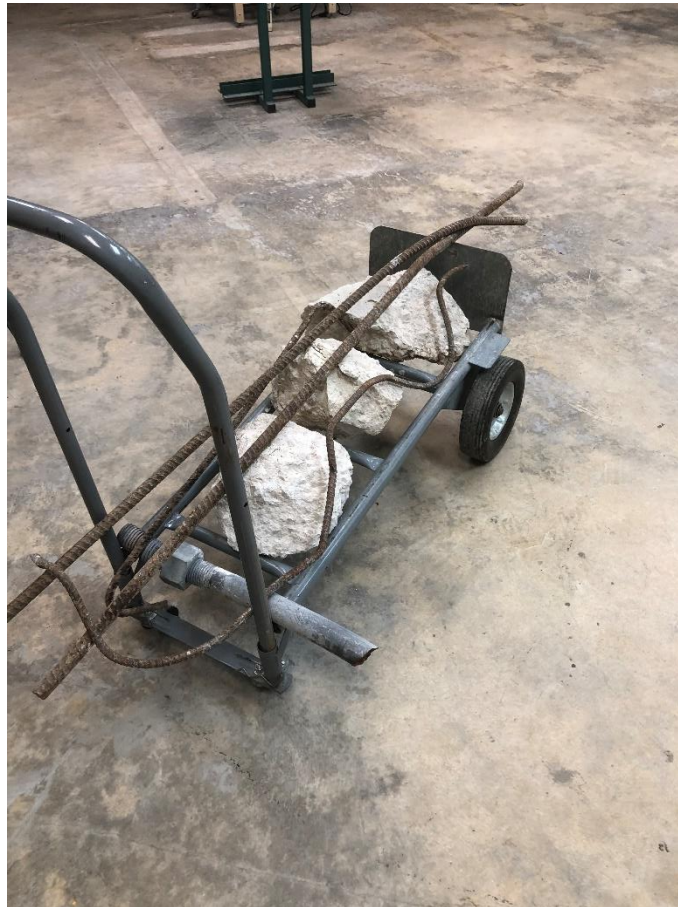
For one of the sites visited, corresponding to sign P-2, samples of the pedestal structural components were collected: they consisted of pieces of detached concrete, longitudinal and transverse reinforcing steel, and anchor bolts, as presented in Figure 8-1. The main idea was to perform mechanical tests on these components, to assess if any material deficiency (lack of strength) could have contributed to the failures observed in the field visits. The following sections summarize the test performed.

Figure 8-1: Samples collected from damaged pedestal

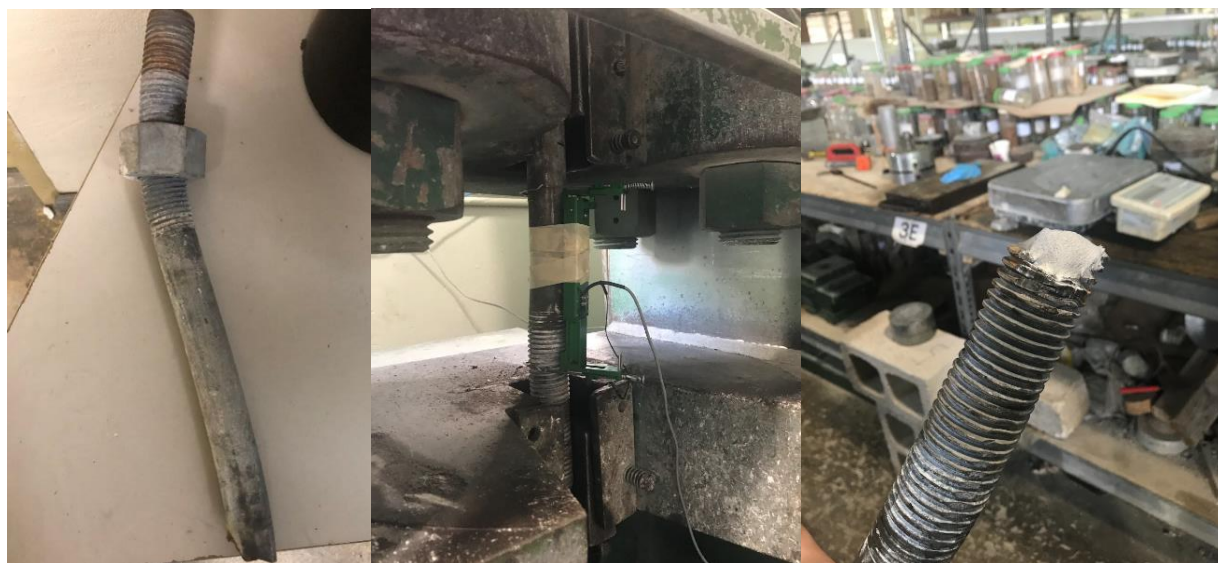
Figure 8-5 presents the collected specimen, the tension test layout, and the specimen after testing. Before the test, the specimen was straightened, since it had a significant deflection in the plastic range, as displayed in Figure 8-6. The threads could not be avoided for the test. Nevertheless, the results gave a good estimate of the capacity, and the strength of the anchor bolt was considered appropriate.

Figure 8-5: Anchor Bolt Tension Test

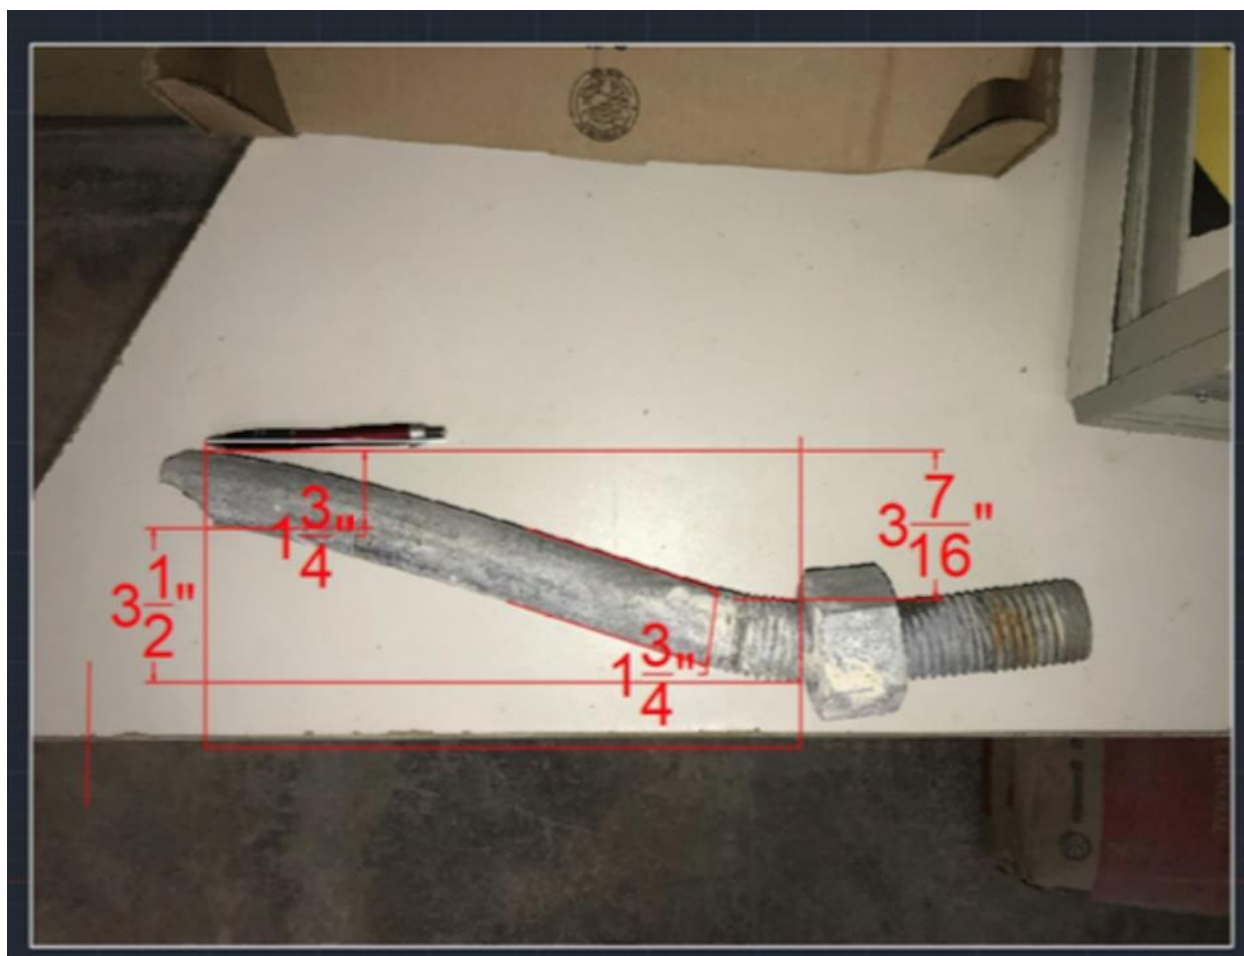
Figure 8-6: Anchor Bolt Sample with Plastic Deformations

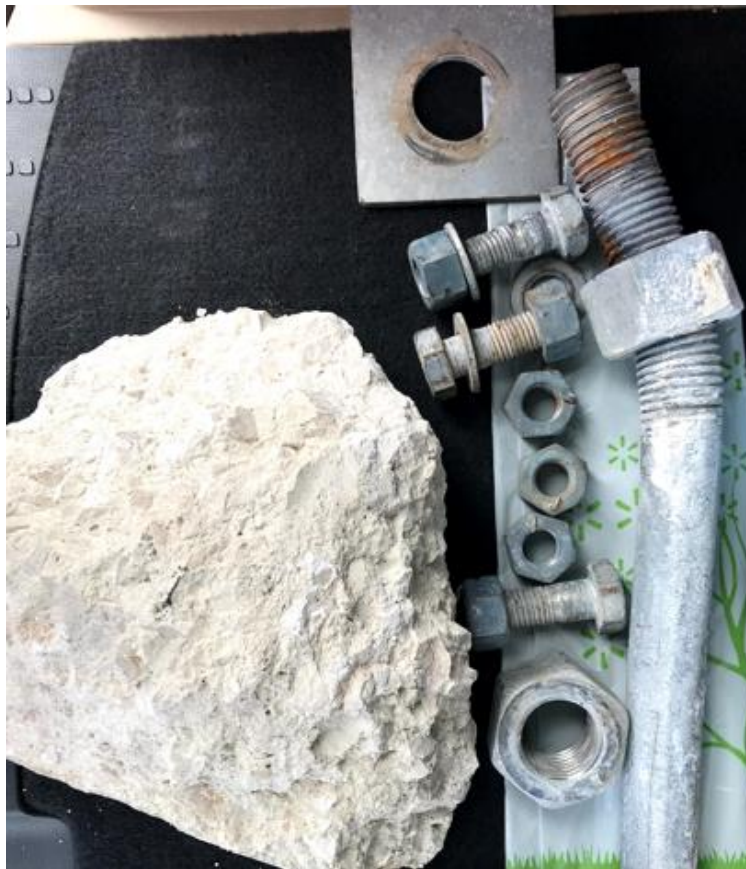
The specimens collected in the field visits are presented in Figure 8-1 and Figure 8-7. These pieces of concrete were part of the pedestal that collapsed due to the tension strains exerted on the concrete produced by the large lateral deflection of the anchor bolts, which were the consequence of the torsional rotation of post base plate due to the wind loads. Figure 8-7 shows segments of the pedestals that collapsed in the Salinas region, Sign P-2, in addition, anchoring elements such as bolts and screws with their nuts were found.

Figure 8-7 Specimens Collected During the Field Visit

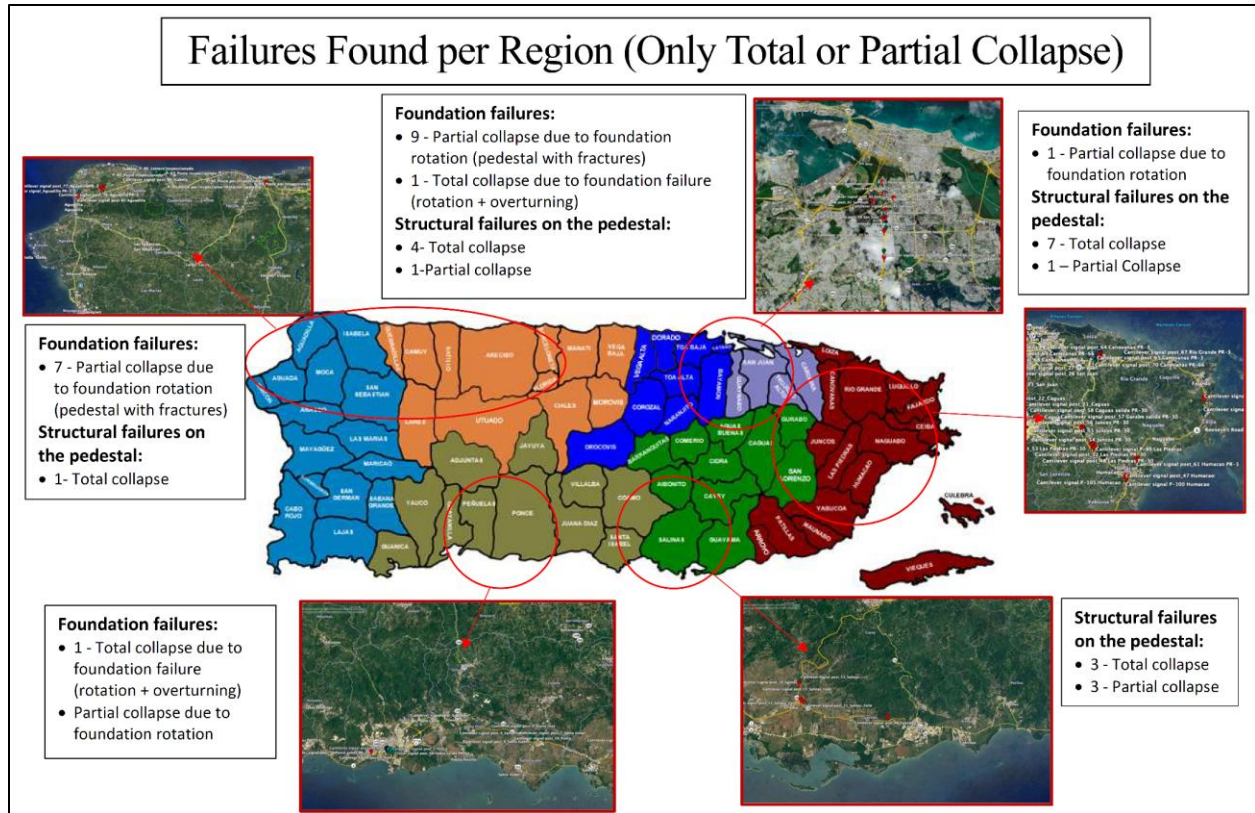
In Figure 9-1 presents the geolocation of the most severe findings by region (those that produce a total or a partial collapse), with a summary of the cases observed in each mentioned level of damage observed, and the causes (mode of failure). It can be appreciated that the structural damages to the pedestal due to large lateral movements of the anchor bolts had more density to the east side of the island, where the intensity of the wind speed was higher.

Figure 9-1: Geolocation of Most Severe Findings by Exploration Region
