Improving Transportation Infrastructure Resilience Against Hurricanes, Other Natural Disasters, and Weathering: Part II - Analysis of Pedestrian Bridges Failures Due to Hurricane Maria

FINAL REPORT
August 2021

Transportation Infrastructure Research Center – TIRC
Polytechnic University of Puerto Rico
377 Ponce de Leon Ave, San Juan, PR 00918

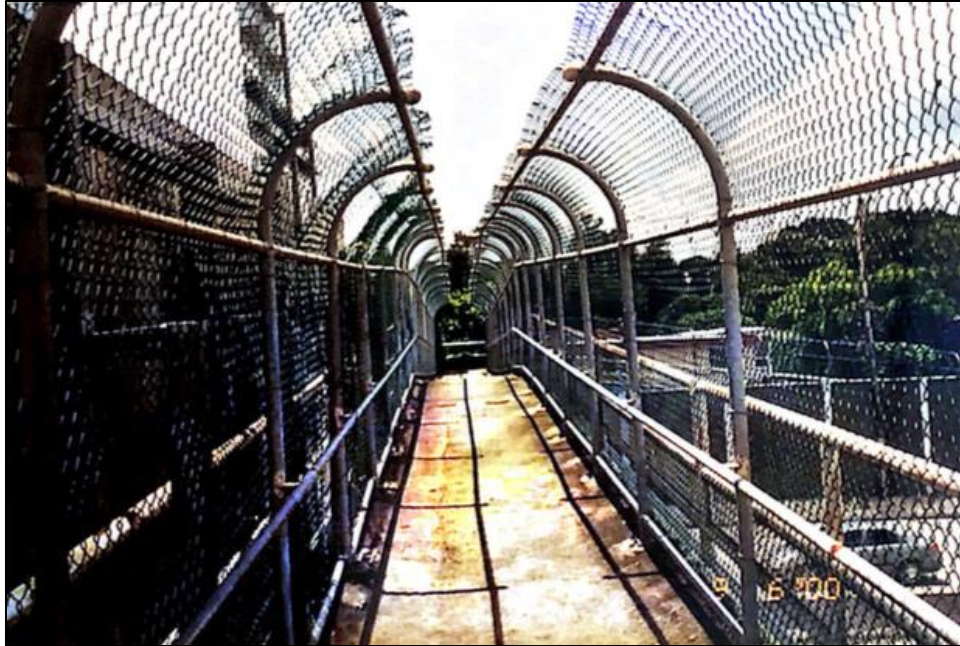
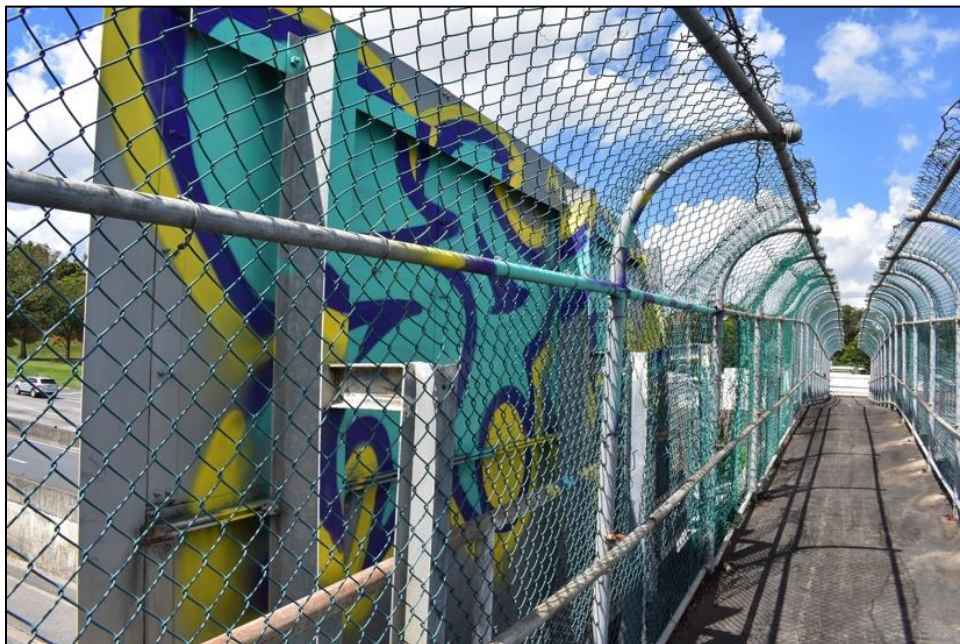
To detect if the bridge suffered any major deformations due to Hurricane Maria, old photographs from PRHTA were compared to pictures taken in 2019. One such comparison can be made between a photo of the walkway from 2000 (Figure 5.9) and a another from 2019 (Figure 5.10). No deformation in the structural elements was detected from the comparison of photographs.

Figure 5.9: Walkway of PB 0960 on September 6, 2000 (Source: PRHTA)

Figure 5.10: Walkway of PB 0960 on March 13, 2019

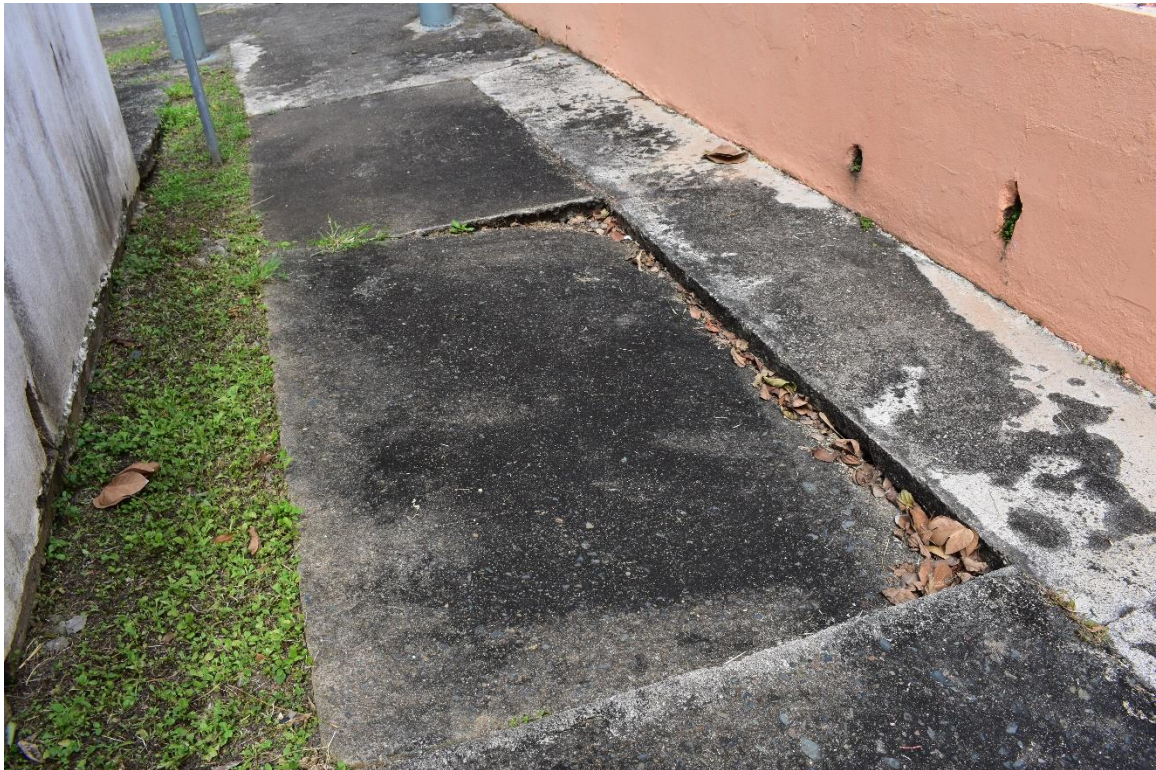
Figure 5.13: Sunk section of sidewalk

During the visit, a neighbor approached the inspection team and expressed concern for the safety of the people that use the bridge. One of the concerns was that the sidewalk (at the location indicated in Figure 5.11) used to approach the bridge ramp on the west side has a hole with a depth of more than 1 ft. This hole was covered with a pallet, as shown in Figure 5.12. In the same area, a section of the sidewalk has sunk, as shown in Figure 5.13. Other observations made by the inspection team were the growing vegetation on the chain-link fence of the ramp (see Figure 5.14) and presence of corrosion on the support bases of the chain-link fence (see Figure 5.15).

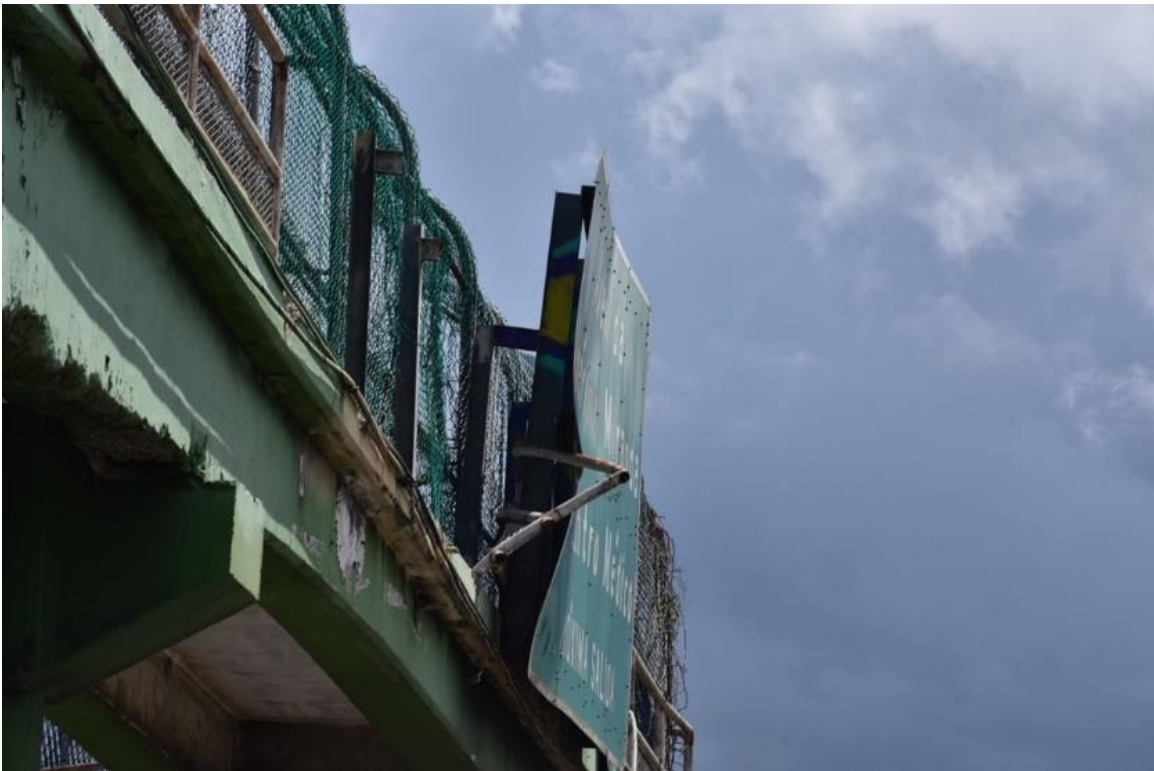
Figure 5.20: Deformed sign due to handrail bent

It was observed that all the traffic signs mounted on the bridge were attached to the handrails, as shown in Figure 5.17. It was noticed that there were cracks at the base of handrails posts (see Figure 5.18), and one section was detached (see Figure 5.19) and bent, affecting the sign (see Figure 5.20). Wind vibrations may have induced the cracks and triggered the bent.

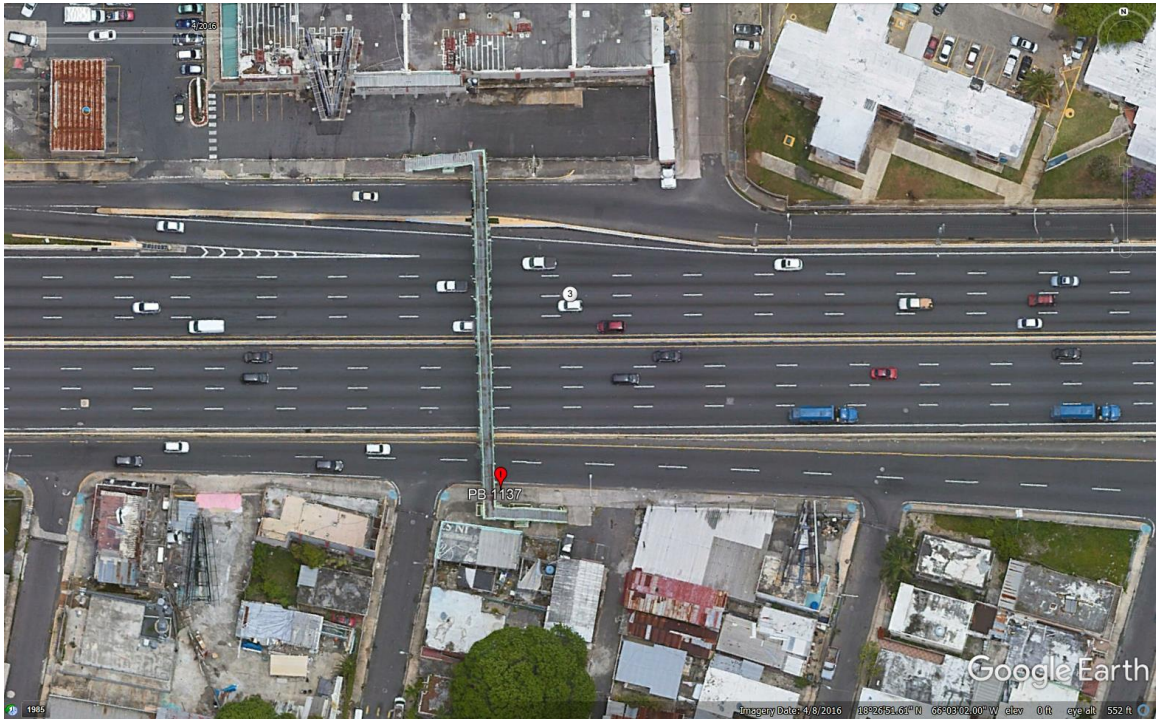
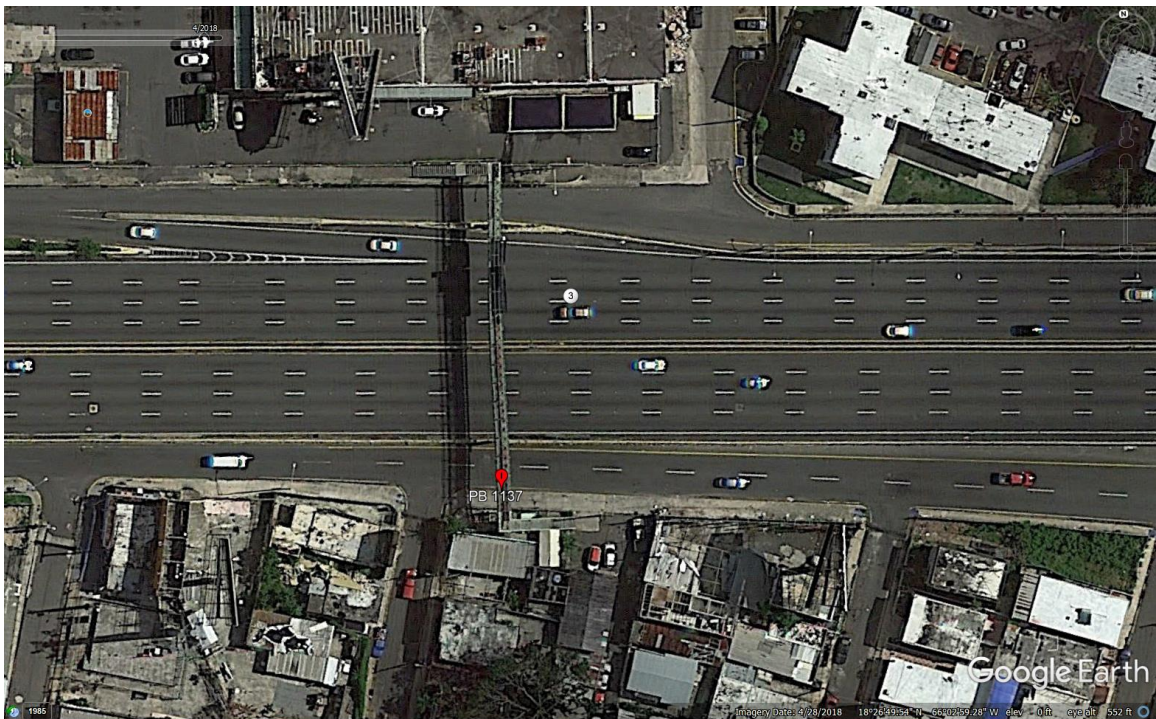
To detect if the bridge suffered any major deformations due to Hurricane Maria, photographs from before and after the hurricane were compared. Examples of these are the comparison that can be made between Figure 5.34 and Figure 5.35, and between Figure 5.36 and Figure 5.37. By the

comparing the photographs, it is appreciated that the bridge experienced lateral deflections in the plastic range.

Figure 5.34: Aerial photo of PB 1137 before Hurricane Maria (April 8, 2016) (Source: Google Earth Pro)

Figure 5.35: Aerial photo of PB 1137 after Hurricane Maria (April 28, 2018) (Source: Google Earth Pro)

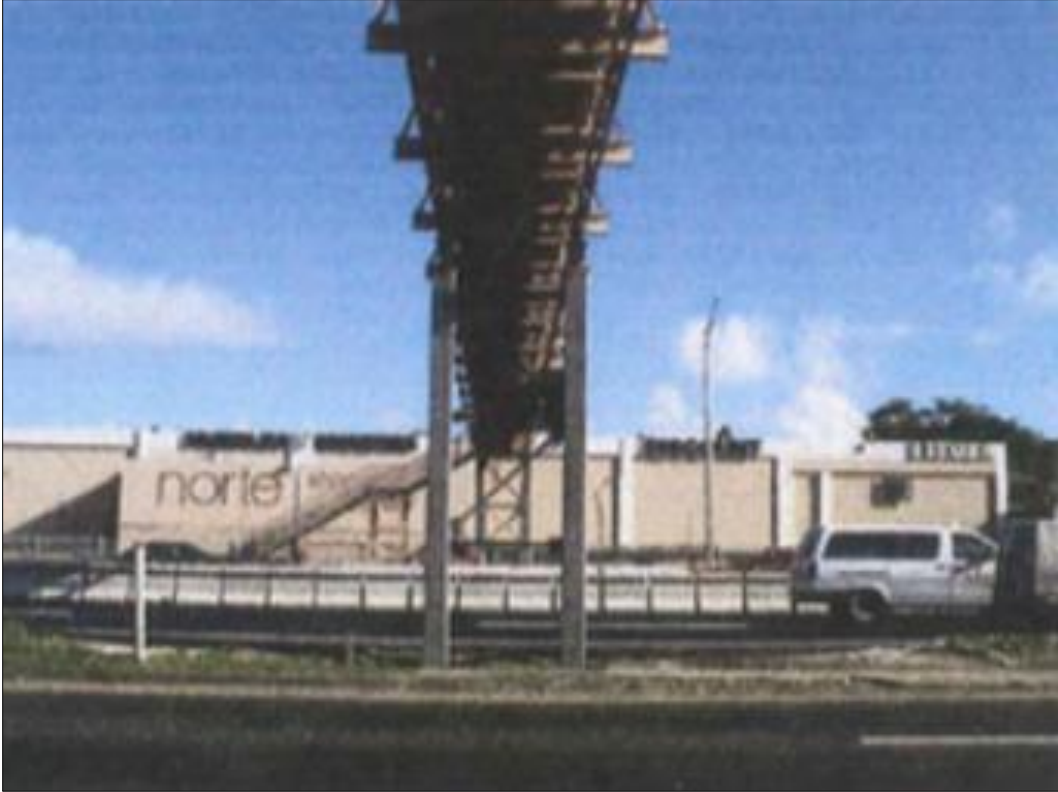
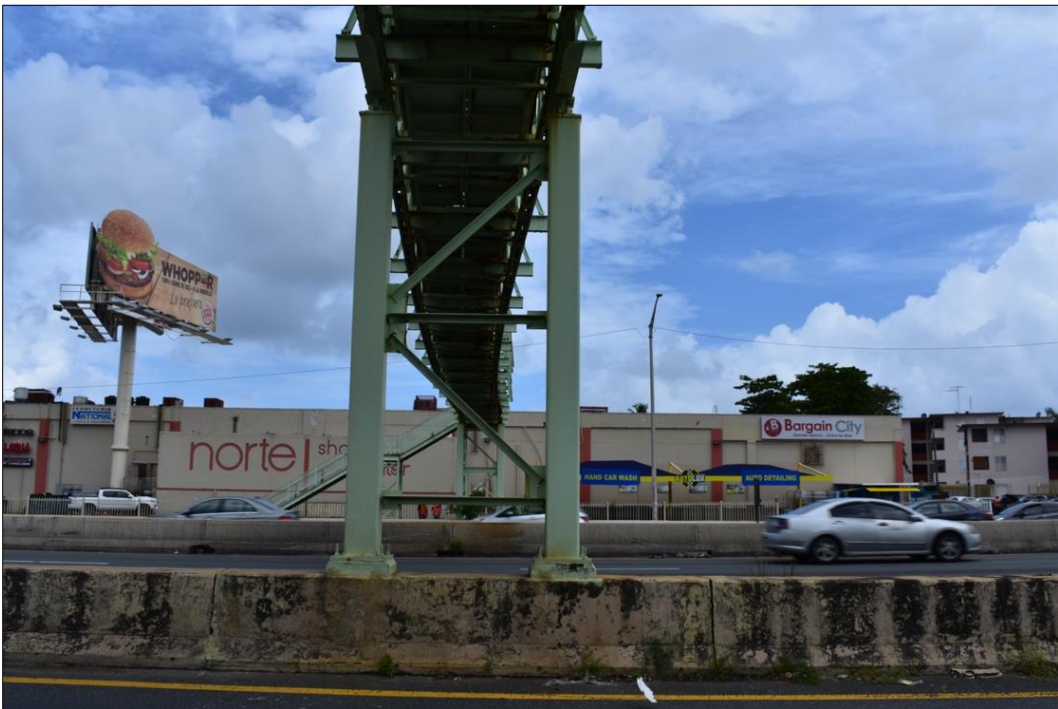
Figure 5.36: Underside of PB 1137 before Hurricane Maria (March 5, 1999) (Source: PRHTA)

Figure 5.37: Underside of PB 1137 after Hurricane Maria (November 3, 2018)

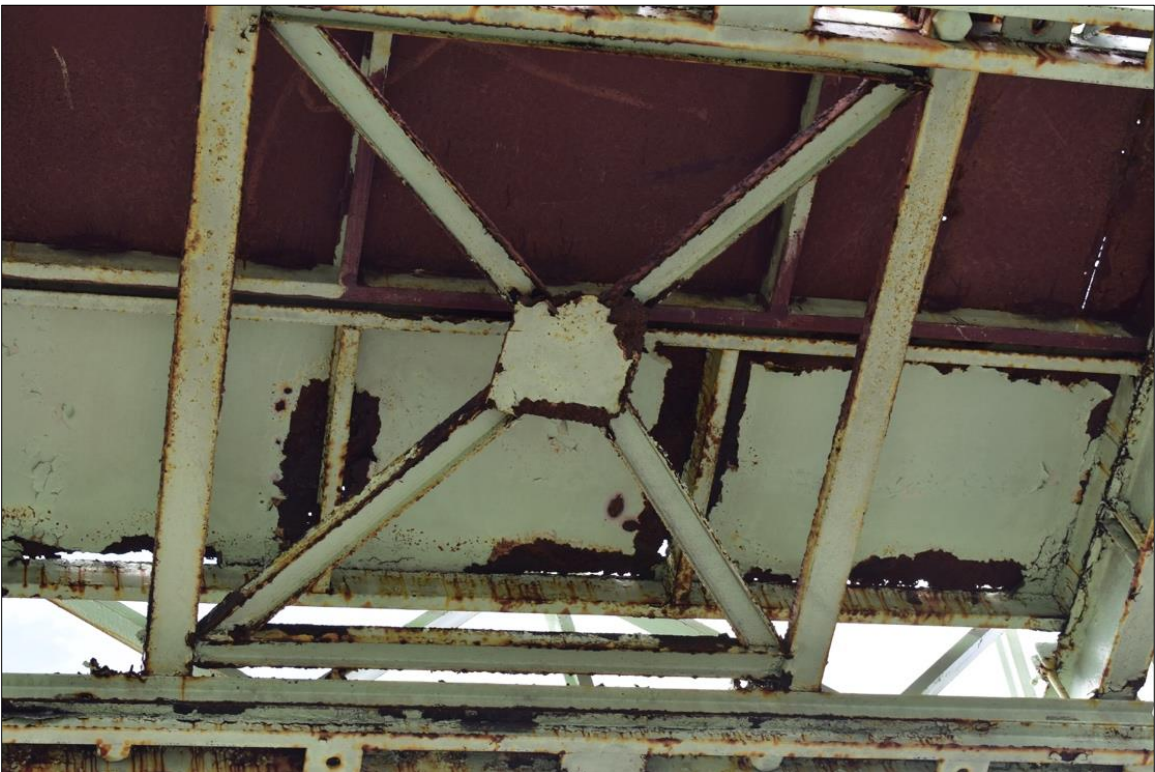
Figure 5.39: Original piece with all elements

During the visit, it was evident that the bridge had corrosion problems in many components. Corrosion had caused holes in the walkway, as shown in Figure 5.38 and Figure 5.39. Some transversal elements were missing, as shown in Figure 5.40. (Further details about the inspection of this bridge can be found in Volume 2 of this document).

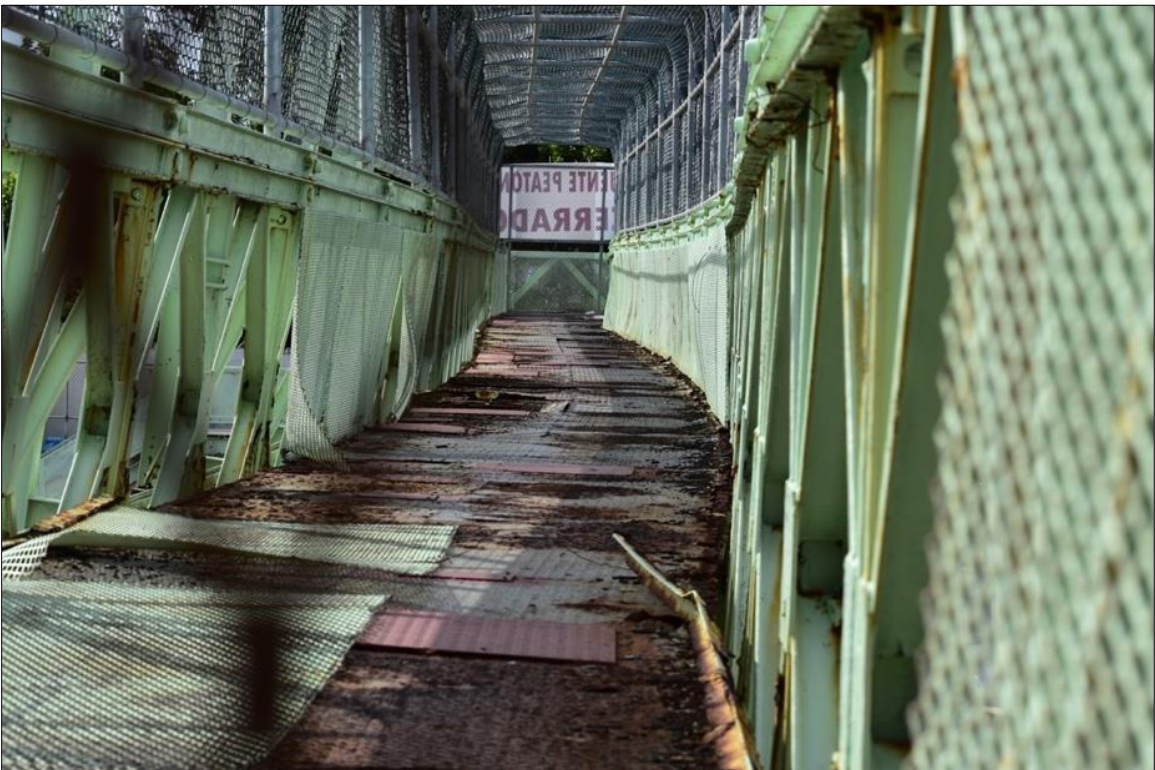
Figure 5.41: Curvature in deck

In terms of possible damages caused by Hurricane Maria, it was evident that the bridge had experienced lateral deflections in the plastic range as evidenced by the curvature in the structure that can be appreciated in Figure 5.41 and Figure 5.42. Although the traffic signs that were attached to the bridge had already been removed, the mounting assembly was still present, as shown in Figure 5.43. It was observed that the location of the mounting assembly coincides with the section of the bridge with larger curvature. Therefore, it is theorized that the lateral deflection on the bridge was partly due to the extreme wind loads on the signs during Hurricane Maria. This theory is furthered studied in Volume 2 of this document.

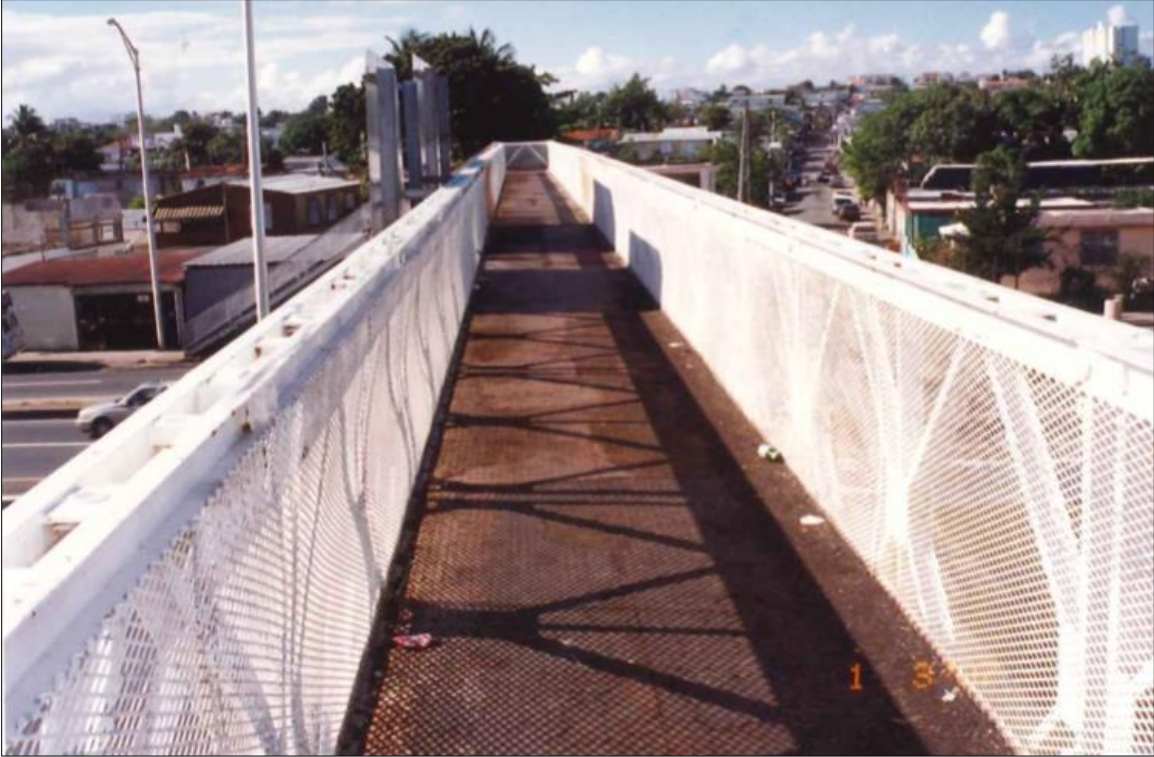
To detect if the bridge suffered any major deformations due to Hurricane Maria, photographs from before and after the hurricane were compared. Examples of these are the comparisons that can be made between Figure 5.57 (taken in 1996) and Figure 5.58 (taken in 2019), and between Figure 5.59 (taken in 1993) and Figure 5.60 (taken in 2019). By the comparing the photographs, it is appreciated that the bridge experienced lateral deflections in the plastic range as evidenced by the curvature exhibited by the deck and the superstructure in the most recent photographs.

Figure 5.57: Deck of PB 1307 before Hurricane Maria (March 18, 1996) (Source: PRHTA)

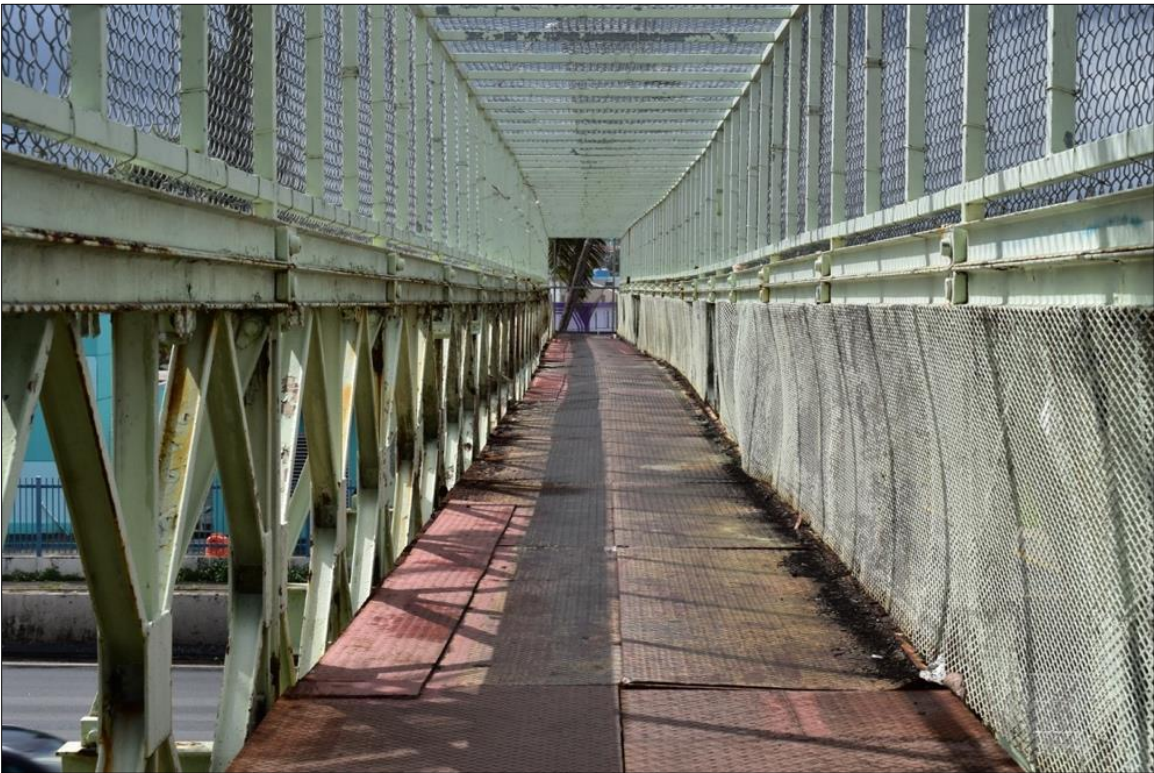
Figure 5.58: Deck of PB 1307 after Hurricane Maria (February 28, 2019)

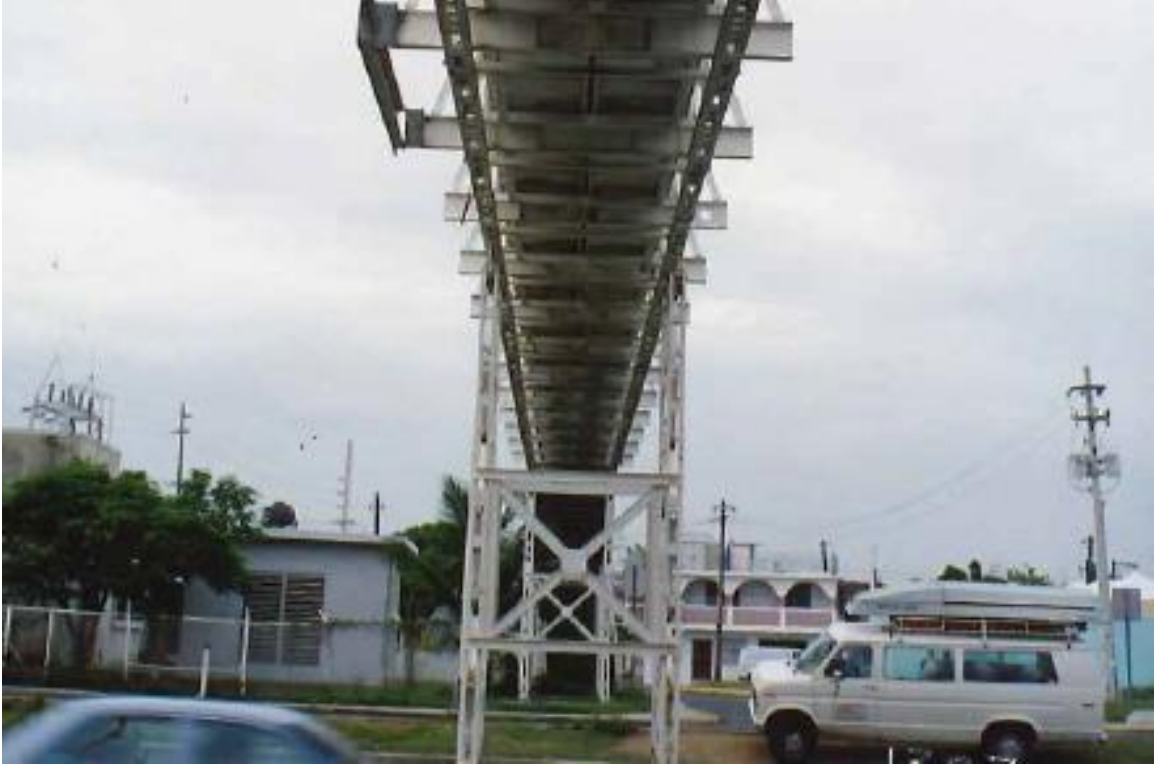
Figure 5.59: Underside of PB 1307 before Hurricane Maria (September 24, 1993) (Source: PRHTA)

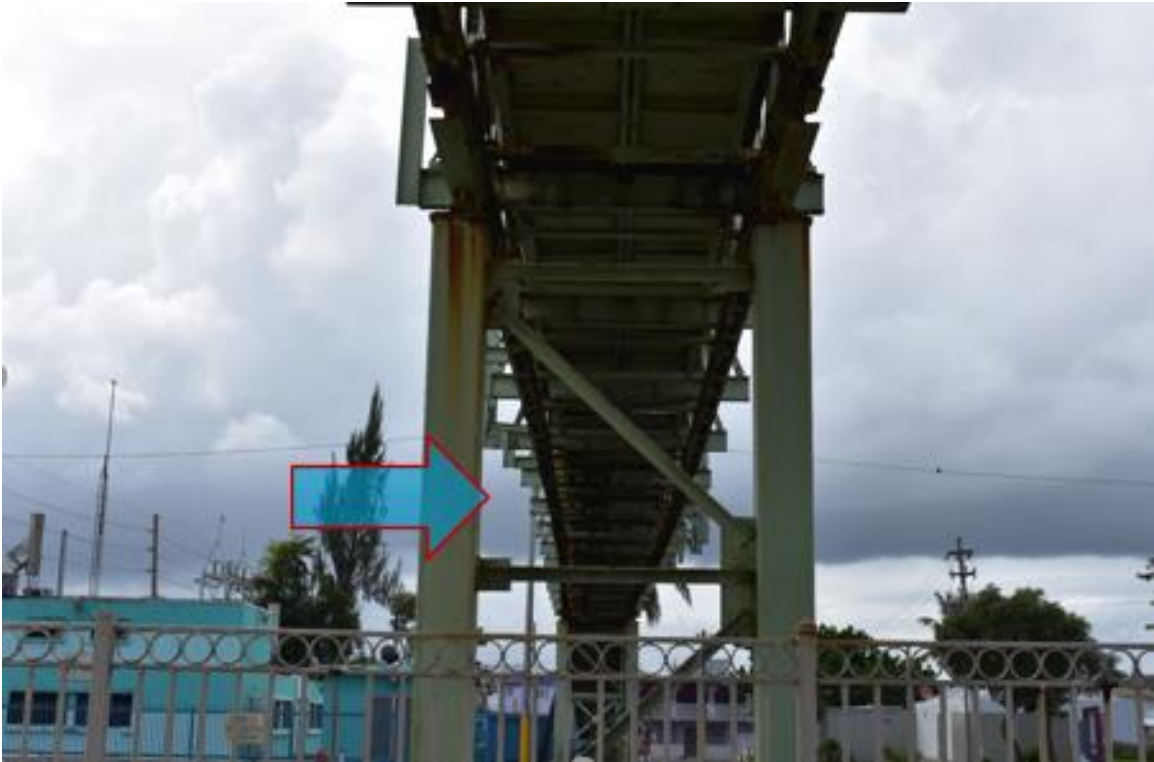
Figure 5.60: Underside of PB 1307 after Hurricane Maria (February 28, 2019)

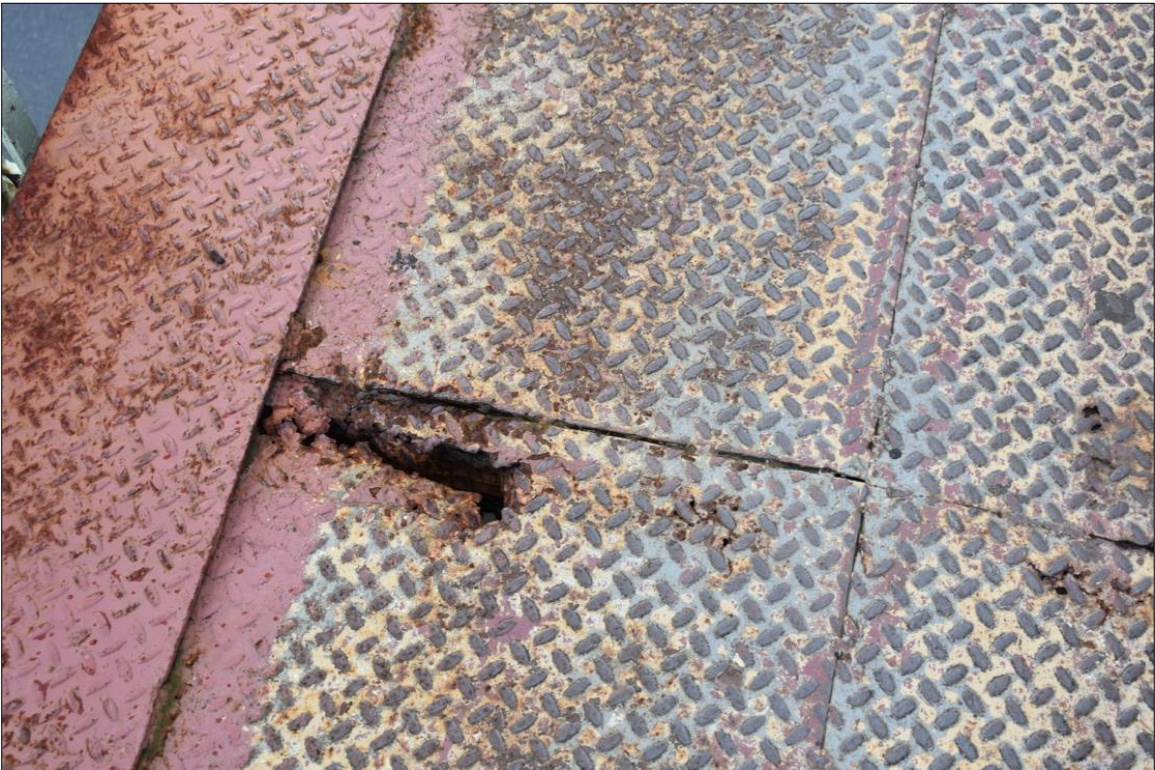
During the inspection, the stairs and deck exhibited corrosion, as shown in Figure 5.61 and Figure 5.62, respectively. It can also be observed in Figure 5.62 that sections of the security meshing attached to the guardrail had fallen off. Gaps and holes in the deck were observed as shown in Figure 5.63 and Figure 5.64.

Figure 5.64: Hole in plates

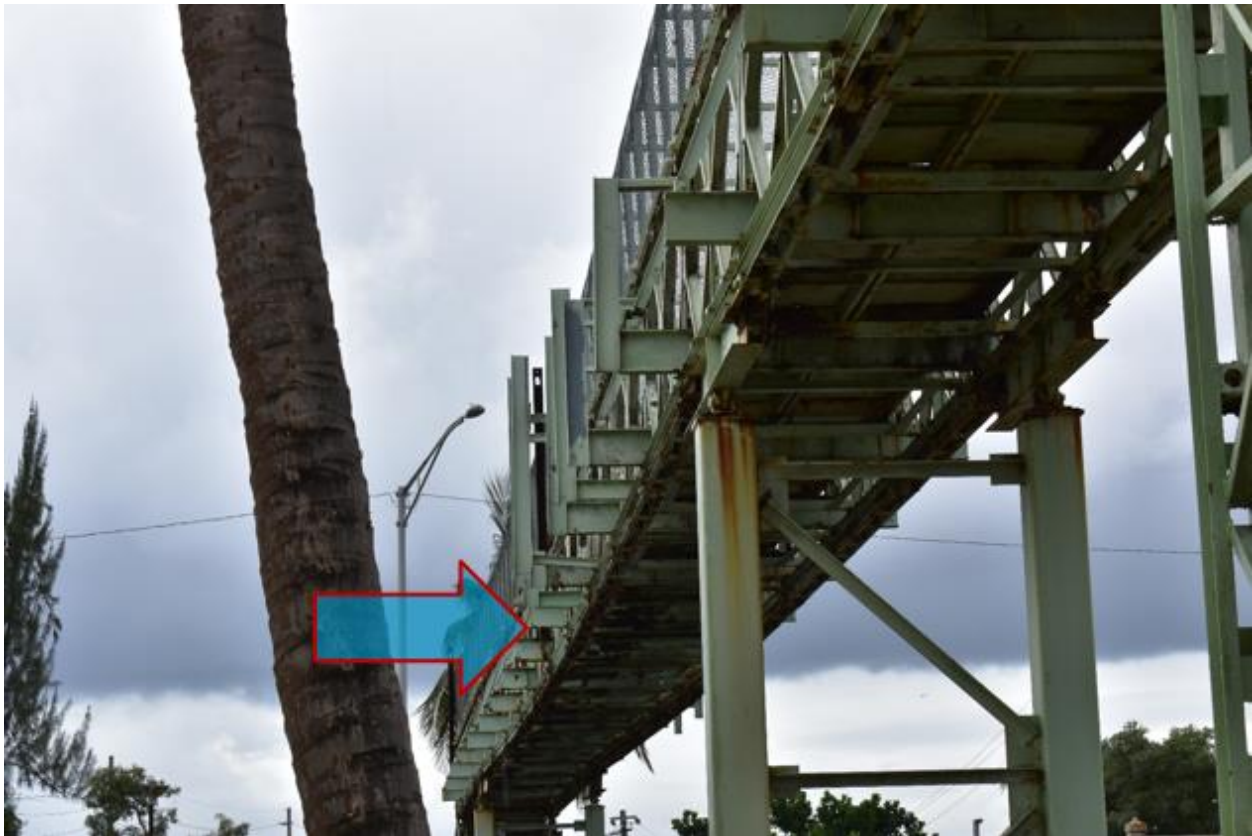
In terms of possible damages caused by Hurricane Maria, PB 1307 exhibited the same damage found on PB 1137, which was a lateral deflection in the plastic range. Although the traffic signs that were attached to the bridge had already been removed or had been blown away, the mounting assembly was still present, as shown in Figure 5.65. It was observed that the location of the mounting assembly coincides with the section of the bridge with larger curvature. Therefore, as with PB 1137, it is theorized that the lateral deflection in PB 1307 was partly due to the extreme wind loads on the signs during Hurricane Maria.

Figure 5.65: Lateral deflection at mounting assembly location

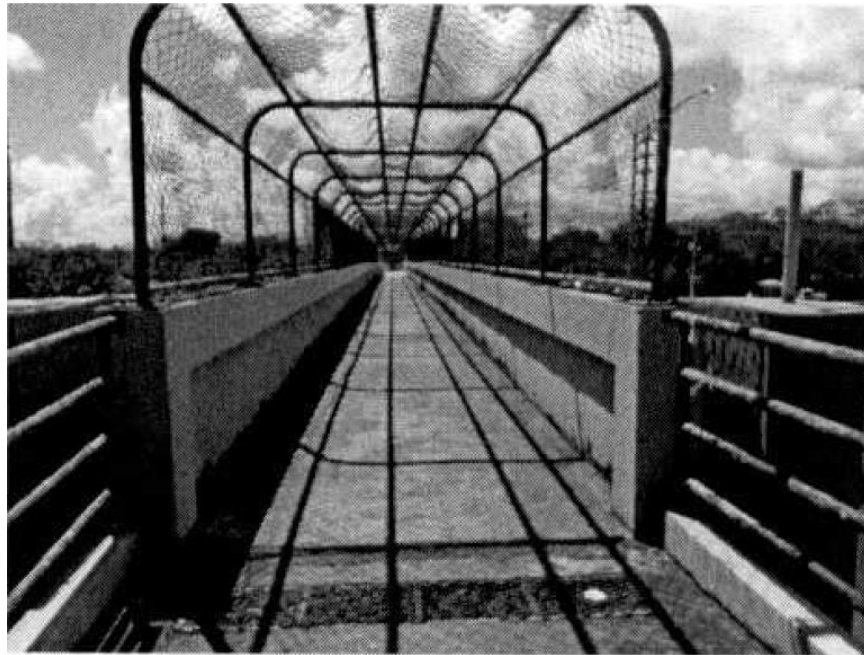
To detect if the bridge suffered any major deformations due to Hurricane Maria, photographs from 2014 by PRHTA were compared to pictures taken in 2019. An example of this is the comparison between Figure 5.71 and Figure 5.72. No deformation in the structural elements was detected from the comparison of photographs.

Figure 5.71 Walkway of PB 2336 on April 16, 2014 (Source: PRHTA)

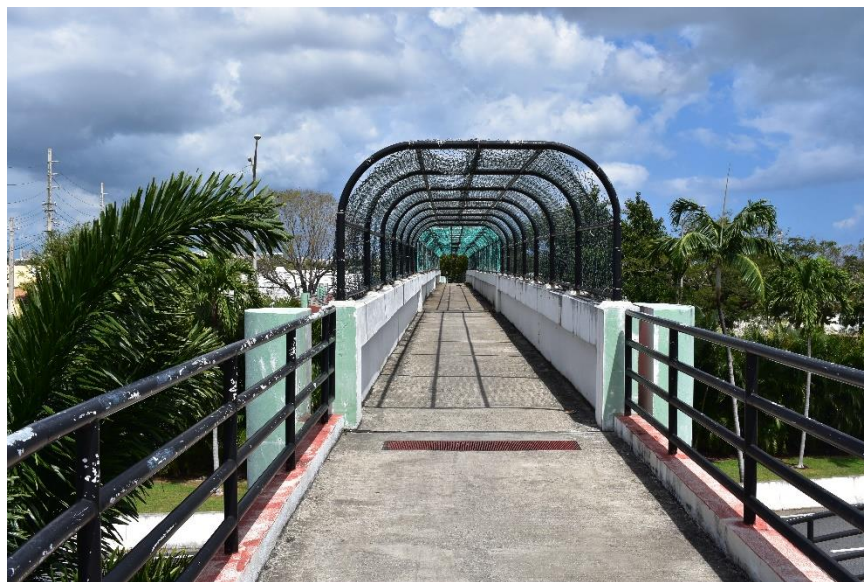
Figure 5.72: Walkway of PB 2336 on April 12, 2019

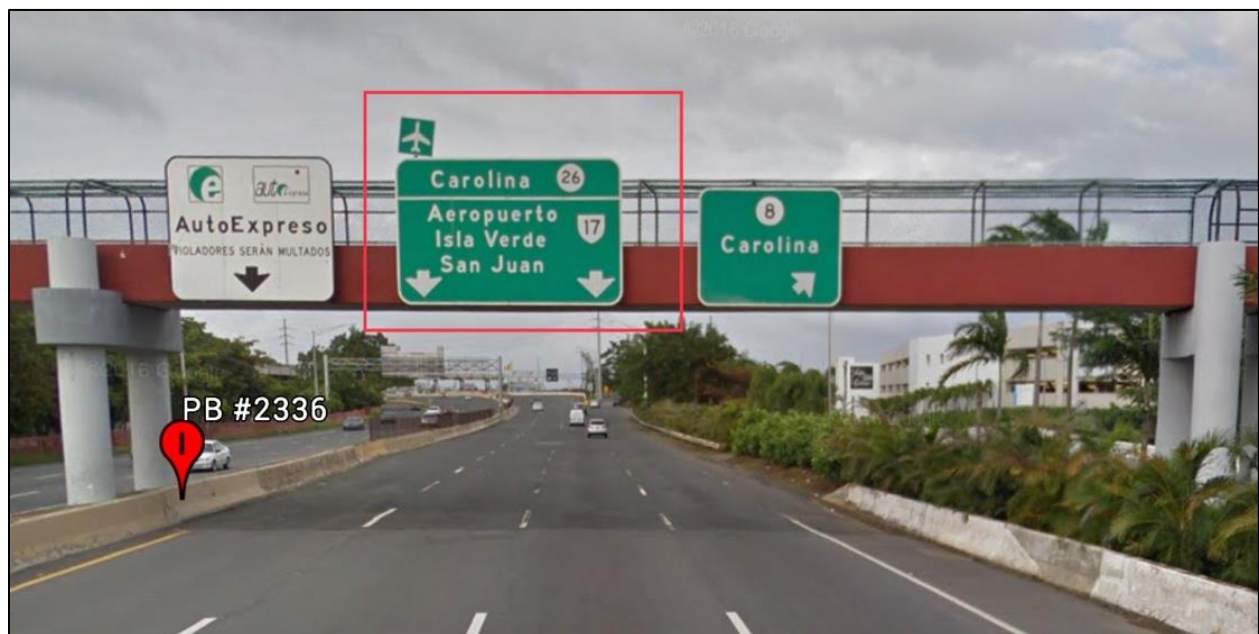
The bridge itself did not appear to have any problems. In terms of possible damages caused by Hurricane Maria, it was observed that one of the traffic signs mounted on the bridge (the larger sign inside the red rectangle indicated in Figure 5.73) detached at the bottom end from the mounting assembly (see Figure 5.74) It is theorized that the detachment was due to wind induced vibrations that occurred during the hurricane. It was also observed that the smaller airport sign has only one support (see Figure 5.75), and it was oscillating and twisting.

Figure 5.73: Transit Signs in south side of PB 2336 (Source: Google Earth Pro)

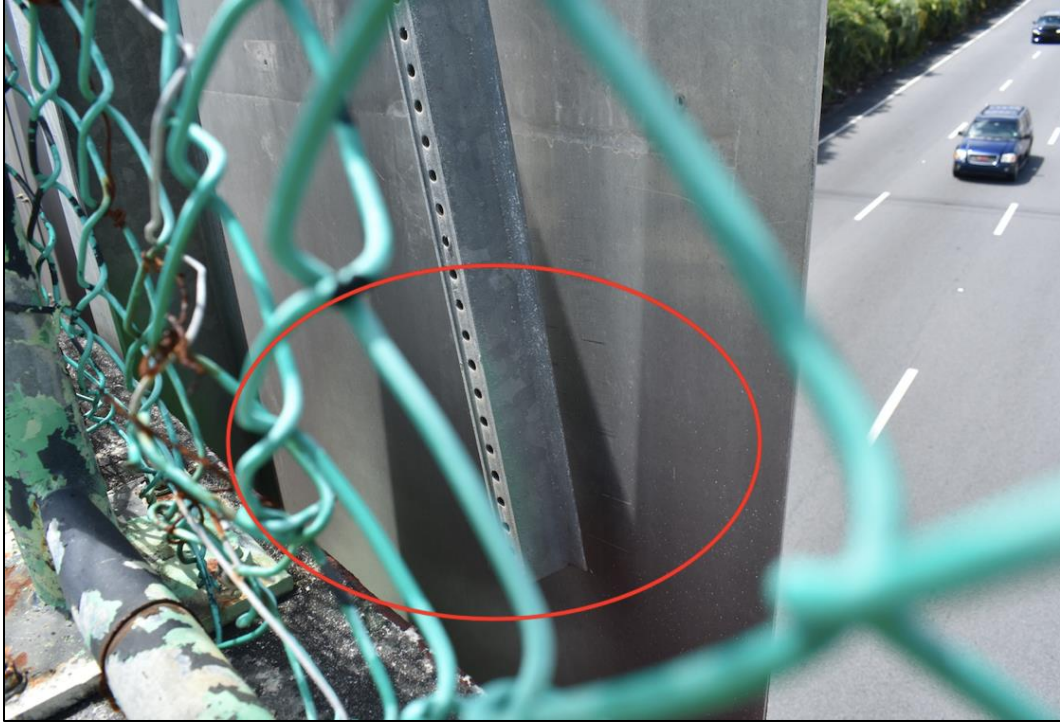
Figure 5.74: Transit sign detached from mounting assembly

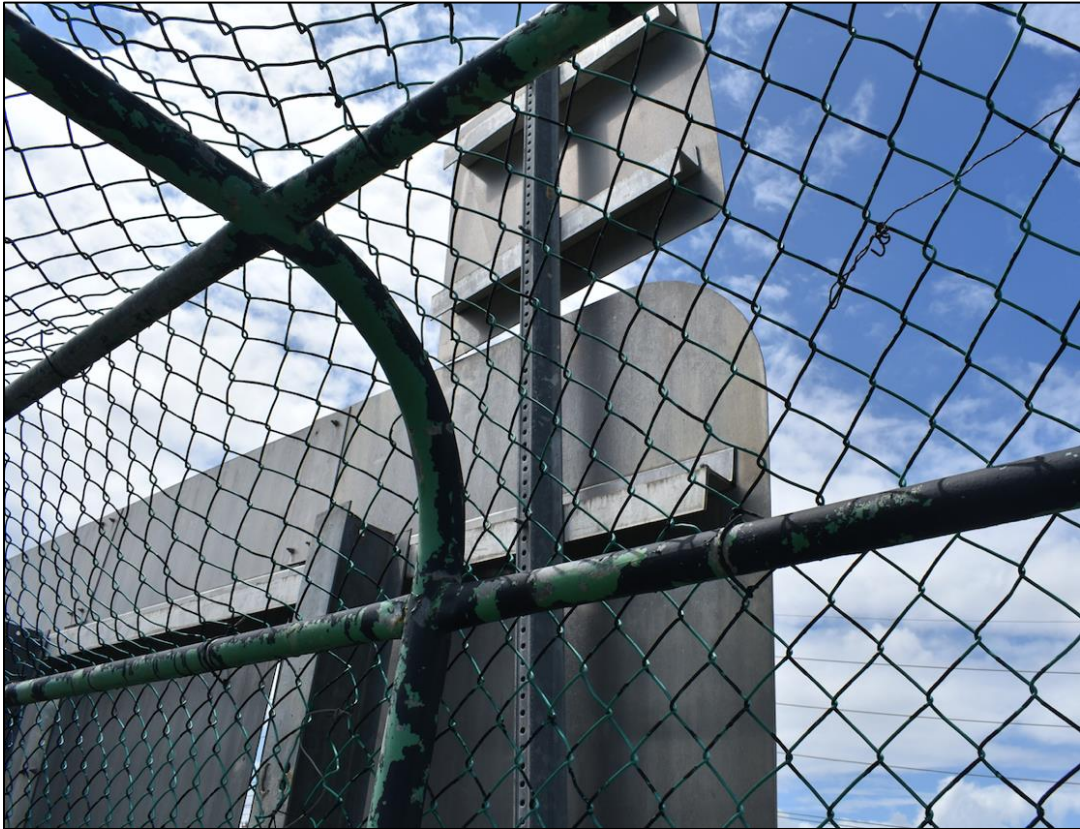
Figure 5.75: Small airport sign on top of larger sign

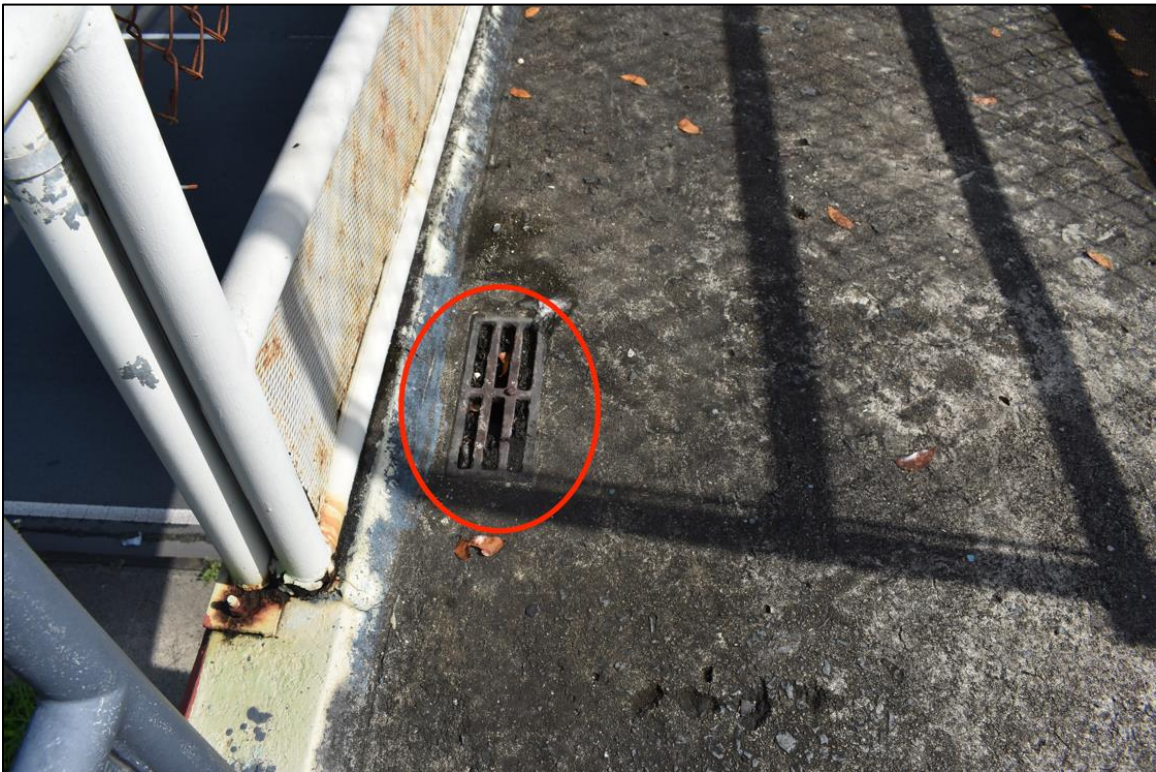
Figure 6.2: Blocked pluvial drain in PB 0626

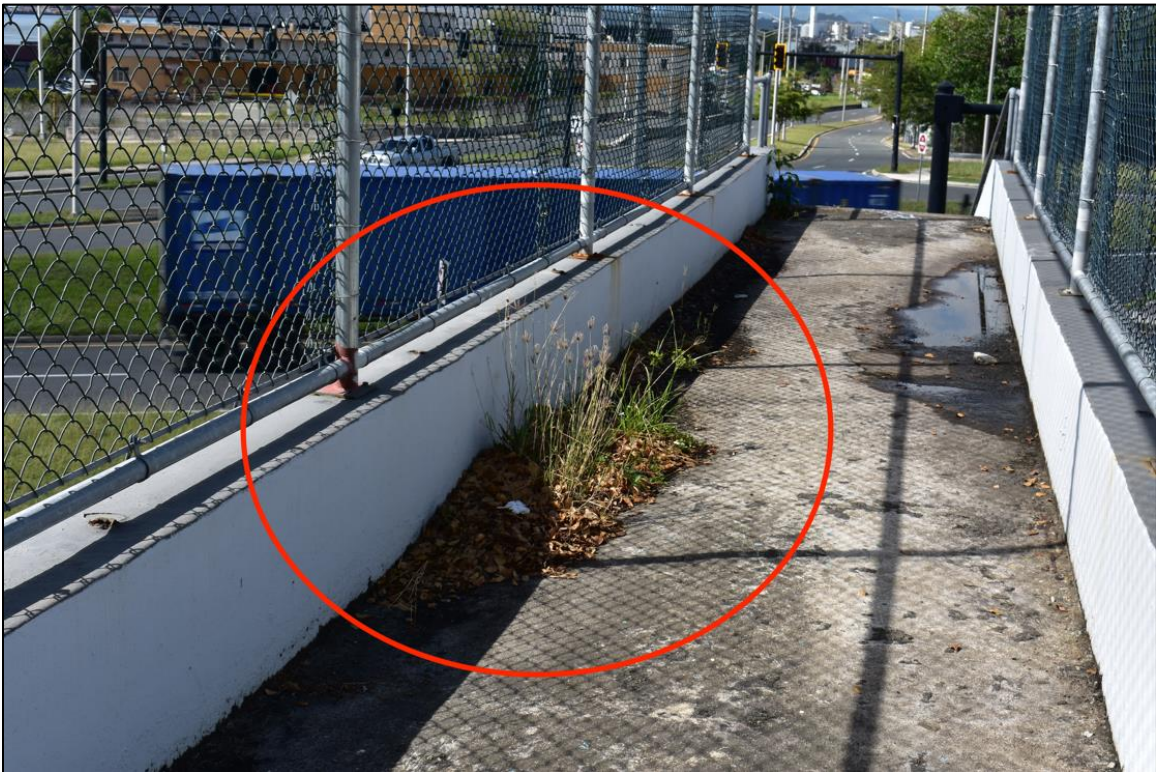
Figure 6.7: Blocked pluvial drains in PB 0745

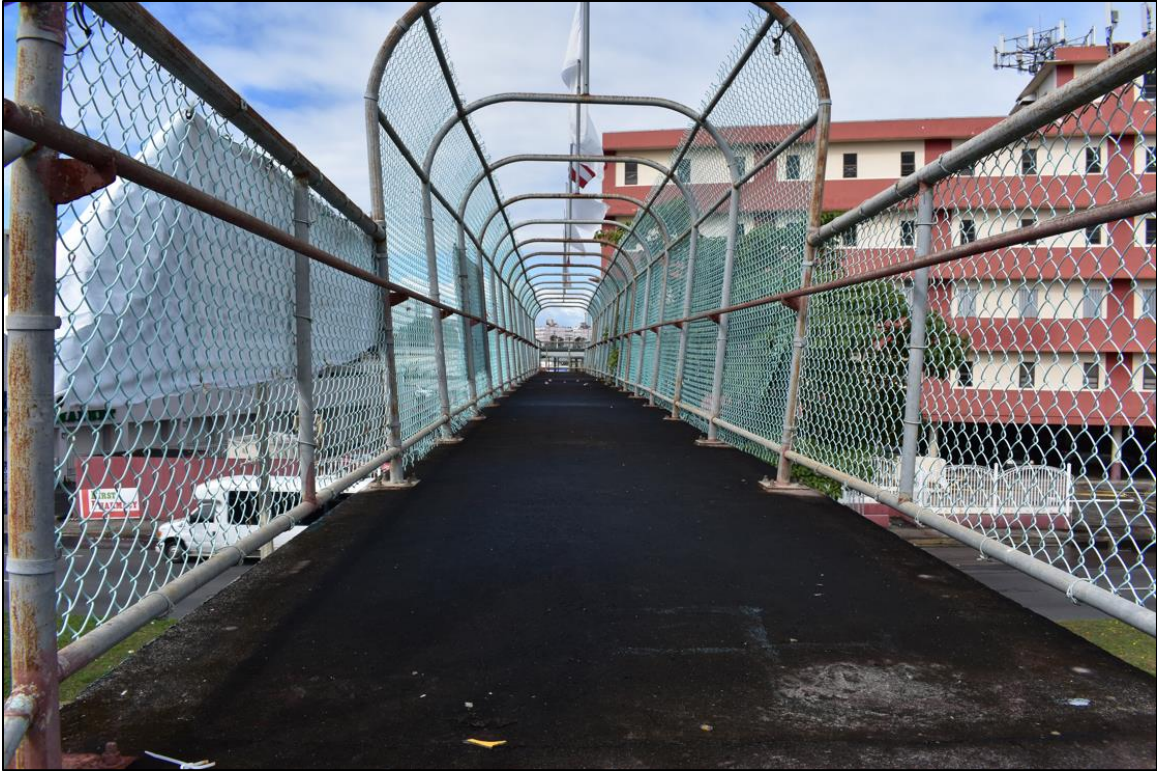
Figure 6.10: Mold and silt on PB 1095

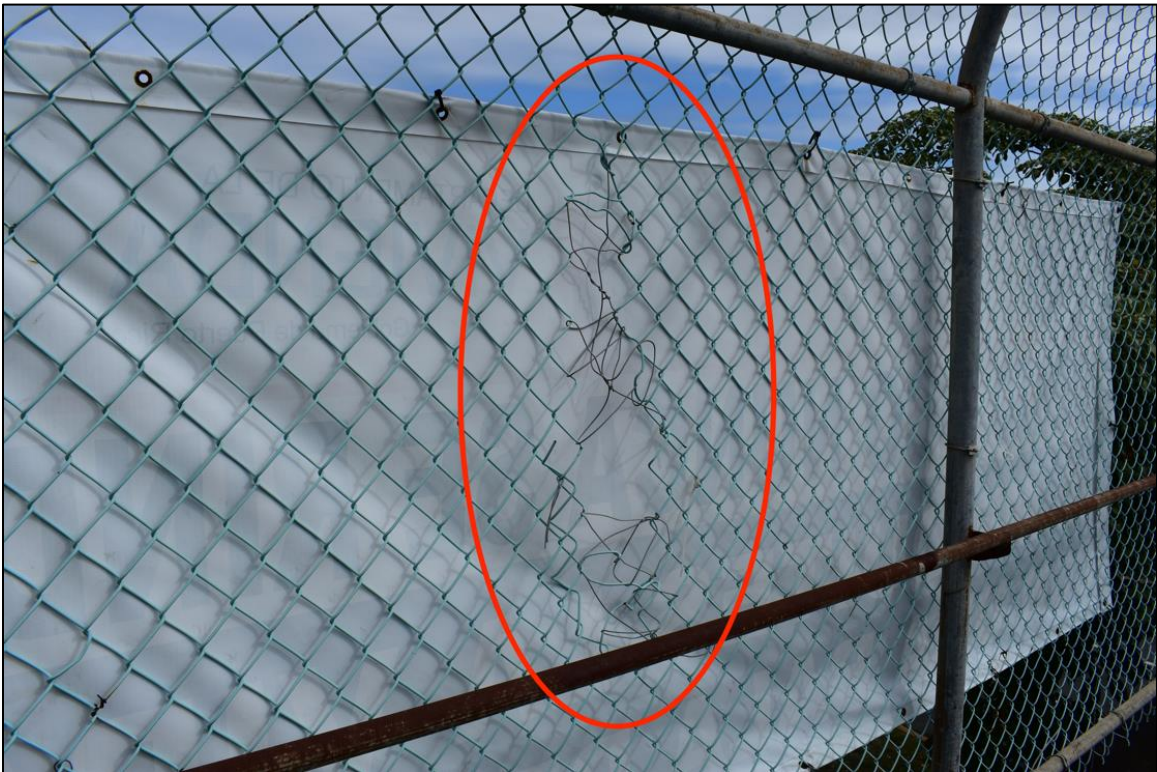
Figure 6.11: Hole in safety fence on PB 1095

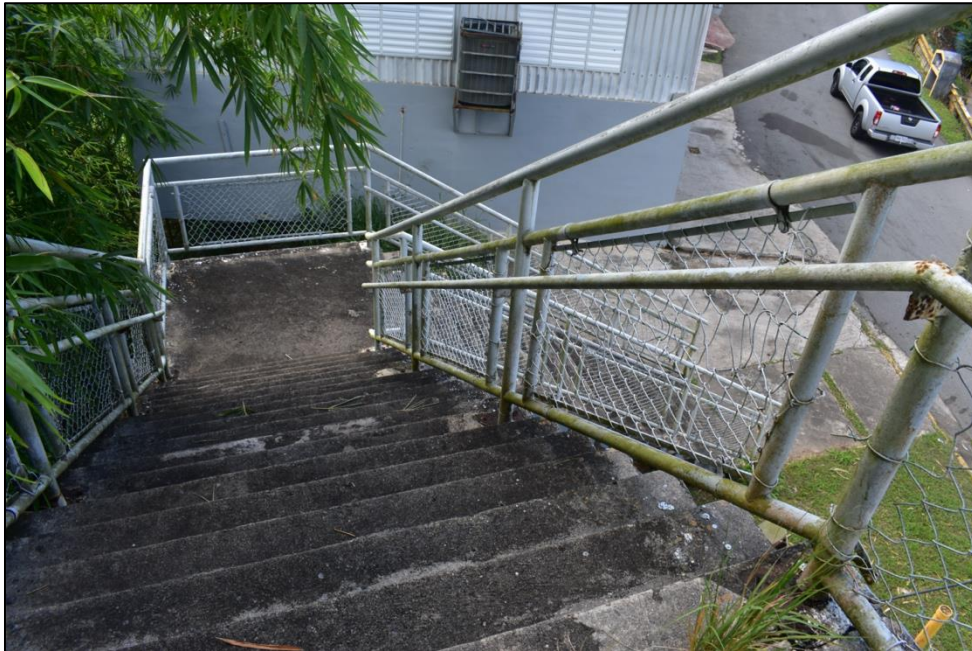
Figure 6.20: Mold and silt on PB 1513
