Improving Transportation Infrastructure Resilience Against Hurricanes, Other Natural Disasters, and Weathering: Part II - Analysis of Pedestrian Bridges Failures Due to Hurricane Maria

FINAL REPORT
August 2021

Transportation Infrastructure Research Center – TIRC
Polytechnic University of Puerto Rico
377 Ponce de Leon Ave, San Juan, PR 00918

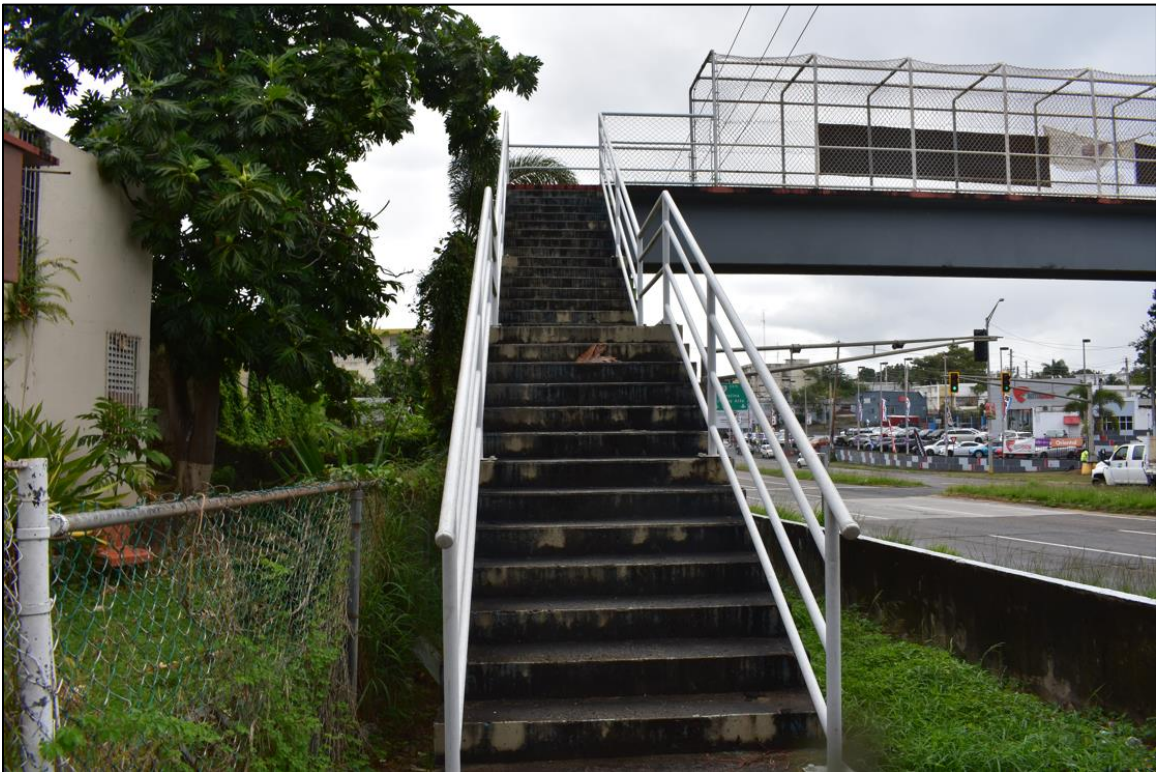
Figure 6.22: Mold and silt on stairway of PB 1736

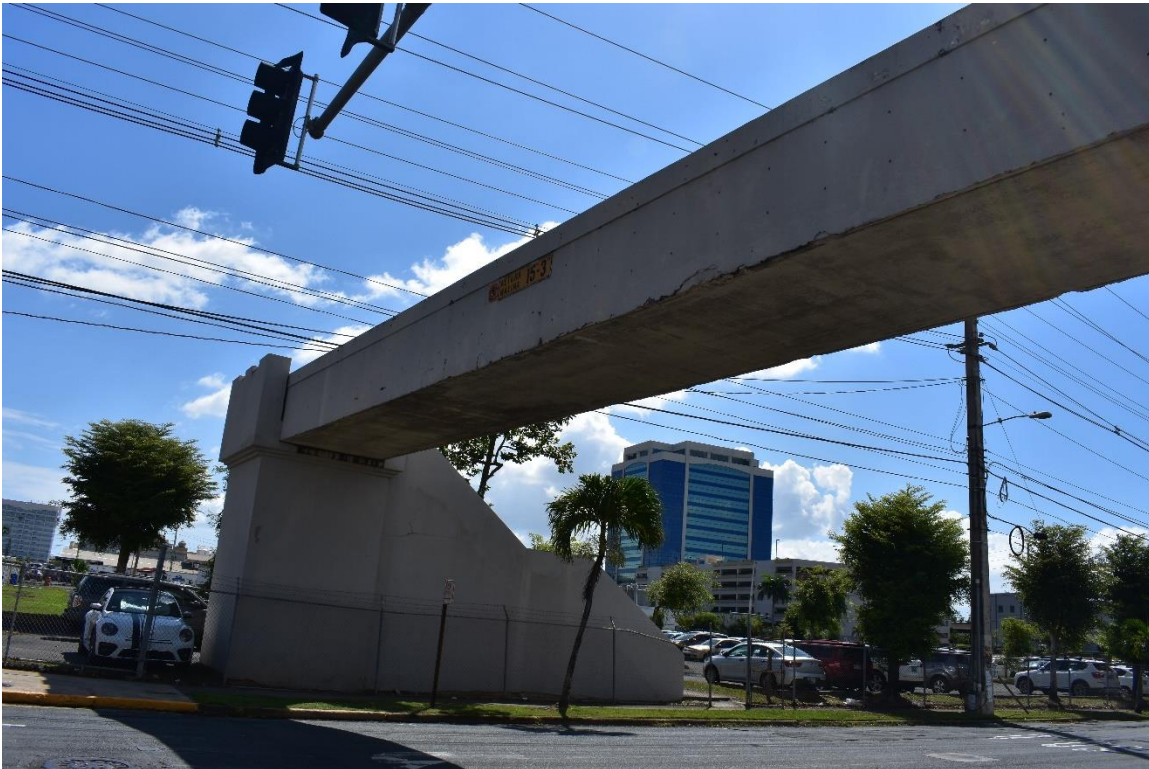
- Electrical cables block the pathway of pedestrians (see Figure 6.28 and Figure 6.29)
- Mold and silt on deck and stairways (see Figure 6.29)

Figure 6.28: Electrical cables passing closely over PB 1926

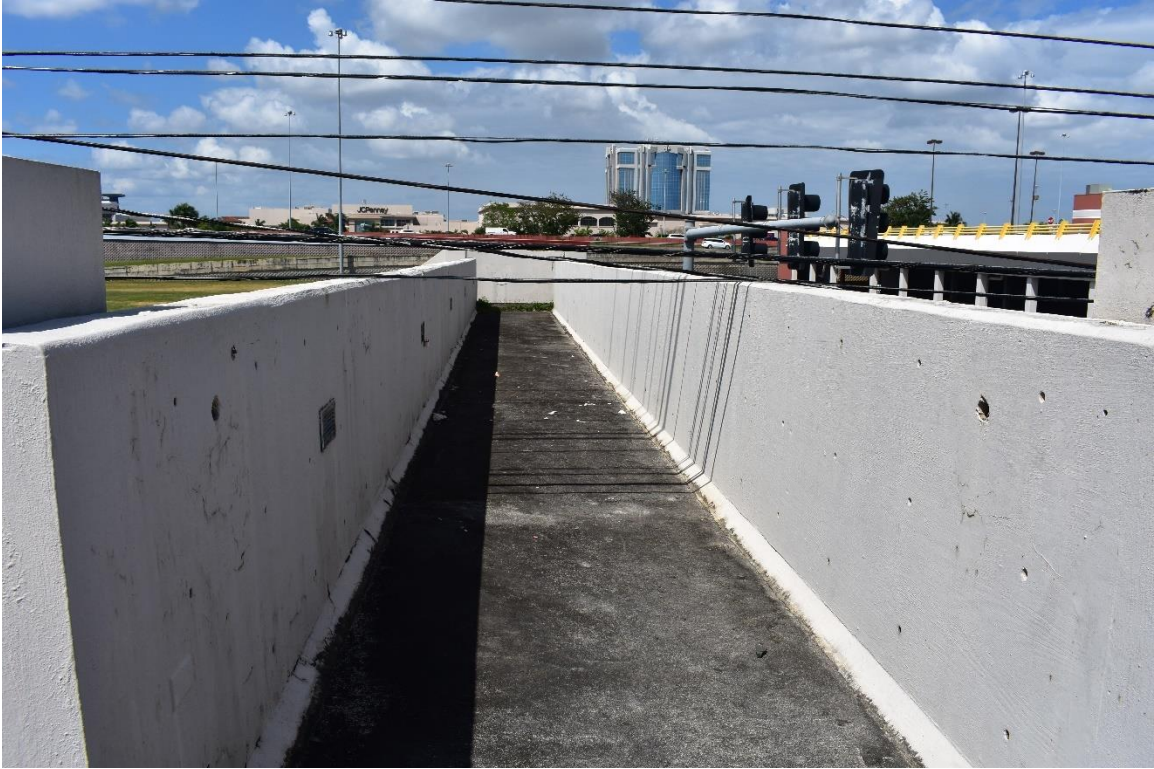
Figure 6.29: Electrical cables blacking pathway and mold and silt on PB 1926

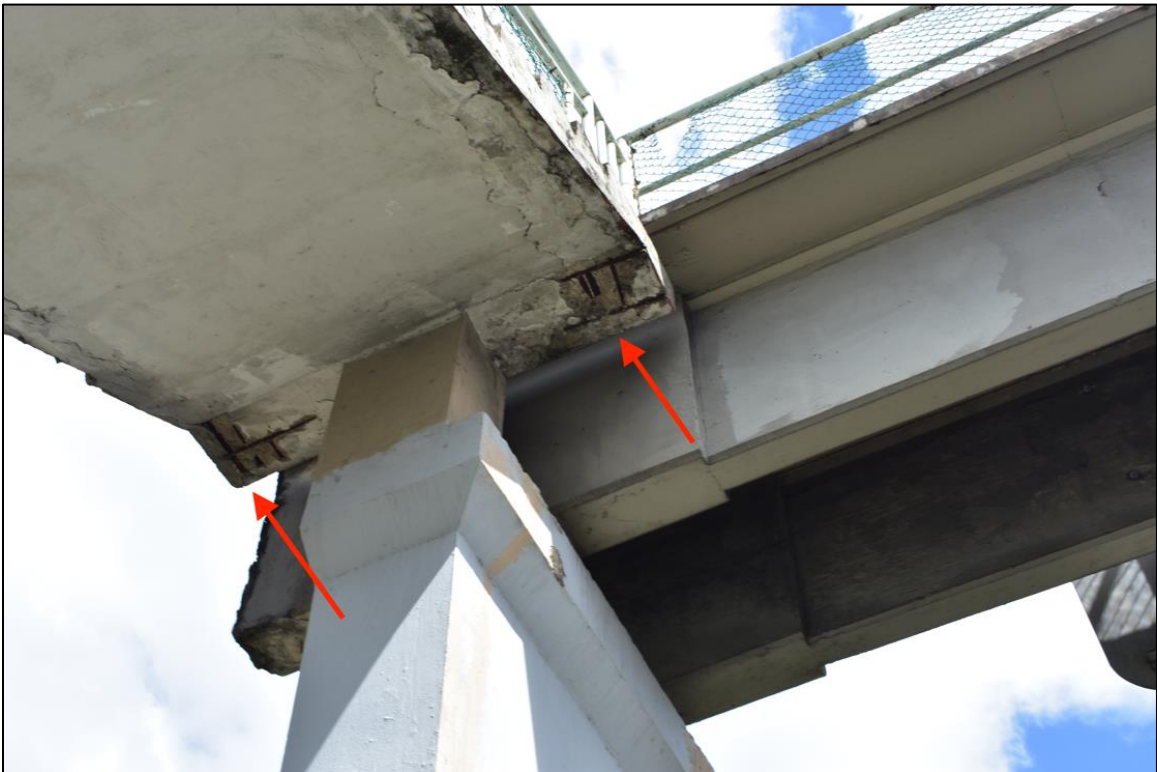
Figure 6.31: Exposed rebars on PB 2087

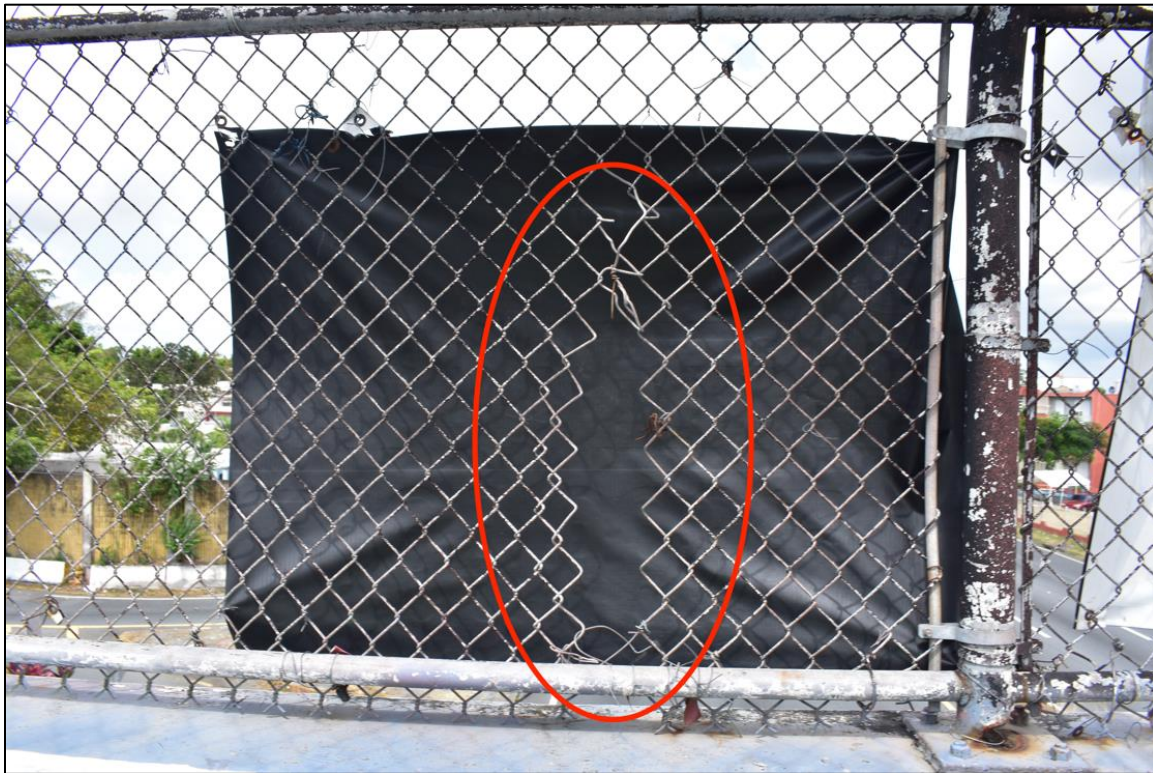
Figure 6.34: Security Fence with holes, Pedestrian Bridge 2355

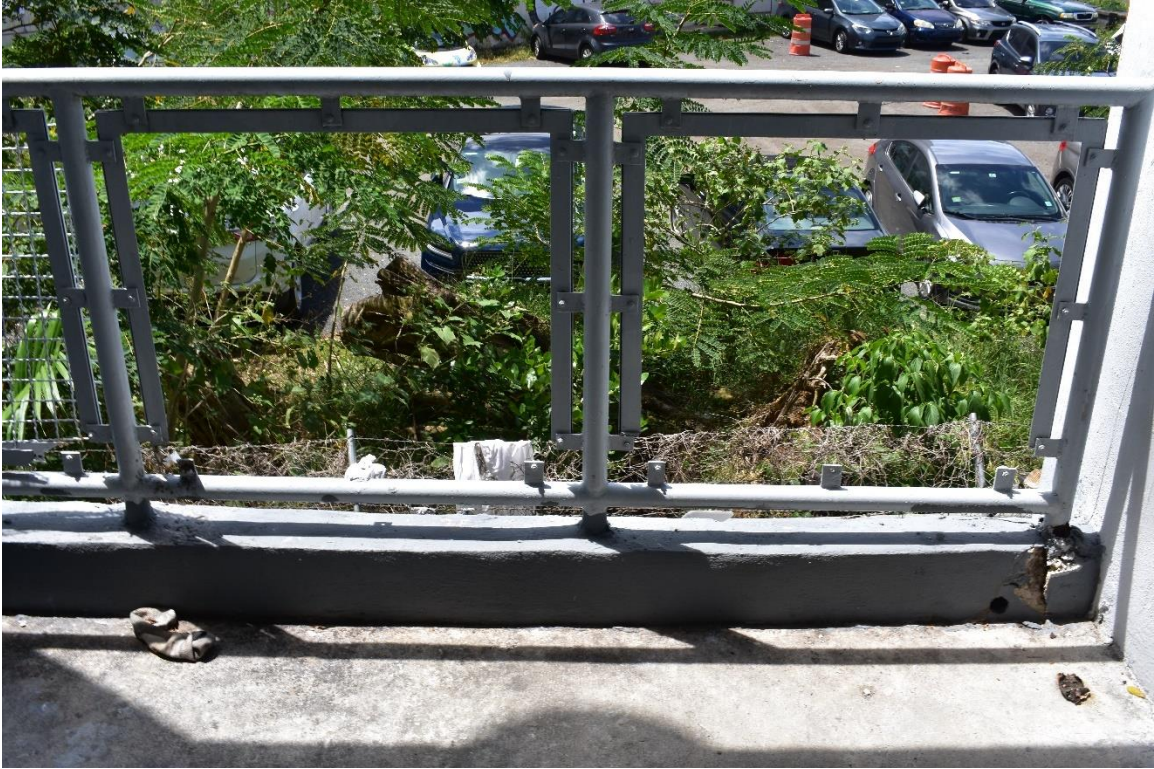
Figure 6.35: Detachment of security mesh from guardrail on PB 2566

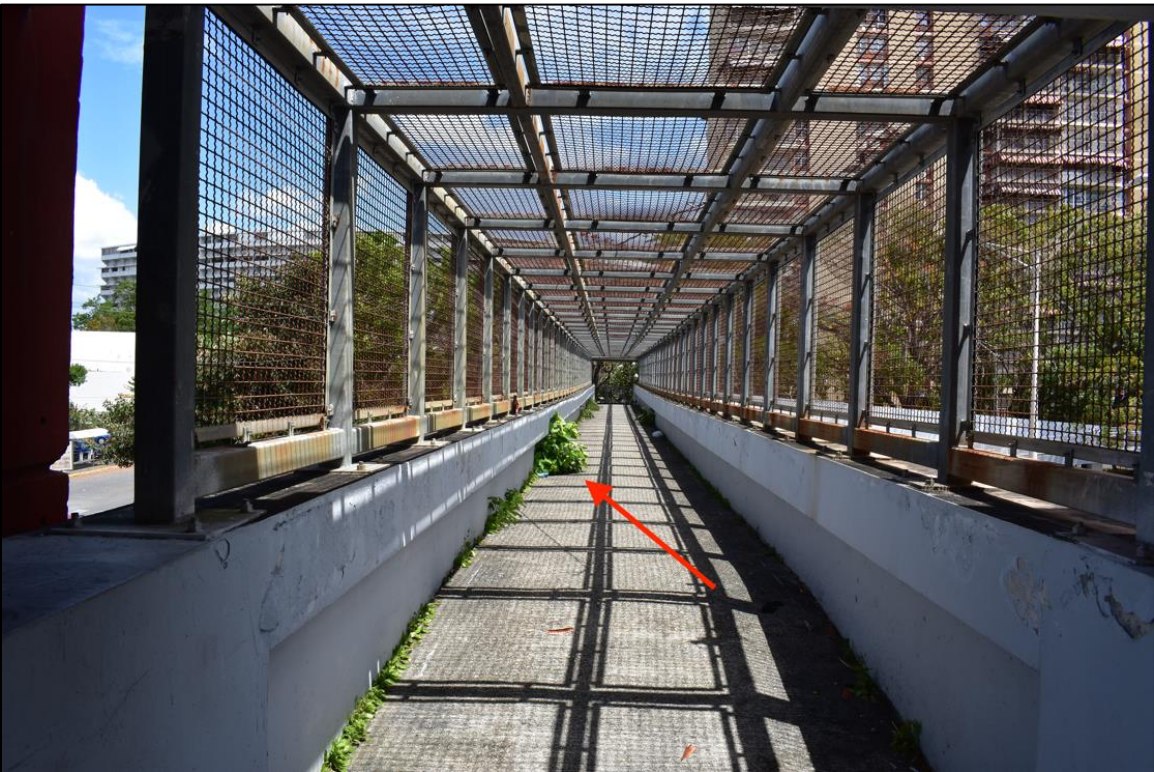
Figure 6.36: Vegetation covered drains on PB 2566

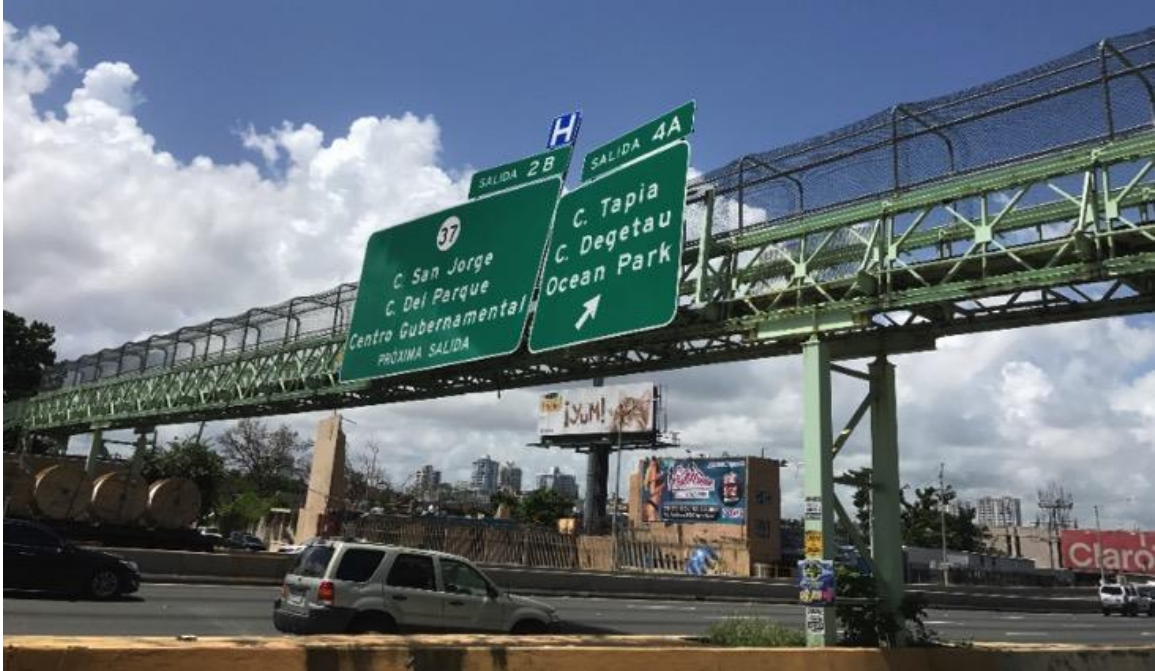
Figure 4.3: Image of the Bridge from September 2018 (Provided by PRHTA)

Figure 4.2 presents a view of the bridge from March 2016, while Figure 4.3 presents a view of the bridge after the damages produced by Hurricane Maria. Notice that at some point between March 2016 and the passage of Hurricane Maria in September 2017, a sign on the bridge was replaced with multiple signs. At the time of the field visit, all the signs had been removed.

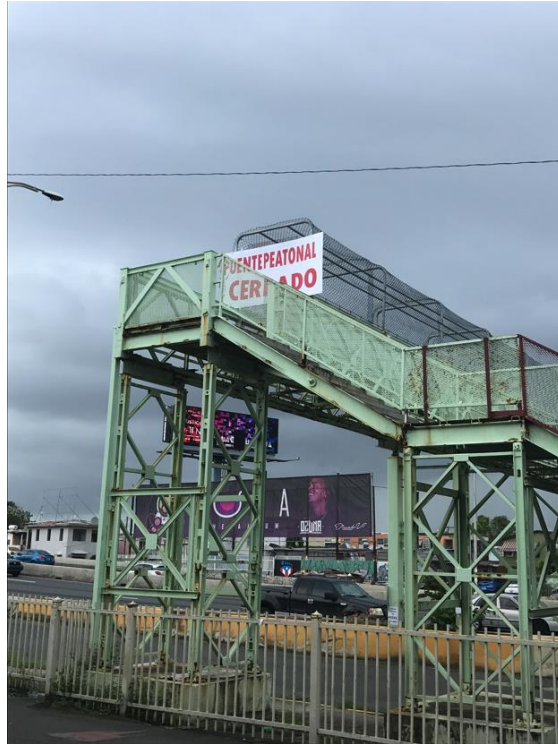
Figure 5.2: Sign Indicating Pedestrian Bridge is Closed

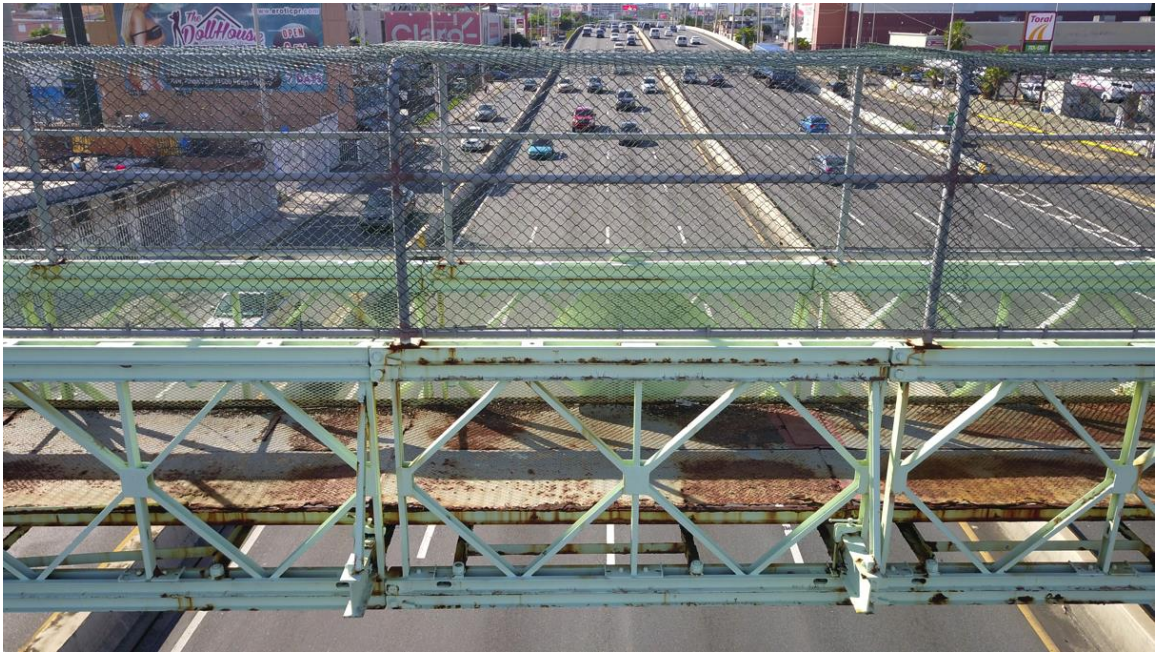
Figure 5.7: Up-close Photo of the Bridge

For the third site visit, the Administration of the Public Housing Residency was visited, and permission was asked to enter the area and to stay several hours. Security was offered during the site inspection. During this final site visit, another drone flight was made, and a series of high quality and high-definition photographs were taken. Also, closer images were taken so that the structural elements could be analyzed for their condition assessment directly from the photos. Every picture taken up-close included two to three truss panels. An example of this is presented in Figure 5.7. More photos taken of the bridge are presented in Appendix B.

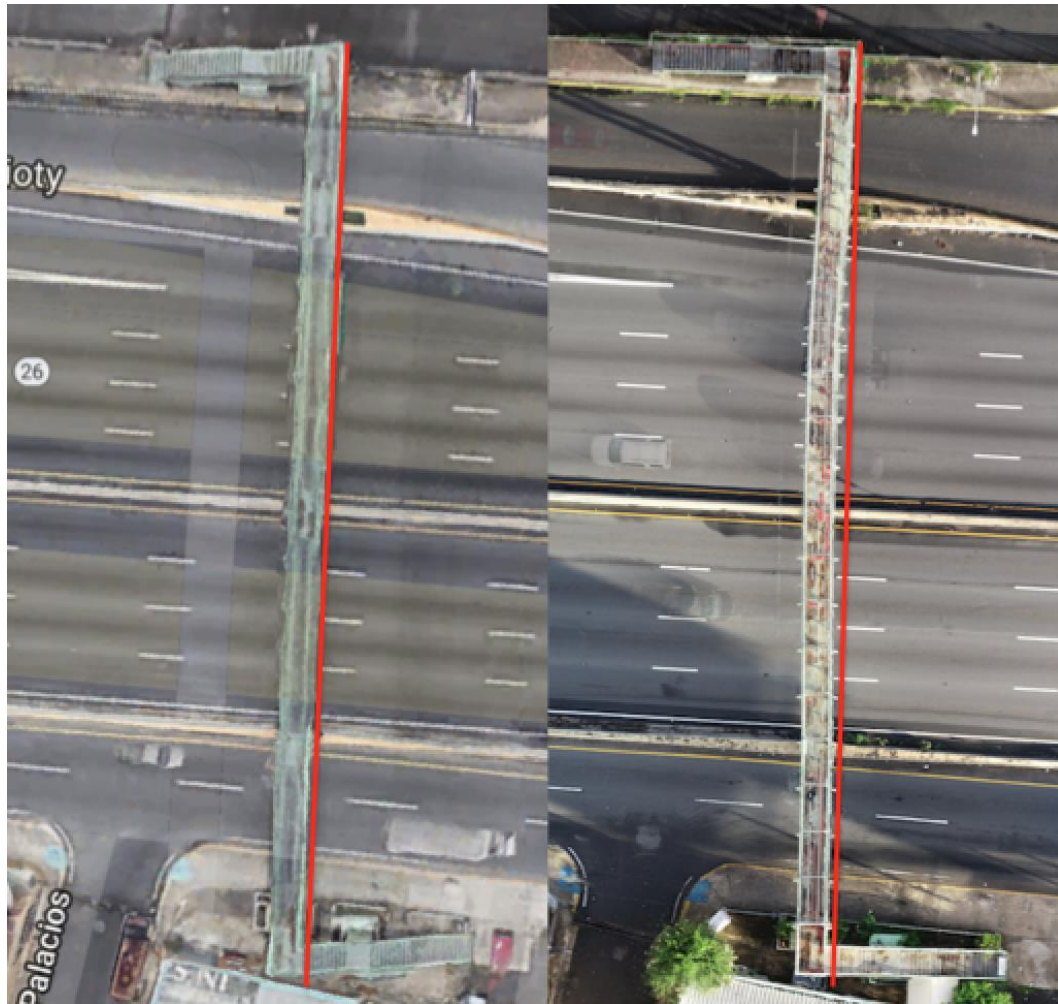
With the image obtained from the aerial mapping, measurements of the bridge may be obtained. First, the image was compared to the aerial image that was retrieved from Google Maps. In Figure 6.3, the image from Google Maps is compared to the one obtained from the survey. A red line was overlaid on both images to make the lateral deformation of the bridge after Hurricane Maria more noticeable. To accurately determine the lateral deformation of the bridge, the image obtained from the survey was imported to AutoCAD.

Figure 6.3: 2016 (Google Earth) and 2018 (Drone Survey) Bridge Geometry Comparison

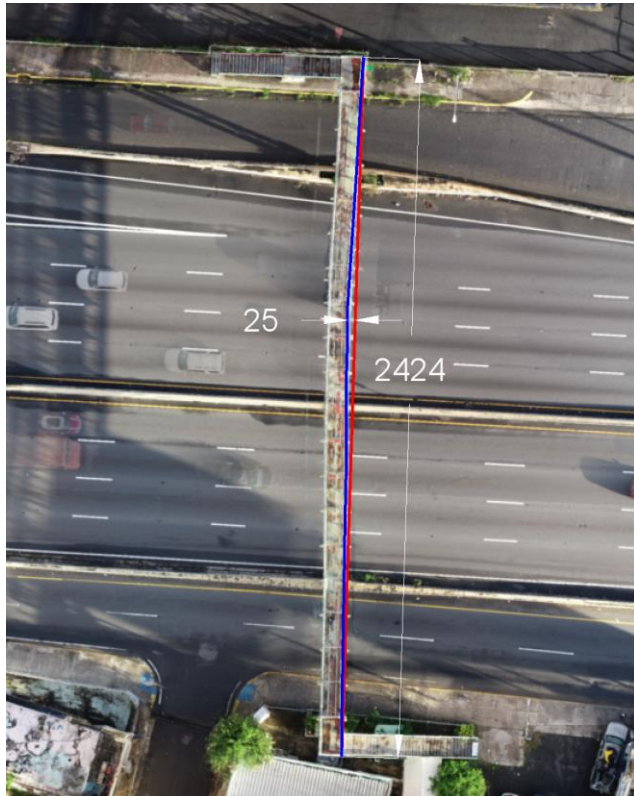
Figure 6.5: Bridge Dimension

Using Google Earth, the dimension of the bridge was verified, as illustrated in Figure 6.4. The length obtained from Google Earth was 202 ft. Considering that the bridge has a length equivalent to 20 truss panels, and every truss panel measures approximately 10 ft, the distance obtained from Google Earth is considered accurate. The distance of 10 feet of the truss panel was verified in the field, and it is also the same length indicated in an old manual for the Bailey Bridge (U.S. War Department, 1943). With the surveyed image imported to AutoCAD, it was scaled to measure the same distance measured using Google Earth. As illustrated in Figure 6.5, the length of the pedestrian bridge was scaled to measure 2,424 inches (202 feet).

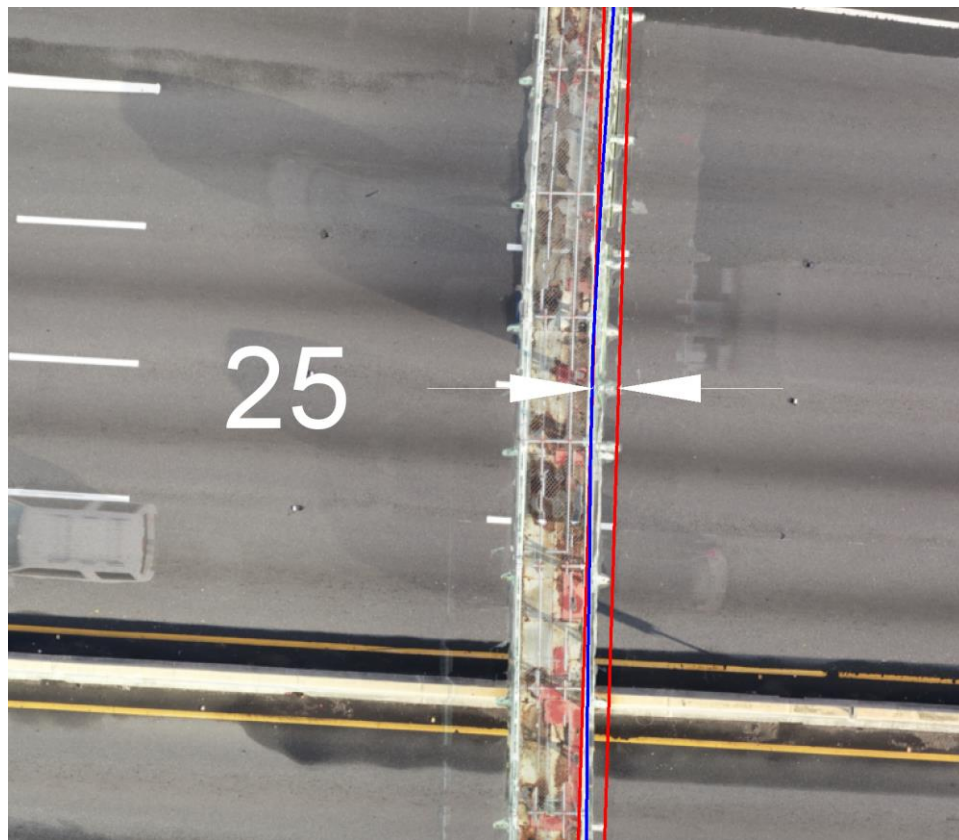
In addition to the bridge length, the deflection was also measured. For this, two colored lines were drawn in AutoCAD and the distance between them was measured (as presented in Figure 6.5 and Figure 6.6). The first line drawn was the red line, which runs straight from north to south of the bridge. The second line drawn was the blue line, which follows the contour of the bridge. Then an offset was given to the red line so that it touched the tangent of the blue line. In the intersection of the tangent point, the distance between the original red line and the blue line measured 25 inches, as illustrated in Figure 6.6. With this dimension, it is understood that the bridge had an approximate lateral deflection of 25 inches in its most critical point. In addition, looking closely, it can be appreciated that this point corresponds to the location of the second to last structural beam that supported the signs.

Figure 6.6: Bridge Maximum Plastic Deflection (in inches)

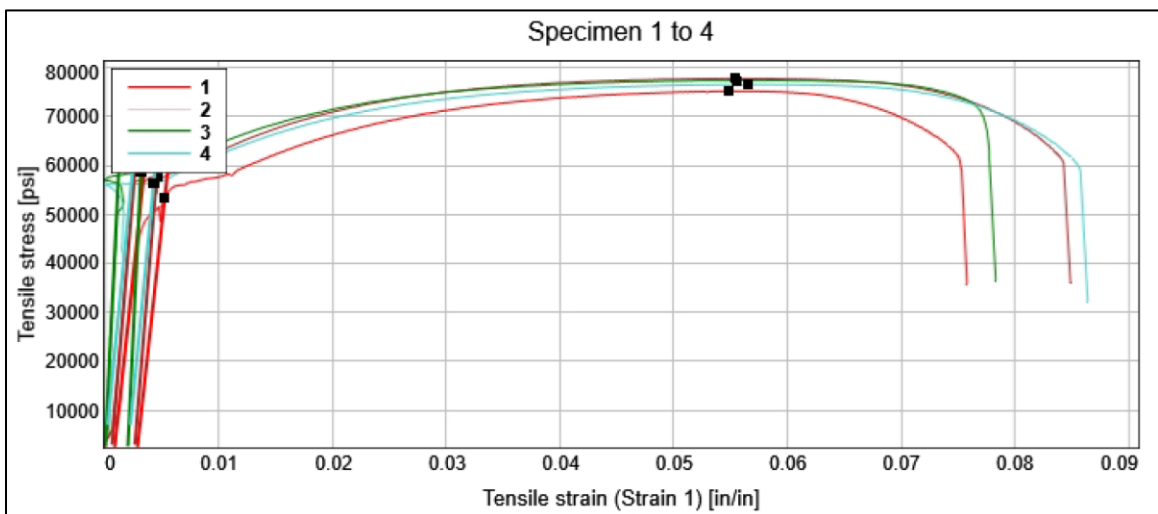
Figure 7.14 presents the stress vs. strain diagrams that were obtained from the tension tests. Table 7-2 illustrates the results obtained from each curve. From these results, an average yield strength of 56.58 ksi, was obtained, as presented in Table 7-3. Given the results of the testing tests, it is suspected that the steel used for the construction of the bridge was A572. Still, the average yield stress of 56.6 ksi was used when modeling the bridge to evaluate the impact of wind loads.

Figure 7.14: Stress vs. Strain Diagrams

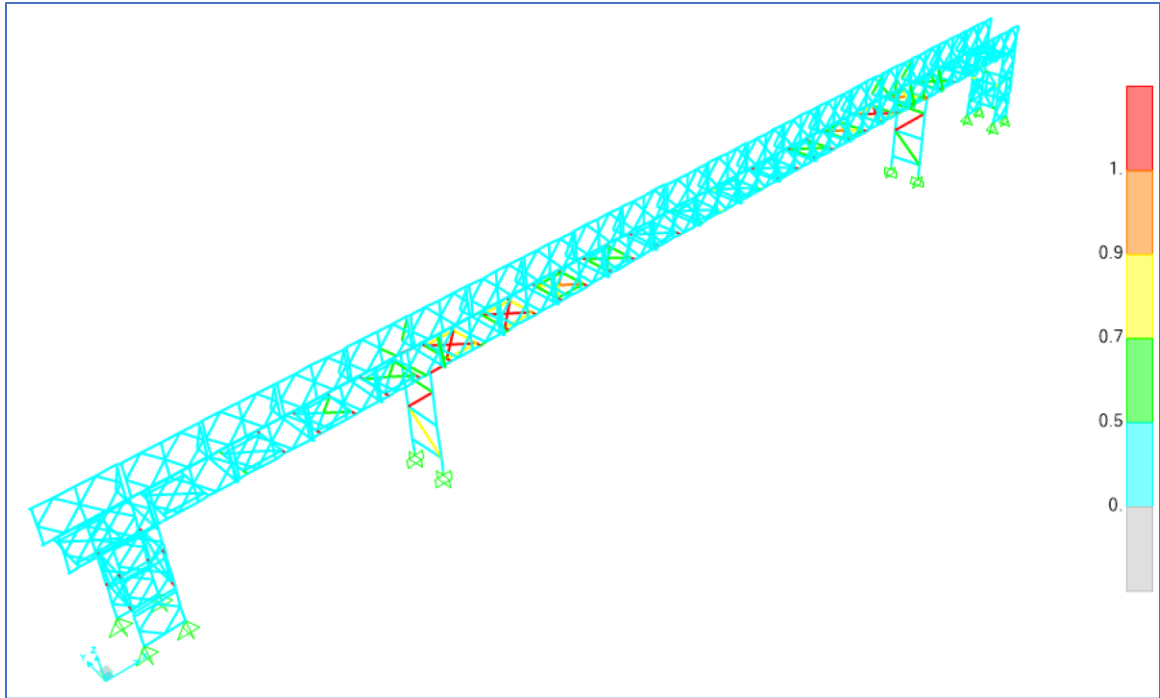
Figure 8.6 presents an image of the resulting lateral deflections due to wind action, while Figure 8.7 presents the results of the design check, showing that the interaction equation results in most of the elements in the plastic deflected area working at low stress demand.

Figure 8.7: Interaction Equation (Strength Demand) Results - Without Signs

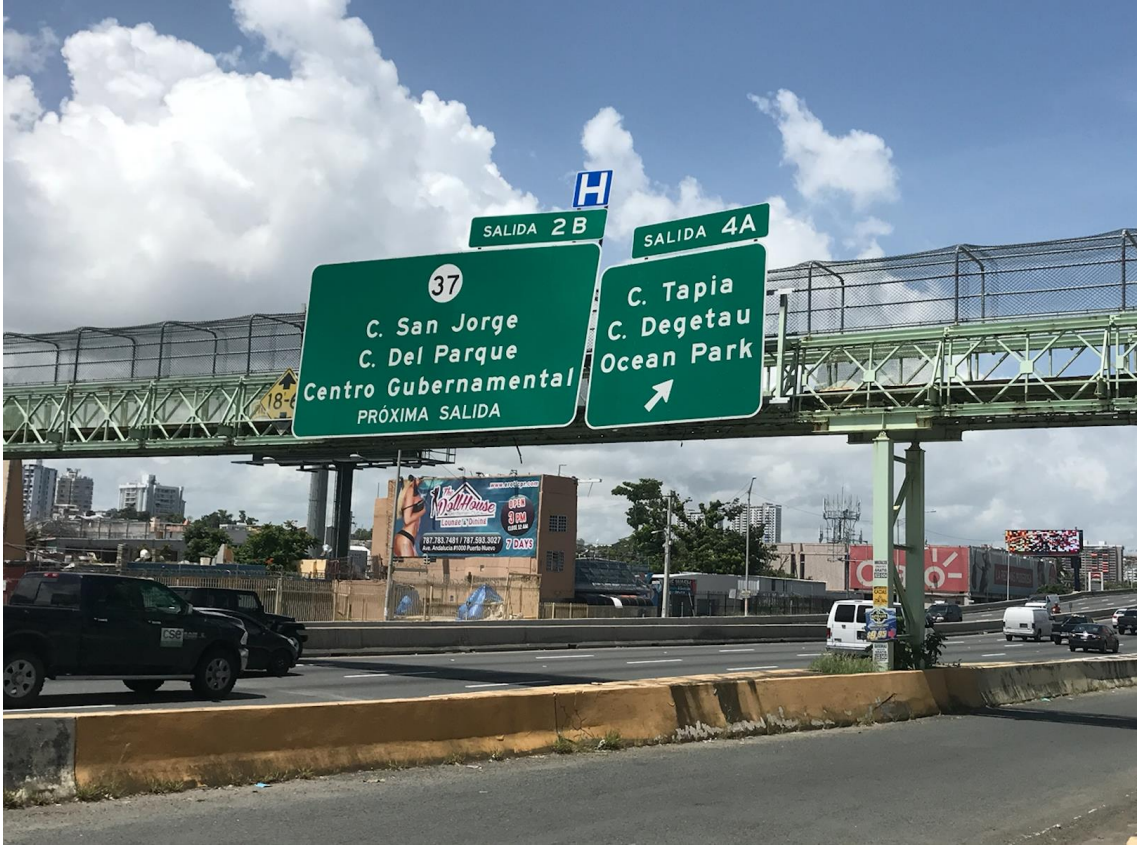
The second model that was created was of the pedestrian bridge with the signage installed. With this model, the bridge can be analyzed to understand the implications that the signage brought to the bridge. Figure 8.8 illustrates the signage that was installed on the bridge at the time Hurricane Maria made landfall in Puerto Rico. Figure 8.9 through Figure 8.11 illustrate the structure that held the signage in place. From Figure 8.11 it was determined that the structure that held the signage in place had 5 vertical beams, and from Figure 8.10 it is evident that the beams were attached to the truss vertical channels with U-bolts in two points.

Figure 8.8: Signage Installed at the Pedestrian Bridge

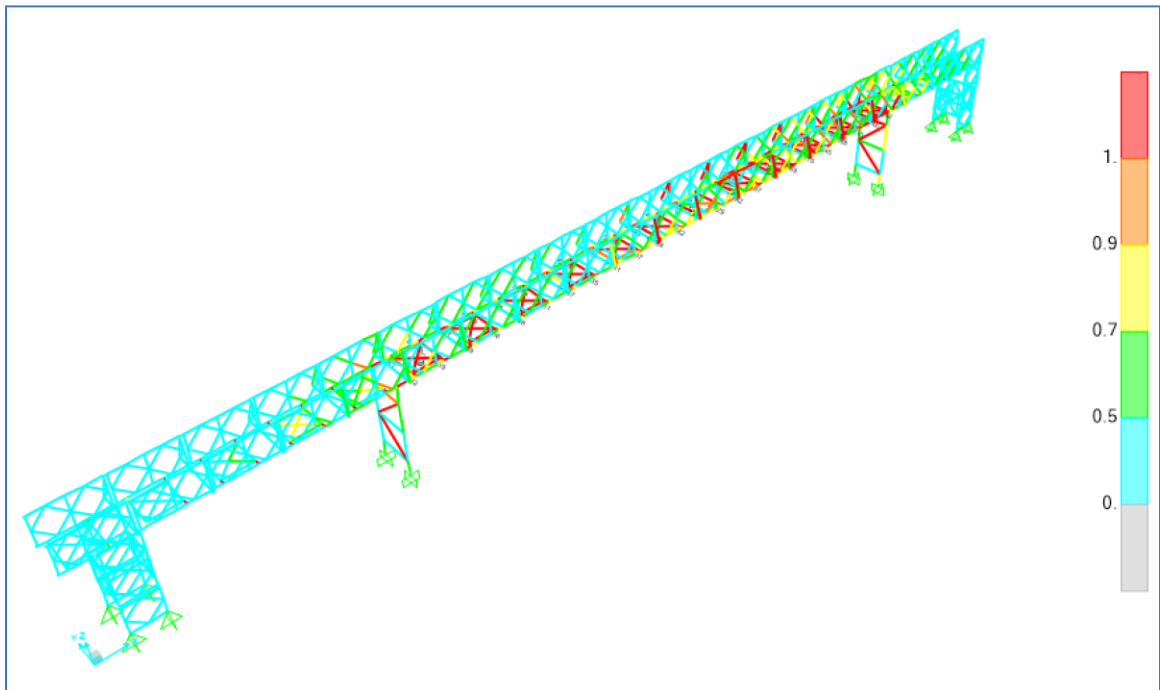
Figure 8.13 displays the results of the design check, showing that the interaction equation results in most of the elements in the plastic deflected area working with a much higher stress demand that the previous analysis. This leads to the conclusion that the installation of the signs had an important role in the lateral inelastic deformations.

Figure 8.13: Interaction Equation (Strength Demand) Results - With Signs Included
