Improving Transportation Infrastructure Resilience against Hurricanes, other Natural Disasters, and Weathering: Part III - Analysis of motor vehicle bridges failures due to Hurricane Maria

FINAL REPORT
August 2022

Transportation Infrastructure Research Center – TIRC
Polytechnic University of Puerto Rico
377 Ponce de Leon Ave, San Juan, PR 00918

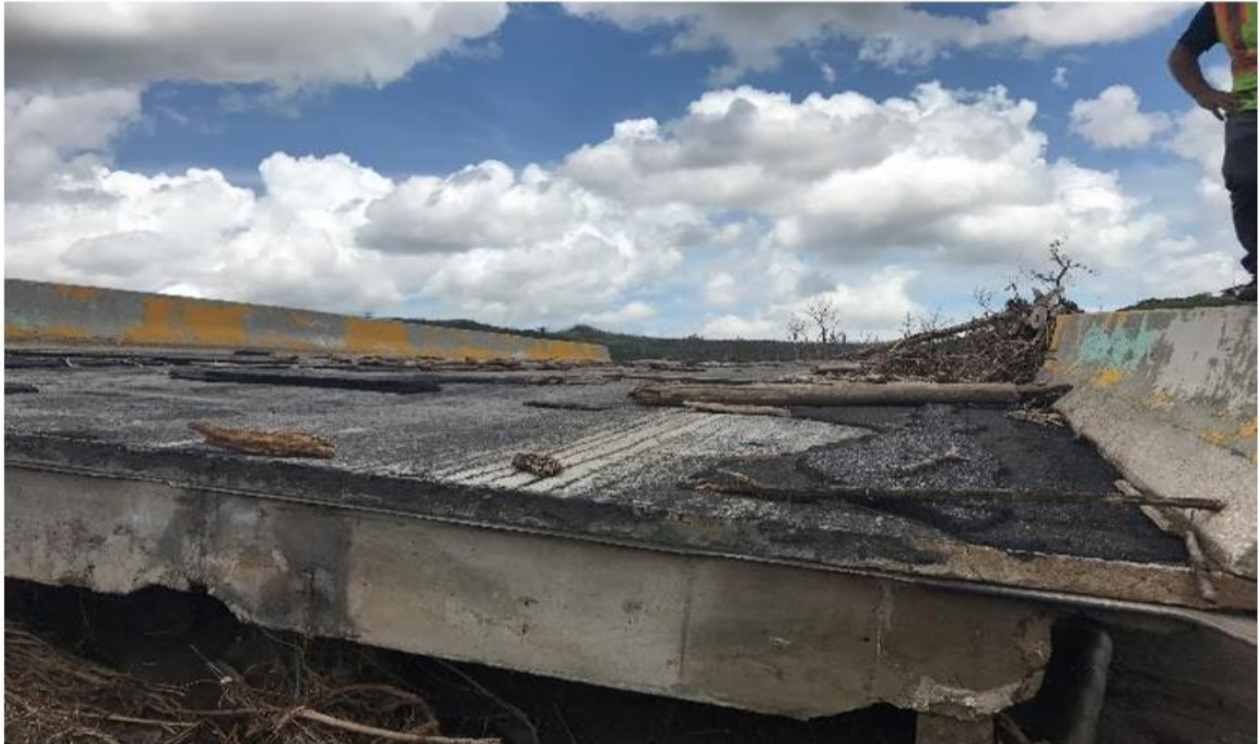
Figure 2-223 Inspection of collapsed Bridge 1462 (source: PRHTA)
