# **Development and Validation of Methodologies for Rapid Inspection and Assessment of Fatigue Damage**

FINAL REPORT  
September 2020

Submitted by:  
Sougata Roy, Ph.D., Associate Research  
Professor Department of Civil and Environmental Engineering  
Center for Advanced Infrastructure and Transportation  
Rutgers, the State University of New Jersey  
100 Brett Road  
Piscataway, 08854

External Project Manager  
Jean H. Laird, P.E., Senior Project Engineer  
New Jersey Turnpike Authority (NJTA)  
1 Turnpike Plaza  
Woodbridge, NJ 07095

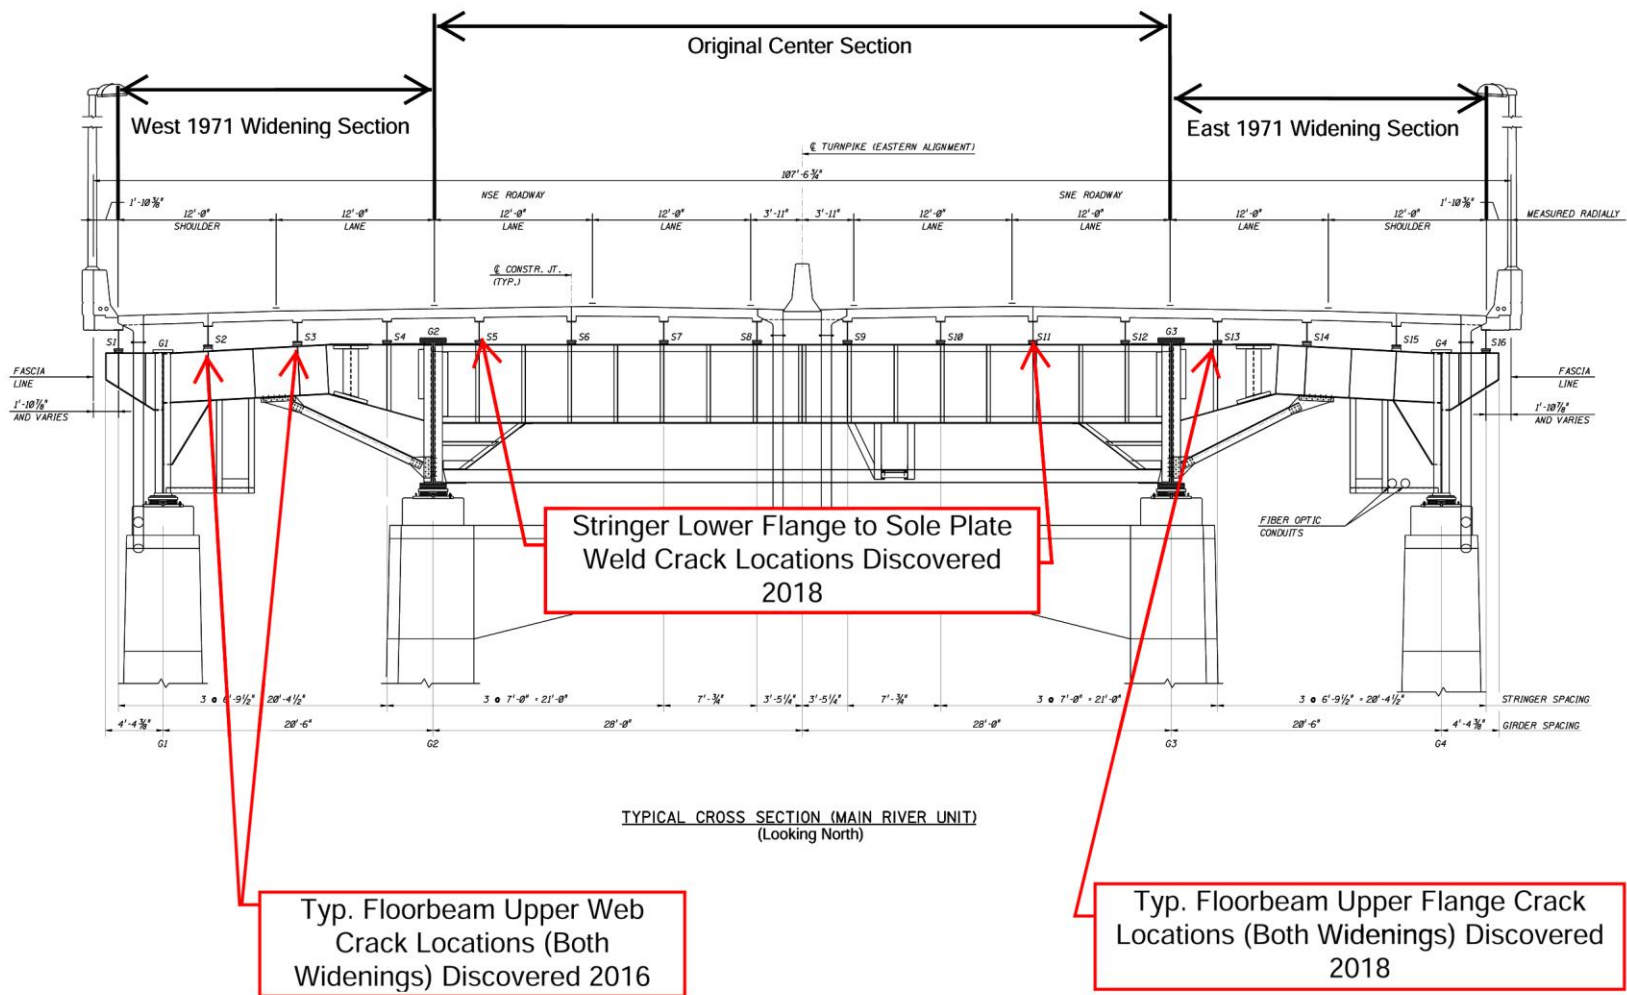
**Figure 2-1 Cross section of bridge (taken from inspection report)**

During the 2016 biennial inspection of the bridge, cracking in the floor beam stiffener-to-top flange welds and the adjacent floor beam web gap was discovered at stringers S2 and S3 (under the west 1971 widened section) and stringers S14 and S15 (under the east 1971 widened section) beneath all seven deck joints within the river spans. This cracking was not identified during the 2012 and 2014 biennial inspections. As evident from Figure 2-1, the subject stringers are located under the left most or the slow travel lane and the shoulder. Such cracking was not found at the outermost stringers S1 and S16 located under the parapet. The floor beam stiffeners in the widened part of the structure are  $\frac{7}{16}$  in. plates welded to the top flange of the floor beam. In the original part of the structure the stiffeners are made of  $5 \times 3\frac{1}{2}$  in. angles, with the longer leg protruding and milled to bear against the floor beam flanges, except for a few locations where the protruding leg of

the angles were welded to the top flange by repair plates (addressing corrosion damage). Cracking of the floor beam top flange at the stiffener connections in the original structure, both with milled to bear and welded details, was also observed under stringers S4 (west carriageway) and S13 (east carriageway). In addition, cracks were discovered in the flange initiating from the holes for the bearing retaining bolts. During subsequent inspections, crack growth was noted leading to severance of the floor beam stiffener-to-flange welds or fracture of the floor beam flange at many locations.

floor beam top flange-to-floor beam web stiffener welds, either at the weld toes or from the weld root that eventually severed the stiffener-to-flange connection.

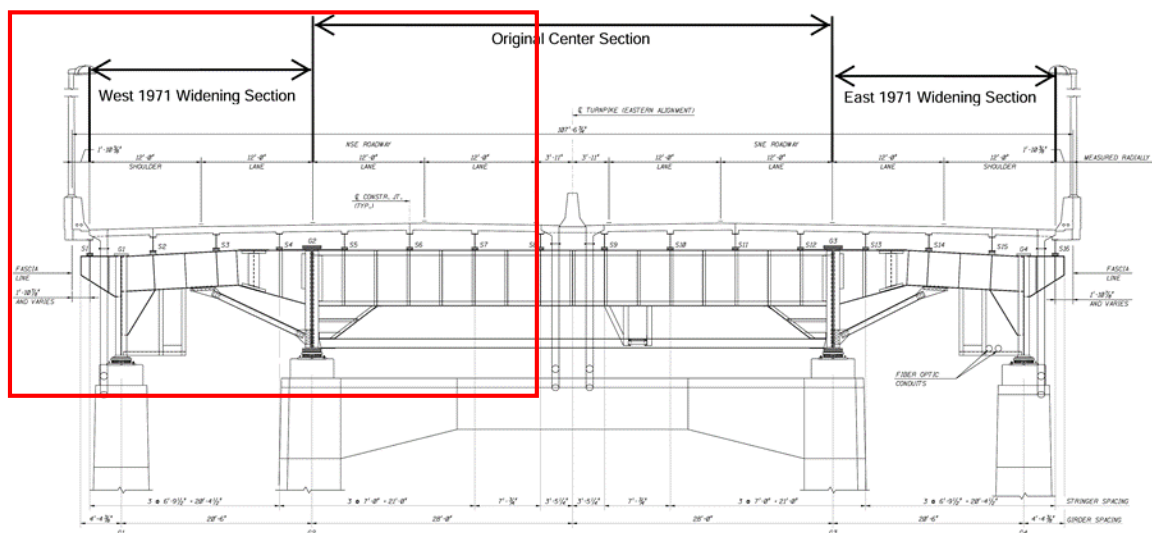
**Figure 3-1** Cross section of bridge identifying the part modeled for FEA

The part of the structure modeled is identified in Figure 2-1 The west side of the bridge carrying the north bound carriageway was modeled. The model included girders G1 and G2, floor beams FB3, FB4 and FB5, and stringers S1 to S8. The length of the model was 80 *ft.* and the width of the model was about 52 *ft.*
