Bridge Deck Surface Profile Evaluation for Rapid Screening and Deterioration Monitoring

FINAL REPORT
September 2022

Submitted by: Adriana
C. Trias-Blanco
Assistant Professor

1. Report No. CAIT-UTC-REG52	2. Government Accession No.	3. Recipient's Catalog No.	
4. Title and Subtitle Bridge Deck Surface Profile Evaluation for Rapid Screening and Deterioration Monitoring		5. Report Date September 2022	6. Performing Organization Code CAIT/Rowan University

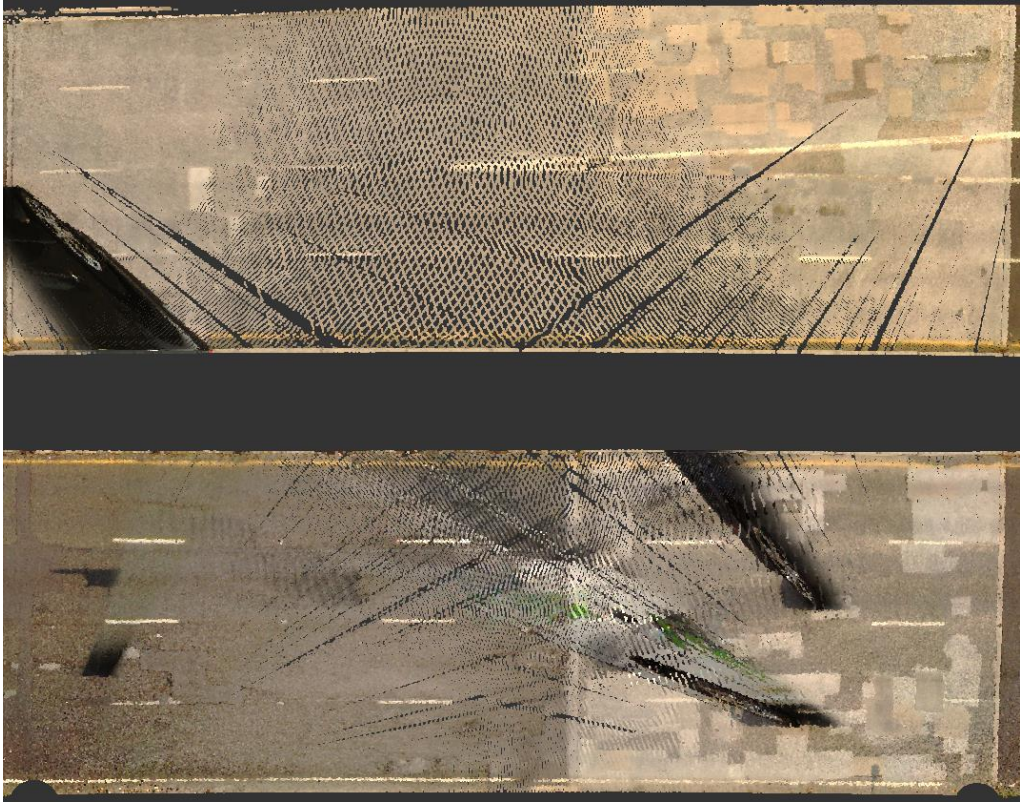
Figure 27. Structure 0416151 - RGB image of the deck's top surface.

Bridge 0416151 presented large flat areas that are explained through Figure 26 and Figure 28. Where, Figure 26 represent the variation in elevation of the deck's top surface, while Figure 28 highlights the areas considered flat, since the variation in elevation or slope is inexistent. Figure 27 presents an RGB view of the deck's top surface. The presence of flat areas within the deck affects how the water runs off the structure. In these areas water is more likely to sit and percolate inside the deck, increasing the risk for corrosion of the reinforcing steel.

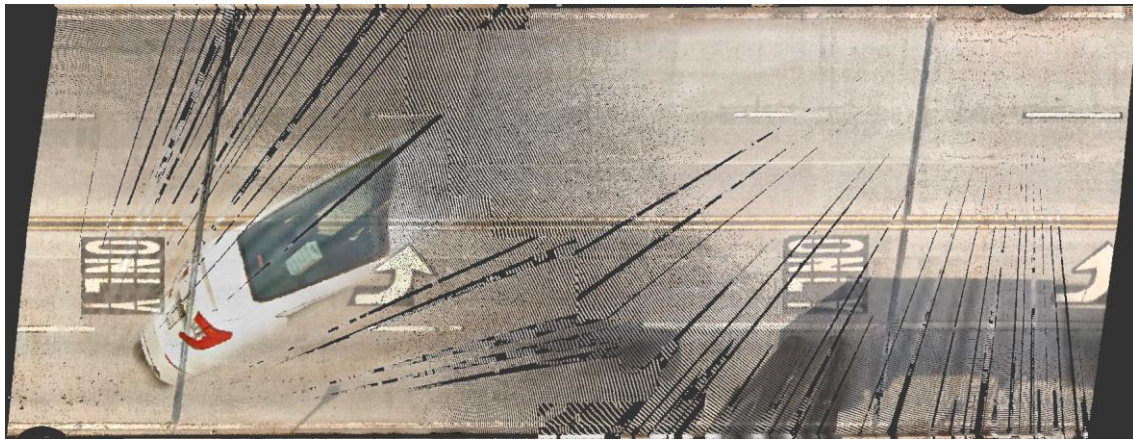
Figure 40 Structure 18G0701 - RGB image of the deck's top surface.

Structure 18G0701 is a newly constructed deck. It can be seen from Figure 39, Figure 43, and Figure 44 that the deck has proper slope for drainage on both the longitudinal and transverse directions. It is important to highlight that some low points were found along the deck as seen in Figure 43, this can be areas of concern in the long term. The plan view presented on Figure 41 indicates the location of the longitudinal and transverse section within the deck. Figure 40, presents an RGB view of the deck's top surface.

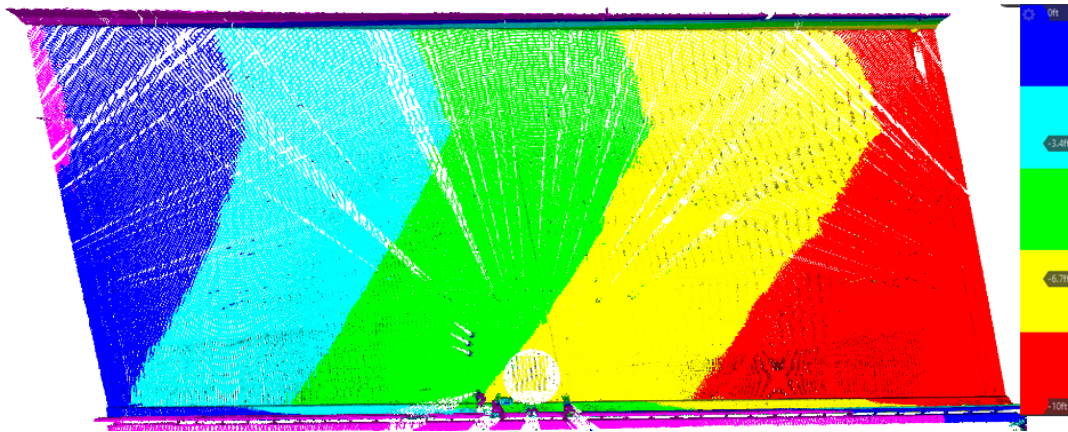
Figure 58. Structure 1816154 - Elevation map.

Structures 1816154 and 1816155 will be compared in this section, since these structures were included on this project as a case study presented by NJDOT. The twin bridges originally presented different levels of deck condition (3 for 1816155, and 6 for 1816154) which was a concern since the structures see the same level of traffic and have same dimensions of their structural components. Figure 58 and Figure 63 show the elevation maps of the top surface of the structures. Both structures present a longitudinal slope of approximately 2.3%, which can be estimated from Figure 61 and Figure 66. Structure 1816154 presents a transverse slope between 1 and 1.3% (see Figure 62), while structure 1816155 presents a uniform transverse slope of 1.3% (see Figure 65).

It is important to mention that during the data collection of Structure 1816155 a construction work was being performed on the premises of the bridge, which obstructed part of the deck and limited the access of the research team. For this, only half of the deck was available for data collection. From Figure 62 and Figure 67, the presence of mild rutting can be seen throughout all transverse directions, this can indicate the potential location of areas where water sits for longer periods of time, increasing the possibility of early deterioration. Based on the information gathered from the analyzed point cloud data, there is no clear evidence of the cause on the difference in condition stage between structures 1816154 and 1816155. The main evidences of deck damage found on the top surface of bridge decks were rutting and low points of vertical curvature. These aspects presented clear correlation with the deterioration stage of the deck.
