DRAINAGE INFORMATION ANALYSIS AND MAPPING SYSTEM

FINAL REPORT

Submitted by:
Jay Meegoda, PhD, PE
New Jersey Institute of Technology
University Heights
Newark, NJ 07102

New Jersey
Department of Transportation
Division of Research and Technology
and
U.S. Department of Transportation
Federal Highway Administration

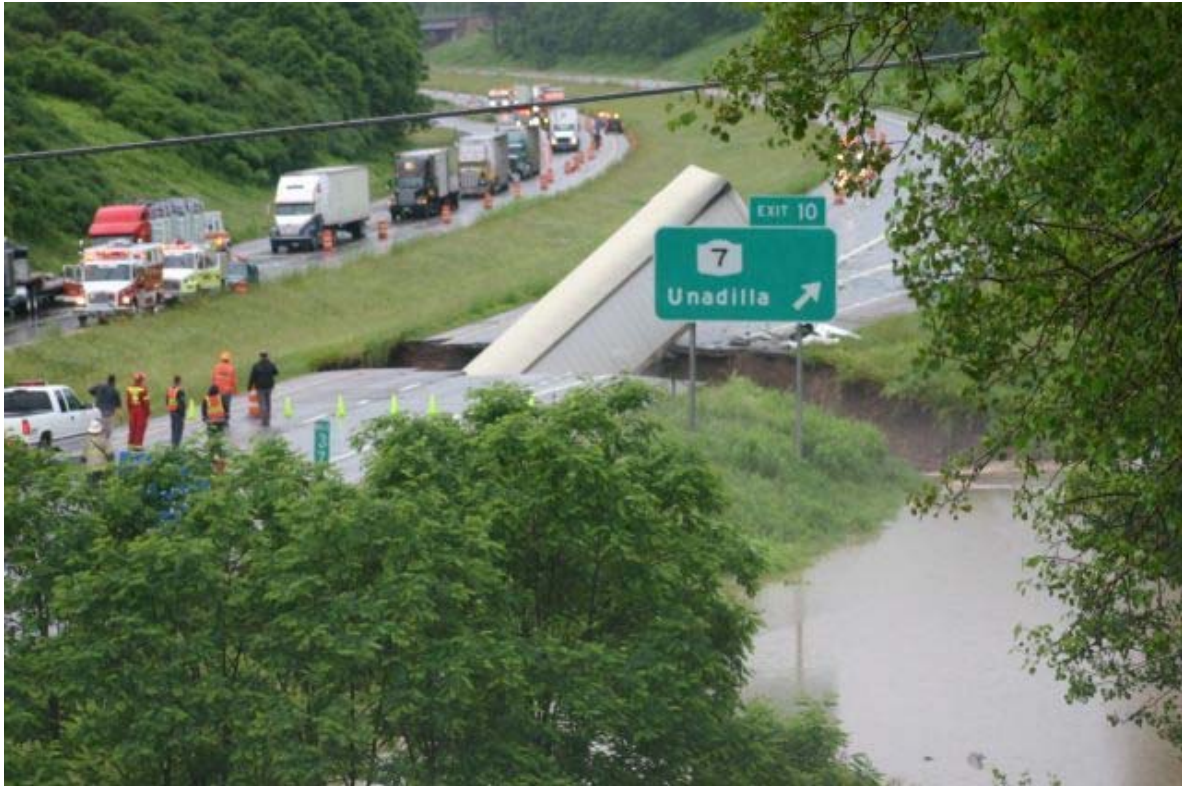
Figure 1. Collapse of a Culvert Crossing I-88 on June 28, 2006

A loss of pipe integrity could result in temporary roadway closure and considerable rehabilitation/replacement/repair costs or even worse. In addition, the total collapse of a drainage pipe could pose a major safety risk to motorists, such as the catastrophic failure that occurred on I-88 near Unadilla, NY on June 28, 2006. The New York State Police photograph shown in Figure 1 illustrates the damage to I-88 resulting from a drainage pipe collapse. Two truck drivers were killed when their rigs fell into the washout caused by heavy rainfall. Due to the collapse of I-88 the New York State Thruway (I-90) was closed in both directions from Schenectady to Syracuse. The washout of all four lanes and center median was a result of a failed 30-foot diameter pipe just beyond the Exit 10 interchange. (Albany Times-Union) Failures of this magnitude typically lead to catastrophic accidents, which may involve the loss of life and property. Hence a drainage information analysis and mapping system is necessary for timely maintenance of drainage assets.

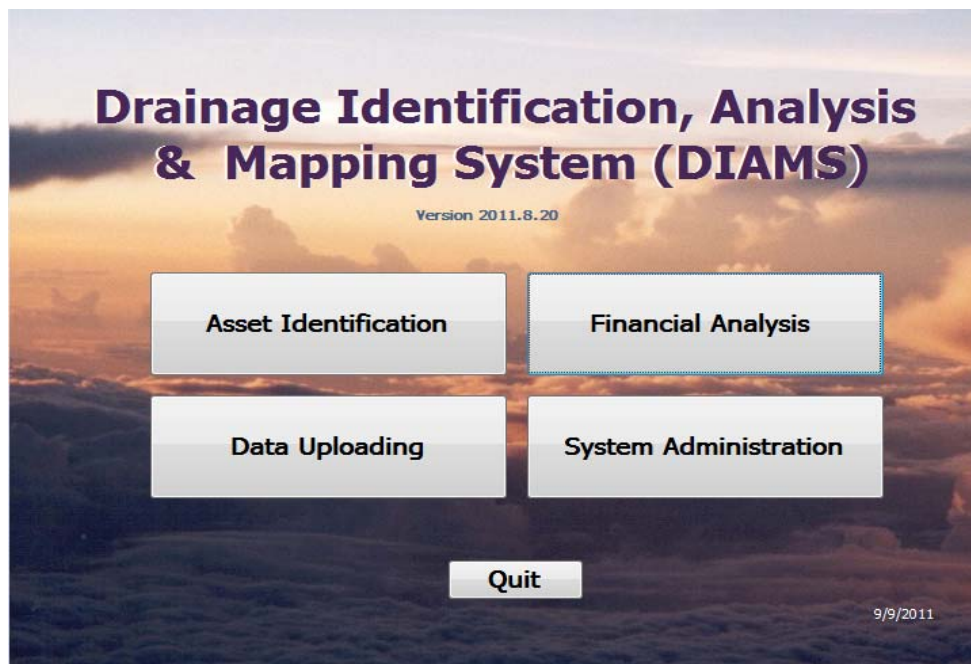
Figure 2. DIAMS Home Screen

The DIAMS home screen is shown in Figure 2. It illustrates the four separate DIAMS modules: asset identification, data upload, financial analysis and system administration.

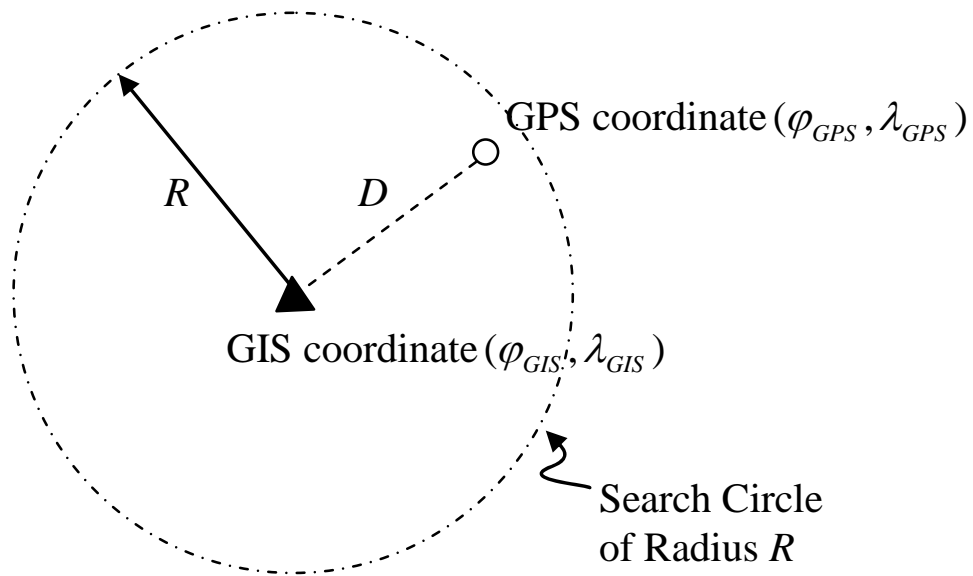
Figure 4. Quantitative Position Validation Procedure

A quantitative check was used to validate the accuracy of the positional attribute of the DIAMS asset. A computerized check compared the asset coordinates to the road centerline coordinates. The latter dataset was obtained from the NJDOT's straight line diagram (SLD) database. In order to verify the acceptable limits of vendor-provided GPS coordinates, a simple radius search is performed. The circle radius will be determined based on project criterion and database functionality. The objective of this QA/QC is to check if the GPS coordinates are within a prescribed limit (say a circle of radius 0.1 mile) from the GIS coordinate. The concept is illustrated in Figure 4.

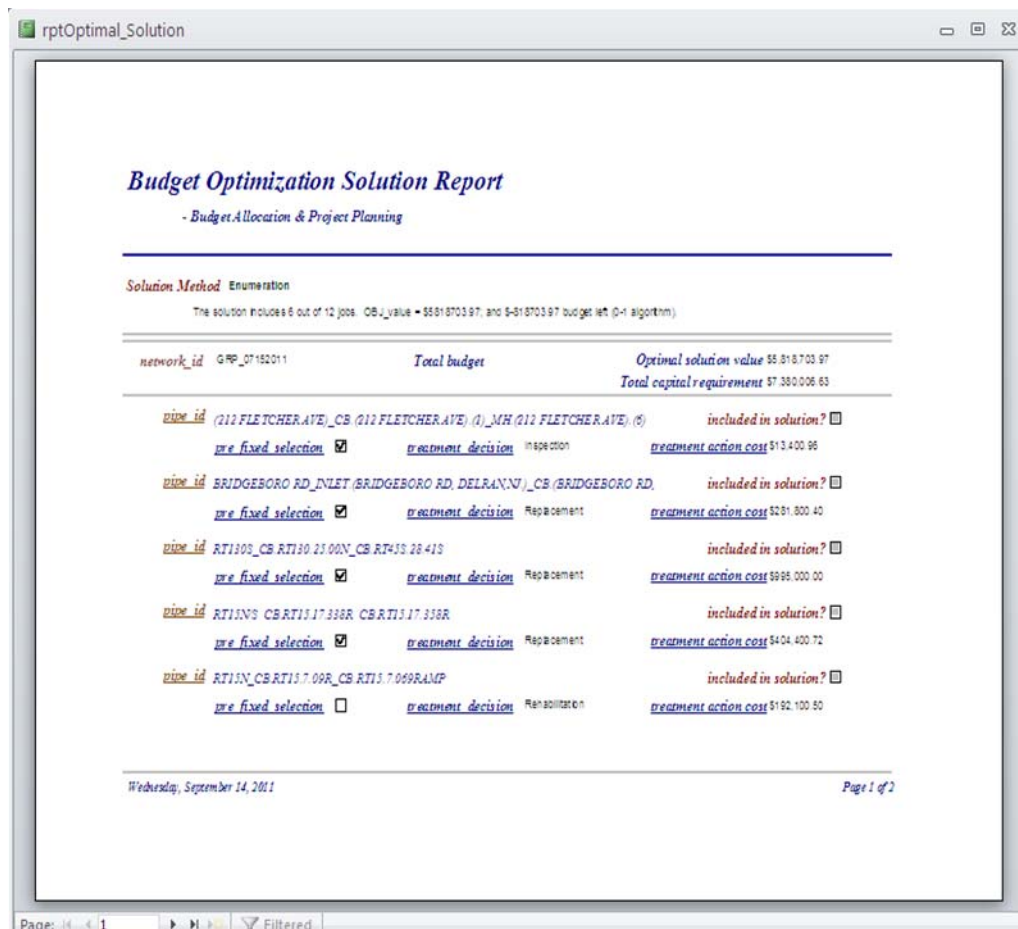
Figure 14. Sample Budget Solution Report

Financial reports are an important part of DIAMS financial analysis module. These reports provide valuable information about the current status of the drainage system under NJDOT management. These timely generated reports are an effective tool for managers to set the priority of work orders and to schedule maintenance jobs in the most cost efficient way. Figure 14 shows one such report based on Network optimization.

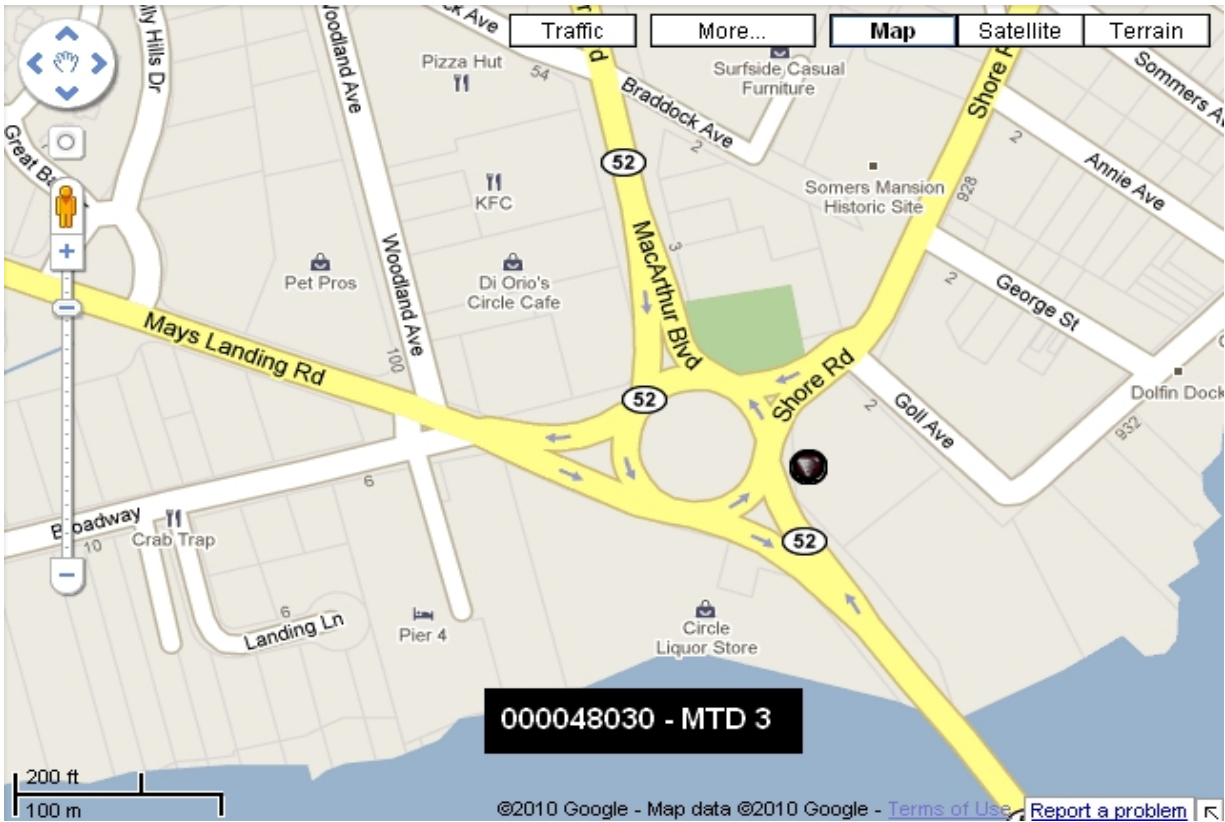
Figure 3. Sample of map showing location of a MTD

Each identified device was marked on a Google map (see Figure 3 for a sample). See Appendix A-II for all the location maps.

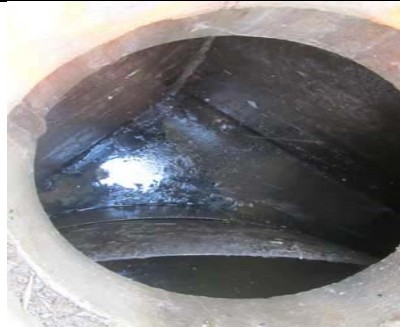
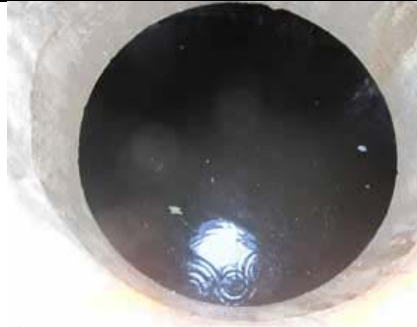
Photo Taken During Structural Inspection Immediately after Cleanout

There is no high flow control weir.

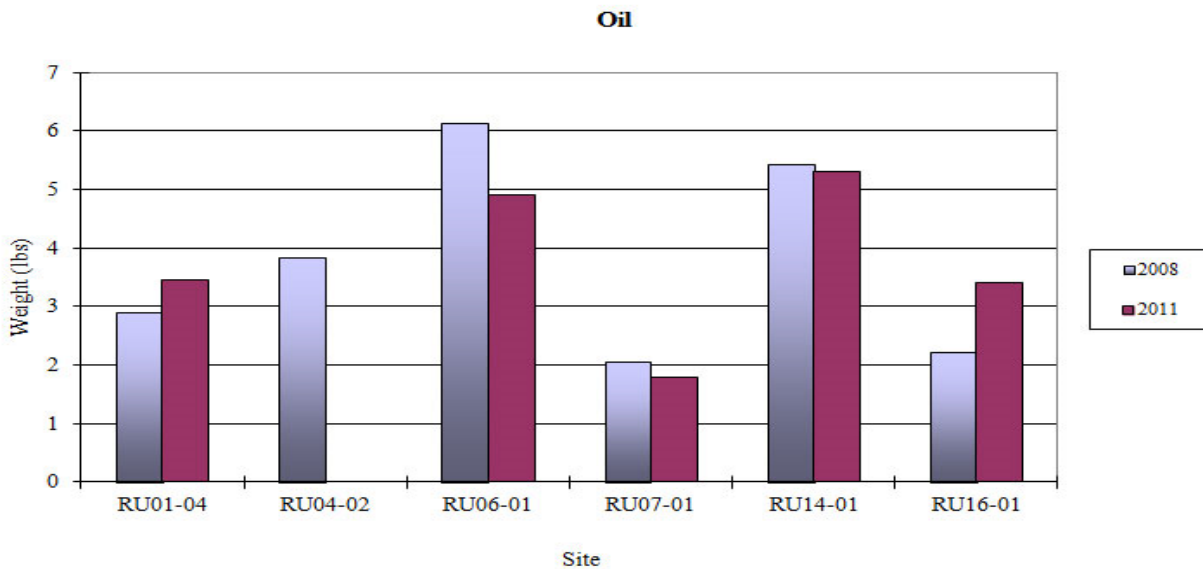
During both cleanout years, a larger amount of oil was observed at sites with higher commercial and industrial activity (i.e. RU06-01: North Bergen and RU14-01: Parsippany).

Figure 4. Comparison of weight of oil trapped in device from 2008 to 2011 (grit and floatables chambers)

The amount of oil in the devices was measured using oil-only absorbents. This material absorbs and retains oil and oil-based liquids including lubricants, fuels, and cleaning agents. Each skimmer is designed to absorb 1.8 gallons of oil without absorbing water. The weight of oil in each device compared to previous results is shown in Figure 4. The 2011 cleanout date for RU04-02 device was not reported to Rutgers University. The sediment samples and floatables were collected by the contractor. However, the oil was not collected immediately prior to cleanout.

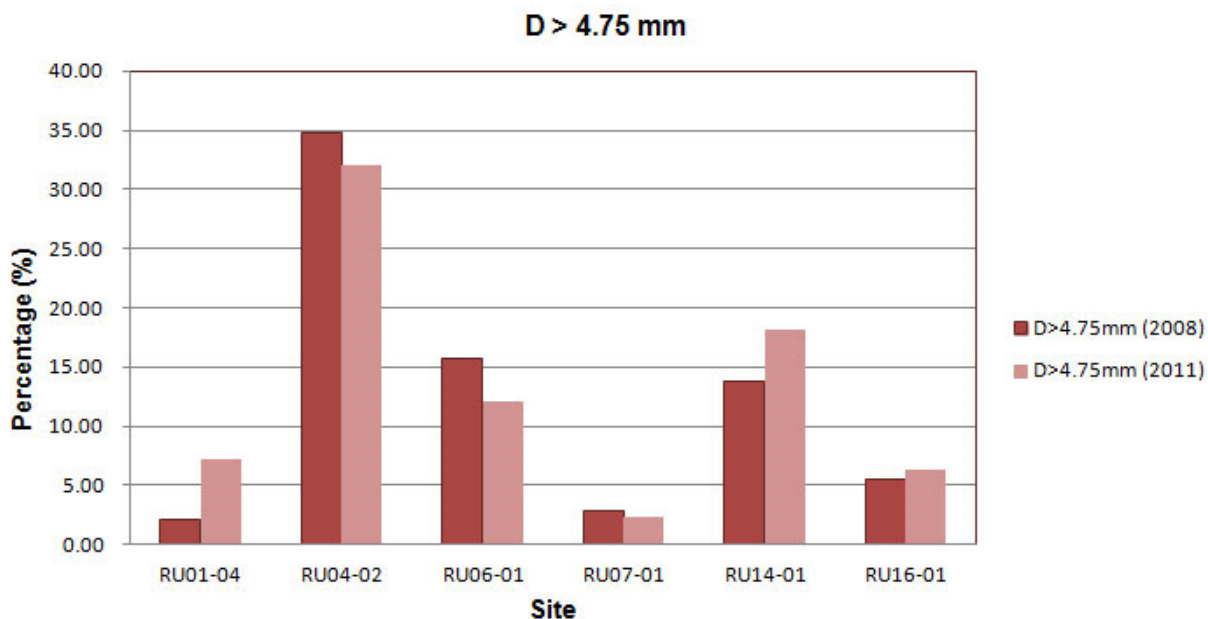
Figure 7. Comparison of particles larger than 4.75 mm

The device is designed to remove litter and large particles from stormwater runoff. A sieve analysis was performed using standard procedures with five sieve sizes. The sieves used ranged from the #4 to the #200 sieve sizes. A #4 sieve (4.75 mm) was used to separate coarser material such as leaves, litter and debris from the sediment. Once the larger debris was sifted out, the Particle Size Distribution (PSD) analysis was conducted. The percentage of particles larger than 4.75 mm in the sediment samples is shown in Figure 7.

This monitoring guideline is designed for devices that primarily collect particles larger than 75 microns (0.075 mm). The sediment samples tested in this study contained 13 percent of particles larger than 4.75 mm and 7 percent of particles smaller than 75 microns by weight on average. In the previous study in 2008, 12 percent of particles by weight on average were larger than 4.75 mm and 11 percent was smaller than 75 microns found from the same 6 devices.

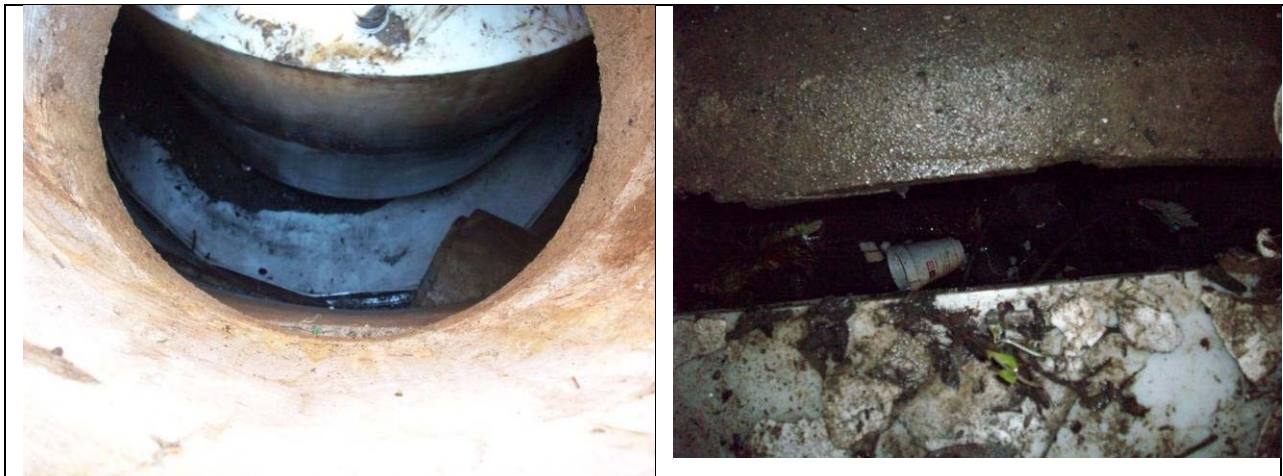
Figure 16. Damaged coupler connecting the device

There was not enough water to skim off floatables. Inspection immediately after cleanout revealed a damaged coupler connecting the stub to the drainage pipe. Due to the gap in the coupler, smaller floatables were not being retained in the floatables chamber. The coupler was repaired to avoid having smaller floatables bypassing the device.

RU15-01: The cleanout operation was completed using the standard procedure. (Date: 06/01/2011). During inspection immediately after cleanout, a damaged coupler connecting the stub to the drainage pipe was found.

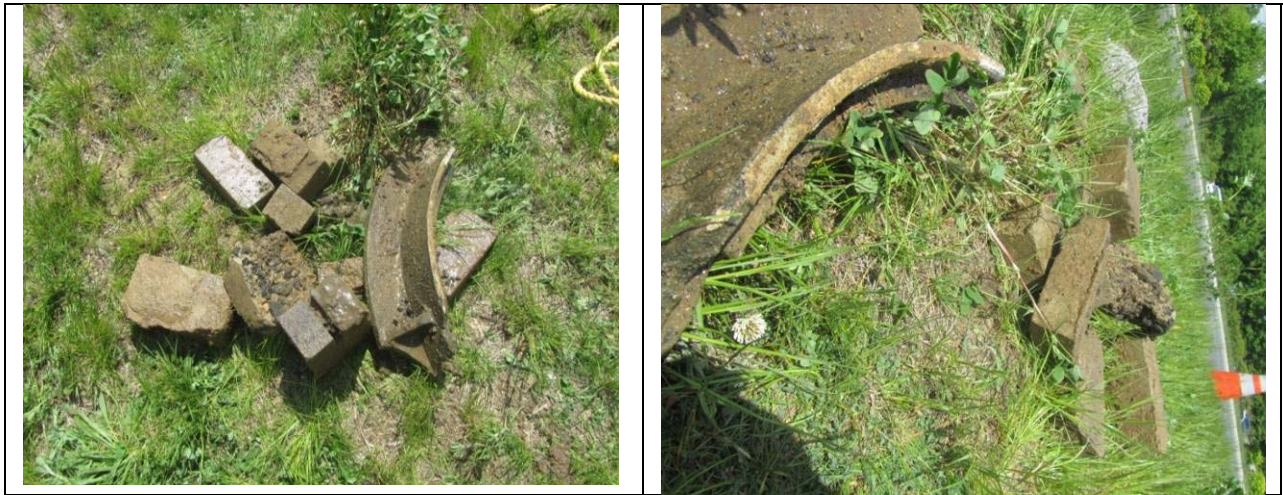
Figure 17. Construction debris found inside the Device

During the cleanout operation, construction debris was found inside the device. The debris found included part of a manhole lid. It is suspected that this debris might have detached during installation. The debris was determined not to be from roadway runoff.

RU18-01: The cleanout operation was completed using the standard procedure (Date: 06/01/2011). Construction debris was found during the cleanout operation. It is suspected that this construction debris might have come from the device installation or other conditions that are not expected during normal operation.

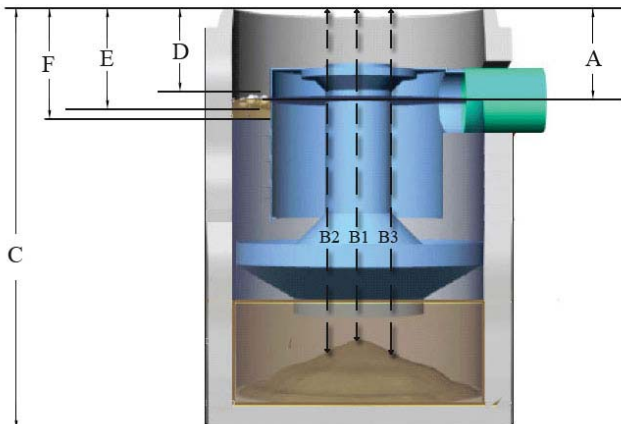
Schematic for Measurements: Downstream Defender®

- A: Distance from Water / Oil Surface to Top of Manhole Rim
- B1: Distance from Center of Sediment Surface to Top of Manhole Rim
- B2: Distance from Intermediate Location of Sediment Surface to Top of Manhole Rim
- B3: Distance from Intermediate Location of Sediment Surface to Top of Manhole Rim
- C: Distance from Bottom to Top of Manhole Rim
- D: Distance from Trash/Debris Surface to Top of Manhole Rim
- E: Distance from Trash/Debris Bottom to Top of Manhole Rim
- F: Distance from Bottom of Oil Layer to Top of Manhole Rim

A (ft)	8.4	Trash/Debris Area Coverage (%)	99%
B1 (ft)	12	D (ft)	12
B2 (ft)	12	E (ft)	12
B3 (ft)	12	Oil Area Coverage (%)	N/A
C (ft)	16.5	F (ft)	12

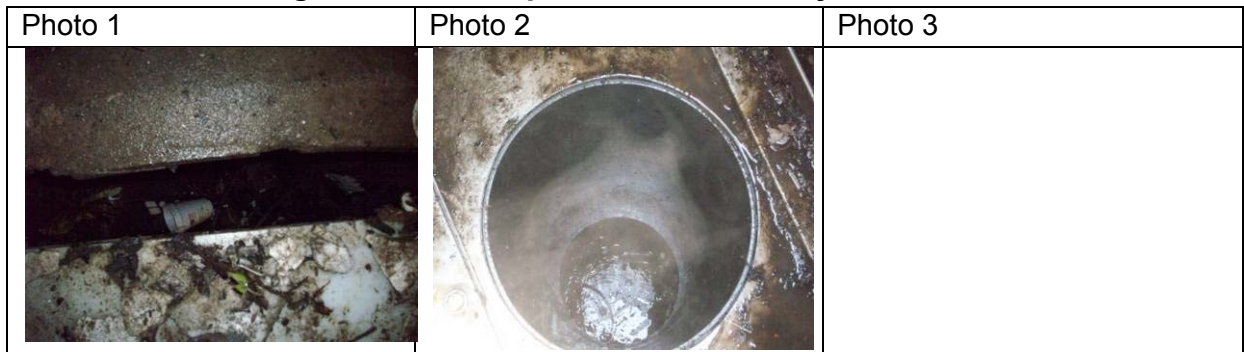
Photo Taken During Structural Inspection Immediately after Cleanout

Damaged coupler connecting the device to the drainage pipe.

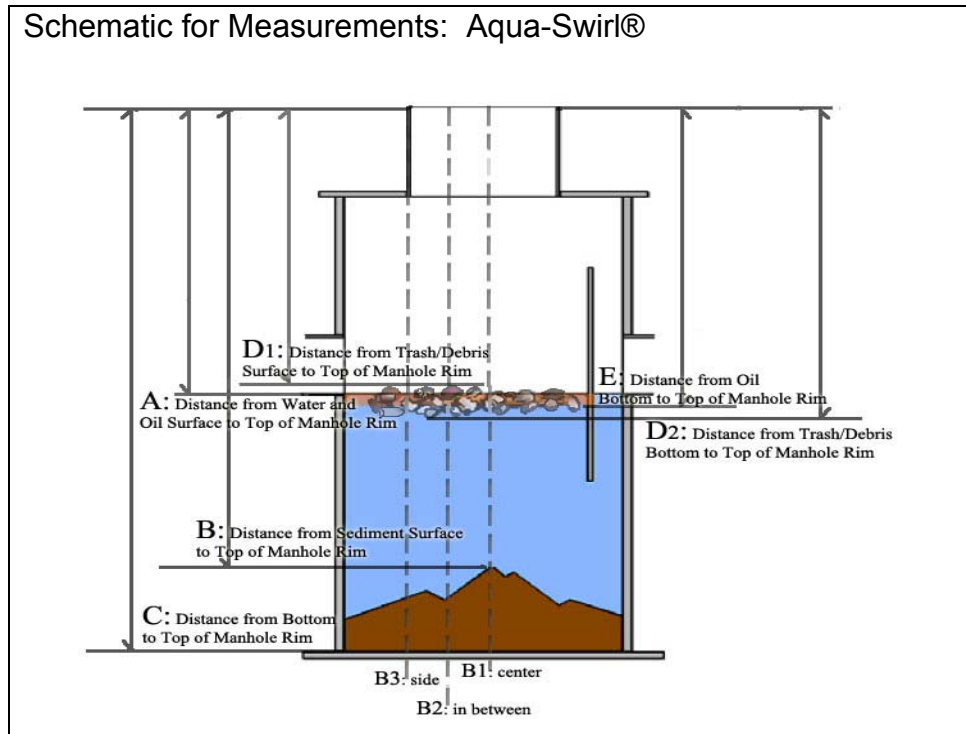
Measurements from Ground above the Device (Routine Inspection or Inspection Immediately before Cleanout)

Swirl Chamber					
A (ft)	B (ft)			C (ft)	
7	B1 [Center]	B2 [In Between]	B3 [Side]	12.3	
	8.5	8.5	8.4		
Trash/Debris Area Coverage (%)		D1(ft)	D2(ft)	Oil Area Coverage(%)	E(ft)
30		7	7	10	7
