Improving Transportation Infrastructure Resilience against Hurricanes, other Natural Disasters, and Weathering: Part III - Analysis of motor vehicle bridges failures due to Hurricane Maria

FINAL REPORT
August 2022

Transportation Infrastructure Research Center – TIRC
Polytechnic University of Puerto Rico
377 Ponce de Leon Ave, San Juan, PR 00918

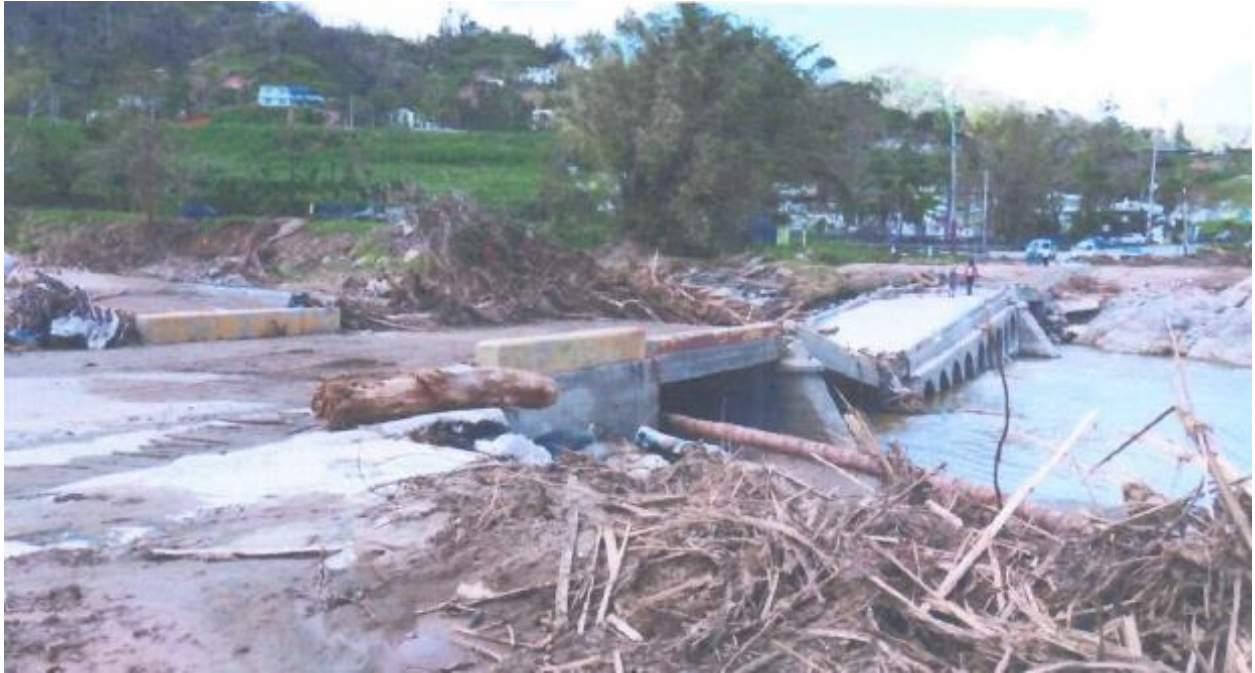
Figure 2-12: Bridge 505 photo from October 4, 2017 inspection (source: FHWA)

COMMENTS: The bridge was failed.

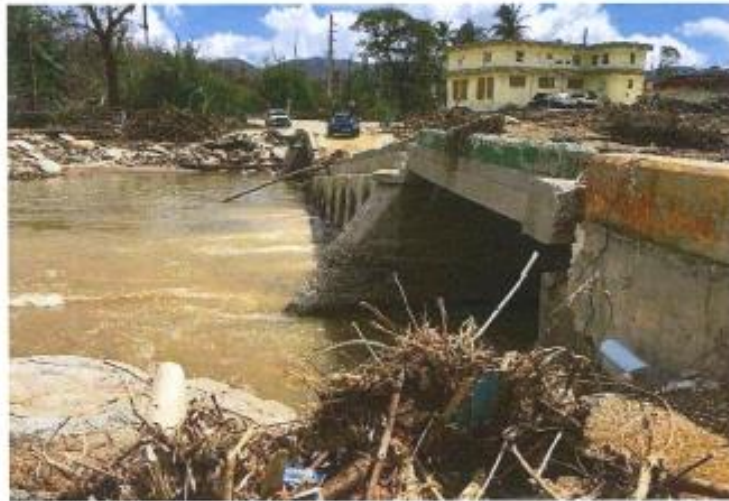
Figure 2-16: Bridge 505 photos from October 12, 2017 inspection (source: PRHTA)

Collapsed Low Bridge from North Abutment Downstream

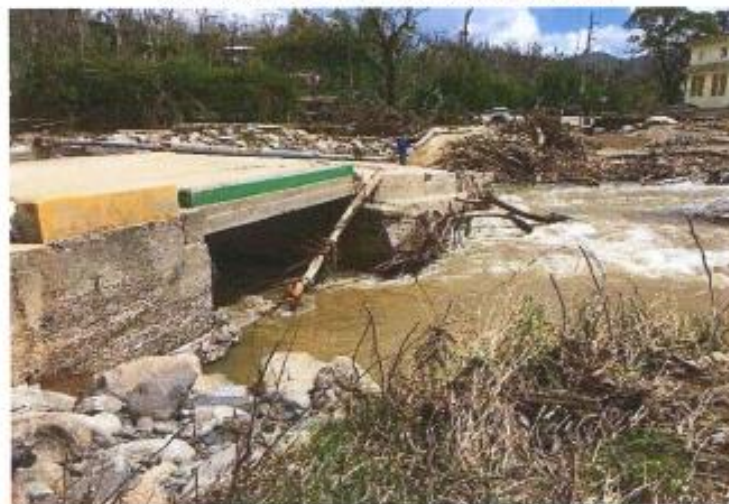
Collapsed Low Bridge from North Abutment Upstream

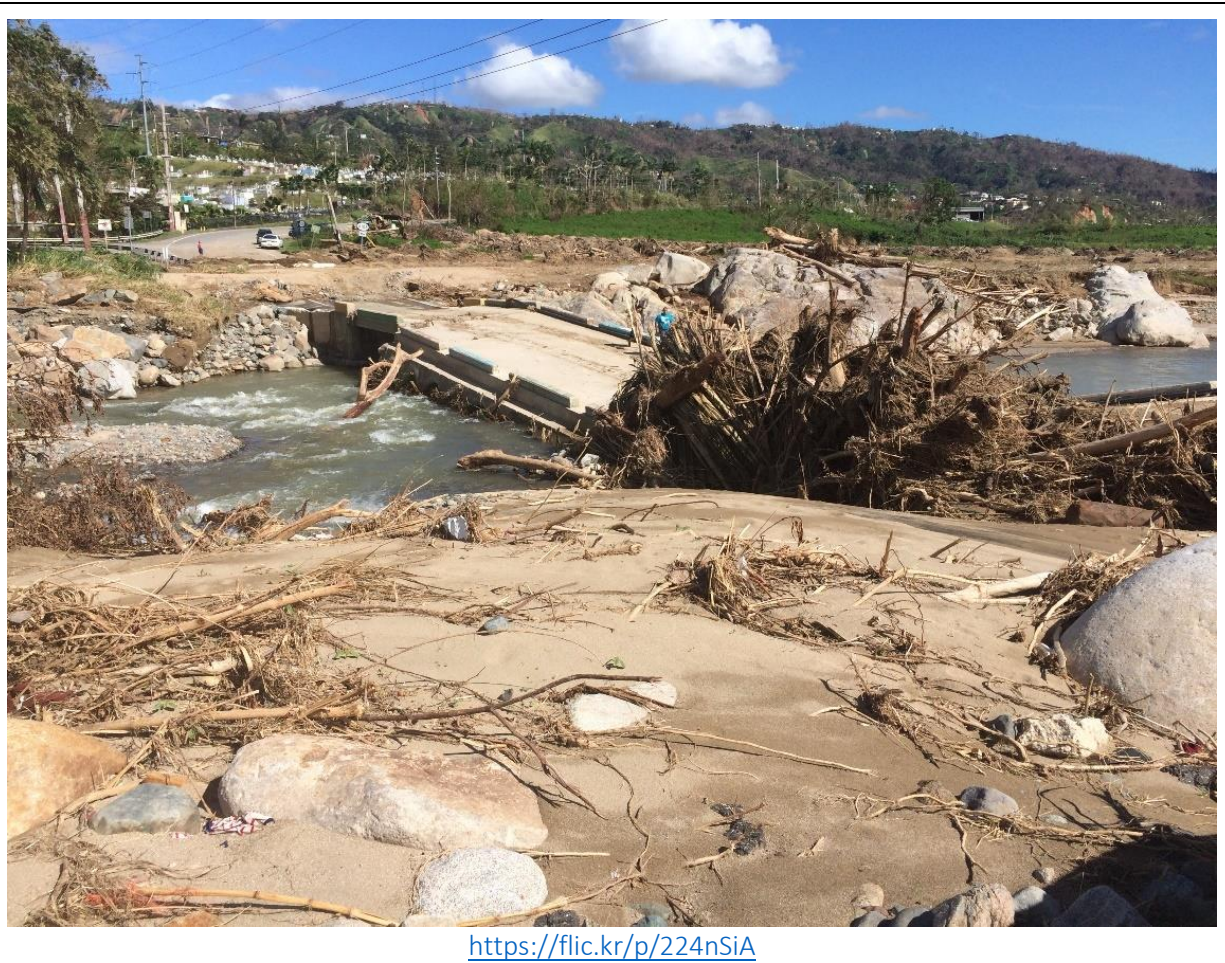
Figure 2-19: Social media image of collapsed Bridge 505 (source: Julia Maldonado)

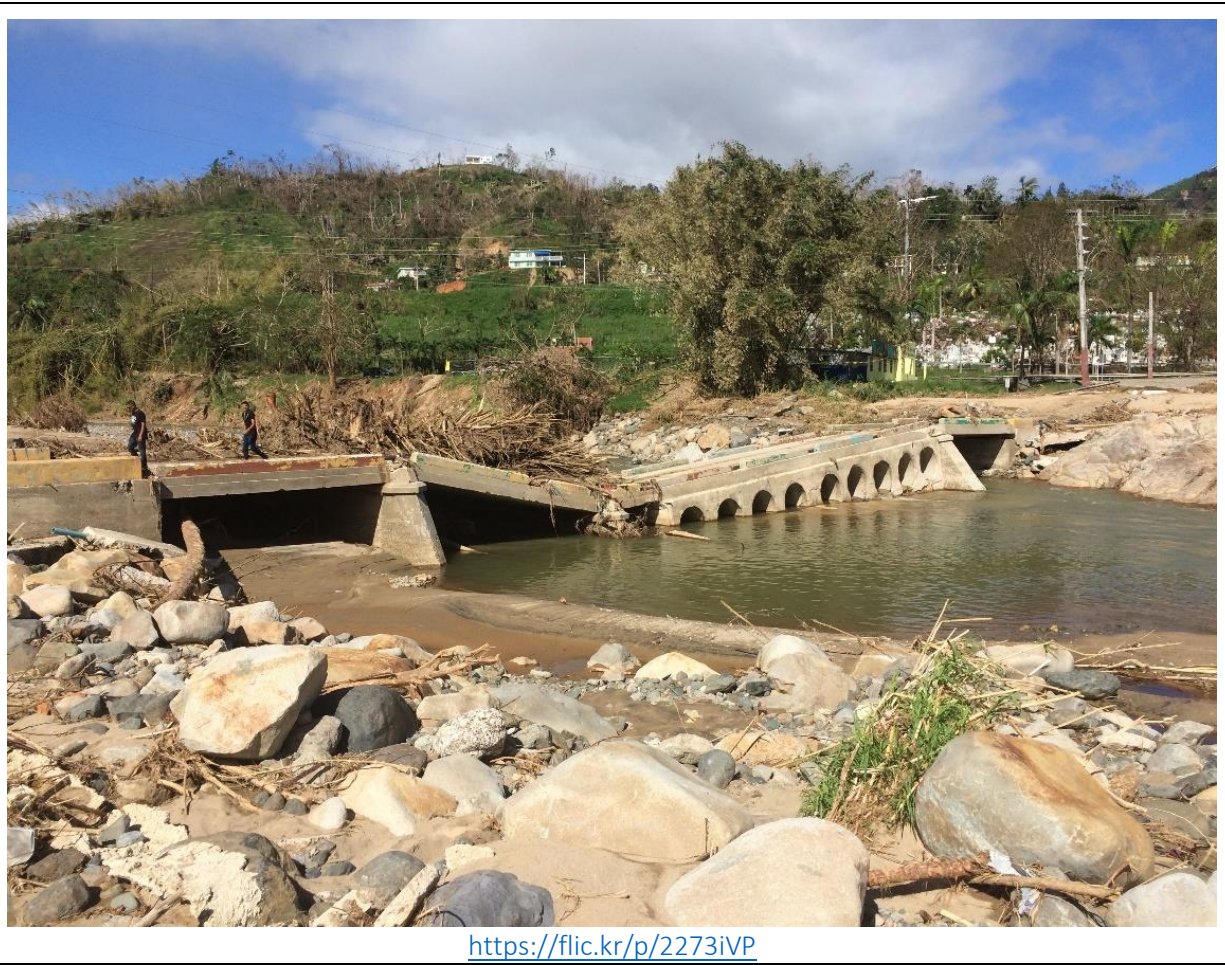
Figure 2-20: Social media image of collapsed Bridge 505 (source: Julia Maldonado)

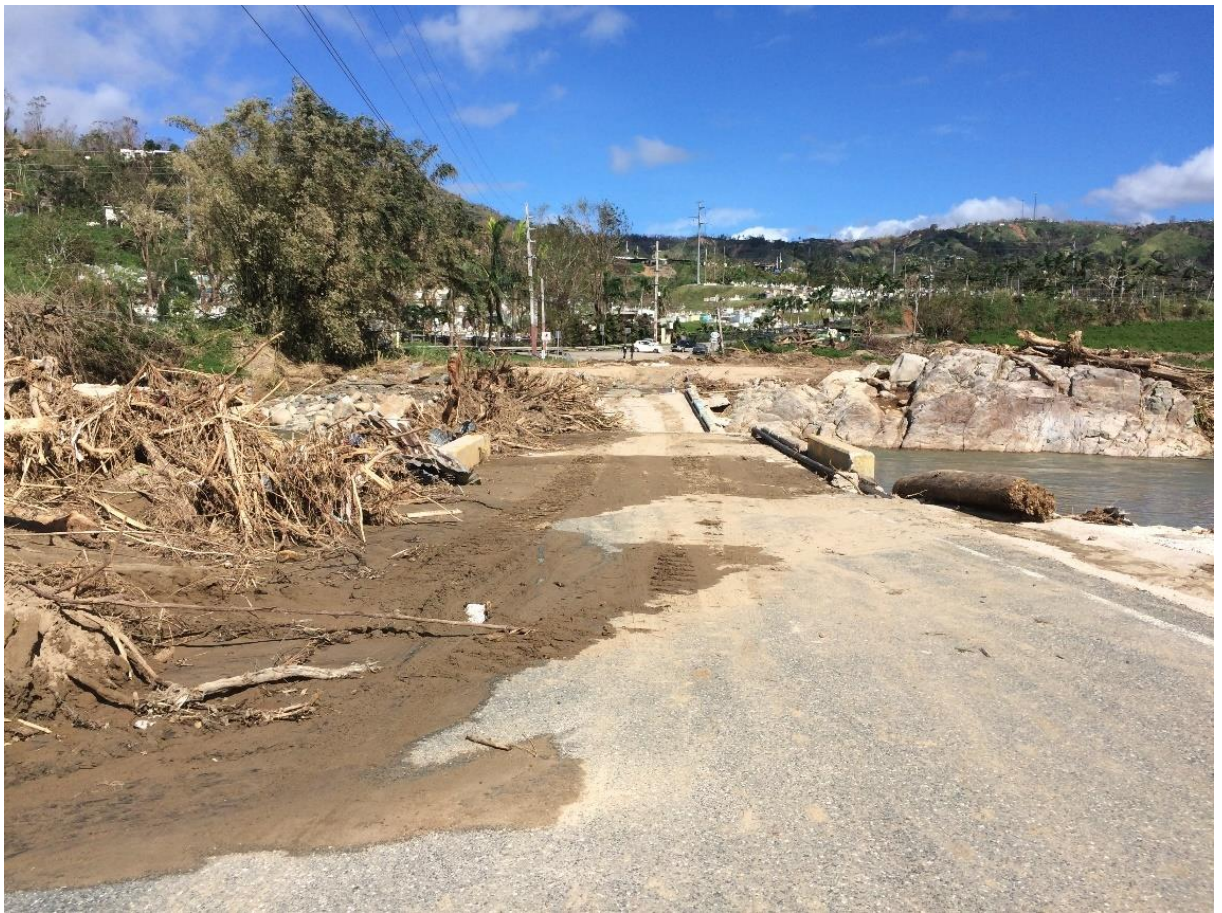
Figure 2-21: Social media image of collapsed Bridge 505 (source: Julia Maldonado)

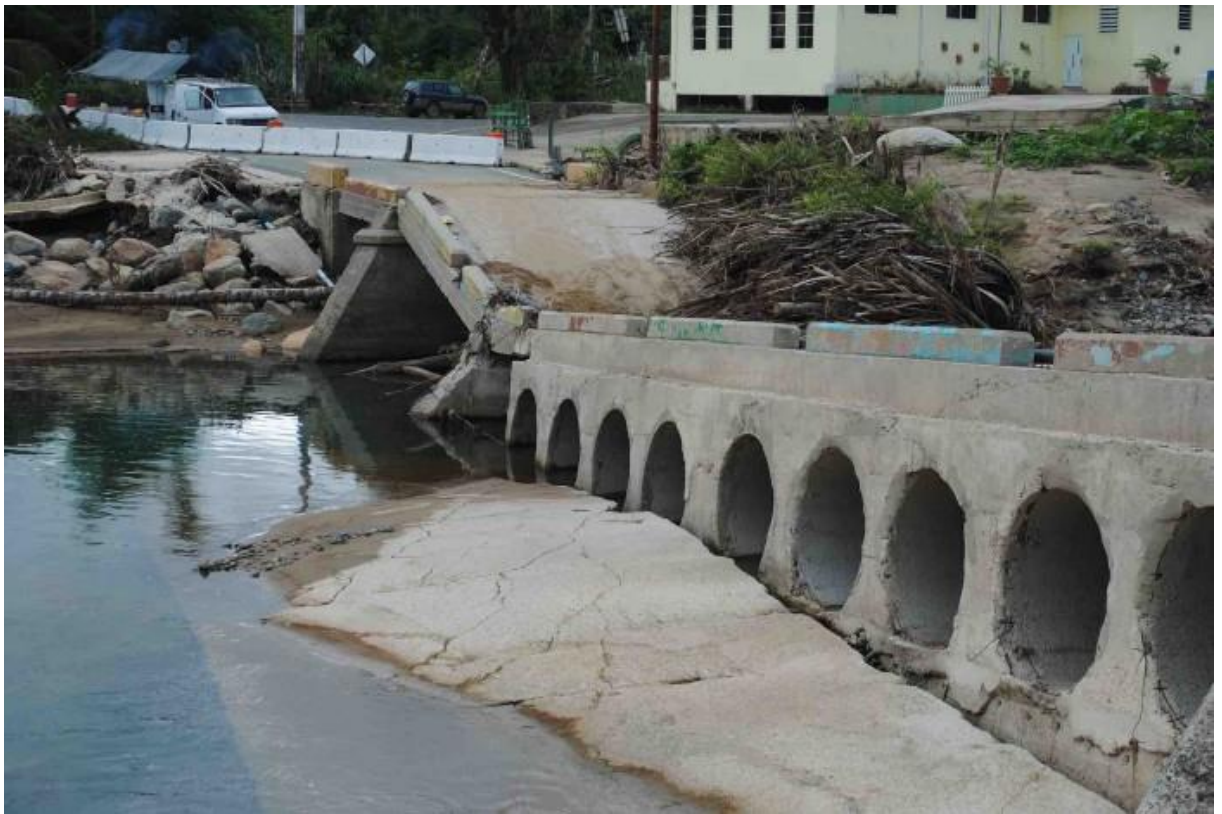
Figure 2-22: Social media image of collapsed Bridge 505 (source: Robert L. Read)

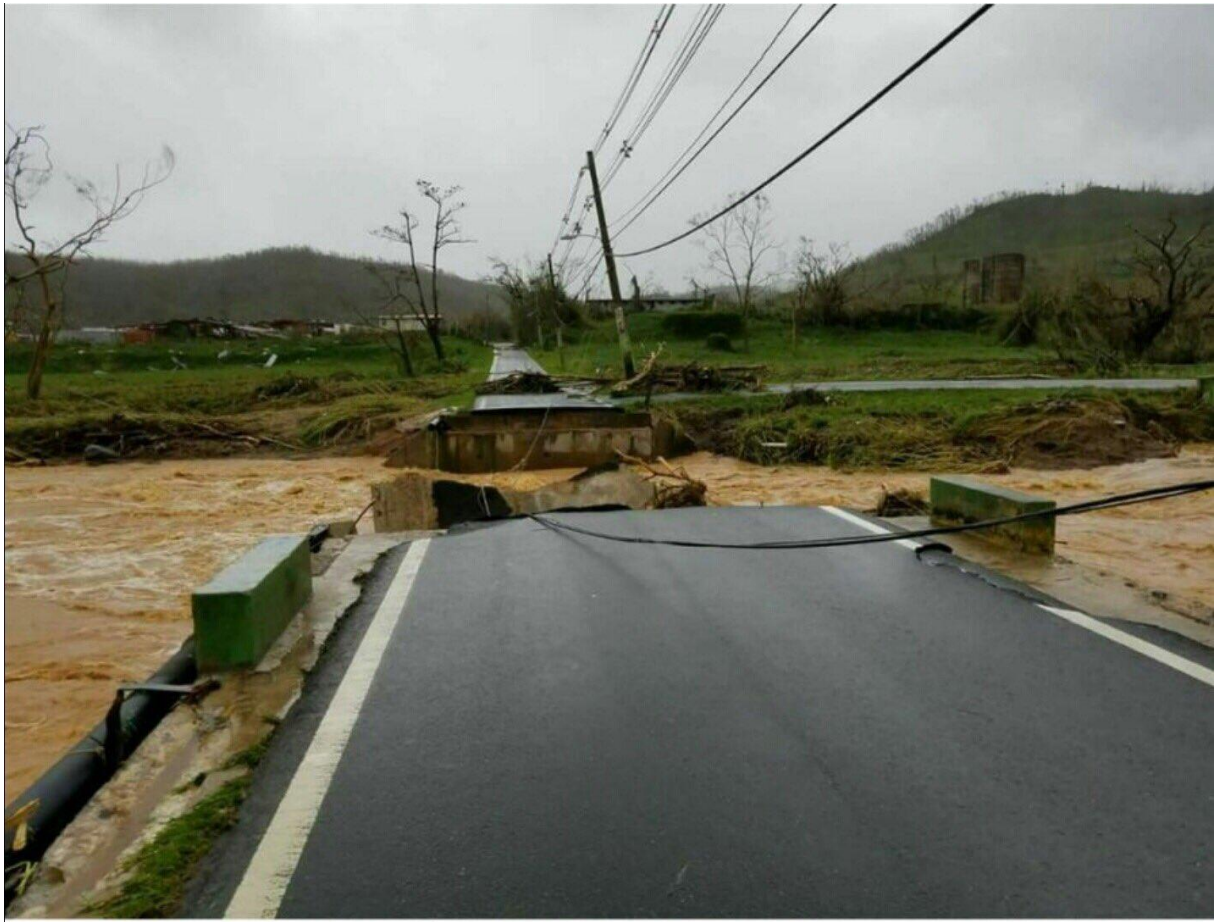
Figure 2-39: Social media image of collapsed Bridge 653 (source: L. Anqueira)

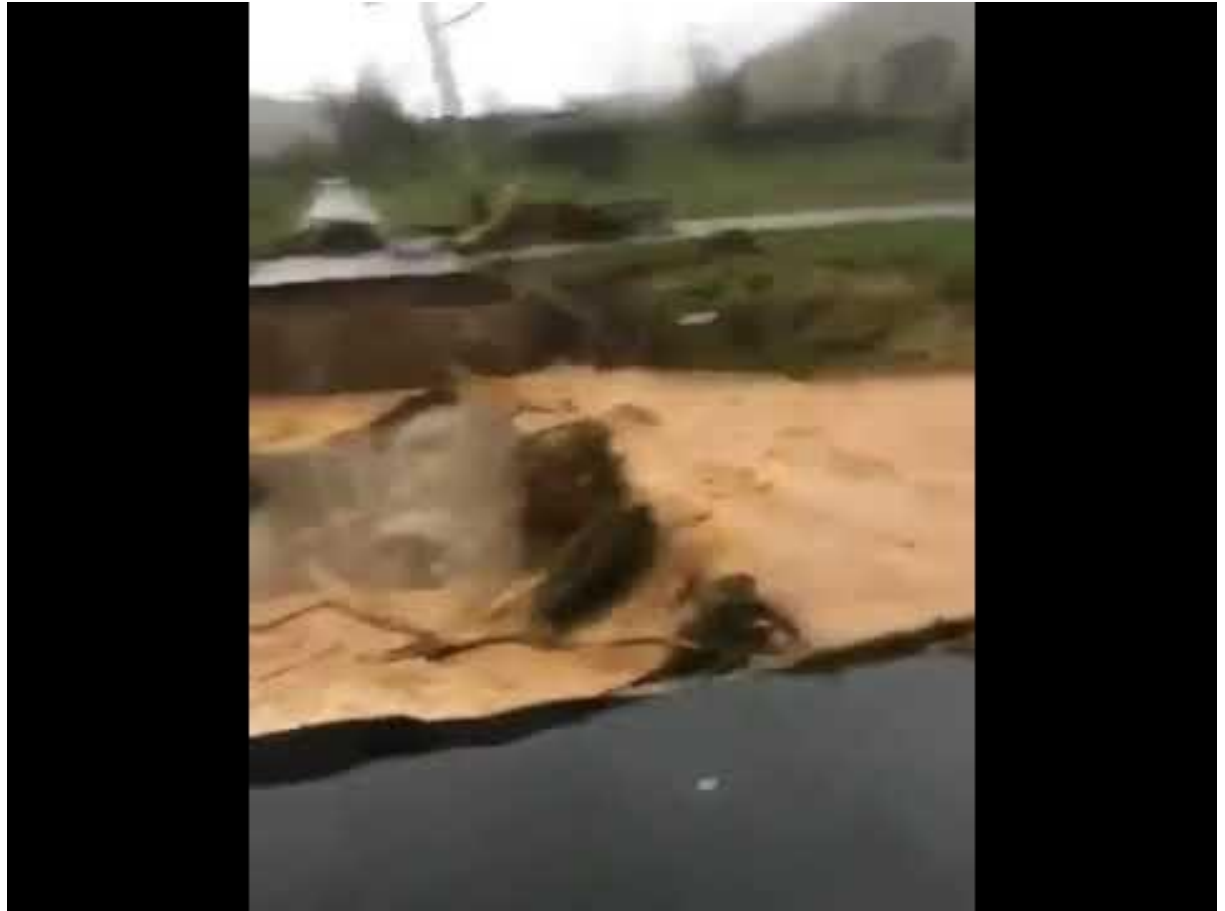
Video 2-1: Social media video of collapsed Bridge 653 (source: Love Me)

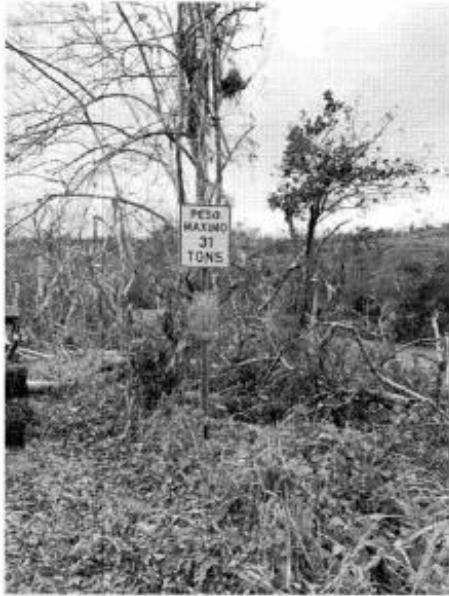
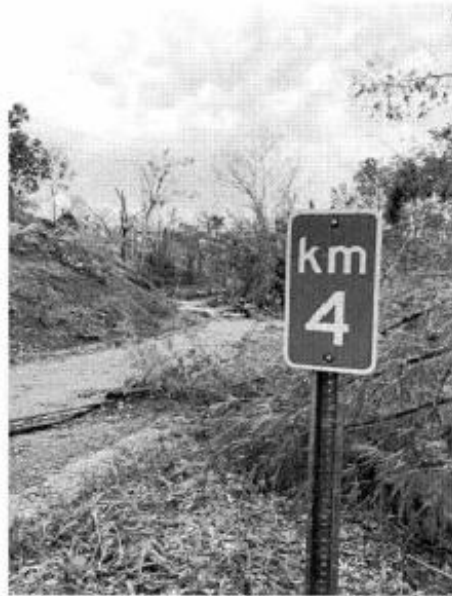
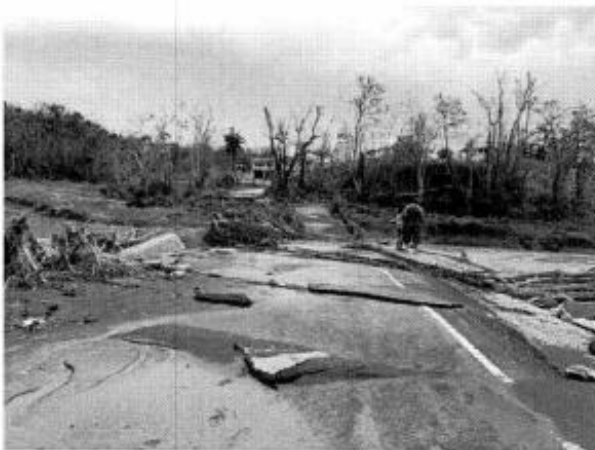
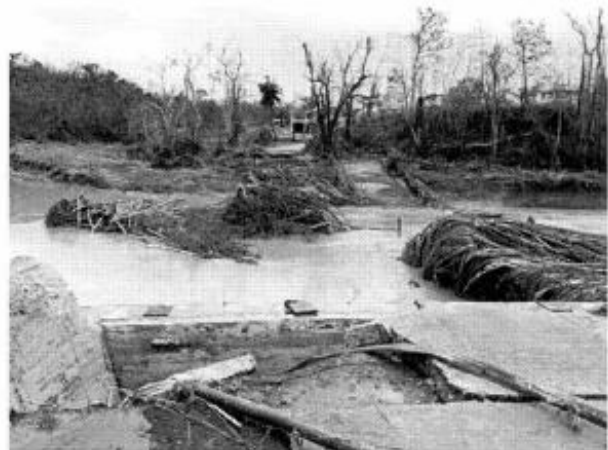
Figure 2-53: Bridge 679 photos from September 22, 2017 inspection (source: PRHTA)

COMMENTS: <u>Cerrado - Puente colapsó (4 spans)</u>		
INCLUDE PHOTOS IN A SEPARATE SHEET

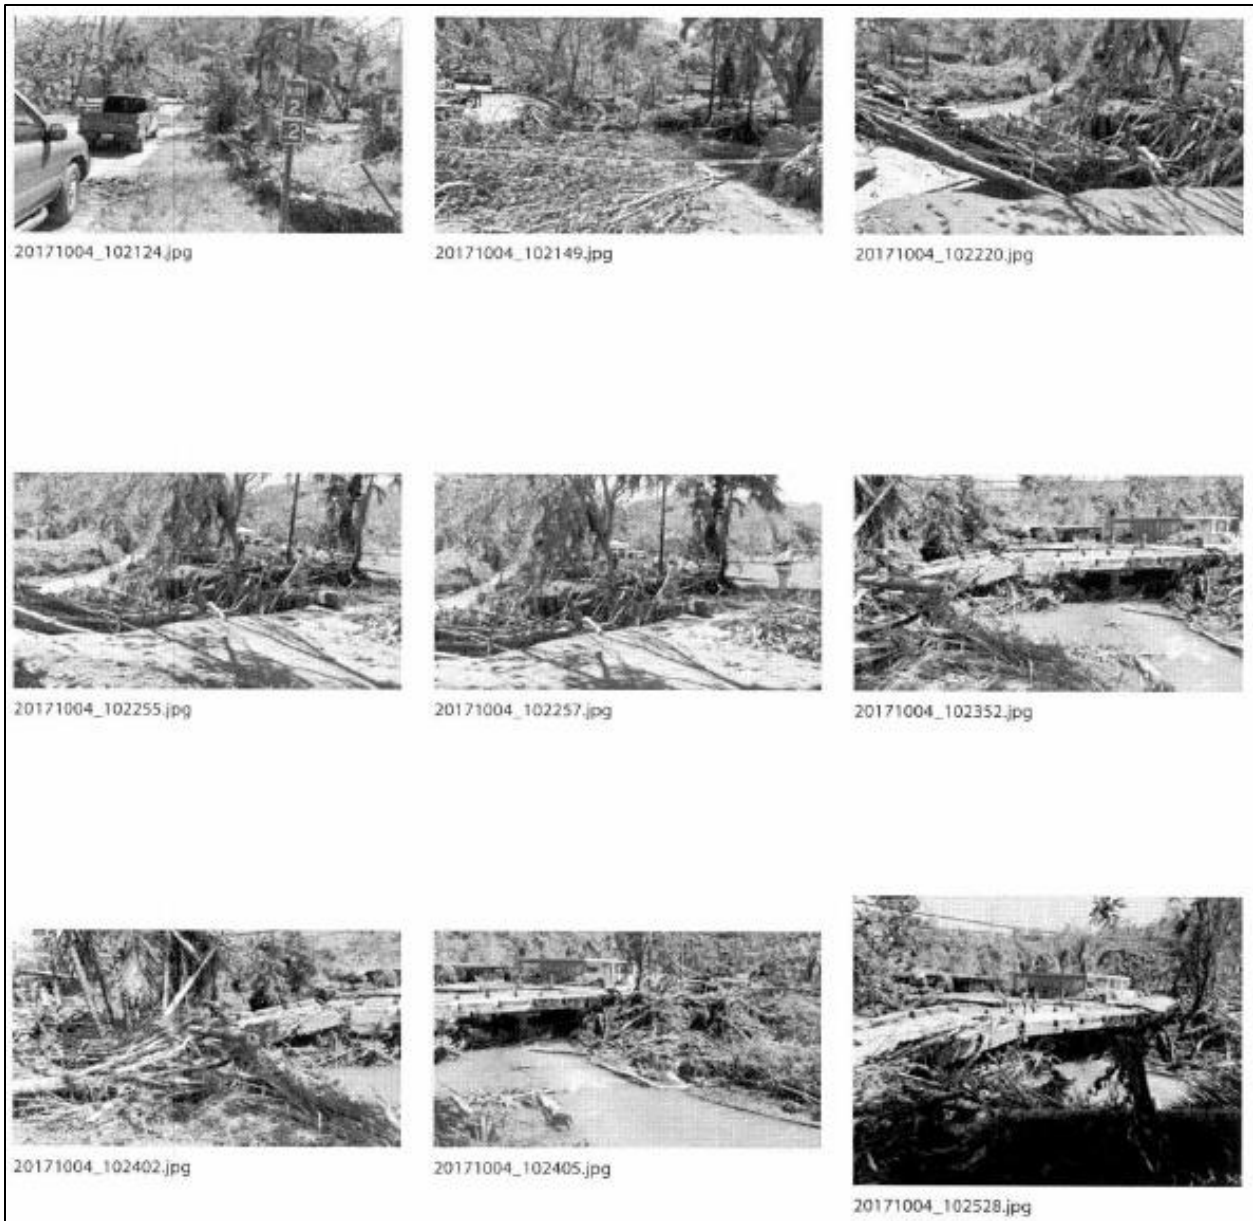
Figure 2-71: Bridge 769 photos from October 4, 2017 inspection (source: PRHTA)

COMMENTS: <u>Extensión colapso, Abutment y terminal colapsan</u>		
_____ INCLUDE PHOTOS IN A SEPARATE SHEET

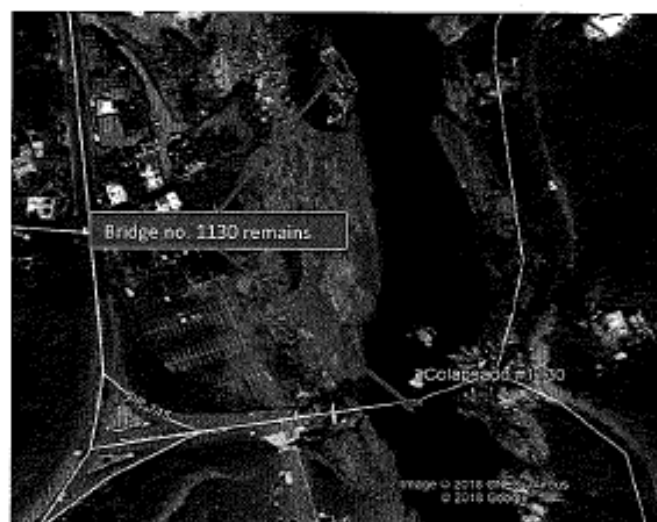
Figure 2. Bridge no. 1130 after Hurricane Maria

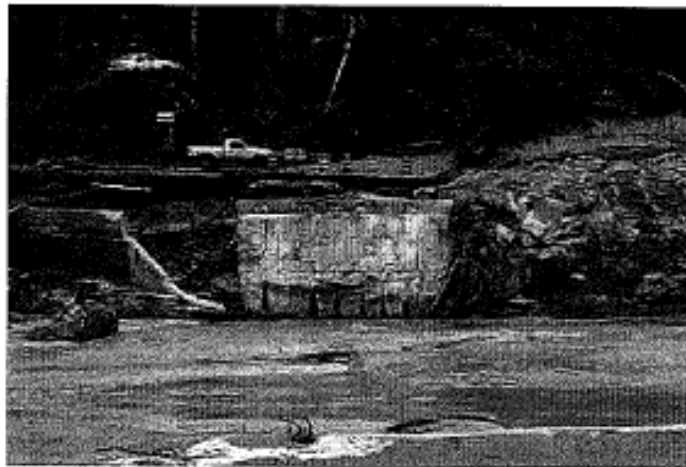
Figure 4. Remains of East Abutment

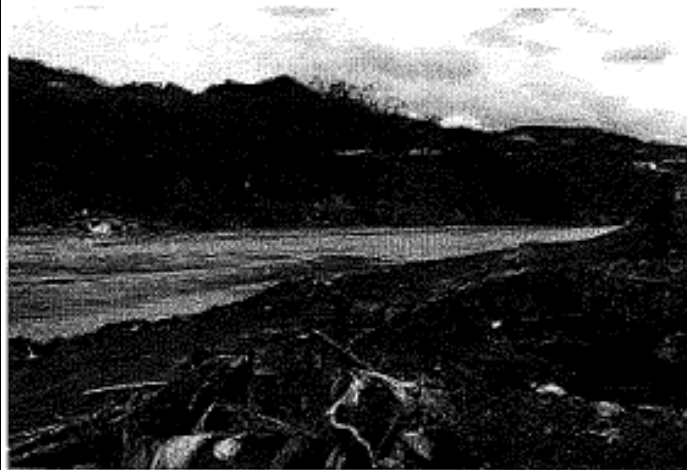
Figure 5. Upstream View

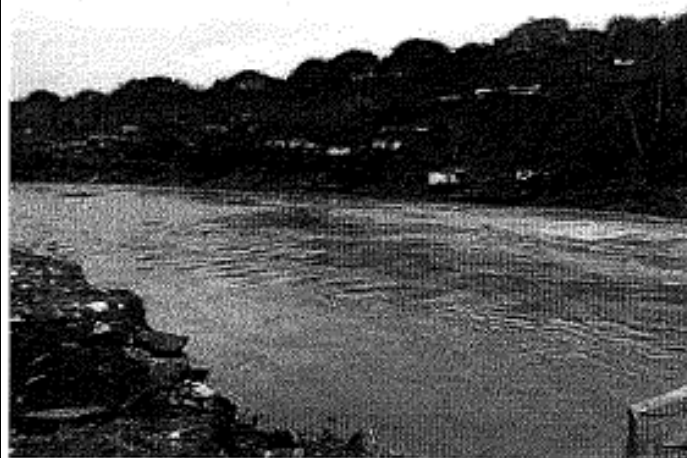
Figure 6. Downstream View

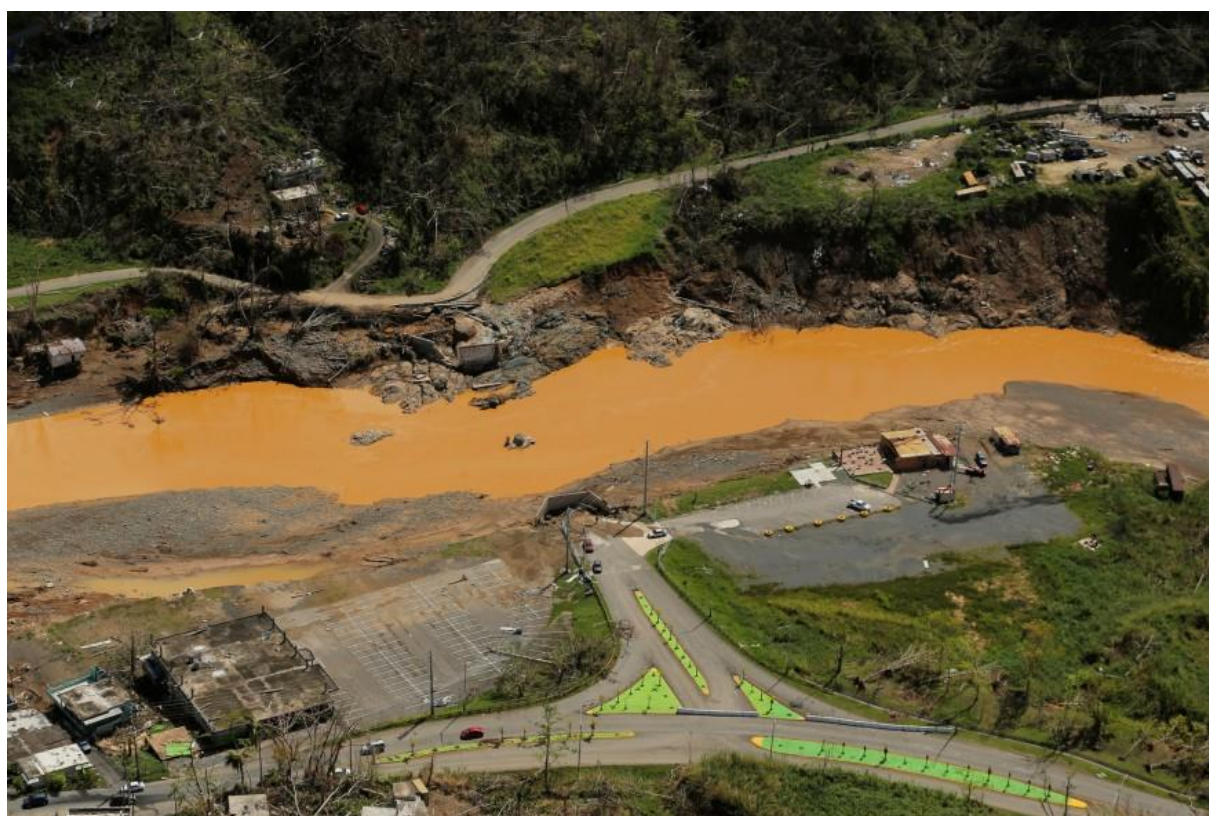
Figure 2-113: Aerial image of collapsed Bridge 1130 (source: NY Post)

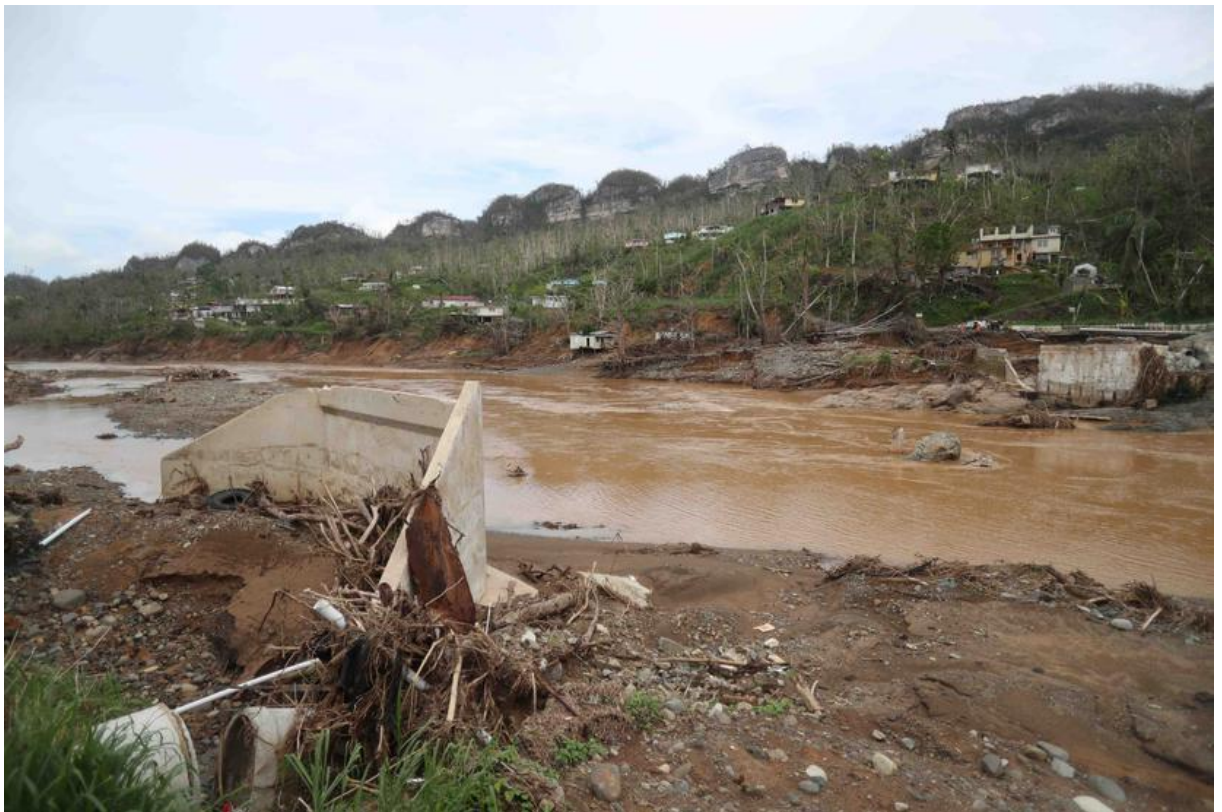
Figure 2-114: News outlet image of collapsed Bridge 1130 (source: El Nuevo Día)

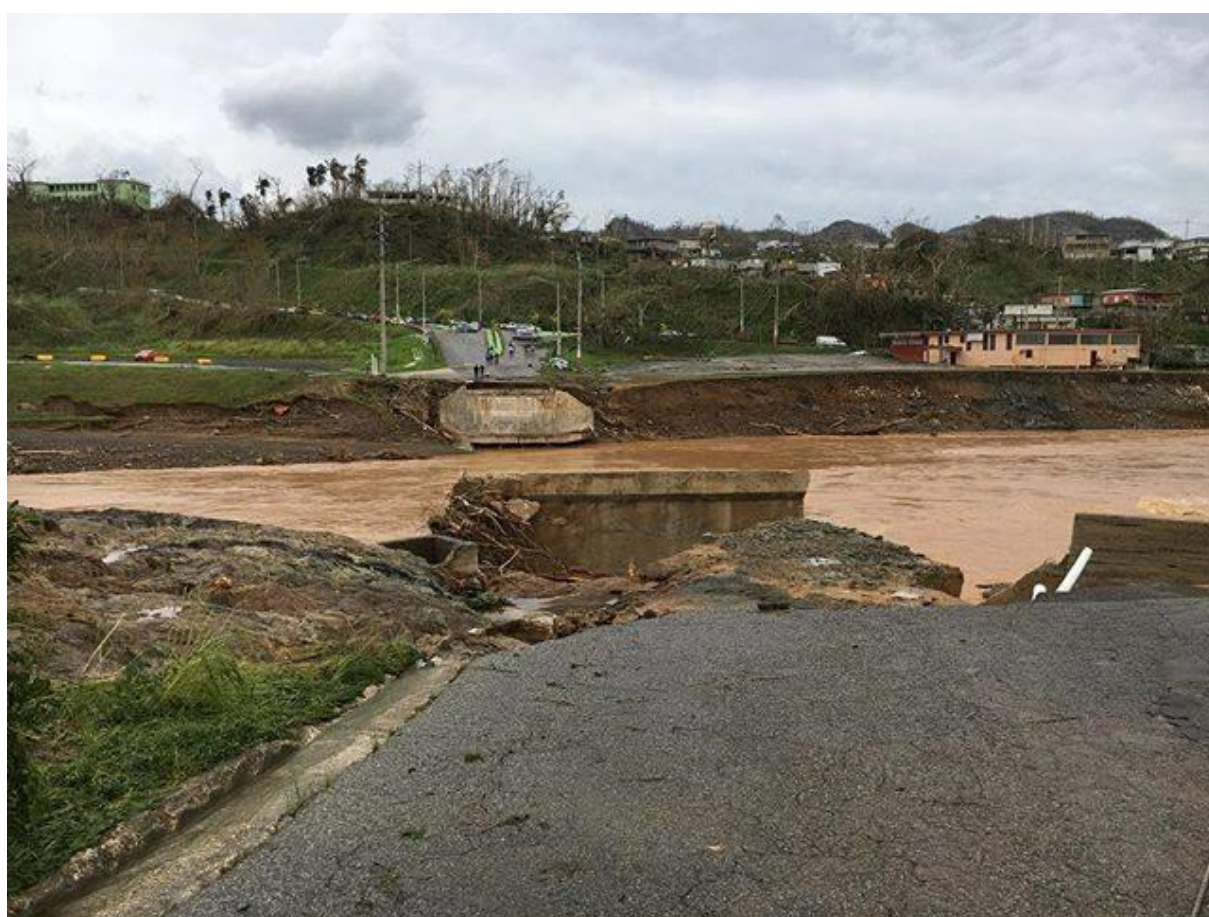
Figure 2-115: Social media image of collapsed Bridge 1130 (source: Jay Fonseca)

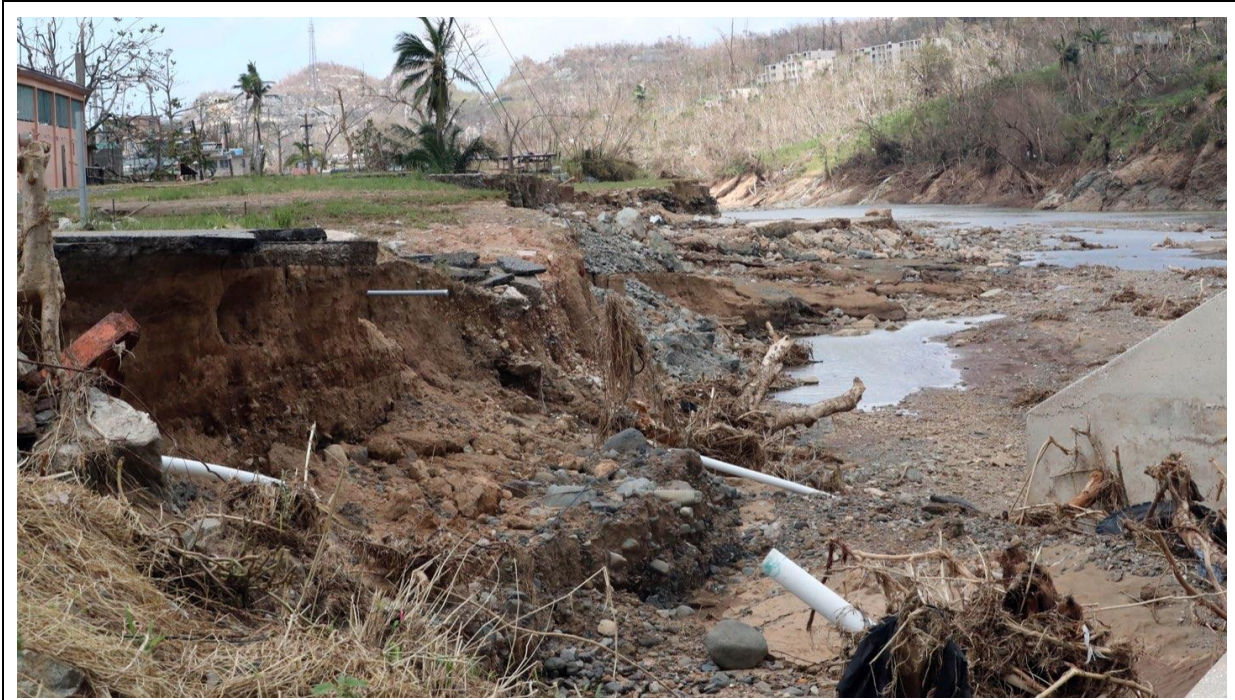
Figure 2-116: News outlet image of collapsed Bridge 1130 (source: El Nuevo Día)

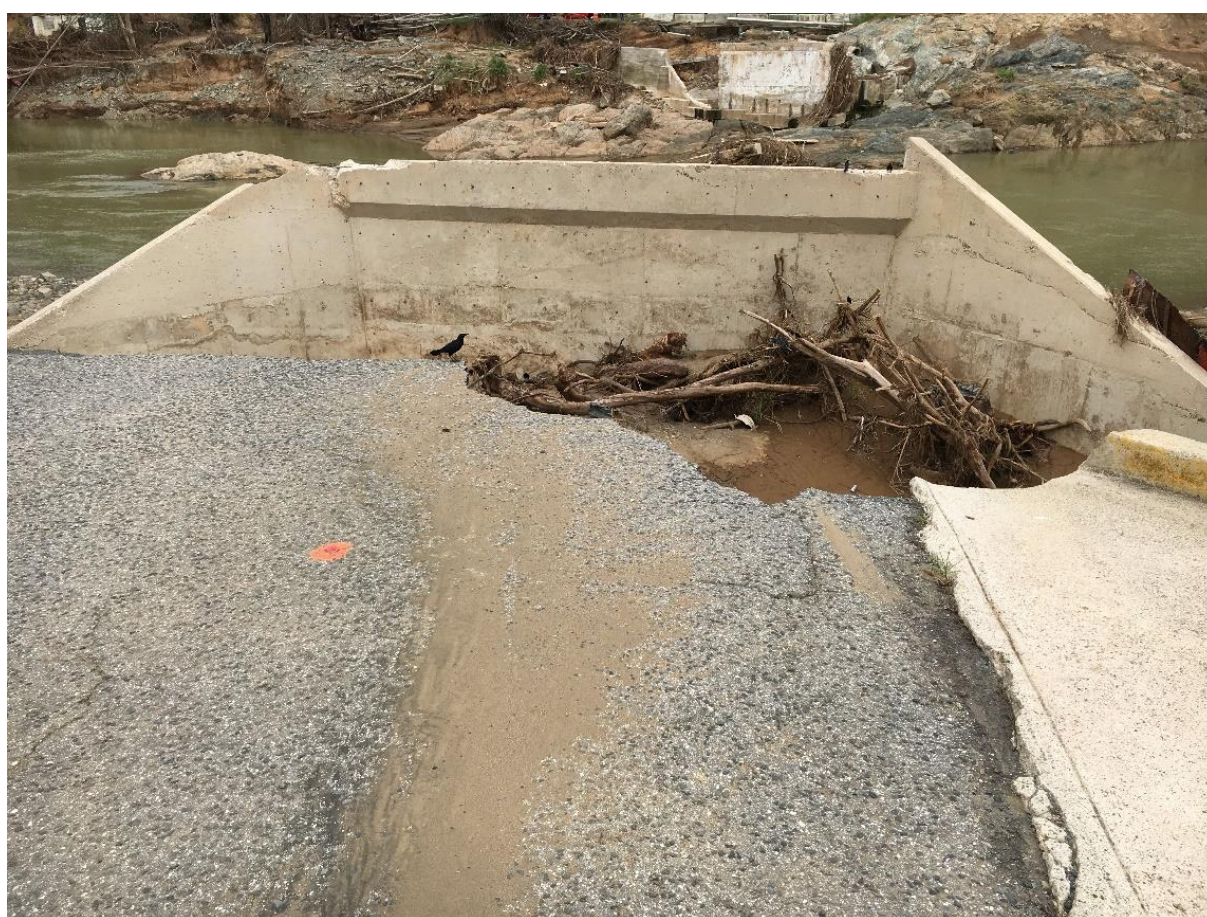
Figure 2-117: Social media image of collapsed Bridge 1130 (source: Julia Maldonado)

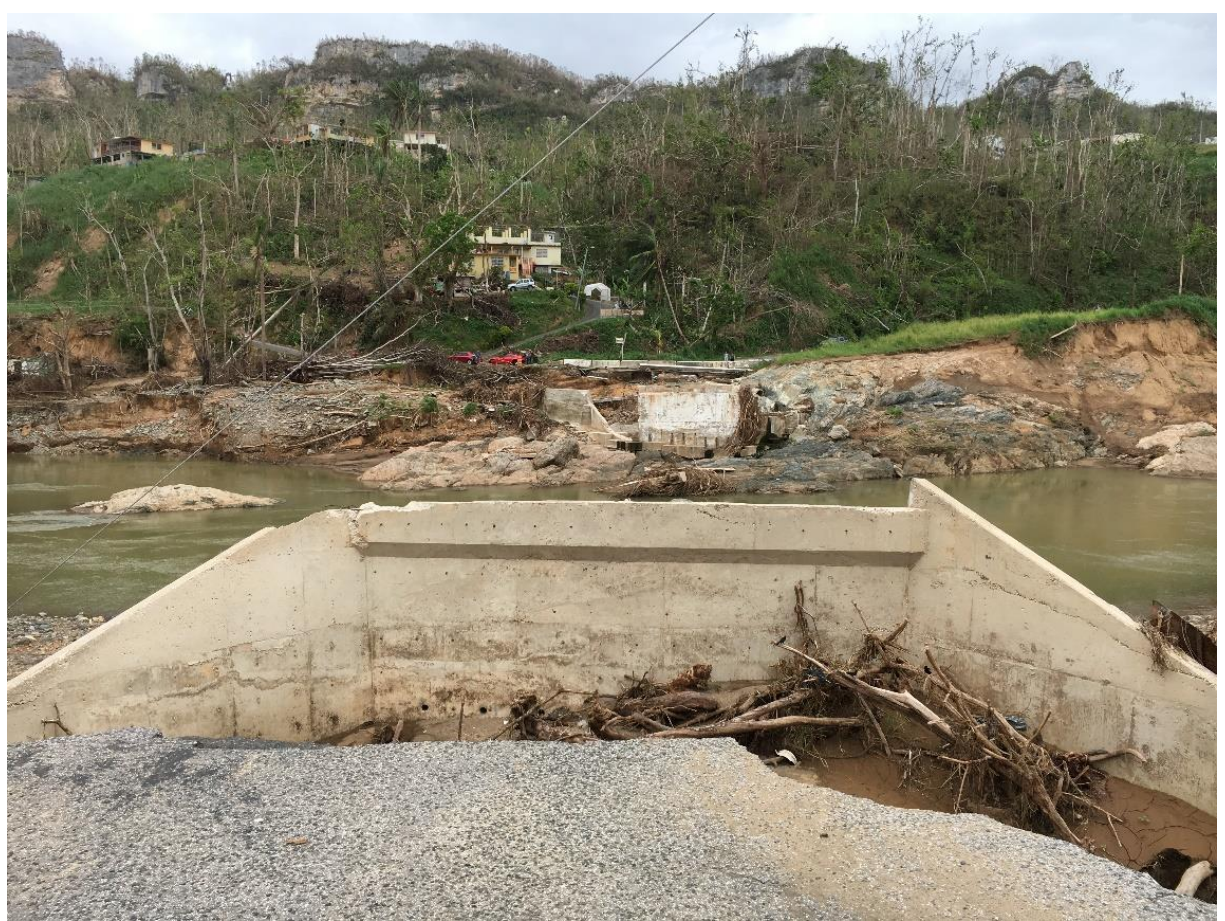
Figure 2-118: Social media image of collapsed Bridge 1130 (source: Julia Maldonado)

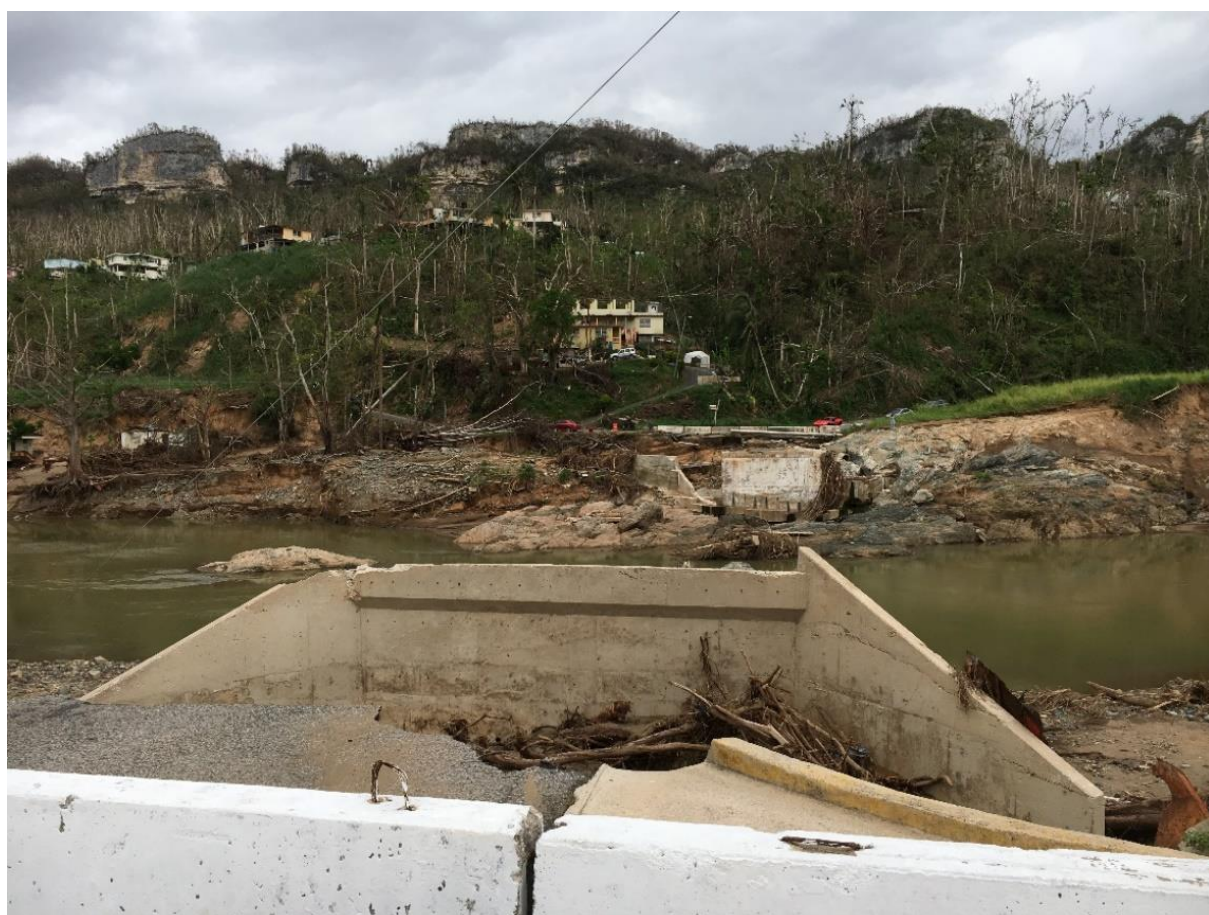
Figure 2-119: Social media image of collapsed Bridge 1130 (source: Julia Maldonado)

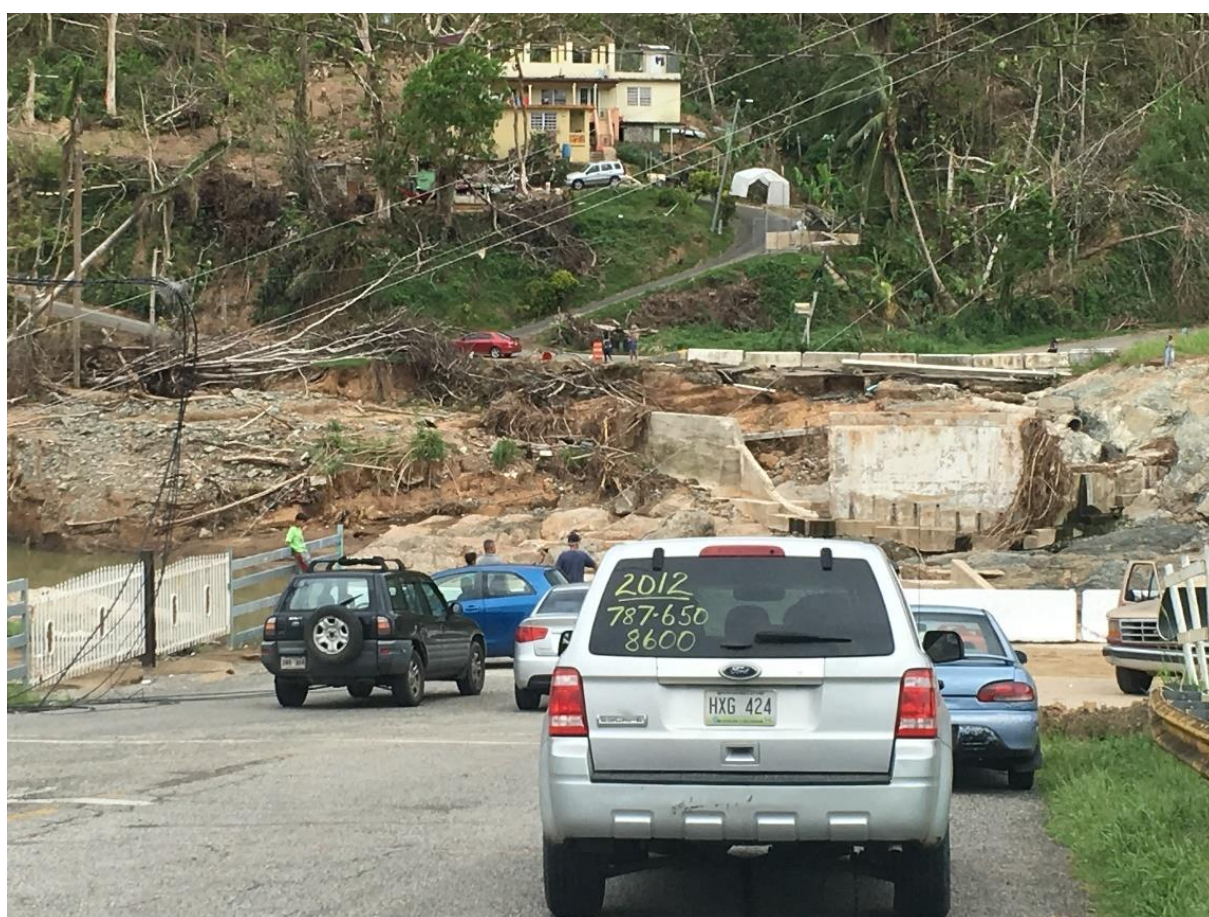
Figure 2-120: Social media image of collapsed Bridge 1130 (source: Julia Maldonado)

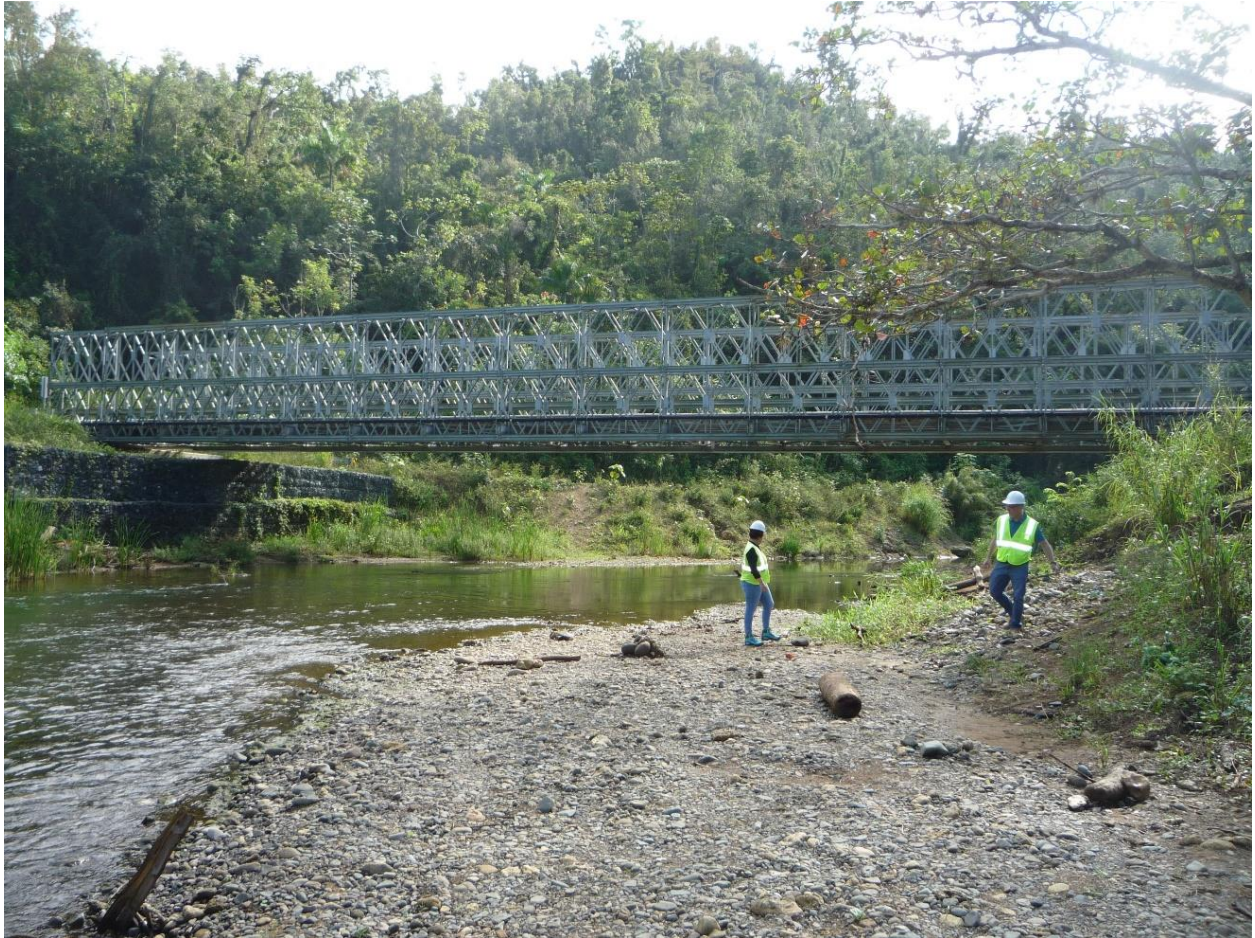
Figure 2-143: Bridge 1199 replacement (source: PRHTA)
