Improving Transportation Infrastructure Resilience against Hurricanes, other Natural Disasters, and Weathering: Part III - Analysis of motor vehicle bridges failures due to Hurricane Maria

FINAL REPORT
August 2022

Transportation Infrastructure Research Center – TIRC
Polytechnic University of Puerto Rico
377 Ponce de Leon Ave, San Juan, PR 00918

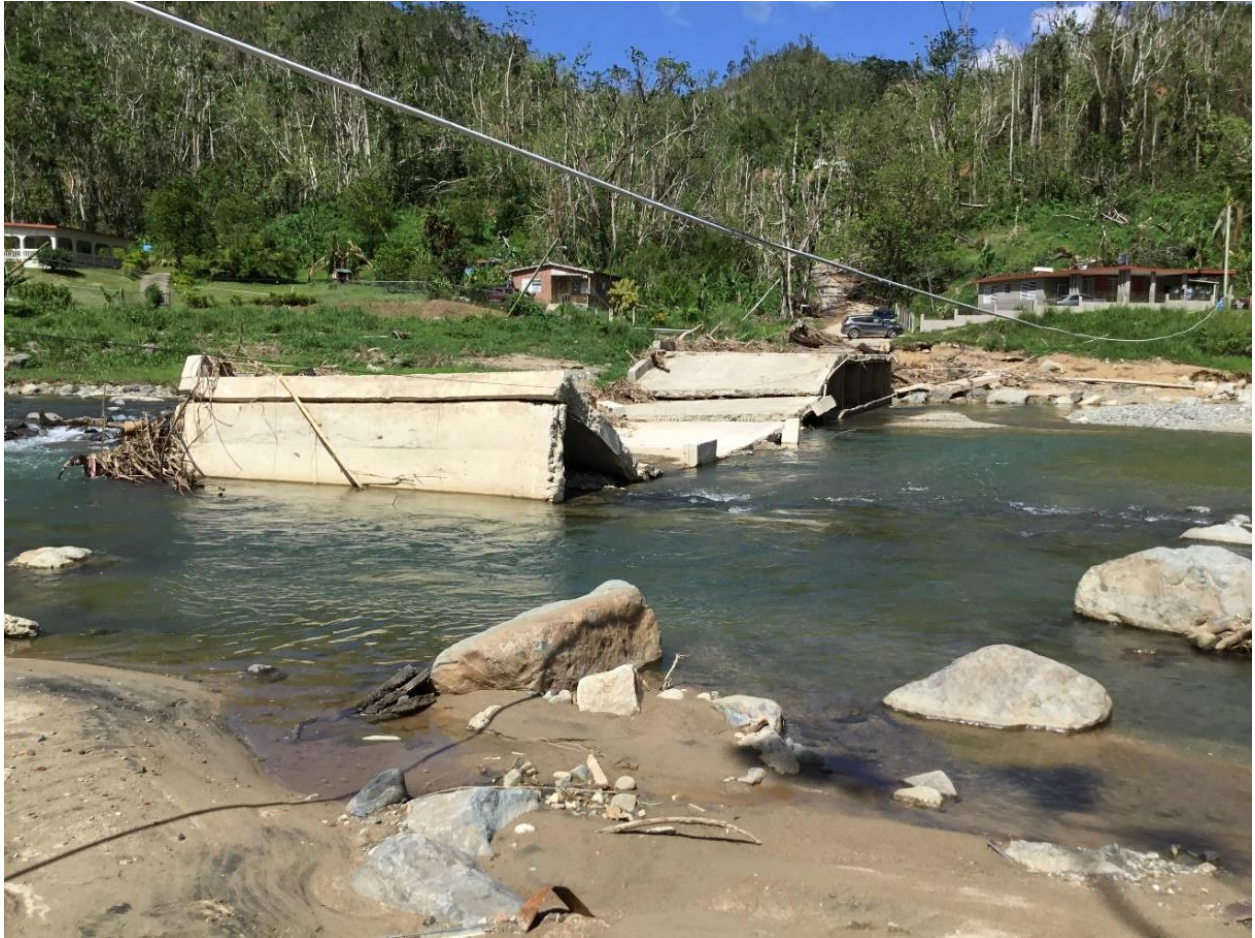
Figure 2-159: Image of collapsed Bridge 1355 (source: FHWA)

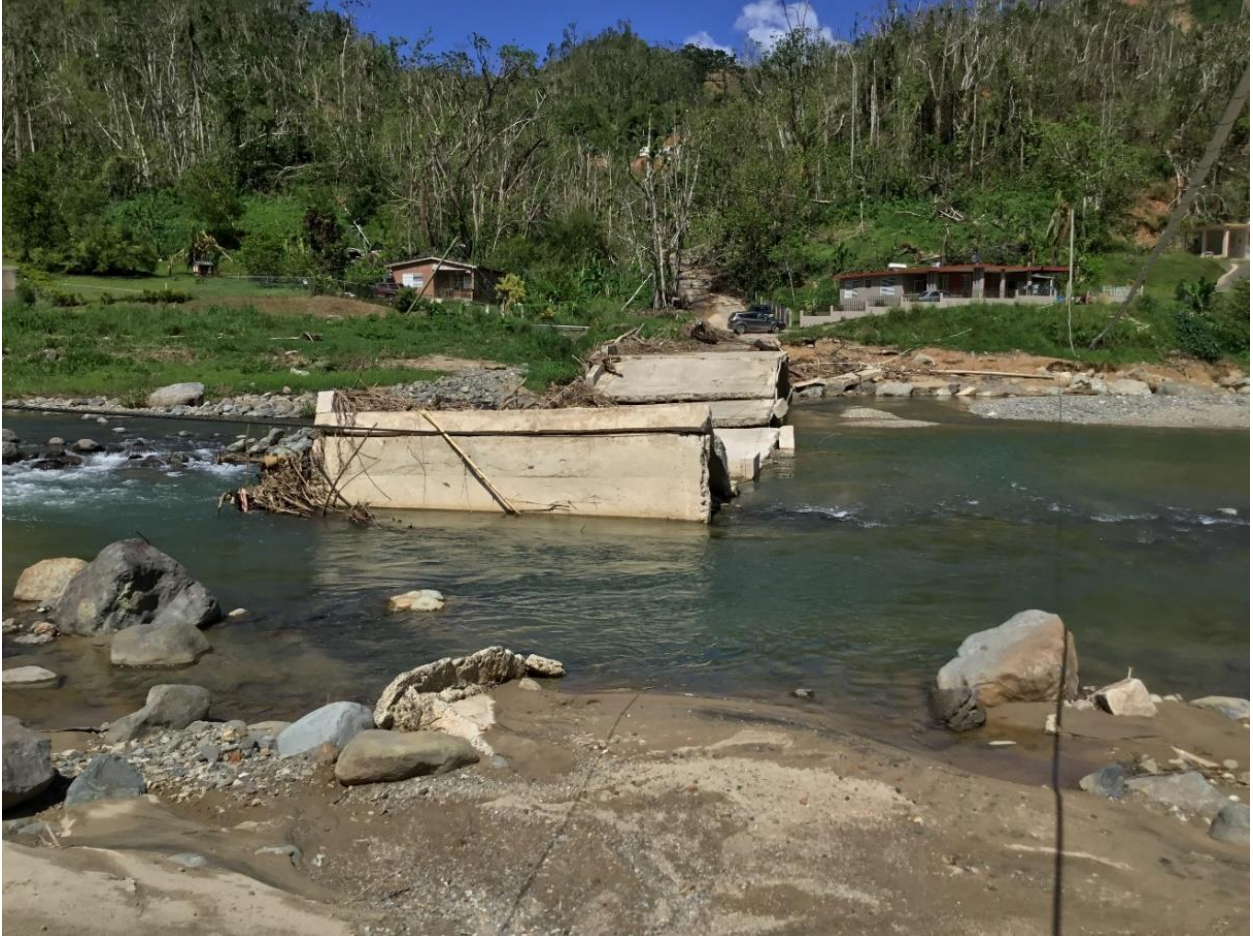
Figure 2-160: Image of collapsed Bridge 1355 (source: FHWA)

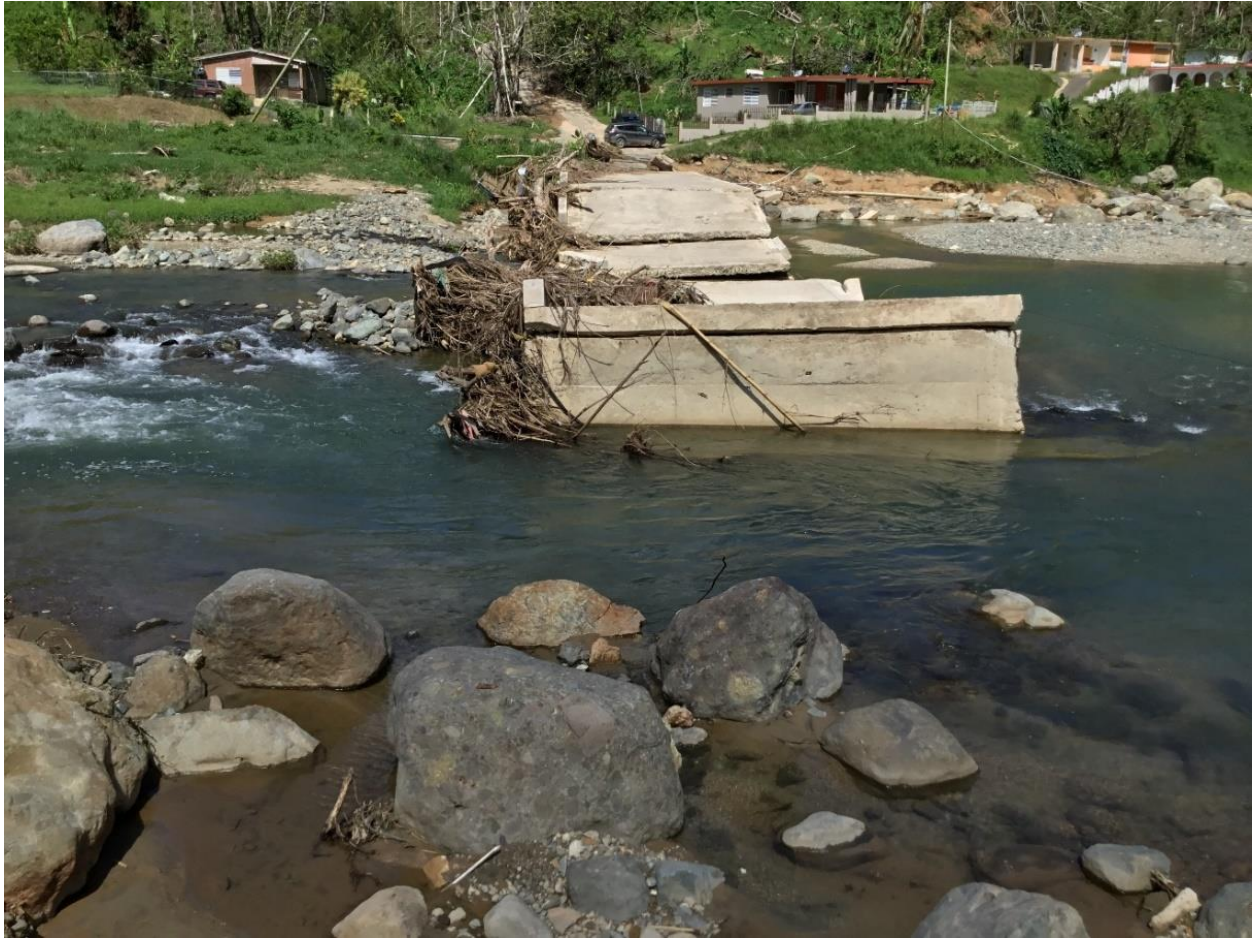
Figure 2-161: Image of collapsed Bridge 1355 (source: FHWA)

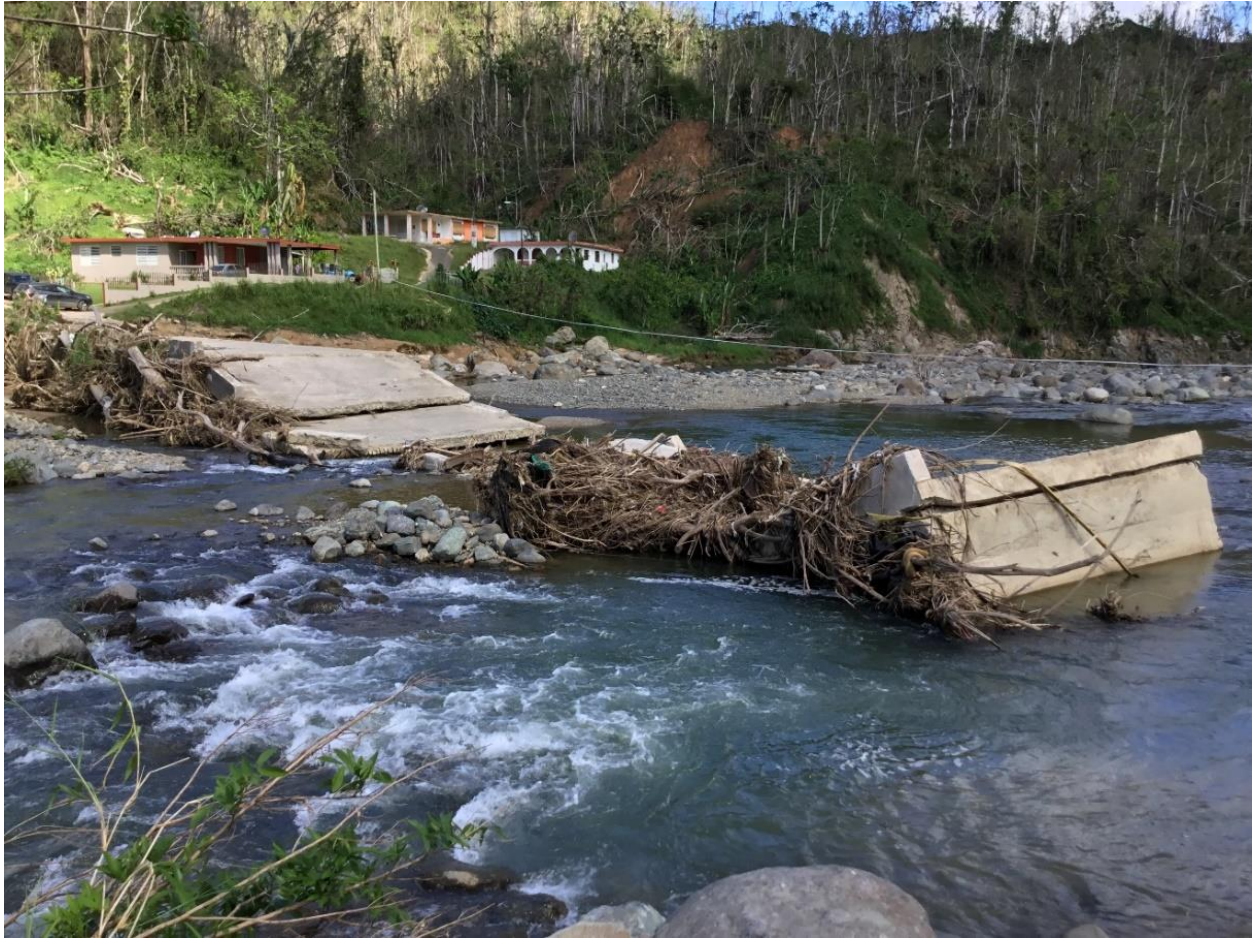
Figure 2-162: Image of collapsed Bridge 1355 (source: FHWA)

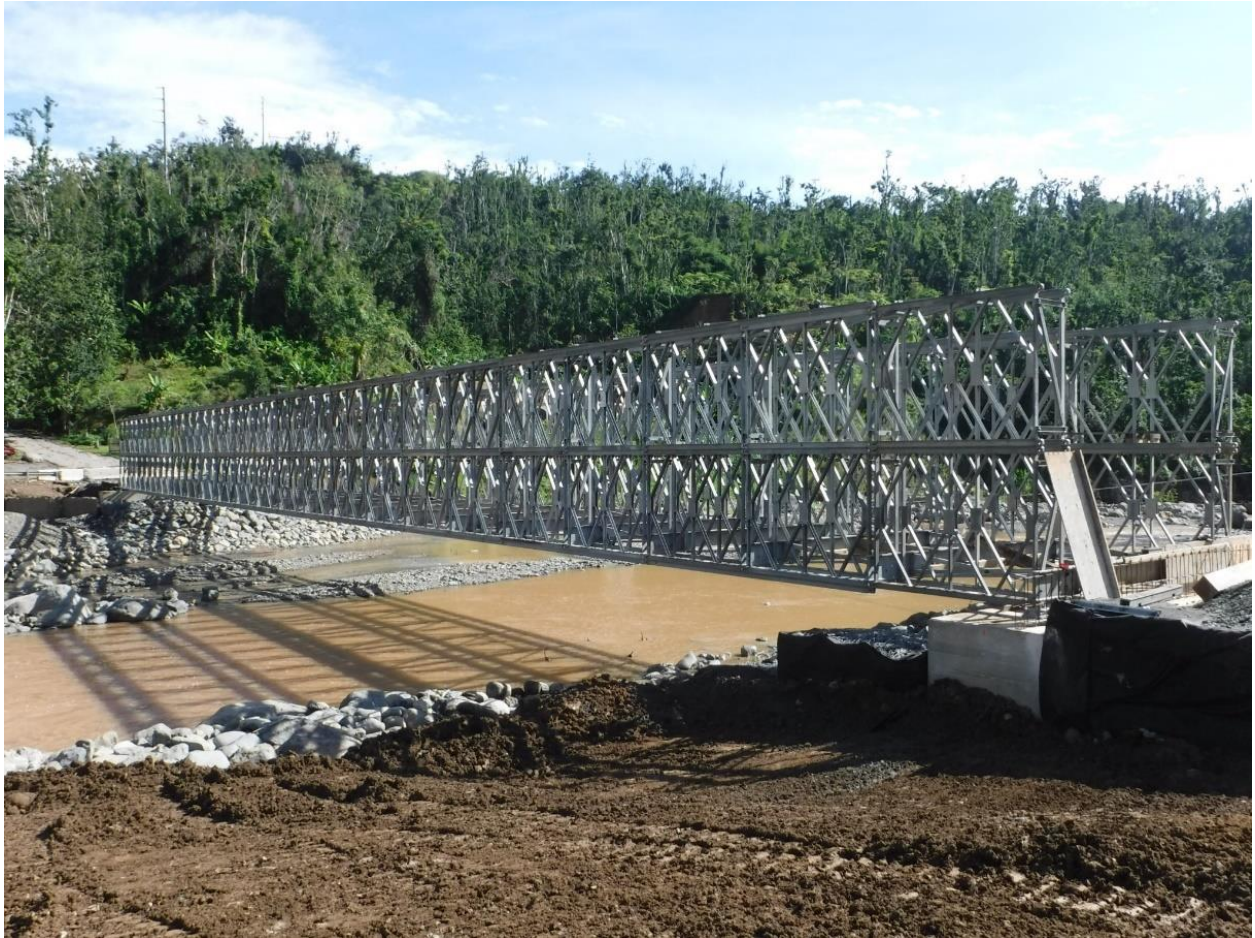
Figure 2-168: Bridge 1355 replacement under construction (source: PRHTA)

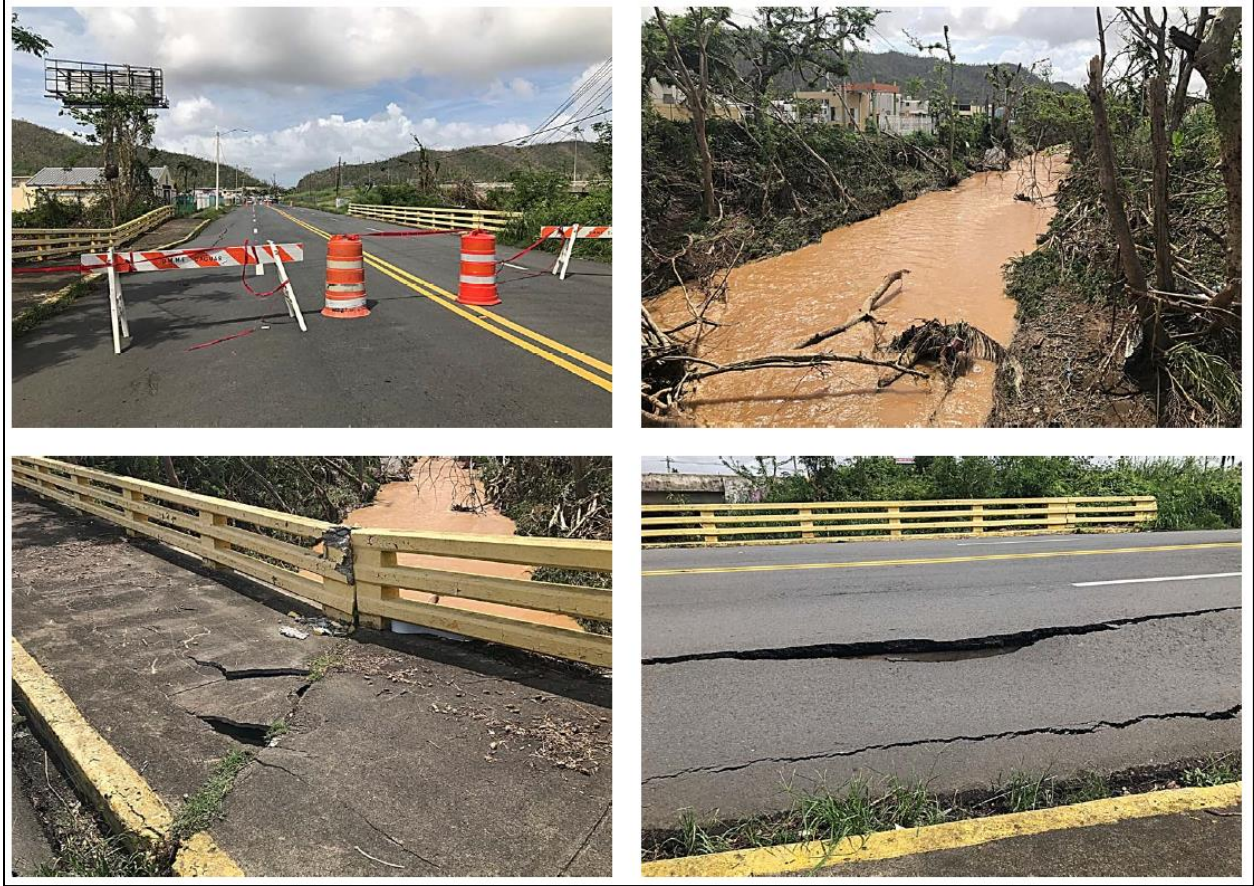
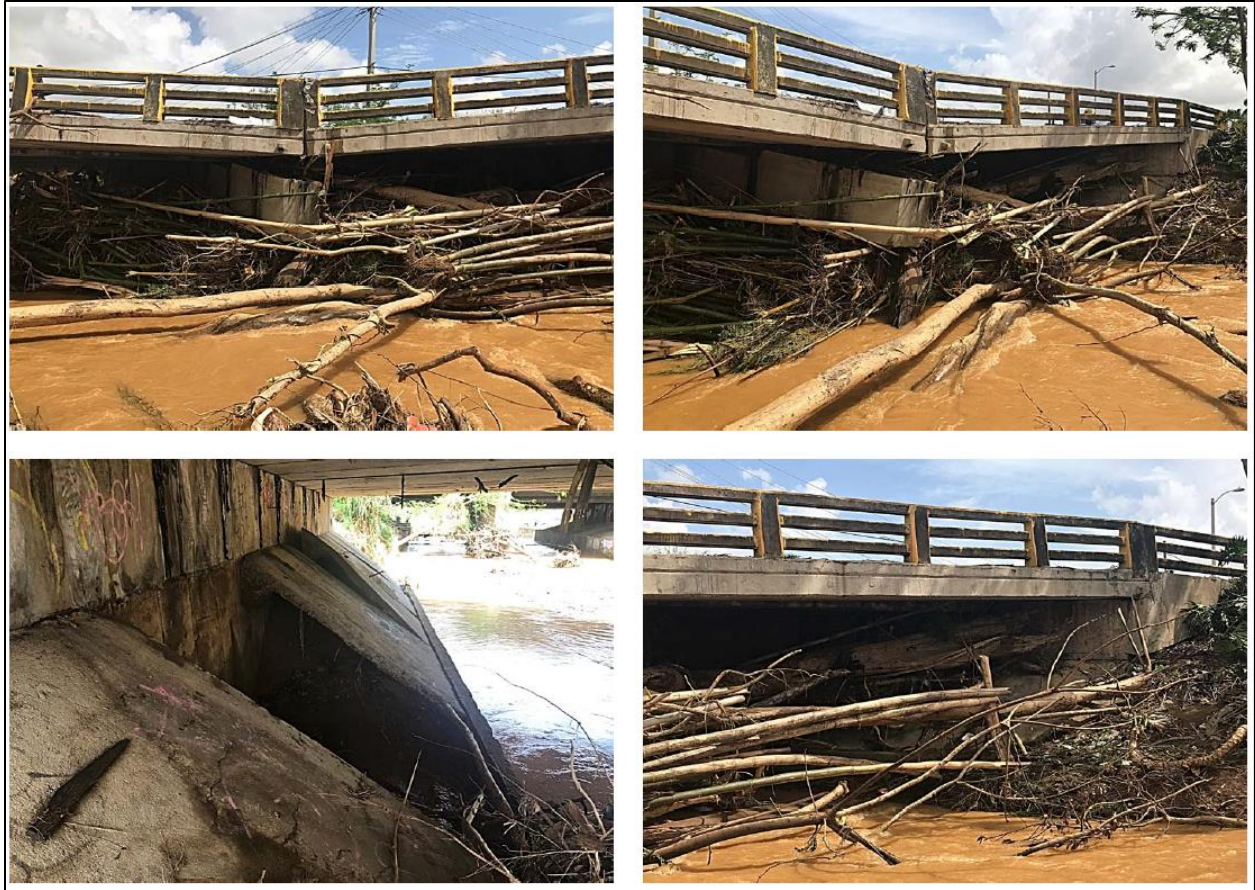
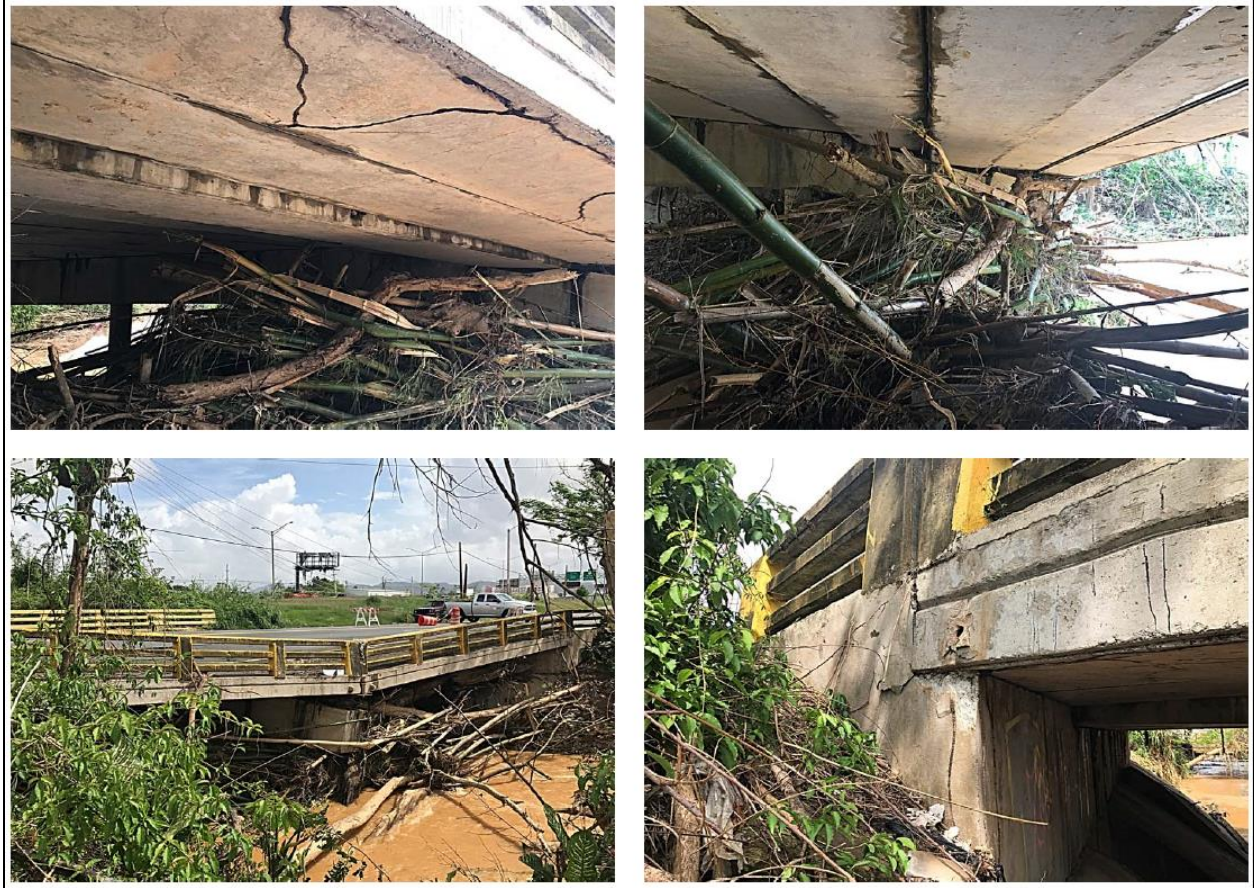
Figure 2-179: Bridge 1453 photos from October 17, 2017 inspection (source: PRHTA)

Figure 2-180: Bridge 1453 photos from October 17, 2017 inspection (source: PRHTA)

Figure 2-181: Bridge 1453 photos from October 17, 2017 inspection (source: PRHTA)

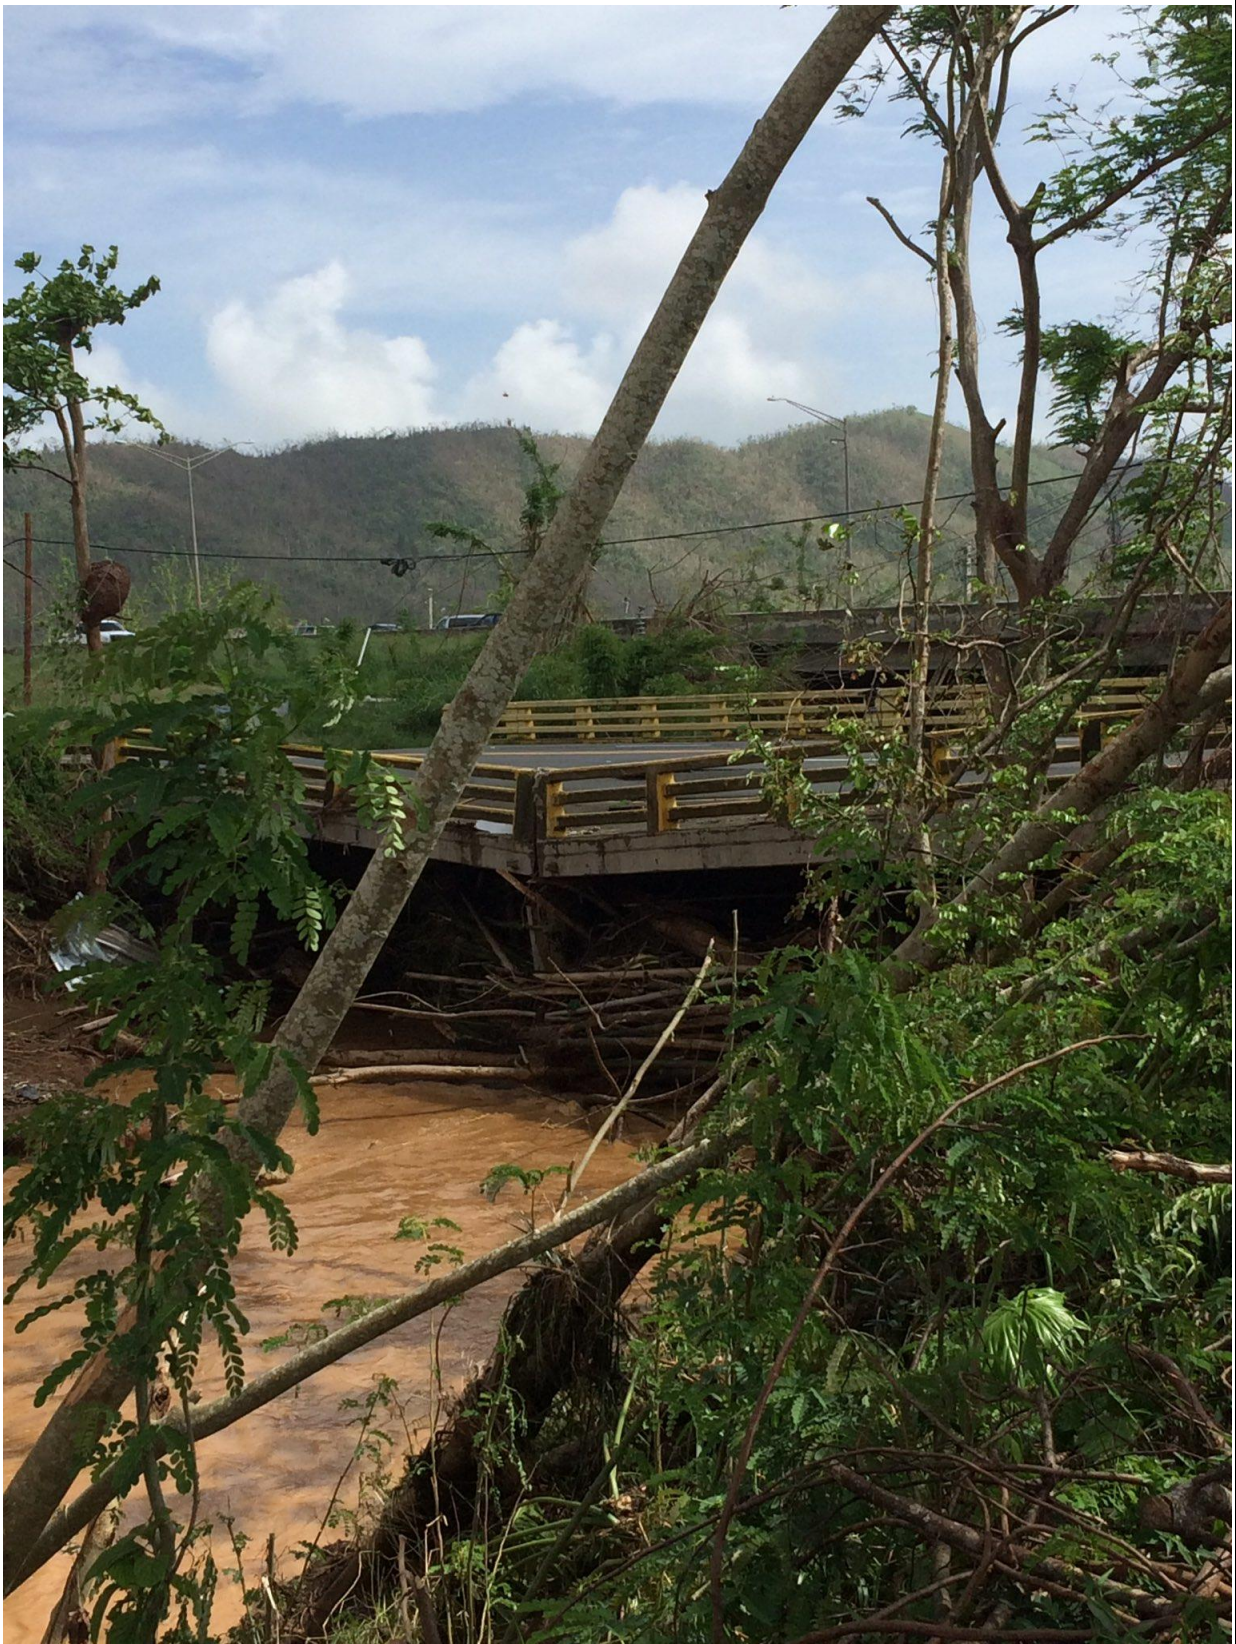
Figure 2-200: Tweet showing damaged Bridge 1453 (source: Ivette Sosa)

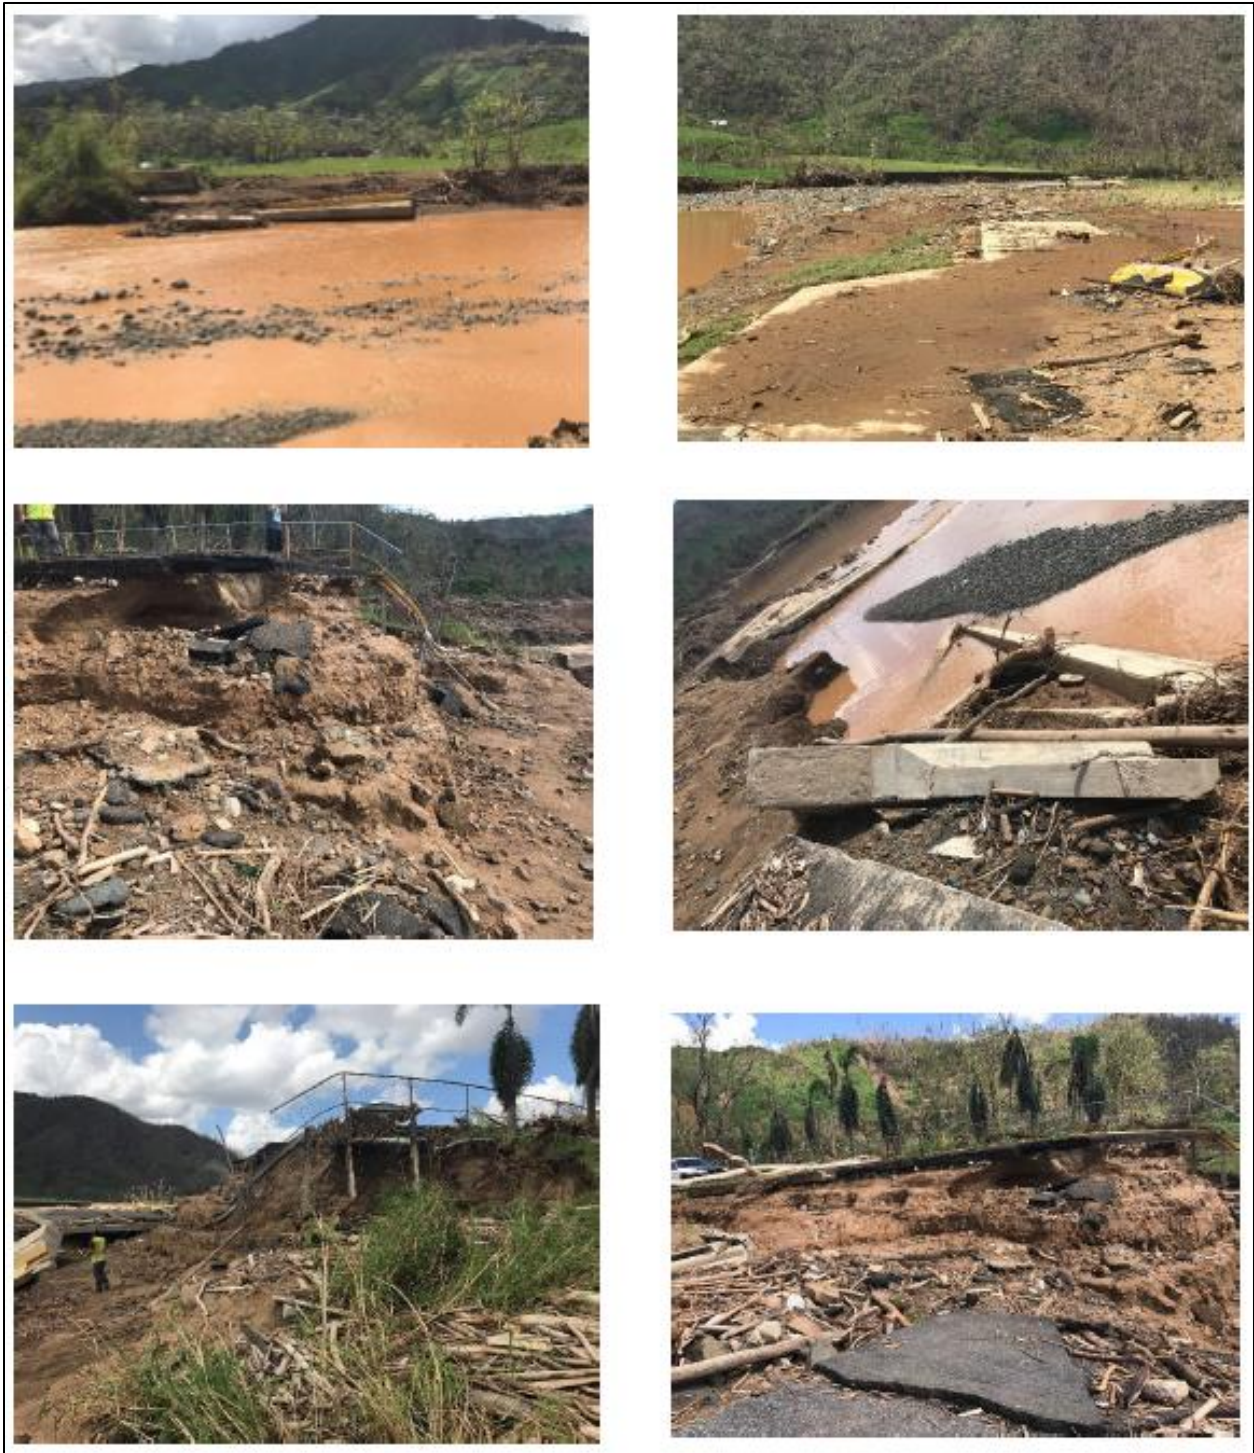
COMMENTS: <u>El puente colapsó, o. Se encontraron 2 spans del puente a orillas del río en el lado derecho. Se encontró 2 spans del puente a 185m aprox. aguas abajo. Otro span fue encontrado a 350m aprox. aguas abajo y una pilaota a 310m aprox. aguas abajo. Las otras 5 pilaotas no fueron encontradas.</u>

Figure 2-215: Bridge 1462 photos from October 9, 2017 inspection (source: PRHTA)

Figure 2-216: Bridge 1462 photos from October 9, 2017 inspection (source: PRHTA)

Figure 2-217: Bridge 1462 photos from October 9, 2017 inspection (source: PRHTA)

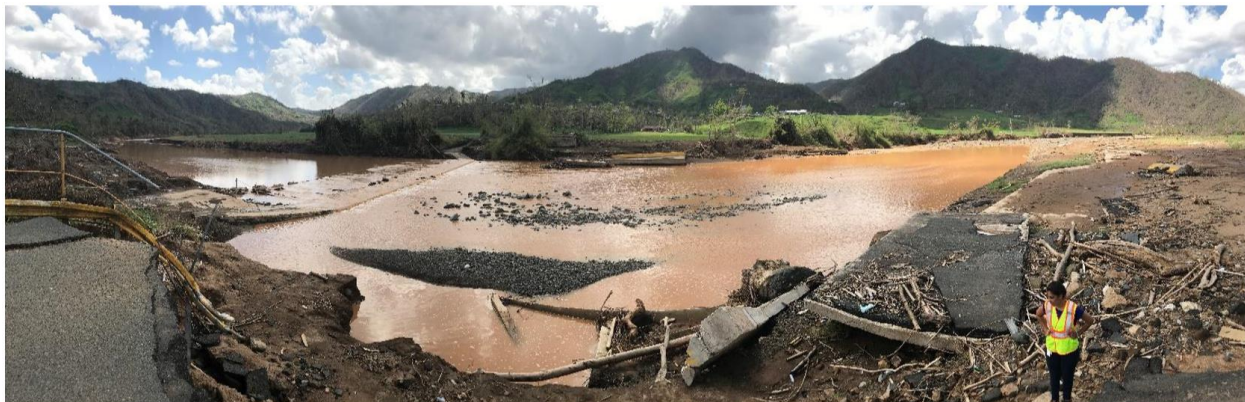
Figure 2-221: Inspection of collapsed Bridge 1462 (source: PRHTA)

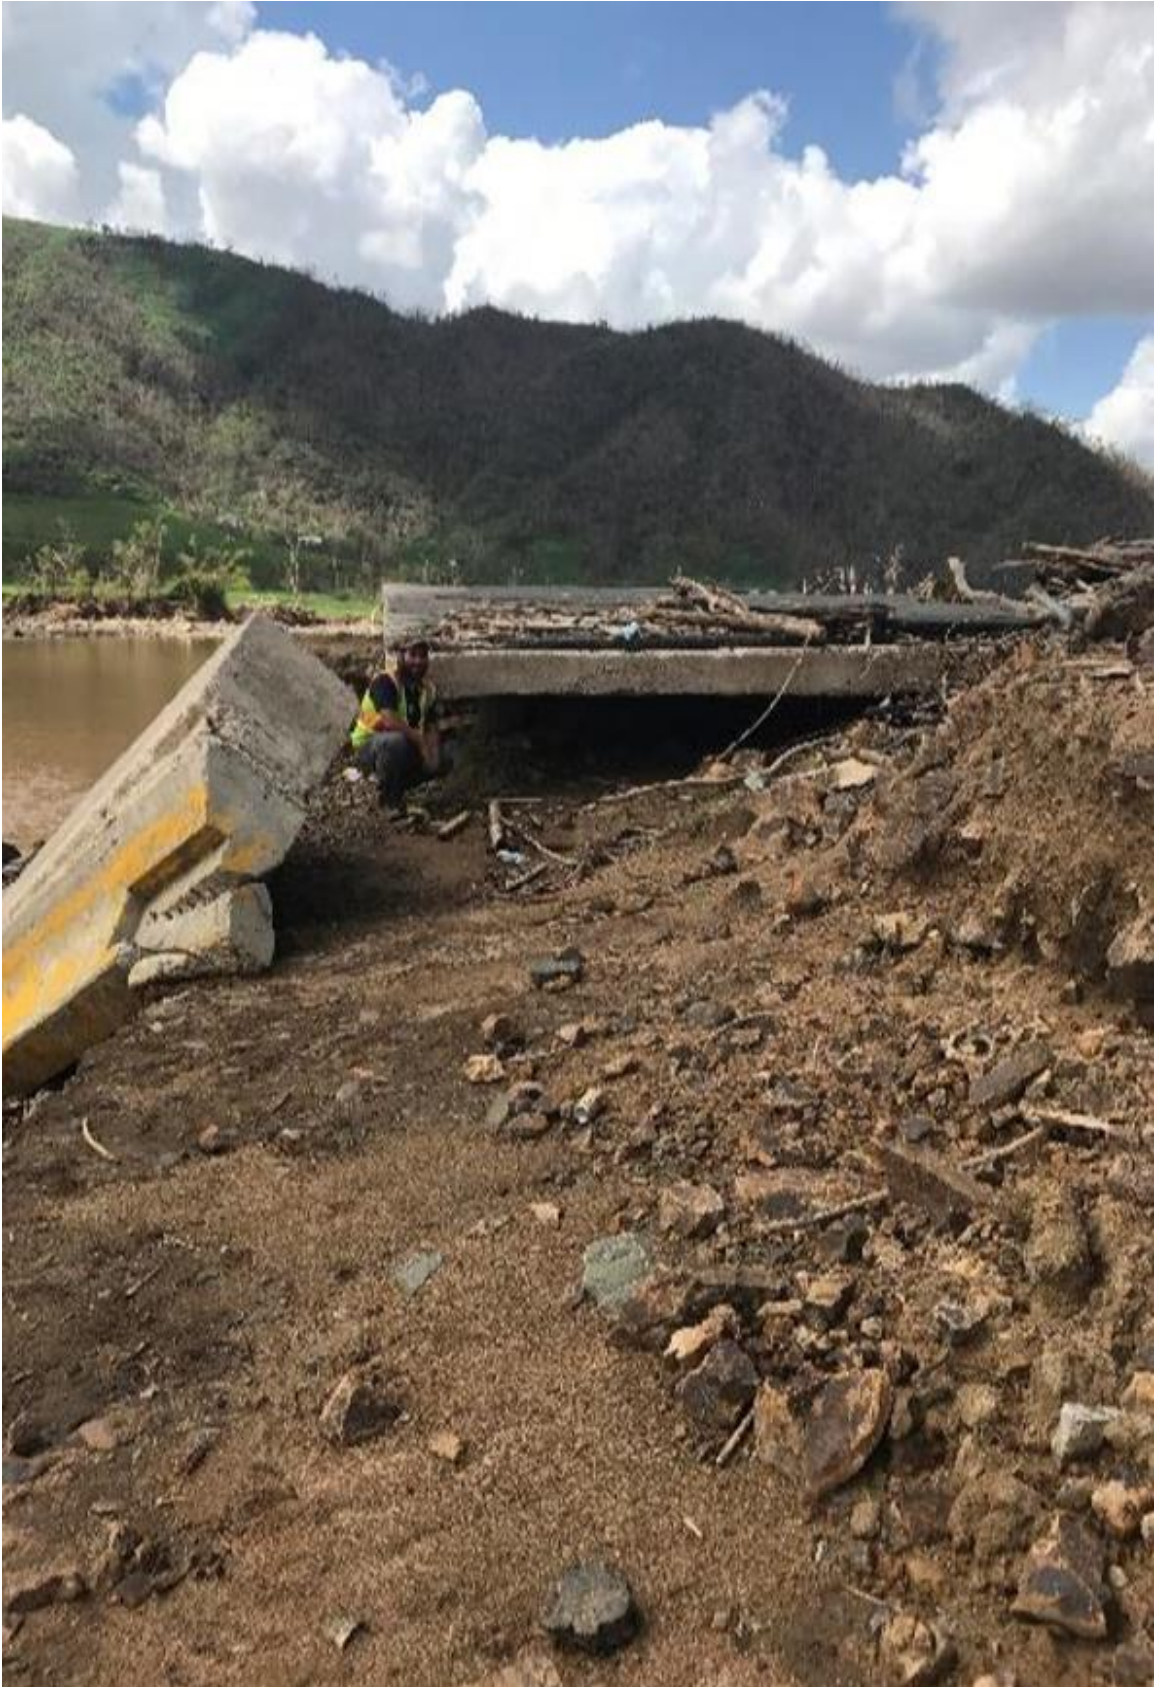
Figure 2-222: Inspection of collapsed Bridge 1462 (source: PRHTA)

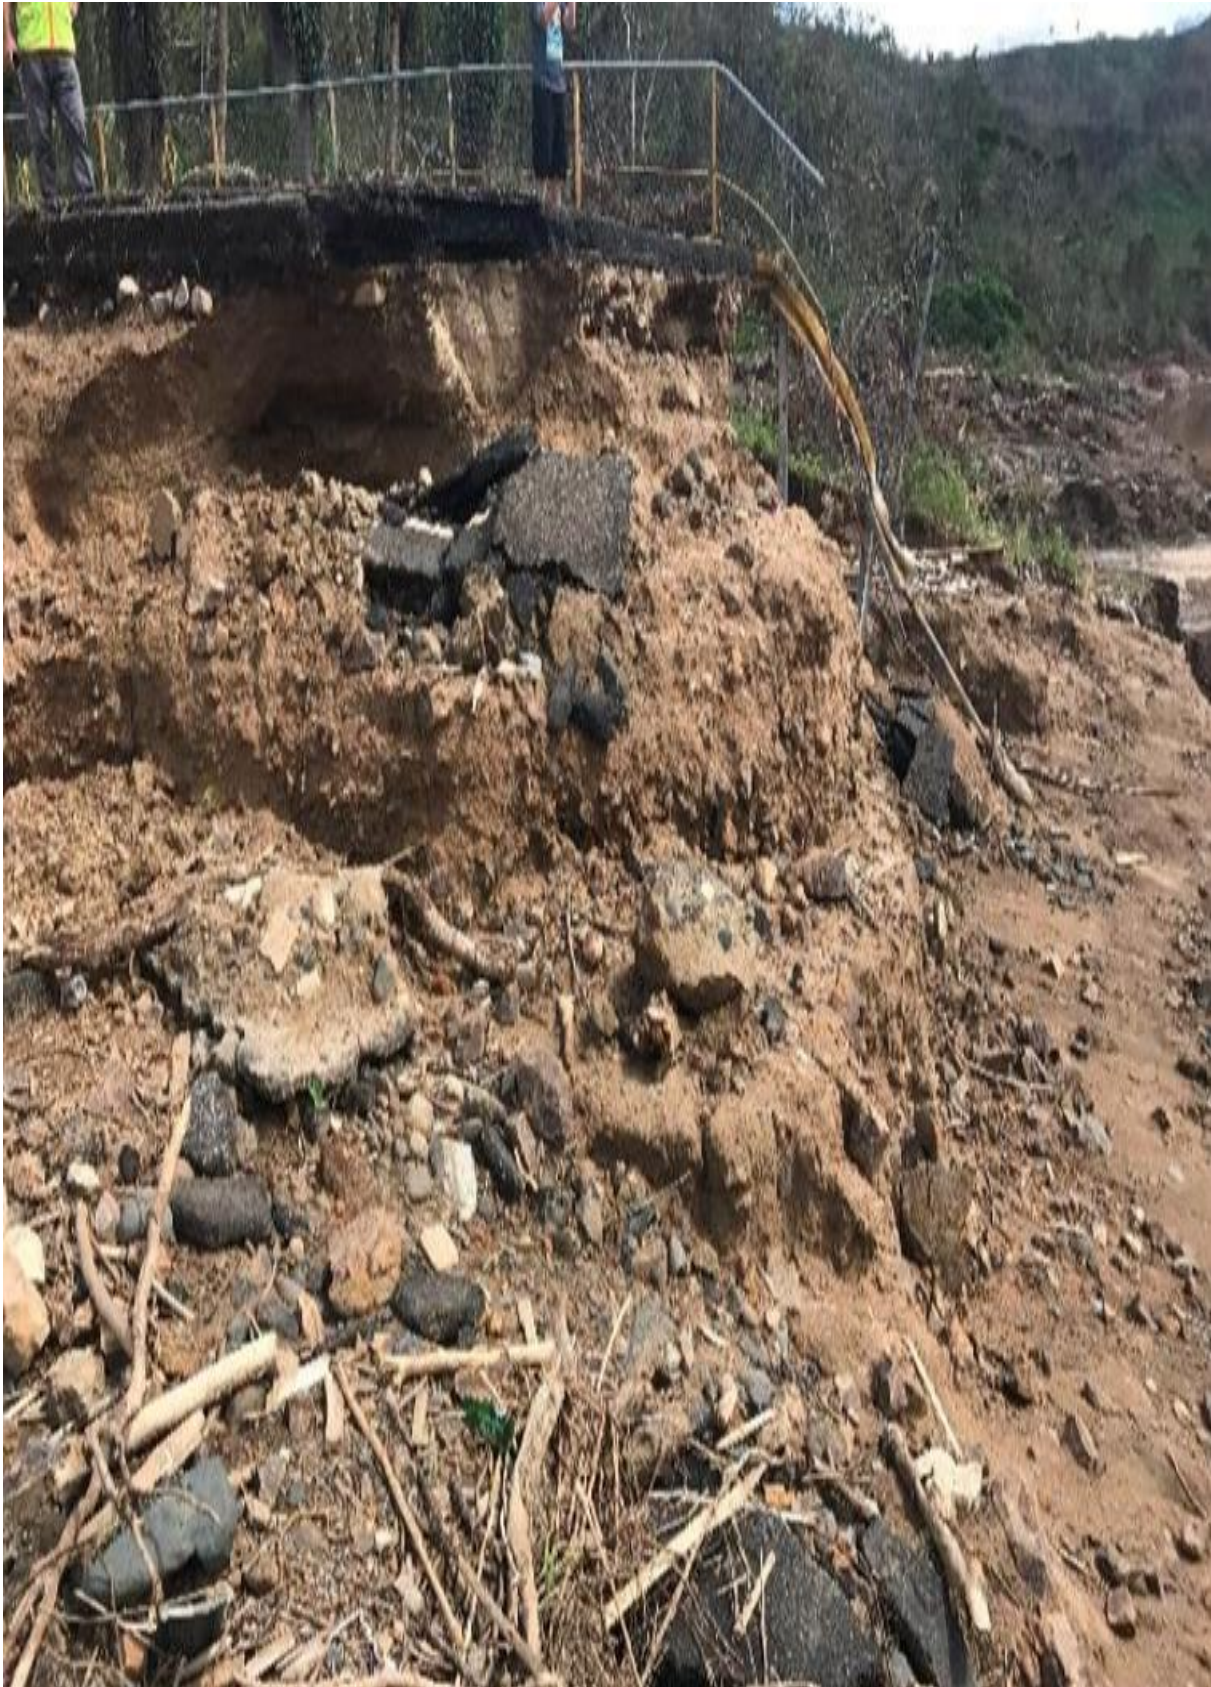
Figure 2-223 Inspection of collapsed Bridge 1462 (source: PRHTA)

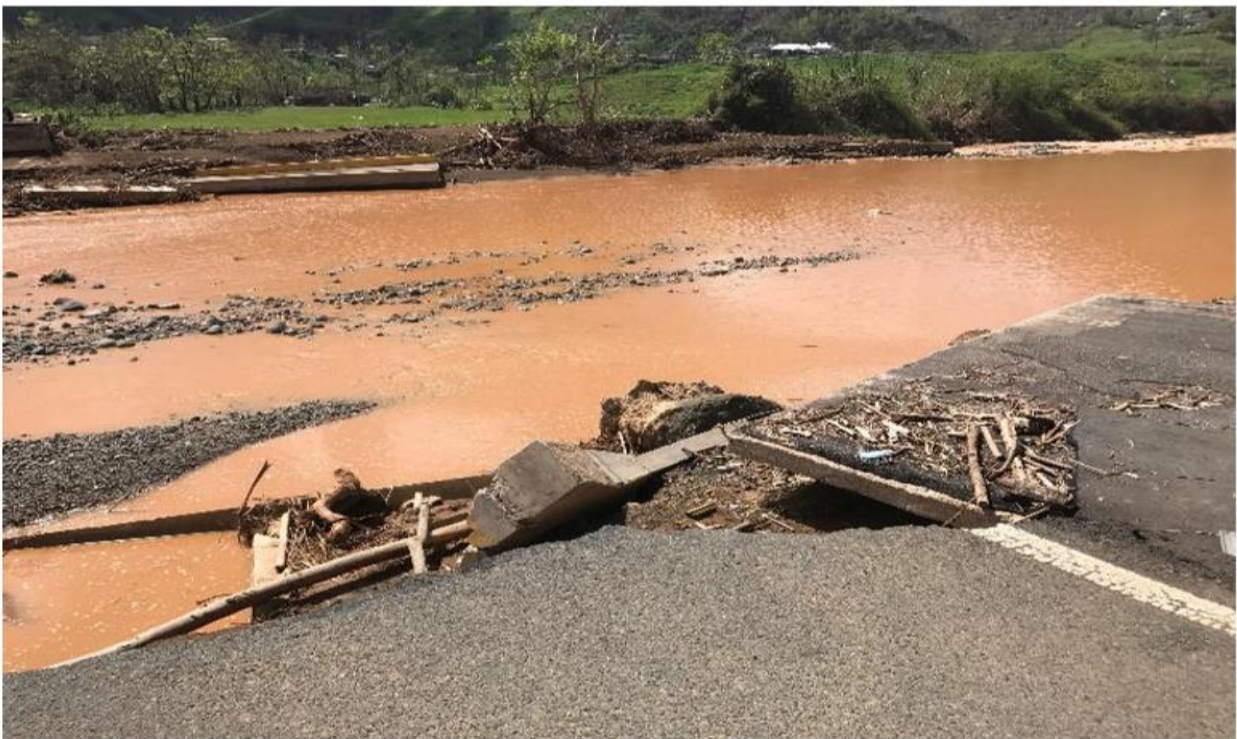
Figure 2-224: Inspection of collapsed Bridge 1462 (source: PRHTA)

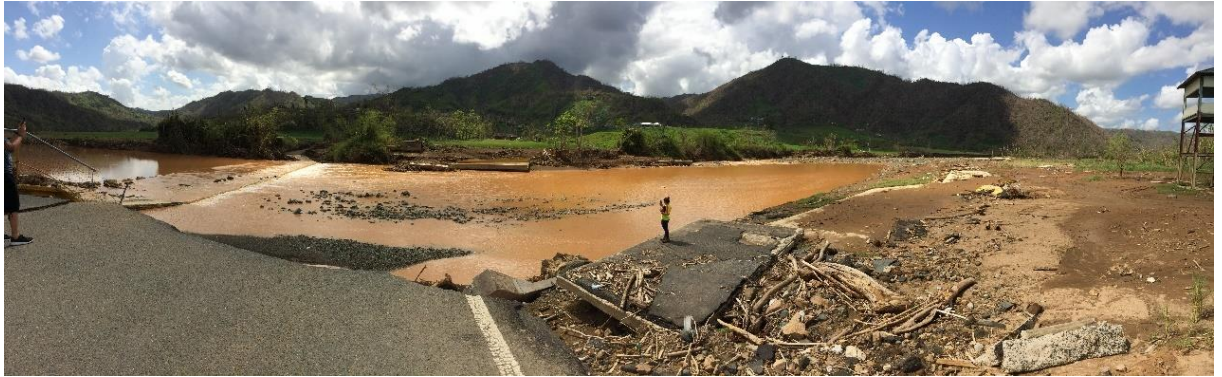
Figure 2-225: Inspection of collapsed Bridge 1462 (source: PRHTA)

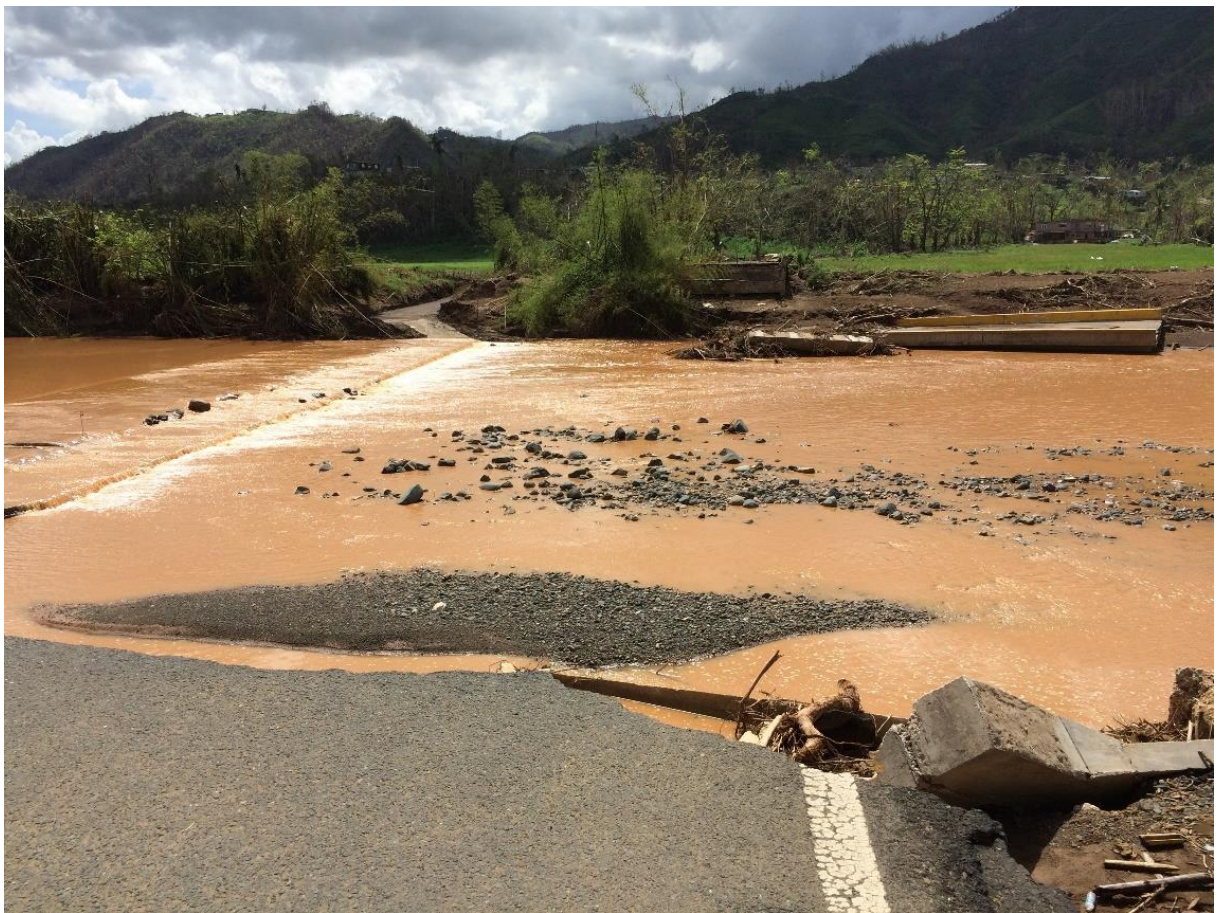
Figure 2-226: Social media image of collapsed Bridge 1462 (source: Julia Maldonado)

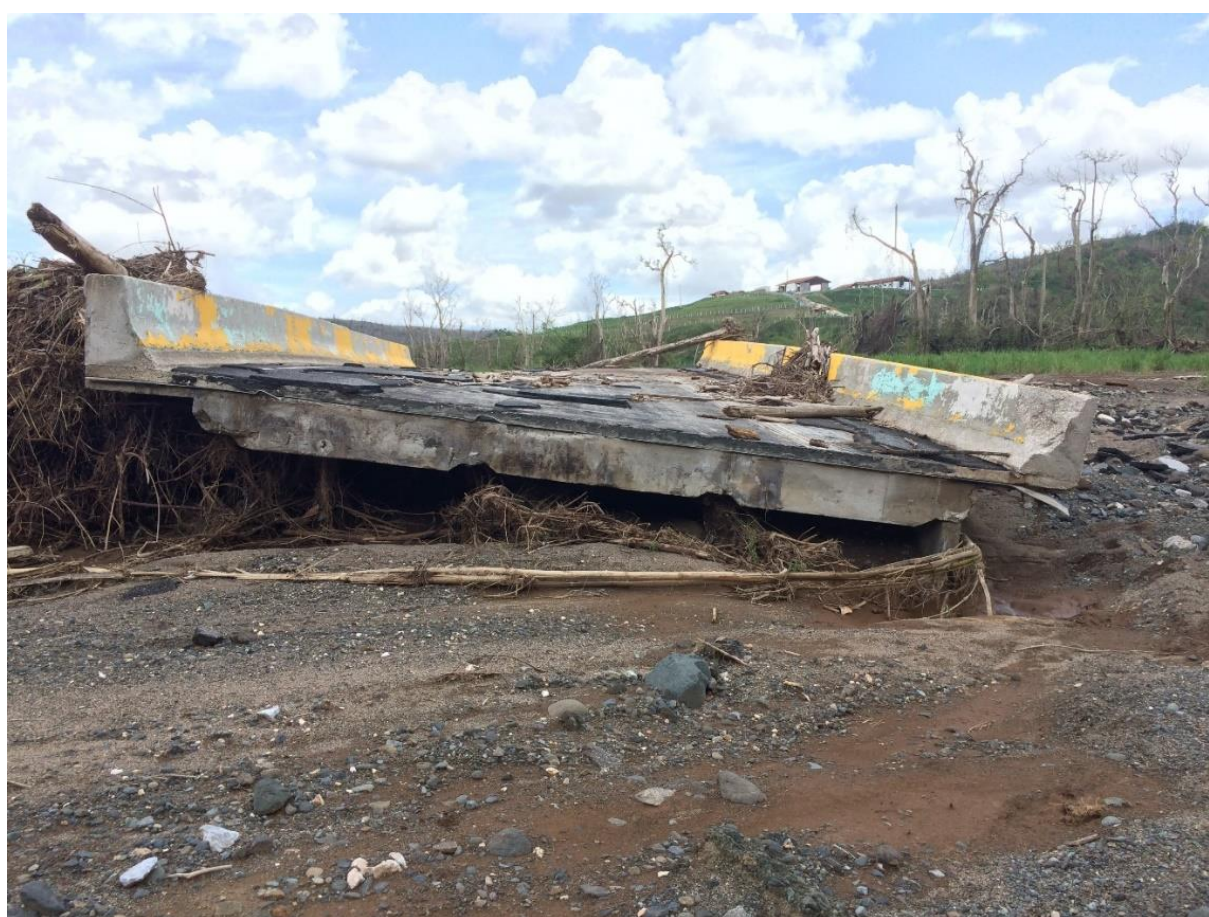
Figure 2-227: Social media image of collapsed Bridge 1462 (source: Julia Maldonado)

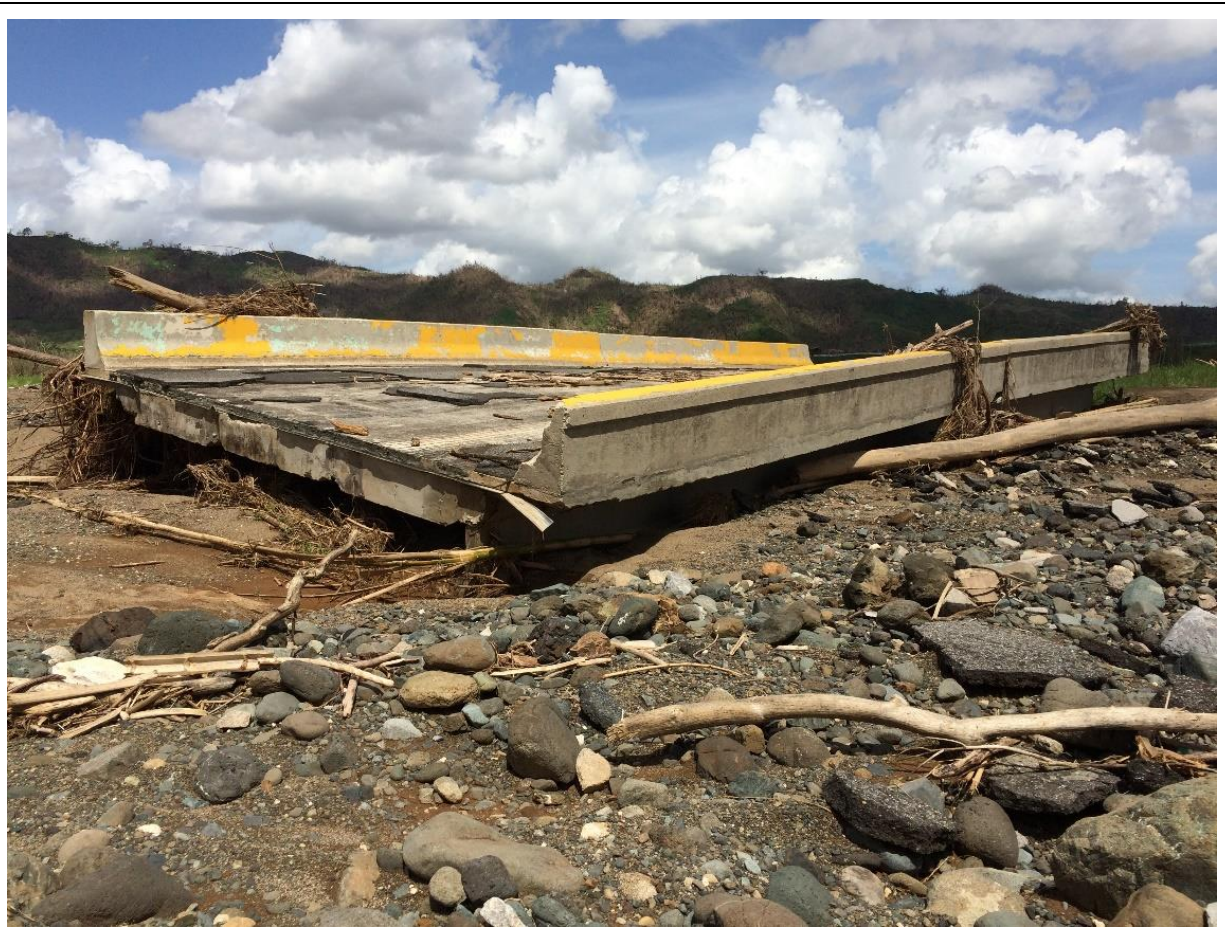
Figure 2-228: Social media image of collapsed Bridge 1462 (source: Julia Maldonado)
