Improving Transportation Infrastructure Resilience against Hurricanes, other Natural Disasters, and Weathering: Part III - Analysis of motor vehicle bridges failures due to Hurricane Maria

FINAL REPORT
August 2022

Transportation Infrastructure Research Center – TIRC
Polytechnic University of Puerto Rico
377 Ponce de Leon Ave, San Juan, PR 00918

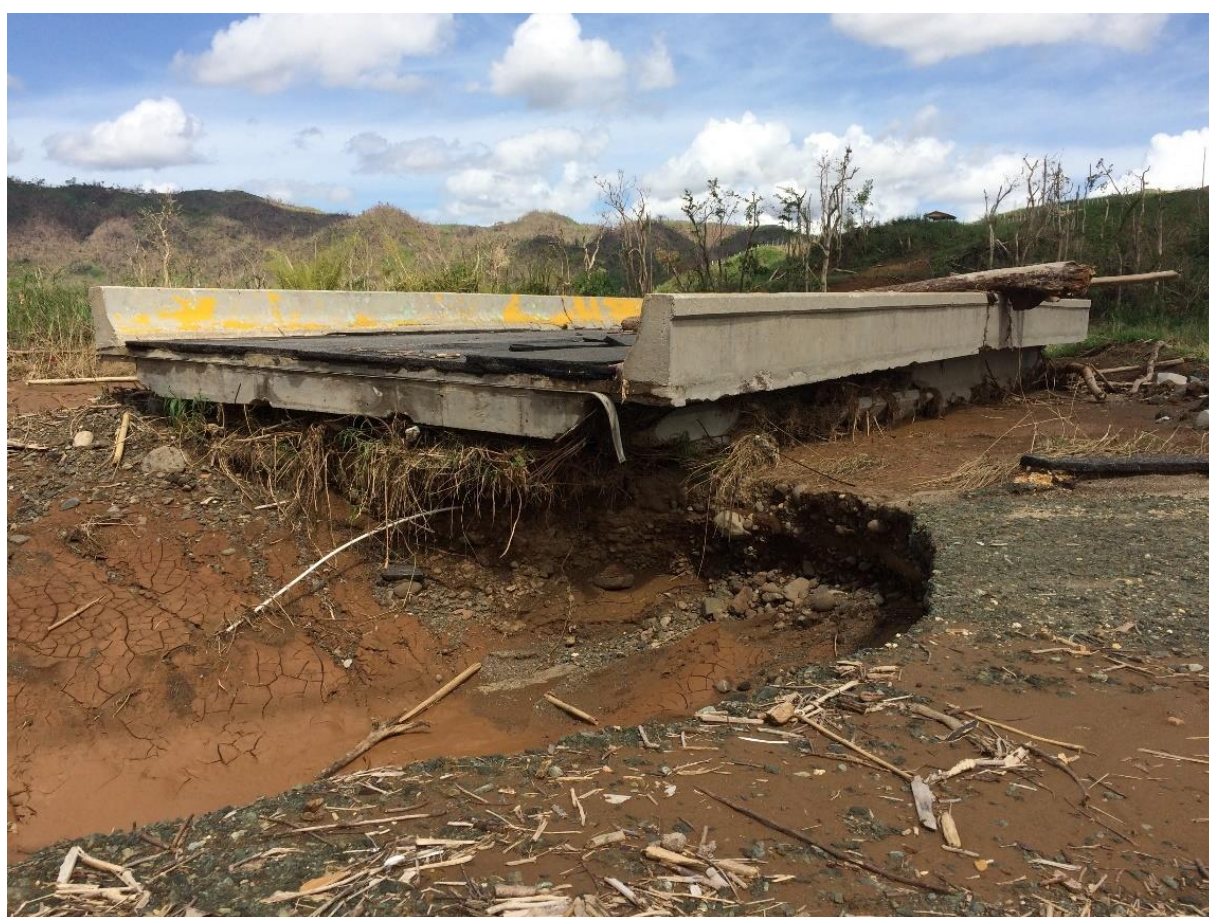
Figure 2-229: Social media image of collapsed Bridge 1462 (source: Julia Maldonado)

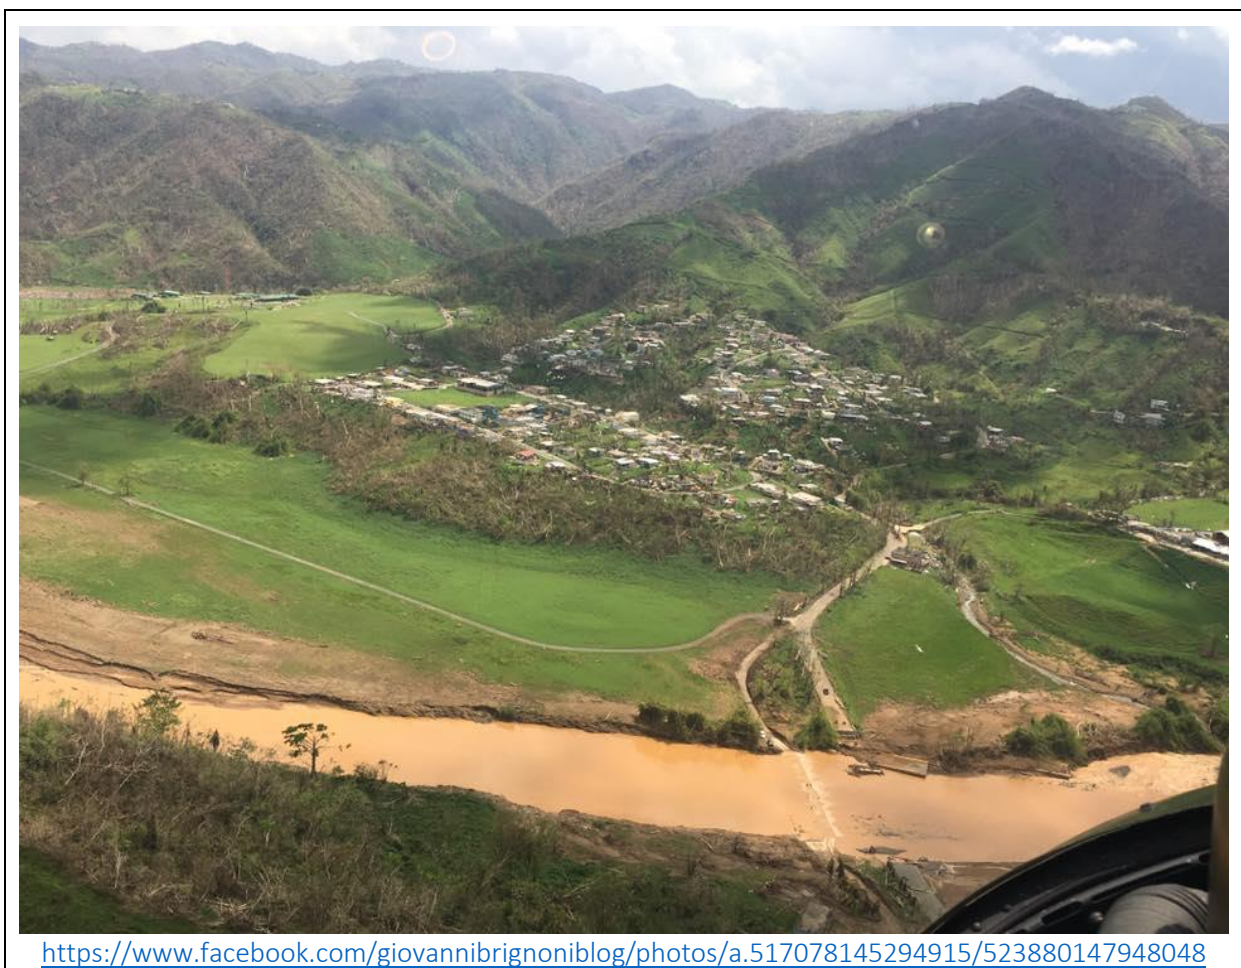
Figure 2-230: Social media image of collapsed Bridge 1462 (source: Julia Maldonado)

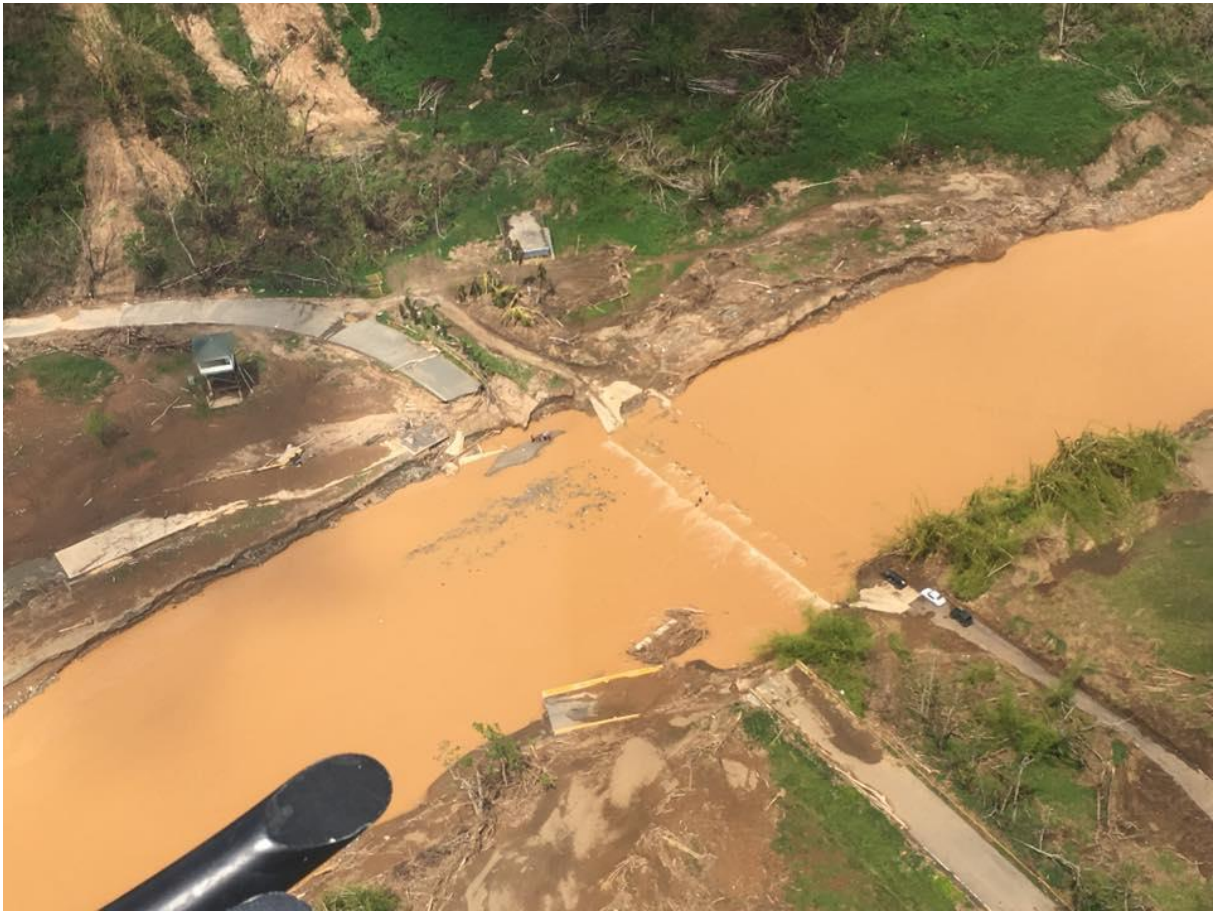
Figure 2-231: Social media image of collapsed Bridge 1462 (source: Giovanni Brignoni)

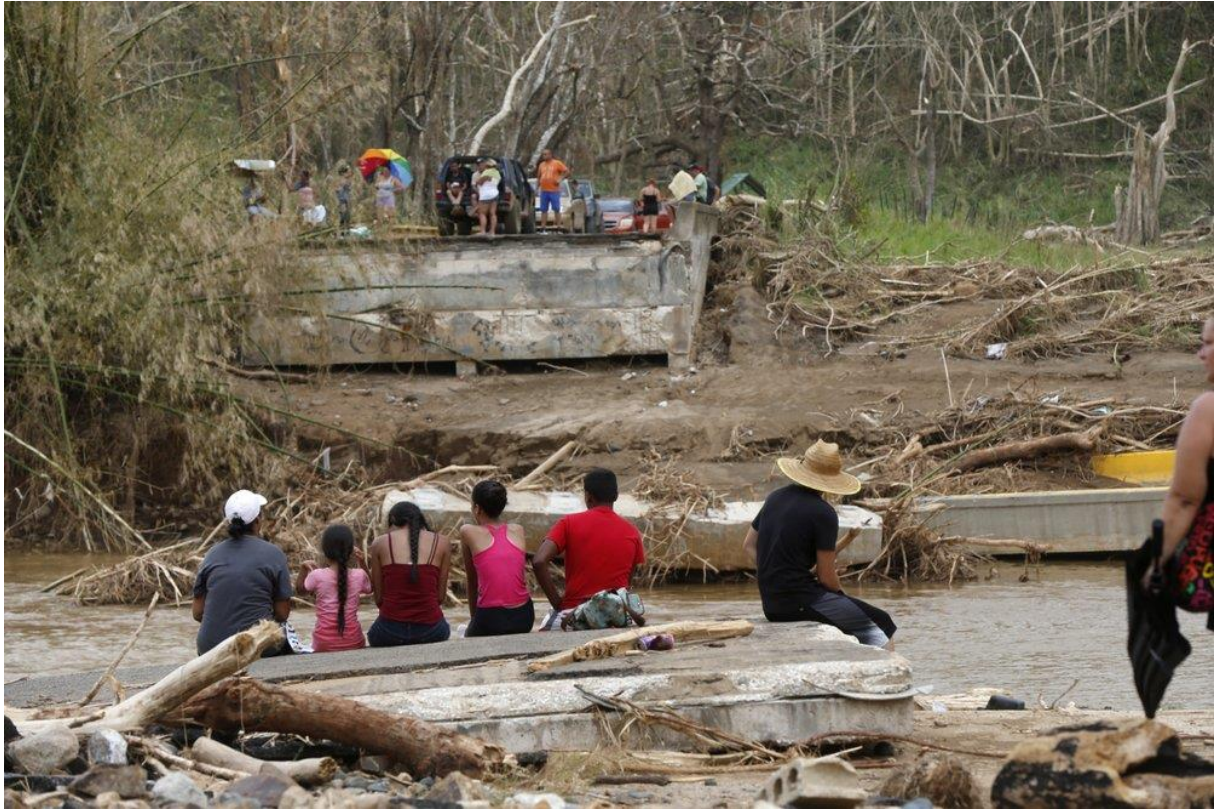
Figure 2-232: Social media image of collapsed Bridge 1462 (source: Giovanni Brignoni)

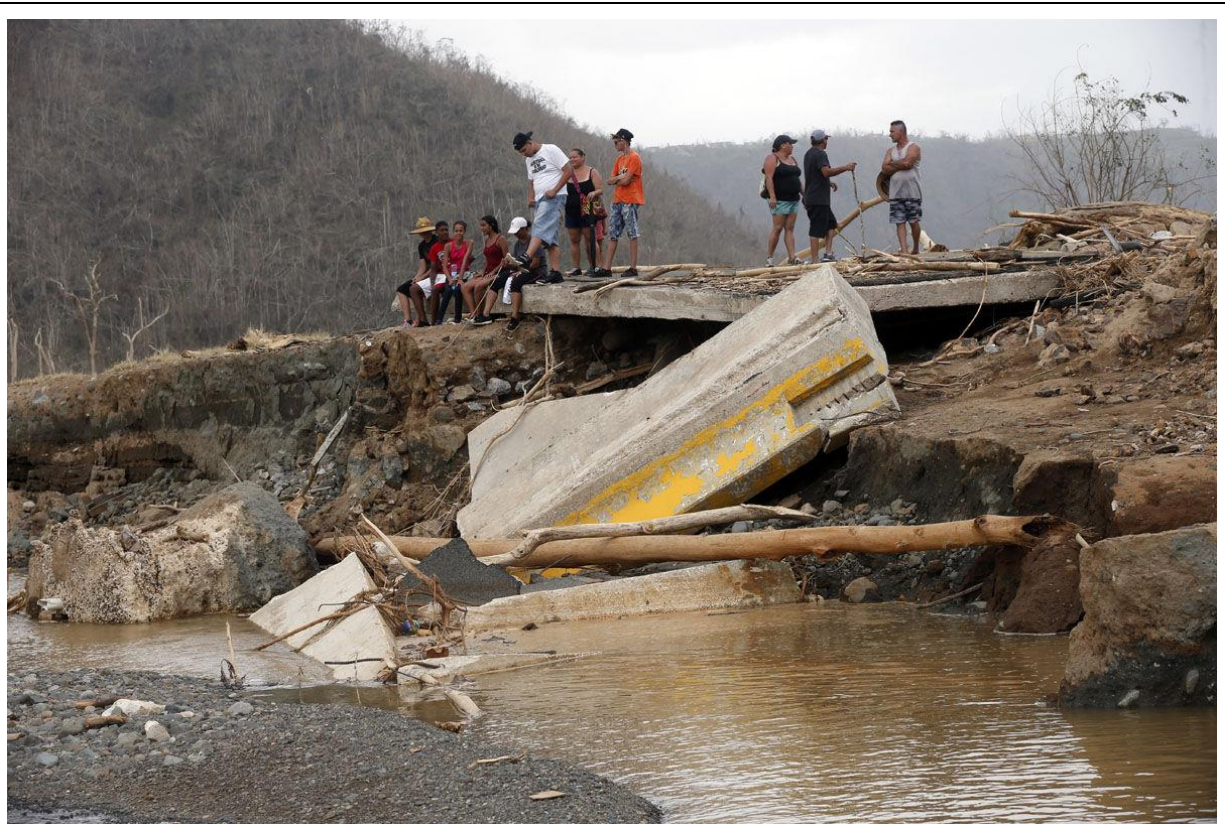
Figure 2-233: Collapsed Bridge 1462 image from news report (source: AP News)

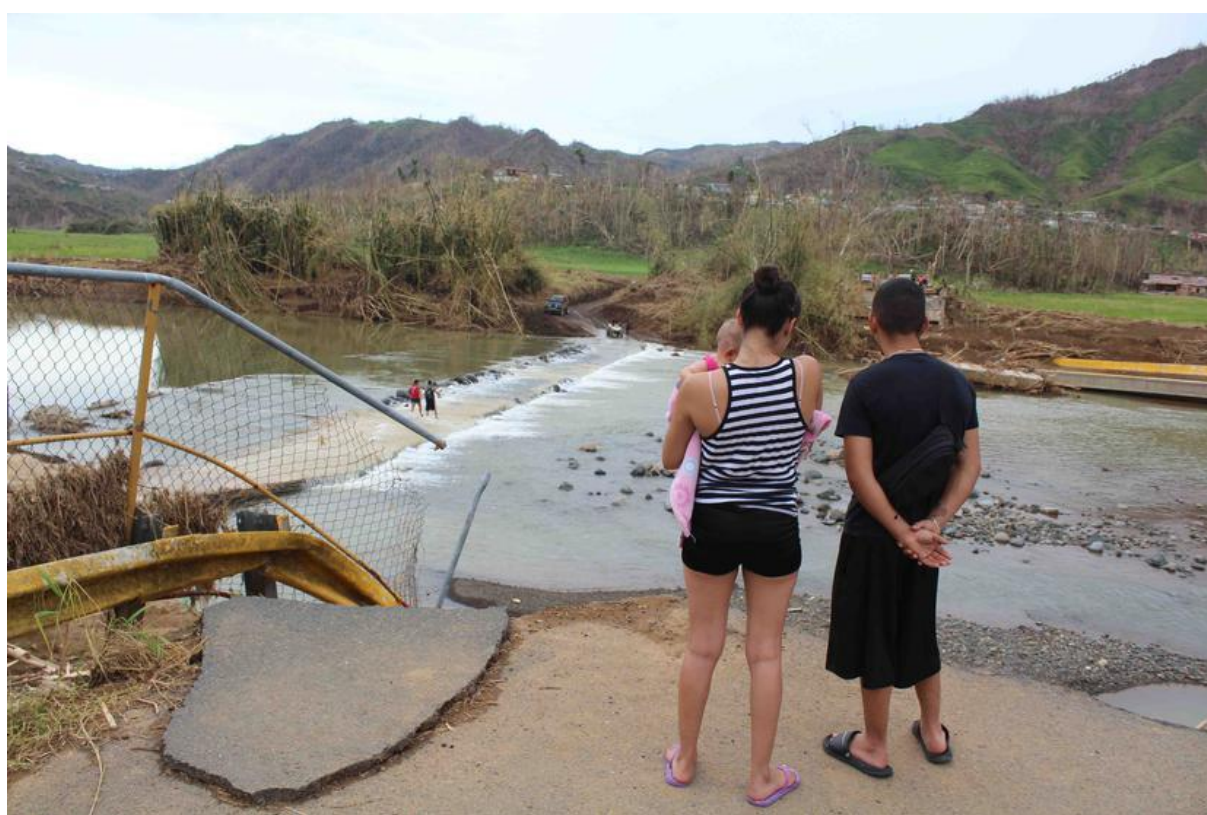
Figure 2-234: Collapsed Bridge 1462 image from news report (source: AP News)

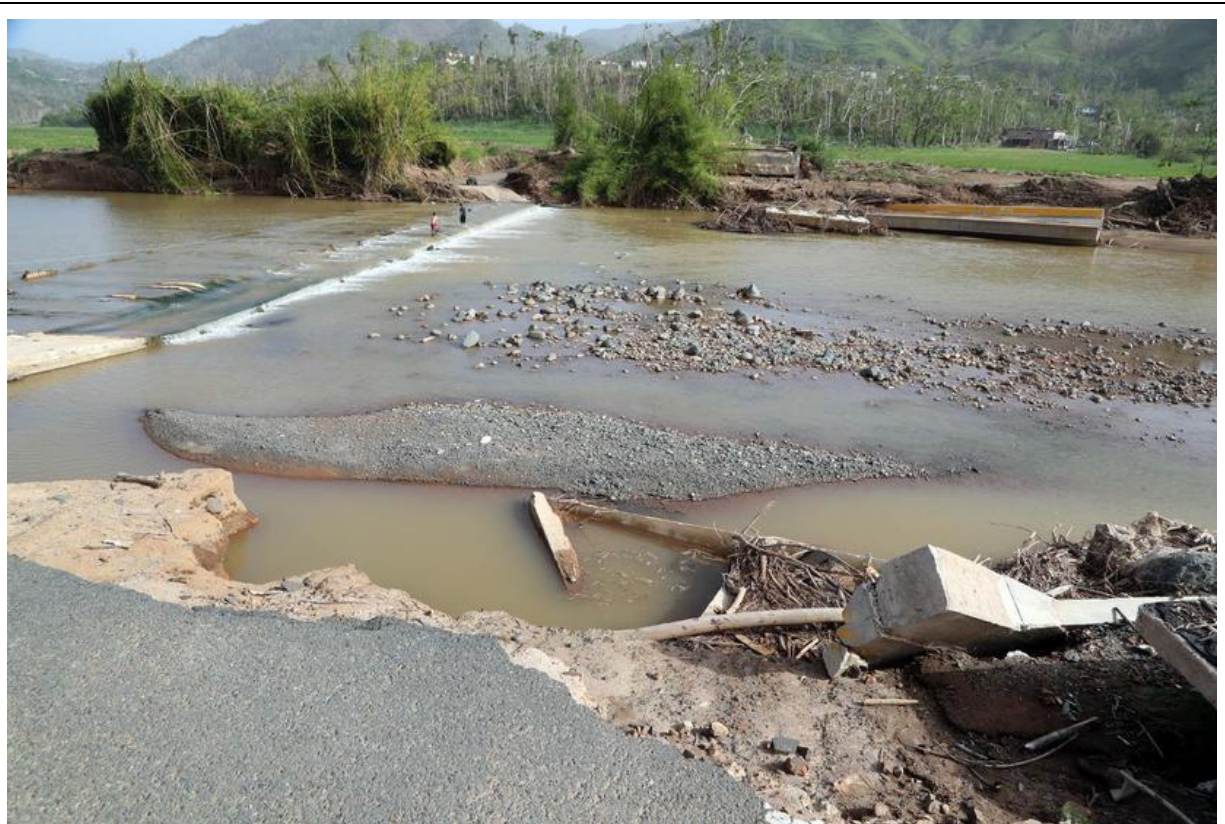
Figure 2-235: Collapsed Bridge 1462 image from news report (source: El Nuevo Día)

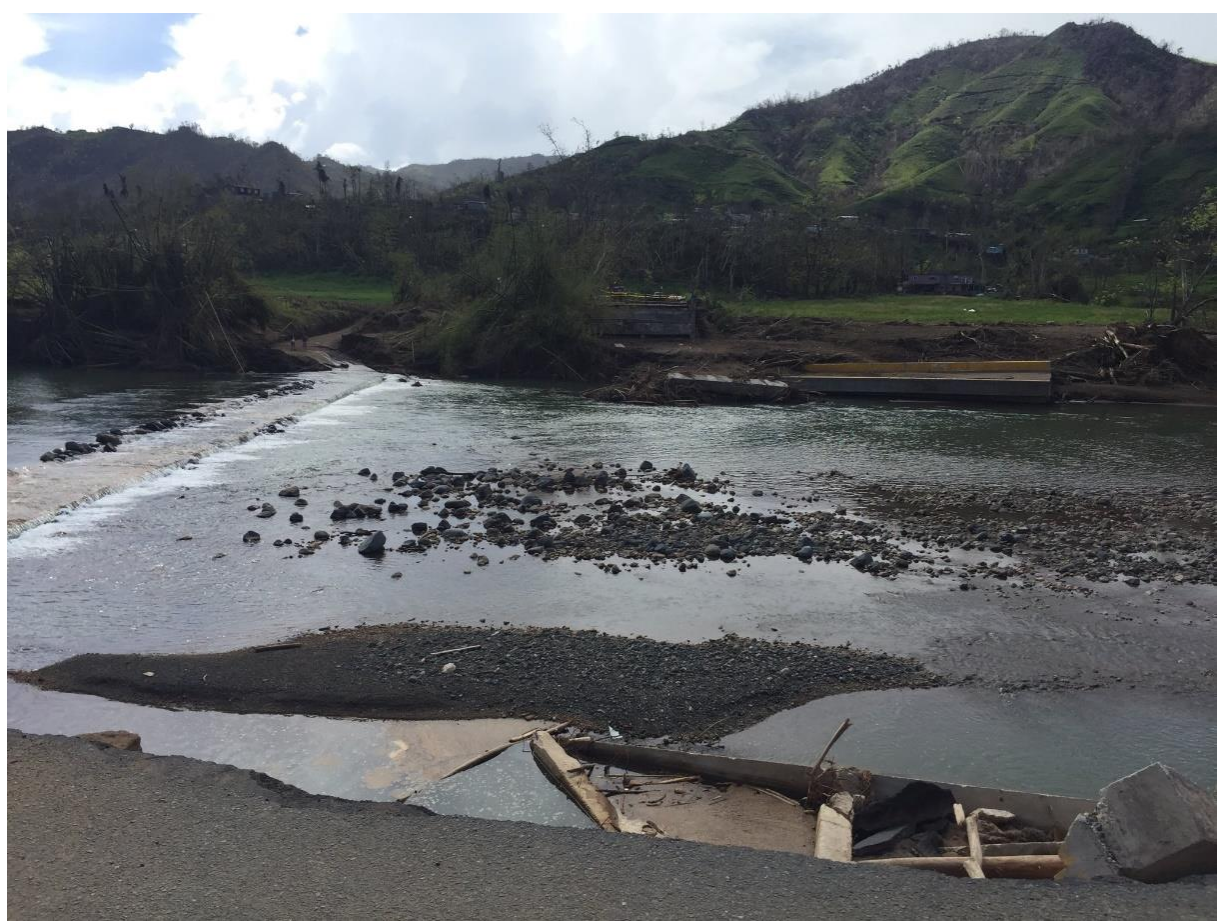
Figure 2-236: Collapsed Bridge 1462 image from news report (source: El Nuevo Día)

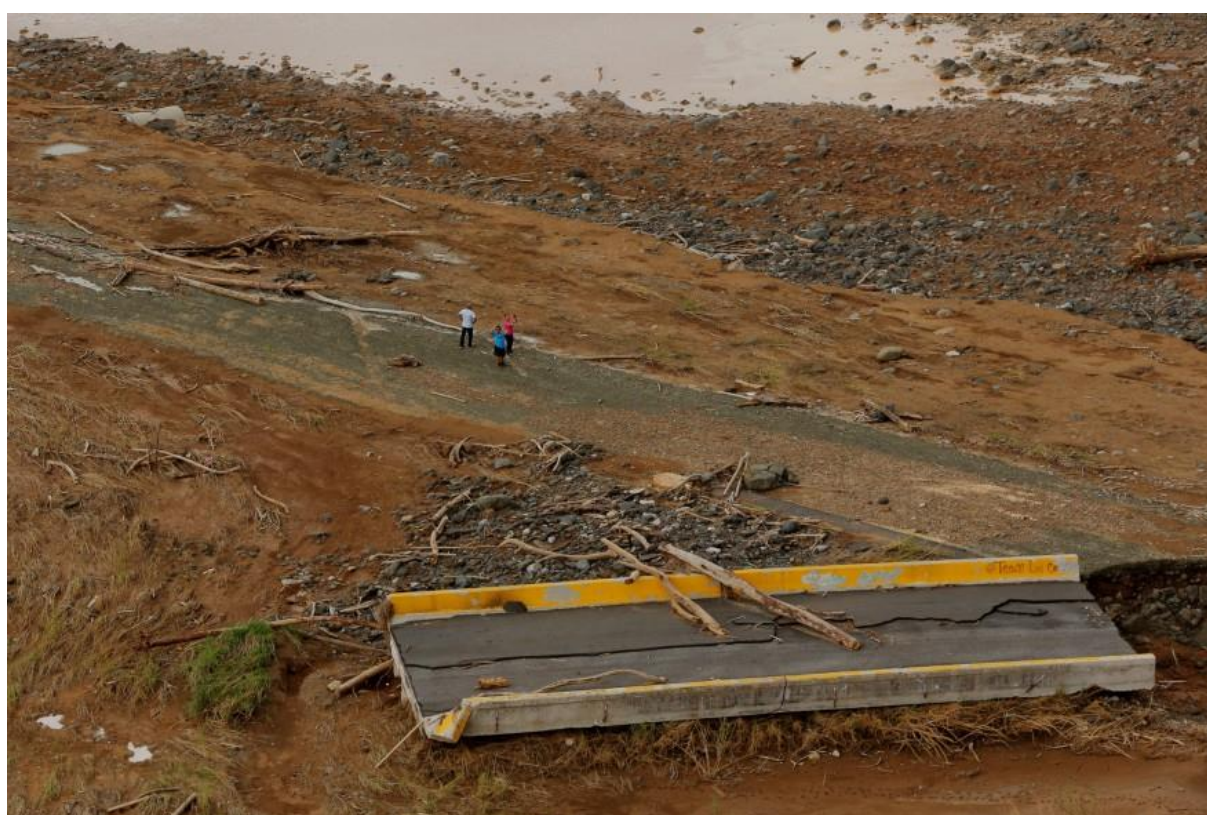
Figure 2-237: Social media image of collapse of Bridge 1462 (source: Jose Esteves)

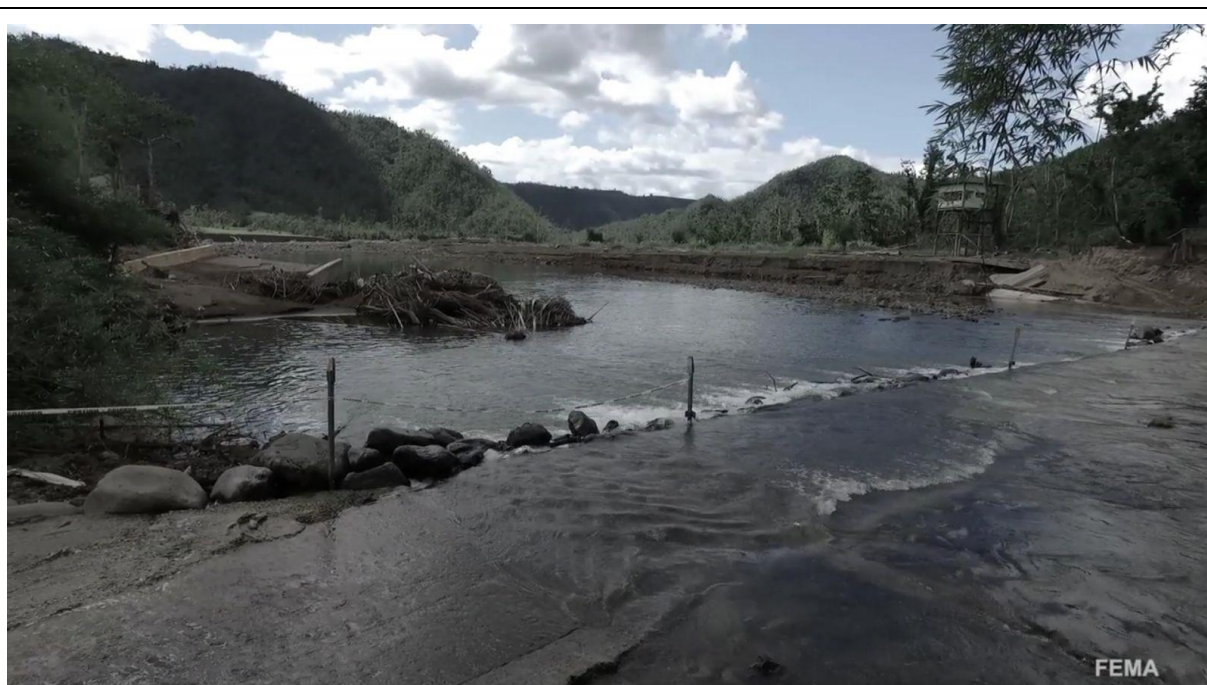
Figure 2-238: Collapsed Bridge 1462 image from news report (source: New York Post)

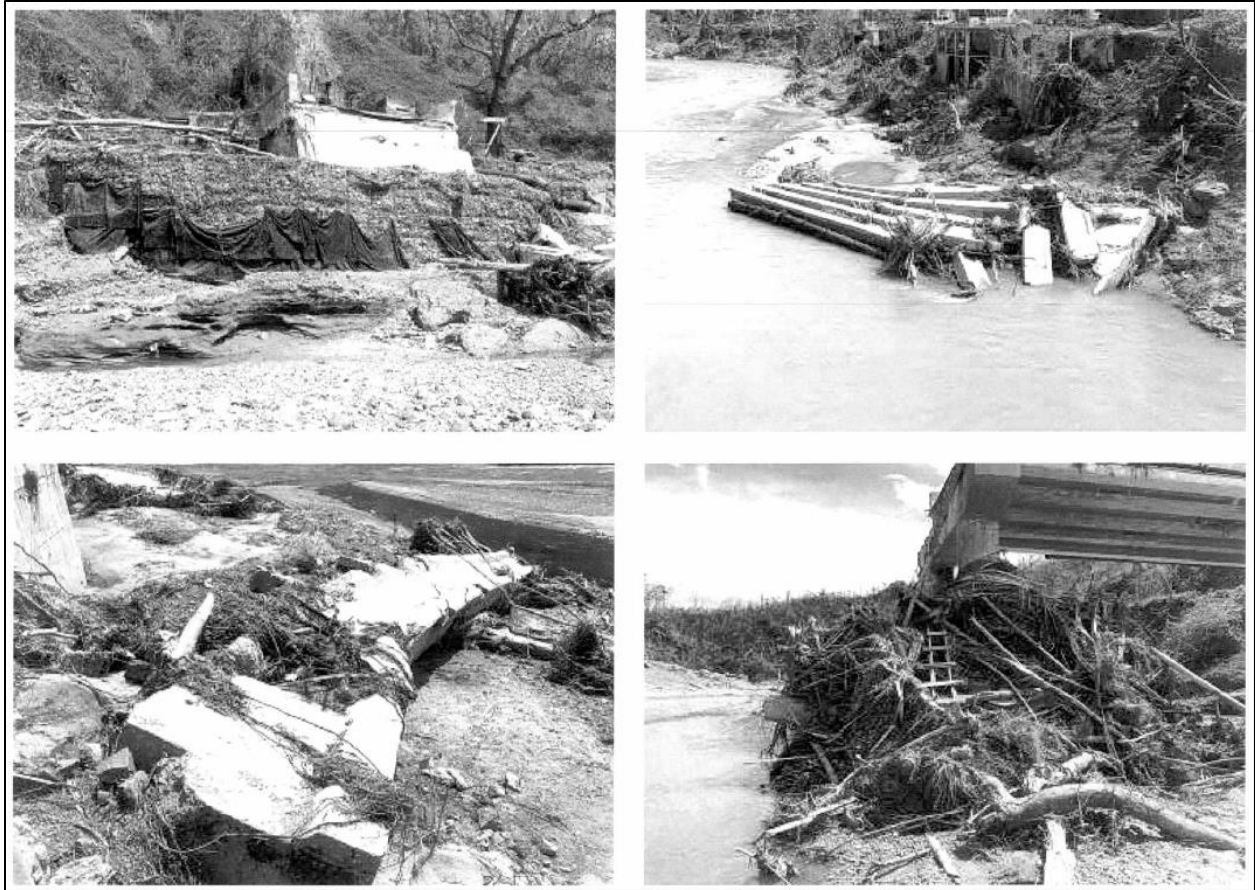
Figure 2-258: Bridge 1499 photos from October 5, 2017 inspection (source: PRHTA)

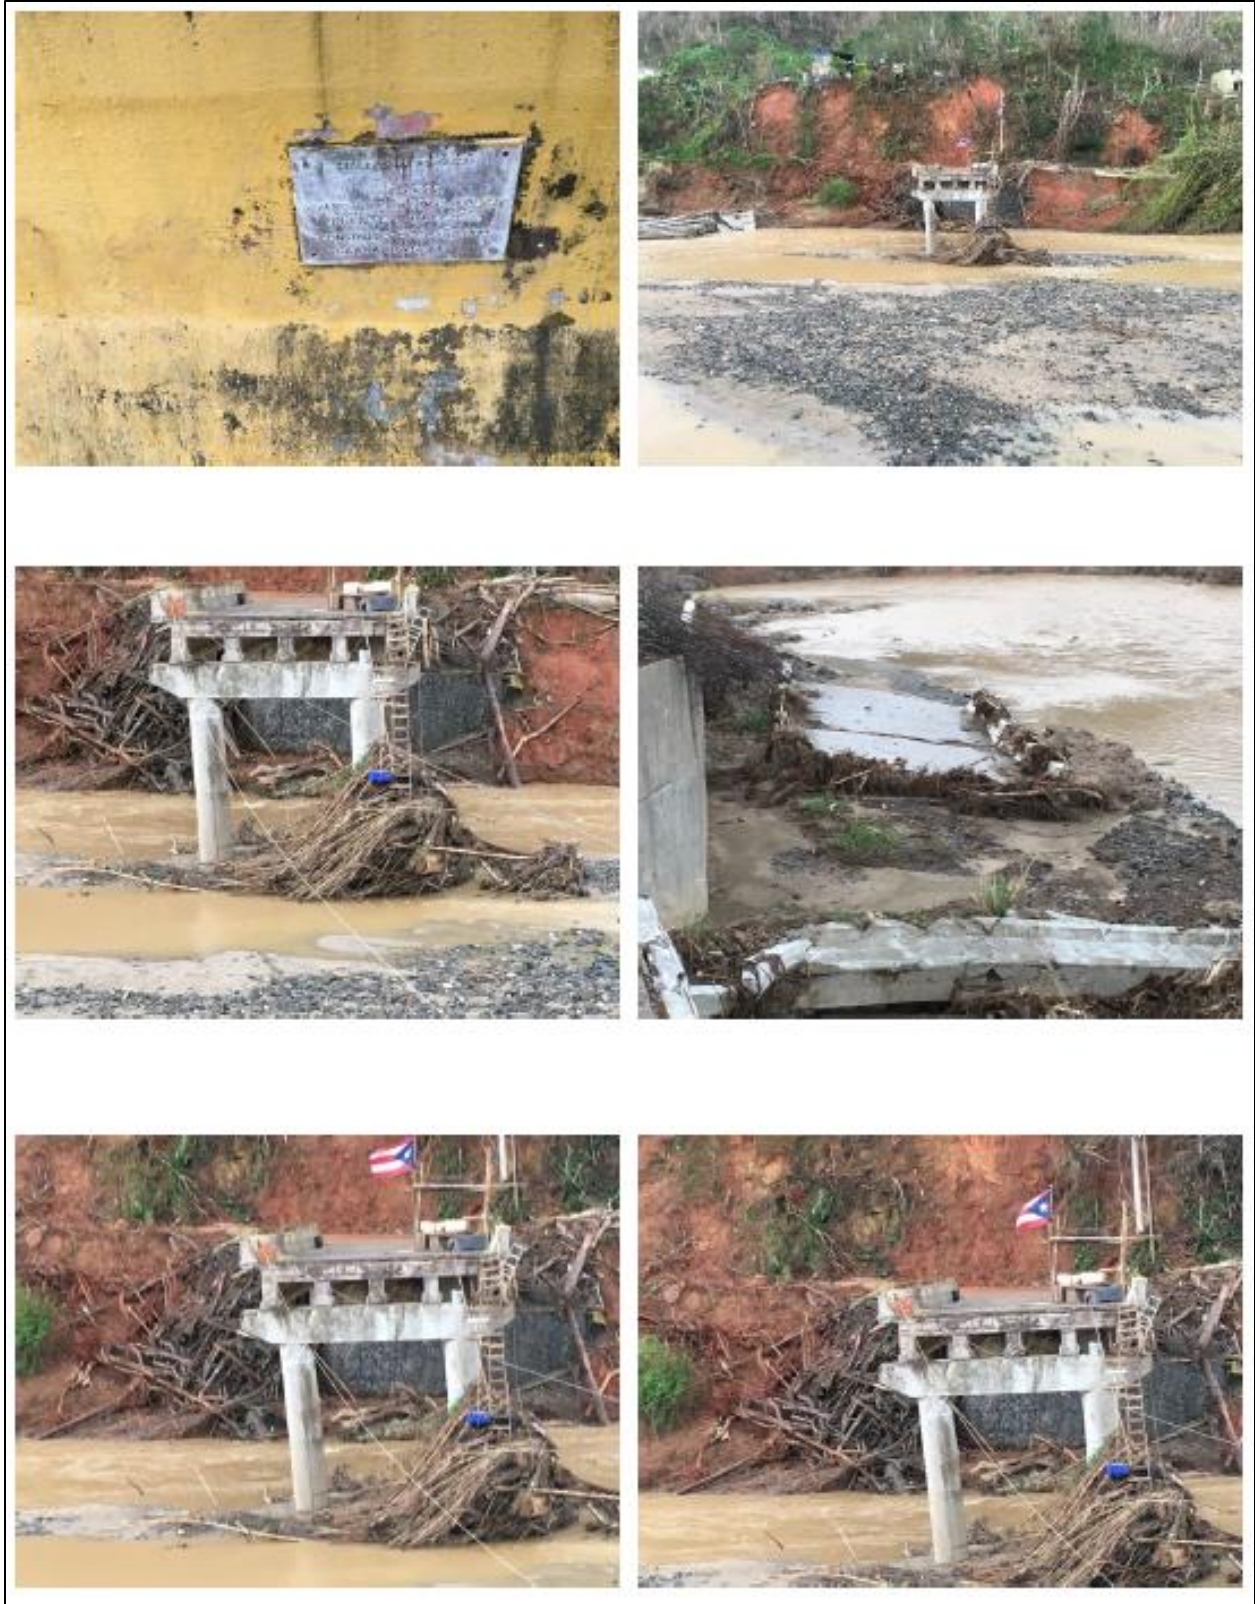
COMMENTS: Item 113 - 0 The bridge was failed

Figure 2-260: Bridge 1467 from October 11, 2017 inspection (source: PRHTA)

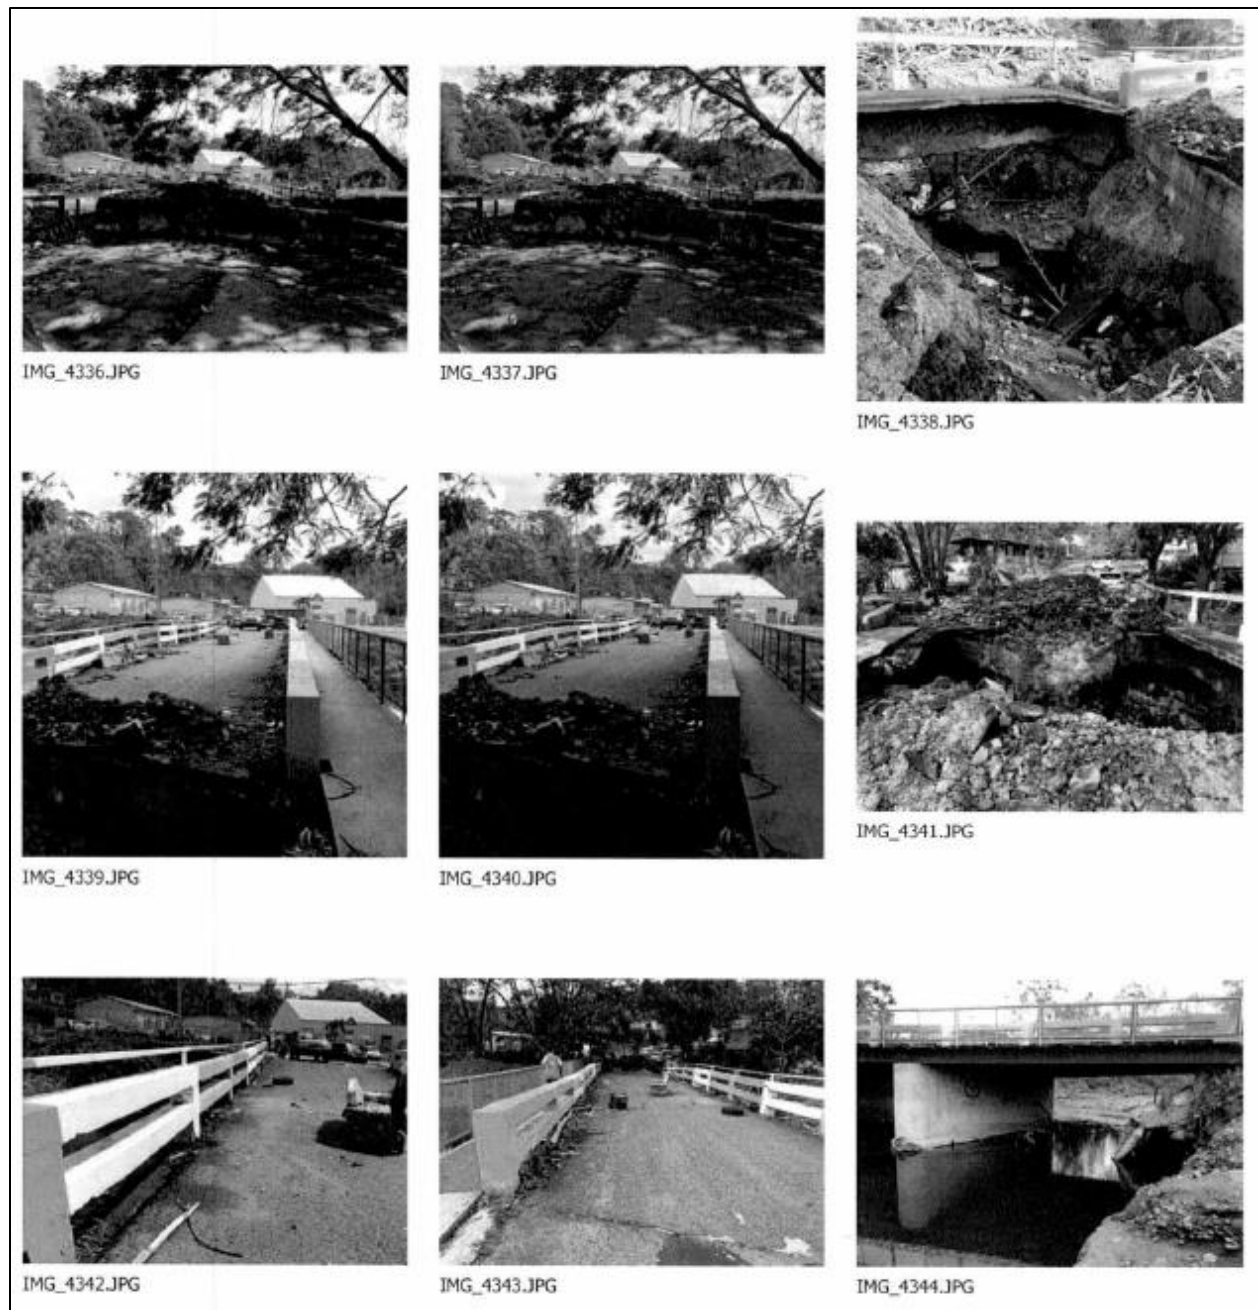
Figure 2-291: Bridge 1714 photos from September 22, 2017 inspection (source: PRHTA)

ACTION REQUIRED (PROVIDE COMMENTS):		
<input type="checkbox"/> NO FURTHER ACTION	<input type="checkbox"/> FURTHER INSPECTION REQUESTED	<input checked="" type="checkbox"/> EMERGENCY CLOSURE
COMMENTS: <u>Puente colapso</u>		
_____ INCLUDE PHOTOS IN A SEPARATE SHEET

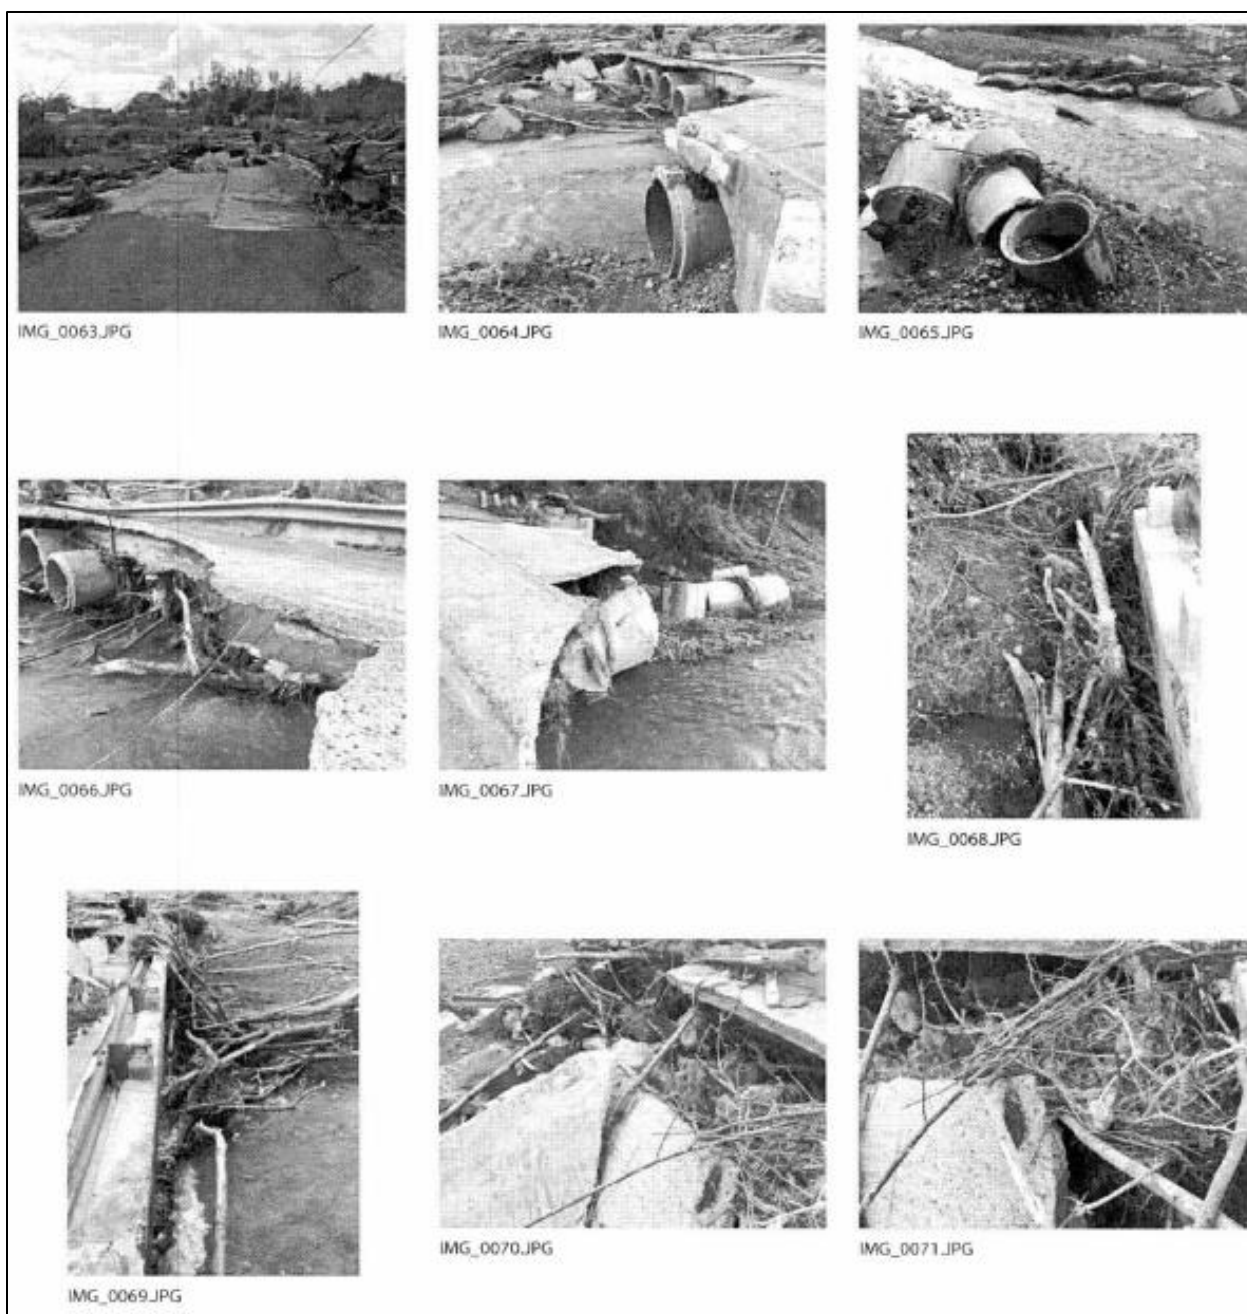
Figure 2-310: Bridge 1728 photos from September 23, 2017 inspection (source: PRHTA)

COMMENTS: <u>Puente colapsó, barrels fallaron</u>		
_____ INCLUDE PHOTOS IN A SEPARATE SHEET

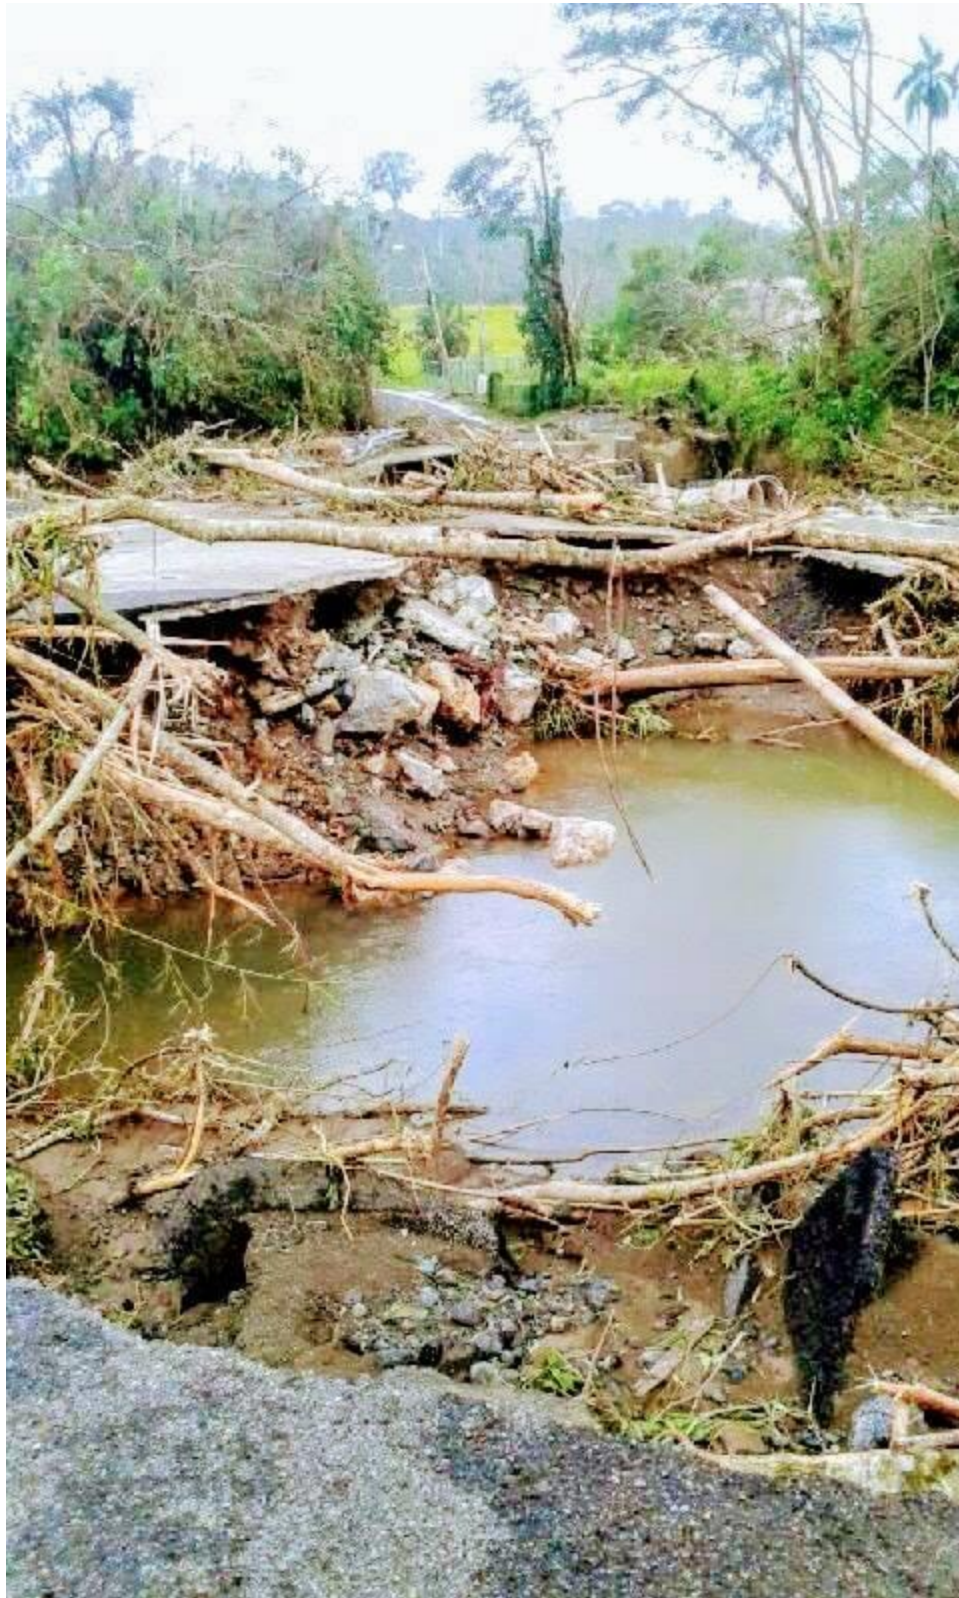
Figure 2-314: Social media image of collapsed Bridge 1728 (source: Coleccionistas Coampi)

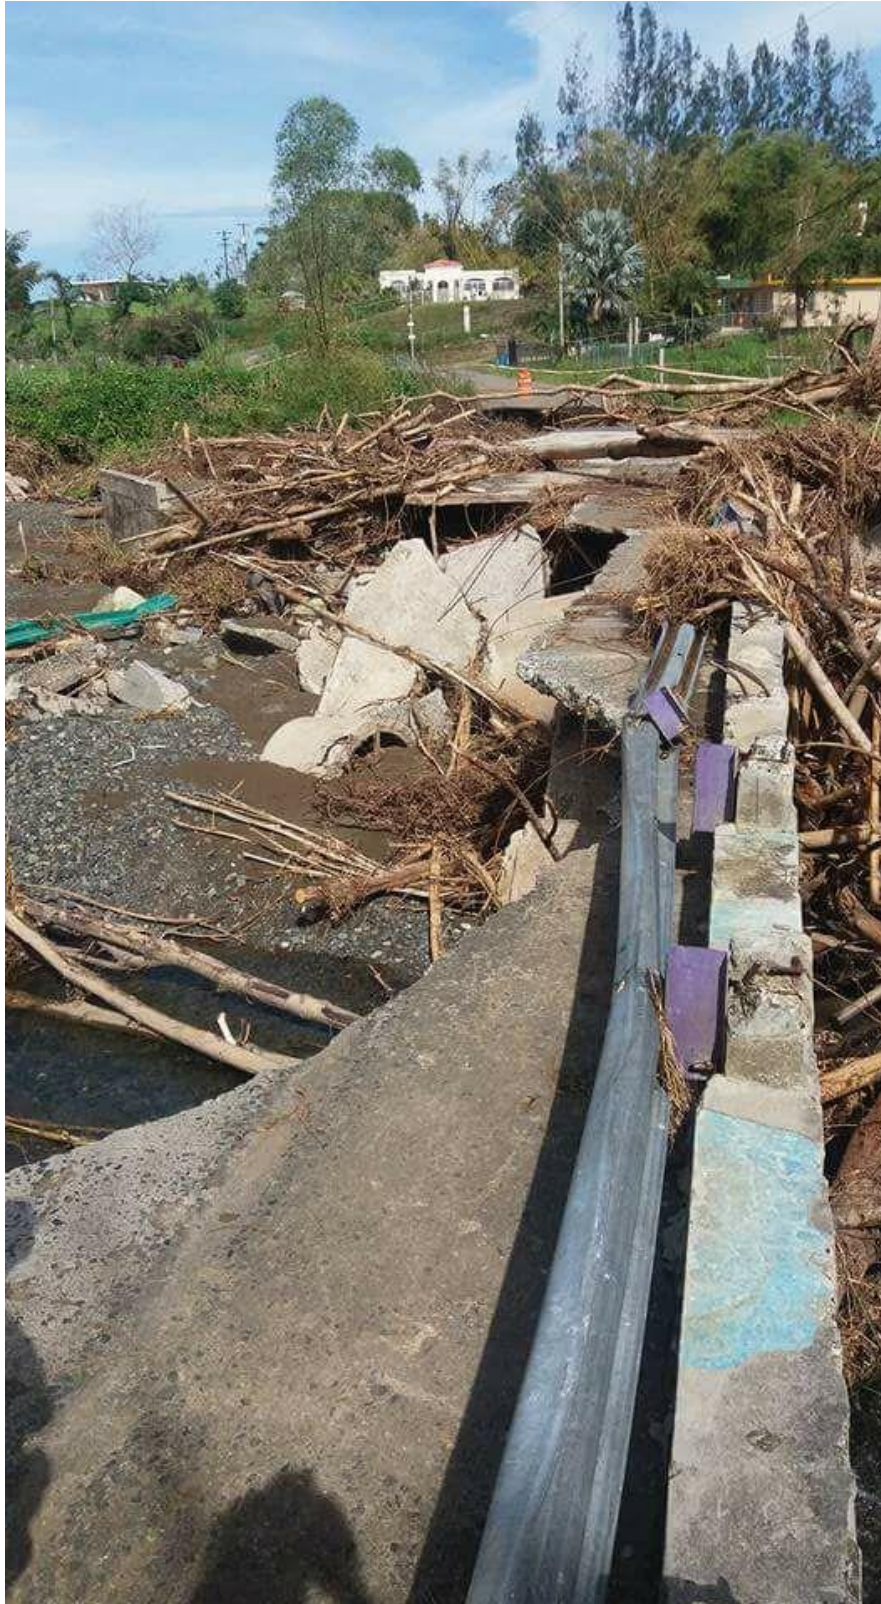
Figure 2-315: Social media image of collapsed Bridge 1728 (source: Leyda Ortiz)

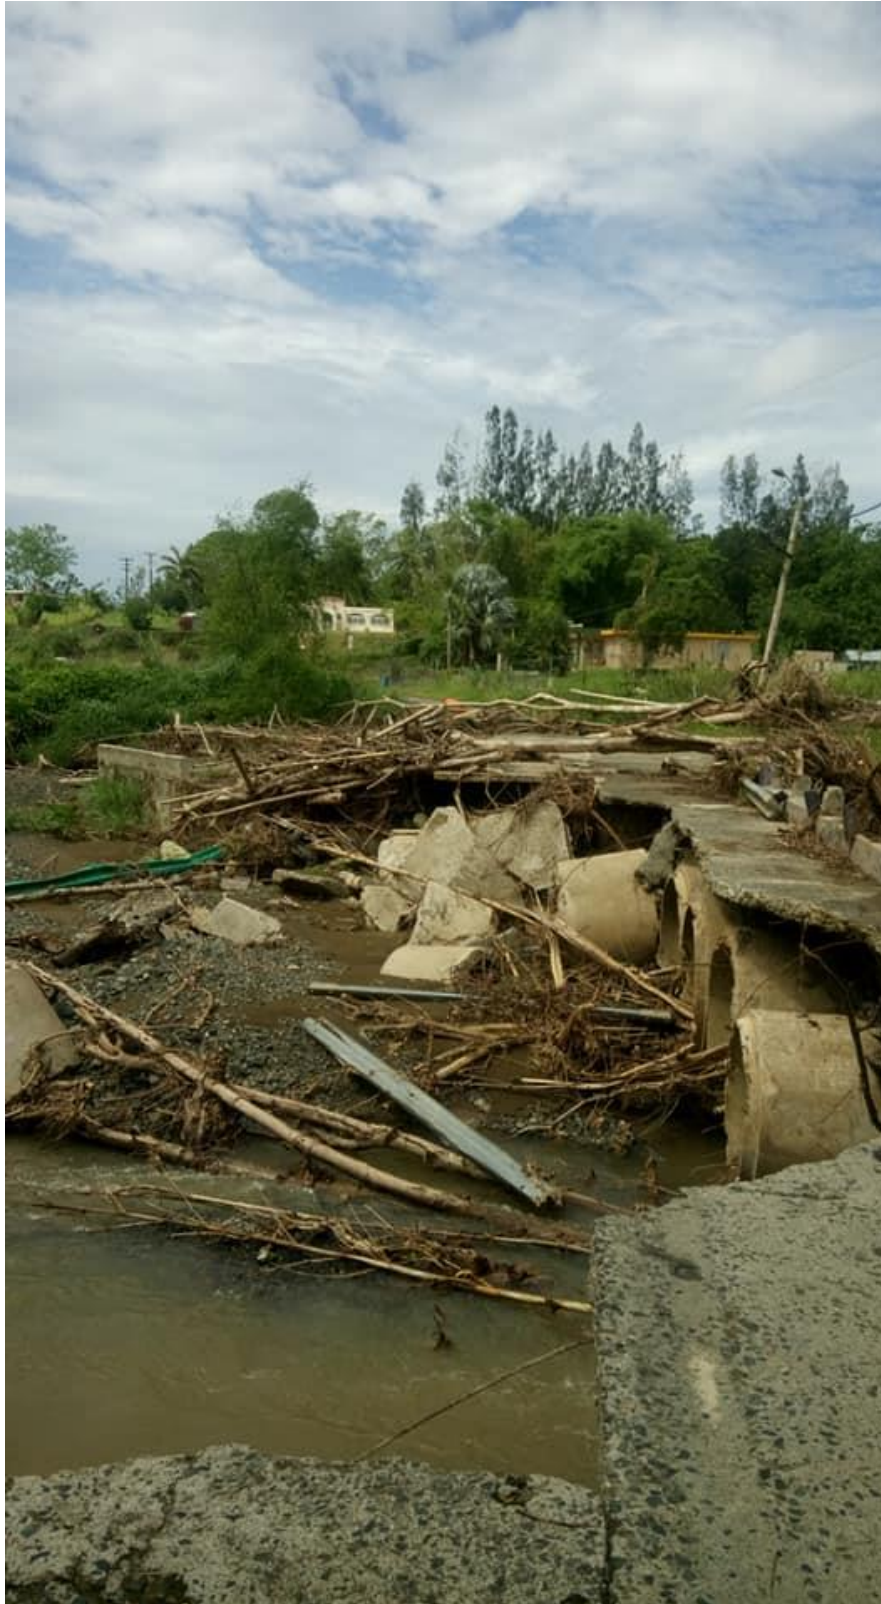
Figure 2-316: Social media image of collapsed Bridge 1728 (source: Miriam Cruz Miranda)

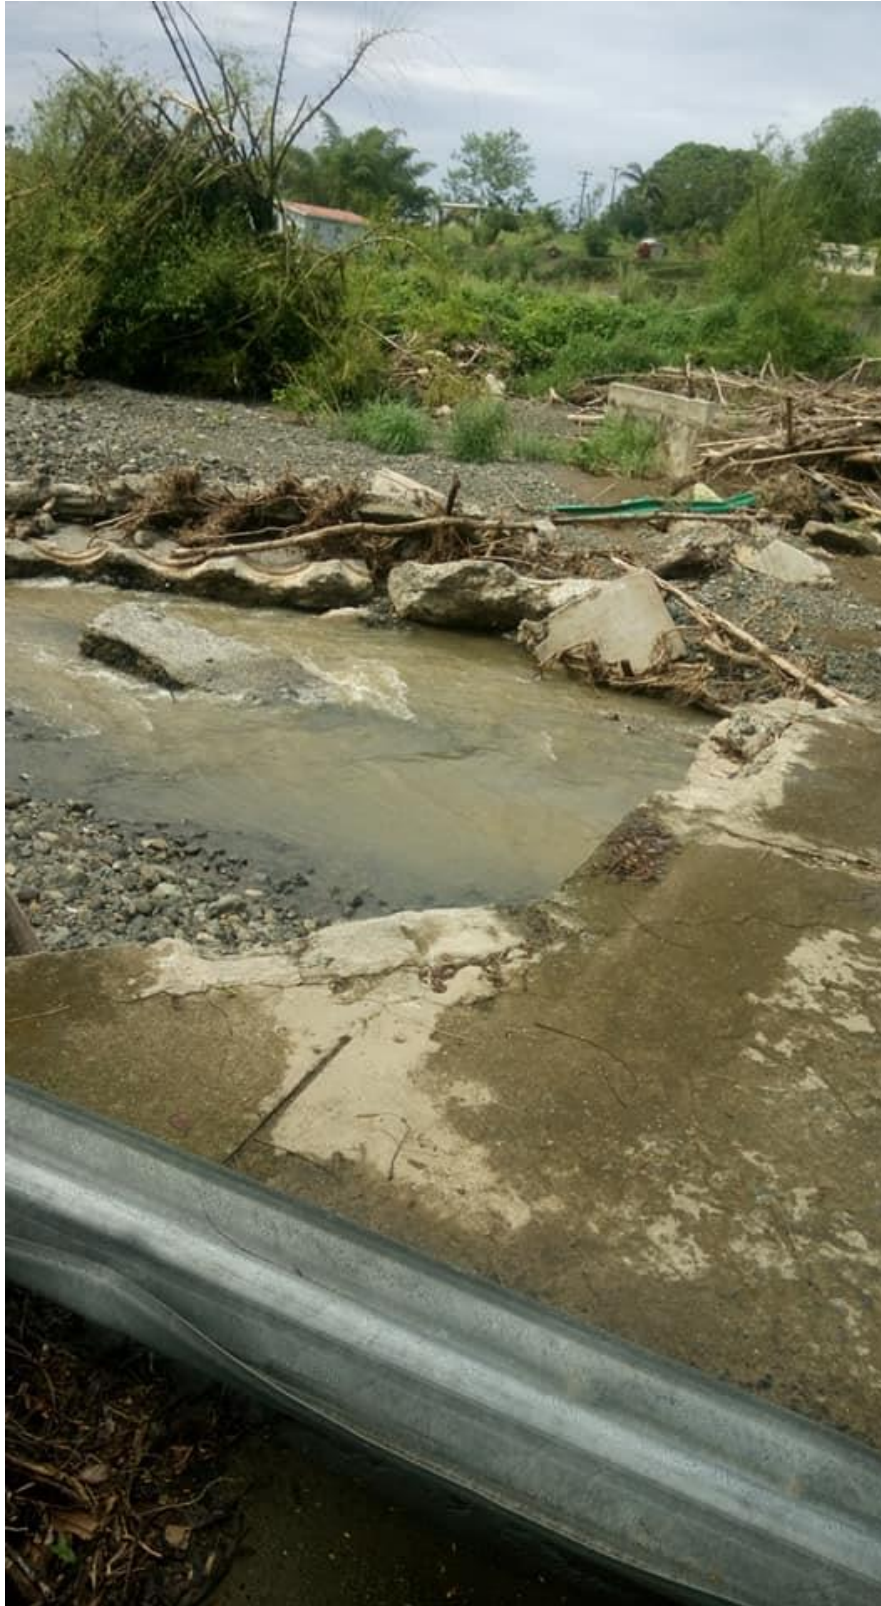
Figure 2-317: Social media image of collapsed Bridge 1728 (source: Miriam Cruz Miranda)
