Improving Transportation Infrastructure Resilience against Hurricanes, other Natural Disasters, and Weathering: Part III - Analysis of motor vehicle bridges failures due to Hurricane Maria

FINAL REPORT
August 2022

Transportation Infrastructure Research Center – TIRC
Polytechnic University of Puerto Rico
377 Ponce de Leon Ave, San Juan, PR 00918

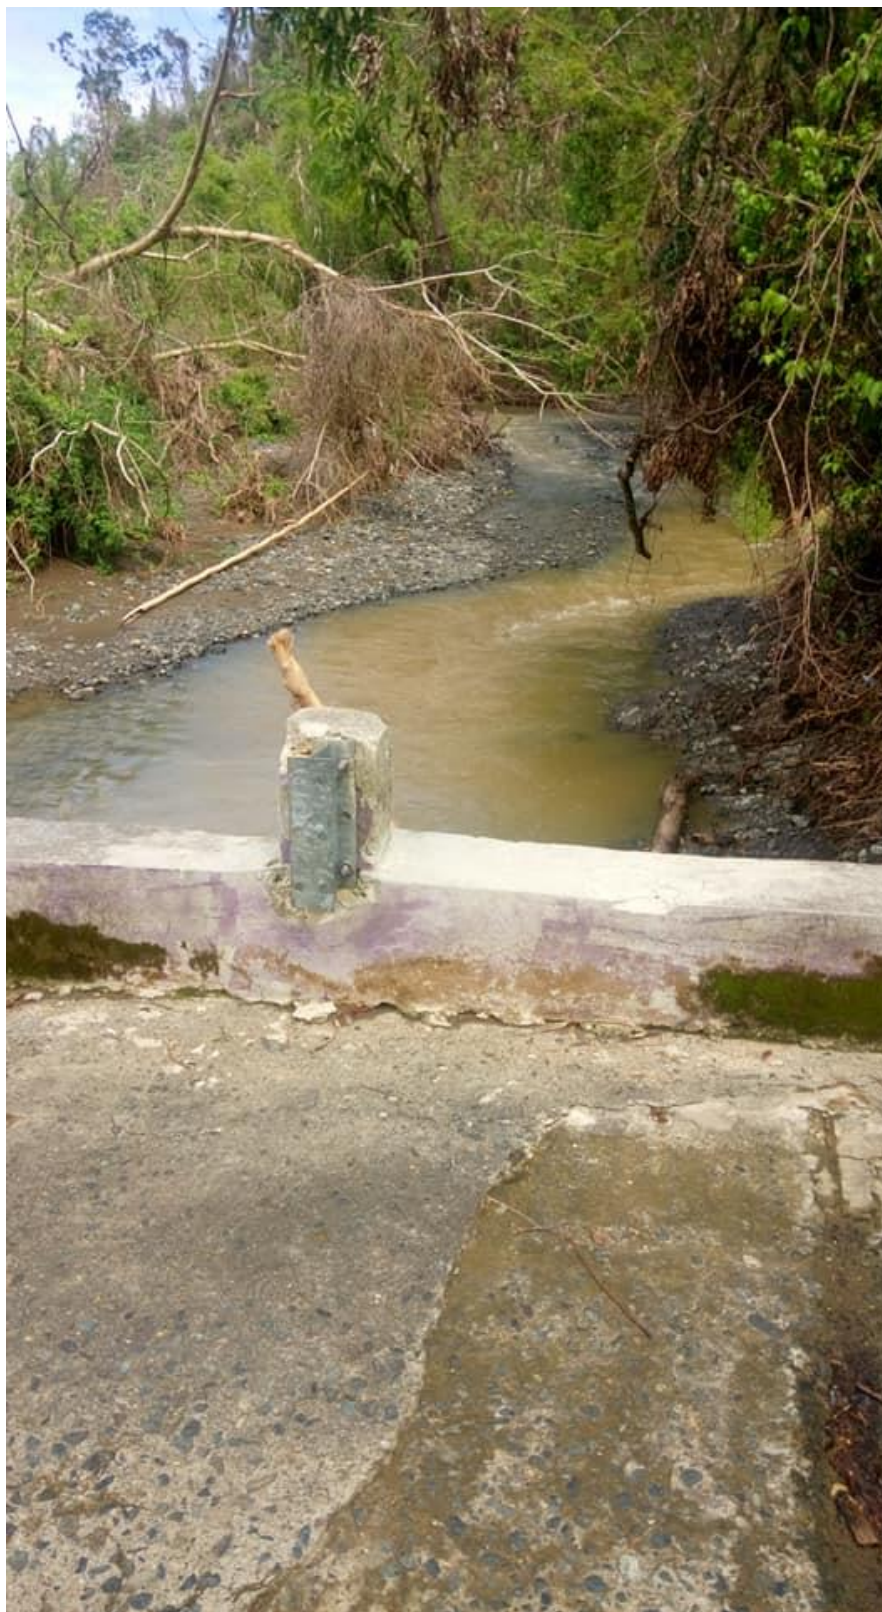
Figure 2-318: Social media image of collapsed Bridge 1728 (source: Miriam Cruz Miranda)

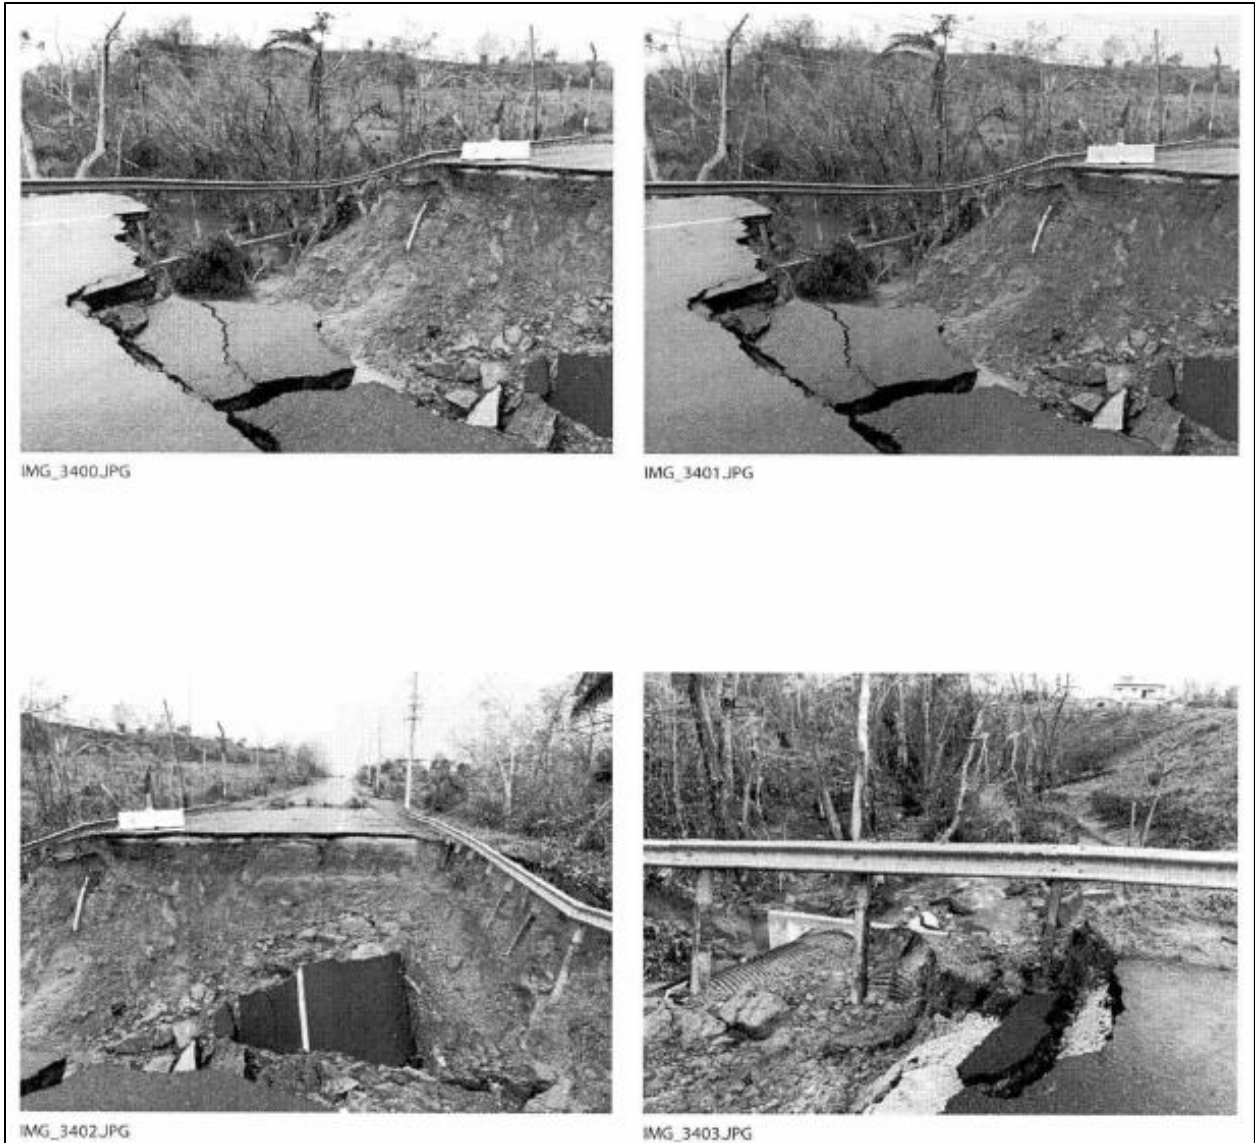
Figure 2-328: Bridge 1733 photos from September 22, 2017 inspection (source: PRHTA)

<input type="checkbox"/> NO FURTHER ACTION	<input type="checkbox"/> FURTHER INSPECTION REQUESTED	<input checked="" type="checkbox"/> EMERGENCY CLOSURE
COMMENTS: <u>Cerrado, Puente Celapá 12 tubos corrugados</u> <u>fallaron</u>		
INCLUDE PHOTOS IN A SEPARATE SHEET

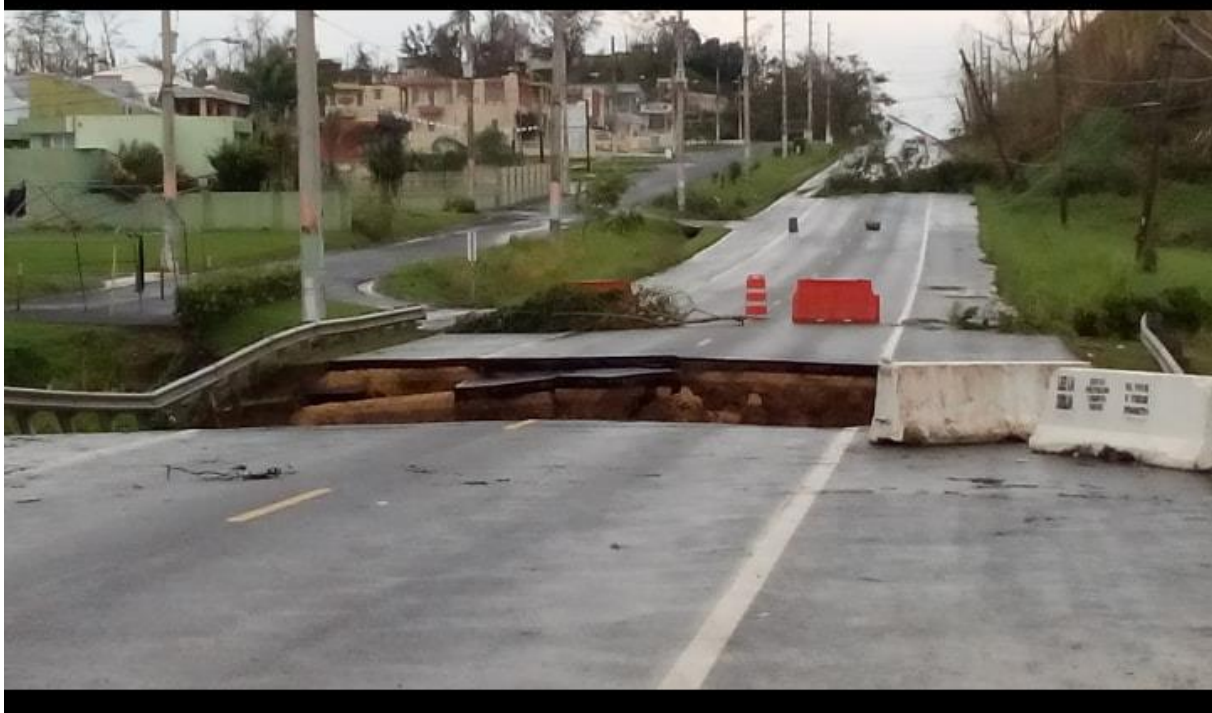
Figure 2-334: Social media image of collapsed Bridge 1733 (source: Joaquín Lebrón Rosado)

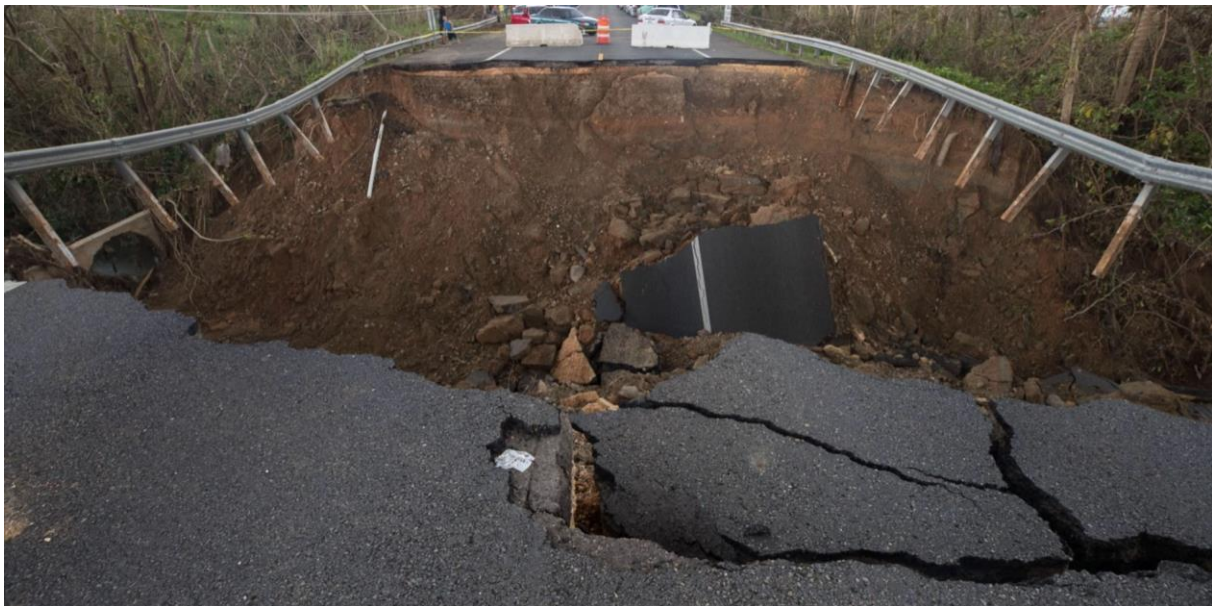
Figure 2-335: Collapsed Bridge 1733 image from news report (source: El Nuevo Día)

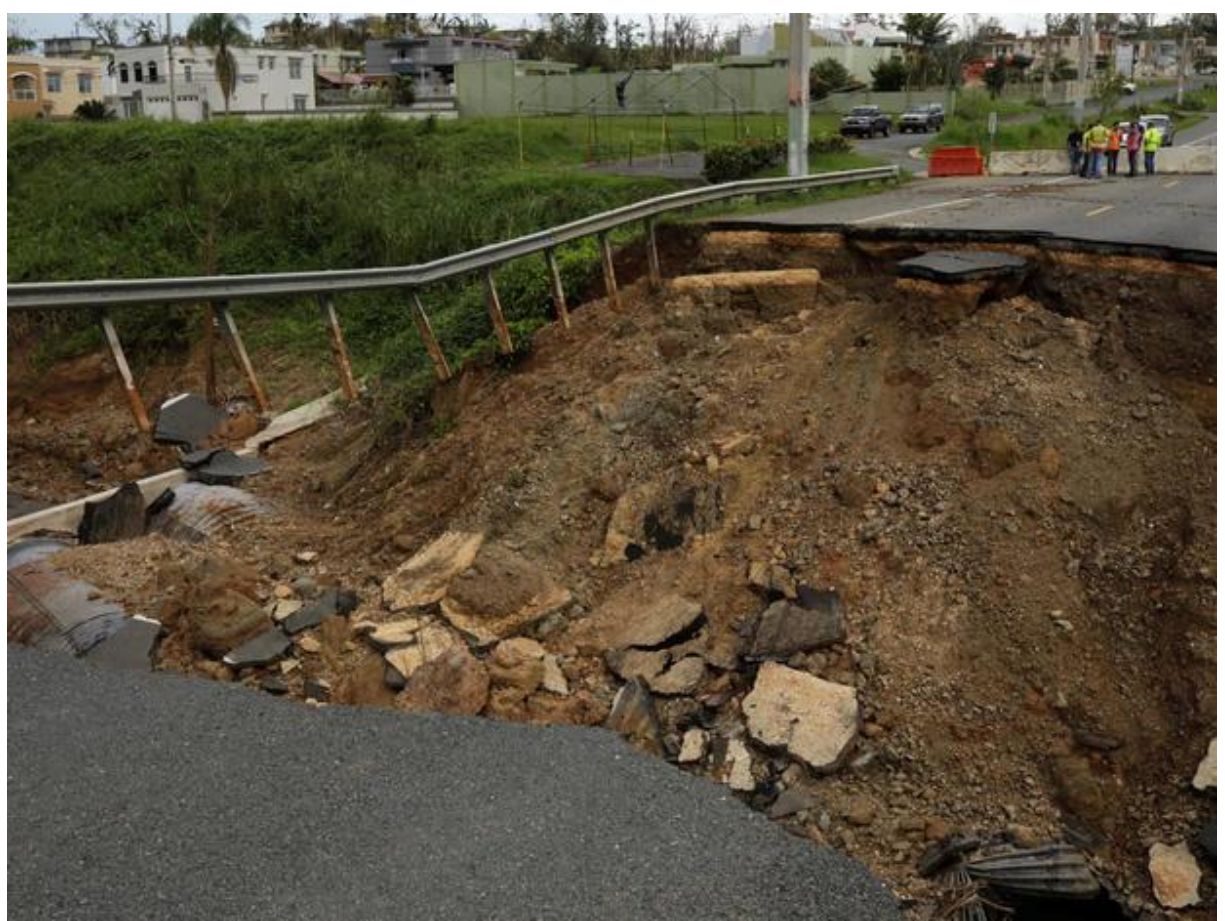
Figure 2-336: Collapsed Bridge 1733 image from news report (source: CBS News)

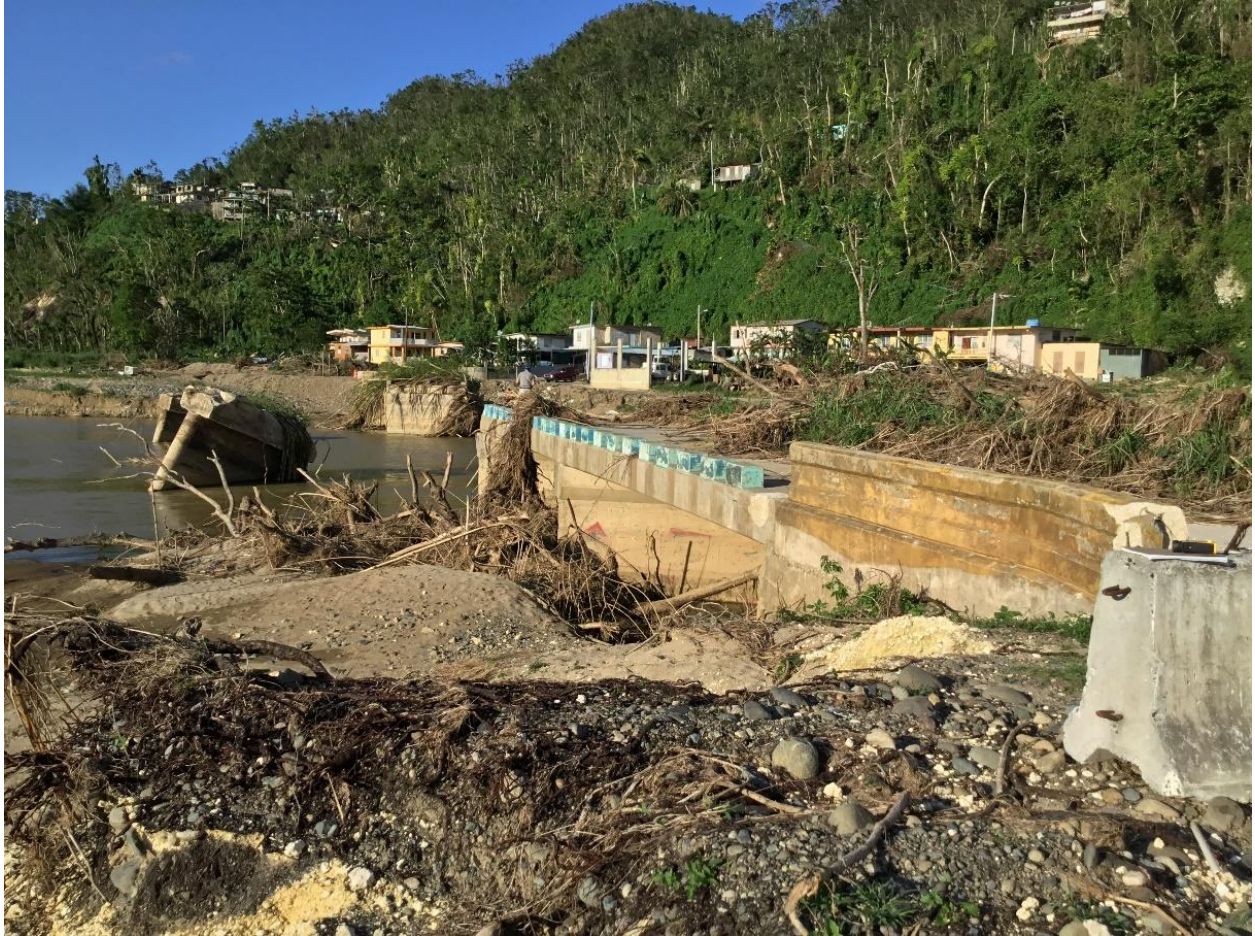
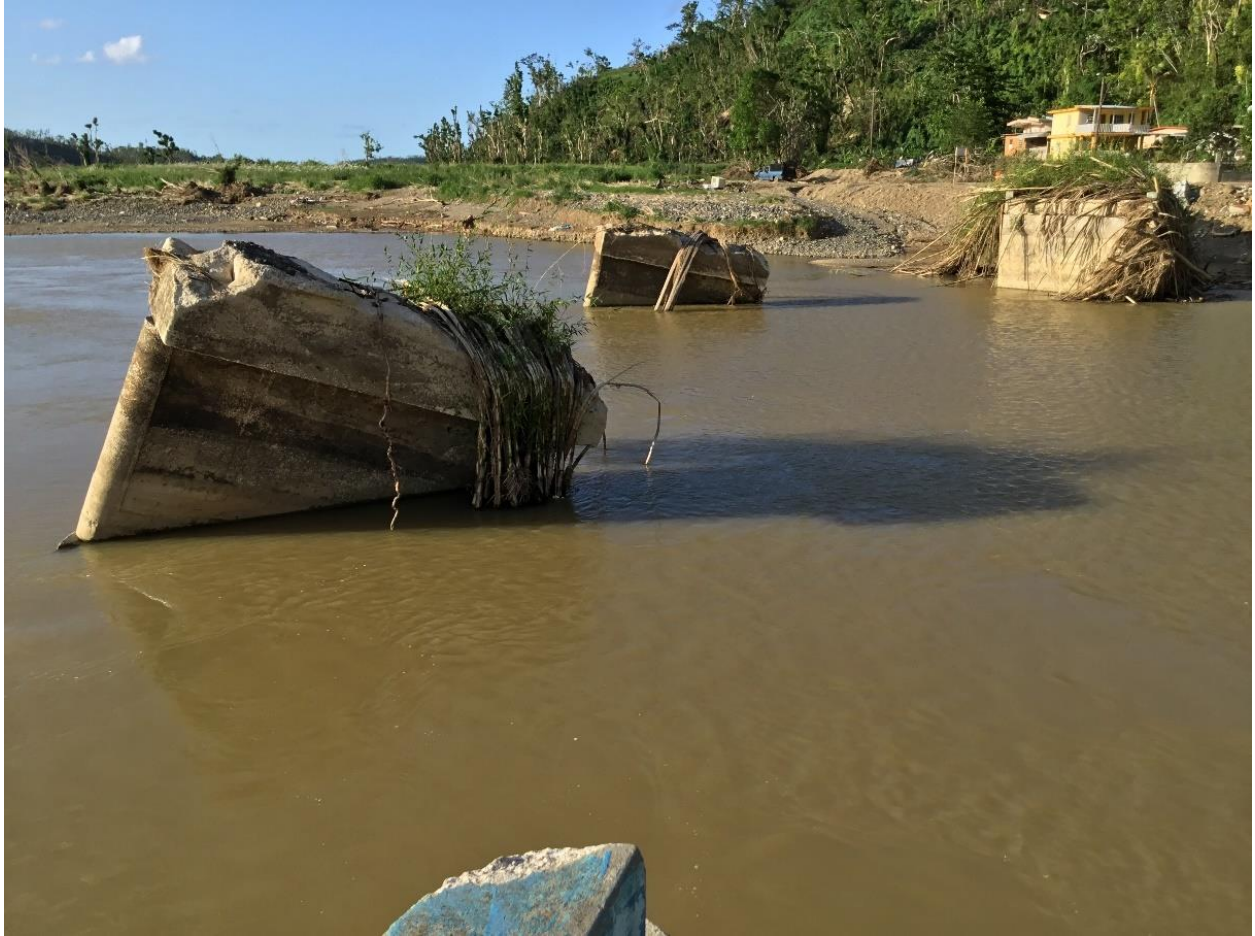
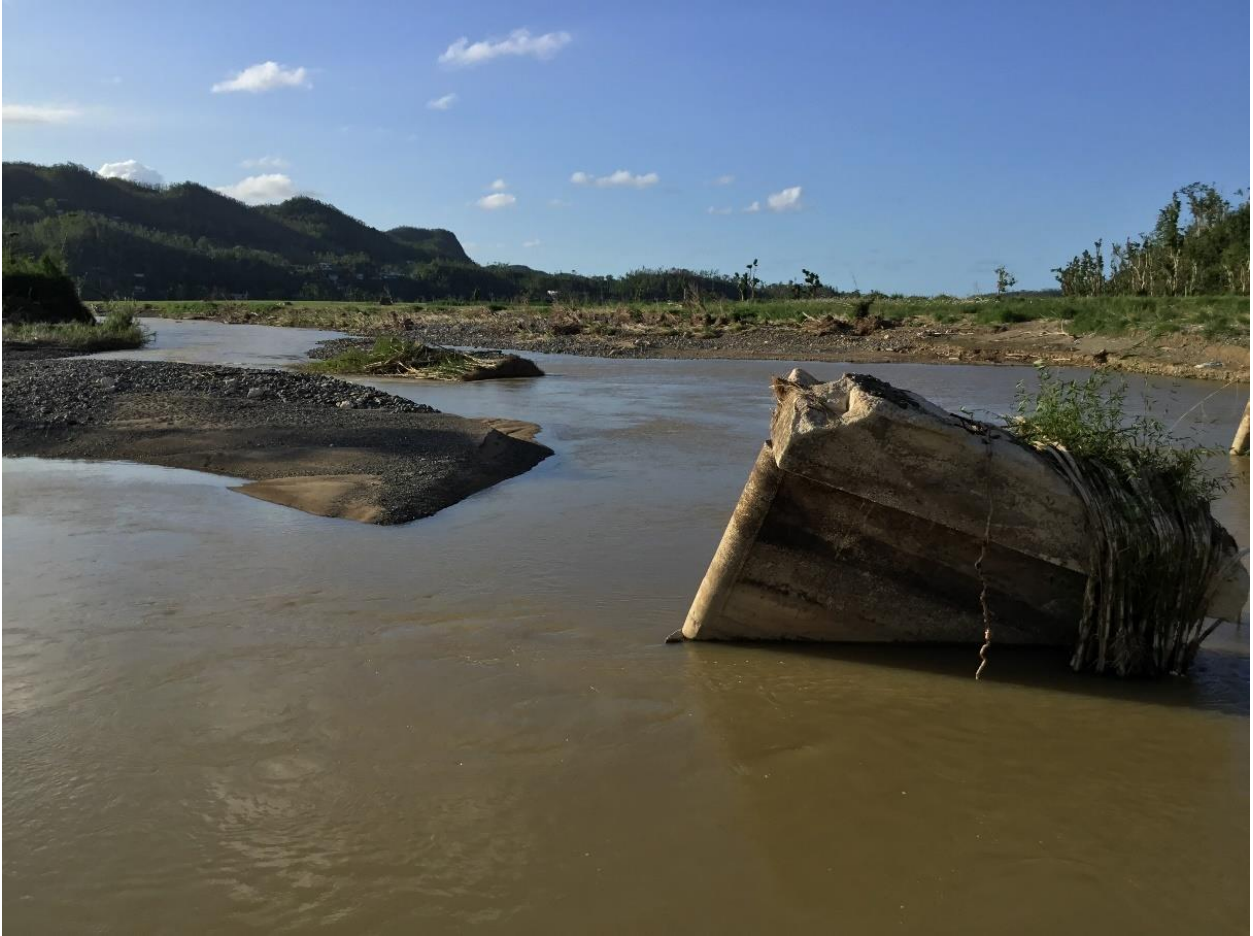
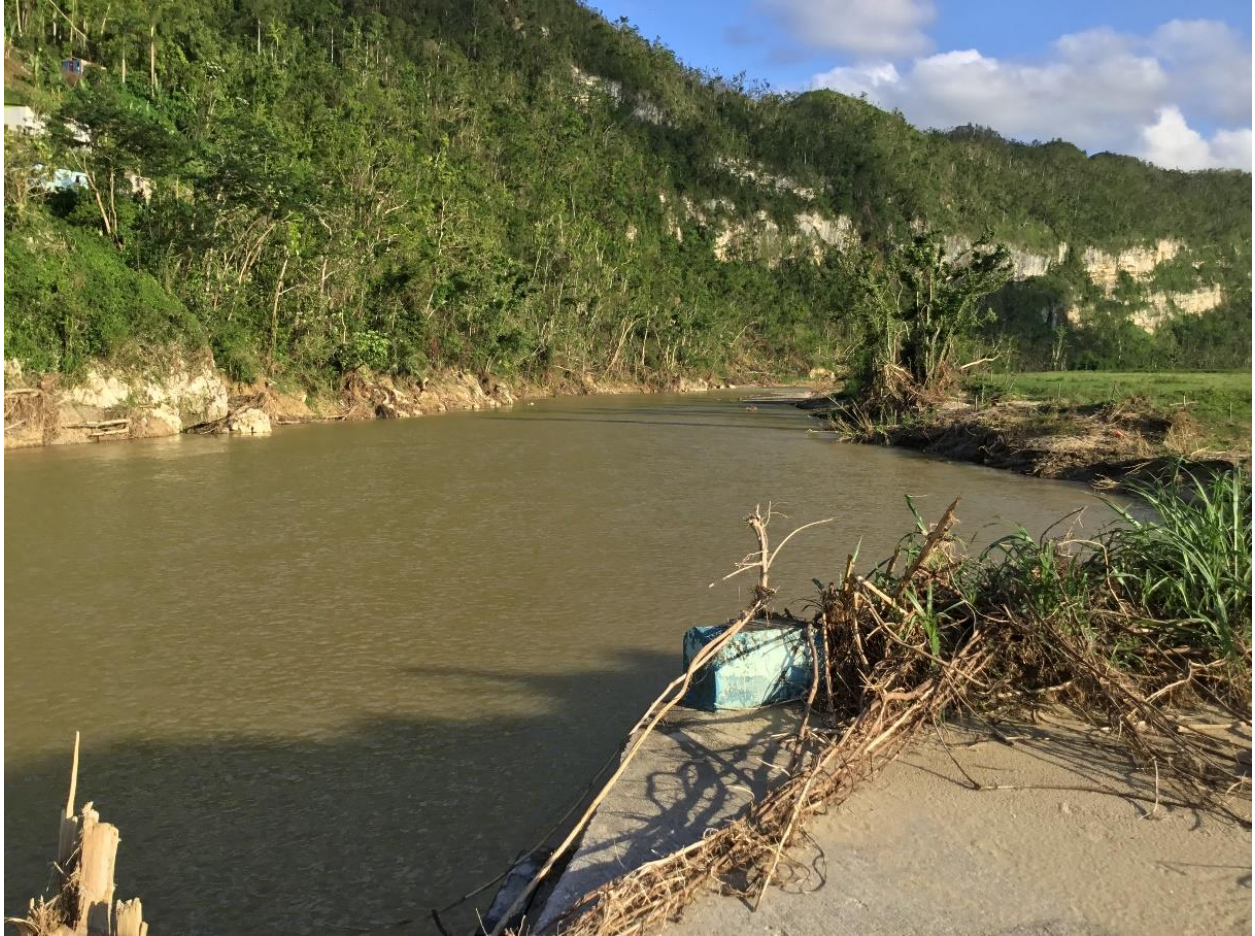
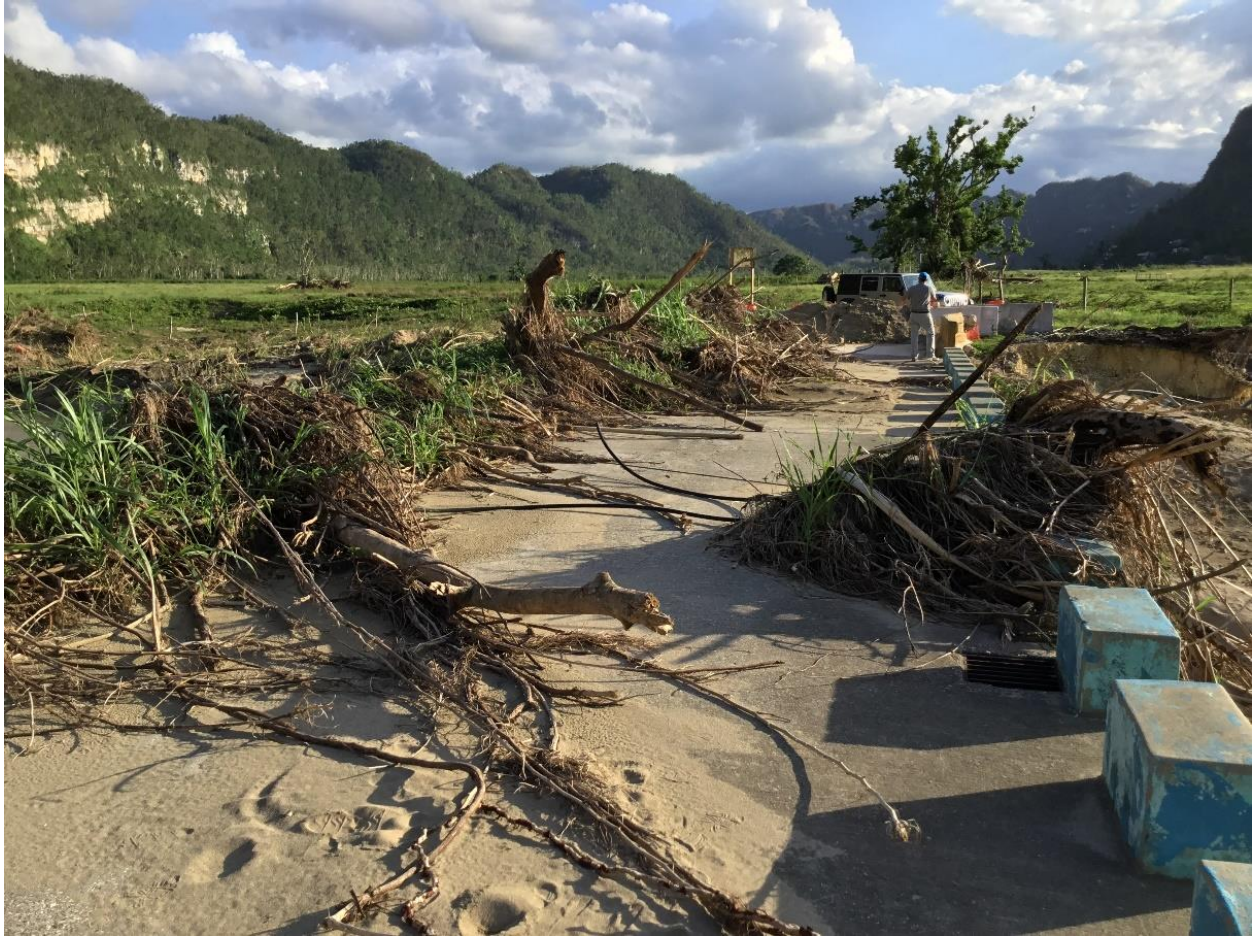
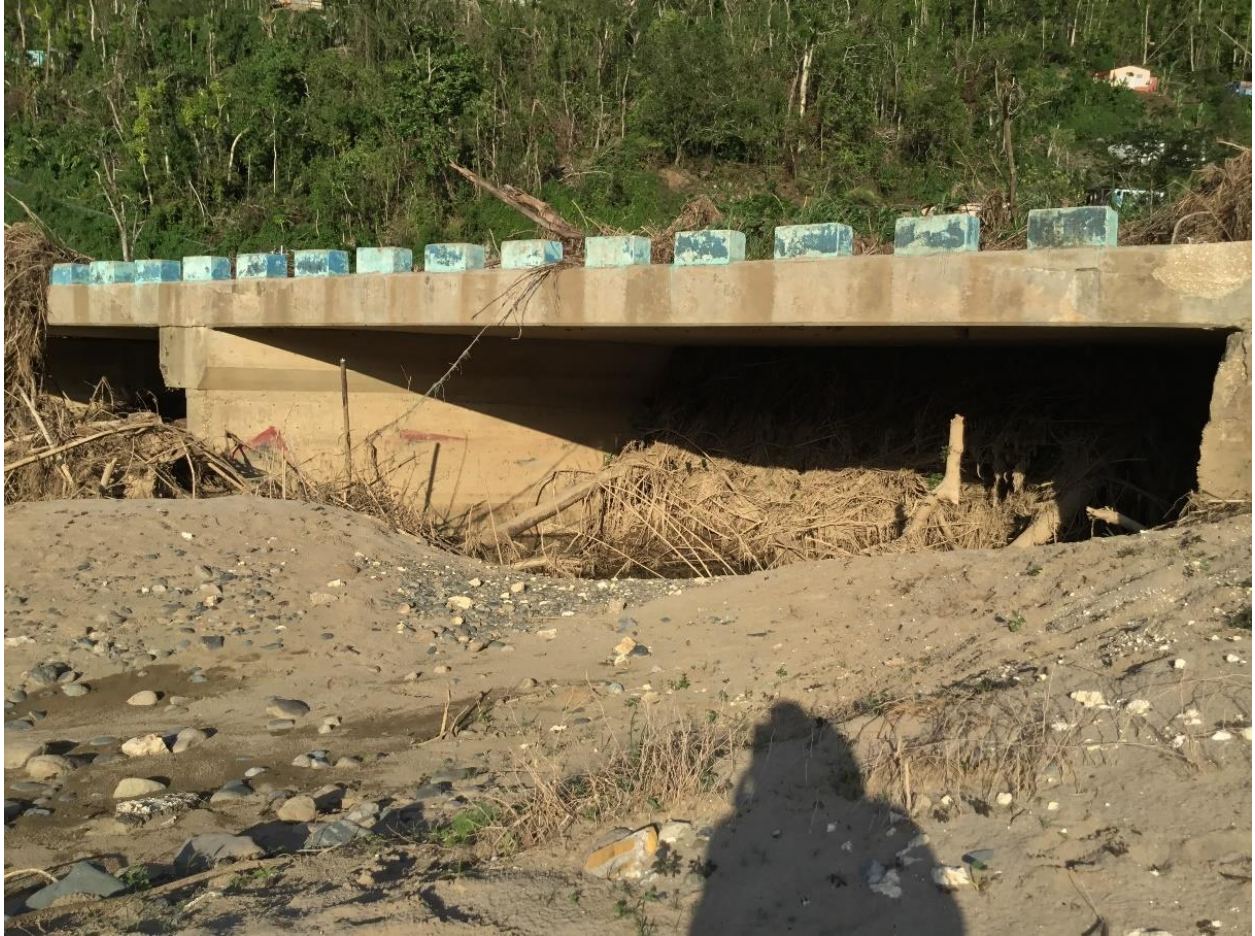
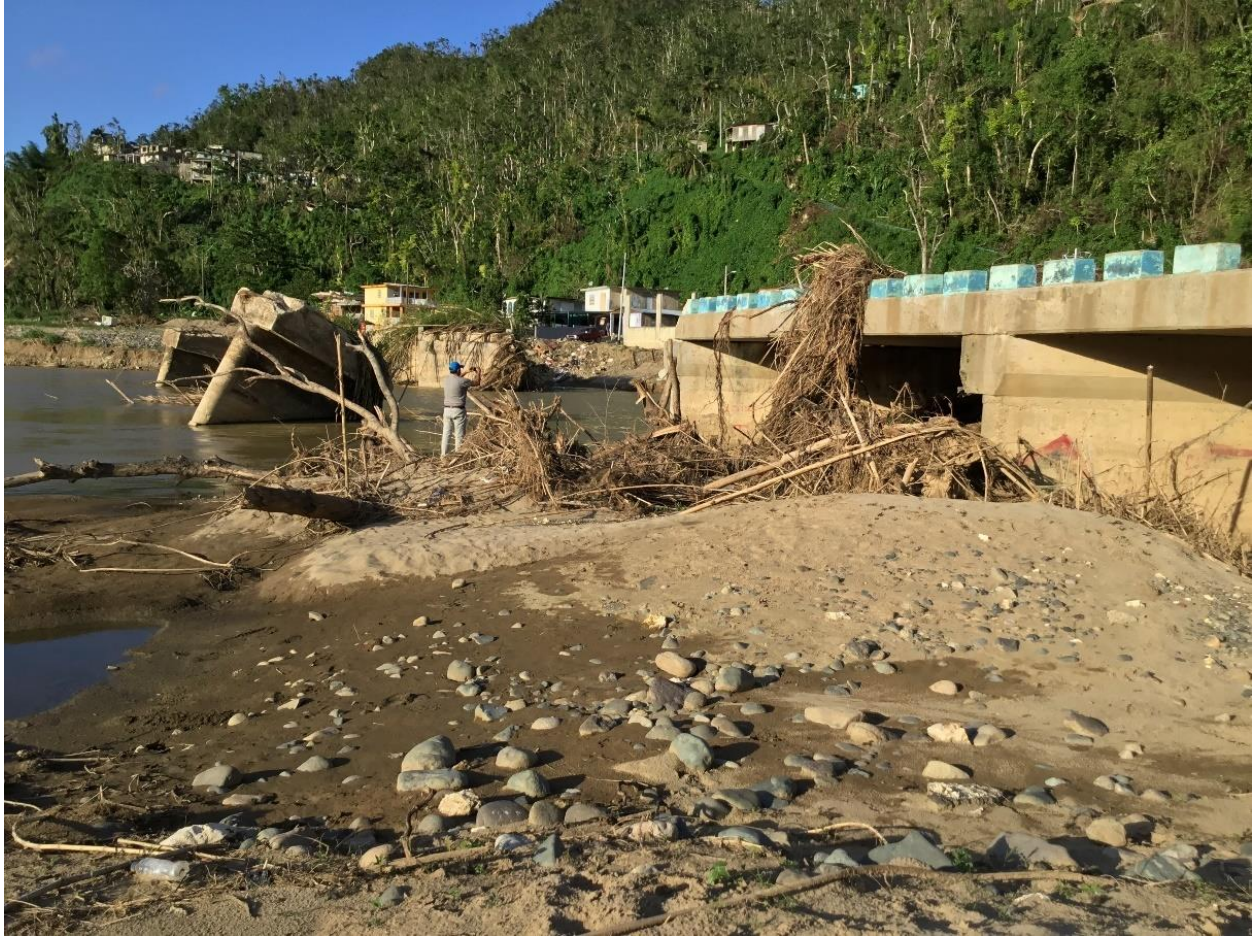
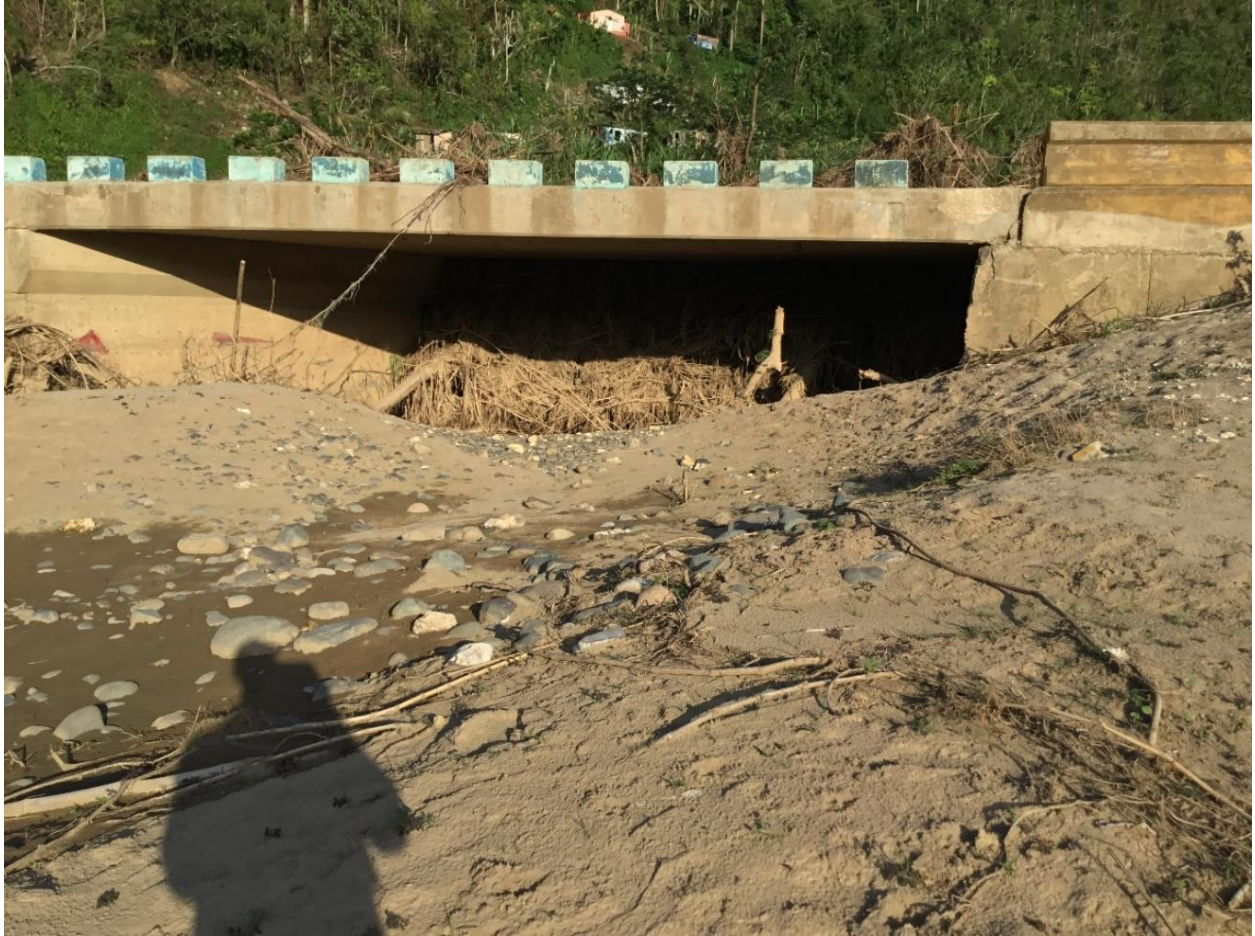
Figure 2-355: Collapsed Bridge 1917 (source: PRHTA)

Figure 2-356: Collapsed Bridge 1917 (source: PRHTA)

Figure 2-357: Collapsed Bridge 1917 (source: PRHTA)

Figure 2-358: Collapsed Bridge 1917 (source: PRHTA)

Figure 2-359: Collapsed Bridge 1917 (source: PRHTA)

Figure 2-360: Collapsed Bridge 1917 (source: PRHTA)

Figure 2-361: Collapsed Bridge 1917 (source: PRHTA)

Figure 2-362: Collapsed Bridge 1917 (source: PRHTA)

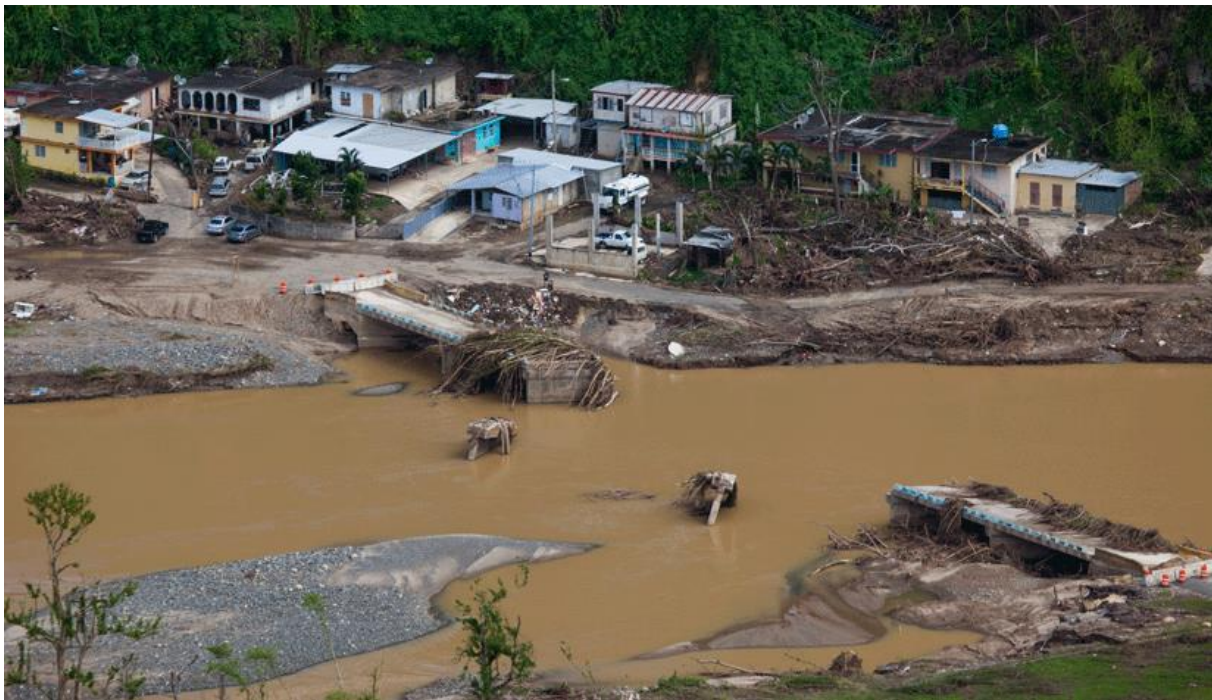
Figure 2-363: Social media image of collapsed Bridge 1917 (source: FEMA)

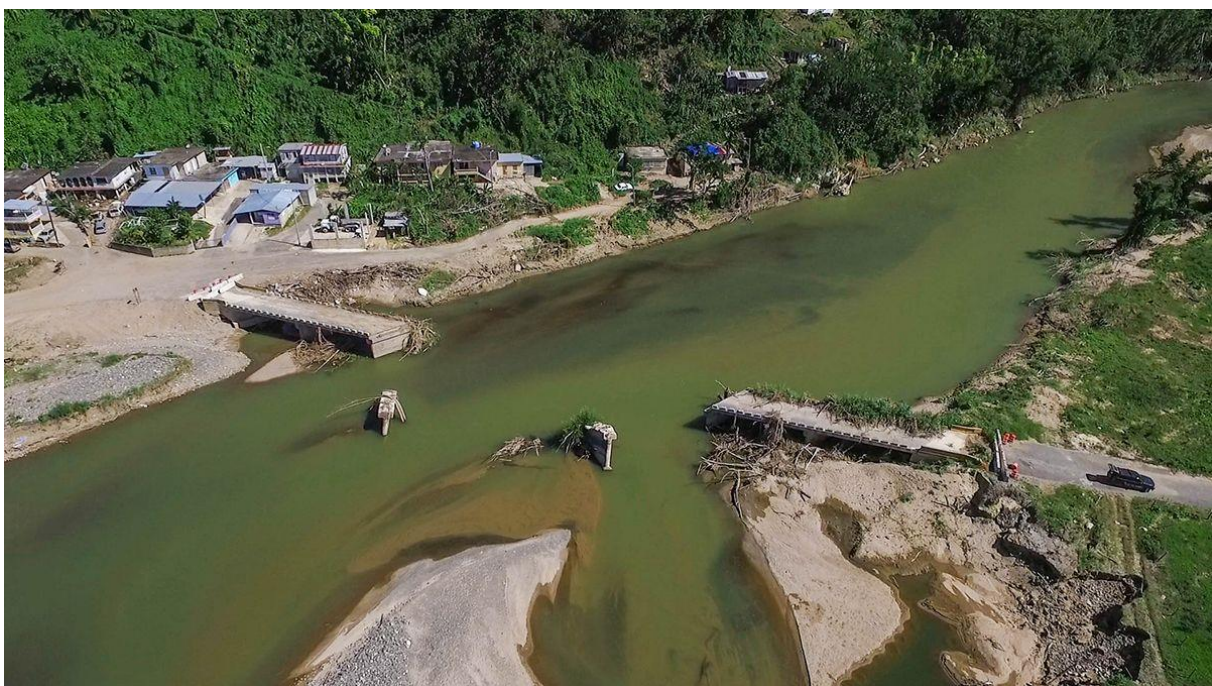
Figure 2-364: Social media image of collapsed Bridge 1917 (source: Mabey Bridge)

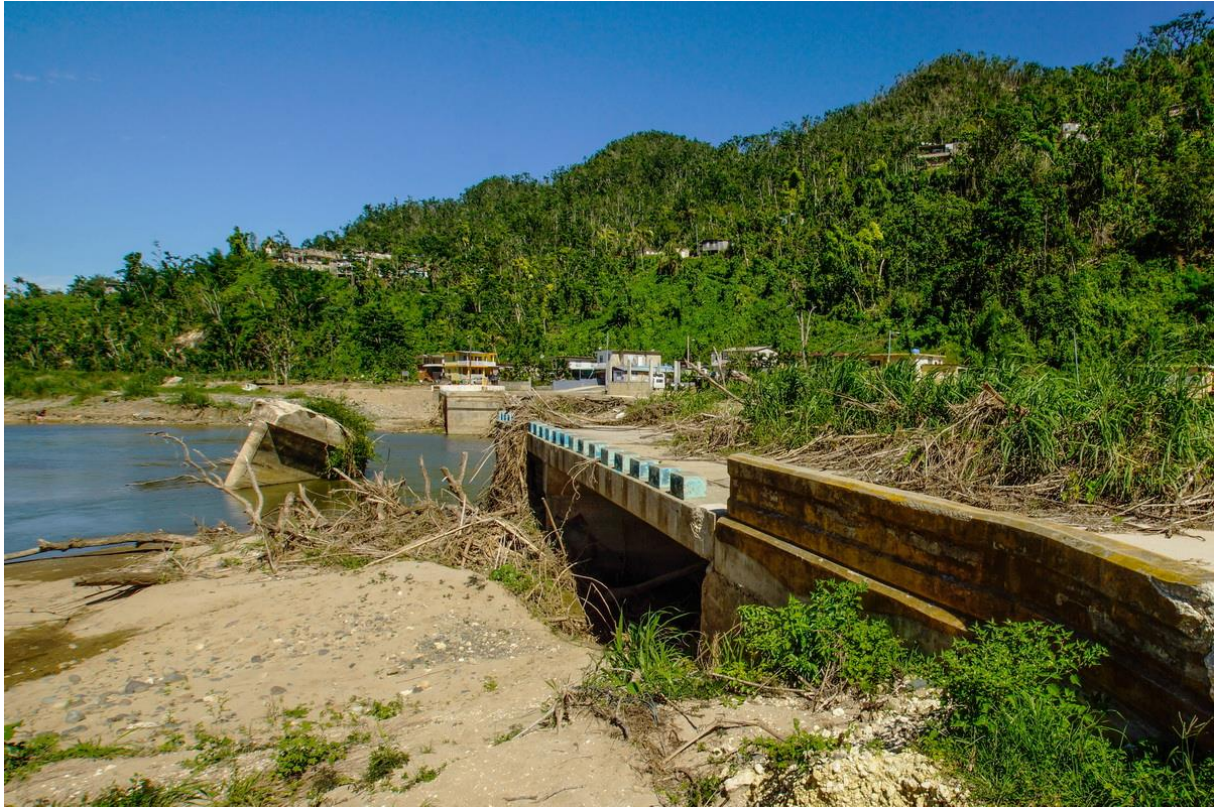
Figure 2-365: Social media image of collapsed Bridge 1917 (source: Construcciones José Carro)

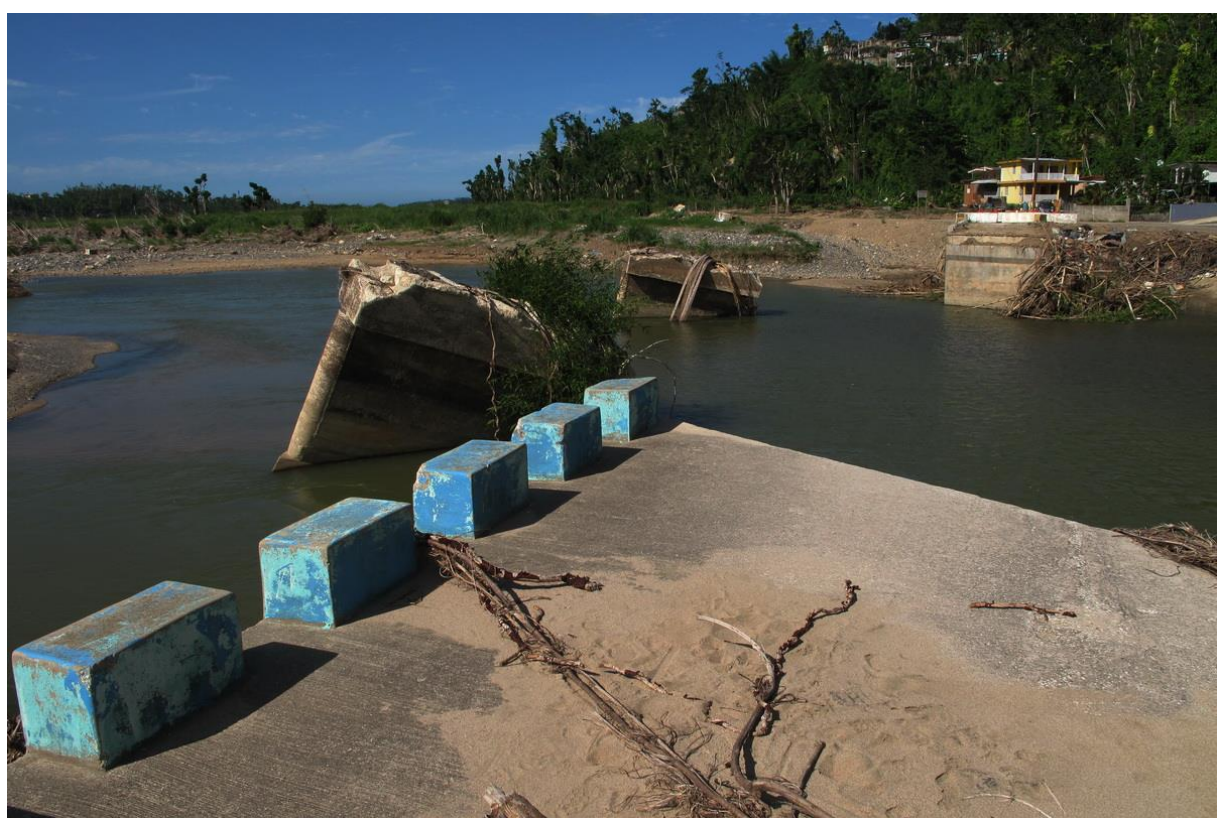
Figure 2-366: Social media image of collapsed Bridge 1917 (source: Construcciones José Carro)

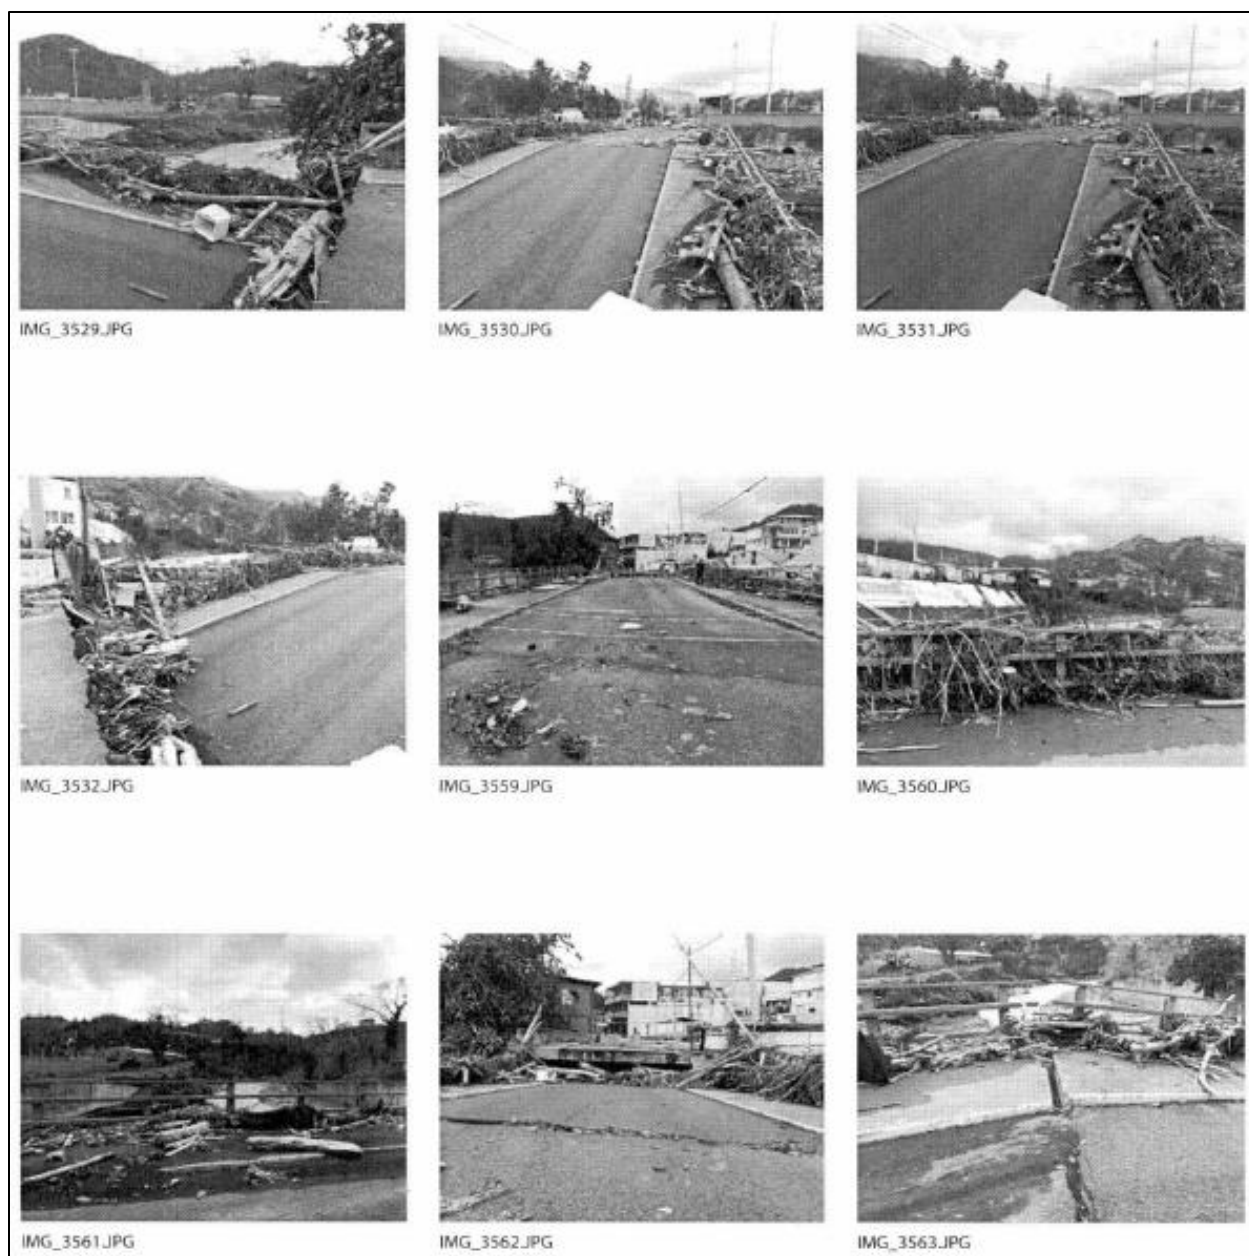
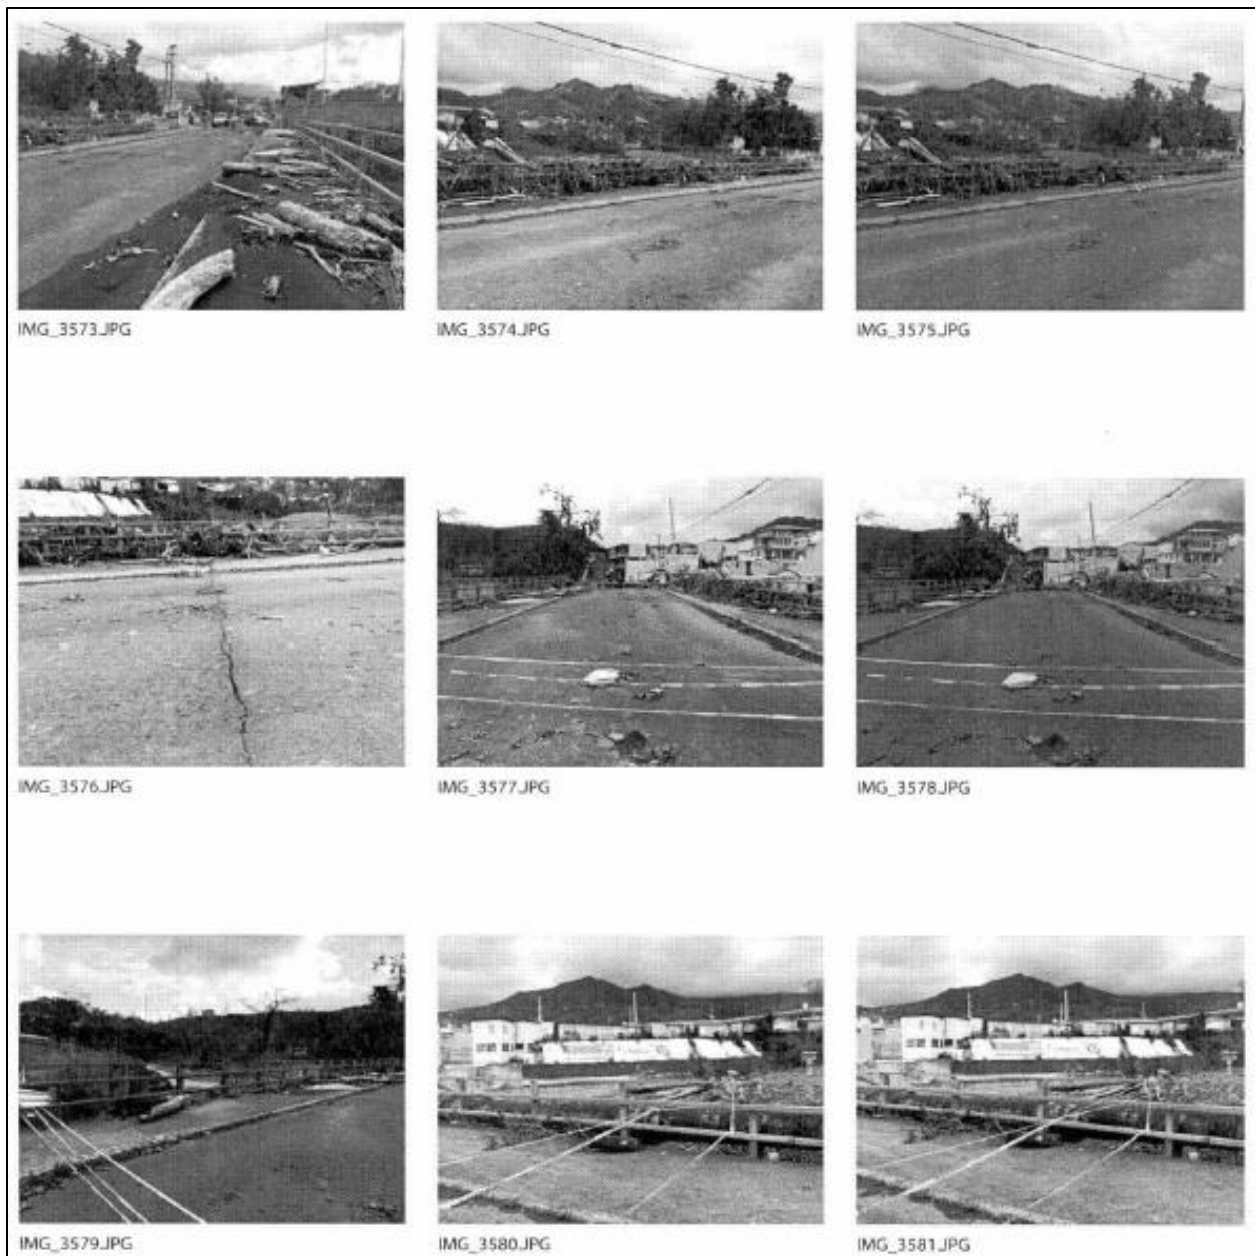
<input type="checkbox"/> NO FURTHER ACTION	<input type="checkbox"/> FURTHER INSPECTION REQUESTED	<input checked="" type="checkbox"/> EMERGENCY CLOSURE
COMMENTS: <u>Cerrado, tramo estribo pucbb colapso</u>		
<hr/>		
INCLUDE PHOTOS IN A SEPARATE SHEET

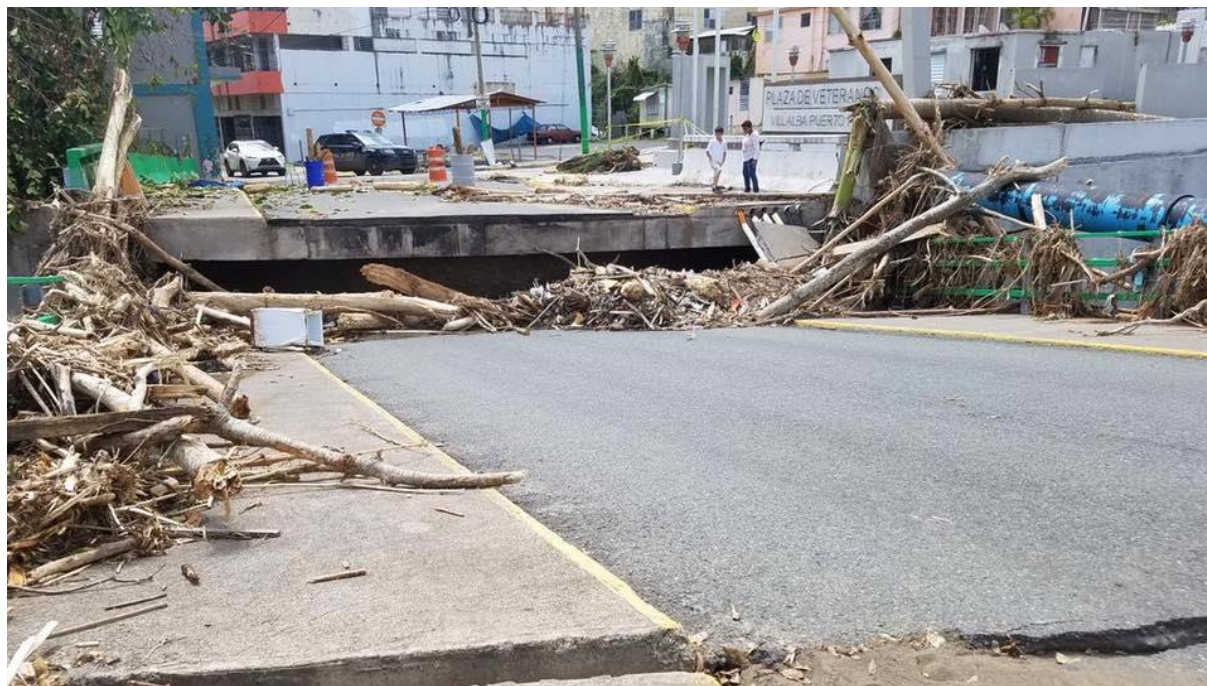
Figure 2-388: Social media image of collapsed Bridge 1962 (source: CHE)
