Improving Transportation Infrastructure Resilience against Hurricanes, other Natural Disasters, and Weathering: Part III - Analysis of motor vehicle bridges failures due to Hurricane Maria

FINAL REPORT
August 2022

Transportation Infrastructure Research Center – TIRC
Polytechnic University of Puerto Rico
377 Ponce de Leon Ave, San Juan, PR 00918

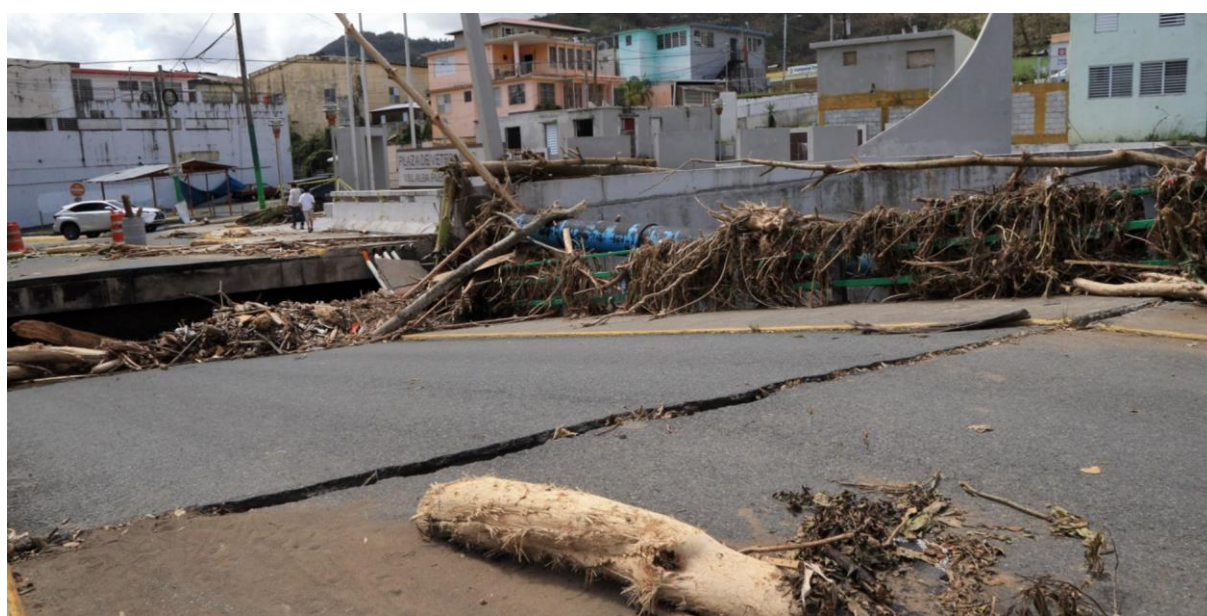
Figure 2-389: News report image of collapsed Bridge 1962 (source: El Nuevo Día)

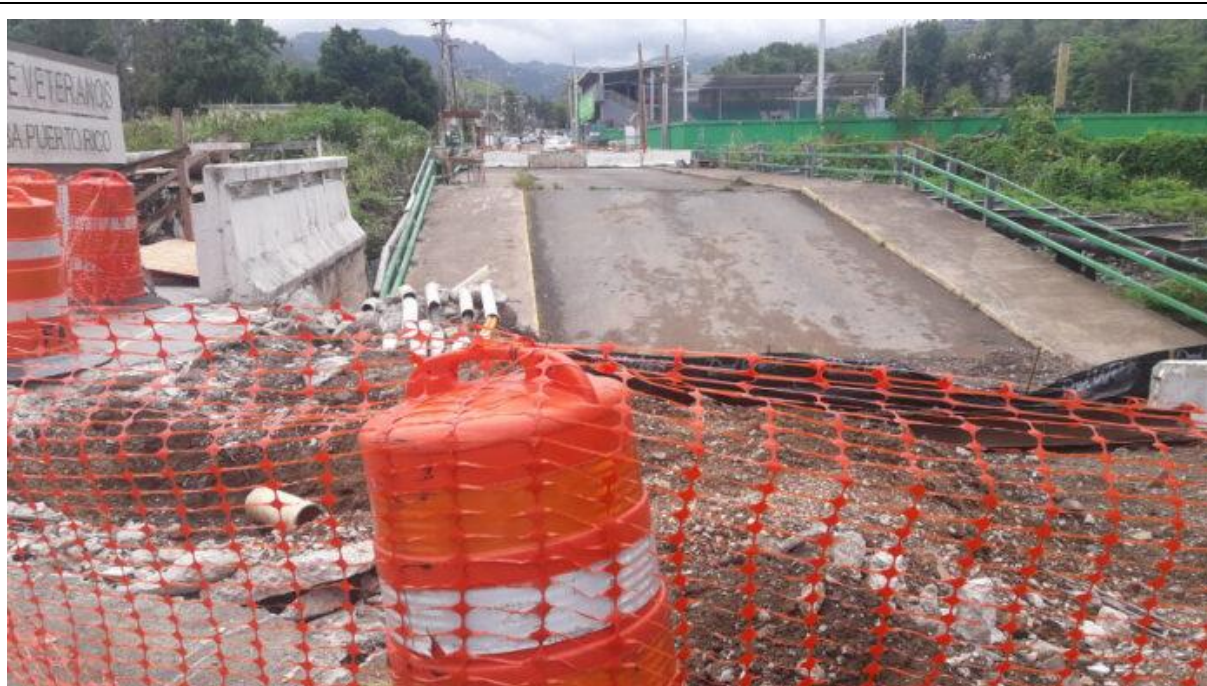
Figure 2-390: News report image of collapsed Bridge 1962 (source: Voces del Sur)

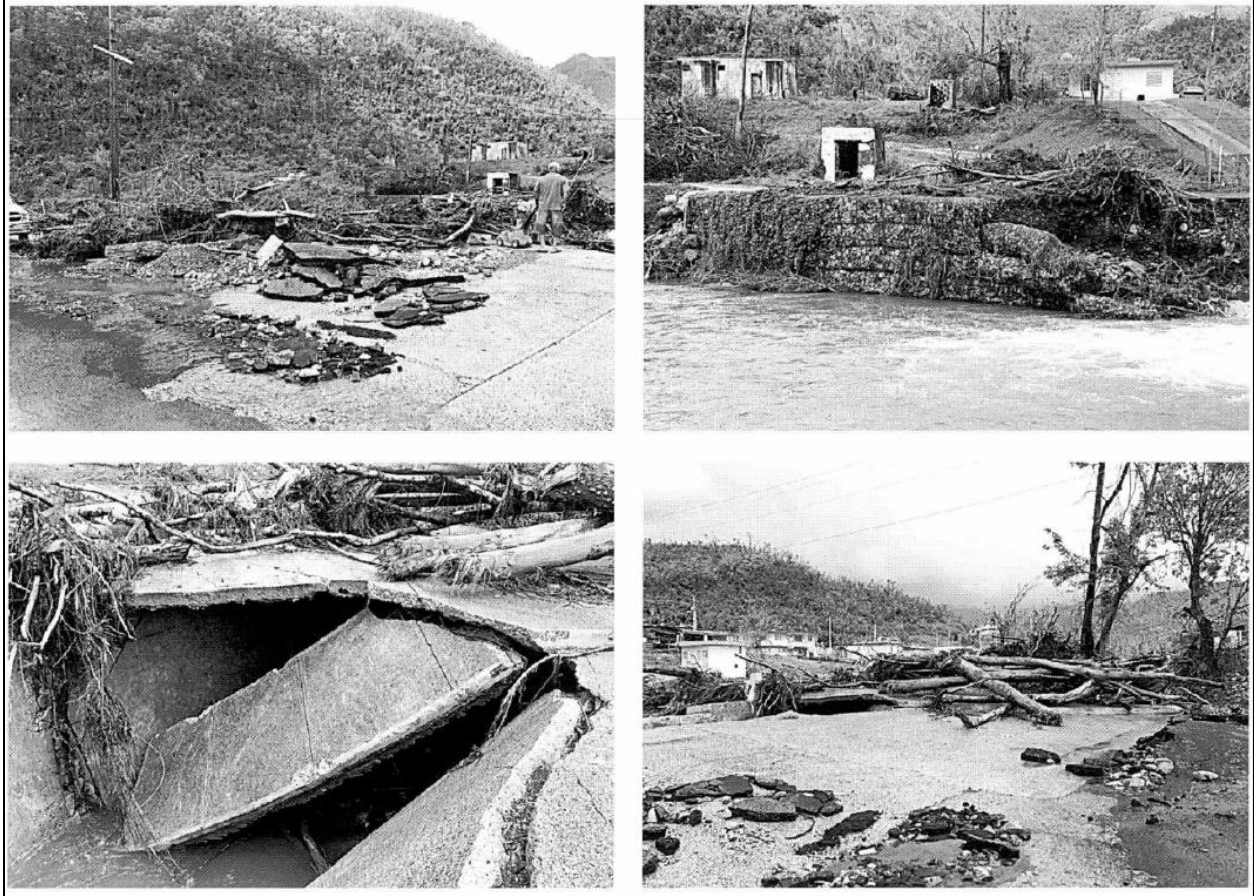
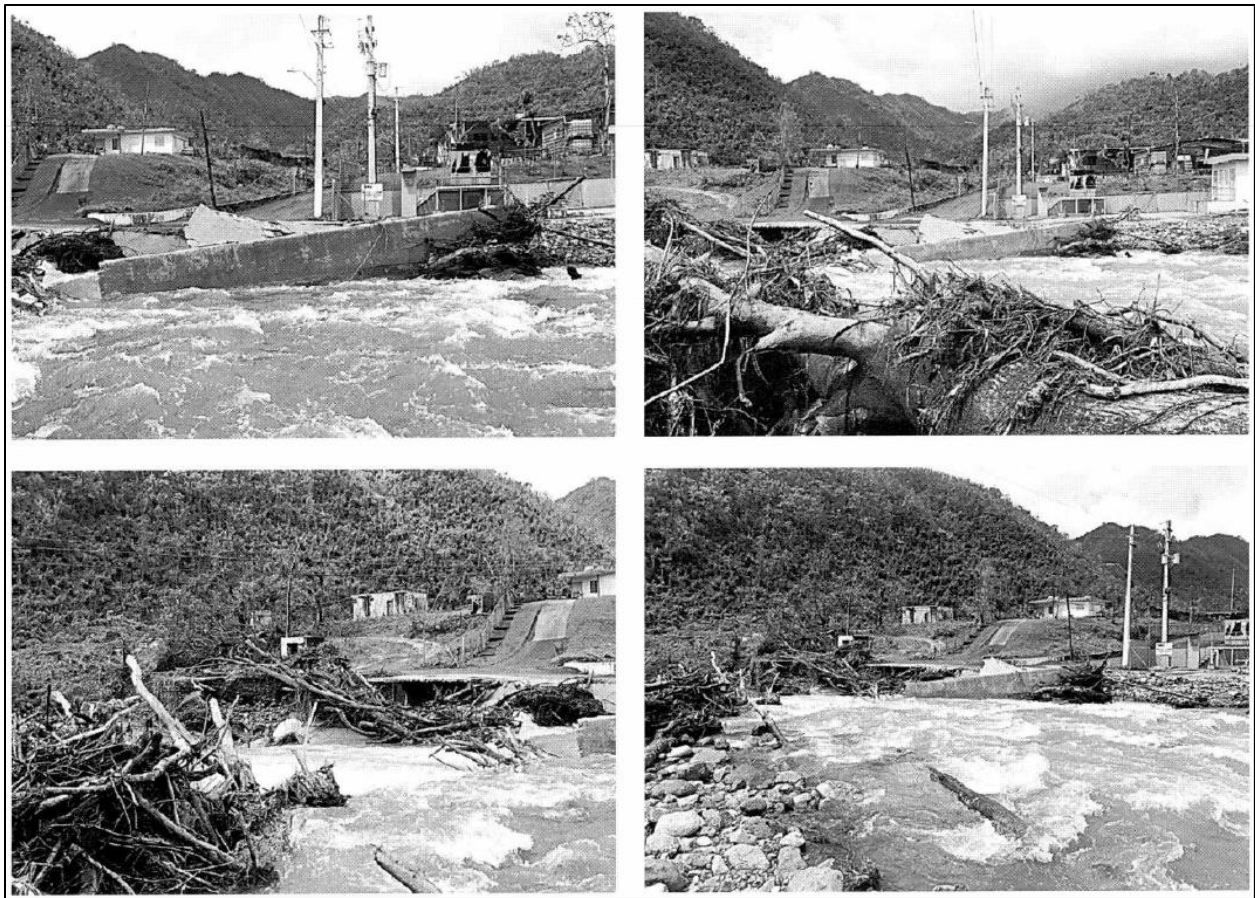
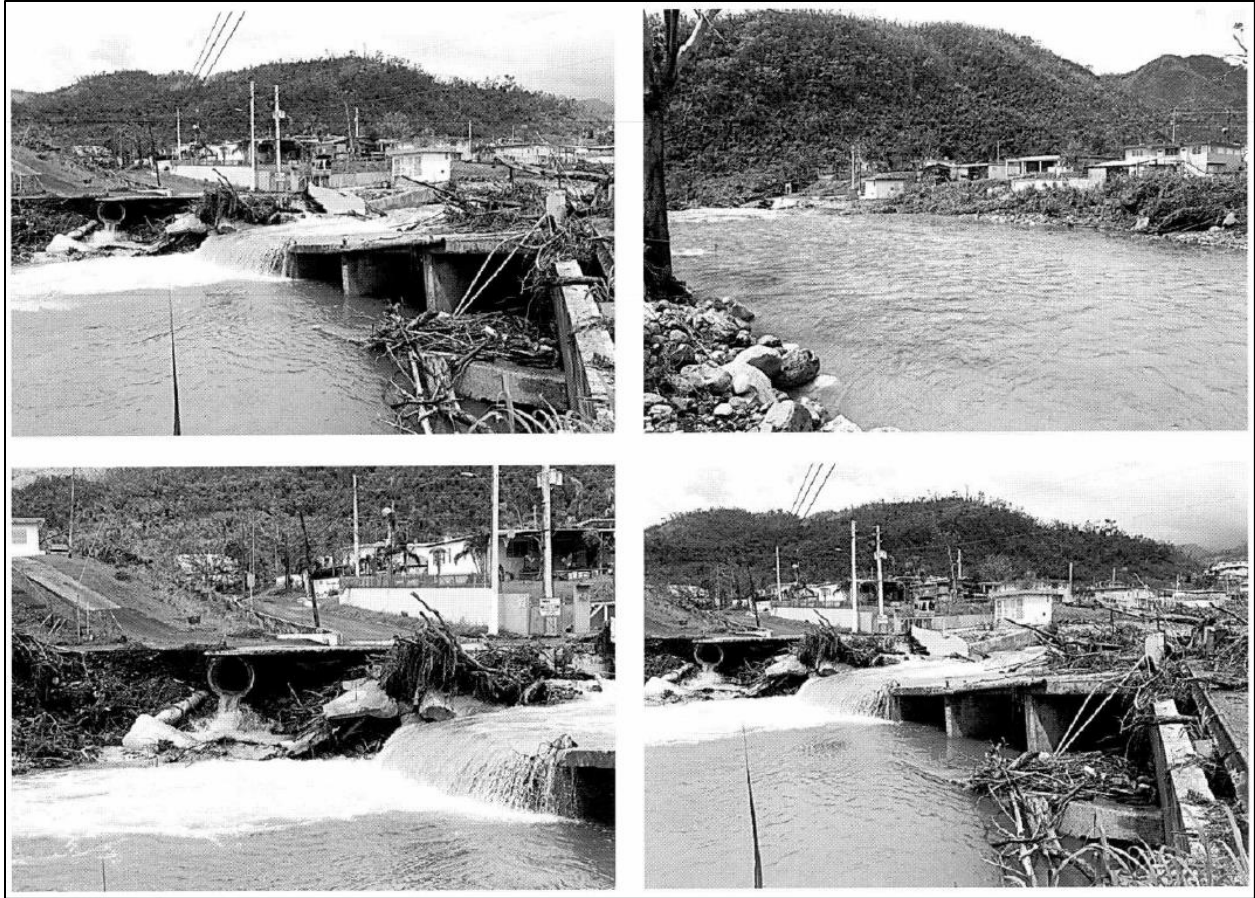
Figure 2-424: Bridge 2842 photos from October 17, 2017 inspection (source: PRHTA)

ACTION REQUIRED (PROVIDE COMMENTS):		
<input checked="" type="checkbox"/> NO FURTHER ACTION	<input type="checkbox"/> FURTHER INSPECTION REQUESTED	<input type="checkbox"/> EMERGENCY CLOSURE
COMMENTS: <u>Bridge already closed due to collapse. Reported to CoE for further action.</u>		
<hr/>		
INCLUDE PHOTOS IN A SEPARATE SHEET

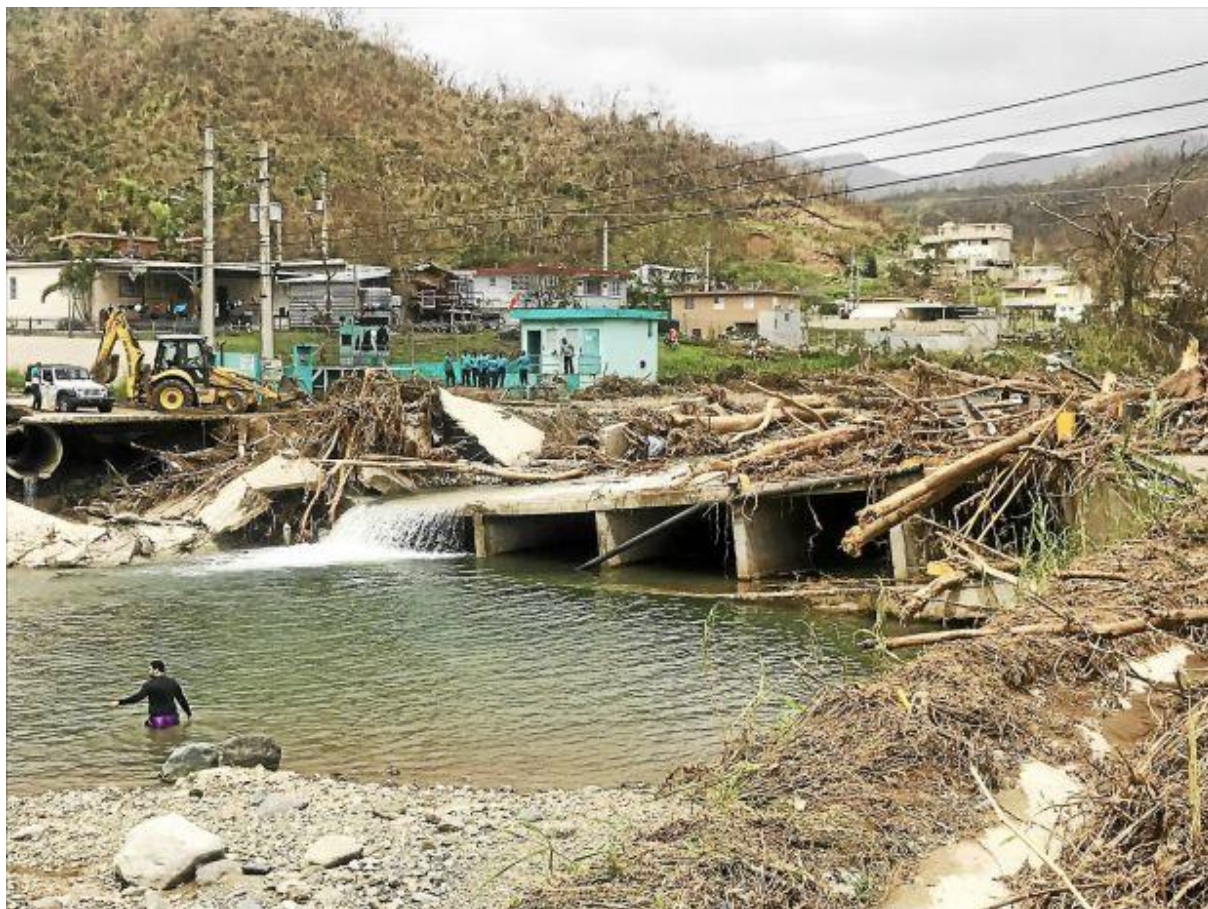
Figure 2-429: News report image of collapsed Bridge 2842 (source: Héctor Martínez)

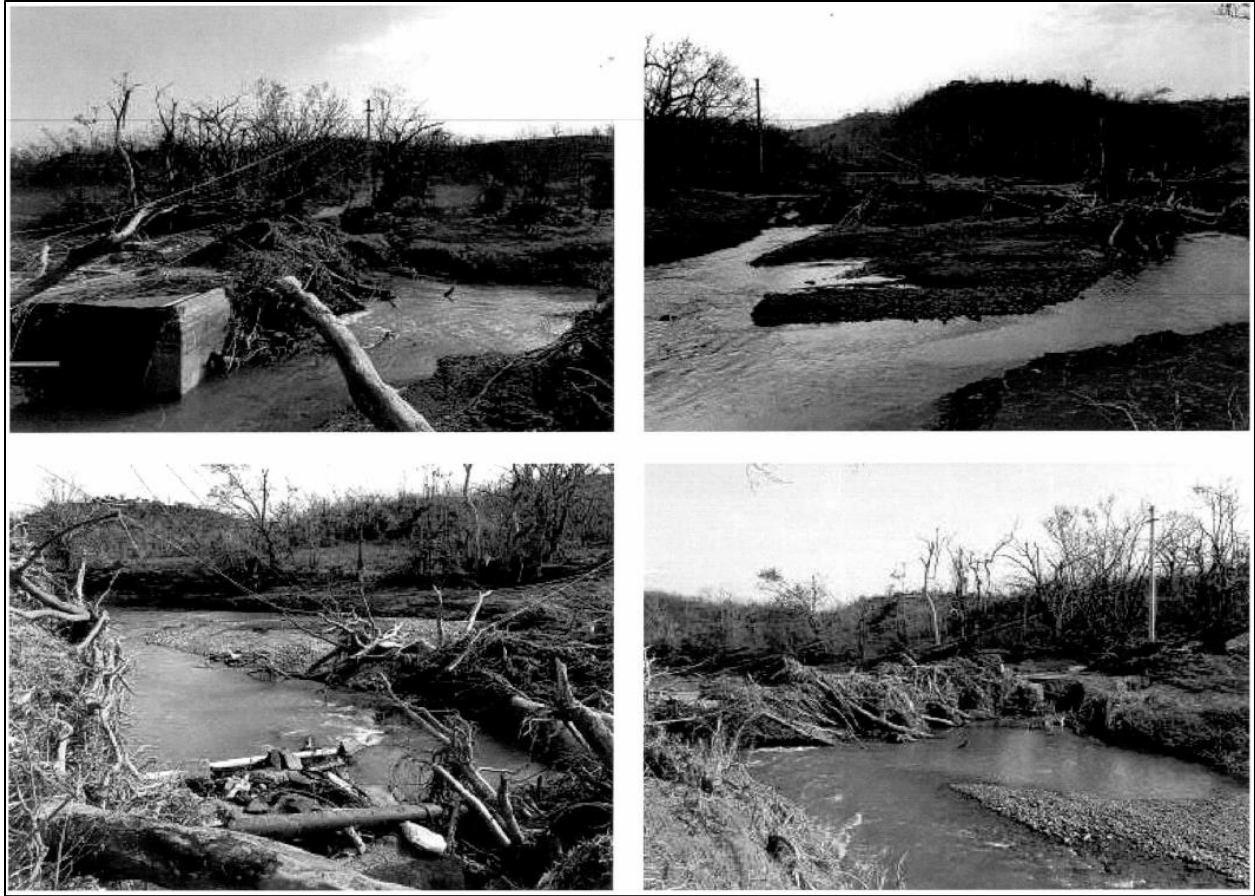
Figure 3-10: Bridge 606 photos from September 26, 2017 inspection (source: PRHTA)

ACTION REQUIRED (PROVIDE COMMENTS):		
<input checked="" type="checkbox"/> NO FURTHER ACTION	<input type="checkbox"/> FURTHER INSPECTION REQUESTED	<input type="checkbox"/> EMERGENCY CLOSURE
COMMENTS: <u>Bridge already collapsed/closed along with 0.3 km of PR-962. Reported to CoE for immediate works.</u>		
INCLUDE PHOTOS IN A SEPARATE SHEET

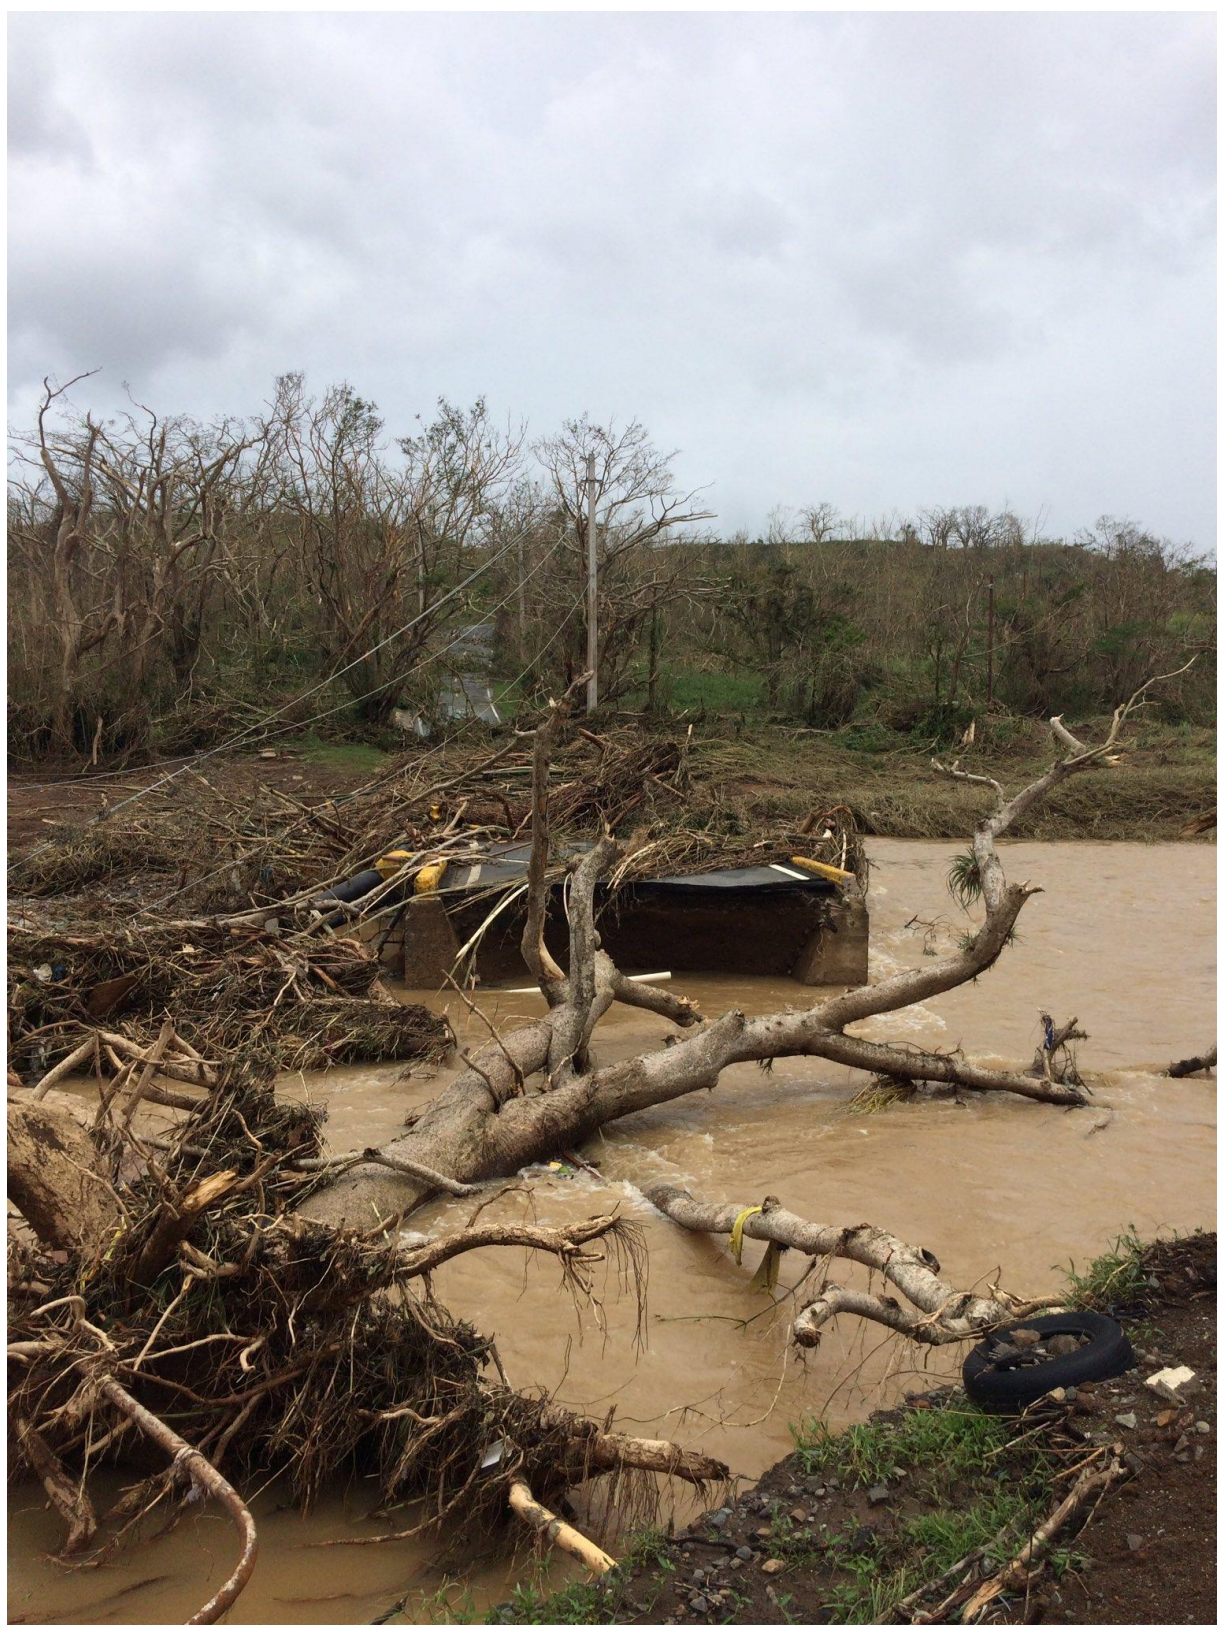
Figure 3-15: Social media image of collapsed approach of Bridge 606 (source: Ivette Sosa)

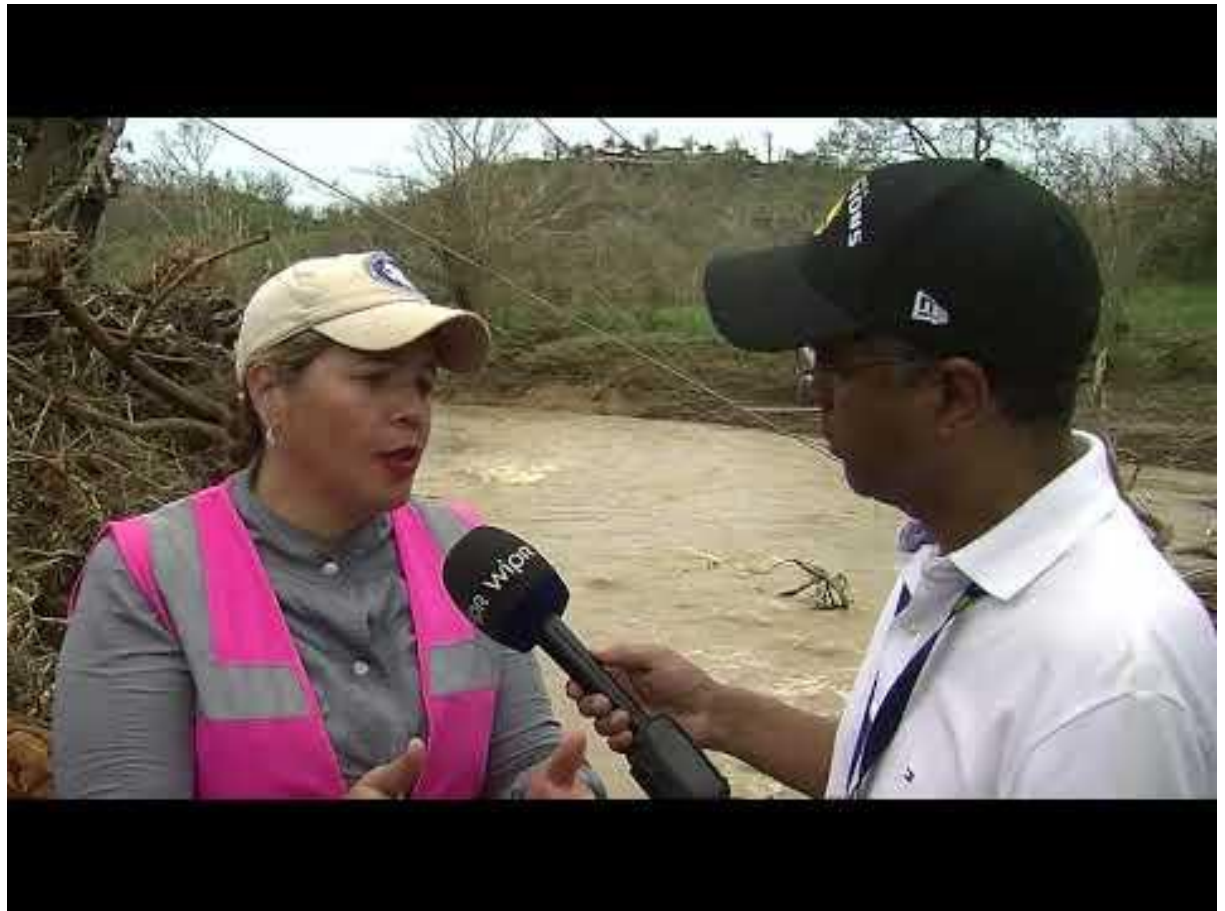
Video 3-1: News report showing collapsed approach of Bridge 606 (source: Notiséis 360)

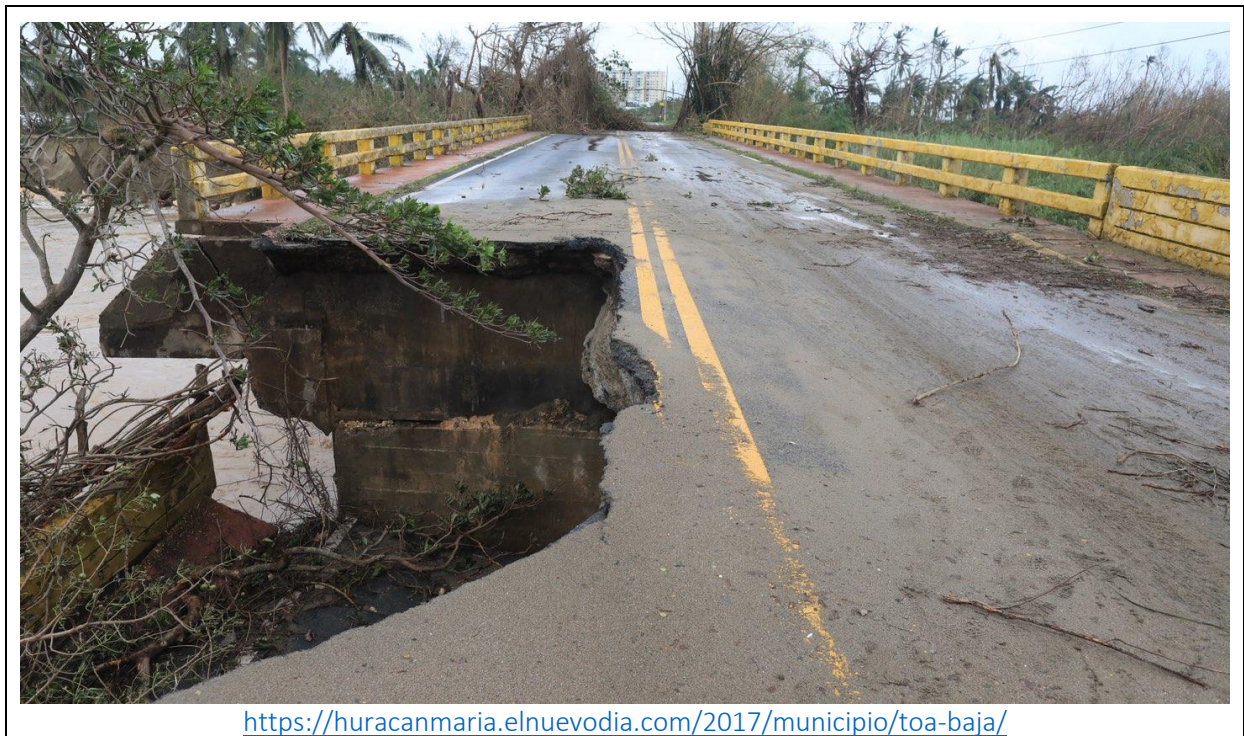
Figure 3-24: News report image of partial collapse of approach of Bridge 635 (source: El Nuevo Día)

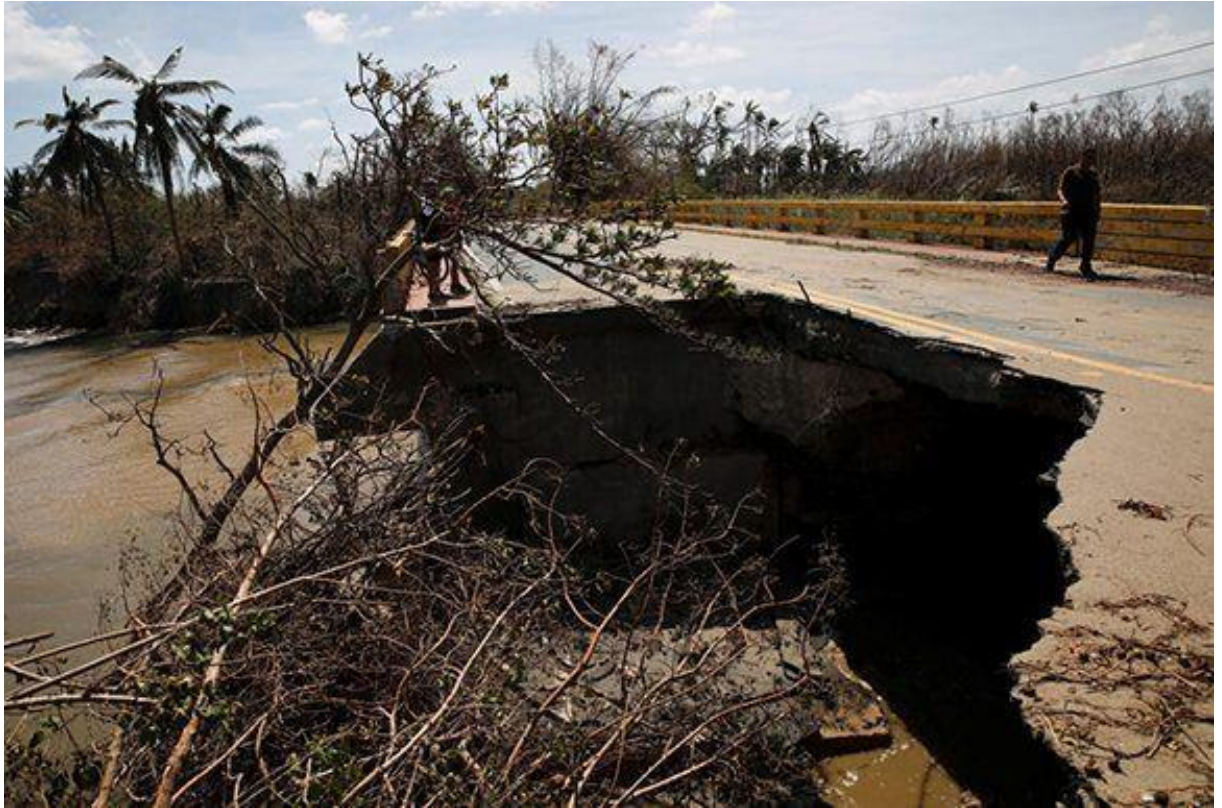
Figure 3-25: News report image of partial collapse of approach of Bridge 635 (source: Cuba Debate)

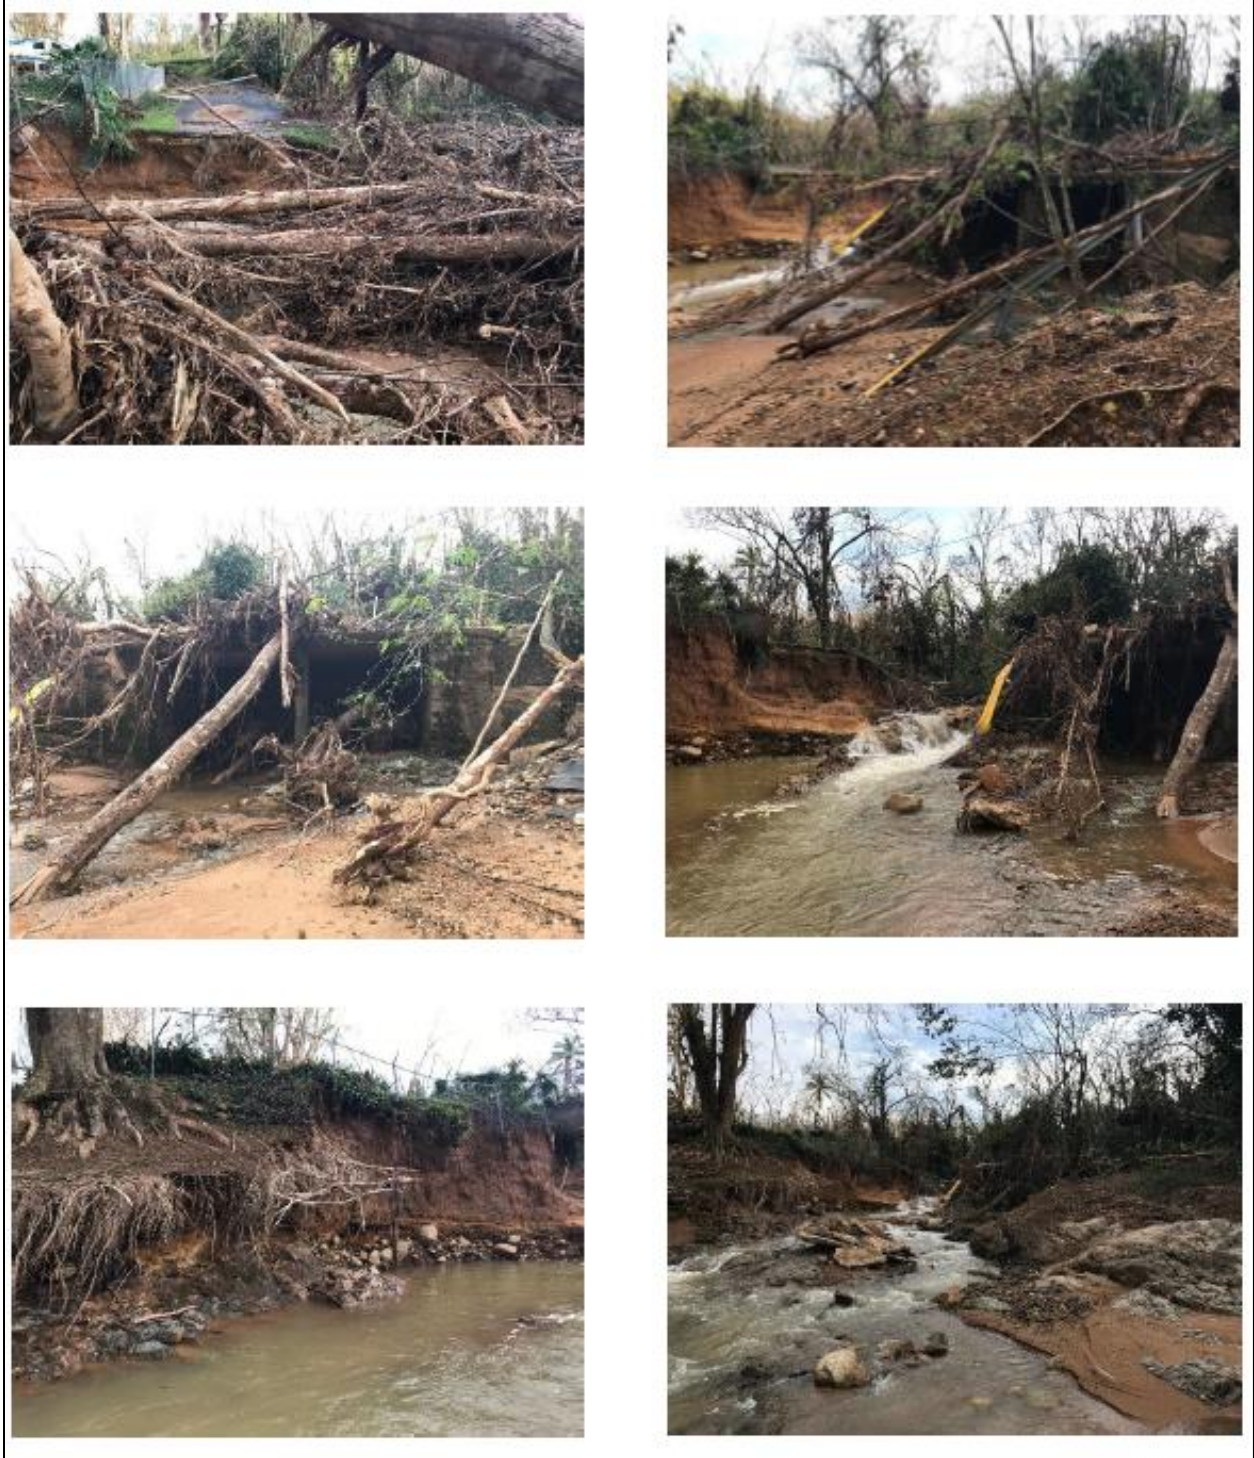
Figure 3-40: Bridge 1684 photos from October 11, 2017 inspection (source: PRHTA)

COMMENTS: <u>El puente colapsó, y se destruyeron totalmente las 2 coronas de</u> <u>plazo del puente y el agua sucio al approach totalmente izquardo</u>		
INCLUDE PHOTOS IN A SEPARATE SHEET

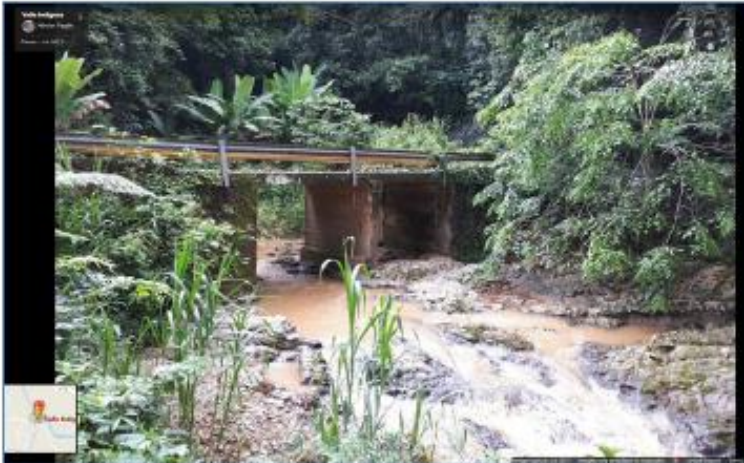
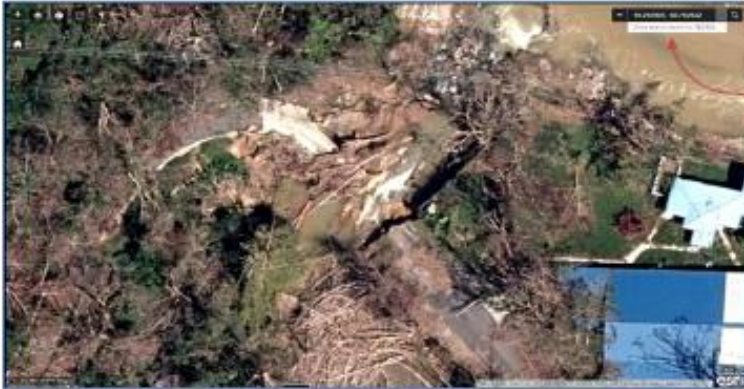
<p align="center">DETAILED DAMAGE INSPECTION REPORT</p> <p align="center">(Title 23, Federal-aid Highways)</p>		Report Number
<p>U.S. Department of Transportation Federal Highway Administration</p>		<p>Sheet 3 of 6</p>
<p>Location (Name of Road and Milepost) Bridge # 1684- Nearest Intersection PR 111 KM 47 Crossing creek near Tanamá River Coordinates: N 18.293926 (18° 17' 38.134") & W 66.782632 (66° 48' 57.475")</p>		<p>FHWA Disaster Number - PR Emergency Damage Assessment</p>
<p>Description of Damage Bridge No. 1684 over creek close to Tanamá river with damages caused by hurricane Maria on September 20, 2017. This is a 2 span bridge measuring 40 ft. Debris blocked the flow of the water through the bridge resulting in the washout of the West approach. This left a 40 ft span between the bridge abutment and the road. The river migrated.</p>		<p>Inspection Date November 5, 2017</p>
<p>Critical finding: Bridge abutments were damaged Need to demolish and remove failing structure.</p>		<p>Federal-aid Route Number</p>

Proposed emergency repair: Build a 40 ft, 2 span bridge similar to the existing Place riprap at the abutment sides.		Federal-aid Route Number		
		State: PR County: Utuado		
Photo 1 - Location Maps for Bridge 1683

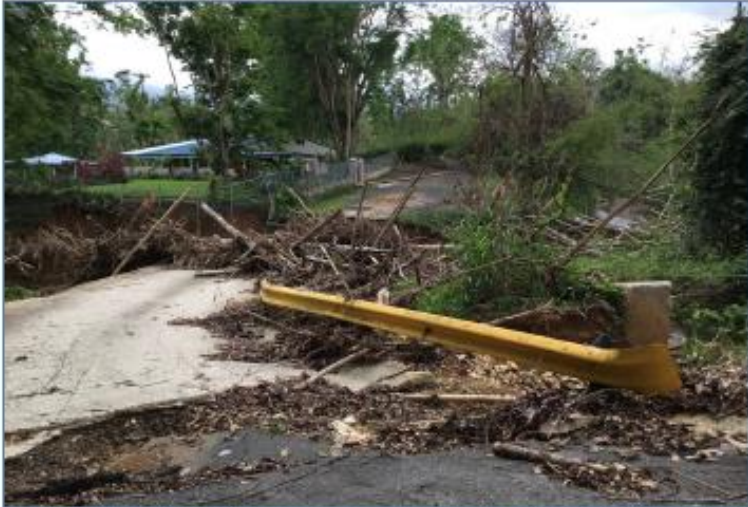
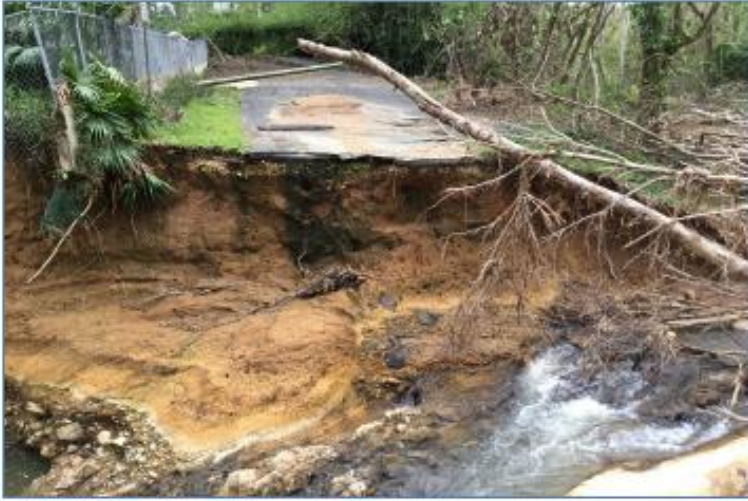
<p>State: PR County: Utuado</p>
<p align="center">Photo 4 - Looking West, asphalt washout: Photo 5 - Looking West, road approach washout</p>		
<div style="display: flex; flex-direction: column; align-items: center;">

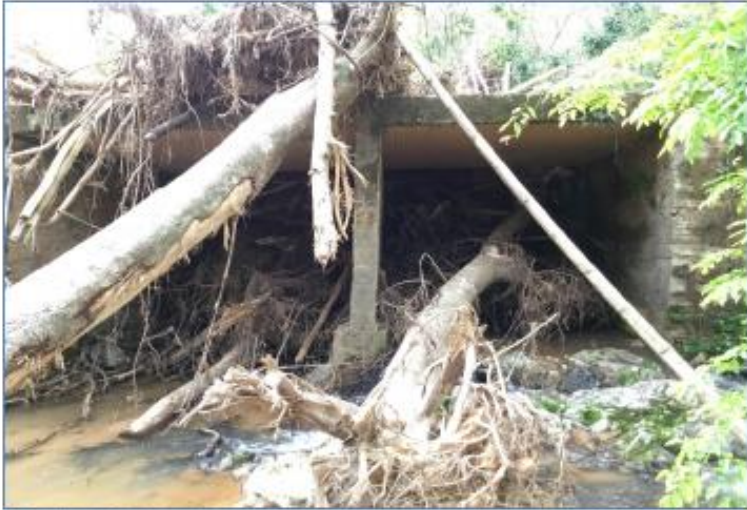
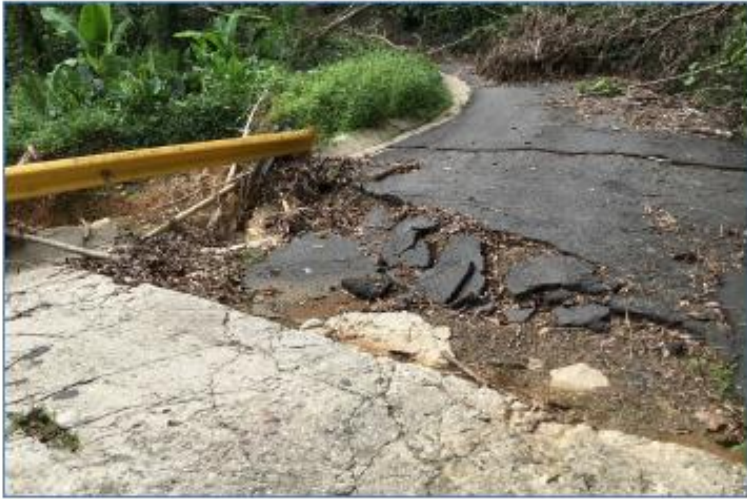
<p>Federal-aid Route Number</p>
		<p>State: PR County: Utuado</p>
<p align="center">Photo 6 - Looking North, existing bridge : Photo 7 - Asphalt washout East approach</p>		
<div style="display: flex; justify-content: space-around;">

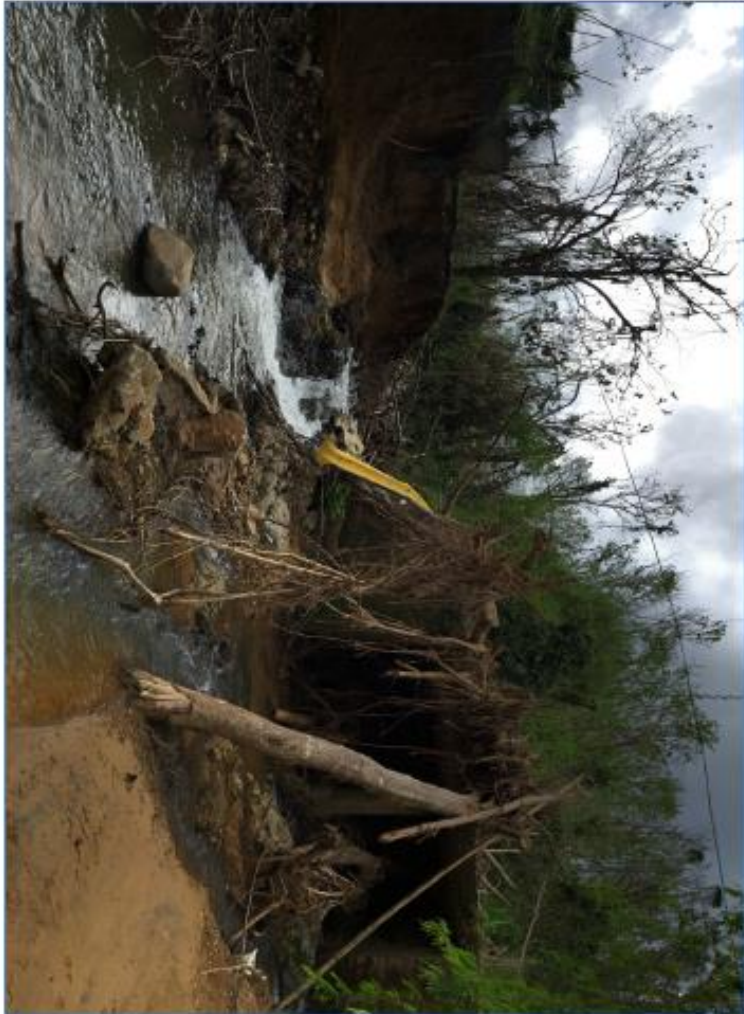
<p>State: PR County: Utuado</p>
<p align="center">Photo 8 - River channel migration</p>

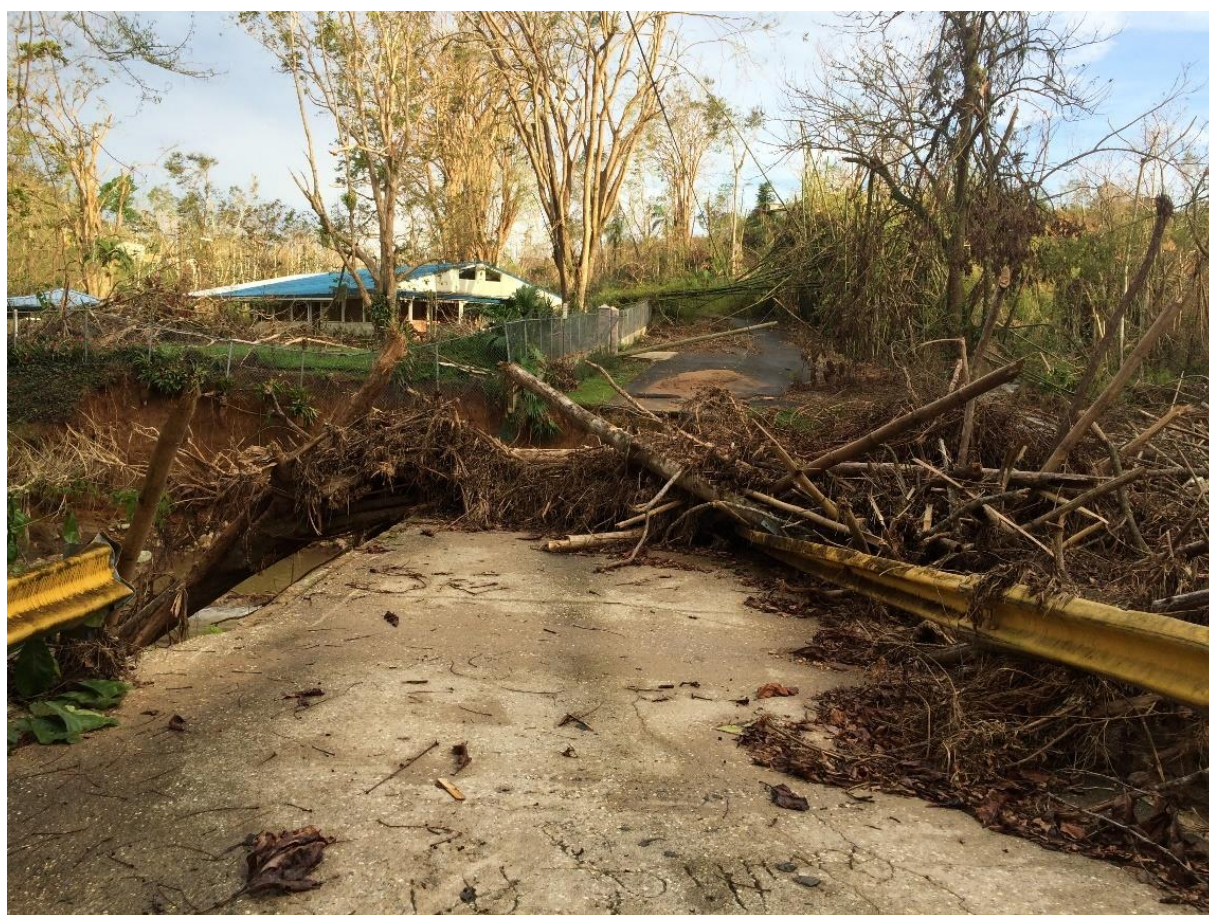
Figure 3-60: Social media image of collapsed approach of Bridge 1684 (source: Julia Maldonado)

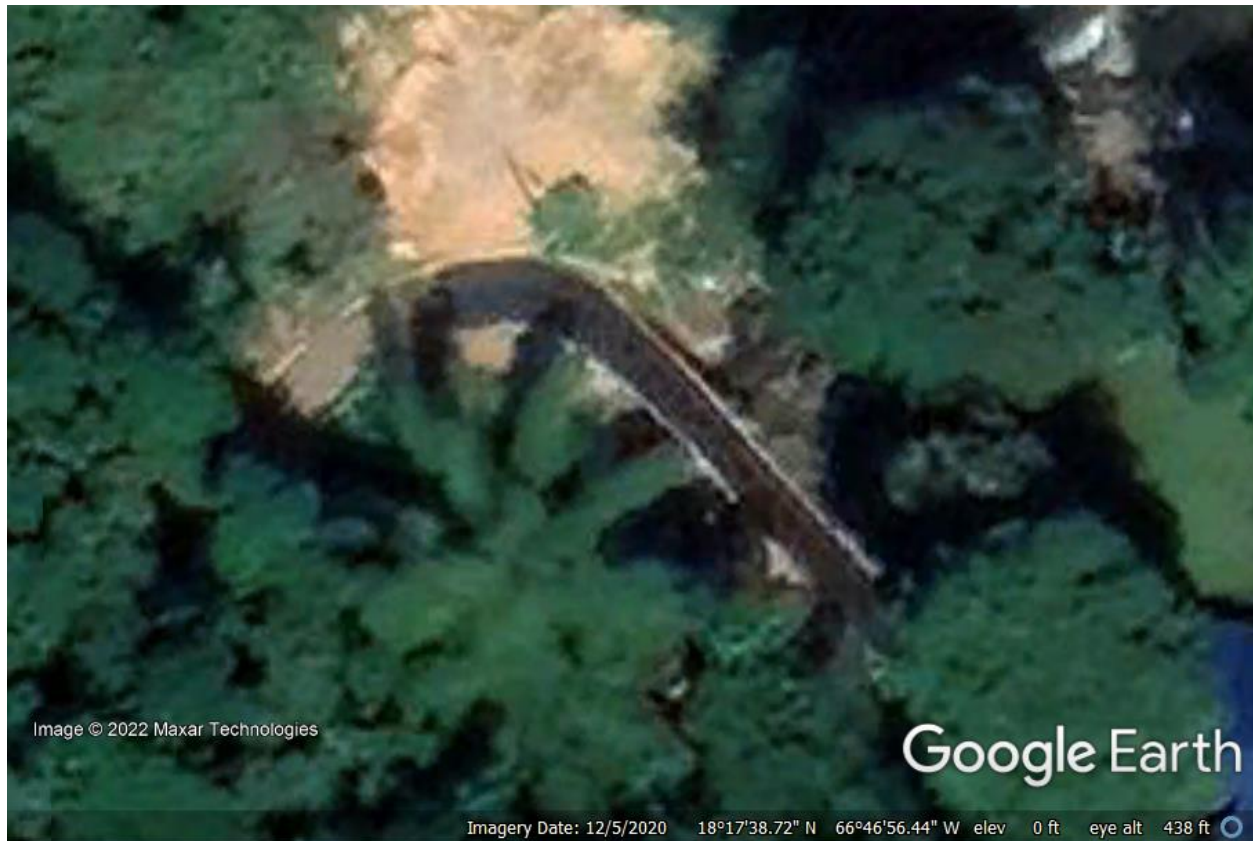
Figure 3-61: Satellite image of Bridge 1684 with repaired approach (source: Google Earth Pro)

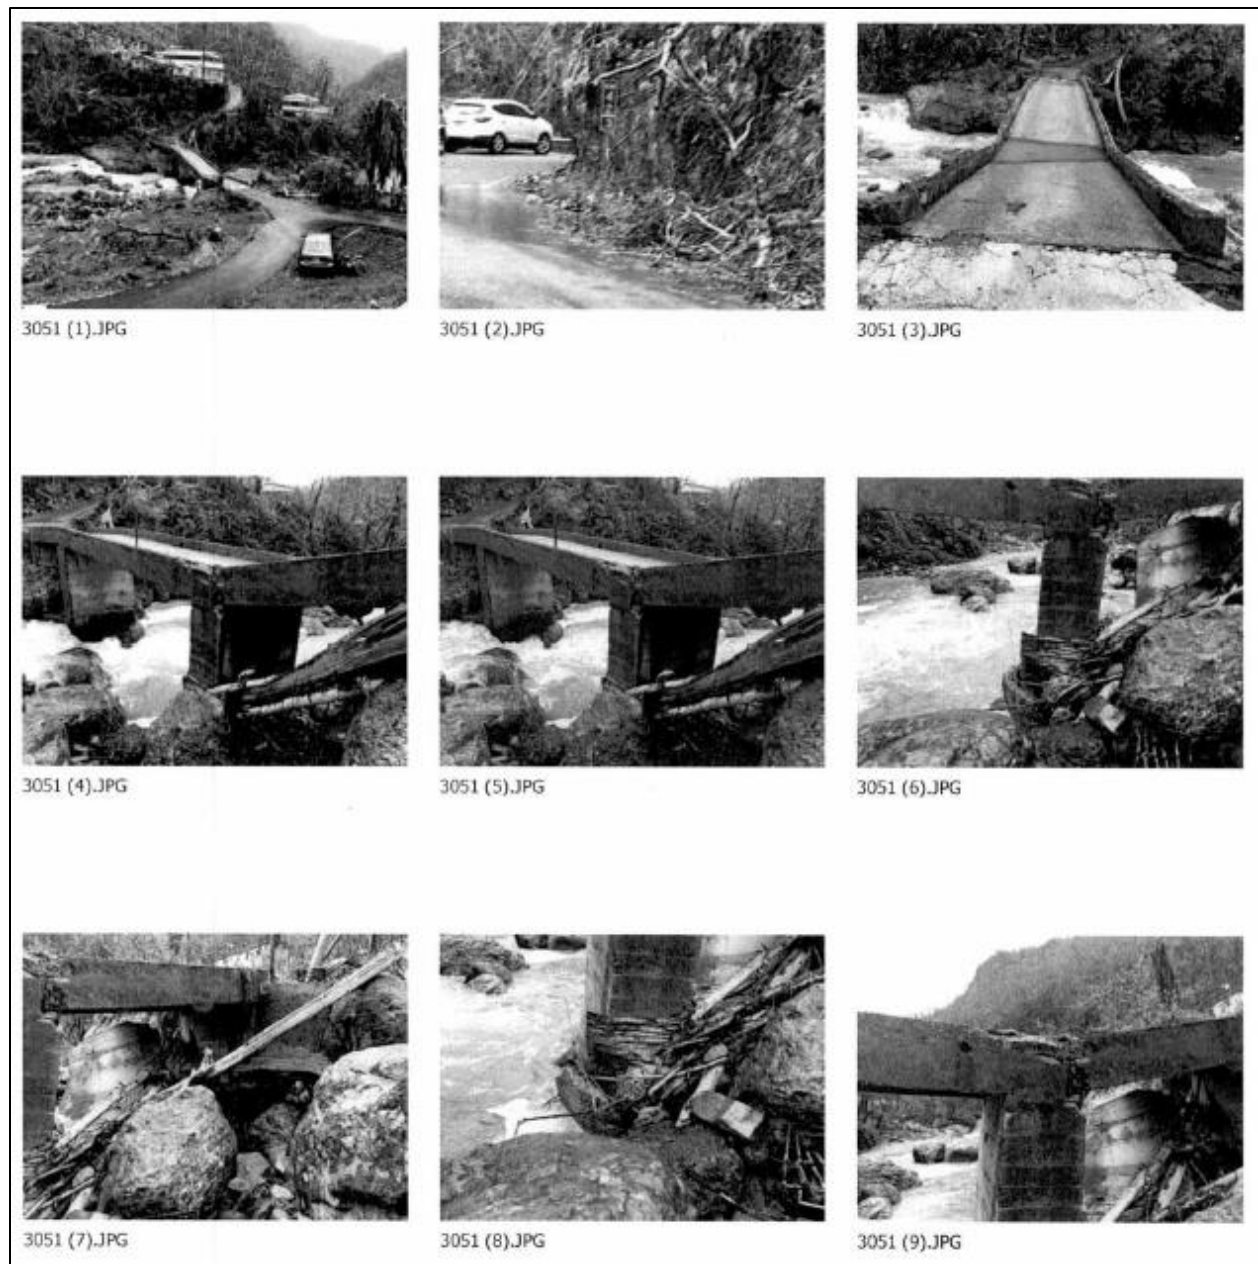
<input type="checkbox"/> NO FURTHER ACTION	<input type="checkbox"/> FURTHER INSPECTION REQUESTED	<input checked="" type="checkbox"/> EMERGENCY CLOSURE
COMMENTS: <u>Estructura inestable, colapso inminente</u> <u>Se recomienda cierre</u>		
INCLUDE PHOTOS IN A SEPARATE SHEET

The engineer that conducted the inspection after Hurricane Maria indicated in the report that one of the abutments had collapsed, that the bridge was unstable, and that collapse was imminent. He recommended that the bridge be closed.
