Improving Transportation Infrastructure Resilience against Hurricanes, other Natural Disasters, and Weathering: Part III - Analysis of motor vehicle bridges failures due to Hurricane Maria

FINAL REPORT
August 2022

Transportation Infrastructure Research Center – TIRC
Polytechnic University of Puerto Rico
377 Ponce de Leon Ave, San Juan, PR 00918

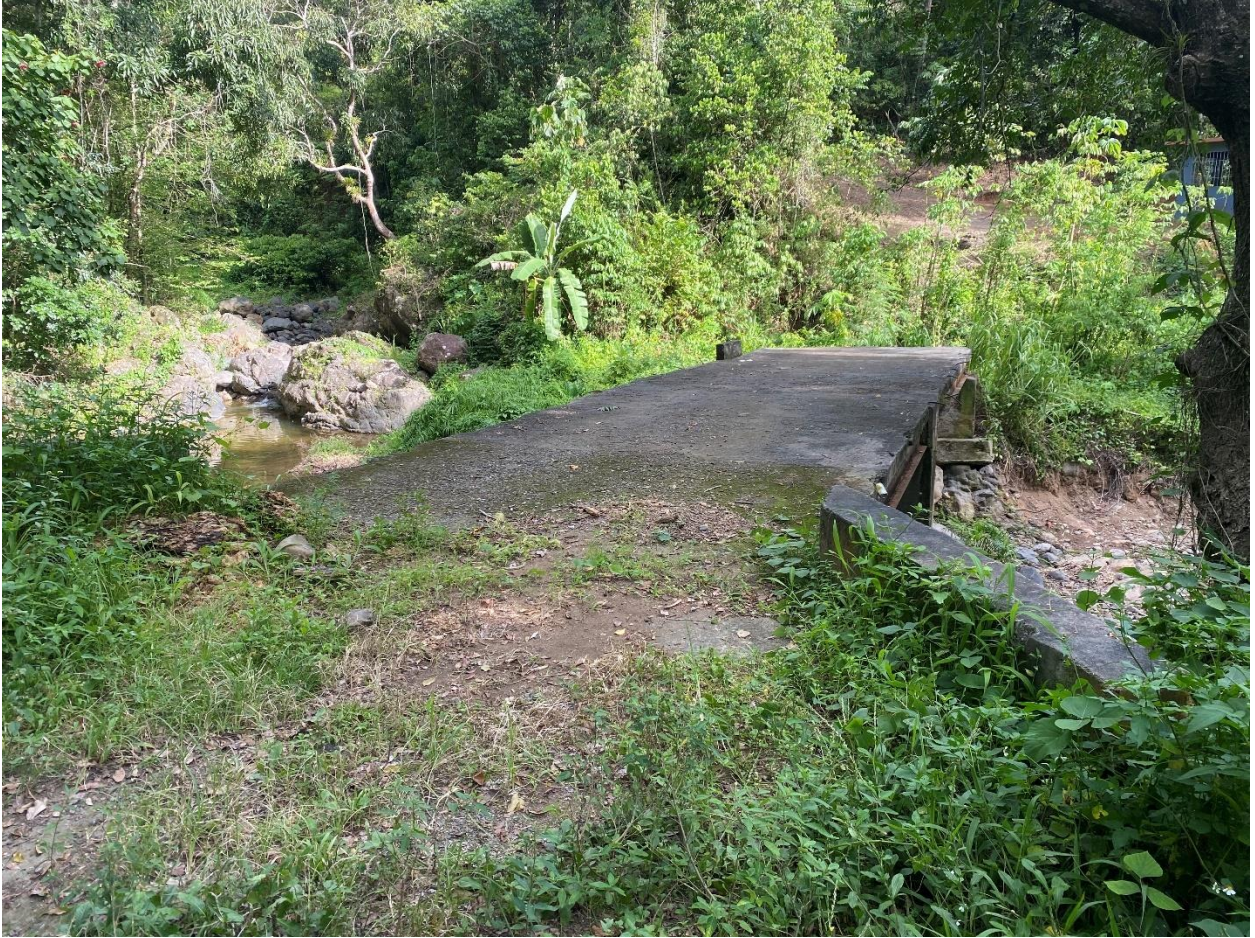
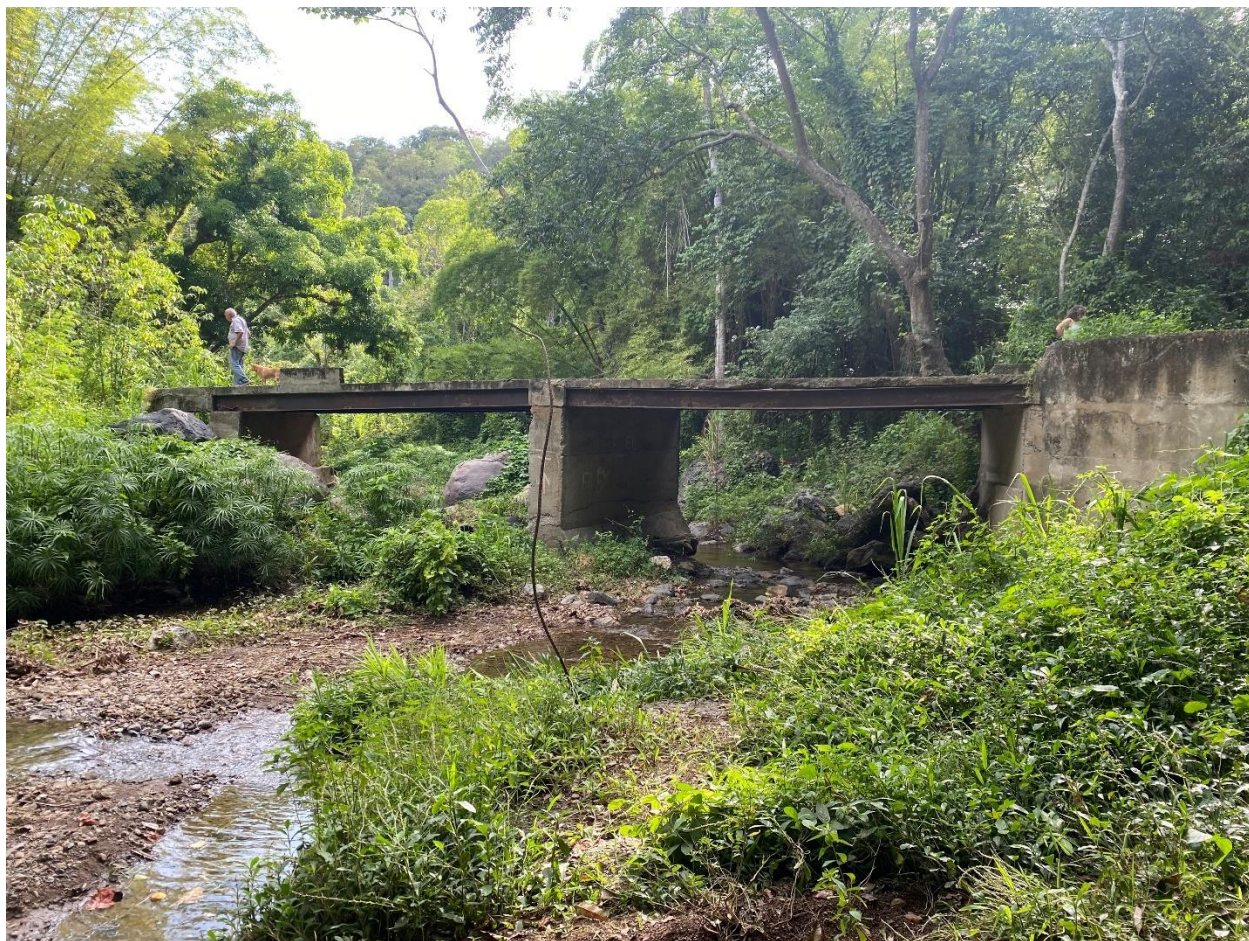
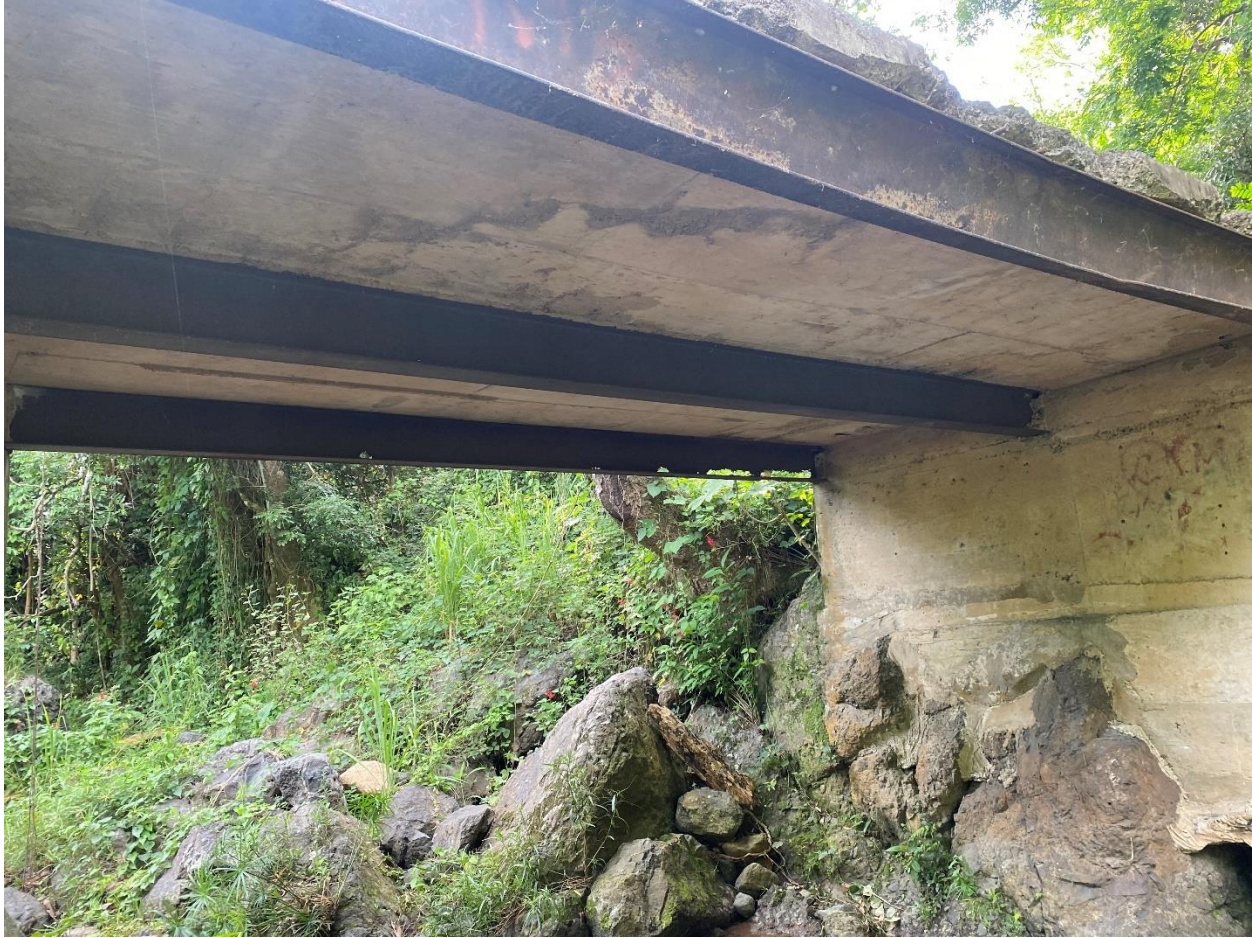
In June 2022, a member of the research project visited this structure. Residents from the area indicated that the bridge had collapsed due to Hurricane Maria. From this inspection another theory was raised: that no span had collapsed, that this was a case of collapsed approach roadway, and that the approach slab had originally been poured together with the bridge's deck. Without drawings or photos of the bridge before Hurricane Maria, the type of failure remains uncertain.

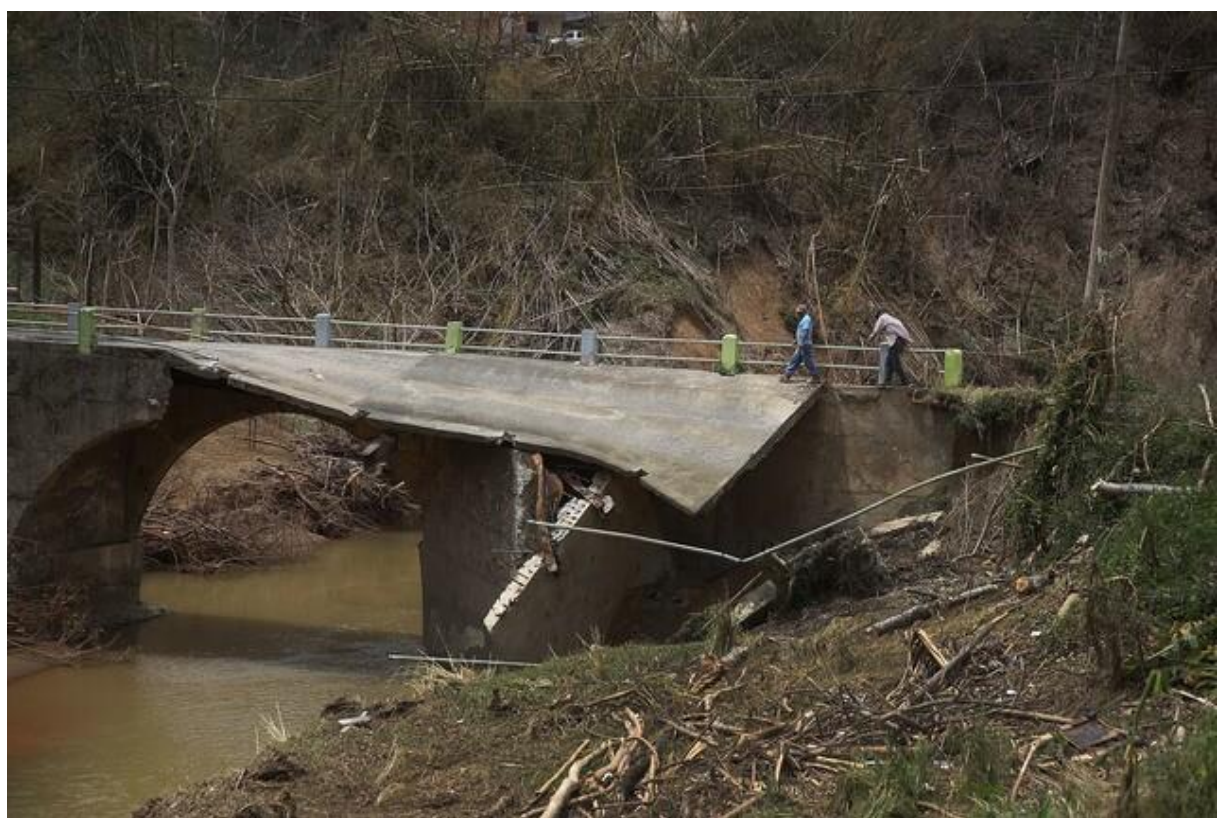
Figure 4-20: News report image of collapsed La Riviera Sector Bridge (source: ABC)

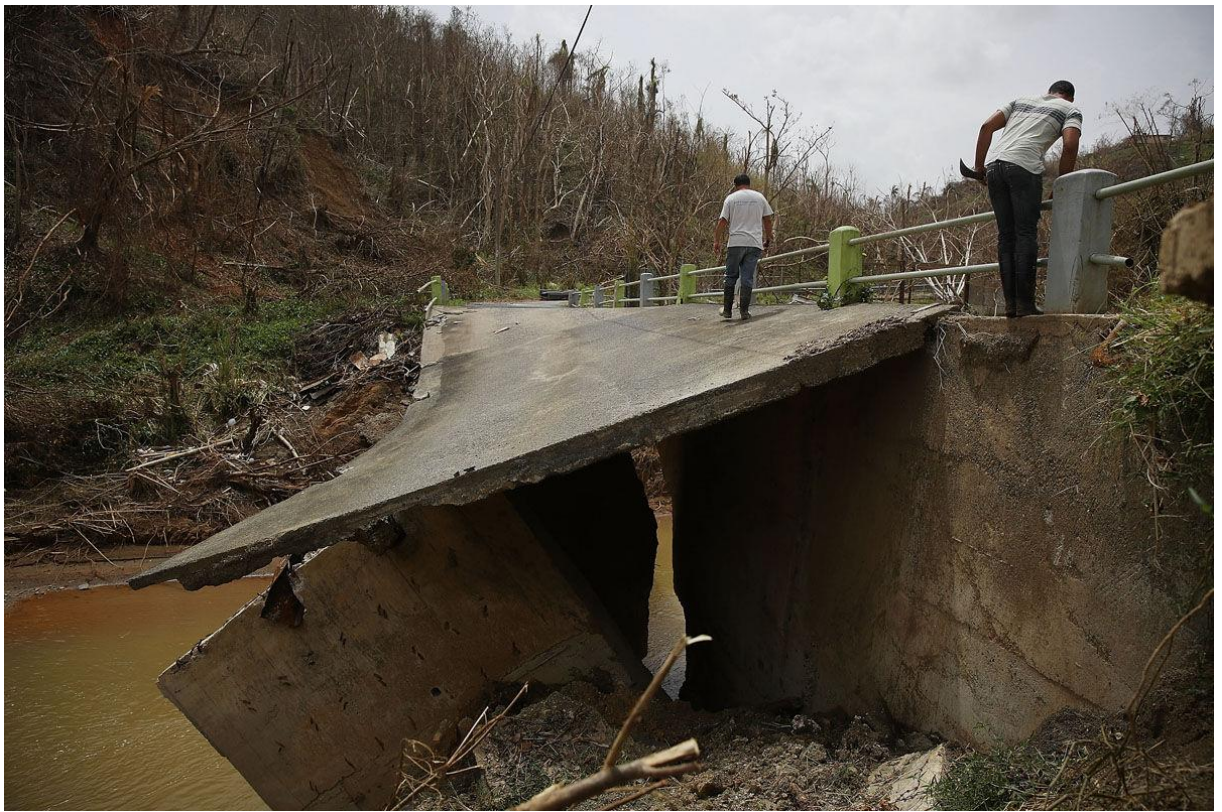
<https://wtop.com/media-galleries/2017/09/photos-scenes-devastation-puerto-rico-maria/>
Figure 4-21: News report image of collapsed La Riviera Sector Bridge (source: WTOP News)

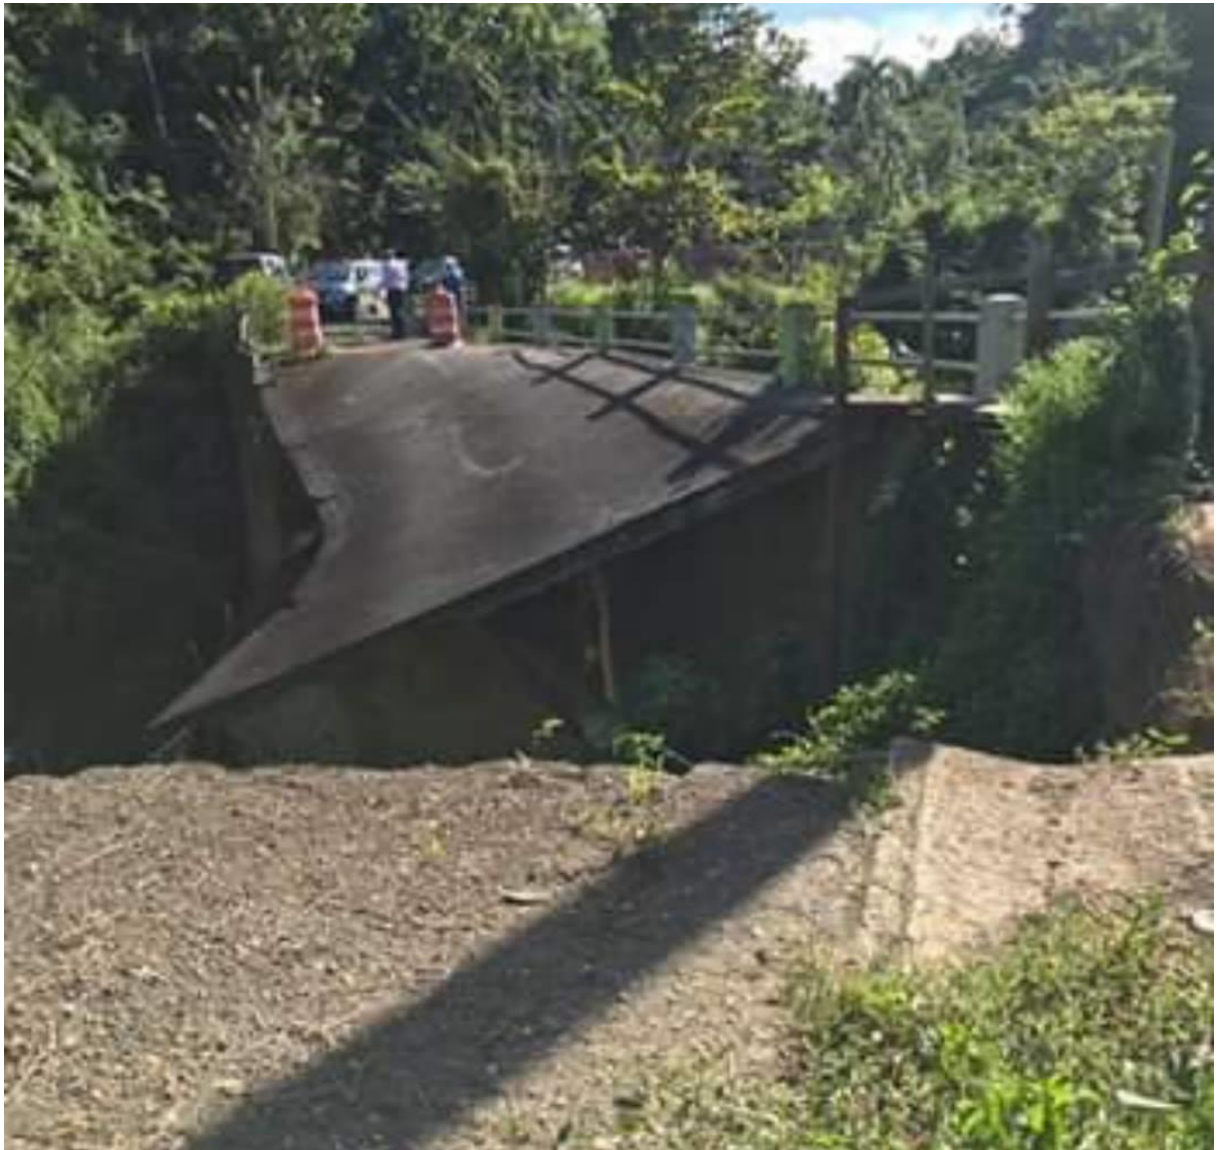
Figure 4-22: Social media image of collapsed La Riviera Sector Bridge (source: Rafael June Rivera)

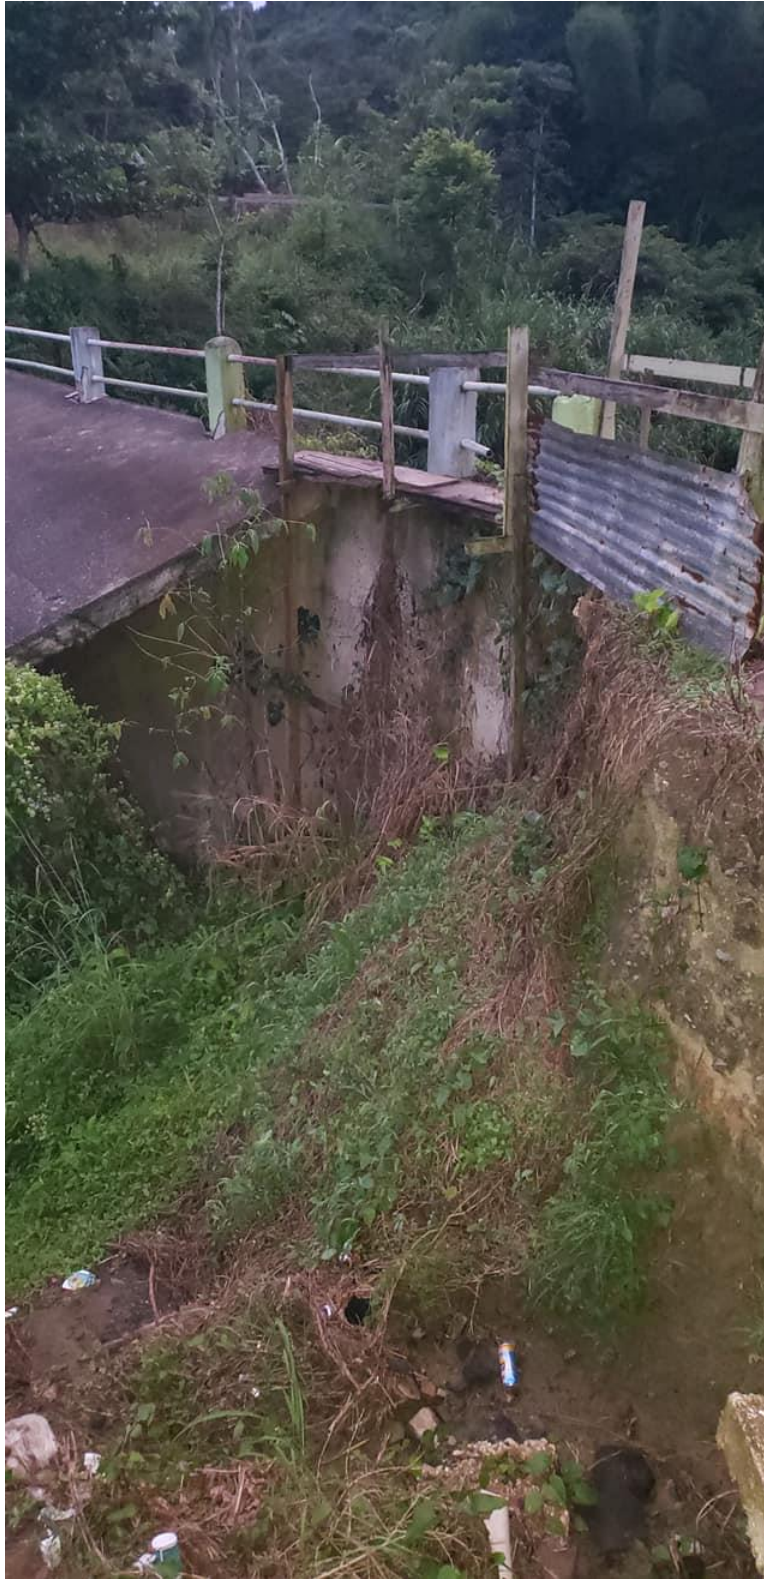
Figure 4-23: Social media image of collapsed La Riviera Sector Bridge (source: Geovanny Torres Rivera)

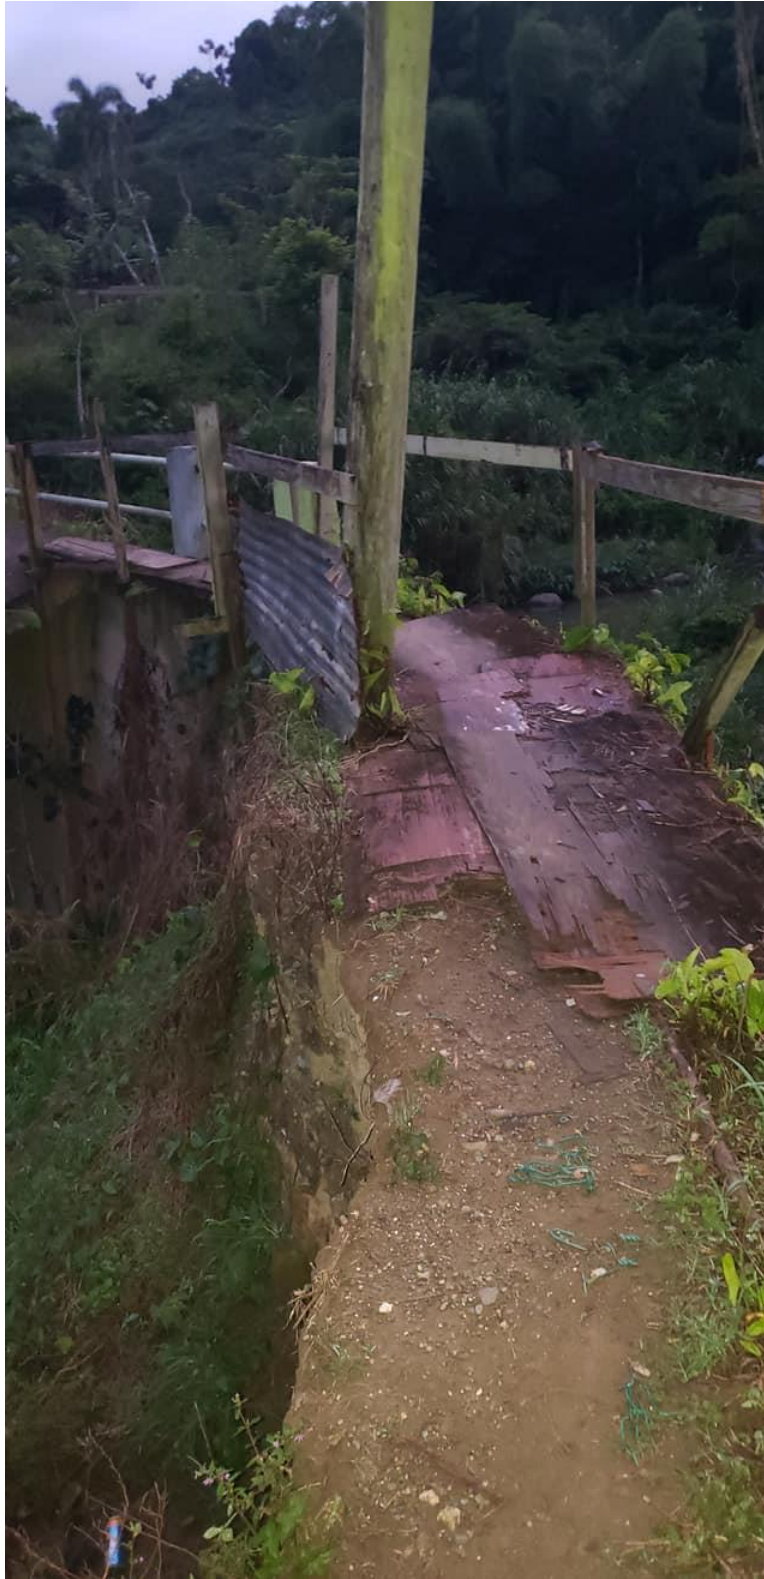
Figure 4-24: Social media image of collapsed La Riviera Sector Bridge (source: Geovanny Torres Rivera)

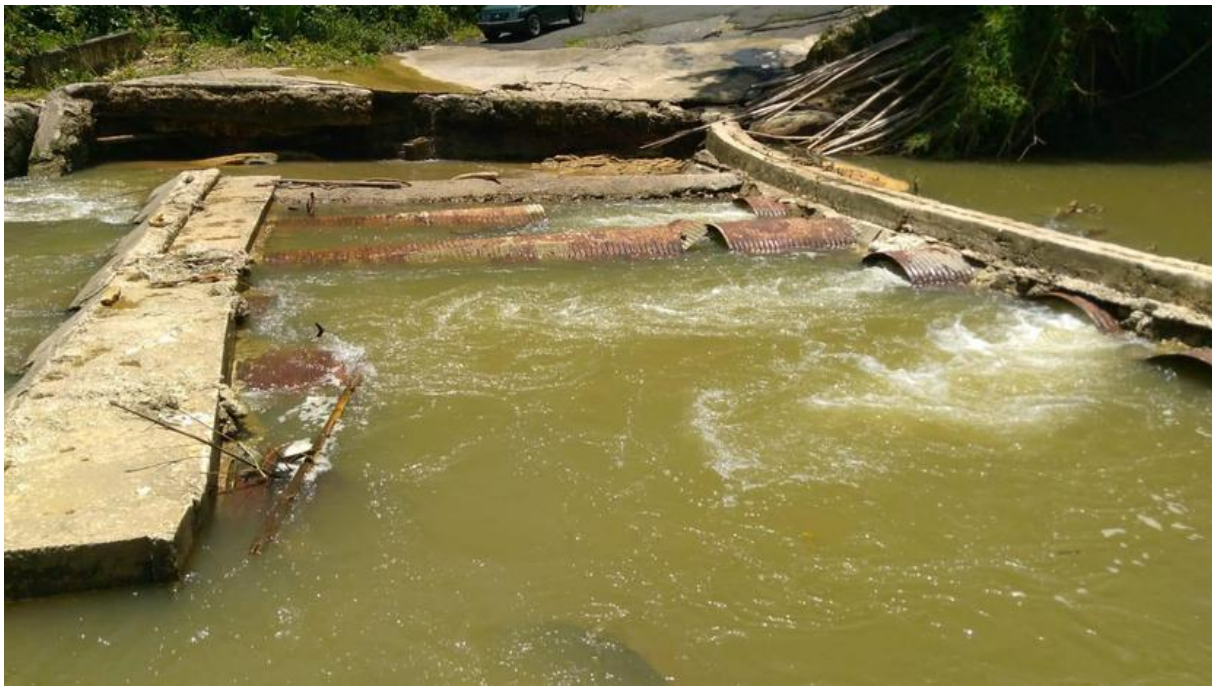
Figure 4-30: News report image of collapsed Bridge Seis Bocas (source: El Nuevo Día)

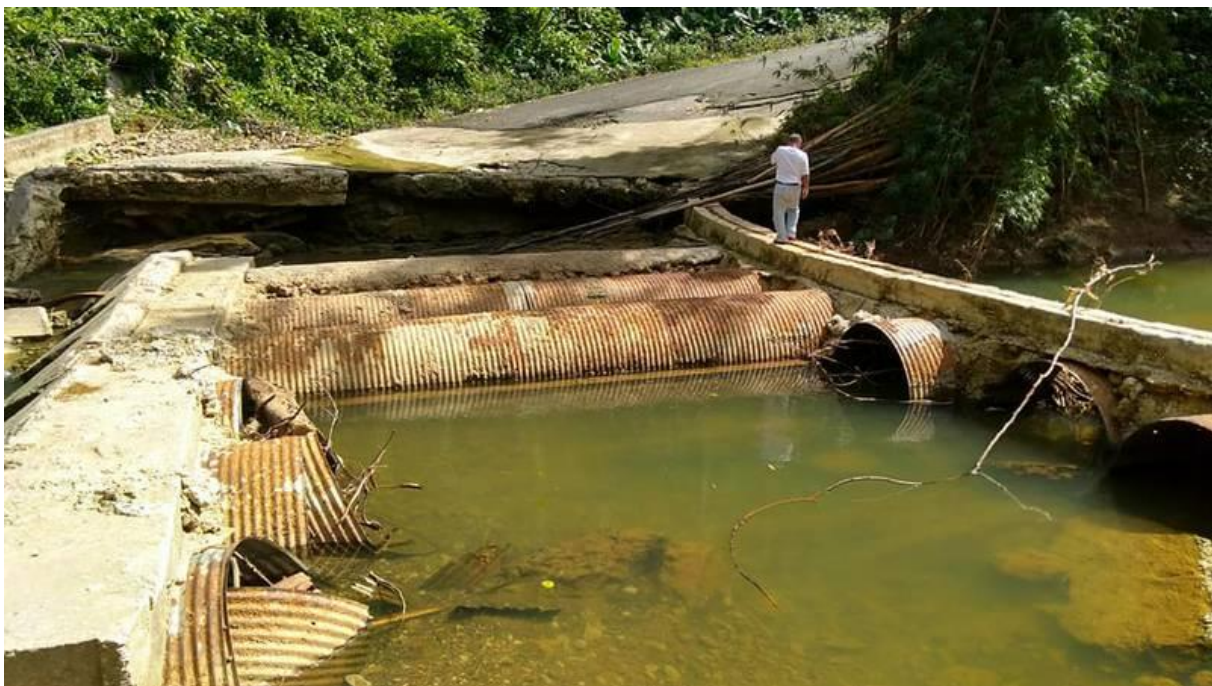
Figure 4-31: News report image of collapsed Bridge Seis Bocas (source: Metro)

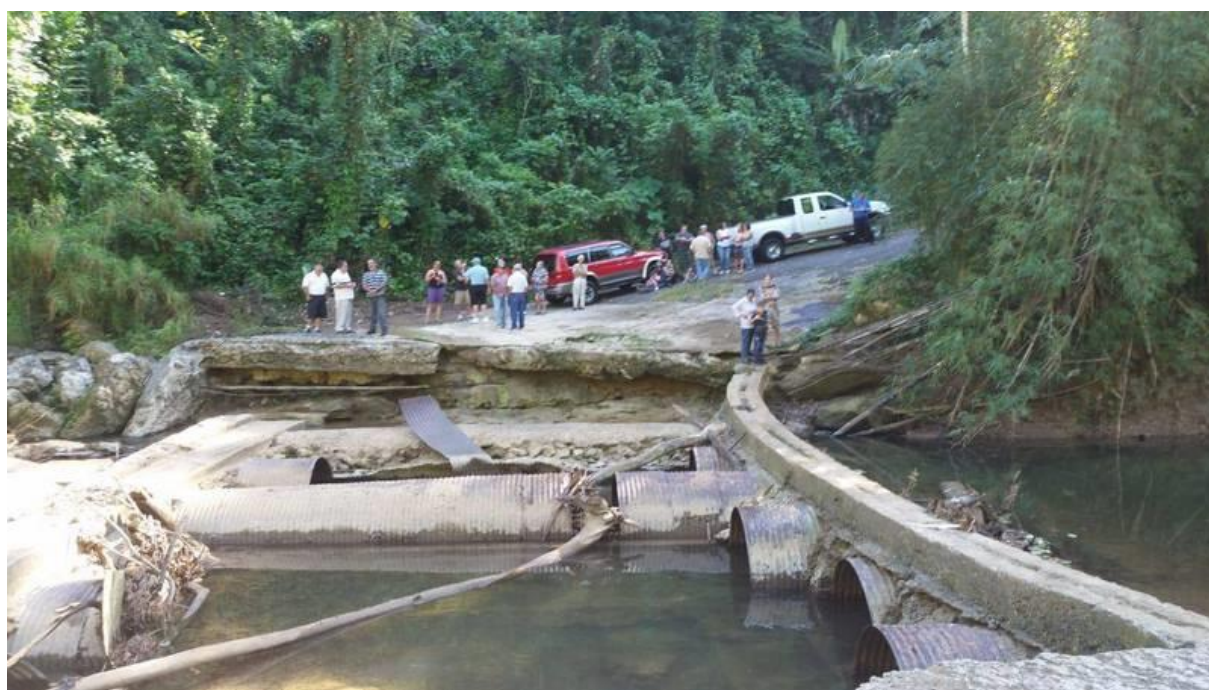
Figure 4-32: News report image of collapsed Bridge Seis Bocas (source: Metro)

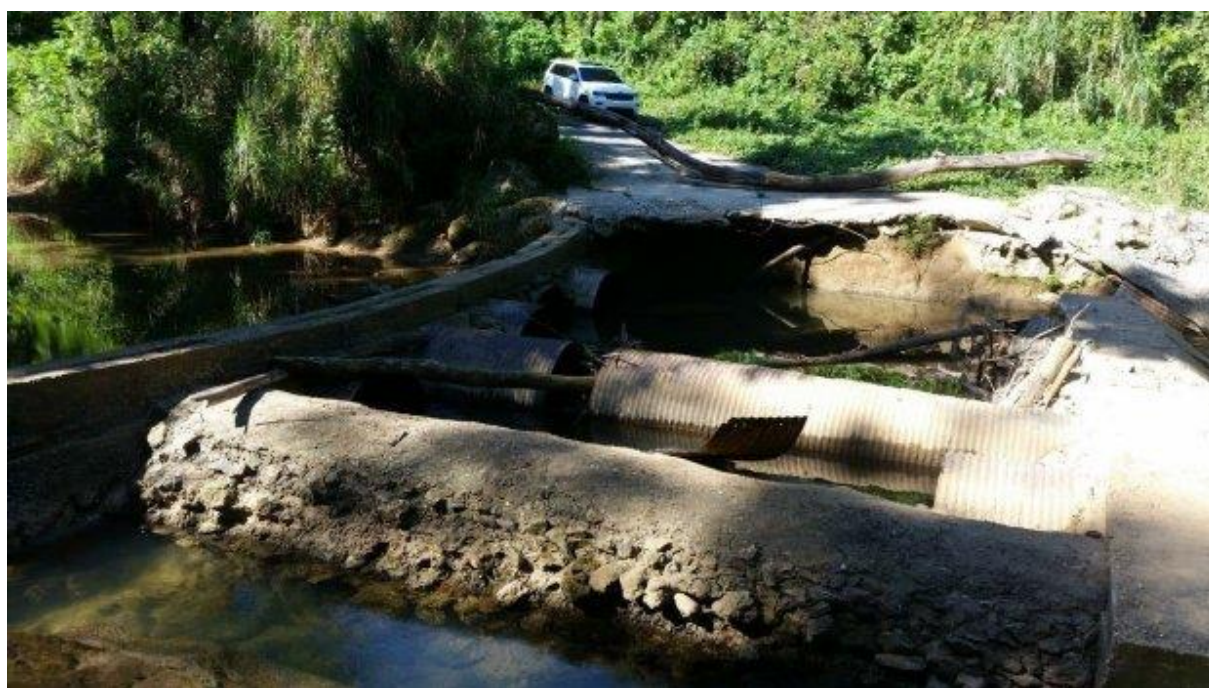
Figure 4-33: News report image of collapsed Bridge Seis Bocas (source: La Isla Oeste)

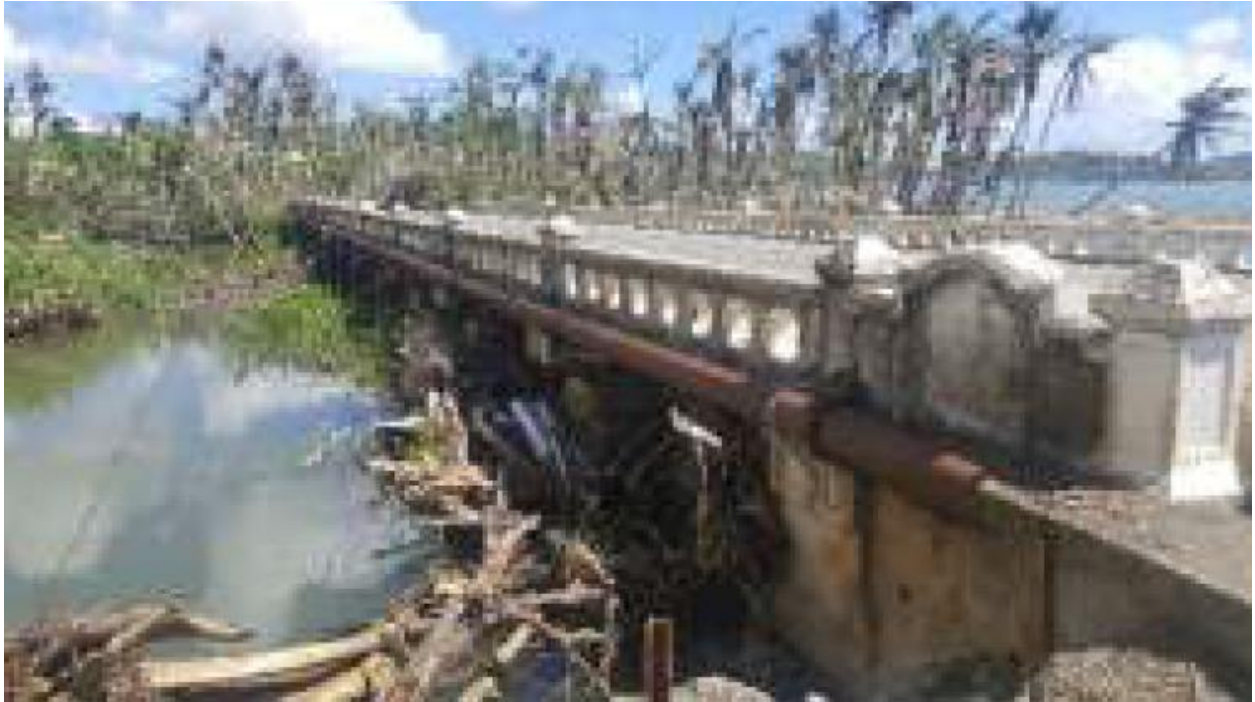
- Bridge 122 was constructed in 1918, therefore it was 99 years old when Hurricane Maria made landfall in 2017. It has been reported that the bridge was already in bad condition before the arrival of Hurricane Maria and that there were plans for it being replaced (Santiago Caraballo, 2013; Díaz Torres, La mayoría de los puentes impactados por el huracán María ya estaban en estado crítico por falta de mantenimiento, 2020). After Hurricane Maria, the bridge did not collapse, as shown in Figure 5-1 and remained open. A temporary steel bridge was built over Bridge 122, as shown in Figure 5-2. It has been reported that Hurricane Maria increased scouring problems that the bridge had, which lead to the construction of the steel structure (Díaz Torres, 2019).

Figure 5-1: Bridge 122 photo from November 2, 2017 inspection (source: PRHTA)

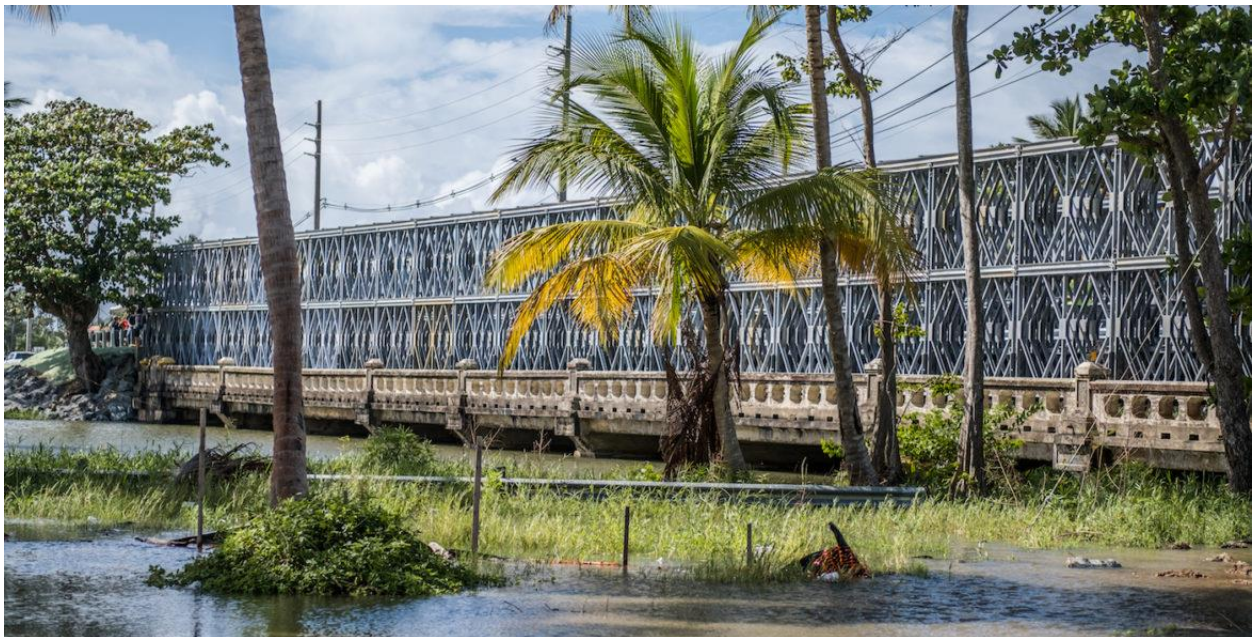
Figure 5-2: New steel bridge over Bridge 122 (source: Centro de Periodismo Investigativo)

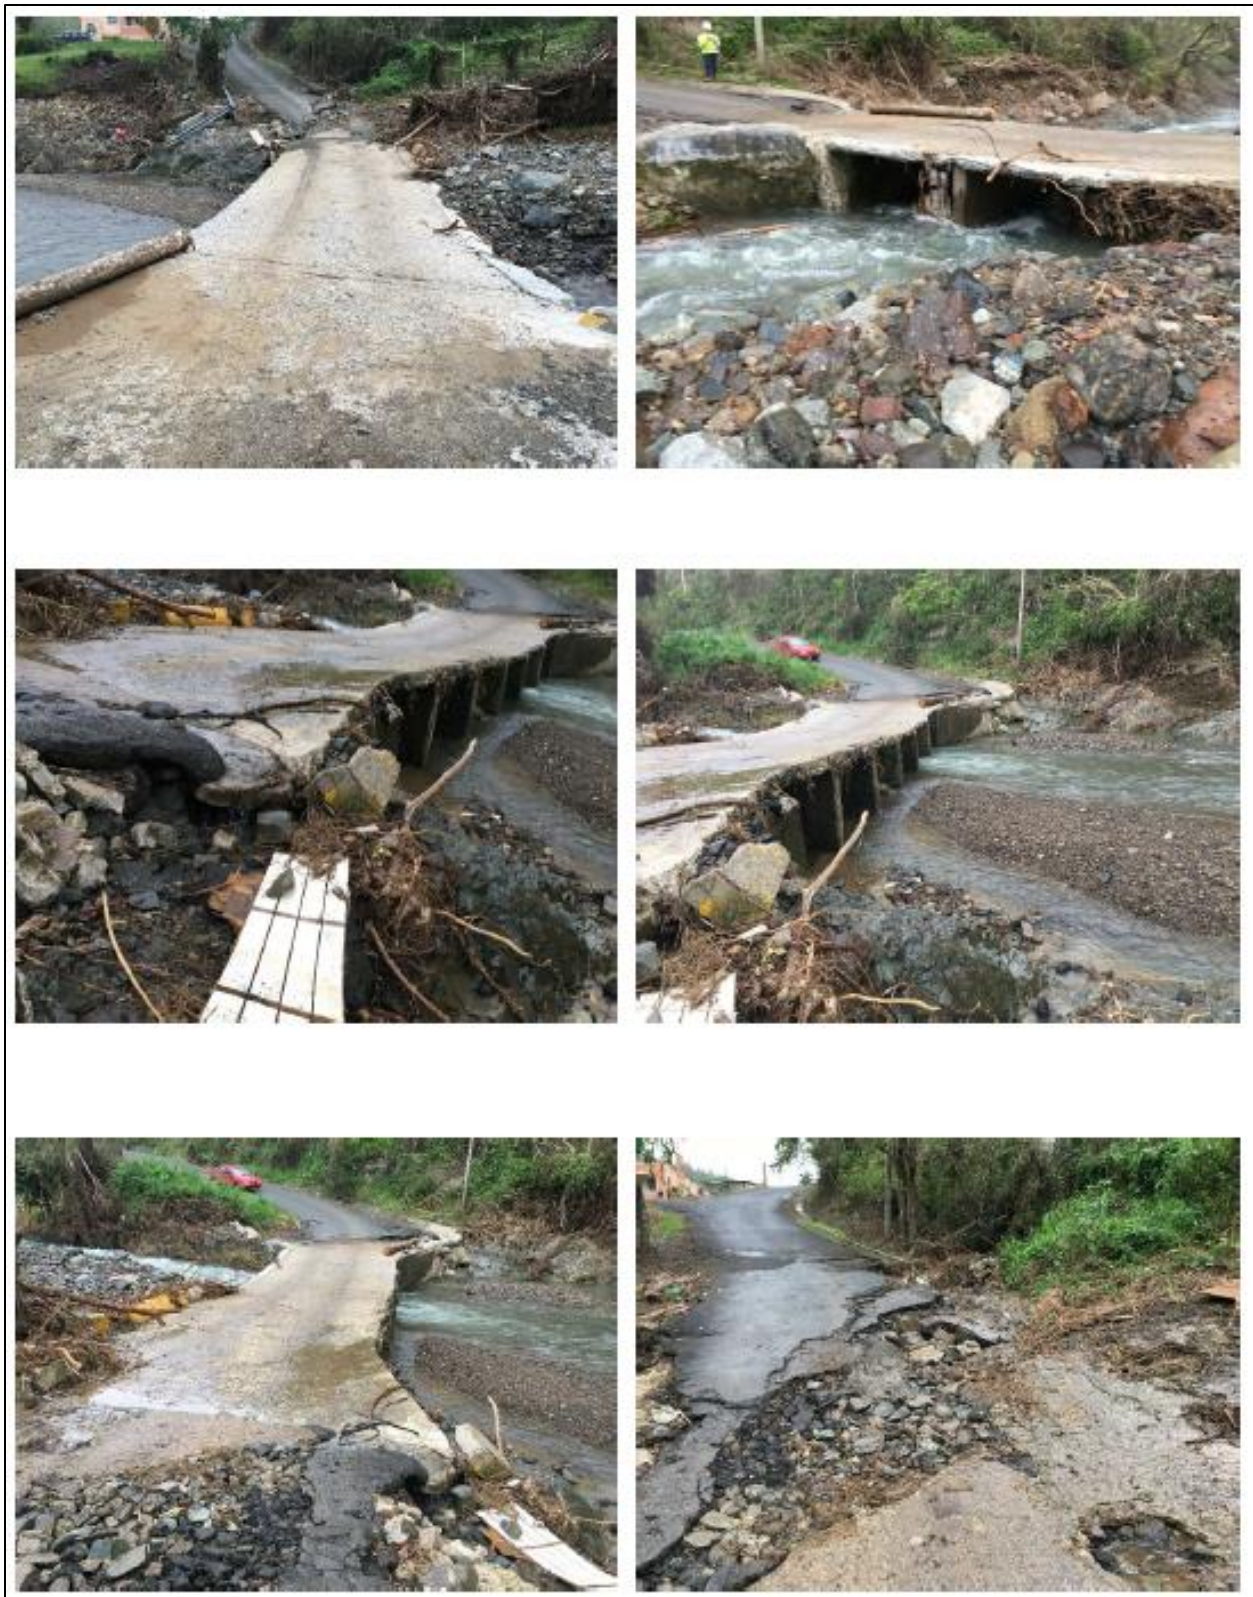
- Bridge 2681 was a concrete structure constructed in 1951. The images of the inspection report conducted after the hurricane show that the bridge did not collapse, but that one of its approaches was damaged, as shown in Figure 5-6. The inspection report indicates that the bridge had lost some segments of its parapets and indicated a scouring critical rating of 3. The bridge was partially demolished and replaced with a temporary modular steel bridge (Primera Hora, 2018), as shown in Figure 5-7.

Figure 5-6: Bridge 2681 photos from October 5, 2017 inspection (source: PRHTA)

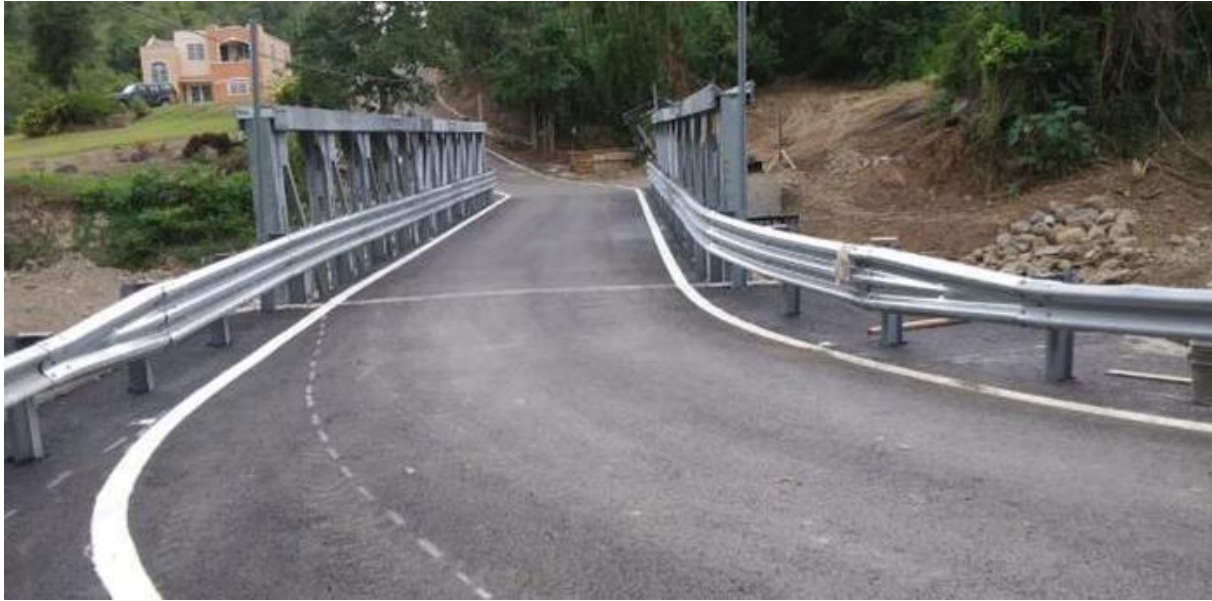
Figure 5-7: Bridge 2681 replacement (source: Primera Hora)

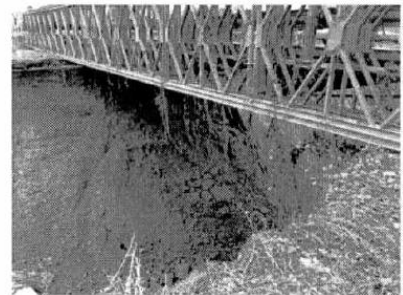
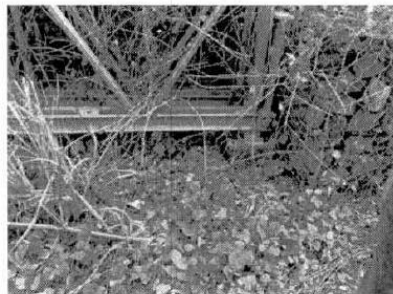
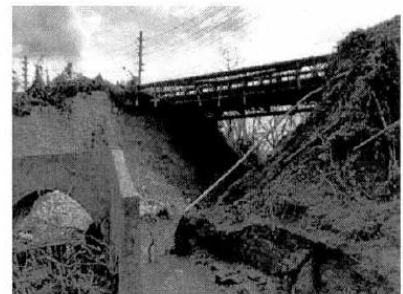
Figure 5-8: Bridge 3048 photos from September 29, 2017 inspection (source: PRHTA)

- Bridge 3048 was a steel modular bridge that was not in the PRHTA inventory at the time Hurricane Maria hit Puerto Rico. Figure 5-8 and Figure 5-9 show photos from an inspection conducted after Hurricane Maria. The inspection report indicates that the river impacted the embankment, which endangers the bridge stability. The temporary steel structure was removed and used to replace collapsed Bridge 1733, which was further down the roadway (Rodríguez, 2018). A new temporary modular steel bridge was constructed at Bridges 3048's location, as shown in Figure 5-10.

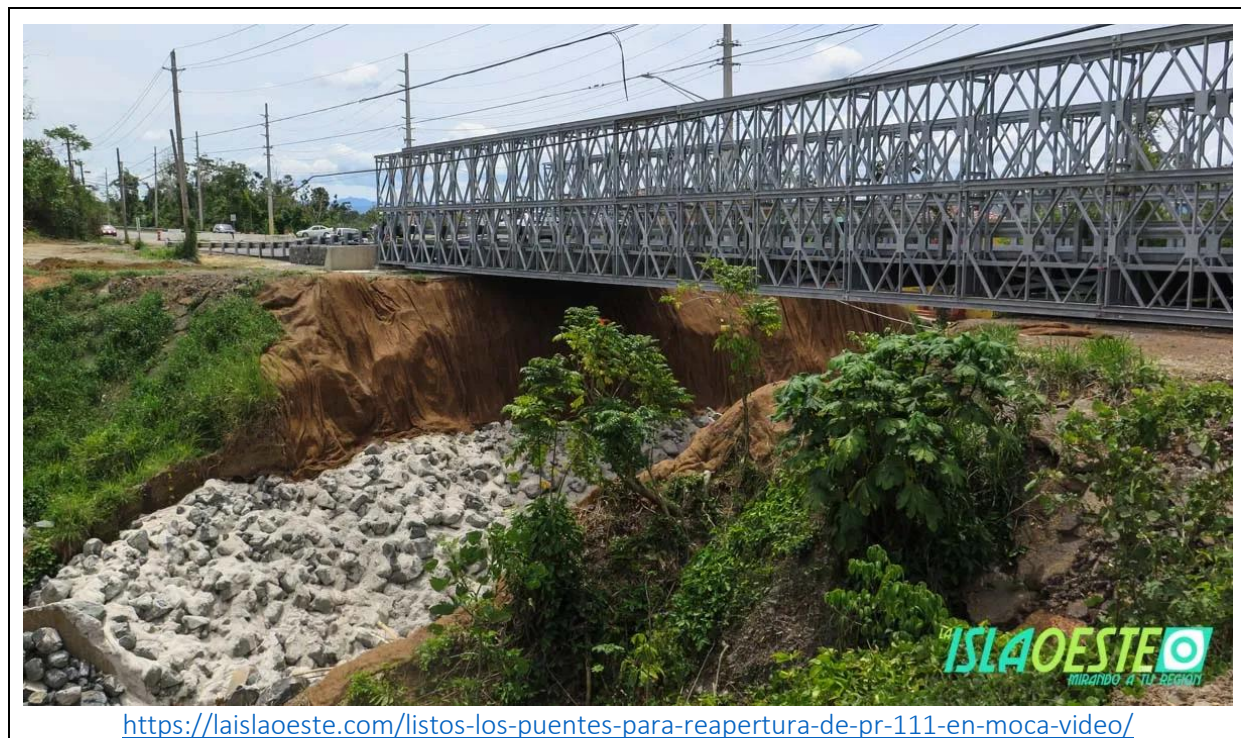
Figure 5-10: Bridge 3048 replacement (source: La Isla Oeste)

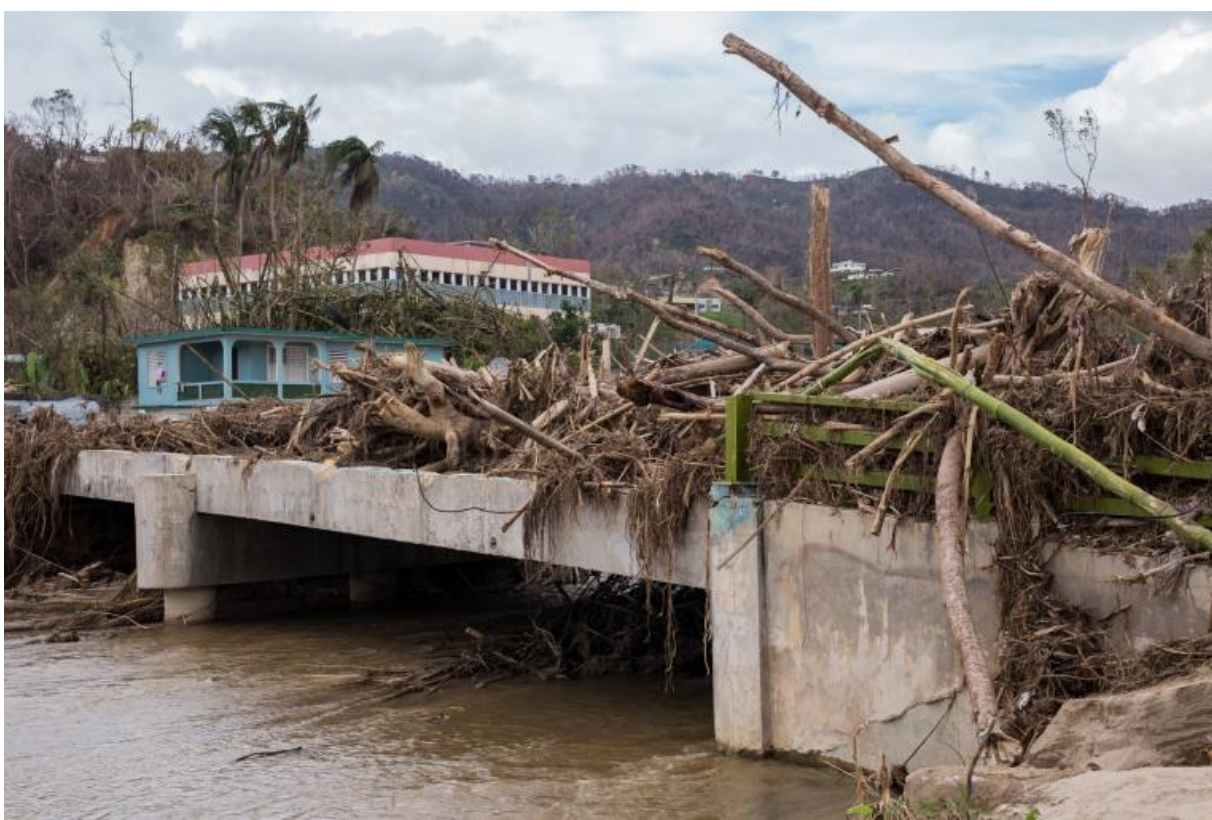
During the examination of photographs done for this research it was observed that many bridges had debris accumulation in their upstream side after Hurricane Maria. This was a very common occurrence in both damaged and undamaged bridge. The main components of the debris appear to be vegetative material and soil. An example of a mostly undamaged bridge with debris accumulation is shown in Figure 5-13. Is possible that debris accumulation led to the collapse of several bridges as well as the collapse of approach roadways.

Figure 5-13: Debris accumulation in a bridge in Utuado (source: NBC News)
